2019 ANNUAL QUARTZ MINING LICENCE REPORT

Yukon Quartz Mining Licence QML-0007

March 2020

Carmacks Copper Project, Yukon Territory

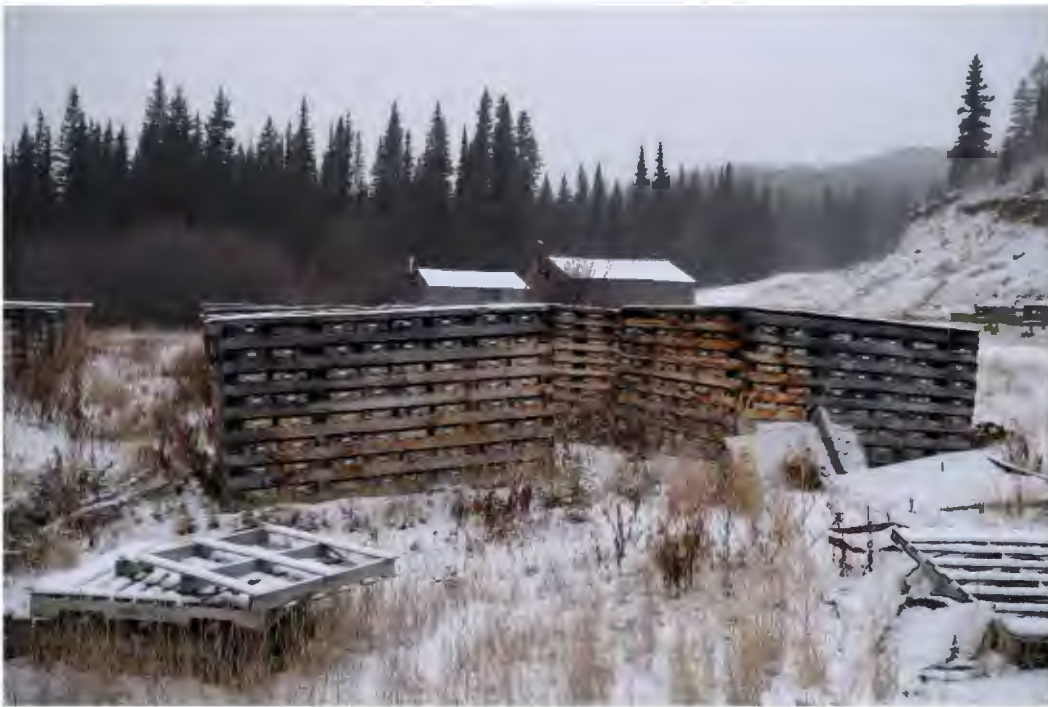
Photograph 1: Core Storage Racks

There are two heated buildings, the core shack and geology office, located adjacent to the core storage racks (Photograph 1). The tanks, valves and hosing were in a satisfactory condition, at the time of inspection. Liners have been placed beneath each tank to act as secondary containment for potential leaks and were also in a satisfactory condition.

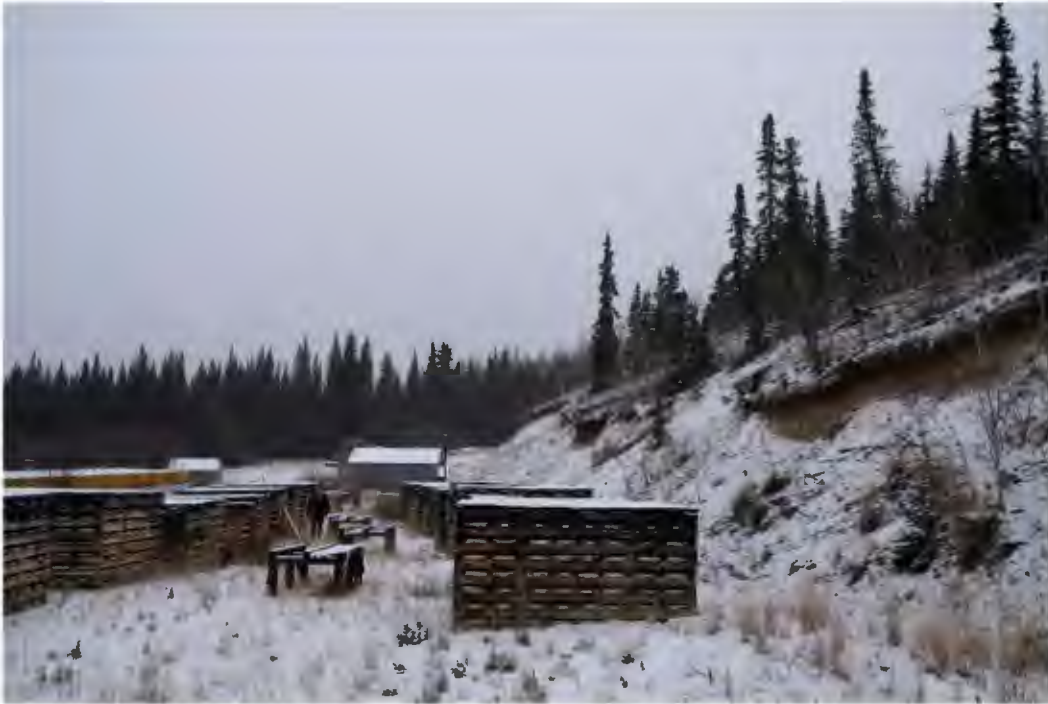
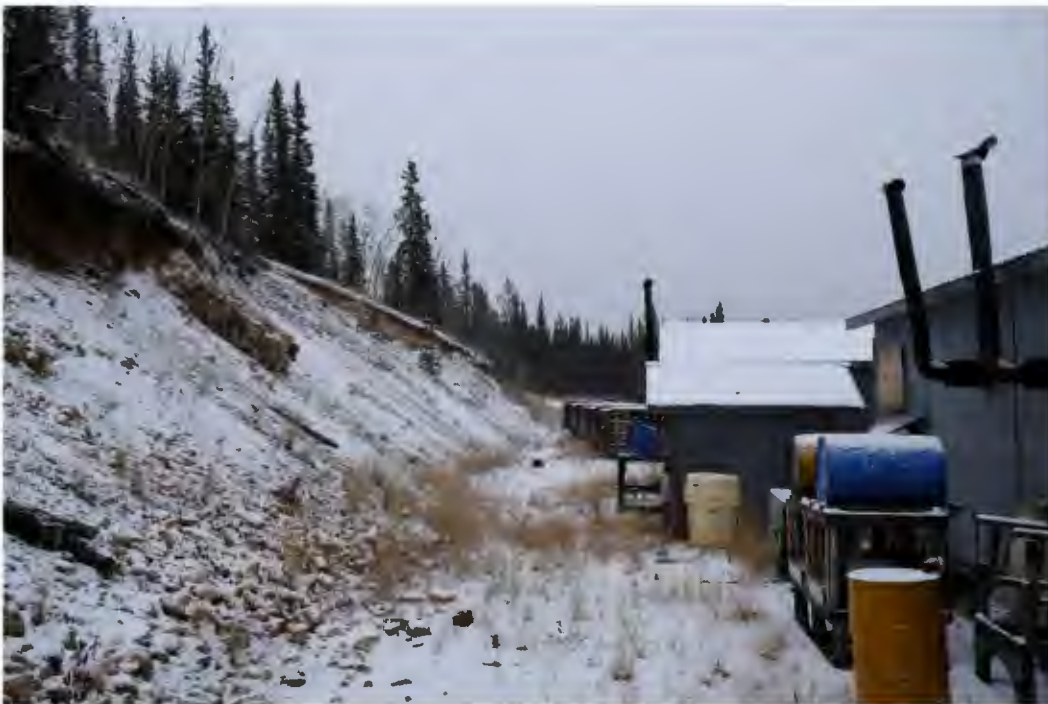
The slope behind the camp (Photographs 3 and 4) is stable and does not pose a safety concern for the camp structures or current operations. There is minor raveling of small sections of the slope, but these are not impacting camp safety nor would they represent a risk for workers on the project. Some regrowth of vegetation was observed in the camp area.

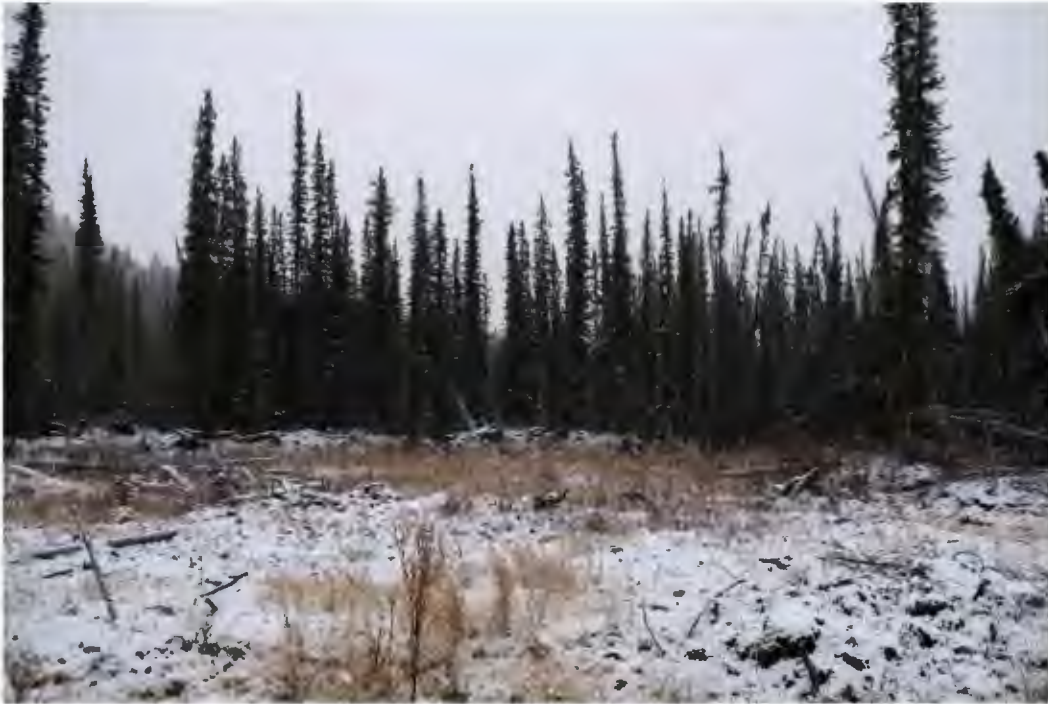
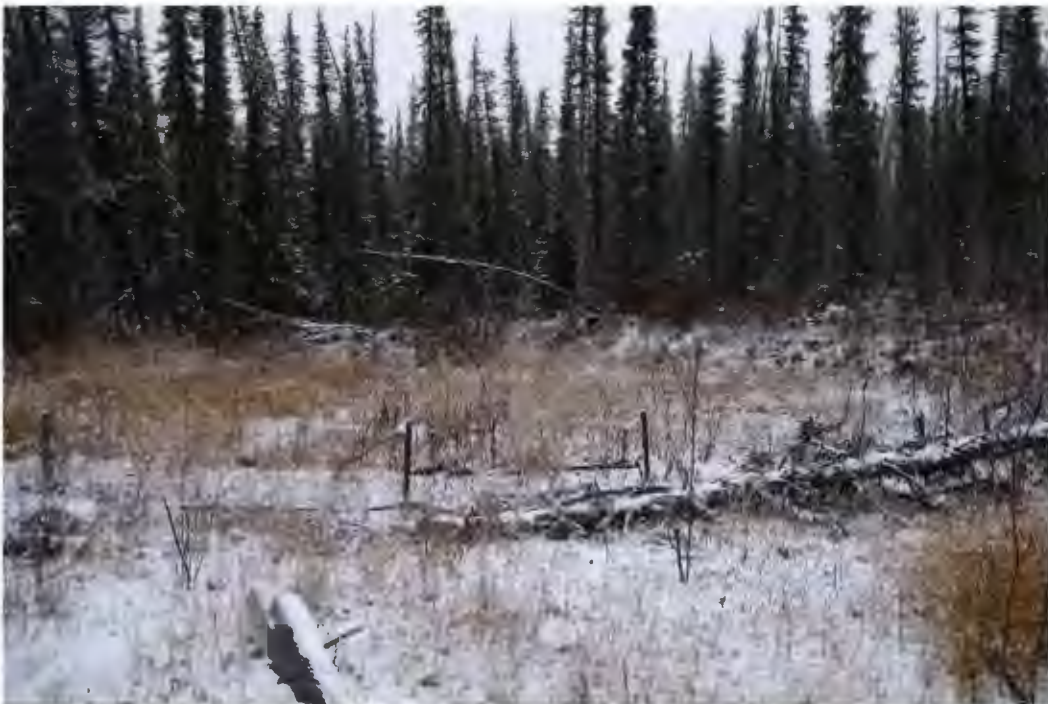
Further downstream, within the floodplain of Williams Creek, silt fences have been installed and the area seeded where sediment from previous site erosion accumulated (Photographs 7 and 8). Grass seed was applied in 2009 to promote the re-establishment of vegetation and to further stabilize sediment. The approach was noted to be generally effective in 2011 and 2012, but with limited regrowth attributed to periodic pooling of water. The area was also re-vegetated with woody plants (willow cuttings), and these plants are now well established. Volunteer species of grass and woody plants are performing very well. There was no evidence of sediment movement, indicating that re-vegetation has been effective in minimizing erosion. Silt fencing surrounding these areas is now overgrown and there is no evidence of sediment movement through the area. Silt fences are typically a temporary measure and could be removed if no further disturbance is expected upgradient.

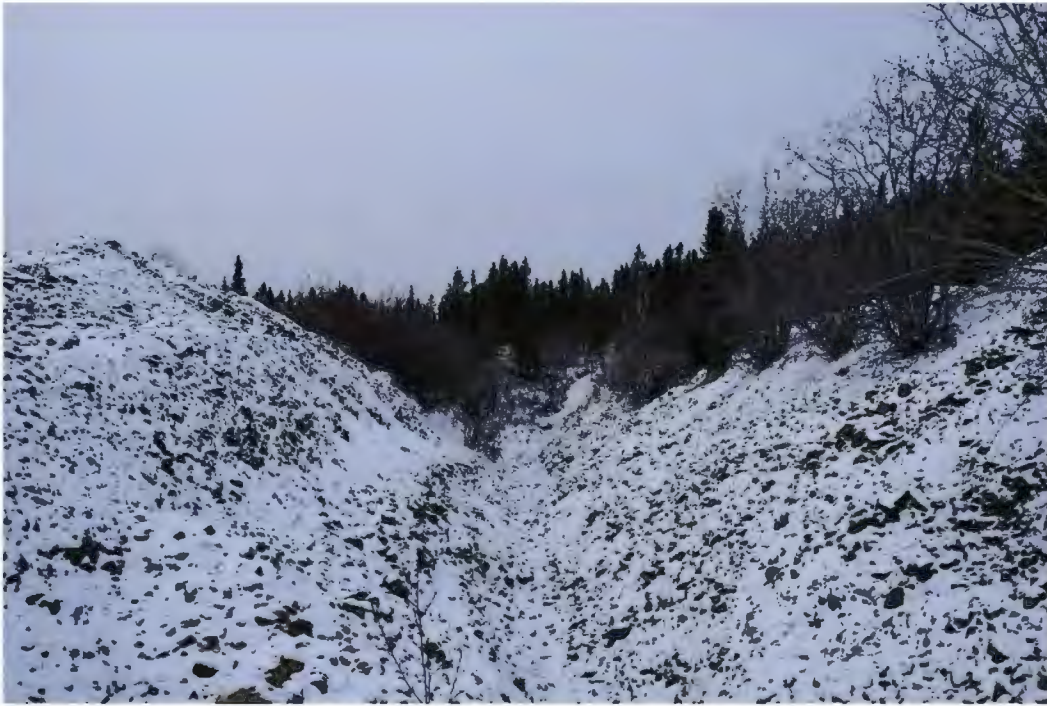
Photograph 9: Exploration Trench at the Discovery Outcrop

The area proposed for the open pit mine was inspected. The slopes of the trenches excavated as part of the effort to obtain bulk samples during exploration activities were observed to be in satisfactory condition (Photograph 9). There was no observed slumping or failures of the trenches and the slopes facilitate egress for wildlife. Several of the closed drill pads were inspected and there did not appear to be any erosion noted from these areas that would require attention.

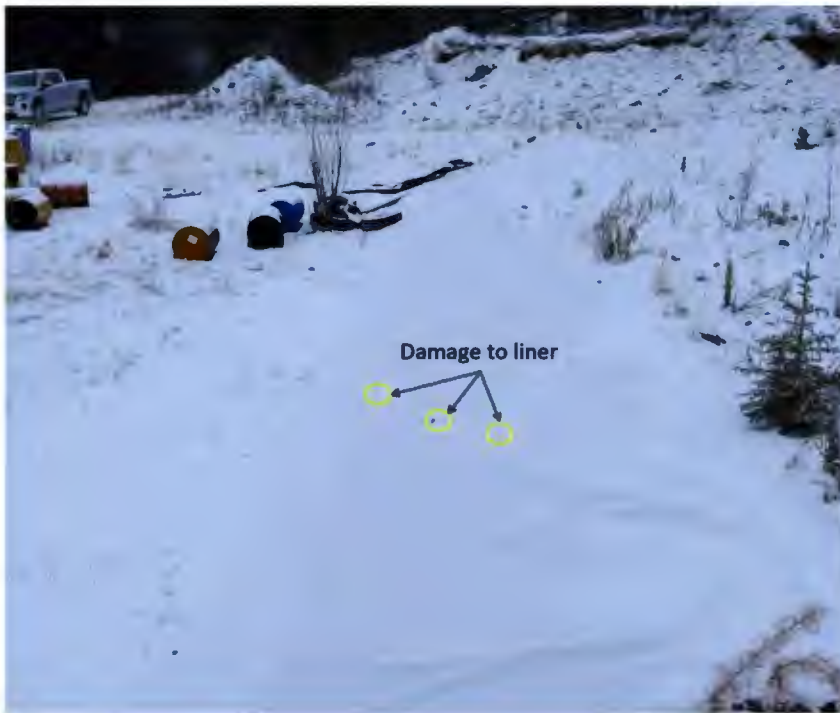
Photograph 11: Liner Damage at Fuel Storage Area

In the 2017 inspection, it was noted that an animal damaged the liner in a few locations (Photograph 11). The damage is still visible and repairs have yet to be completed. The fuel drums have since been organized in a manner to allow wildlife egress from the basin. There is some vegetation growth along the top of the containment berms and within the lined basin. There is one small shrub that is growing on the soil within the bermed area. There is the potential that the roots of the shrub penetrate through the liner. At the time when repairs to the liner are made, the shrub should be removed, the area inspected and repaired, if required.

- The beaver dam located downstream of the Merrice Creek crossing should be dismantled.
- Water crossings, including the bridge abutments at Merrice Creek, should continue to be inspected annually and following major rainfall events. Maintenance should be carried out, as required to maintain the functionality and safety of these crossings.
- The damage to the liner at the fuel storage area should be repaired.

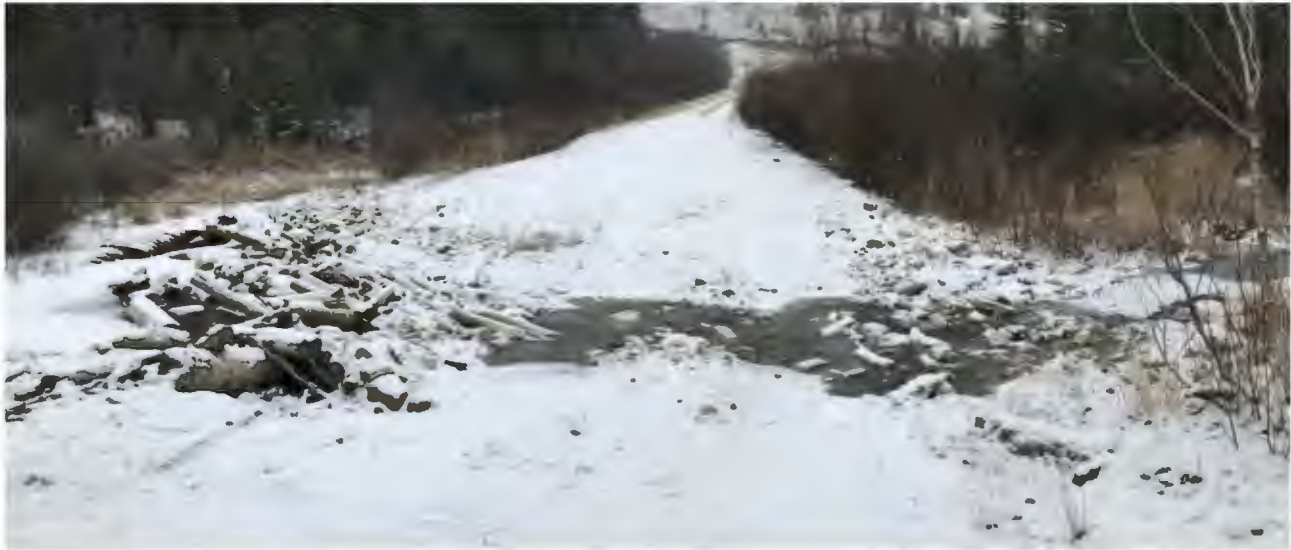
Photograph 15: Williams Creek Ford Crossing

The ford road crossing installed at Williams Creek in 2013 continues to function as intended (Photograph 15). The rockfill in the ford is well-graded and there is no indication of movement of finer materials. Pondered water was observed on the upstream side of the road, with flow across the road. It is possible that a large rainfall event could result in erosion. We therefore recommended that the ford continue to be inspected annually and maintenance be carried out, if required. The ford is appropriate for the current status of the project. However, prior to site development, it is recommended that the crossing is upgraded.

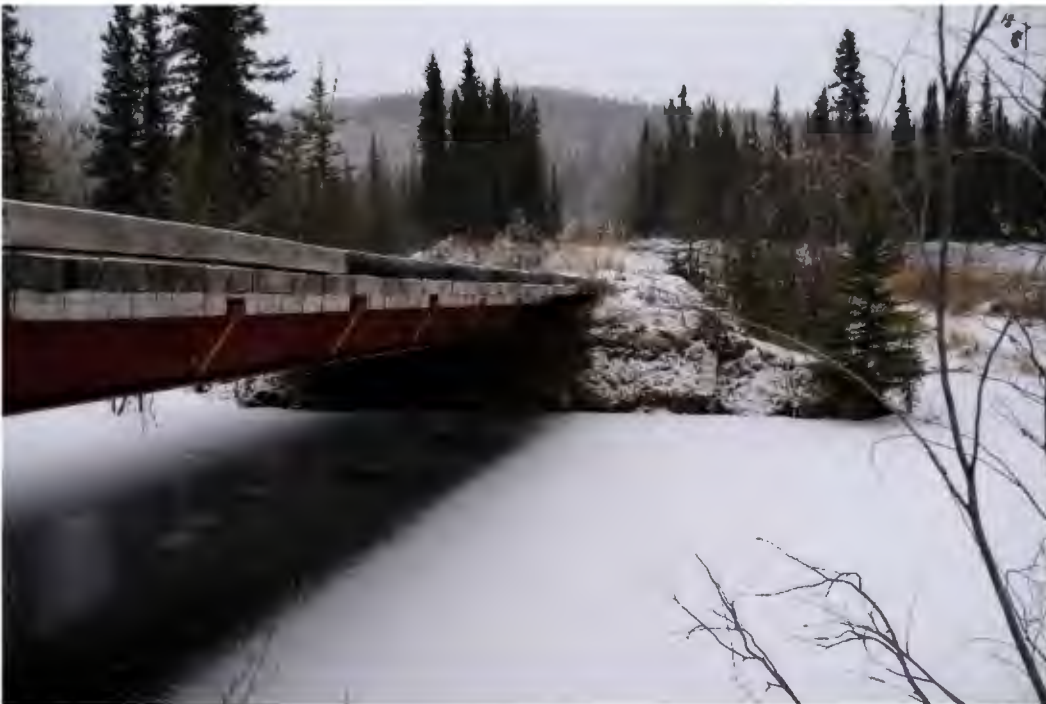
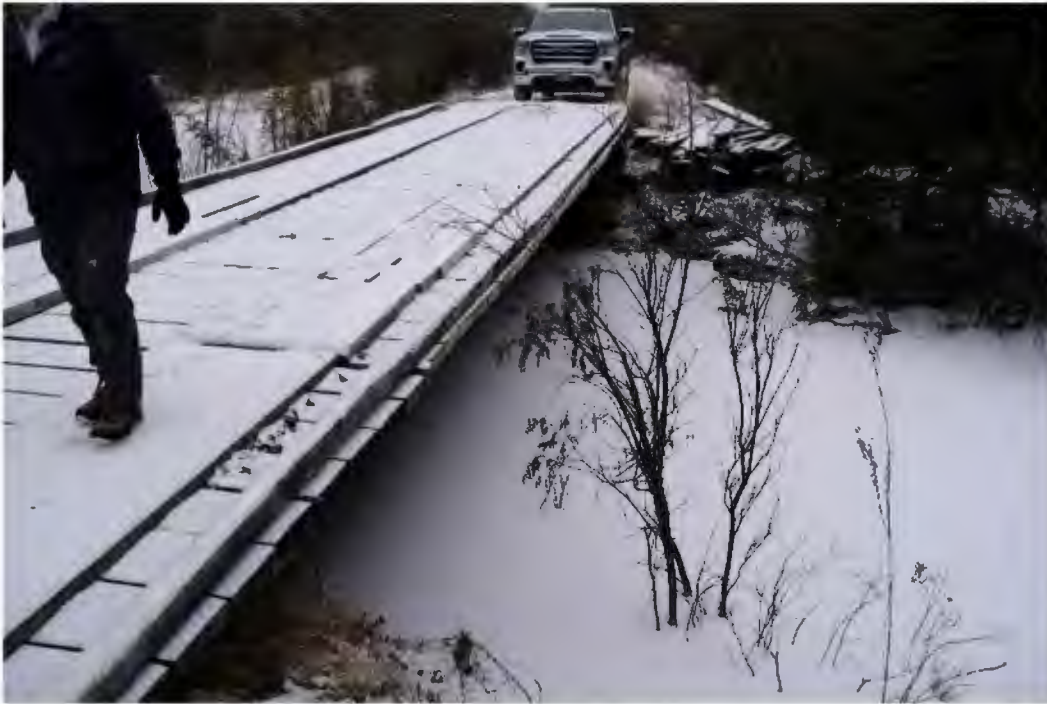
The access road crossing at Merrice Creek includes a single-span bridge (Photographs 16 and 17). Following recommendations in the July 2014 inspection memorandum, the bridge was extended by approximately 3 m and seated 1 to 2 m on the abutments. Approximately 3 m of steel was welded to the existing span, bridge decking was replaced and extended, and the approaches were re-graded to the bridge deck elevation.

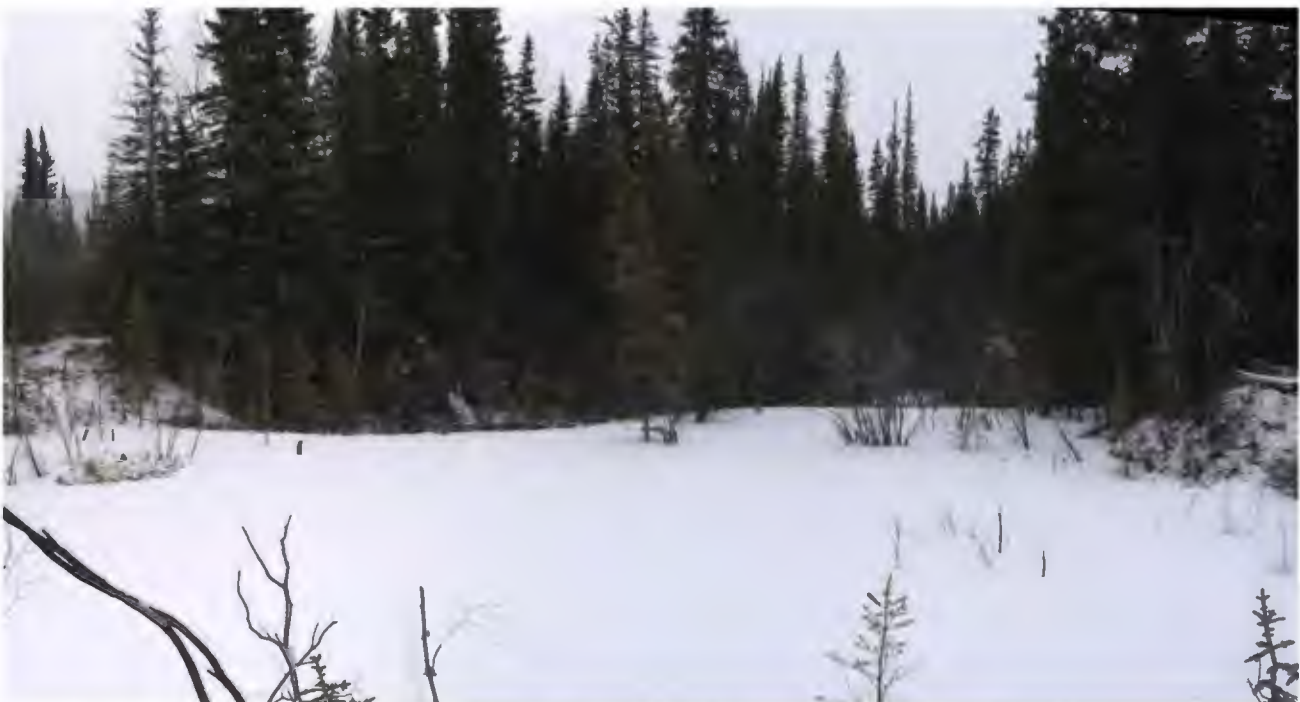
Photograph 18: Bridge Crossing at Merrice Creek – Downstream Beaver Dam

At the time of the inspection there was a large beaver dam downstream of the bridge which had caused higher than normal water levels in Merrice Creek, for the time of year (Photograph 18). The bridge was observed to be in a satisfactory condition and is securely anchored at each of the abutments. The right (or southern) abutment is steep sided and there is evidence that erosion may be continuing to occur at this location under high-flow conditions. The bridge should be monitored annually and following large rainfall events. In the event that erosion begins to compromise the stability of the abutment, consideration should be given to the installation of erosion protection at this location.
