Environmental Assessment, Casino Mine/Camp, Yukon Region – Final Report

(Call Up No. 98-6195-04)

MDA Consulting Limited

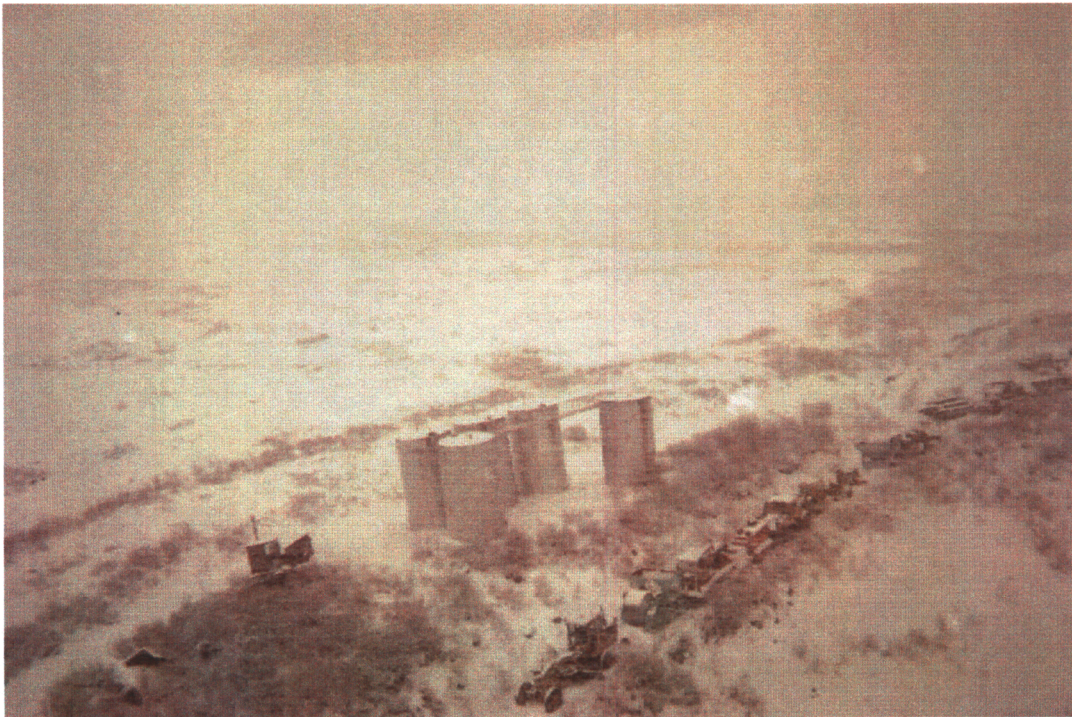
Photograph 1: Aerial overview of the tank farm and equipment storage area of the placer mining site on the headwaters of Canadian Creek at Casino mine/camp site. The quality of the photograph is limited by the heavy snow falling at the time of the visit.

A third, small frame building is located in the vicinity of the tank farm (see Photograph 1). This building, in a poor state of repair, appears to have been used for refueling or possibly for storage of flammable material.

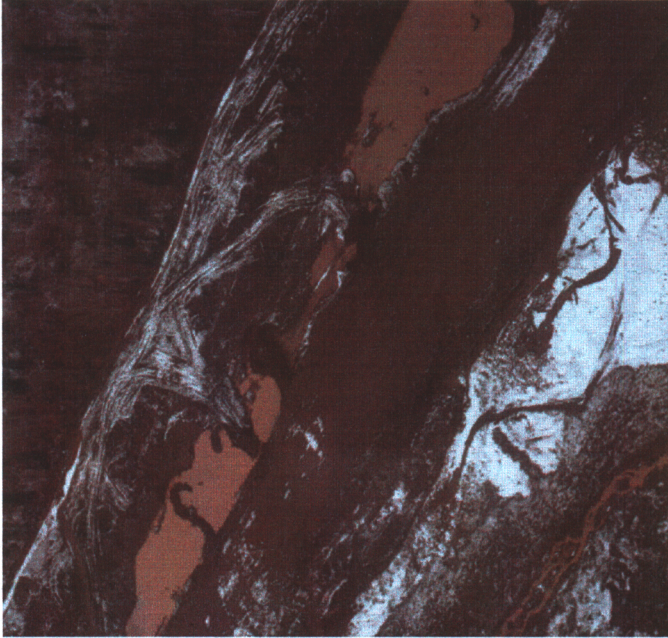
Upstream of the confluence of the Canadian and Britannia Creeks we observed an active placer mining operation extending for several kilometres along Canadian Creek (see Photograph 2). The creek through and below this site was heavily affected at least by suspended solids and thus it was meaningless to collect a water sample on Canadian and Britannia Creeks above their confluence. Helicopter landing locations were also limited at this location. These samples had been planned in order to compare current water quality with historic measurements taken when the mine was active.

Photograph 2: Aerial view of active placer mining operation on Canadian Creek, downstream of Casino site and above confluence with Britannia Creek

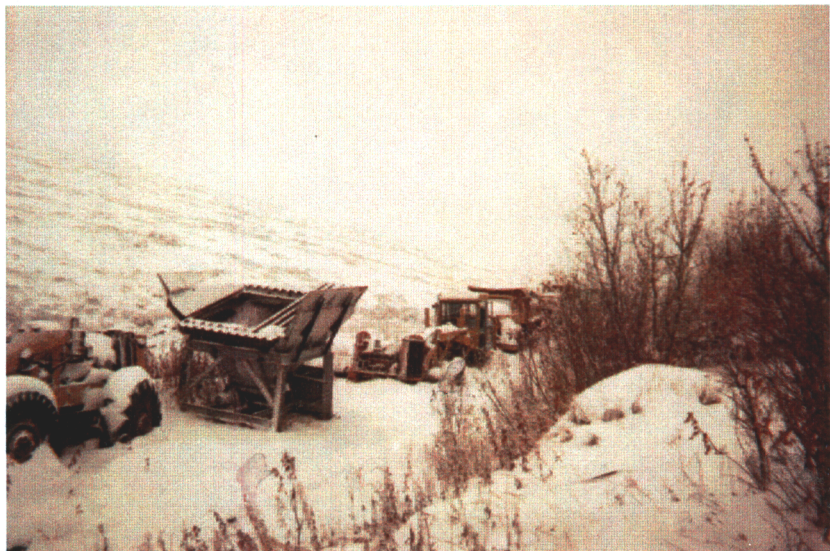
Photograph 3: View of tank farm area and construction equipment stored on roadway in front of the tanks

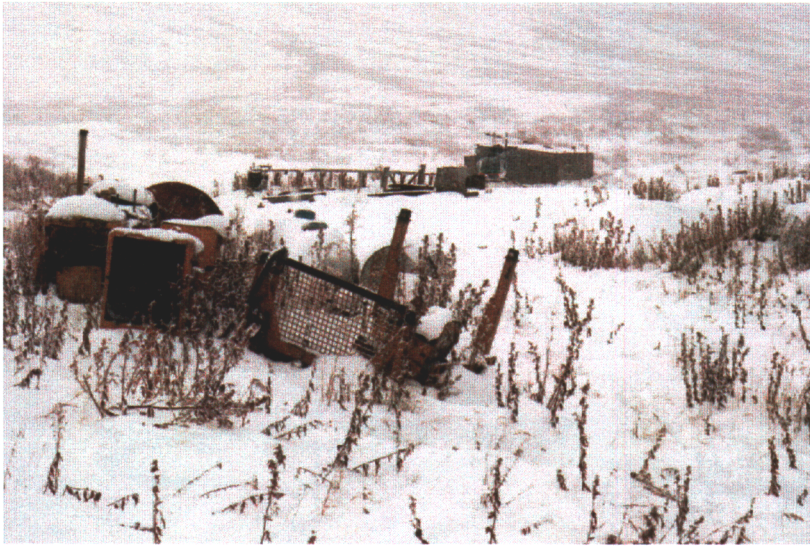
Photograph 4: View toward maintenance shed with disassembled dozers in foreground and conveyor in the middle ground

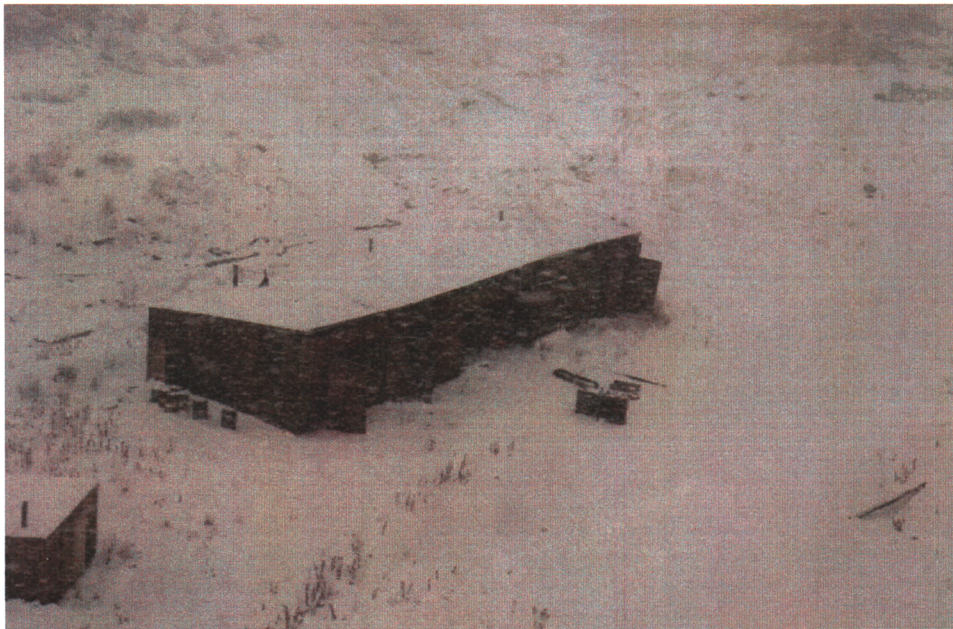
Photograph 5: Frame maintenance shed with drums and transformers located at the "near" end of this shed and small cabin (to the left)

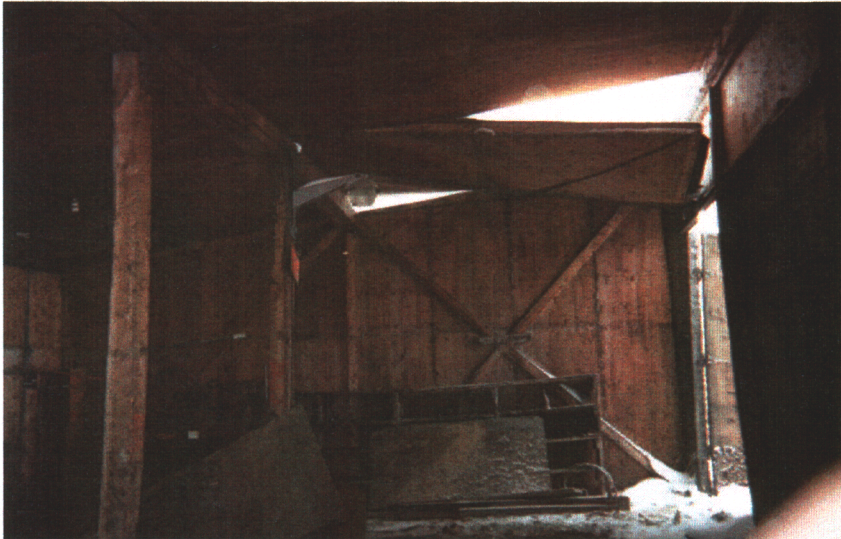
maintenance shed is starting to deteriorate and a section of the roof (see Photograph 6) is precariously perched and could be in danger of collapse as the weight of snow increases. The smaller building (to the left) is a cabin, which appears to be used periodically by transient personnel. The latter building is old but still in reasonably good condition, although the interior is untidy.

Photograph 6: Section of roof on maintenance shed that is in danger of collapse as weight of snow increases

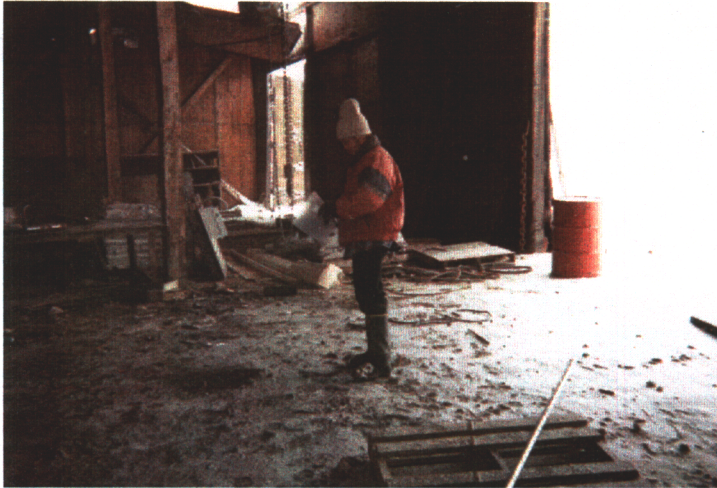
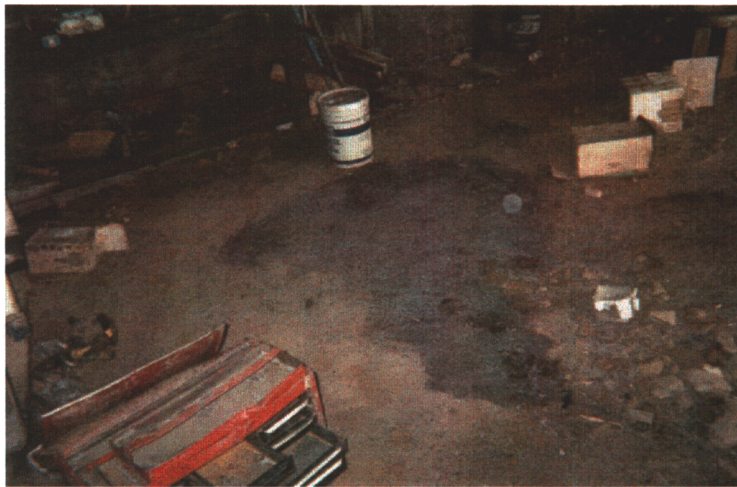
Without digging through the snow at the site of all areas with the potential to have or have had oil leaks, it was impossible to identify all potential stained soil areas. There is potential for hydrocarbon contamination around the maintenance shed, the tank farm, the equipment storage areas and several other areas where tanks and drums occur. At the tank farm, snow was moved at random locations to check the ground, but no staining was observed. Thus the only soil samples collected were from the packed earth floor of the maintenance/generator shed. Sample 1 was from one of the drive bays (Photographs 7a and 7b) and sample 2 was from the generator part of the building (Photograph 8).

*Photograph 7a,b: Stained soil in
service bay of maintenance building
(location of Site 1 sample)*

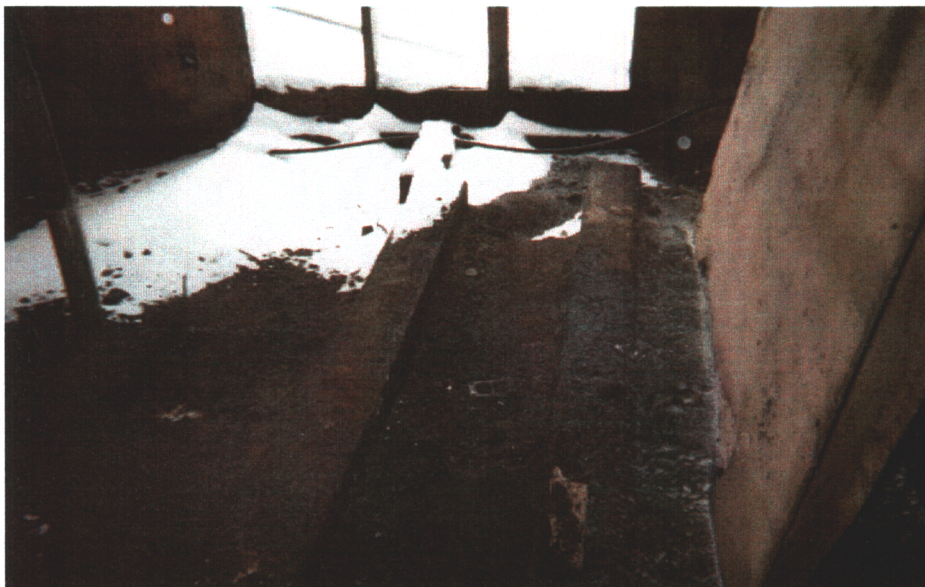
*Photograph 8:
Stained soil on
floor of generator
part of
maintenance shed
(Site 2 sample)*

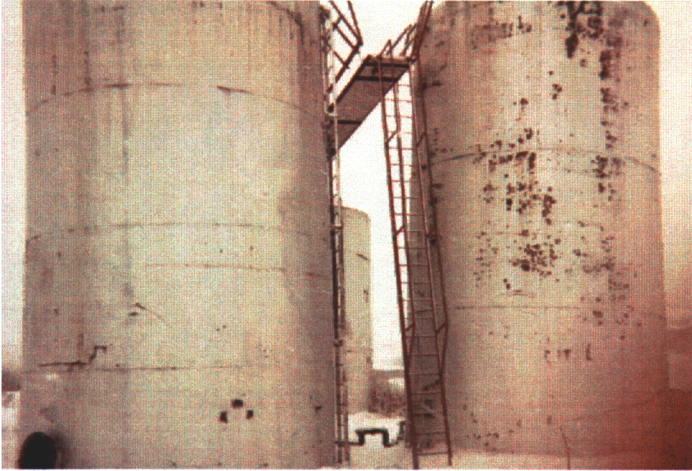
Photograph 9: Three vertical storage tanks on tank farm showing open manhole cover.

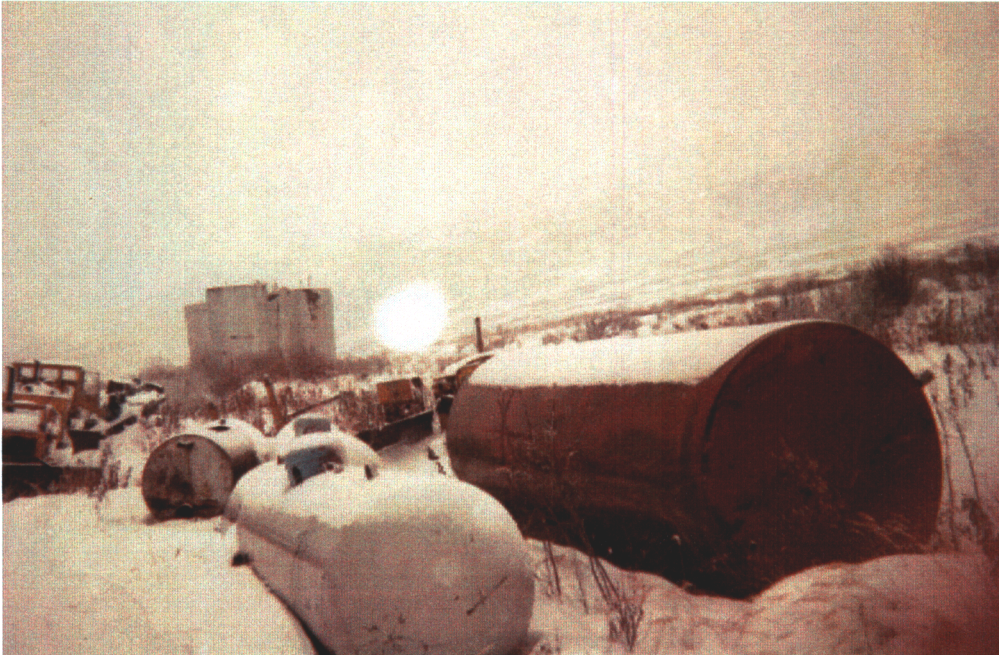
Photograph 10: Two smaller empty horizontal steel tanks and propane tank containing propane

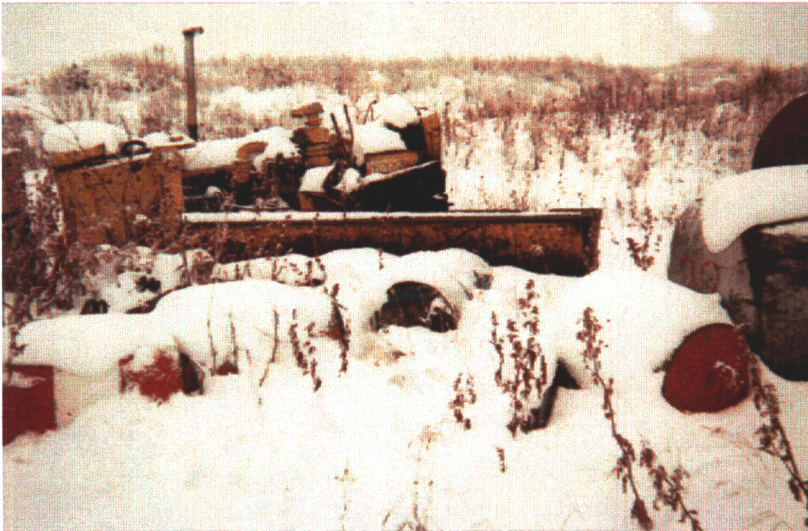
Photograph 11 shows four drums. These are located just behind the large, empty, horizontal fuel tanks shown in the previous photograph. Three of these drums were empty but one was unlabelled but full of an unknown liquid. This drum was secure and apparently not leaking.

Photograph 11: Drums, all empty but one, located in same area as tanks

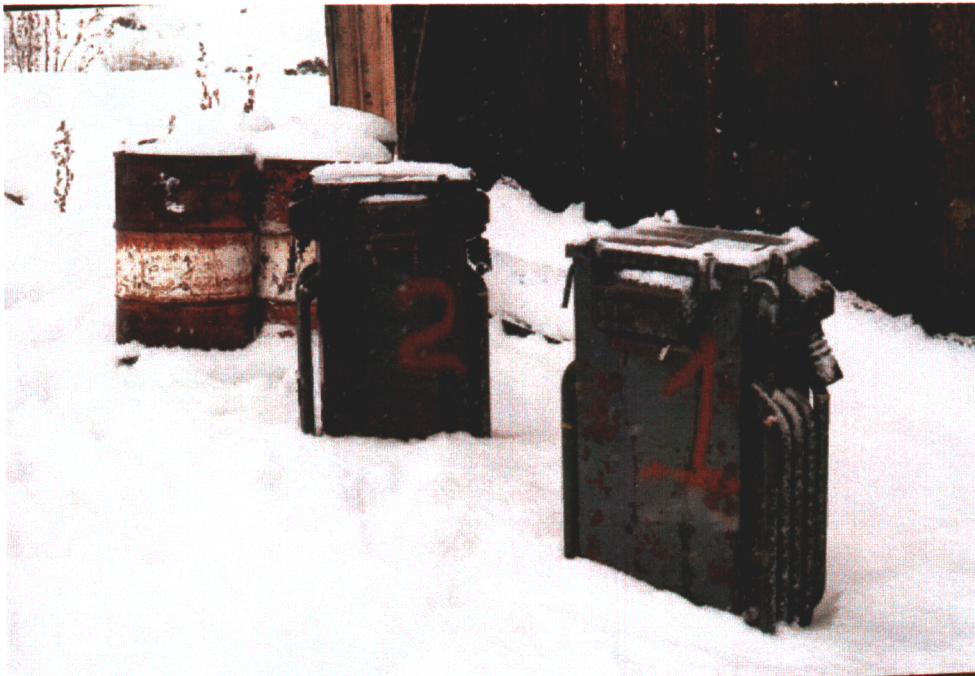
Photograph 12: Five drums located adjacent to generator section of maintenance shed – one contained gas, two contained waste oil and two were empty plus two transformers

A total of three (3) transformers were located at the site. Two, shown in Photograph 12, are sitting outside of the maintenance/generator shed. Both of these transformers were placarded as having less than 1 ppm of PCBs (see Photograph 18). The third was just inside of maintenance shed, near the generator part of the building (Photograph 19). This transformer had a patent date of 1905 and appeared to be a sealed, cast iron unit. It is likely that this transformer precedes the use of PCBs but this should be confirmed.

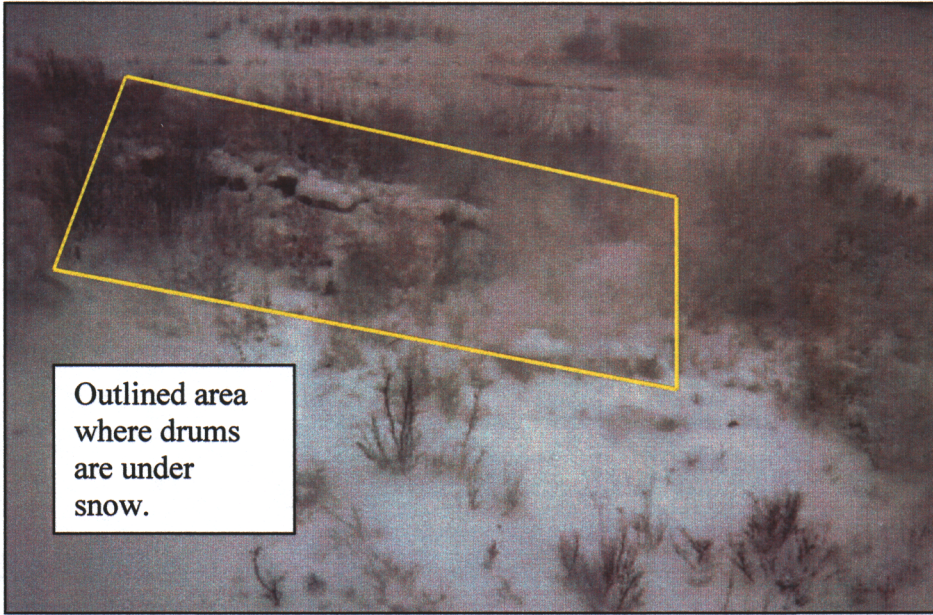
The general condition of the site would suggest that there was likely some quantity of debris at this location; however, much of it was hidden by the snow. Some of the obvious debris included steel decant pipes in the banks of settling ponds along the water course (Photograph 14), crushed drums, and buckets of soil samples on the opposite side of Canadian Creek to the maintenance shed (Photograph 13).

*Photograph 13:
Debris located
on the west side
of Canadian
Creek, across
from the
maintenance
shed*

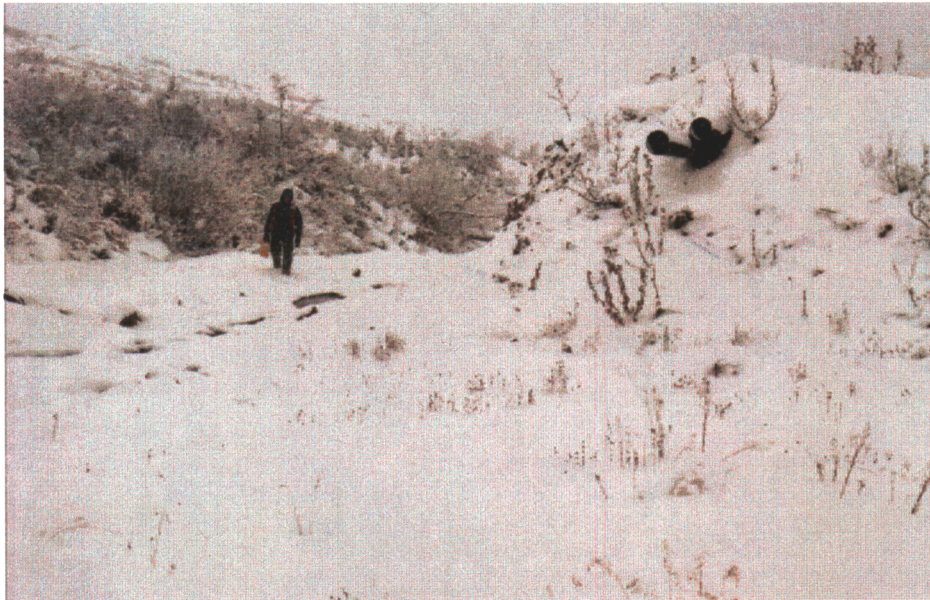
*Photograph 14:
Steel decant
pipes in
constructed
ponds along the
water course*

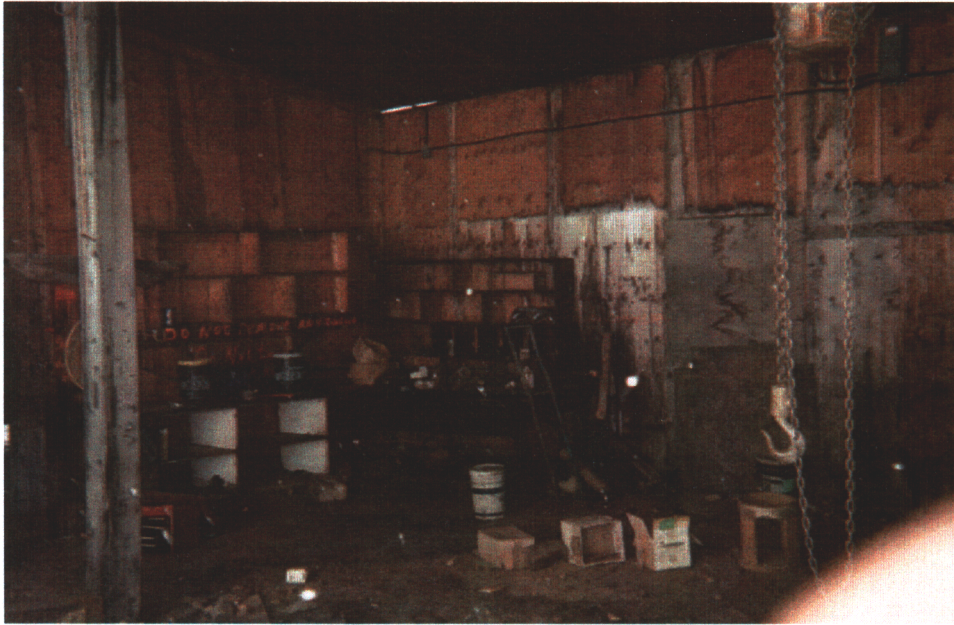
The maintenance shed also contained quantities of old parts, buckets partially full of lubricants and bags of silica sand (Photographs 15 and 16). Also found in the maintenance shed was a small quantity of asbestos brake linings (Photograph 17).

*Photograph 15:
Assorted debris
in the
maintenance
shed including
partially full
pails of
lubricants*

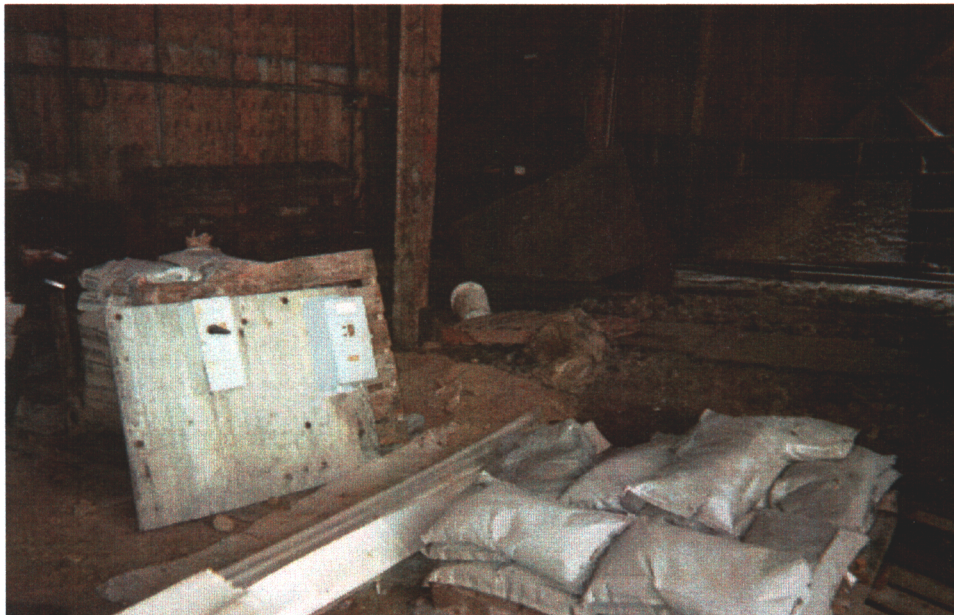
*Photograph 16:
Bags of silica
sand stored in
maintenance
building*

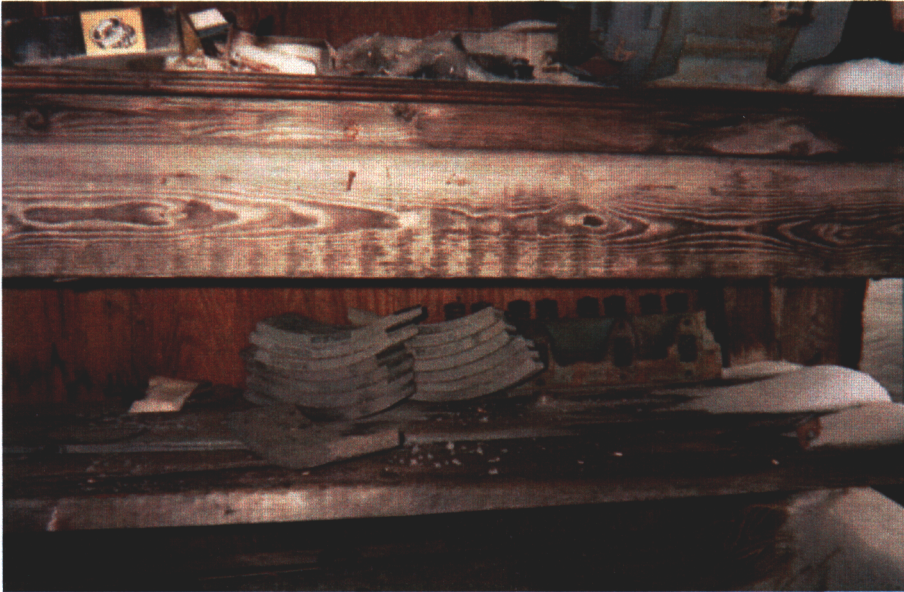
*Photograph 17:
Asbestos brake pads
stored in
maintenance
building.*

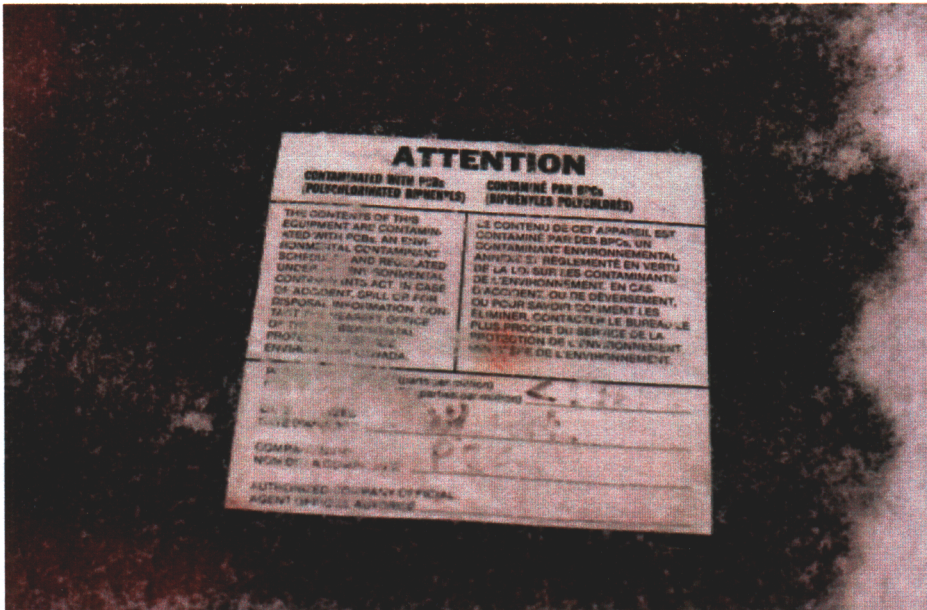
*Photograph 18:
Placard on two
transformers
stating that PCBs
have been tested
and are less than
1 ppm*

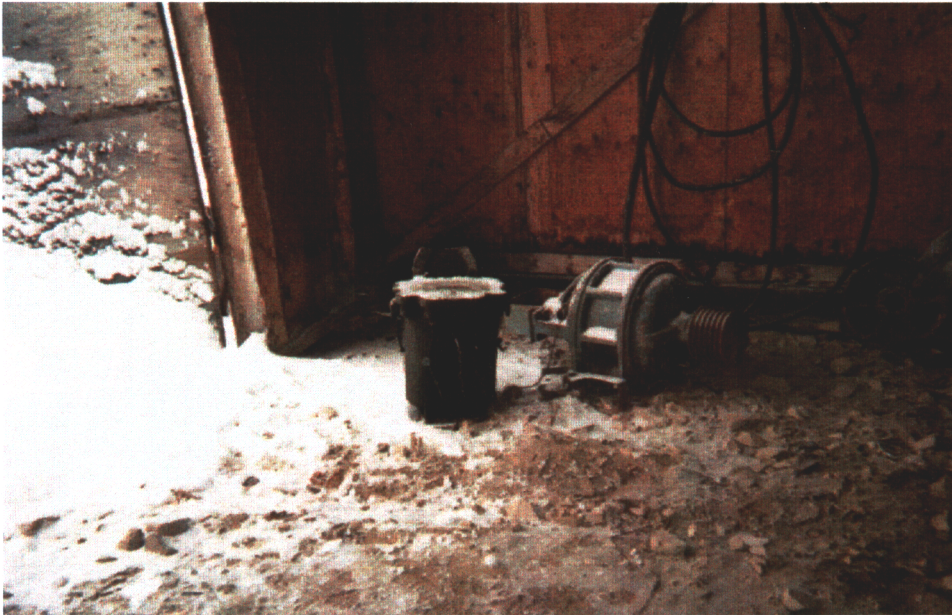
*Photograph 19:
Old cast iron
case
transformer
inside
maintenance
shed*

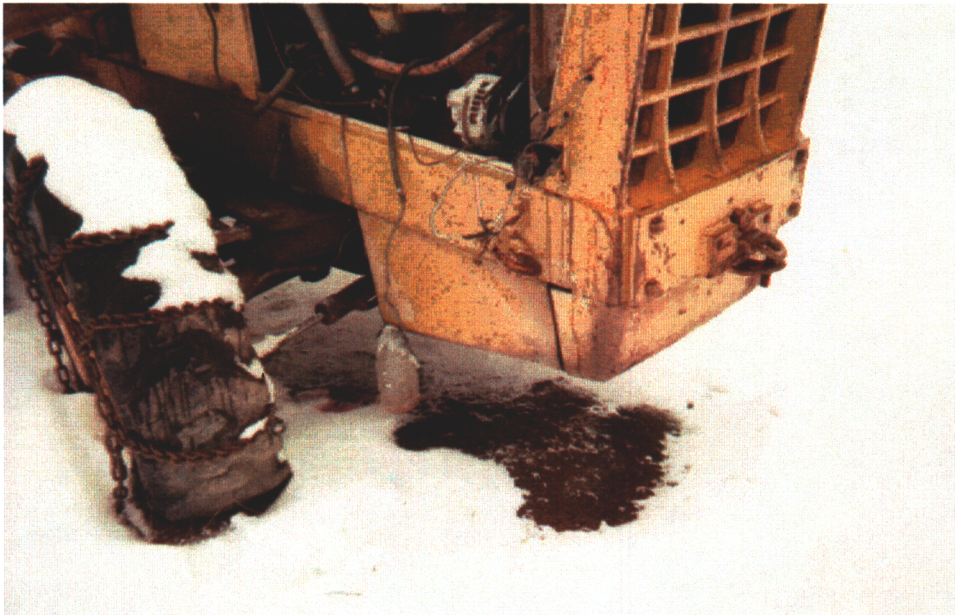
The only equipment at the airstrip at the Casino site was an older rubber tired loader shown in Photograph 20. This equipment is leaking oil and will be considered further in Section 4.4.3.

*Photograph 20:
Rubber tired
loader at
airstrip showing
oil stained soil*

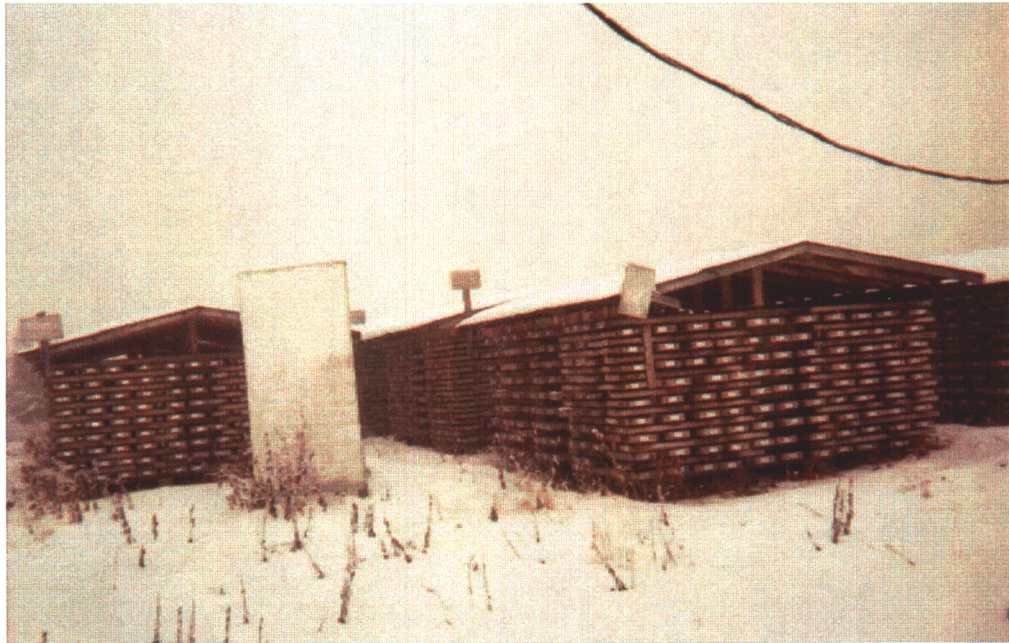
There were over 20 covered core storage structures located at the airstrip. These are well constructed and in good condition as illustrated in Photograph 21. Nearby is a wooden explosives/fuel storage shed with an attached wooden ramp (Photograph 22) and a second small fuel shed near an oval above ground storage tank (Photograph 23) that has partially collapsed. There were no explosives, lubricants or other hazardous items found in the shed.

*Photograph 21:
View of some of
the more than
20 core storage
sheds located at
the airstrip*

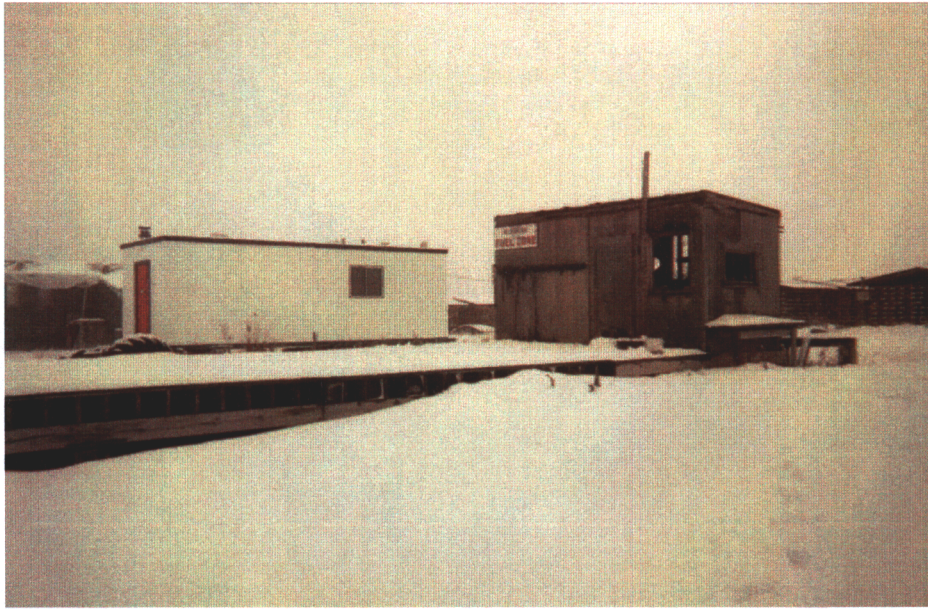
*Photograph 22:
View of
explosives/fuel
shed and attached
ramp with metal
clad laboratory
trailer in
background*

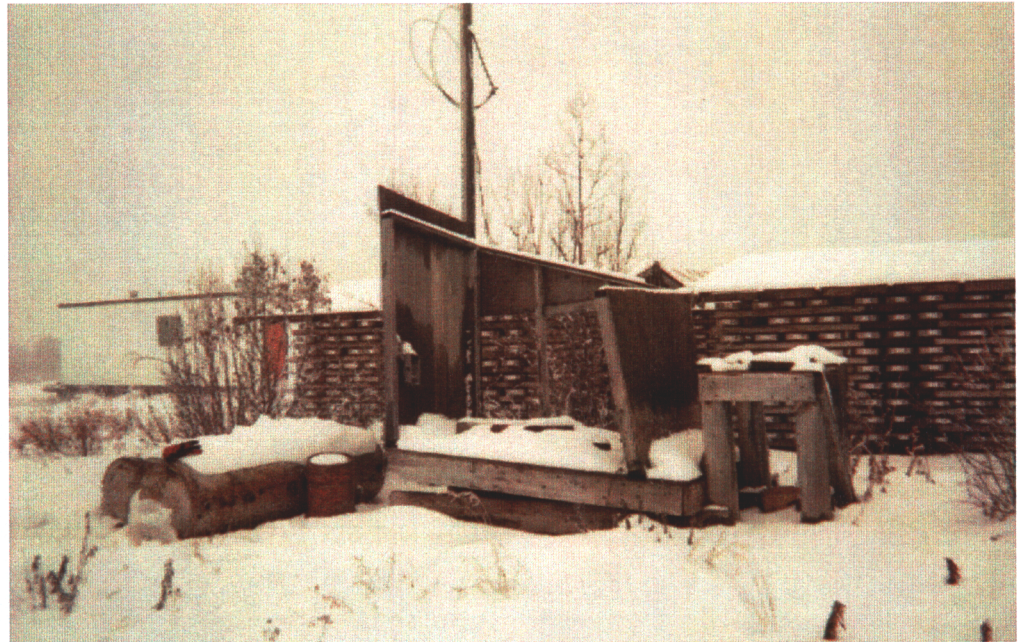
*Photograph 23:
Collapsed shed
presumably used
for refueling or
storage of related
products.*

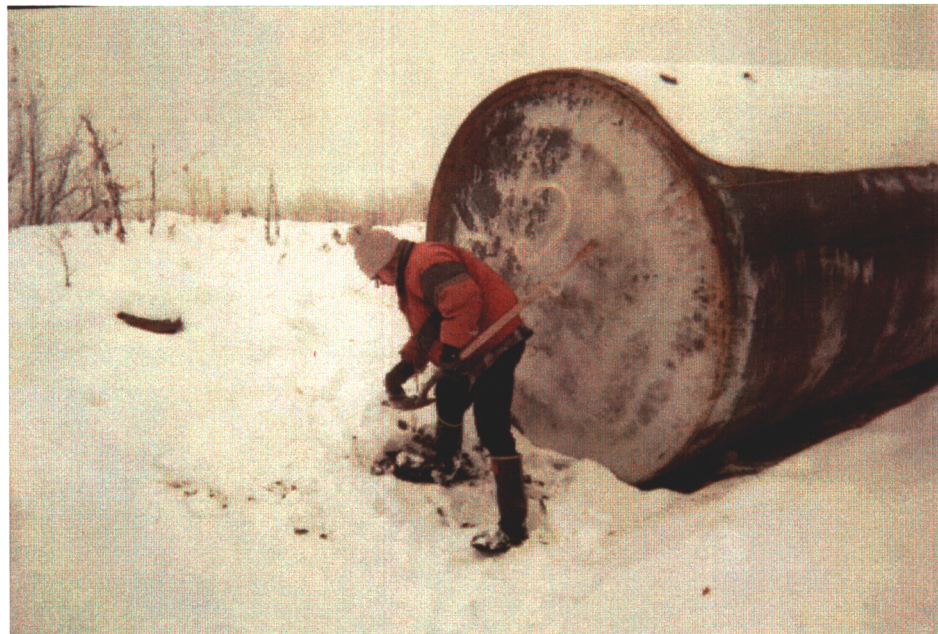
Soil in the vicinity of the Tanks 2 and 3 within the bermed fuel storage area were sampled for hydrocarbon contamination (Photographs 27 and 28). Soil in the vicinity of a third tank (referred to here as PSC and shown in Photograph 29) was also sampled. These sampling locations were chosen near the drains to the tanks; however, the snow cover precluded further definition of the area of the stained soil. The area of these stained soils could be extensive and other areas could exist which were not obvious at the time of the site visit. Areas for further investigation should include the refueling shed and the other storage tanks.

*Photograph 27:
Soil sampling at
fuel tank # 2
showing earthen
berm in
background*

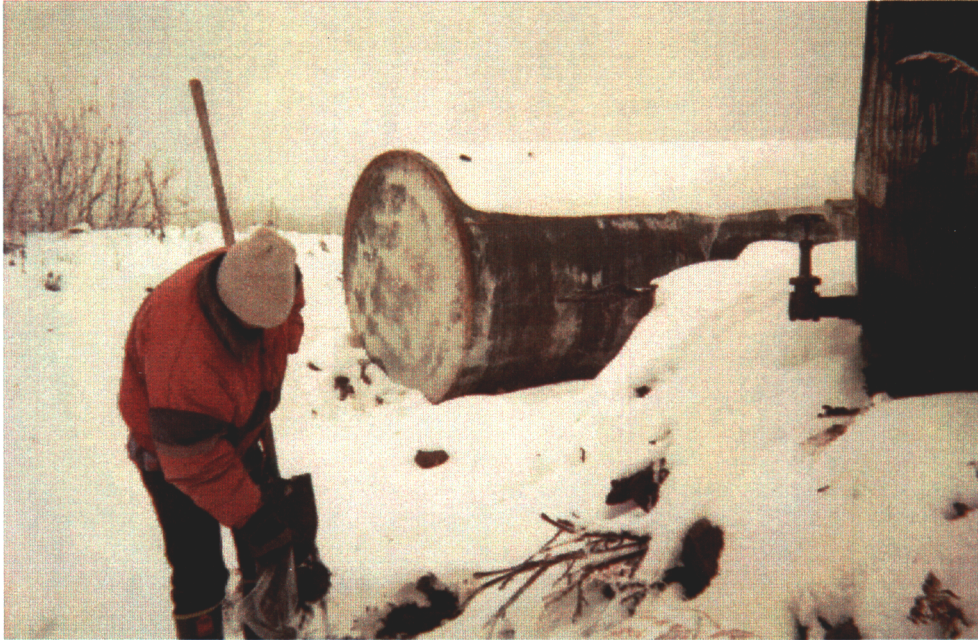
Photograph 28: Soil sampling at fuel tank # 1 showing berm and tank # 2 in background

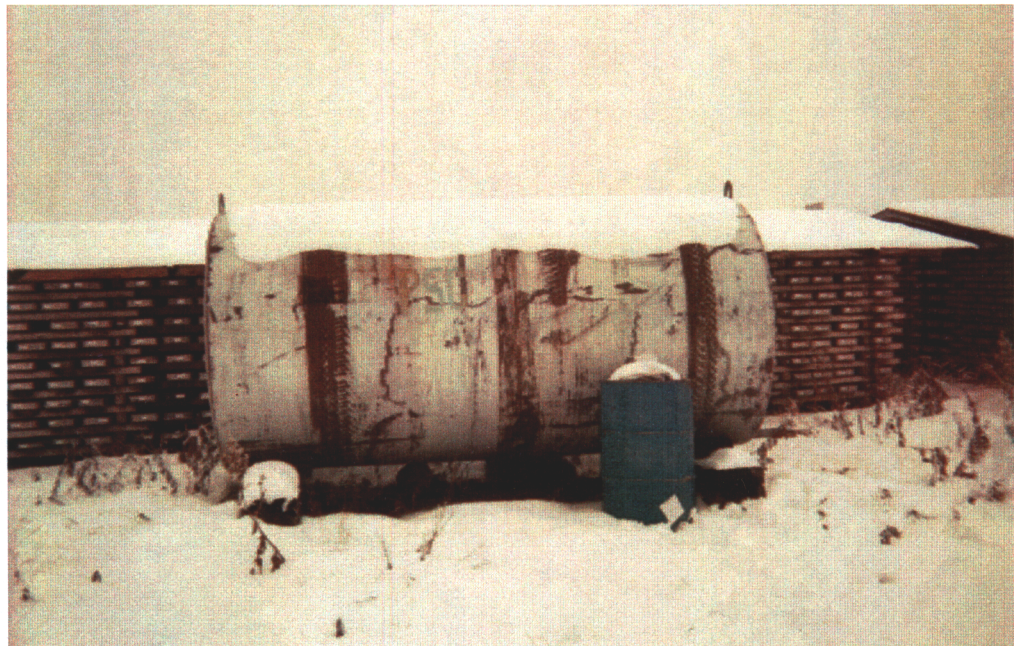
Photograph 29: "PSC" fuel storage tank outside of bermed area

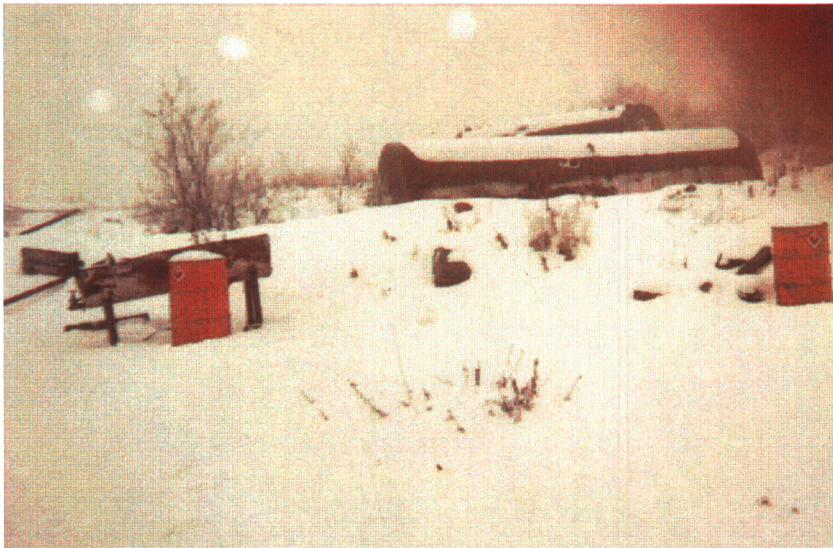
Photograph 30: Two of a total of 6 Avgas drums found at the airstrip with two large fuel tanks inside of earthen berm in background
