# 2021 Geotechnical Annual Review

Minto Mine, Yukon  
Minto Explorations Ltd.

SRK Consulting (Canada) Inc. ■ 1CM002.073 ■ October 2021

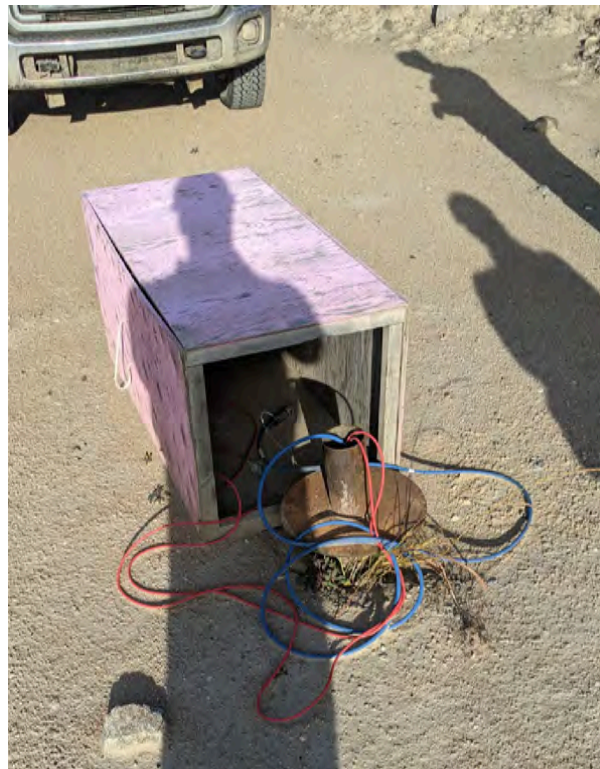
Photo 1-8: Piezometer DSP-06 and Thermistor DST-11 on the DSTSF waste rock crest. The instrumentation was found to be uncovered and exposed to the elements. Precipitation down the borehole could influence the instrumentation readings.

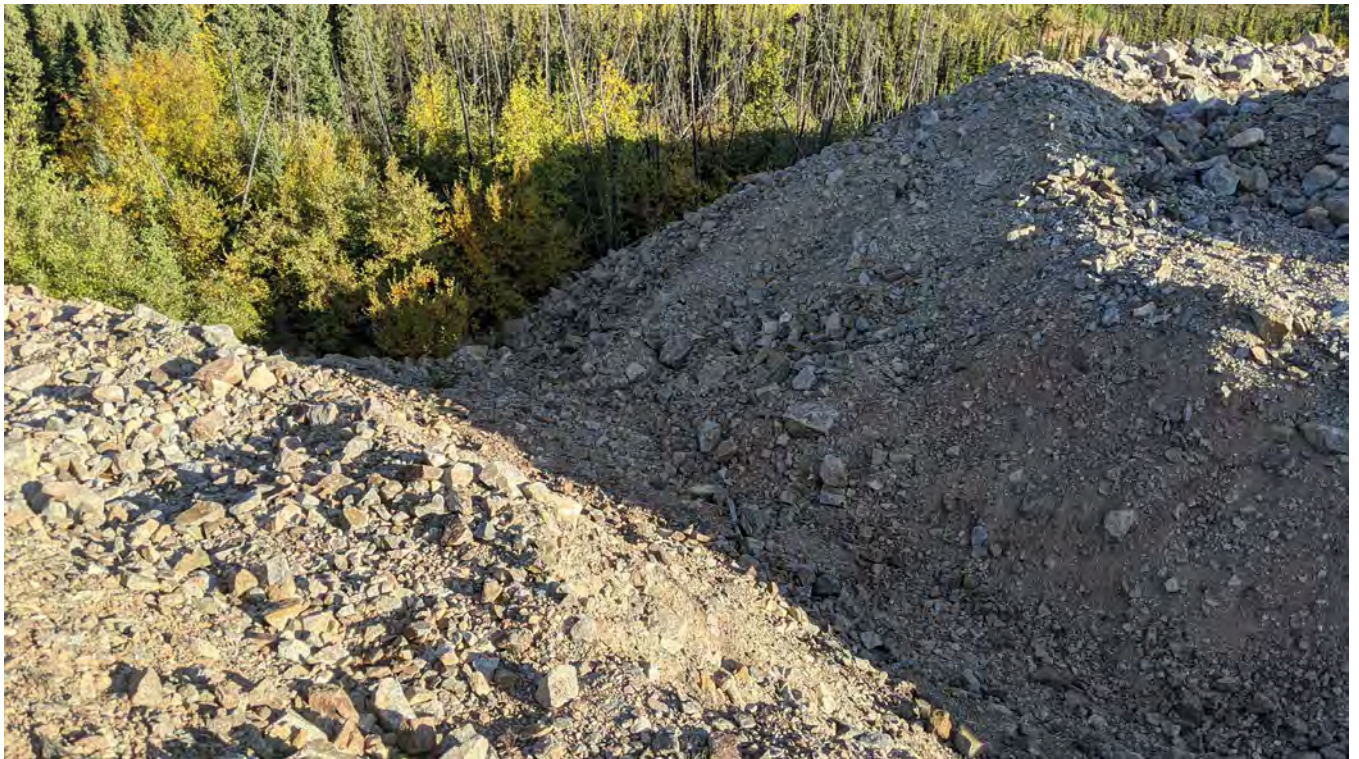
Photo 3-6: TDD Outlet. No flow was observed at the time of the inspection.

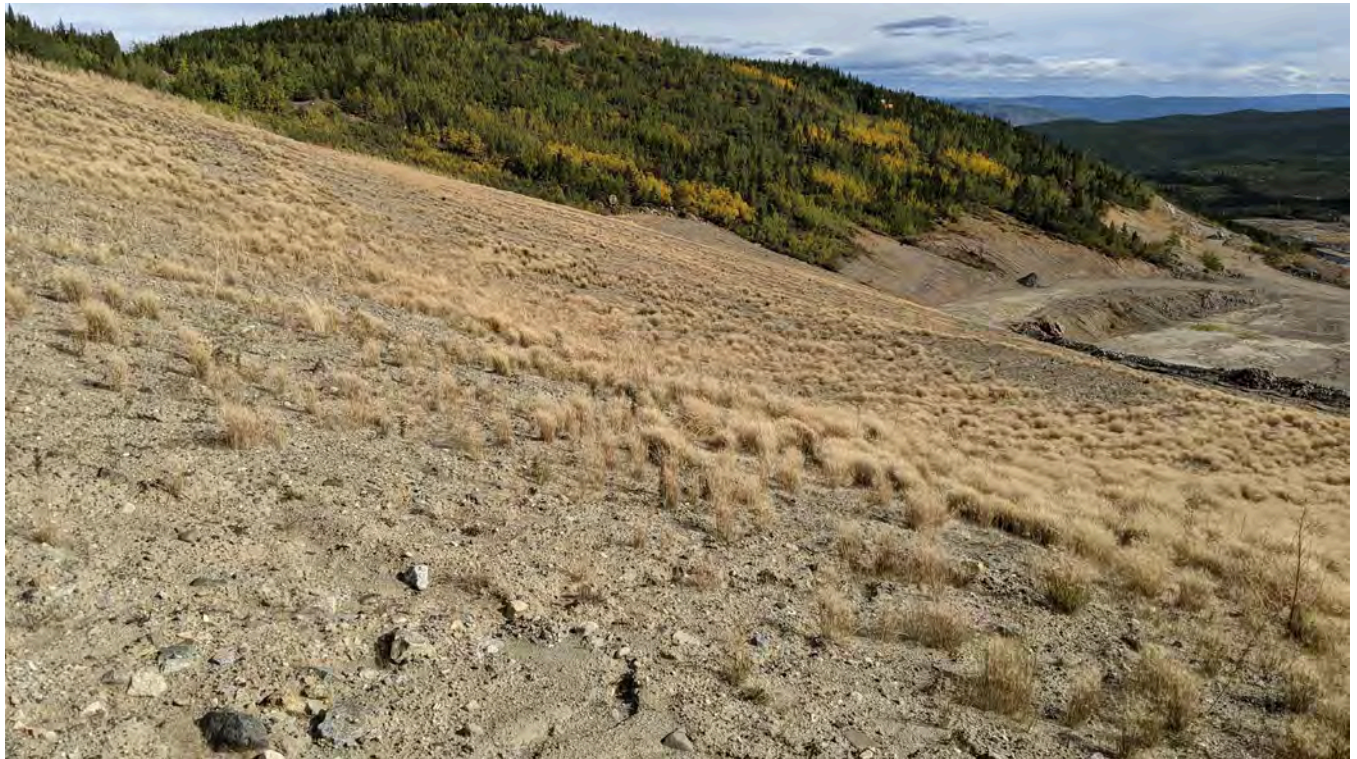
Photo 4-2: MWD regraded slope (looking northeast). Photo is in the location of the cracking of the cover soil noted in the 2019 inspection. The crack was not observed in the 2020 or 2021 inspection. The cover surface in this area has a concave slope.

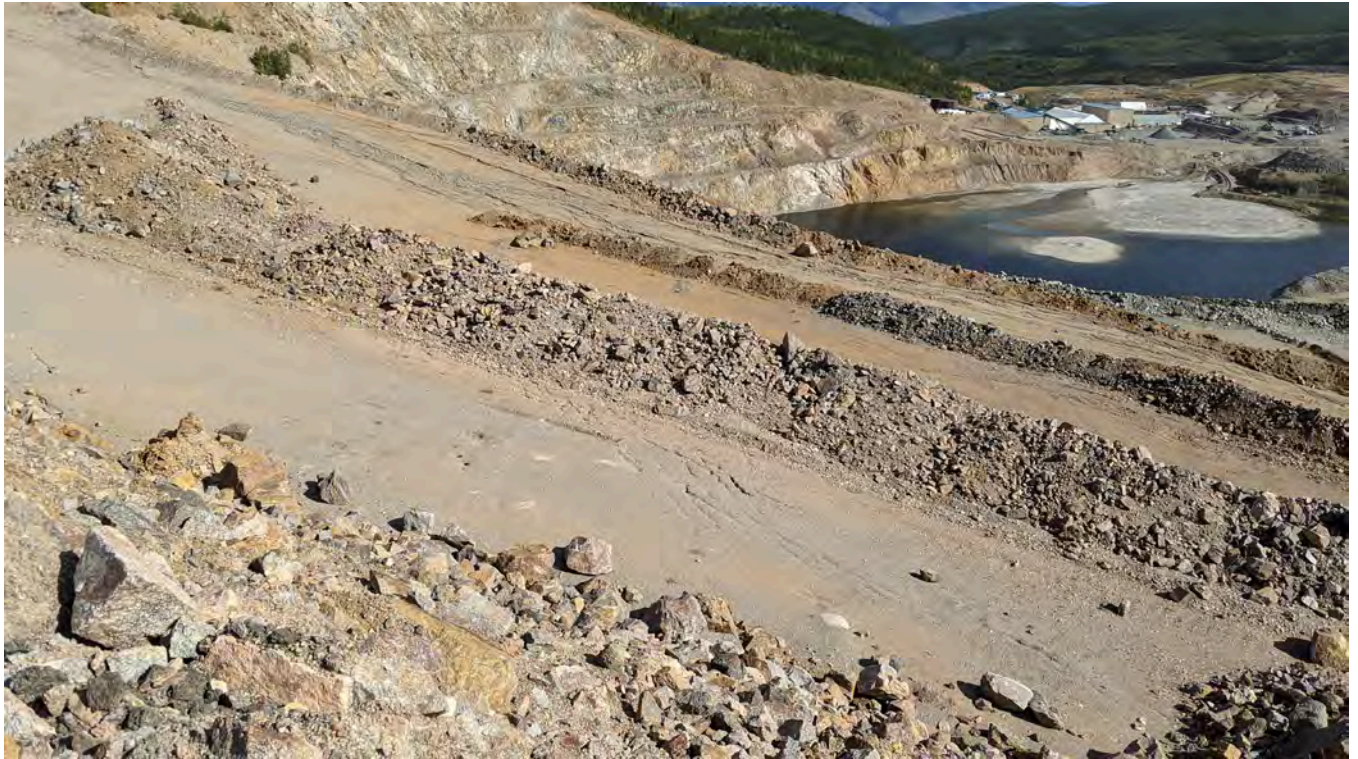
5	Main Waste Dump Wrap	<ul style="list-style-type: none"> <li>■ Differential settlement, cracking and small sinkholes are prevalent on the top bench, likely attributed to snow within the fill during winter construction (Photo 5-1, Appendix A). The condition of the area is consistent with the previous year's inspection.</li> <li>■ In 2020, the upper lift of the MWD Wrap was partially resloped. Since the 2020 inspection, waste rock has been excavated from the toe of the wrap resulting in an over-excavated slope and a risk of surficial slope failures/rockfall. Coarse rock is present at the base of the slope that acts as a small barrier to rockfall, but until the wrap has been regraded, traffic should be restricted near the toe. (Photo 5-2, Appendix A).</li> </ul>
6	Southwest Waste Dump (SWD)	<ul style="list-style-type: none"> <li>■ A crack approx. 180 m long observed along the access road immediately west (upslope) of areas where overburden stockpiles are present.               <ul style="list-style-type: none"> <li>– The crack was first observed in the 2019 annual inspection. In the past year, the crack has grown in length by approximately 40 m to the south and is up to 40 cm wide (up from 35 cm wide in 2020 annual inspection) and has an approximate 20 cm vertical displacement (up from 10 cm in the 2020 inspection. See Photos 6-3, 6-4, and 6-5, Appendix A).</li> <li>– The crack is located above survey hub SWD12 and any large-scale slope deformation would be expected to be detected by SWD012 located downslope of the crack. The survey hub has shown a steady total displacement rate of 0.65 mm/day in the past year (See Section 3.4), which is a slight deceleration compared to the movement rate at the time of the inspection in 2020 (0.70 mm/day).</li> <li>– The crack should continue to be visually monitored as part of routine inspections for any change in condition.</li> </ul> </li> </ul>

Photo 5-1: Cracking on the crest of the lower bench of the MWD Wrap.

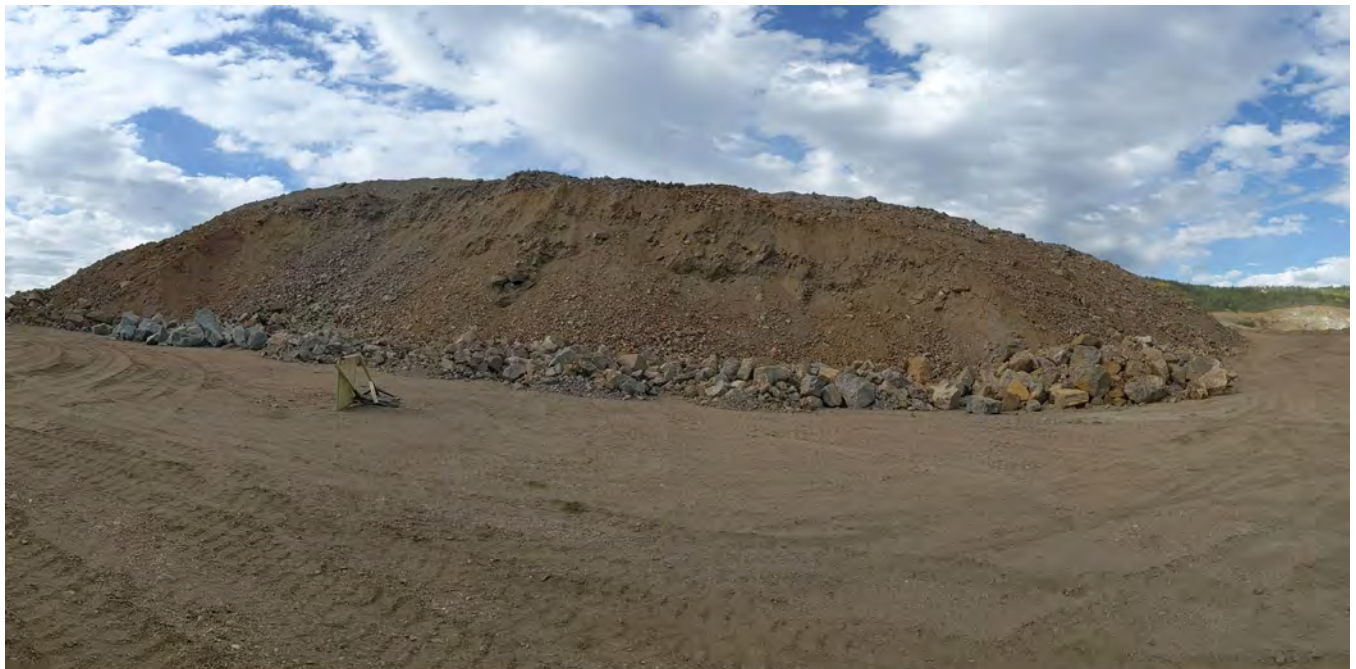
Photo 5-2: Waste Rock excavated from the toe of the MWD Wrap (looking north) that has resulted in an over-steepened slope.

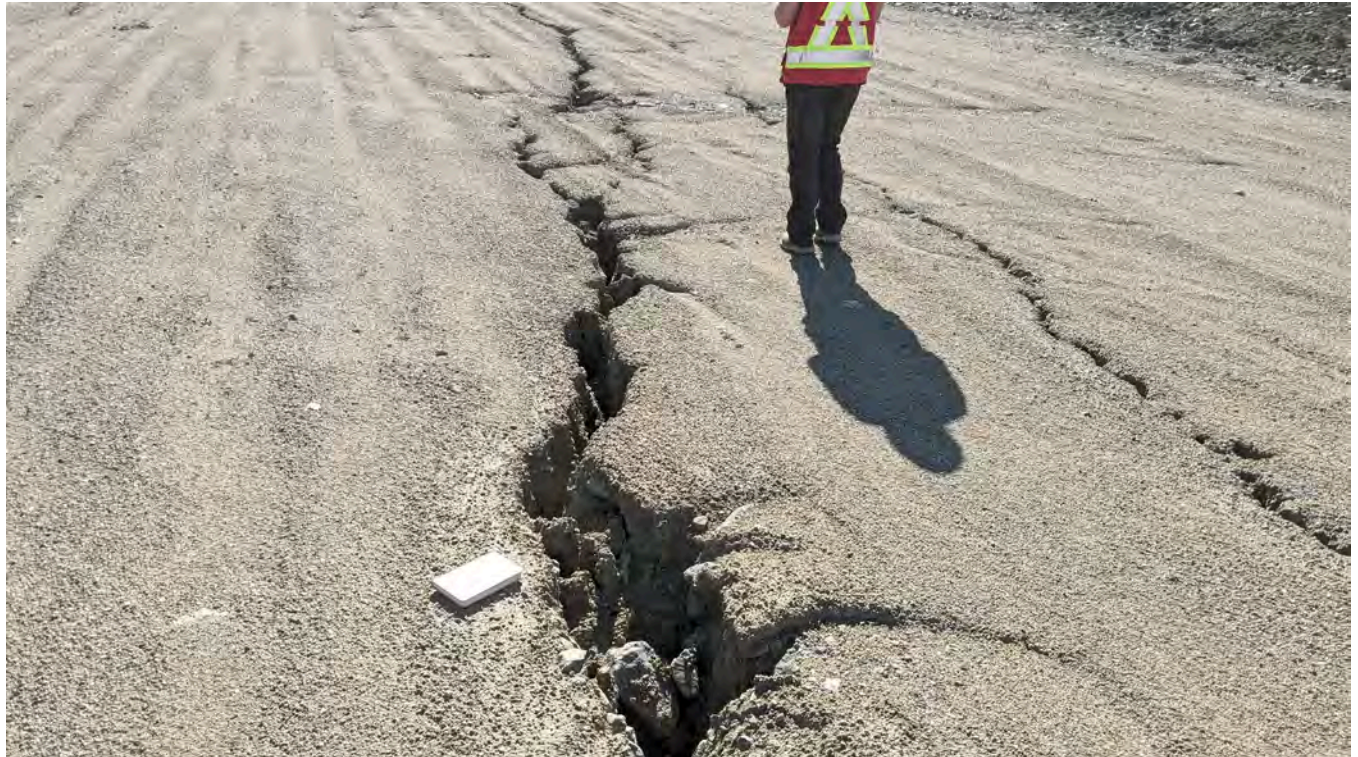
Survey hubs SWD12 and SWD09 are located downslope of the longitudinal crack observed during site inspection (See Figure A-4 and Photos 6-3, 6-4 and 6-5 in Appendix A for crack location and photographs). The movement of these hubs may be due creep or thawing of ice-rich soils present beneath the lower portions of the dump near the valley bottom (east side). In addition, the stockpiled cover material downslope of the crack likely contributes a driving force to the movement. The future spreading of the cover will likely reduce the driving force and movement rate. The foundation soils the upper (western) portion of the dump consists of colluvial soils with low ice content (EBA 2008). The survey hub movement direction is perpendicular to the dump crest with no indication of down valley movement (towards the Main Pit). The crack location was plotted otop of an interpreted overburden isopach plan (Figure 14, Appendix F). The isopach indicates that the overburden is generally thin in the in the area of the crack and downslope; however, this is based on one drillhole in the vicinity of the crack and the accuracy of that borehole was unable to be confirmed at this time. The survey hubs are recommended to continue to be monitored at a quarterly basis.

Photo 6-3: Longitudinal cracking along the crest of the SWD first observed in 2019.

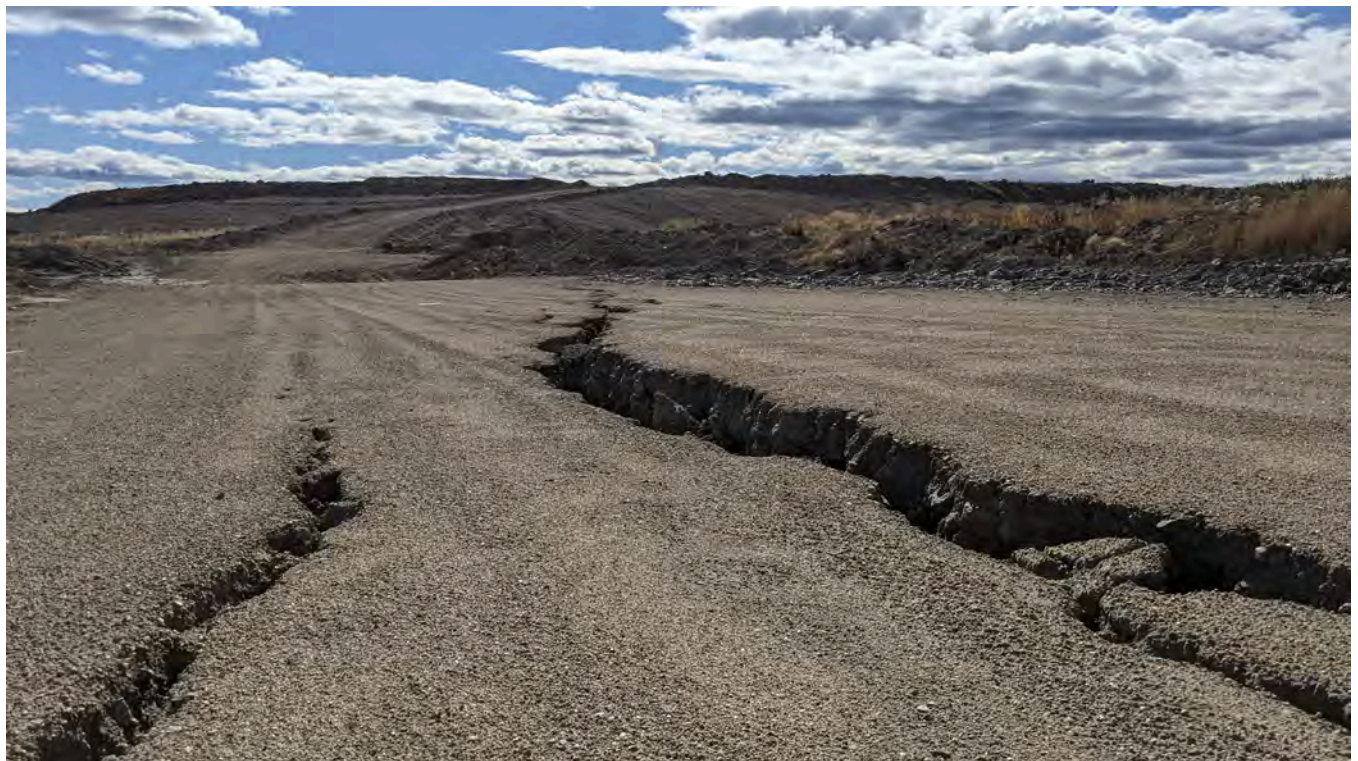
Photo 6-4: Longitudinal cracking along the crest of the SWD first observed in 2019..

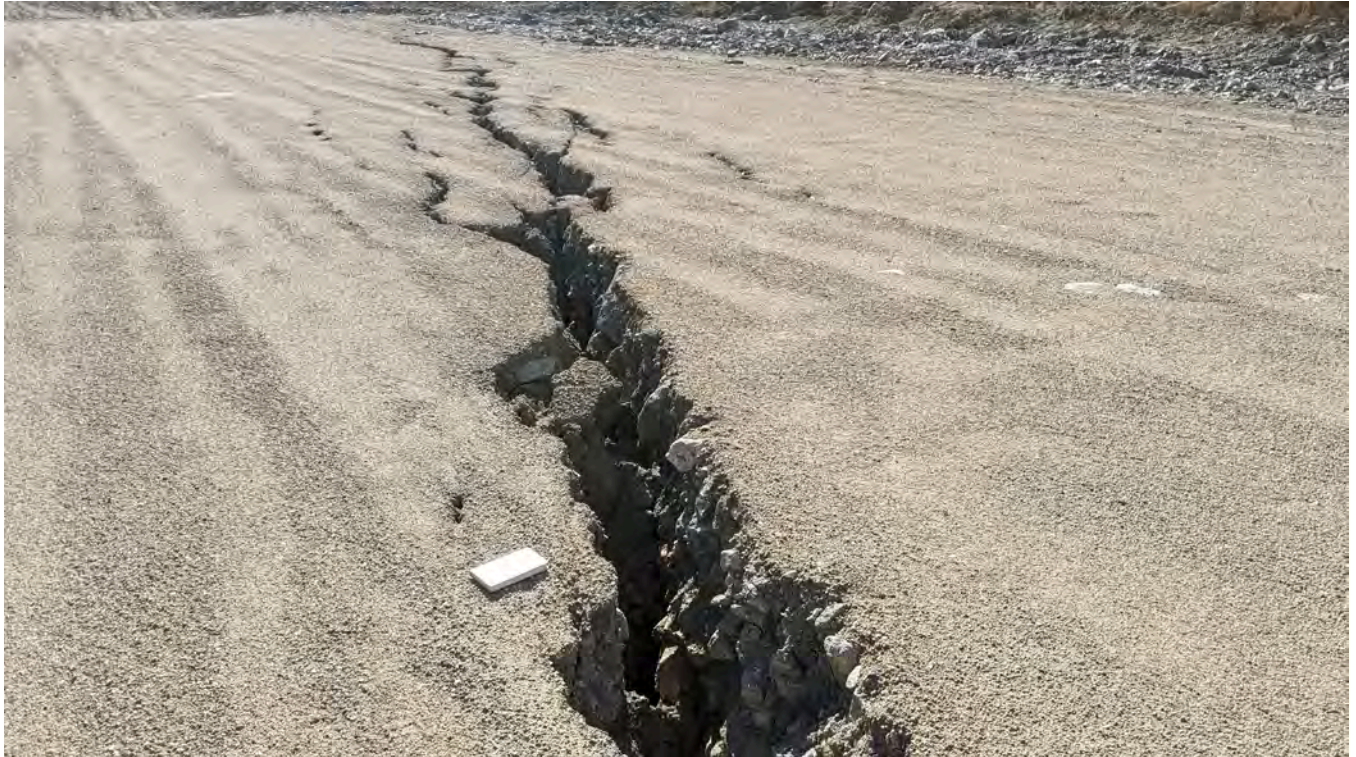
Photo 6-5: Longitudinal cracking along the crest of the SWD first observed in 2019 at its widest point.

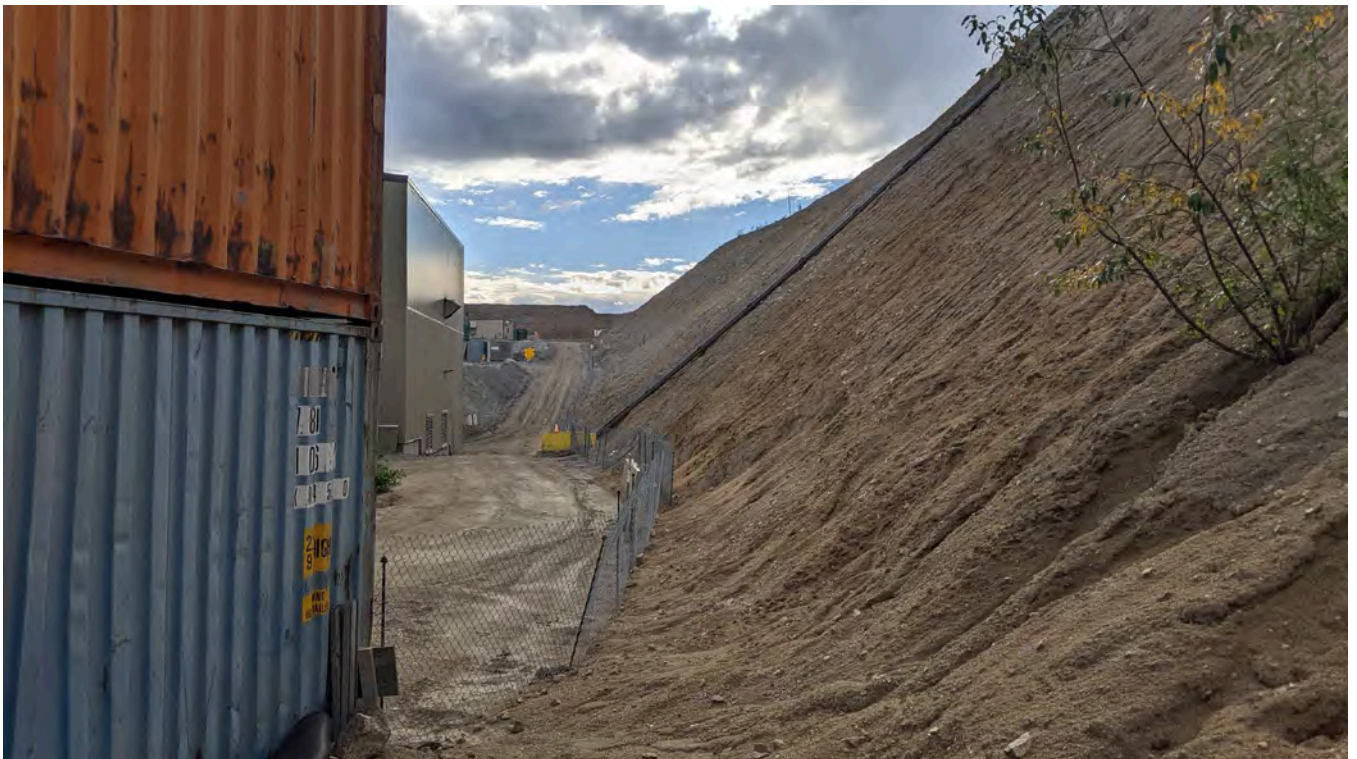
Photo 9-4: Minor slope erosion on the highwall.

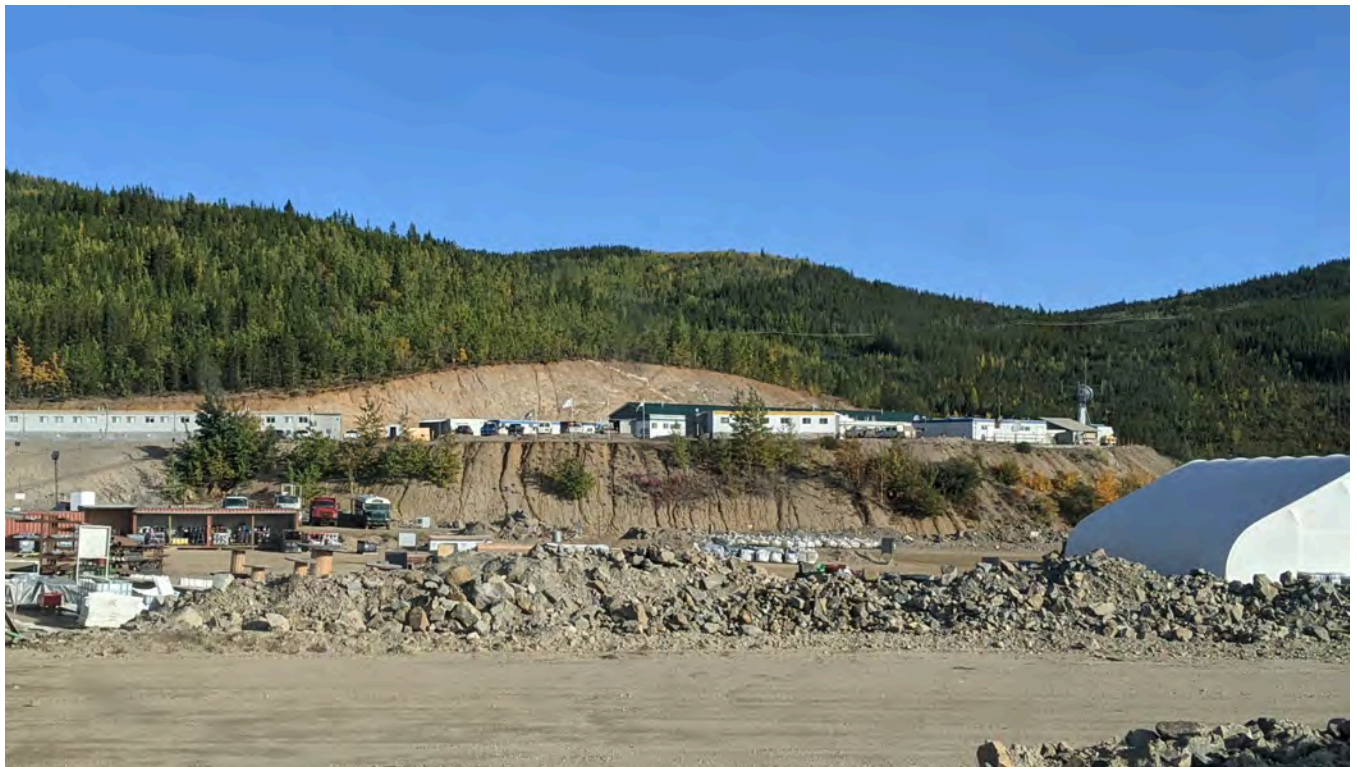
Photo 10-4: Historical erosion gullies below the camp pad. The condition of the gullies is unchanged from previous inspections and the camp pad is graded to prevent runoff entering the top of the gullies.

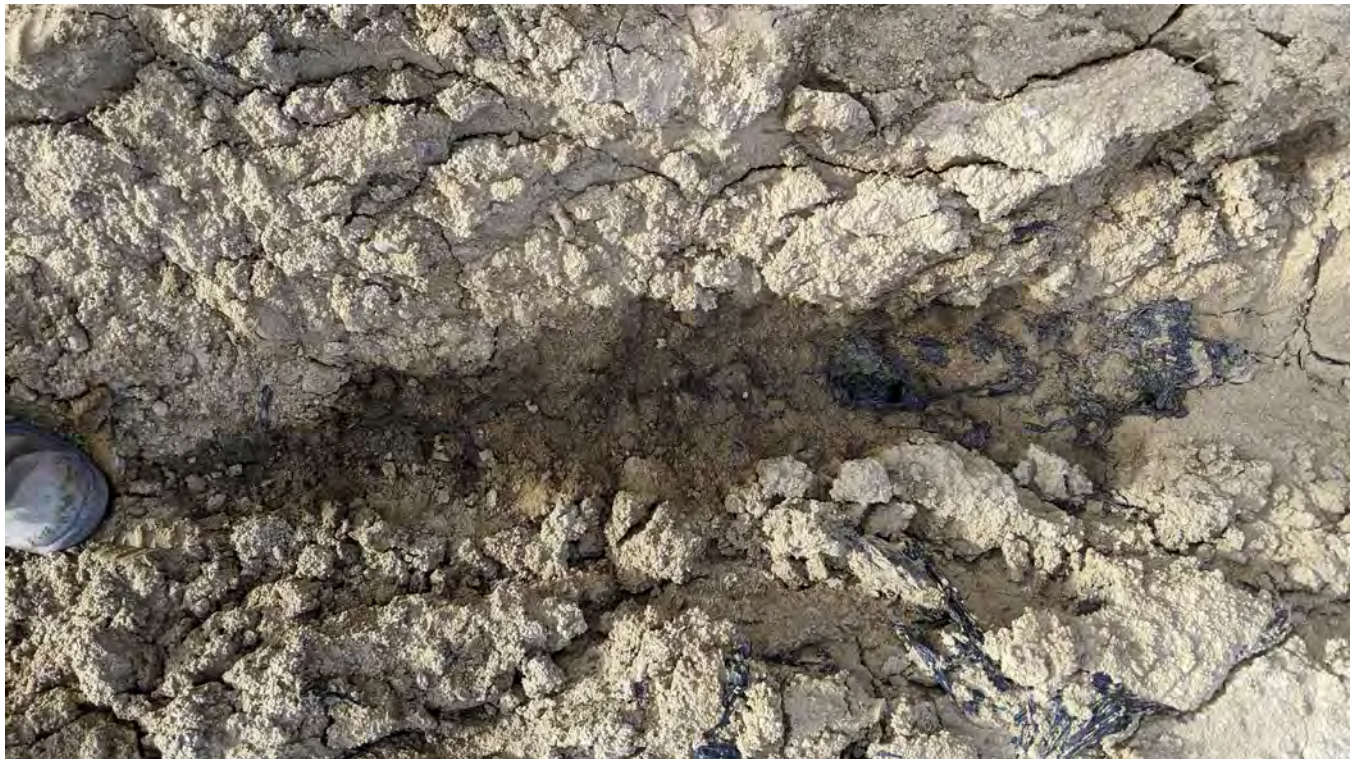
Photo 11-4: Exposed geosynthetics in the rut. A thin plastic is present overtop of the geotextile (that overtops the liner) that appears to be a sacrificial warning layer to prevent liner damage.

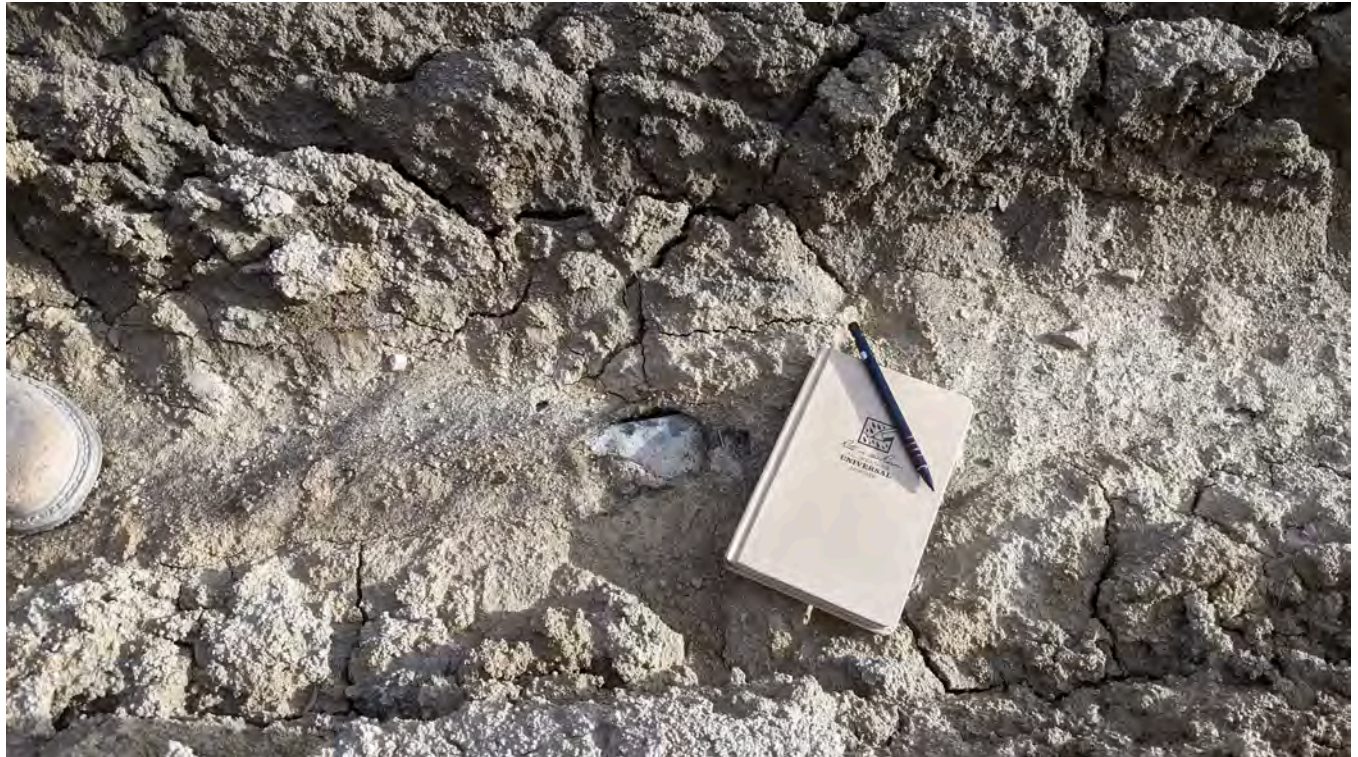
Photo 11-5: A small geotextile tear was found in the rut that is approximately 5cm x 8 cm. Liner damage could not be detected within the tear.

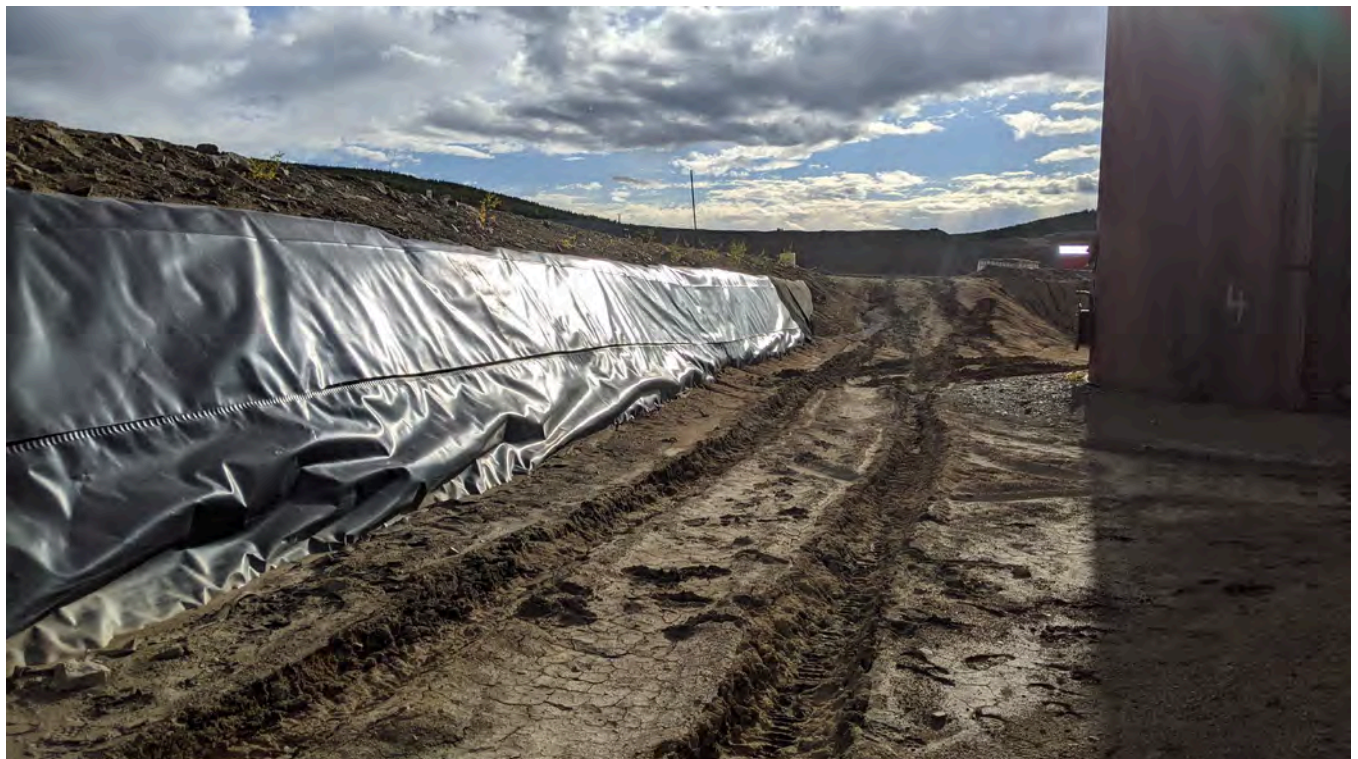
Photo 11-6: View of the ruts and liner along the side wall of the facility.

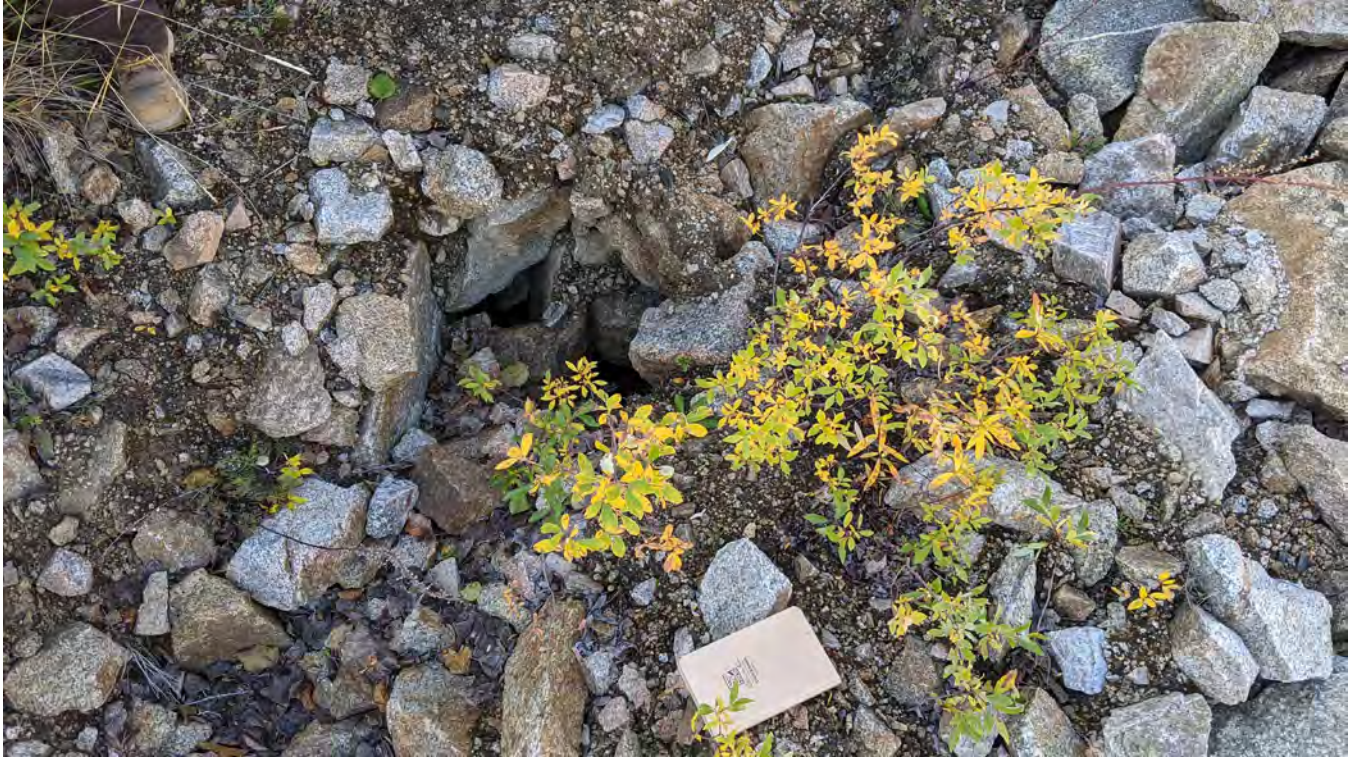
Photo 12-7: Potential minor sinkhole or burrow on the downstream south abutment near ground temperature cable WDT-08. No apparent change in condition since first observed in the 2019 inspection.

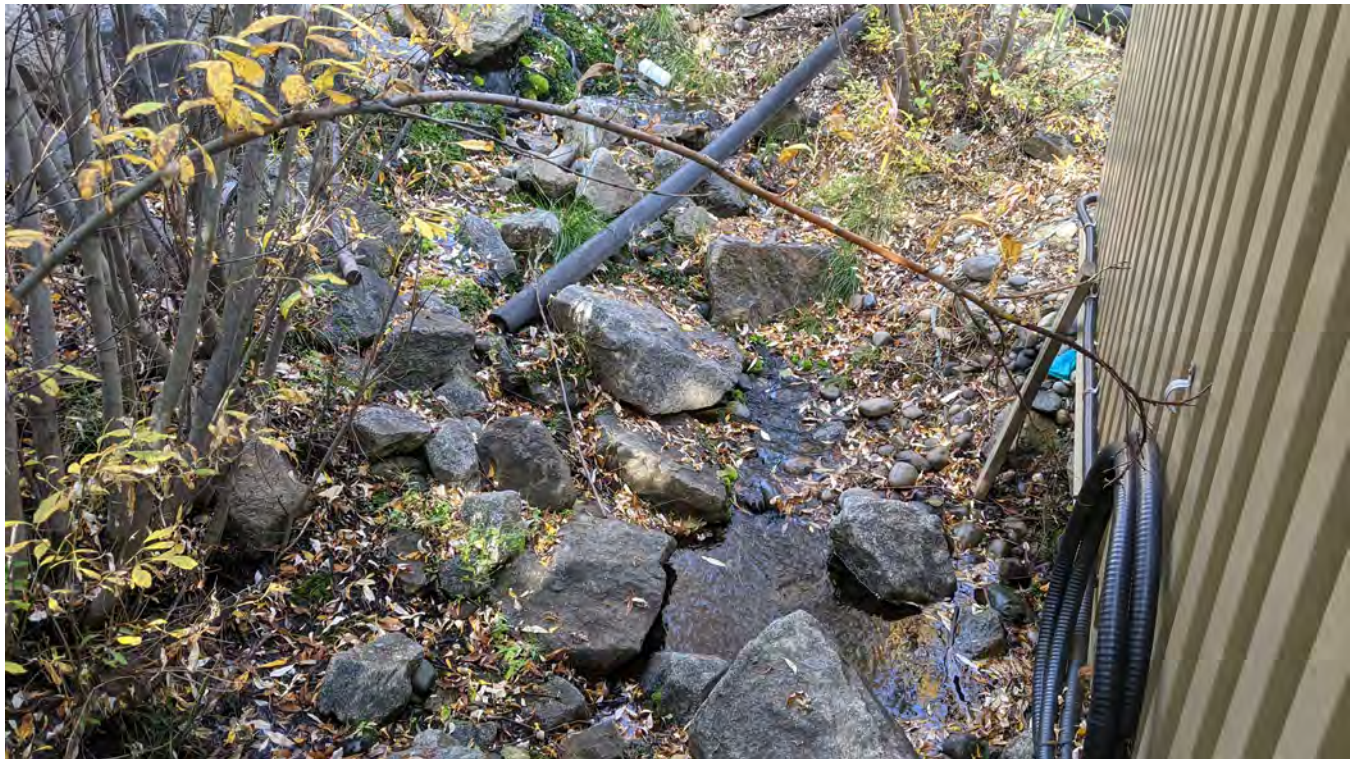
Photo 12-8: Seepage at the toe of the dam immediately upstream of the seepage collection sump. Seepage was clear with no signs of sediment transport.

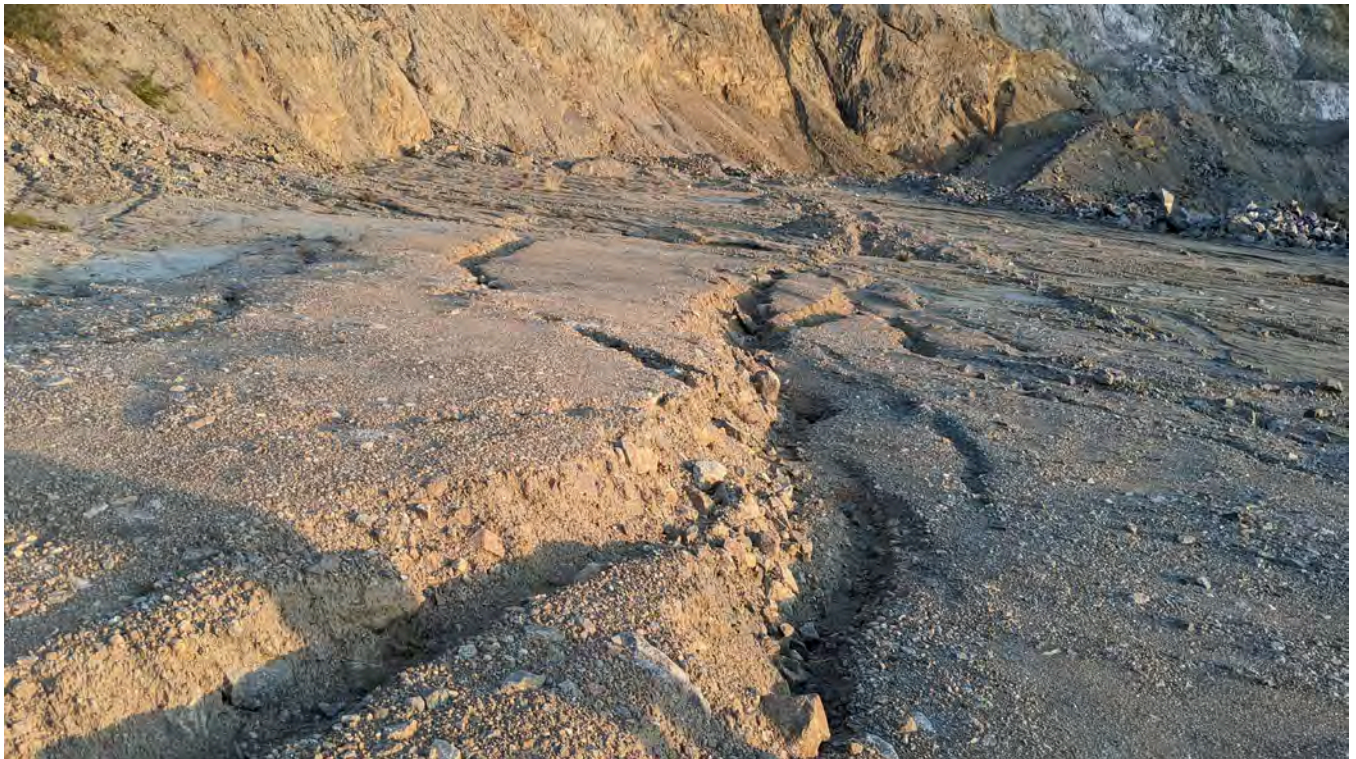
Photo 14-8: Historical cracking of the In-Pit Dump above the SAT Dump. The cracks are filling-in and near-by survey hubs indicate no current movement.

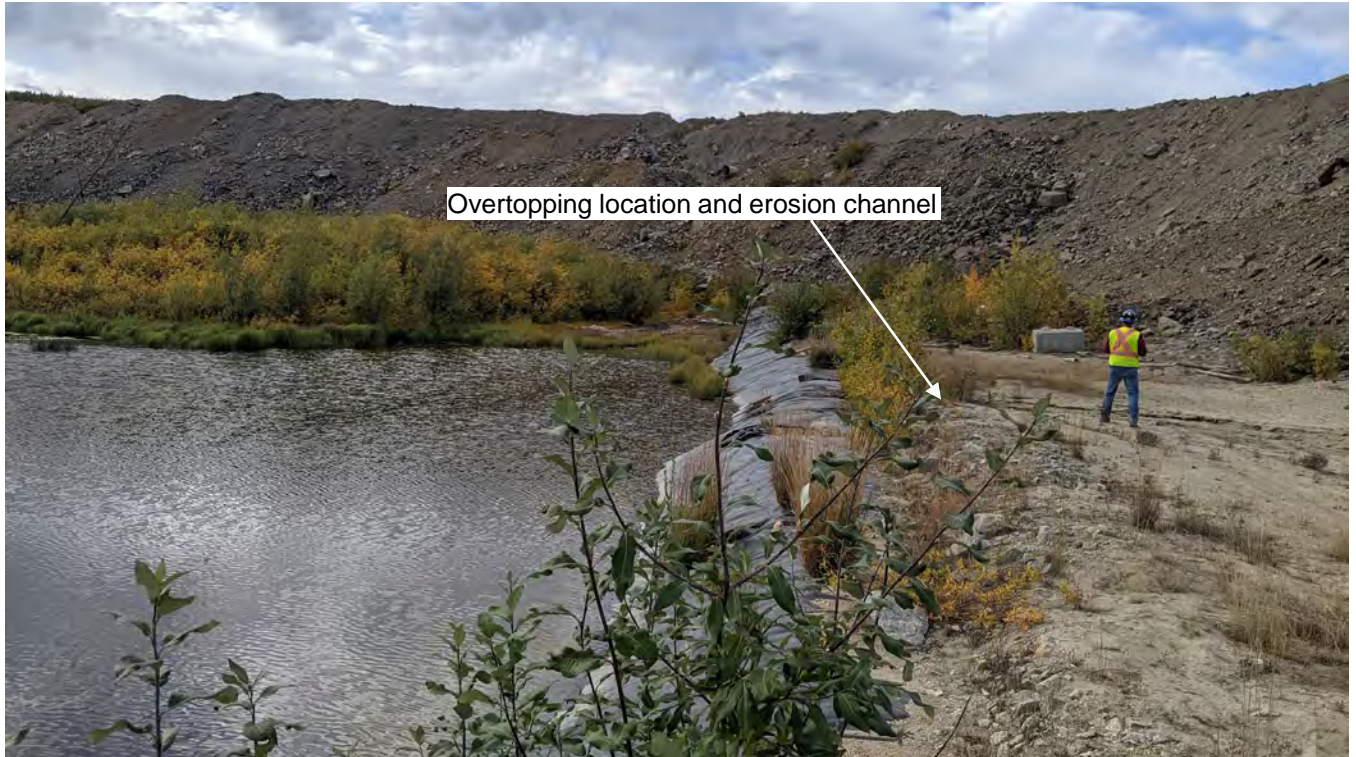
Photo 14-9: W15 Sump south of the Main Pit. The sump appears to have overtopped in the past year with water infiltrating through a sinkhole into the pit.

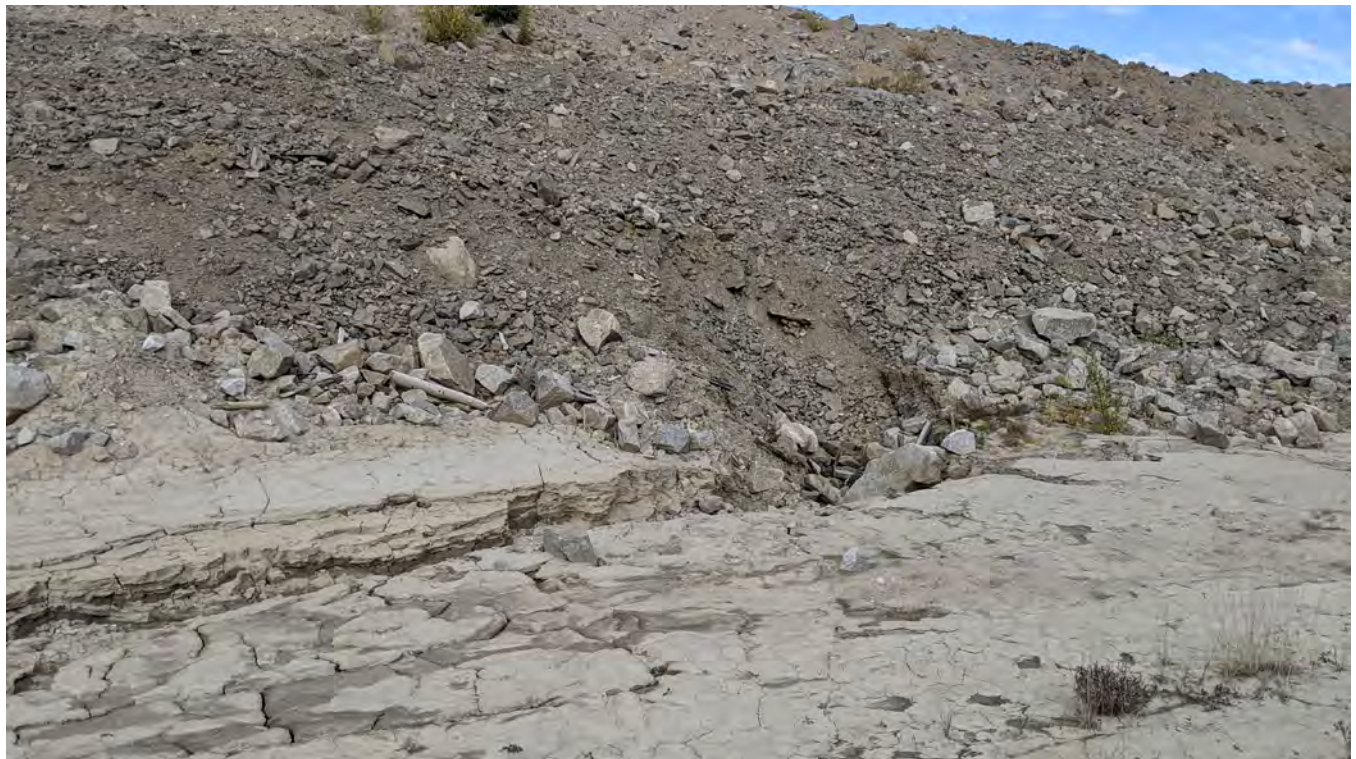
Photo 14-10: Lower end of the erosion channel and sinkhole beneath the haul road..

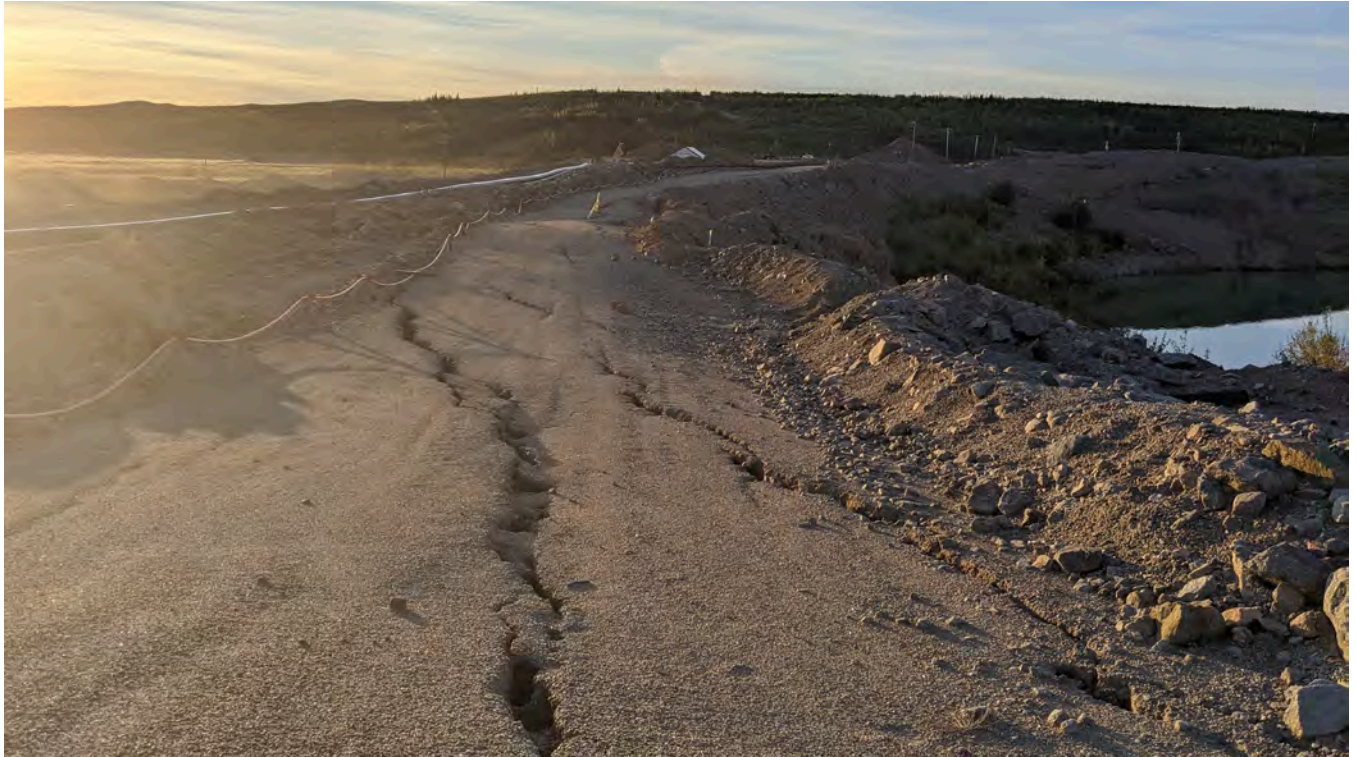
Photo 15-3: Cracking along inactive access road along pit rim.

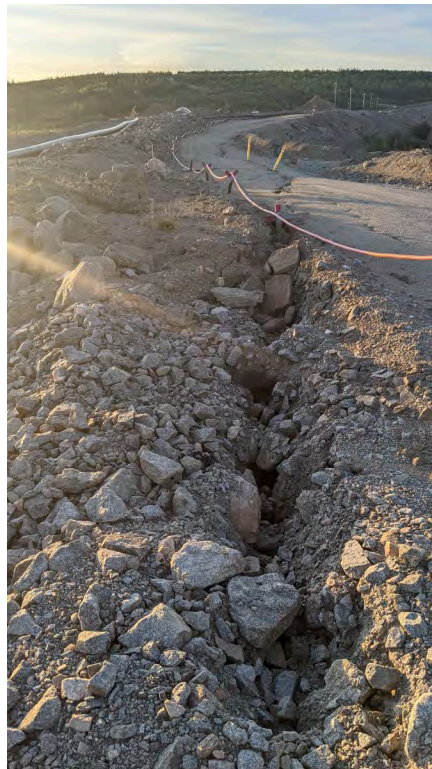
Photo 15-4: Cracking along inactive access road along pit rim.

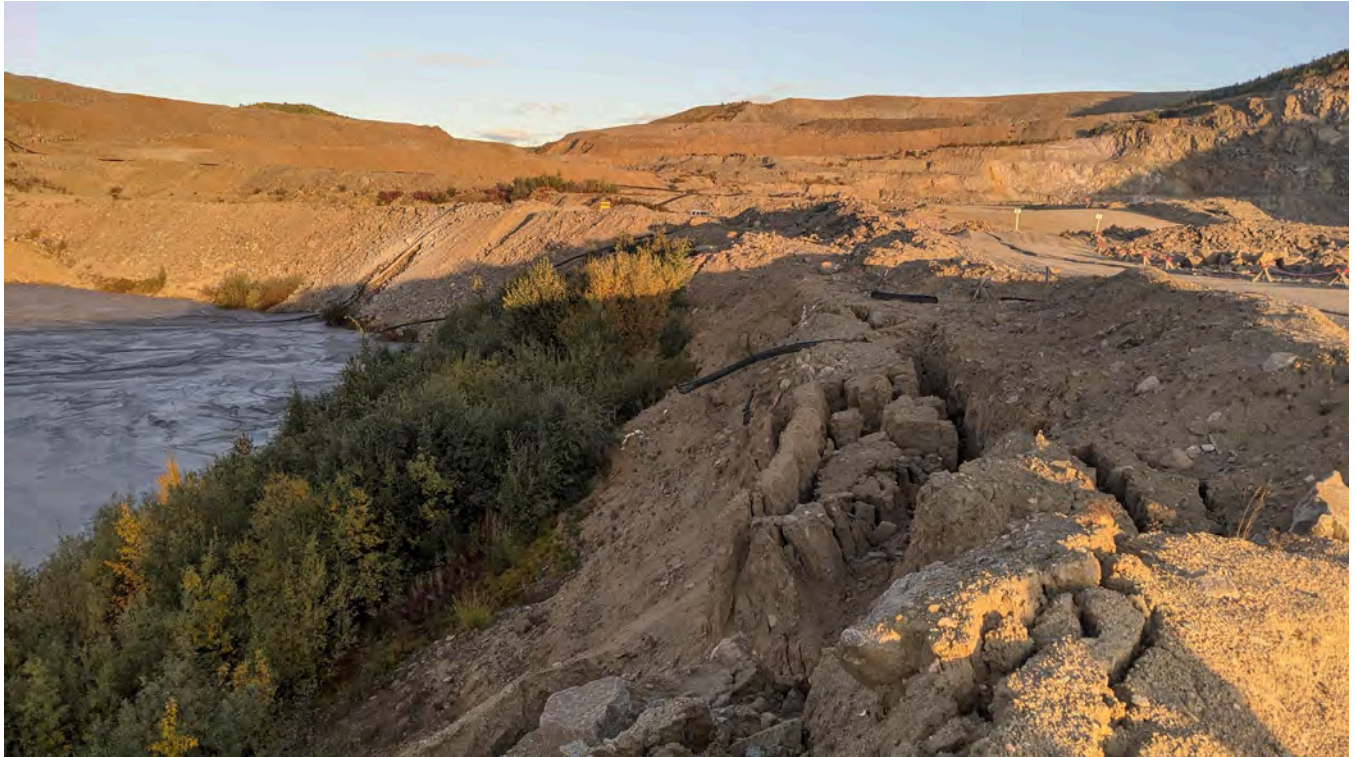
Photo 15-5: Cracking along the pit rim.

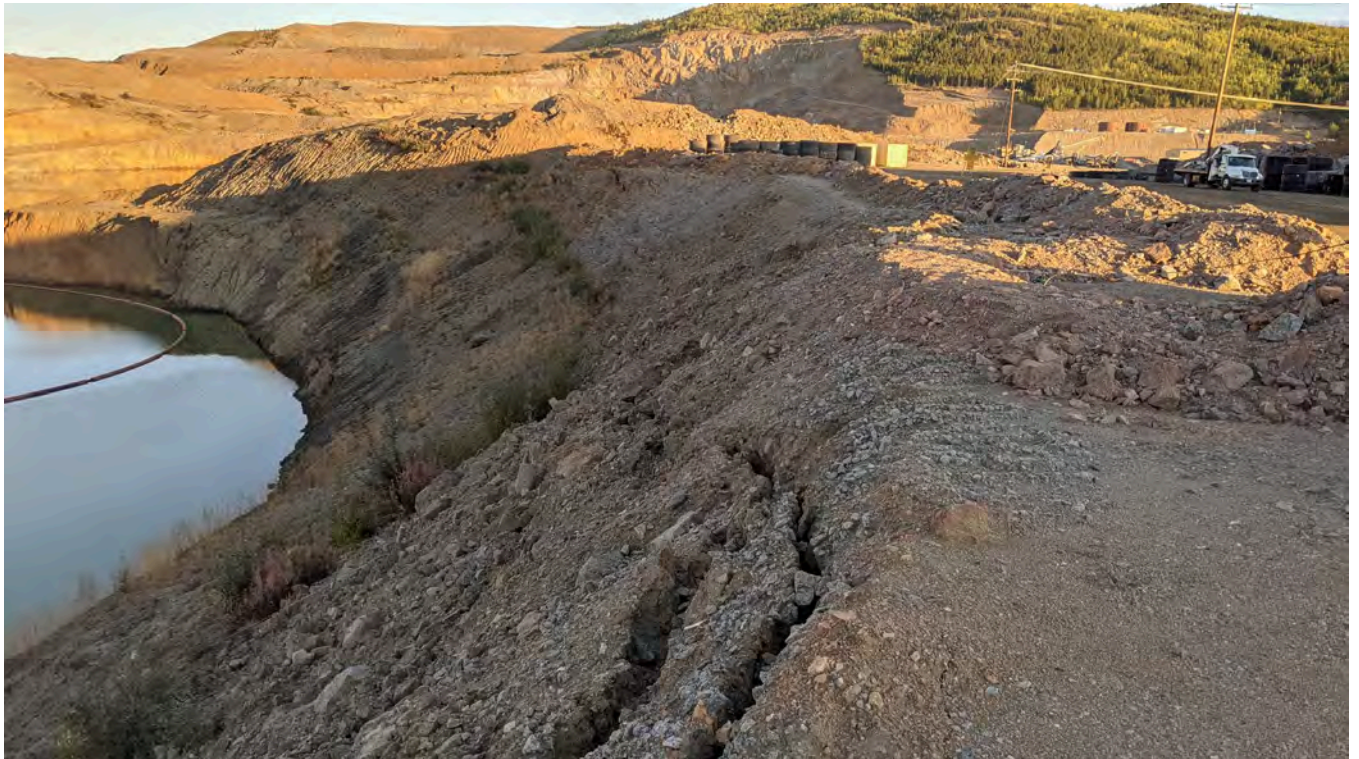
Photo 15-7: Cracking along the Area 2 Stage 3 Pit rim.
