# 2021 Geotechnical Annual Review

Minto Mine, Yukon  
Minto Explorations Ltd.

SRK Consulting (Canada) Inc. ■ 1CM002.073 ■ October 2021

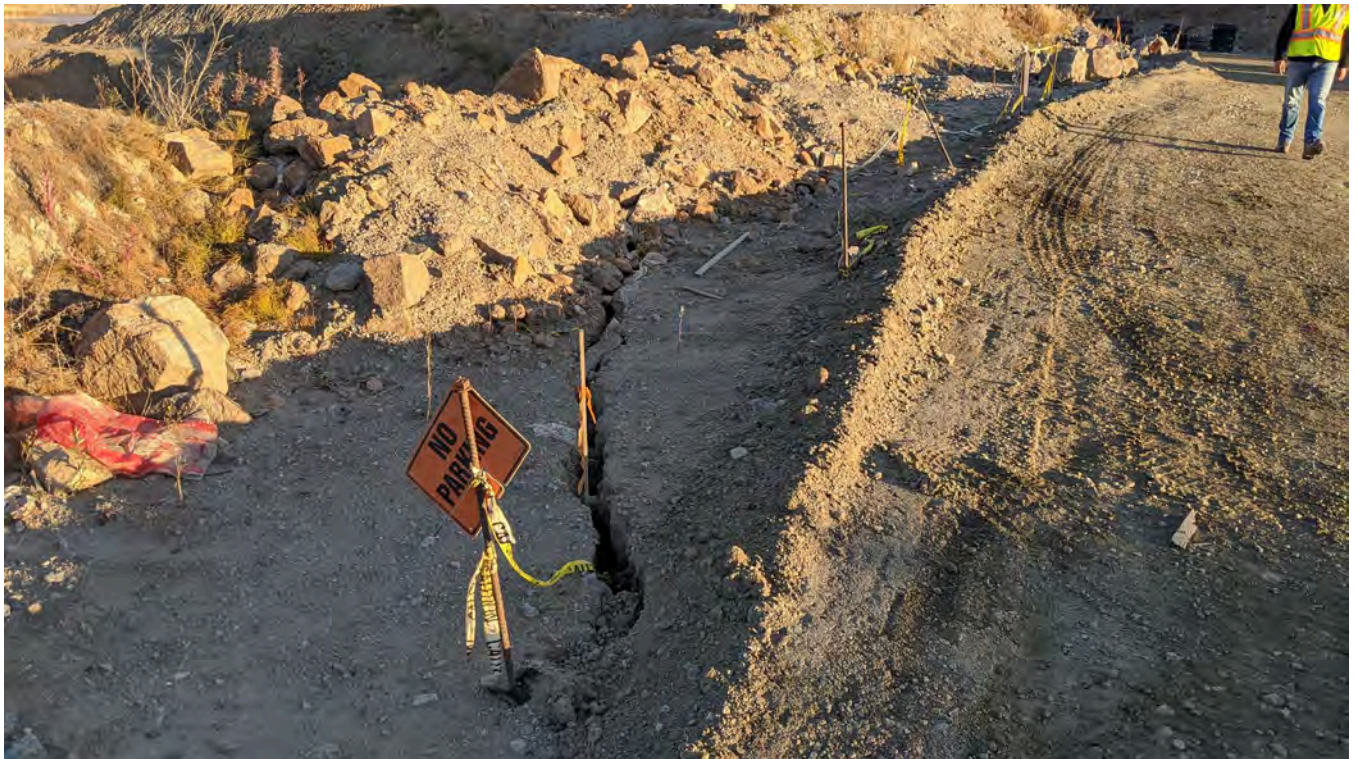
Photo 15-8: Cracking along the Area 2 Stage 3 Pit rim near the Underground Shop.

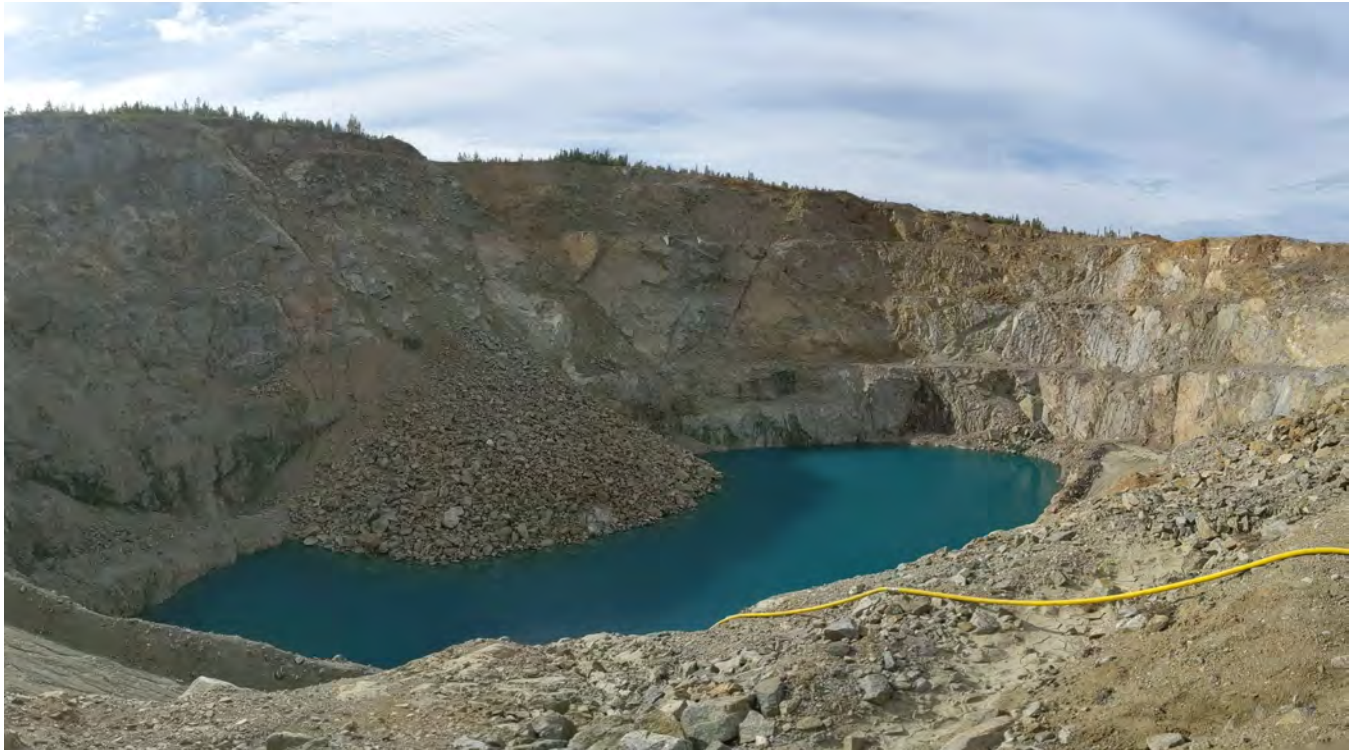
Photo 17-1: Previous pit wall failure in Minto North Pit (looking southwest).
