APPENDIX Q
Dry Stack Tailings Storage Facility
Update Report

September 7, 2010

**Subject: Dry Stack Tailings Storage Facility
Foundation Movement Monitoring Update, Minto Mine, YT**

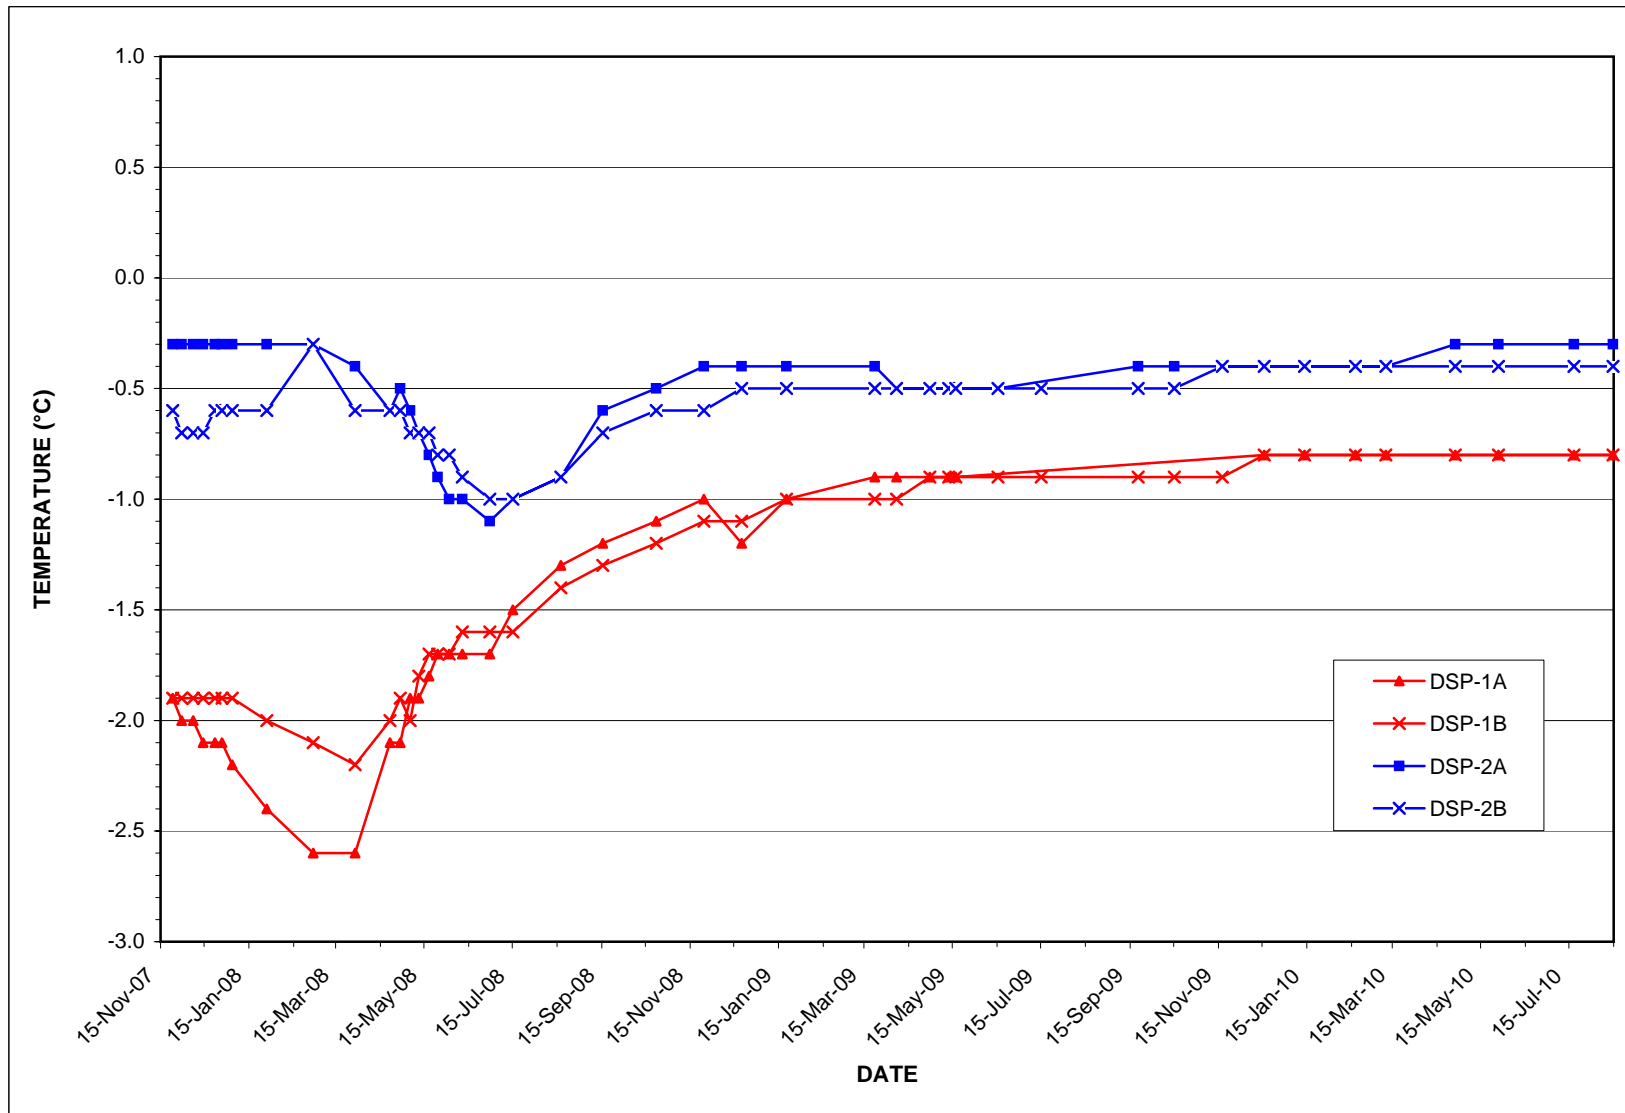
Figure VP01

Although two vibrating wire piezometers were installed in the fall of 2007 and an additional two in February of 2010, no piezometric data is currently available, as the foundation soils have remained frozen. Figures VP01 and VP02 show the ground temperature at each piezometer tip with time. The piezometers were installed to measure porewater pressure only if and when an active layer is established in the foundation soils.

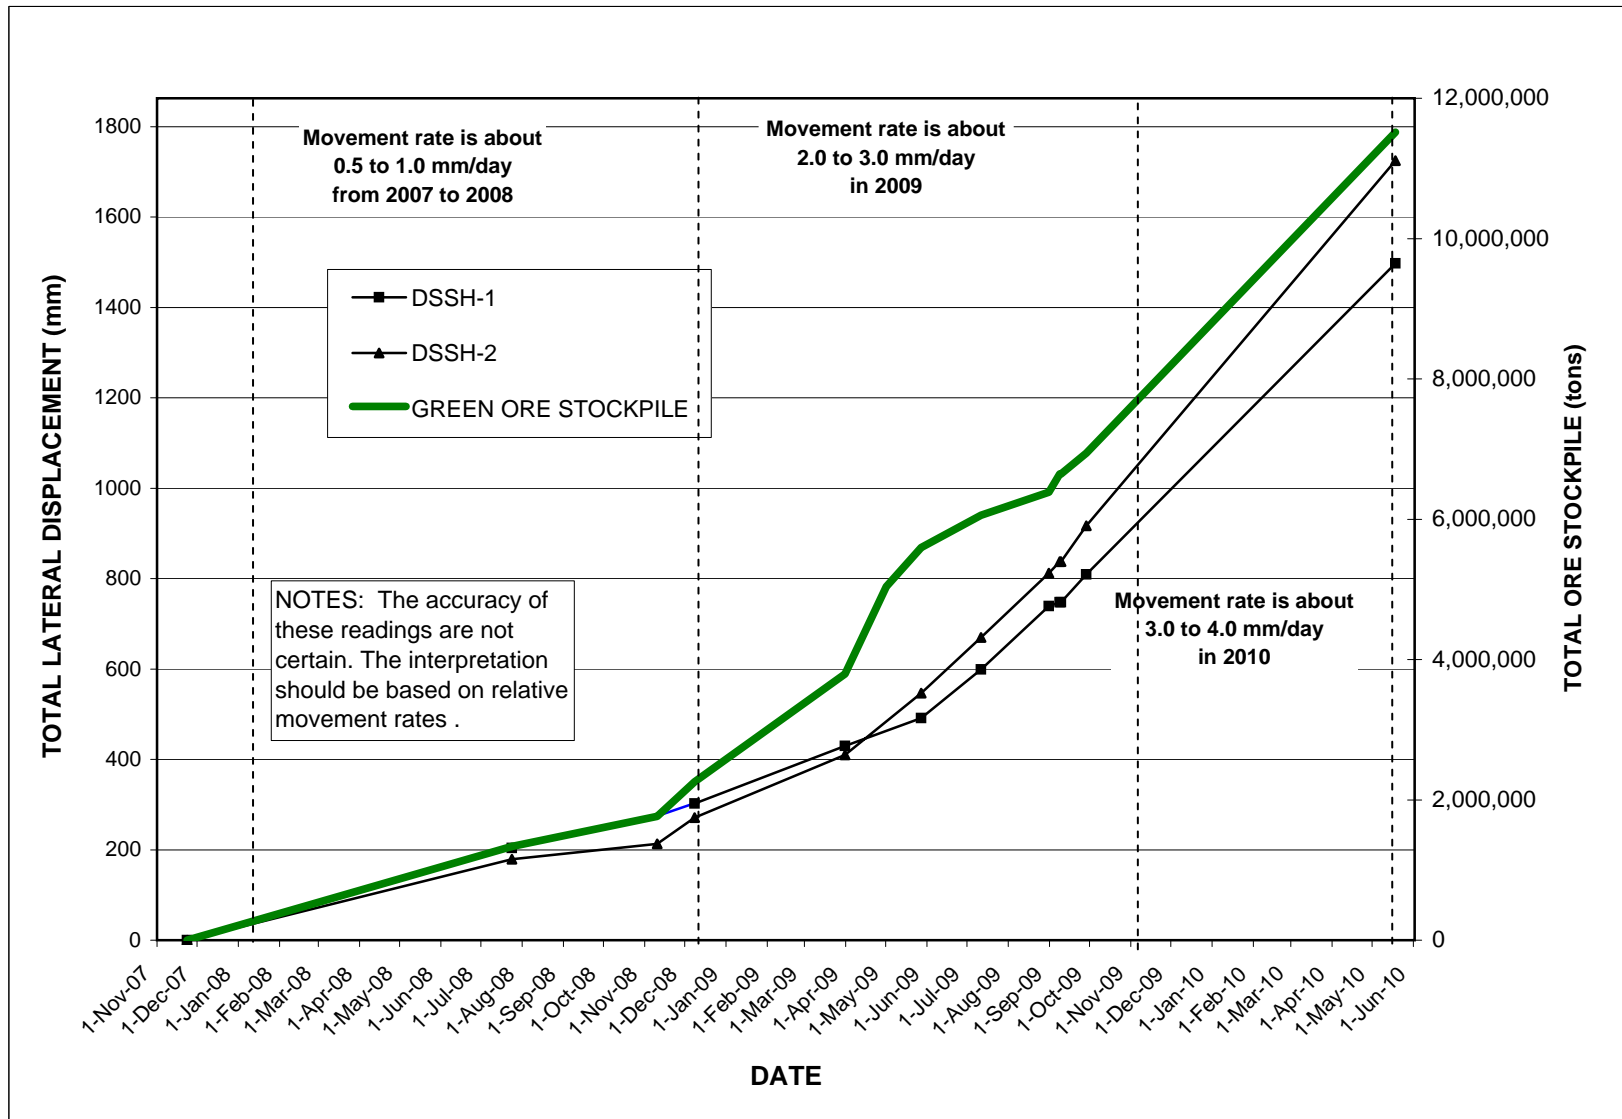
Dry Stack Tailings Storage Facility
Survey Hub-DSSH-1 & DSSH-2
Figure SH01

The data indicates that all of the survey hubs, except for DSSH-11 are experiencing movement. The relative lateral movement rates for DSSH-1 and DSSH-2, presented in Figure SH01, indicate that the rates have increased since installation, and are currently in the order of 3 mm/day to 4 mm/day. These current rates are consistent with the readings from DSSH-5 through -12. The rate of lateral movement for the DSSH-5 through -12 locations, presented in Figure SH03, have been consistent over the last three months as determined by

- Upgrade DSSH-1 and -02 to allow the GPS unit to be attached to the survey hub, similar to DSSH-05 to -12.
- Survey and monitor the top of pipe location of DSI-1 through -5.

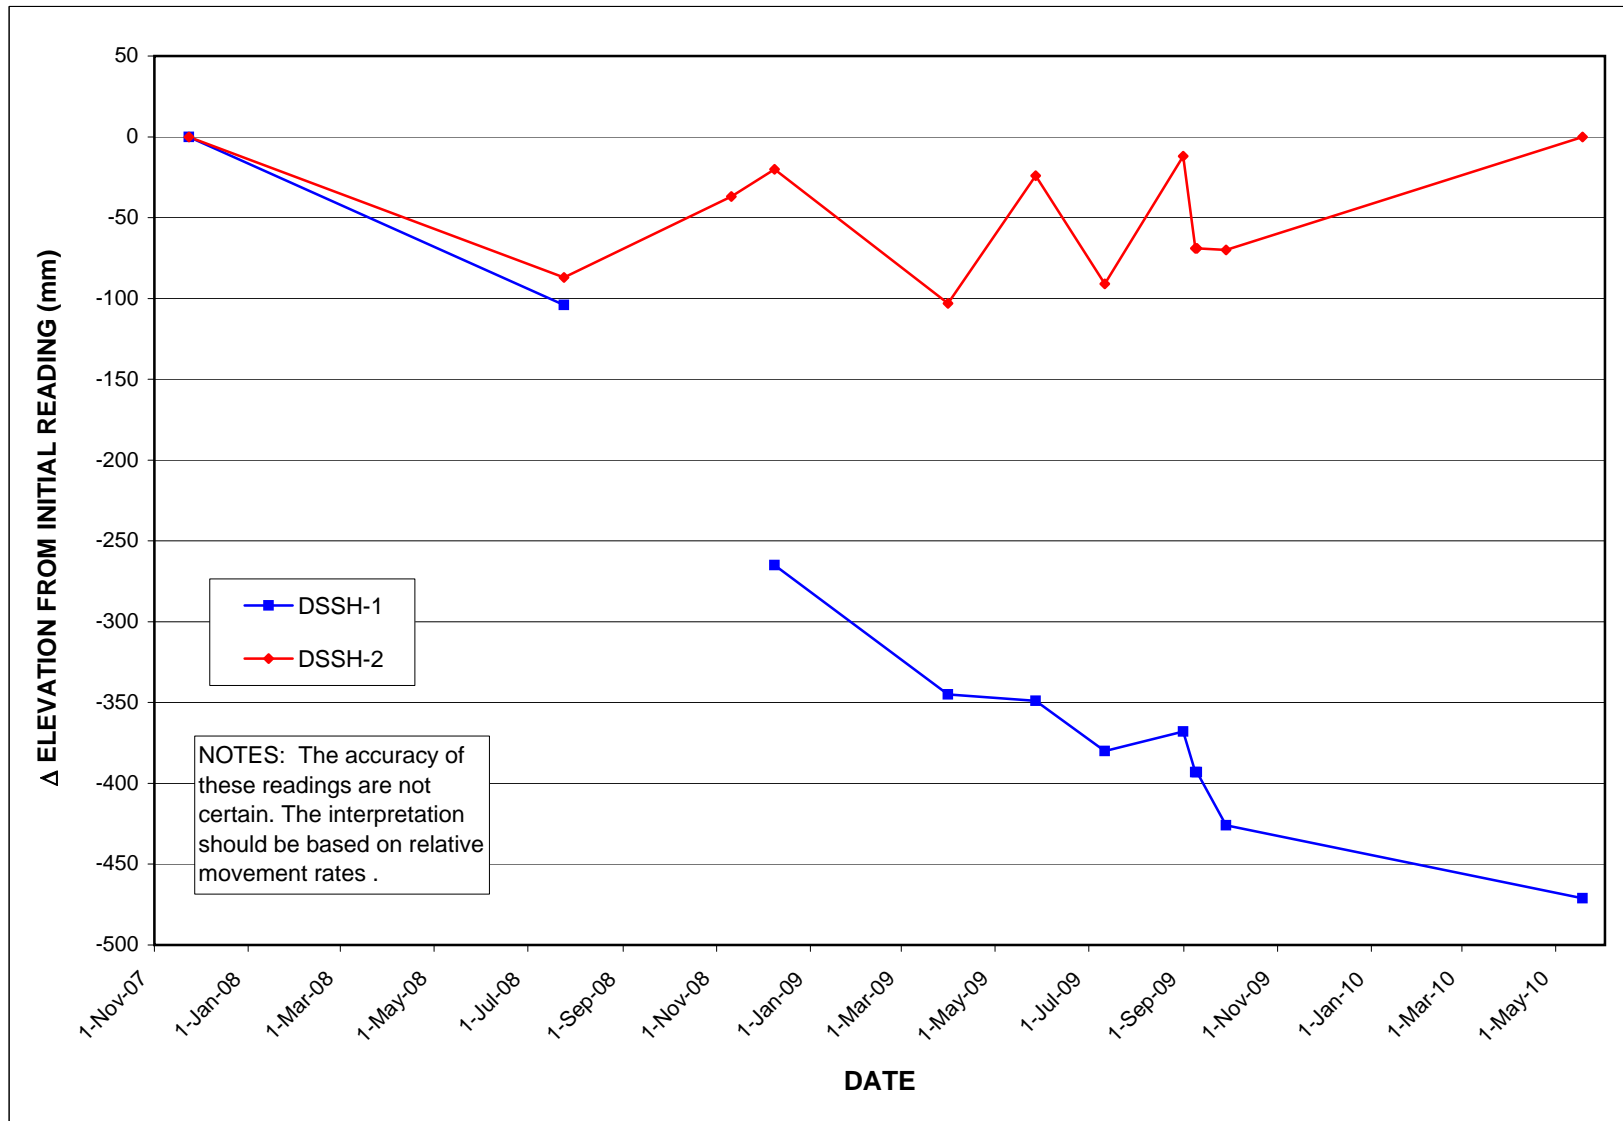
Dry Stack Tailings Storage Facility
Survey Hub-DSSH-1 & DSSH-2
Figure SH04

The change in elevation for DSSH-1 and DSSH-2 are presented in SH04. DSSH-1 shows relatively consistent drop in elevation over time. DSSH-2 shows no change in elevation over time. The change in elevation for DSSH-5 through DSSH-12 are presented in SH05. DSSH-5, -10, and -11 show no change in elevation while DSSH-6 and -12 show a drop in elevation. The remaining hubs, DSSH-7, -8, and -9, show a rise in elevation. Drawing DSTSF-INC-10 presents the change in elevation for each survey hub since installation.

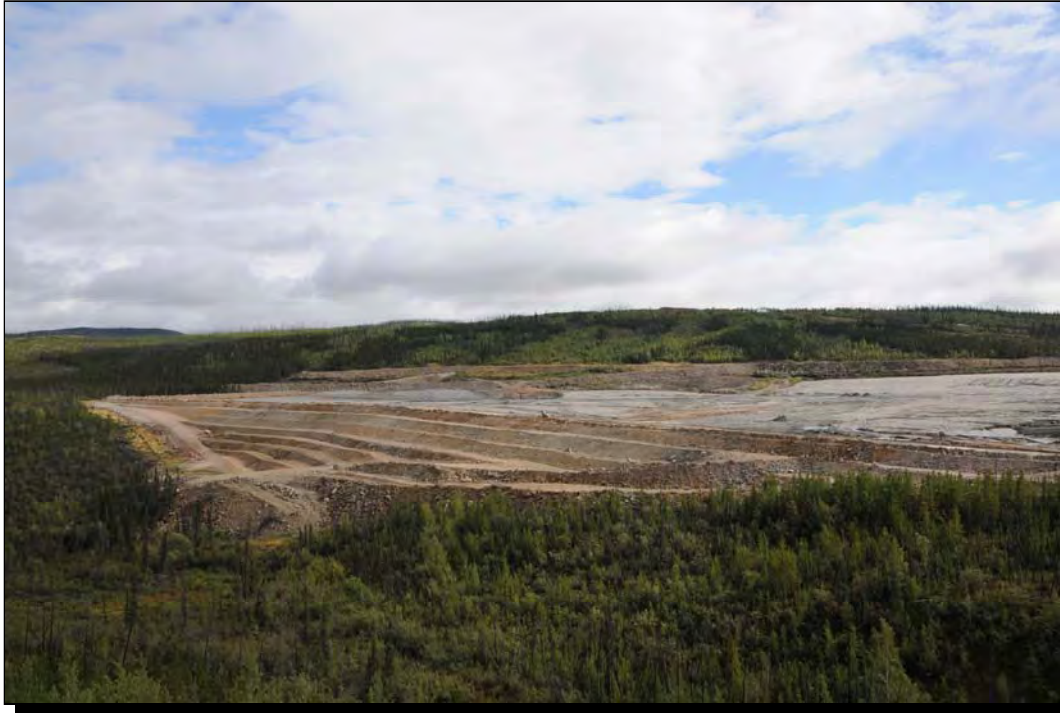
The DSTSF occupies the south slope of Minto Creek valley, immediately east of the Area 1 Pit. A view of the facility from across the valley is shown in Photo 1. The geotechnical information available at the time the design was prepared in 2006 was collected in 1994 and 1996 for an earlier mine development proposal. This data did not include reference to the unexpected thickness of fine grained overburden soils that extend to depths greater than 50 m, which have been exposed in the mining at the Area 1 Pit and recorded in recent

Photo 1
Overview of DSTSF Aspect: Southeast (Photo taken August 18, 2010)

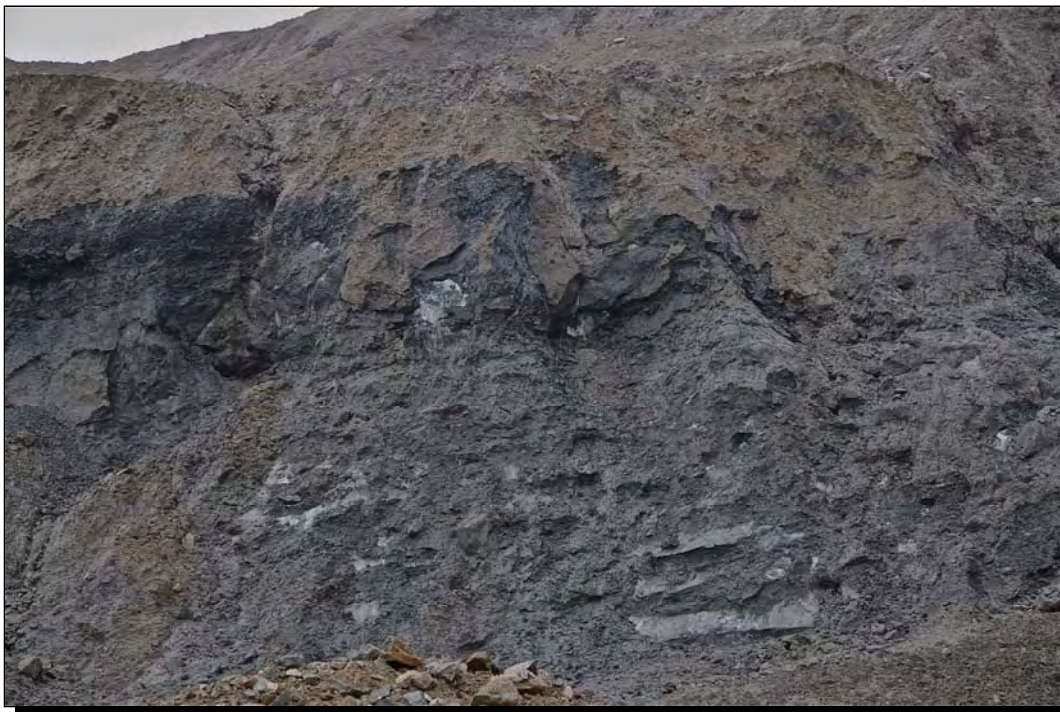
investigations. The soils are in a permafrost condition and contained substantial ground ice in the form of thick lenses and massive ice bodies with some thicknesses exceeding 1 metre. The presence of clay soils with substantial ground ice required a redesign of the final wall slopes and selective excavation of the frozen ground. Photo 2 is a photograph of an exposure of permafrost clay and till with massive ice exposures, taken during the site reconnaissance on August 18, 2010, as the excavation of the south wall 810 m bench was ongoing.

The deep deposits of ice-rich permafrost clay and clay till encountered in the south slope, of the Minto Creek valley and exposed in the Area 1 Pit were not expected nor were they predictable from the drilling that was conducted. These warm permafrost clay deposits extend eastward below the south valley wall and underlie the core of the DSTSF. Boreholes drilled in this area at various stages of mine planning in 1996 encountered mostly granular soils that are a weathering product of the upland country rock. Although these granular soils were in a permafrost condition, they were judged to not pose any particular hazard to the stability of the proposed tailings stack. Data obtained from the 2010 instrumentation program has shown that a substantial clay layer is present below the granular soils at depths below original ground in the order of 35 m (DSI4) and the clay seams extend to depths in the order of 60 m below original ground before bedrock is encountered. Drilling and sampling of the deep permafrost clay deposit identified layers of ice up to 1 metre thick (DSI4 at 53 m, April 2010). These deep clays with warm segregated ground ice have been clearly identified in all the slope indicator data as the zone where movements are now occurring.

Photo 2
Ice exposed in cut for the 810 m bench in Area 1Pit (Photo taken August 18, 2010)

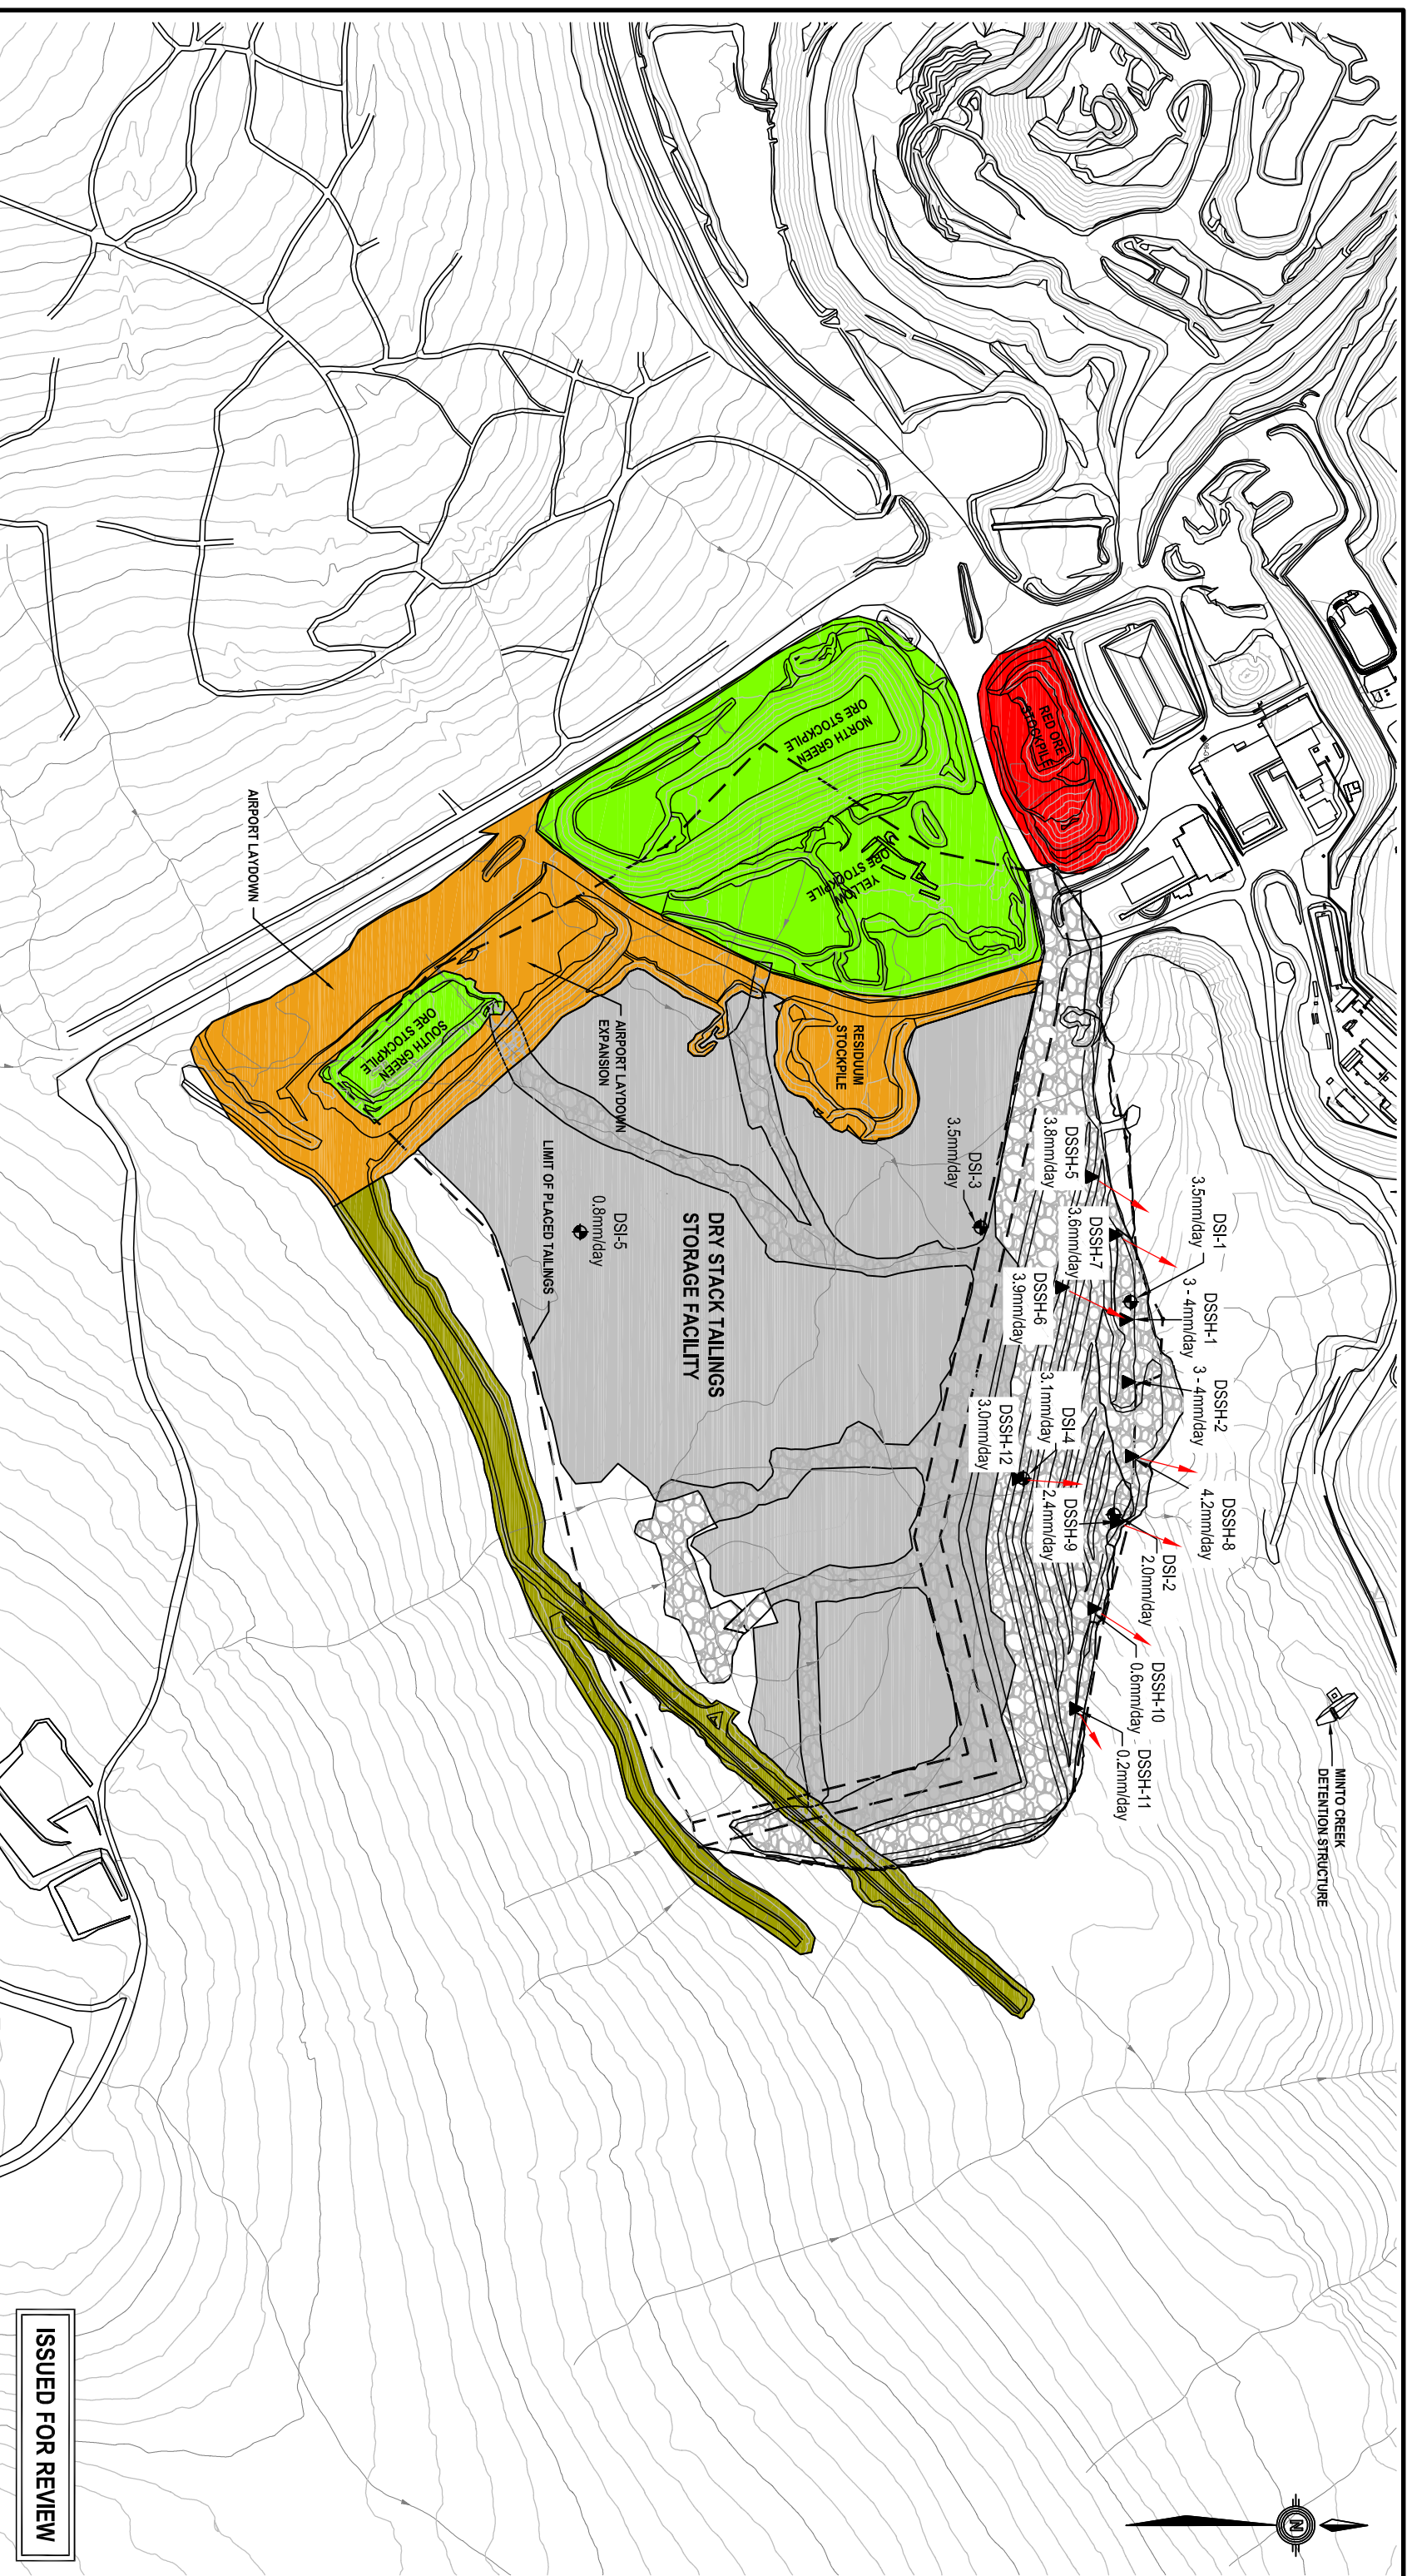
the linear nature of the data. Drawing DSTSF-INC-9 presents the movement rates and scaled vectors for the survey hubs. Survey hub coverage throughout the central and east portion of the waste rock shell is quite good; while additional coverage is required in the south and west portion of the facility.

- Monitor DSI-5 on a weekly basis.
- Continue to observe on a systematic basis both the valley bottom and DSTSF for signs of distress.
- Install additional survey hubs and inclinometers to delineate the extent of movement. This could be a phased approach depending on the results observed.
