## 2014 Geotechnical Inspection Tailings Management Facility Sä Dena Hes, Yukon Territory

SRK Consulting (Canada) Inc.  
1CT008.046  
December 2014

Project No: 1CT008.046

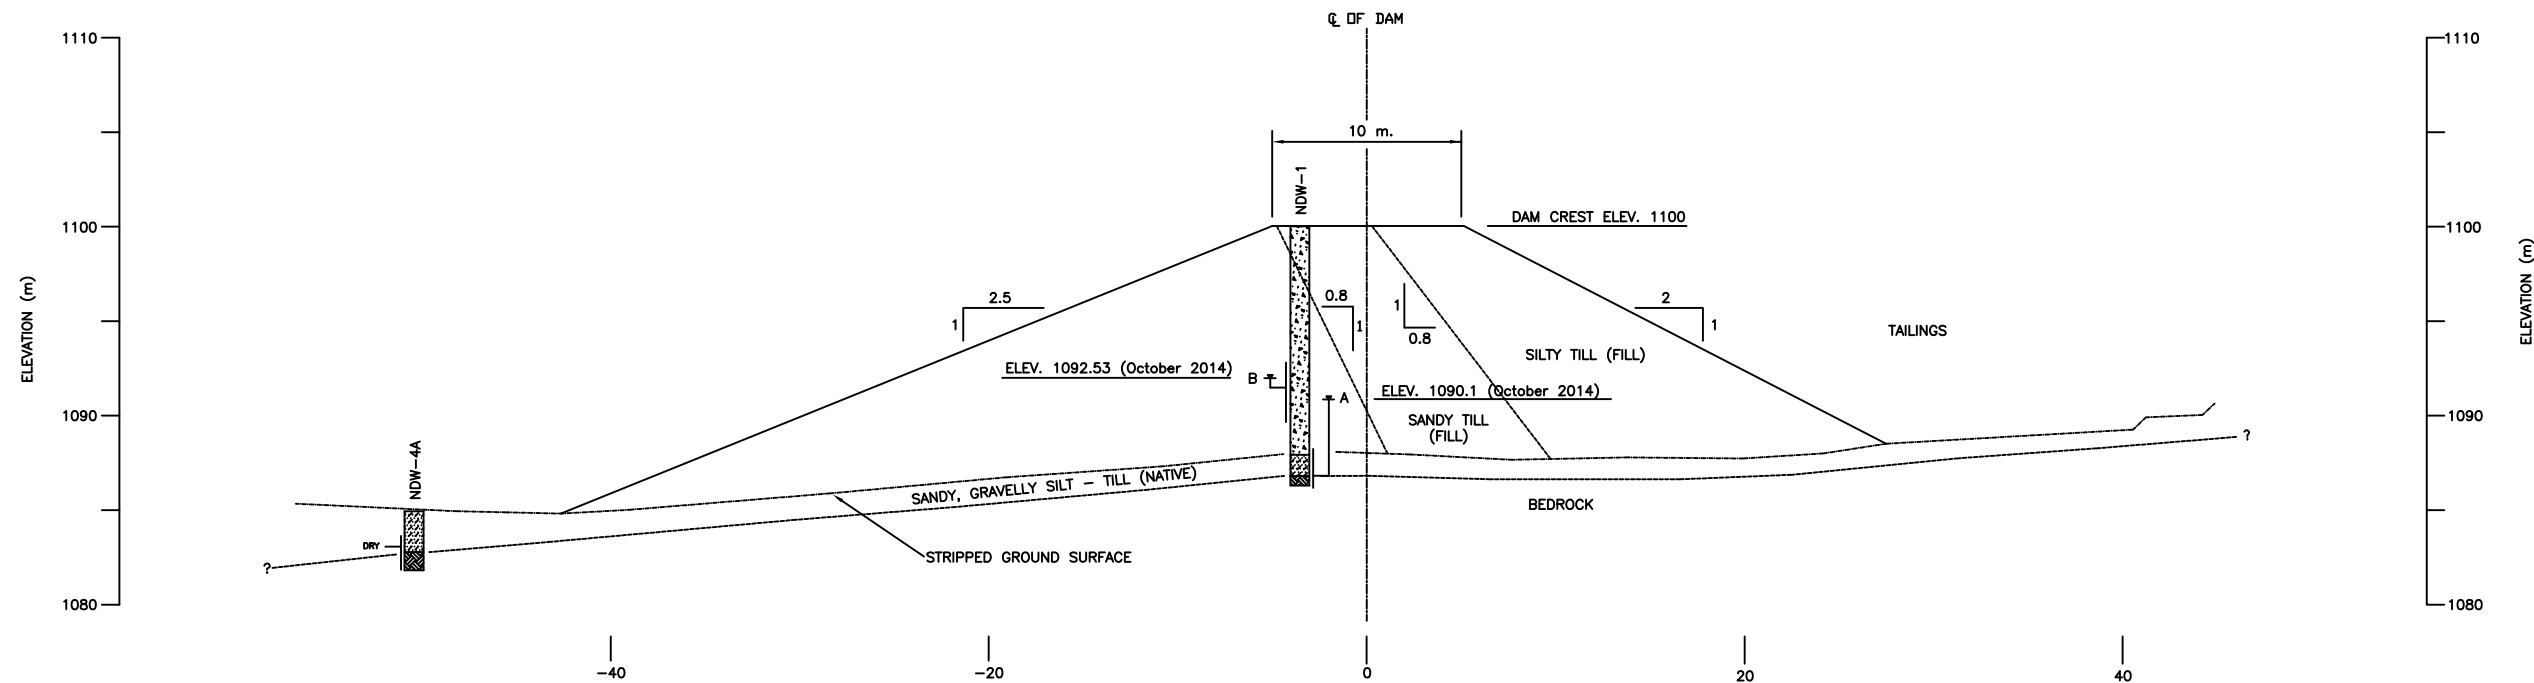
2014 Geotechnical Inspection	
		Section 0+400 North Dam	
SRK JOB NO.: 1CT008.046 Task: 1200 FILE NAME: 1CT008046-1200_Fig3.dwg	Sa Dena Hes Mine	DATE: December 2014	APPROVED: P.M.H.
		FIGURE:	3

The water levels in the piezometers are recorded monthly when accessible and the 2014 data are presented in Appendix B. Levels recorded in October 2014 are plotted on the dam section shown on Figure 3. The seasonal fluctuations recorded this year in the piezometric levels are generally consistent with those in previous years and are within acceptable tolerance limits.

DATE	T.O.P.	READING	ELEV.
NDW-1B	October 2014	1100.57	8.04	1092.53
NDW-1A	October 2014	1100.69	10.59	1090.1

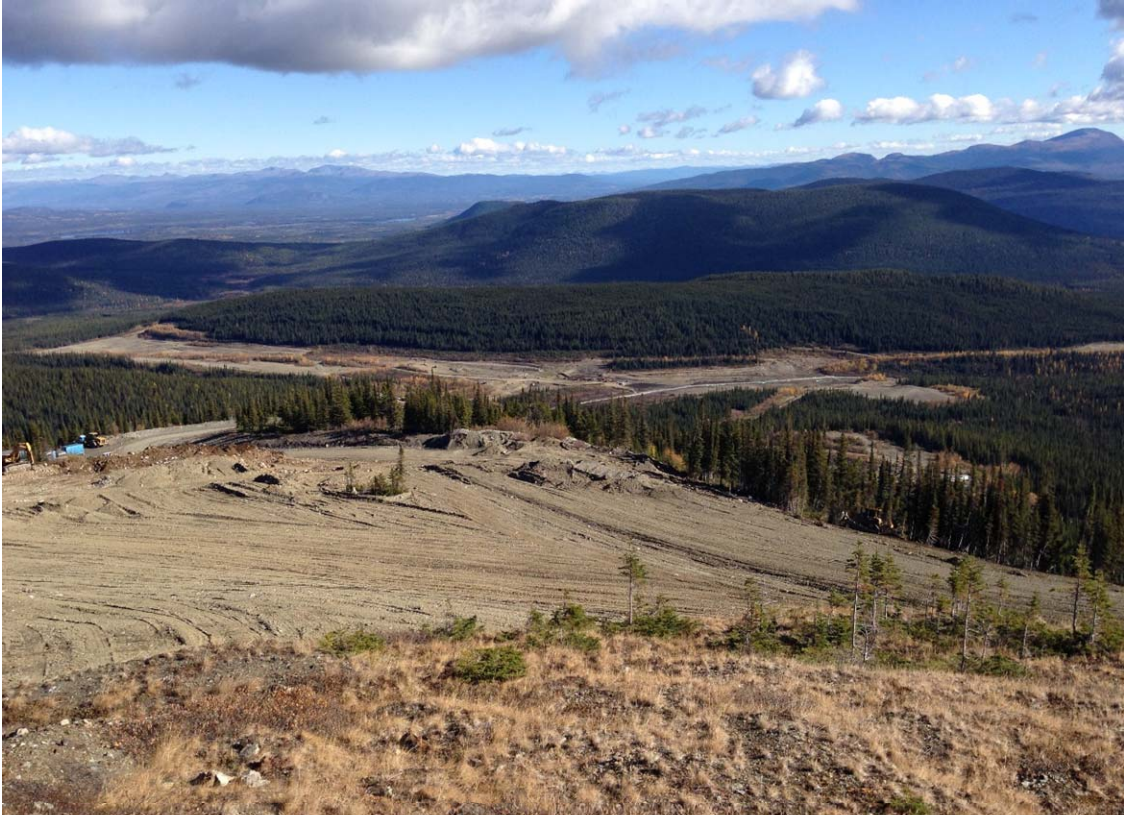
A site plan of the North Dam is presented on Figure 2 and a view of the TMF taken from the Jewelbox waste rock dump is shown in Photo 1.

**Photo1: View of the Decommissioned TMF from Jewelbox Waste Rock Dump (Sept 23, 2014).**

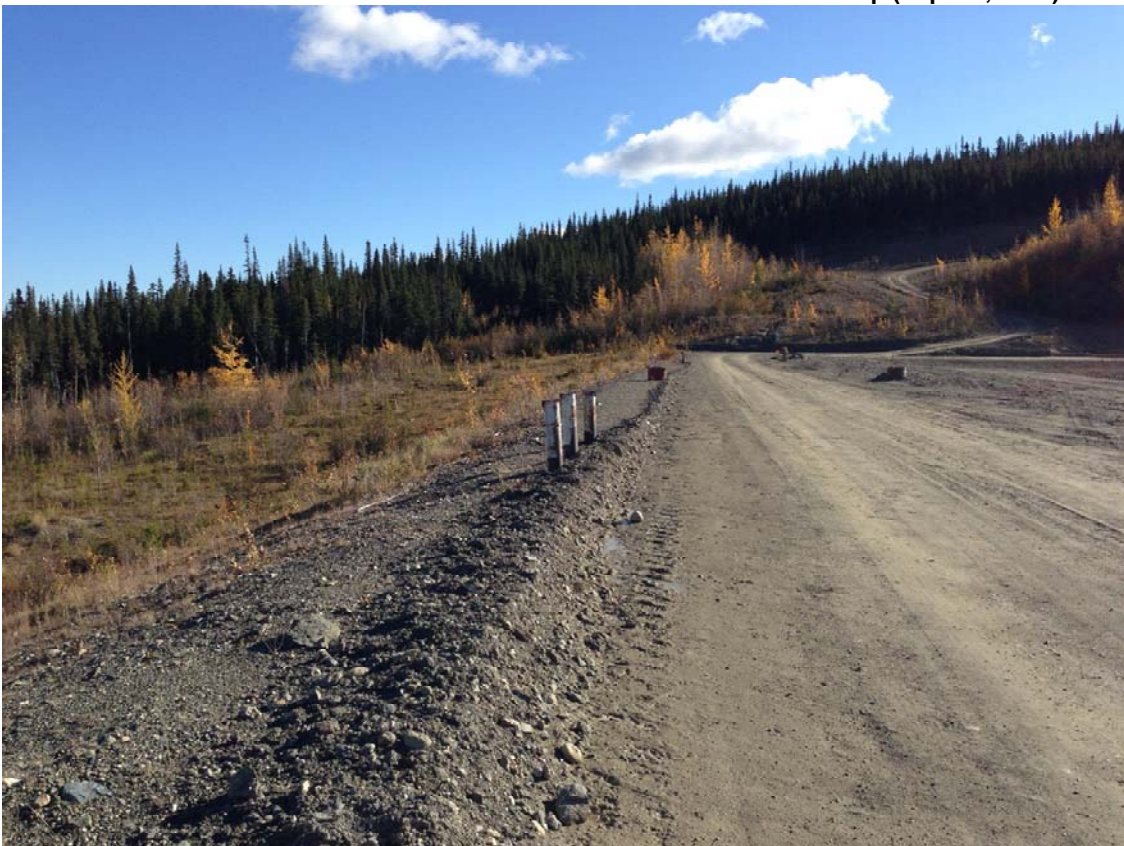
The crest of the North Dam (Photo 2), which is at an elevation of 1100 m, shows no signs of deformation or abnormal settling. The downstream slope of the dam shows no signs of surficial movement or erosion nor is there any sign of bulging at the downstream toe.

The piezometers and protective caps (Photo 2) along the crest of the North Dam remain intact. Some of the deformation monitoring pins and the original settlement gauges protected by 40-gallon drums are still evident on the crest of the dam. Labels on each of the piezometers have recently been upgraded to lower the risk of damage by the elements.

**Photo 2: View east along the North Dam Crest.**

- Continue to take monthly water level readings from the top of the 2" diameter plastic piezometers inside the casing in accordance with the OMS manual. Water levels should not be measured from the rim of the steel casing.
- As Teck has decided to adopt the 2012 datum for the site, the conversion from depths to elevation in future should be carried out using this datum.
- During the construction season in 2015, SRK recommends that readings be taken of the settlement gauges on the North dam and converted to the new datum.
- Continue to monitor the flow at MH-02 monthly and collect water quality samples in accordance with the OMS and the water licence.

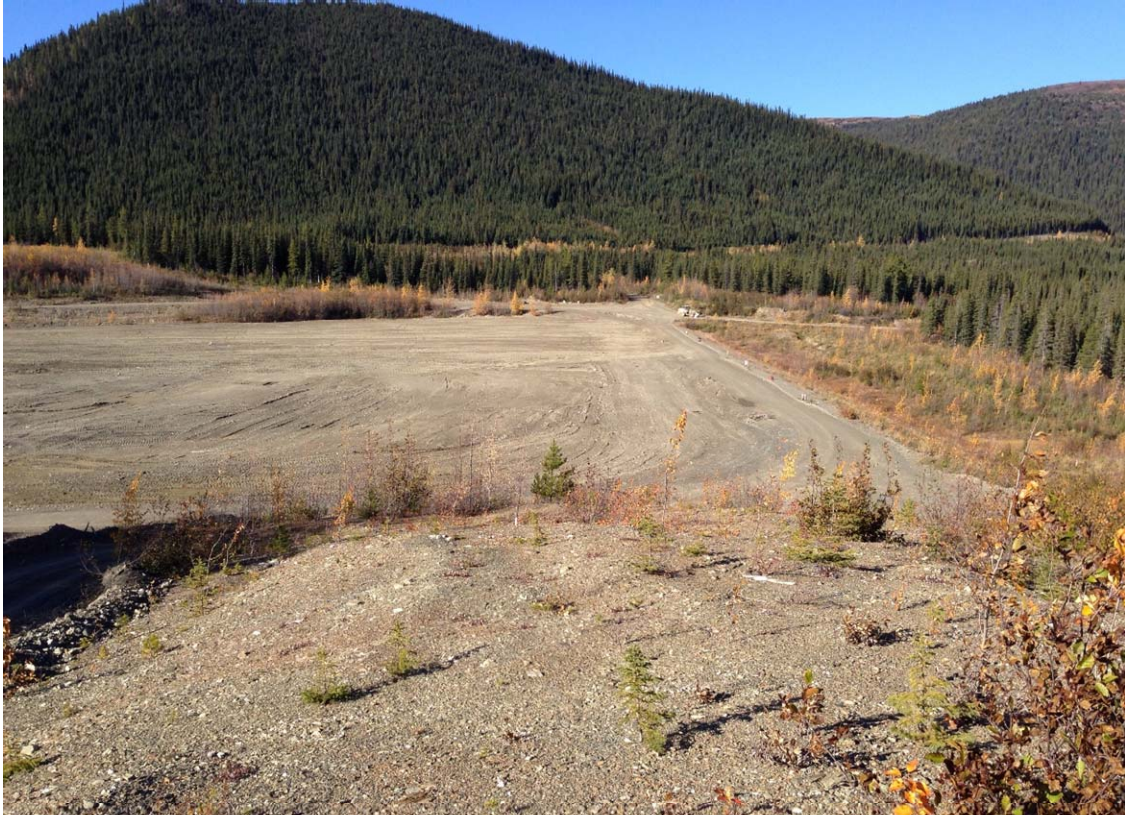
Photos 3 and 4 show the soil cover that was placed in 2014 over the northern portion of the tailings stored in the TMF. By the end of the 2014, 95% of the cover had been placed over the entire TMF area.

**Photo 3: View looking east along the North Dam and the soil cover that was placed over the tailings (Sept 23, 2014).**

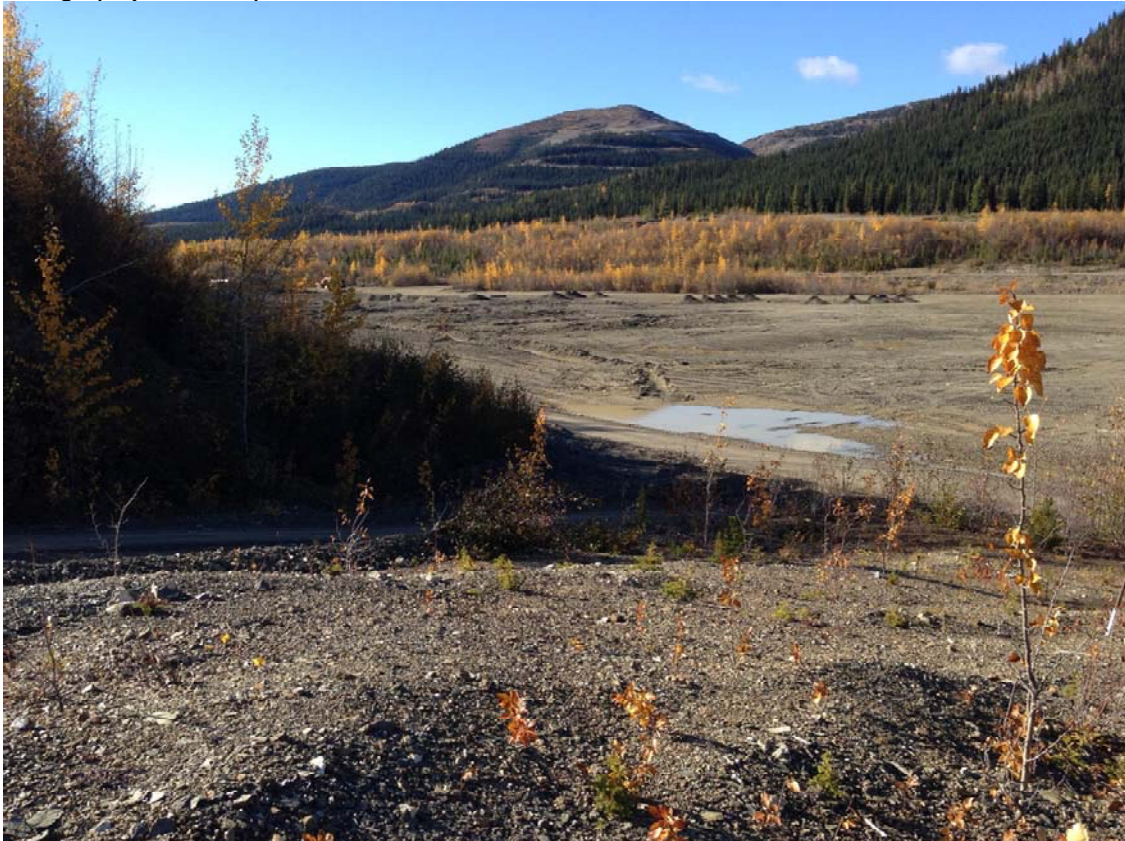
**Photo 4: View over the capped tailings surface at the north end of the TMF (Sept 23, 2014).**

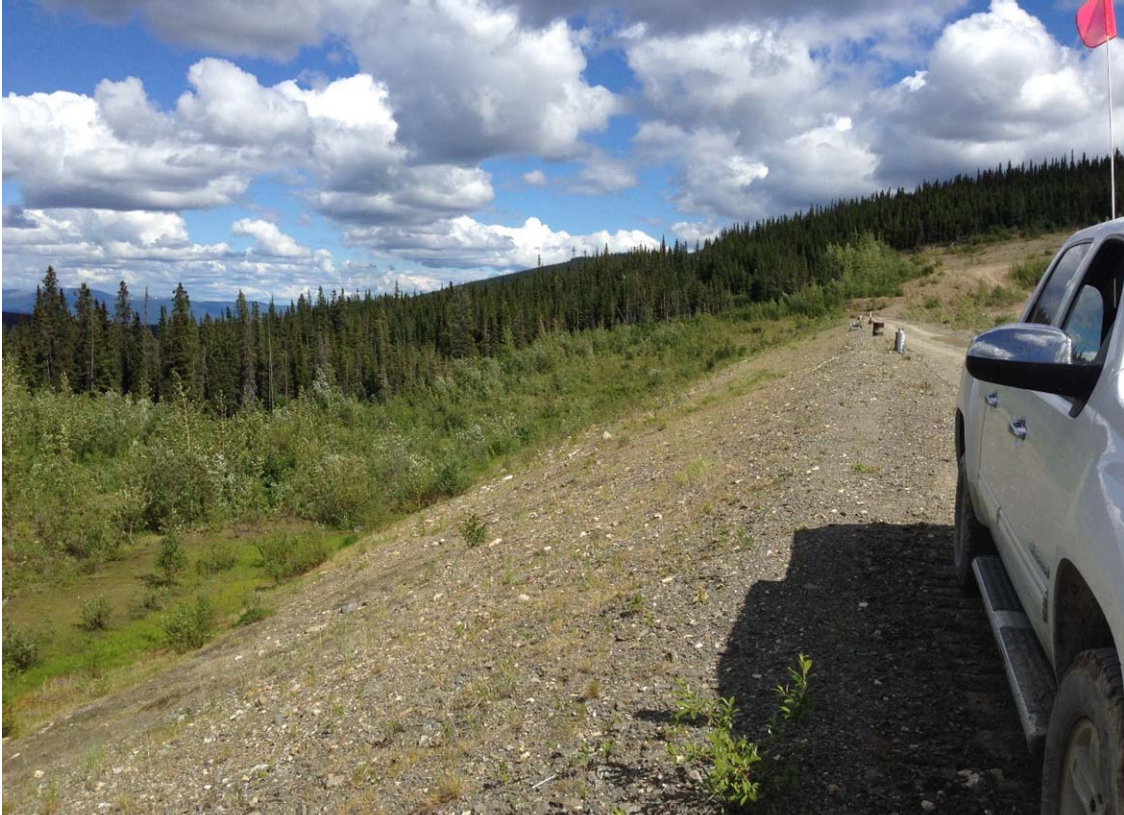
Photo 5 shows the downstream face of the North Dam which was originally built with a slope of 2.5H:1V. Along the toe of this slope there is an 80 m seepage zone. This seepage is collected at a monitoring station referred to as MH-02 and is a combination of groundwater discharge from the surrounding hillsides to the west and minimal seepage flow from the impoundment.

**Photo 5: View of the downstream face of the North Dam.**

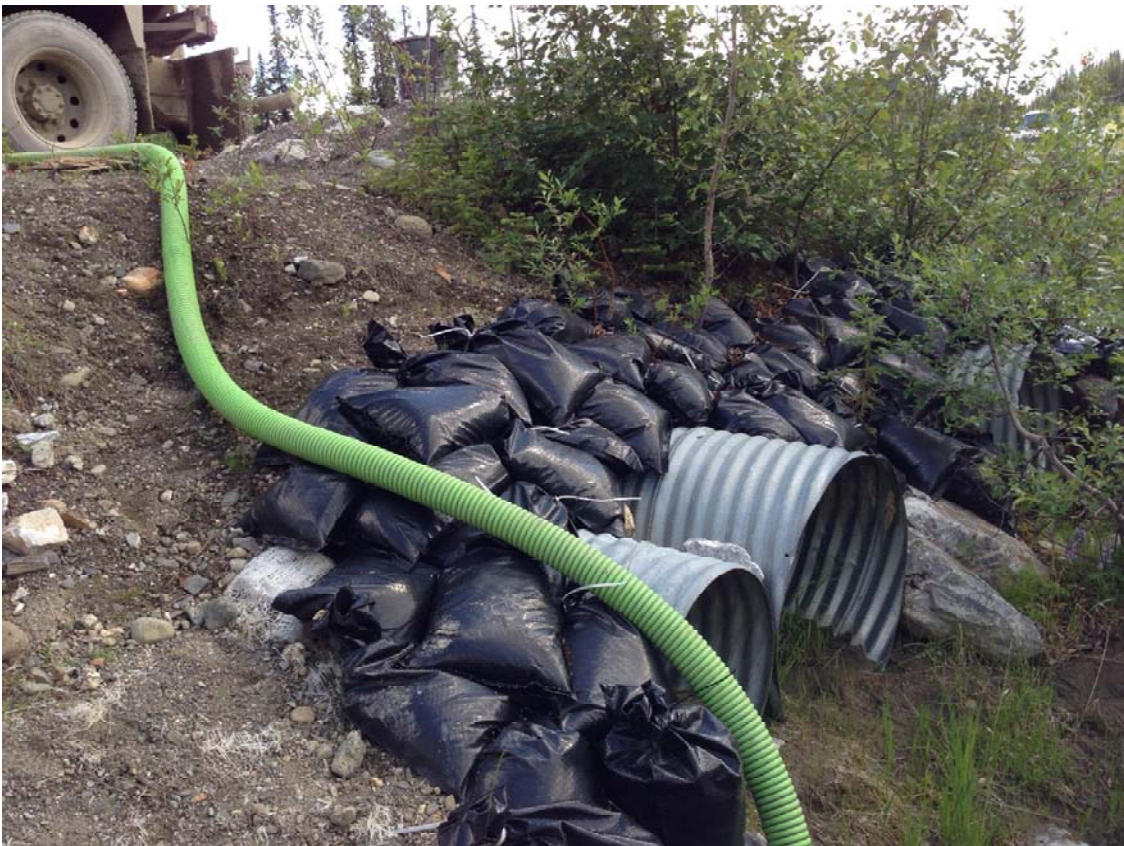
No tension cracks were noted on the dam crest and the upstream and downstream faces were stable. Sandbags that had been placed around the inlets to the three culverts were still in place (Photo 6). No signs of deformation or abnormal settling were observed.

**Photo 6: Inlet Culverts at the North Creek Dyke.**

Monthly inspections should be made of the site to ensure no blockage of the culvert has occurred. Remove any debris that accumulates at the inlet to the culvert when needed.

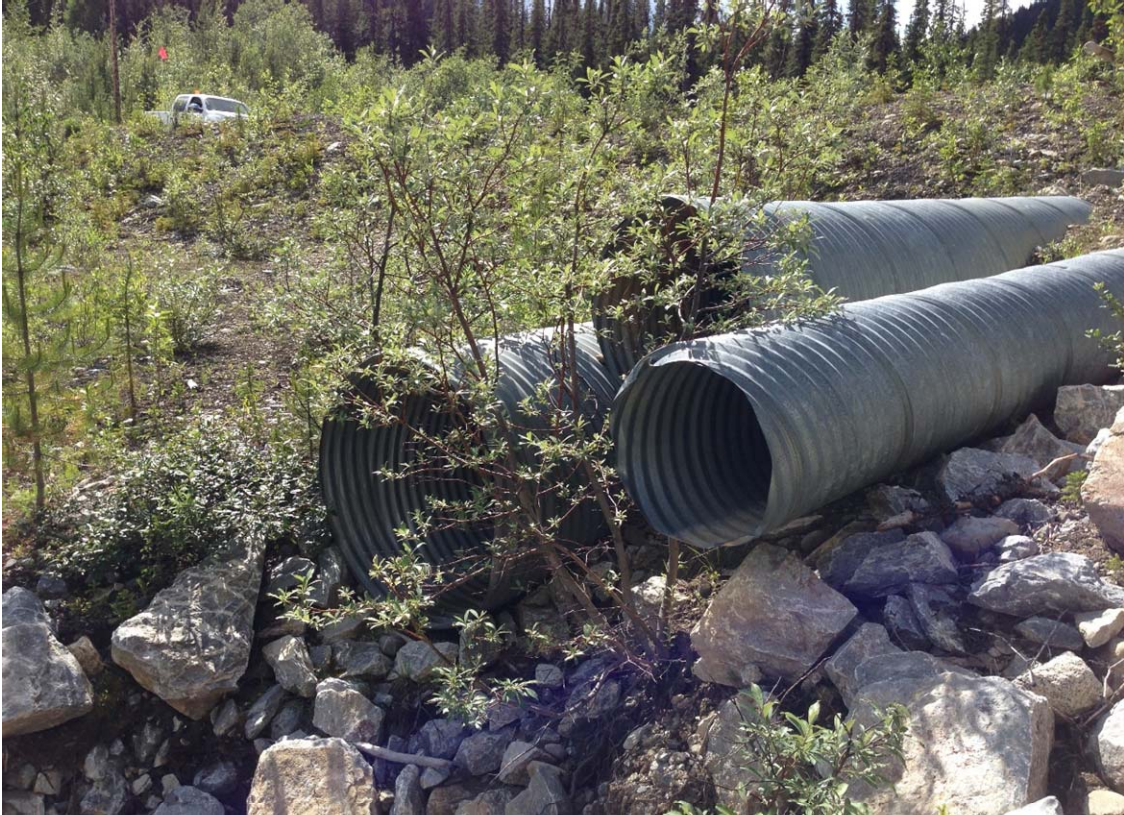
Vegetation is taking hold on the downstream face of the dyke. No significant rills or erosion gullies were evident on the face (Photo 7).

There has been no change in the condition of the three overflow pipes (Photo 7) and an inspection of the buried joint between the 1200 mm and 1000 mm pipe found that it has remained secure. The downstream end of the lower 600 mm pipe is shown on Photo 8.

**Photo 7: Outlet culverts at the North Dyke.**

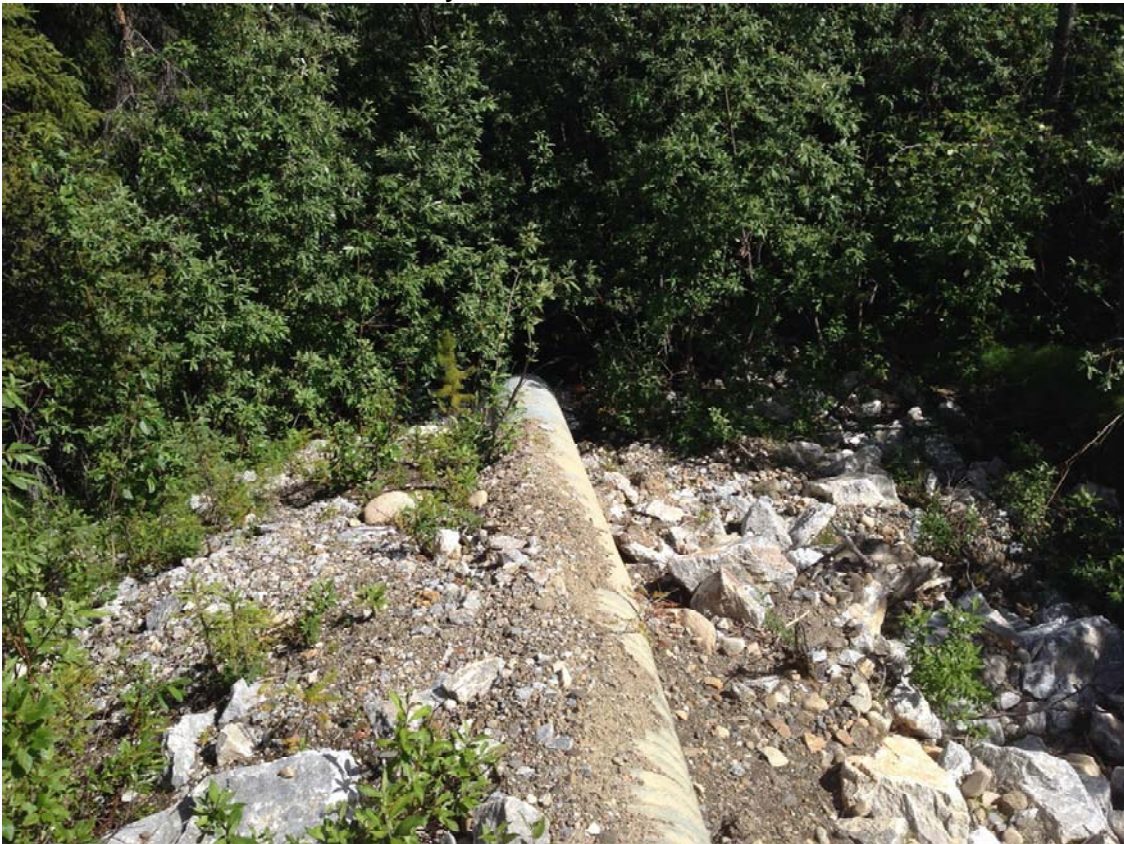
**Photo 8: Main outlet culvert at the North Creek Dyke.**

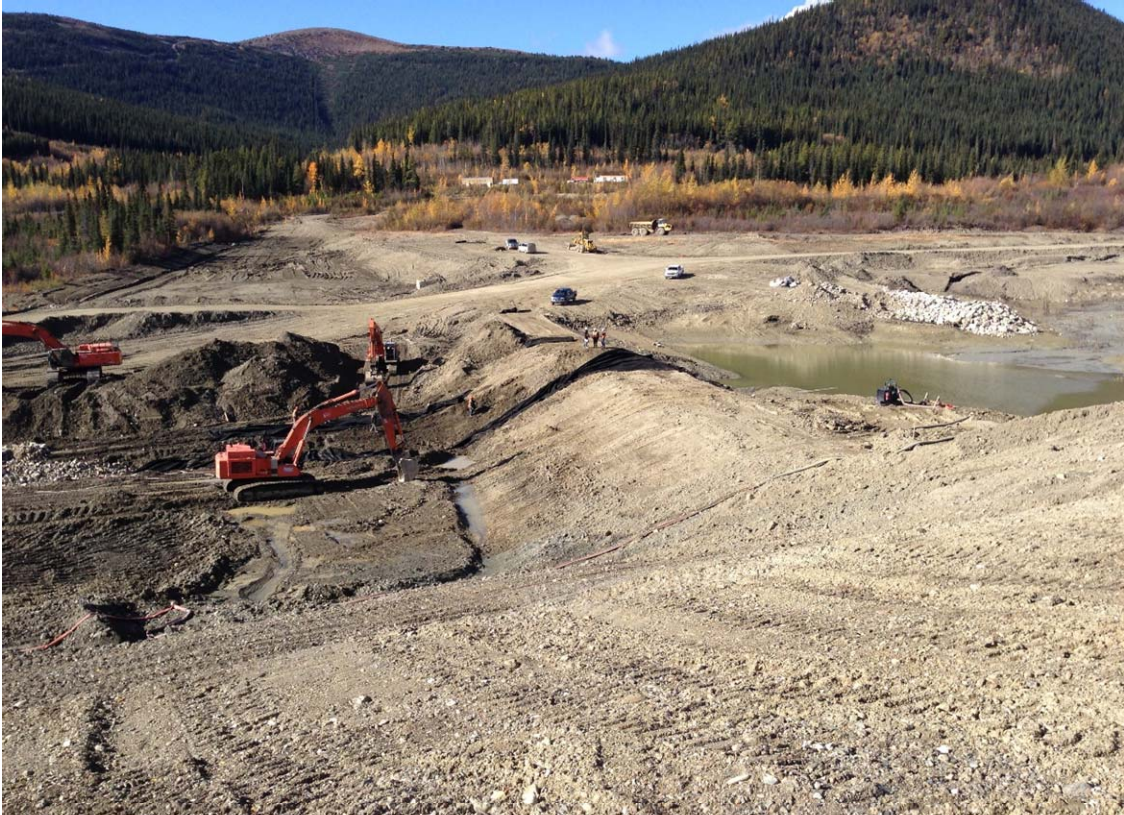
As stated above, the decommissioning plan included the construction of a 5 m (approx.) high sediment retaining structure (SRS) along the upstream toe of the removed South Dam to contain any sediment from erosion of the tailings cover during the early stages of reclamation/ revegetation. Photo 9 provides a view looking west over the original location of the South Dam. The construction of the spillway through the sediment retaining structure can be seen in the middle of the photo.

**Photo 9: View looking west along the centerline of the removed South Dam. The SRS is seen in the middle of the photo with the filter fabric being placed in the new emergency spillway.**

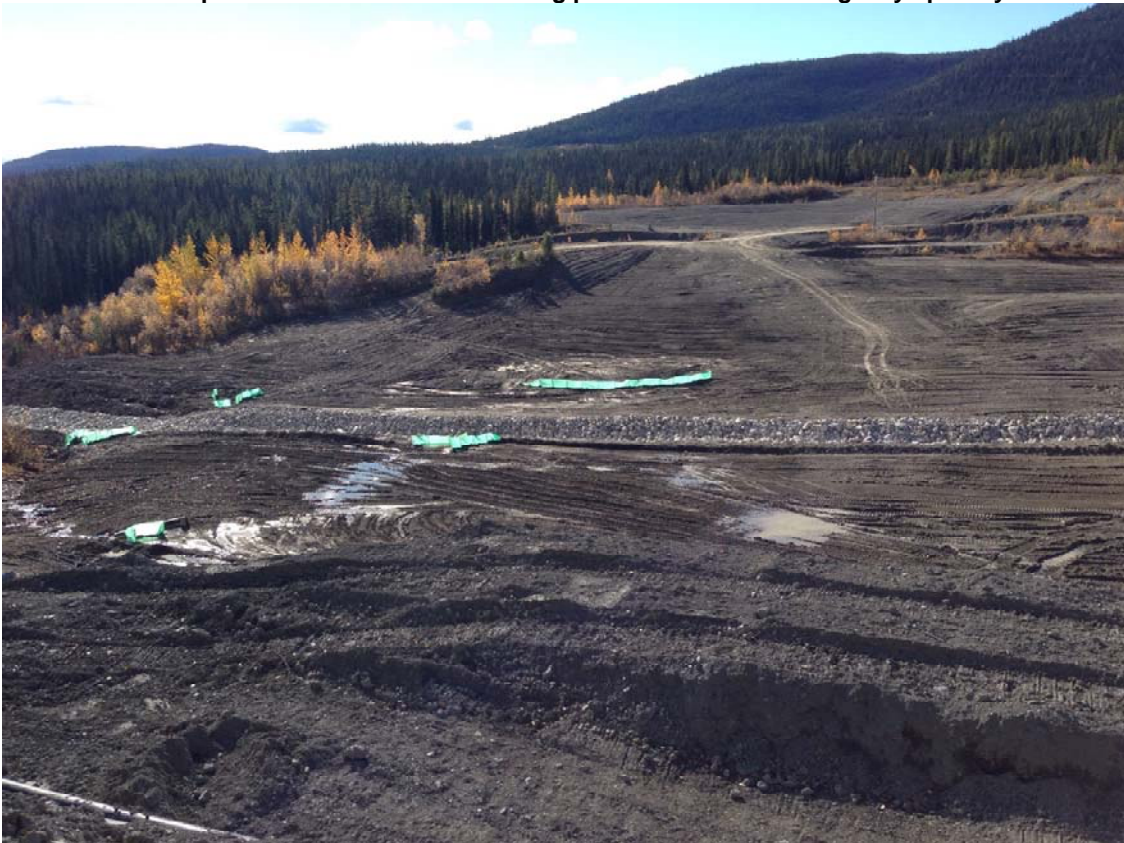
The Reclaim Dam was also decommissioned during the 2014 construction season by excavating and placing the fill material as a soil cover over the tailings surface. Excess fill material not used as a cover was placed in an area just west of the Reclaim Dam buttress previously referred to a borrow area G. A photo looking west over the original location of the Reclaim Dam is shown in Photo 10.

**Photo 10: View looking west along the alignment of the removed Reclaim Dam.**

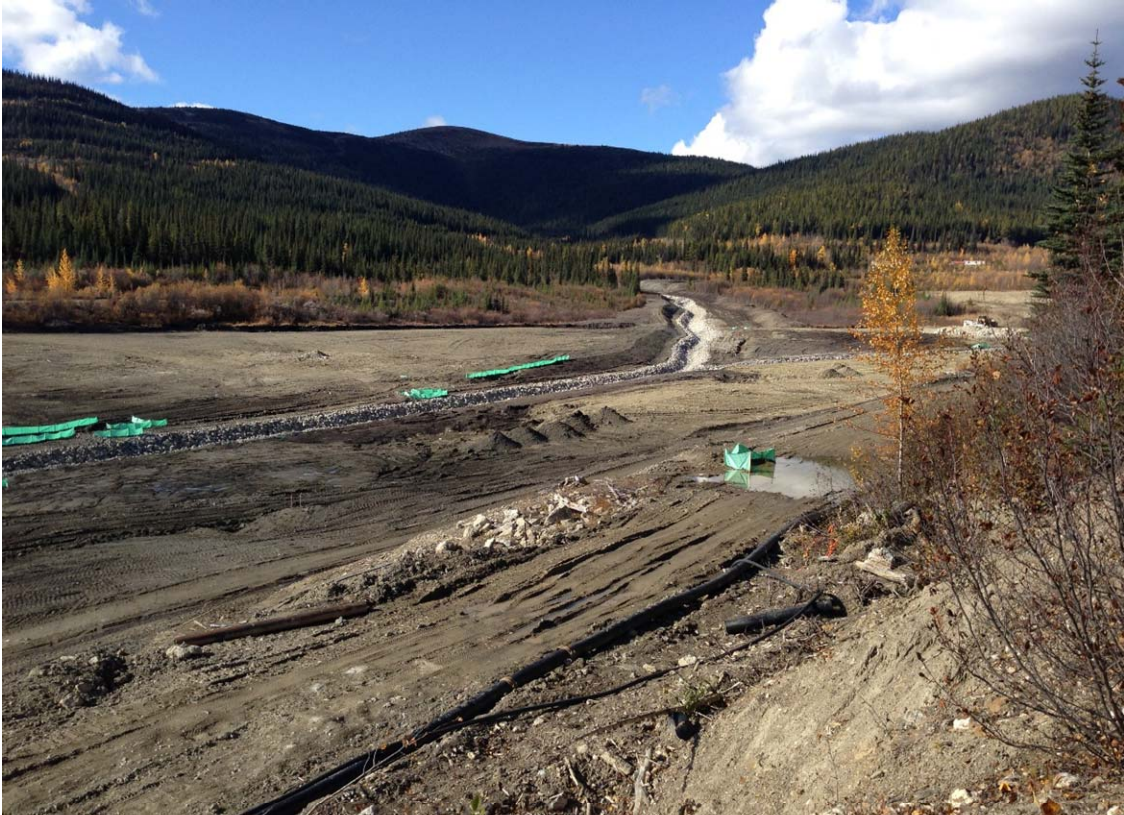
Photo 12 shows a west view of the newly constructed channel that was built to restore Camp Creek to its original alignment. A layout of this channel is shown on Figure 4.

**Photo 11: View looking west over the relocated Camp Creek in the riprapped channel.**

In 2015, Teck will complete the reclamation of the original Camp Creek diversion. This would involve recontouring of the area to provide positive drainage to the new channel. The two 1.2 m culverts would also be removed.

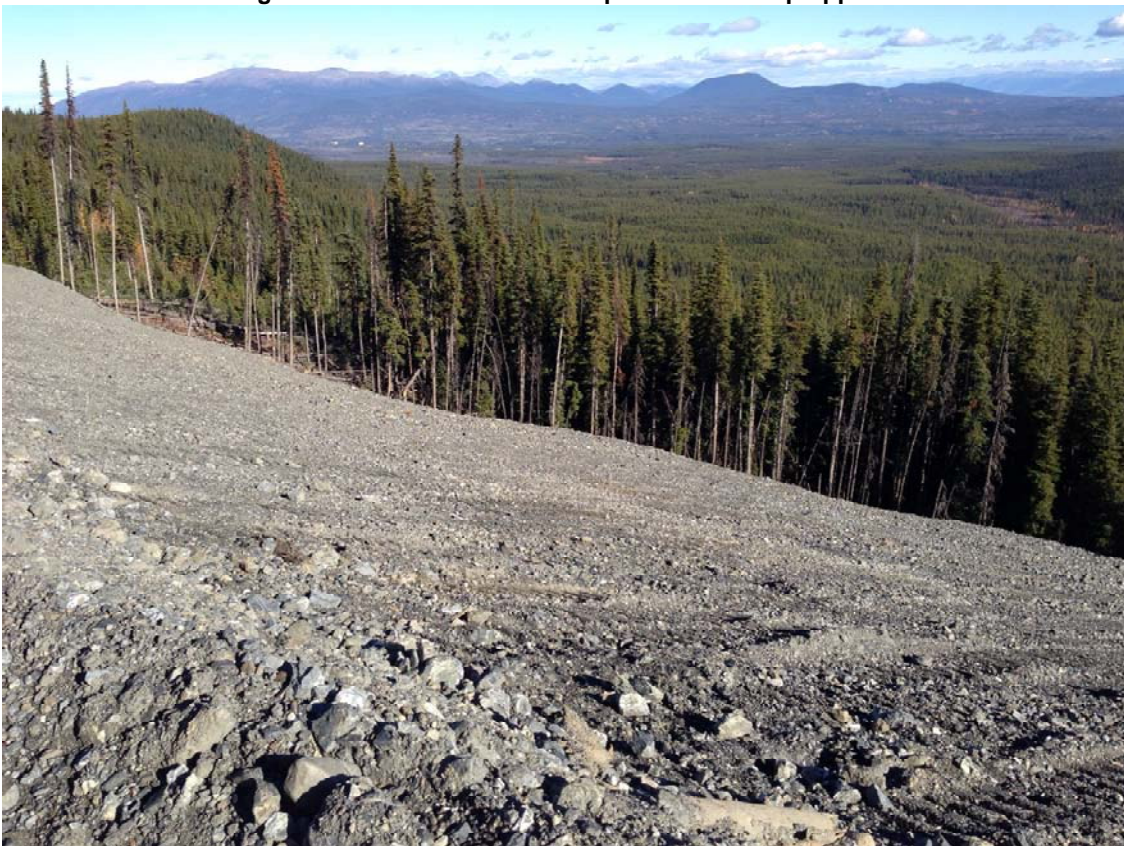
SRK inspected the Burnick waste dump at the 1200 portal (Photo 12). The location of this dump is shown in Figure 5. During the recontouring work this year, the dump face was flattened to ensure greater long term stability. No major toe movement or bulging was noted. SRK did not inspect the dump at the 1300 portal (see Figure 5) because of restricted access.

**Photo 12: Contoured lower slopes of the Burnick Waste Rock Dump.**

SRK recommends that Teck continue to inspect the Burnick 1200 and 1300 dump slopes and the dumps at Jewelbox and the Main Zone for any sign of vertical settlements or displacements.

SRK also recommends that Teck make annual checks of the slide area at the toe of the 1200 portal dump at Burnick for any sign of further movement.

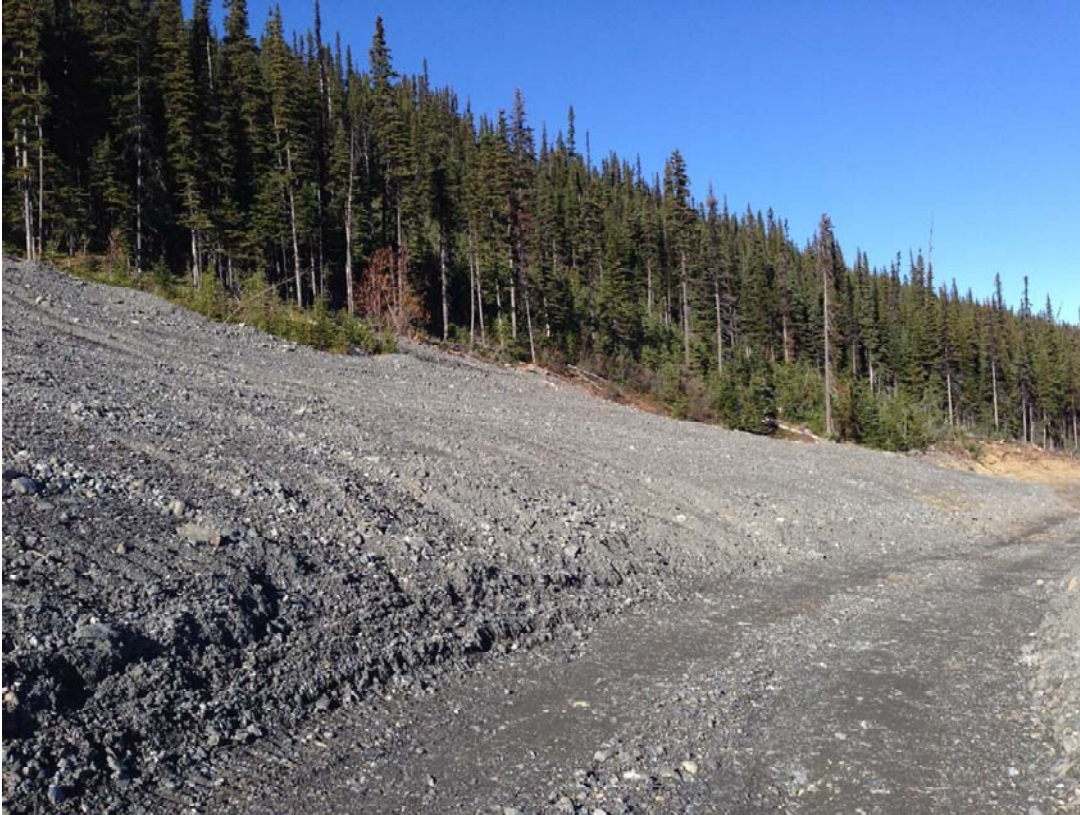
**Photo 13: Contoured backfill placed up against the 1200 Portal.**
