2015 Geotechnical Inspection Tailings Management Facility Sä Dena Hes, Yukon Territory

SRK Consulting (Canada) Inc.
1CT008.053
November 2015

Project No: 1CT008.053

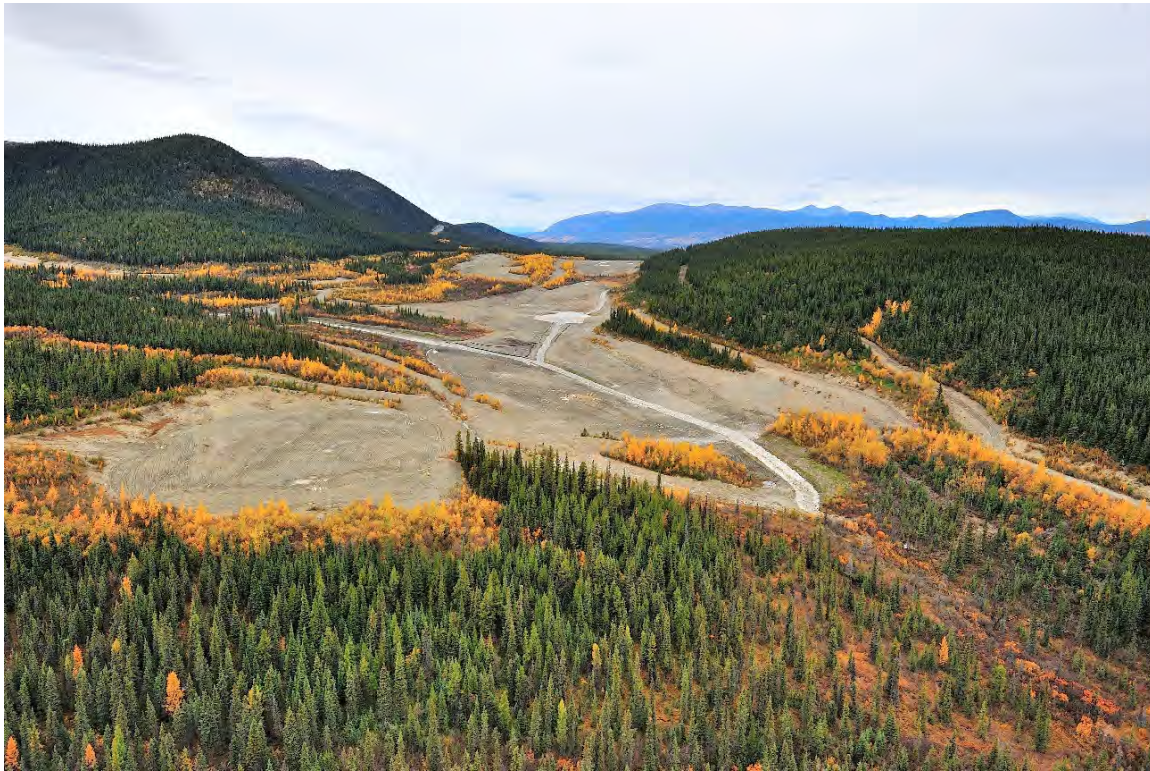
The new riprapped drainage channels (the North channel, the Camp Creek channel and the South channel) were constructed during the TMA decommissioning in 2014. Figure 7 provides a plan view of the three channels. SRK inspected each of the channels for any signs of subsidence and movement of the riprap erosion protection. Other than the silt build up at the toe of the exit

chute, no significant issues were noted. Photo 4 shows a northerly view of the Camp Creek and South channels.

Photo 4: View North of the new Camp Creek Drainage Channel

- Any sloughing of the diversion channel side slopes
- Any loss of the riprap erosion protection
- Any blockage of the outlets and inlets of the SRS spillway by ice and/or debris

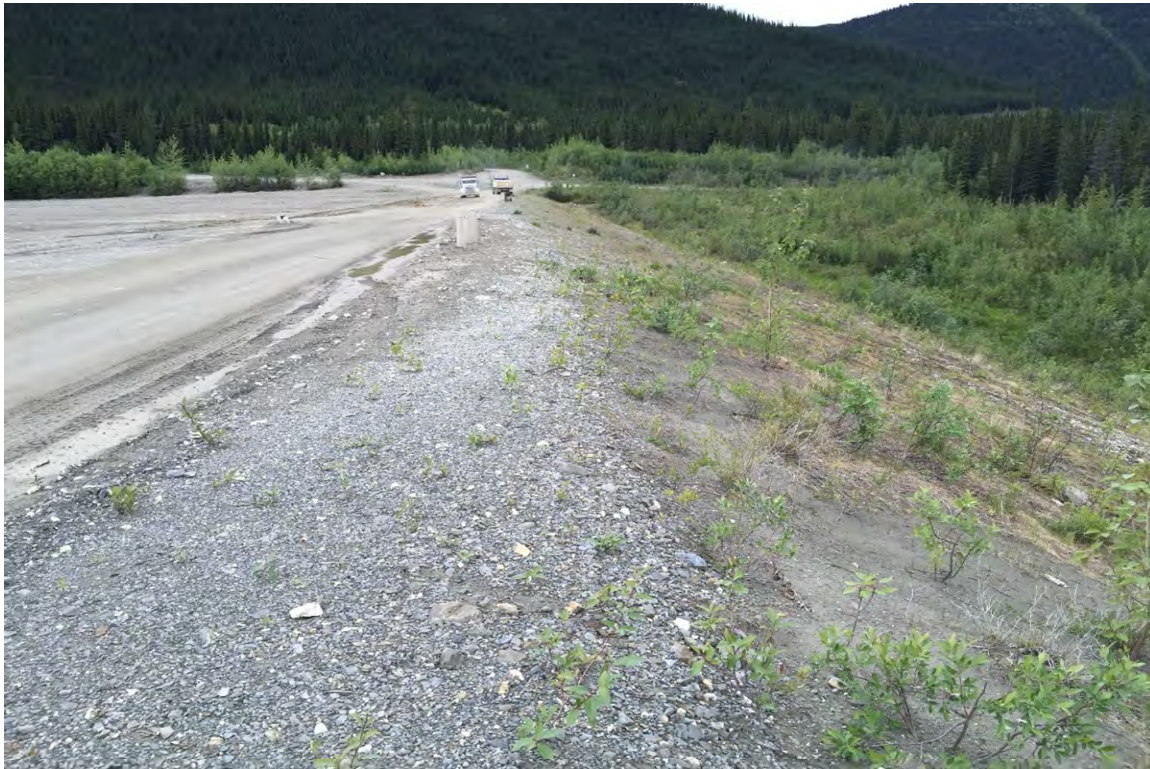
The crest of the North Dam (Photo 6), which is at an elevation of 1100 m, shows no signs of deformation or abnormal settling. The downstream slope of the dam shows no signs of surficial movement or erosion nor is there any sign of bulging at the downstream toe.

Photo 6: View looking west along the North Dam showing the downstream slope

- The following items should be noted during any inspections:
 - Any development of erosion on the slopes
 - Any noticeable settlement of the dam crest
 - Any subsidence on the downstream slope

- Any wet spots on the sideslopes
 - Any changes in rate, colour or turbidity in the seepage
 - Any new seeps, boils or soft areas along the toe

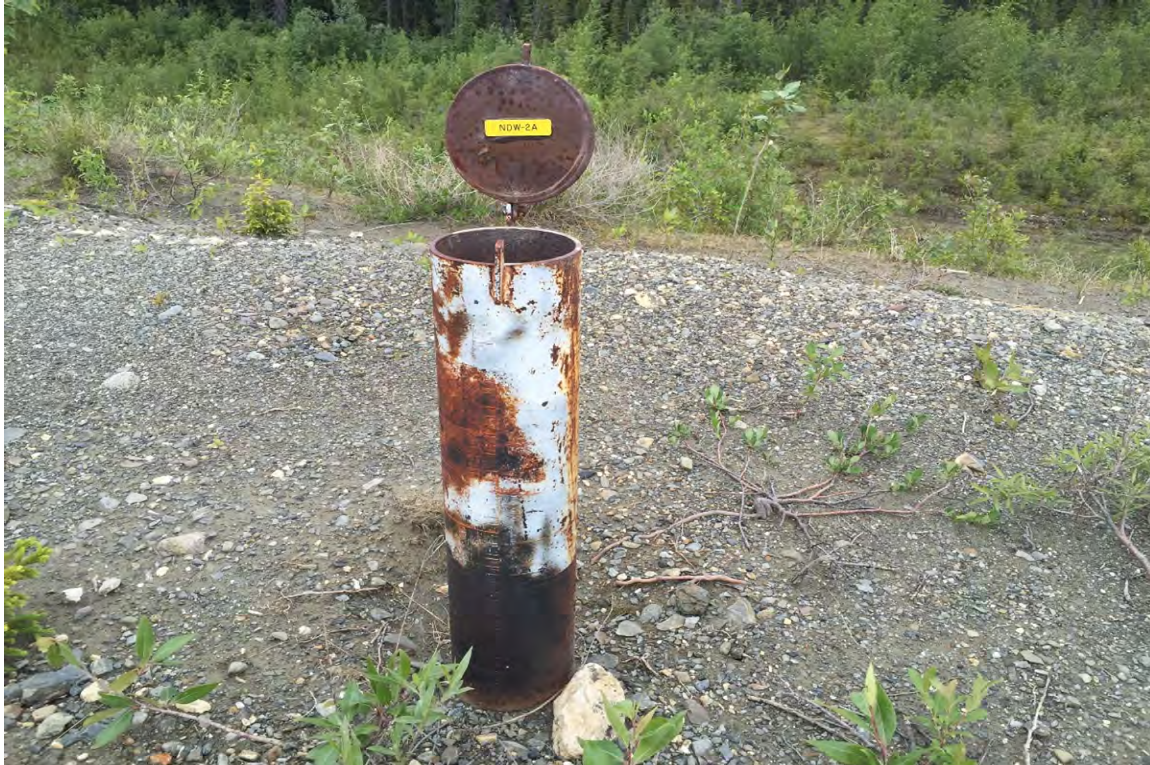
The three sets of piezometers and protective caps (Photo 7) along the crest of the North Dam remain intact. Some of the deformation monitoring pins and the original settlement gauges protected by 40-gallon drums (Photo 9) are still evident on the crest of the dam but currently serve very little purpose. Labels on each of the piezometers were recently upgraded and are weathering the elements well.

Photo 7: Protective steel casing for the Piezometers in the North Dam

- Take water level readings from the top of the North Dam 2” diameter plastic piezometers inside the casing during the bi-monthly (every two months) site visits for the next two years. If site is considered stable, the readings would be reduced to bi-annually (twice a year) for the

- following three years and then annually for a period of five years. Water levels should not be measured from the rim of the steel casing.
- As Teck has decided to adopt the 2012 datum for the site, the conversion from depths to elevation in future should be carried out using this datum.

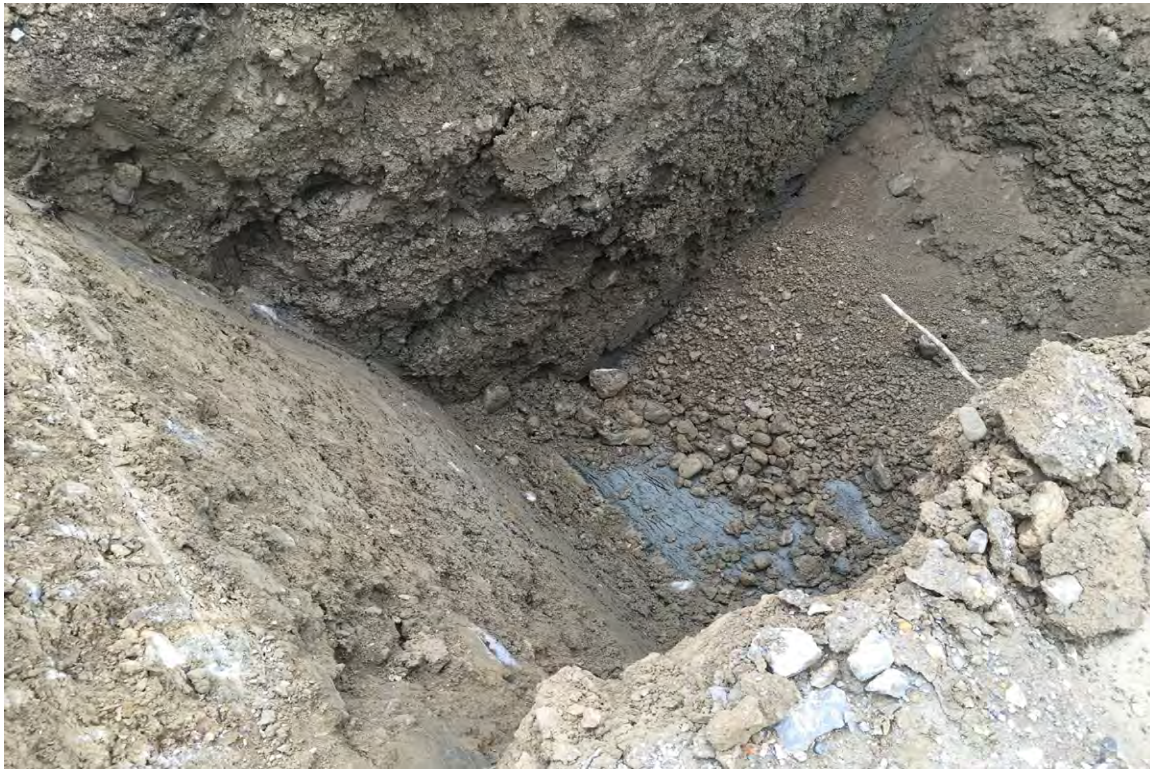
Photos 2 and 5 show the soil cover that was placed in 2014 and 2015 in the TMA. Photo 10 indicates the depth of the cover in one location.

Photo 10: Test through the till cover on the tailings. Depth of cover about 2.14m

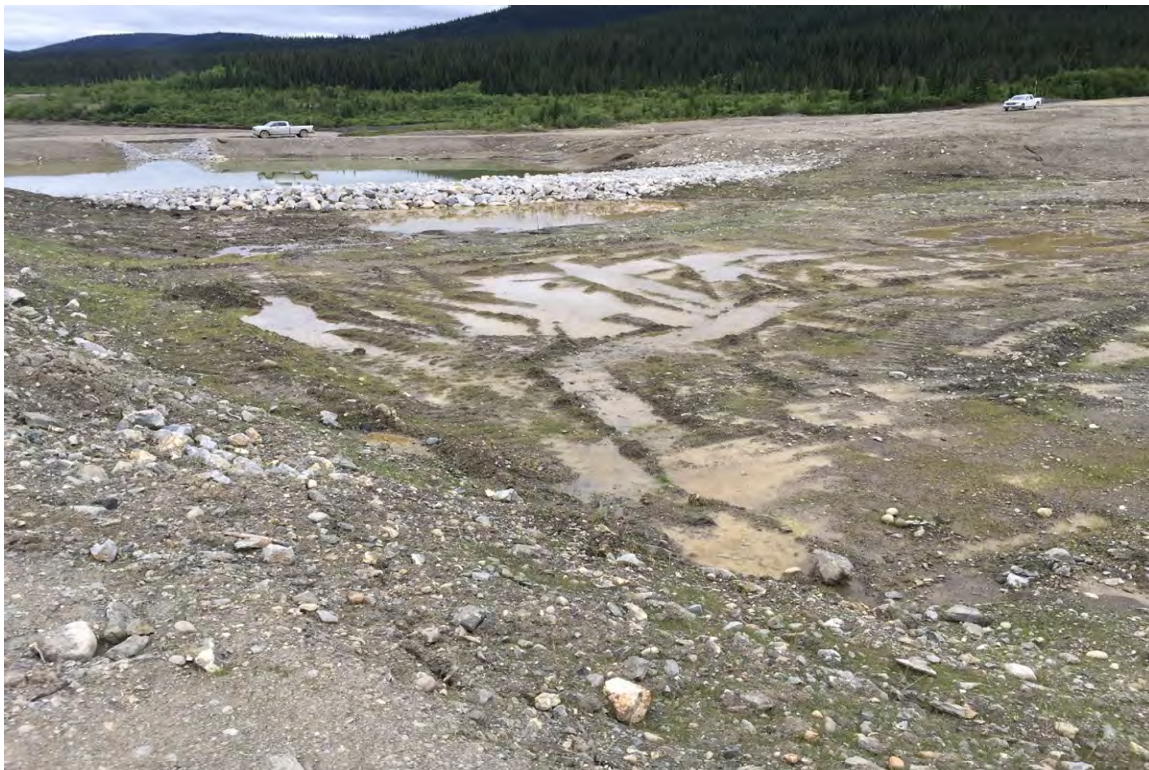
During the placement of the till cover just above the SRS pond, a rock cofferdam (Figure 6 and Photos 13 and 14) was constructed to retain the movement of tailings that had liquefied as a result of the vibration caused by the earth moving machines. This cofferdam successfully stopped the slow moving tailings. Some of the excess riprap that was used to build the cofferdam was used to repair the spillway exit chute and to riprap the channel built along the downstream toe of the SRS.

Photo 13: View of the rockfill cofferdam above the SRS

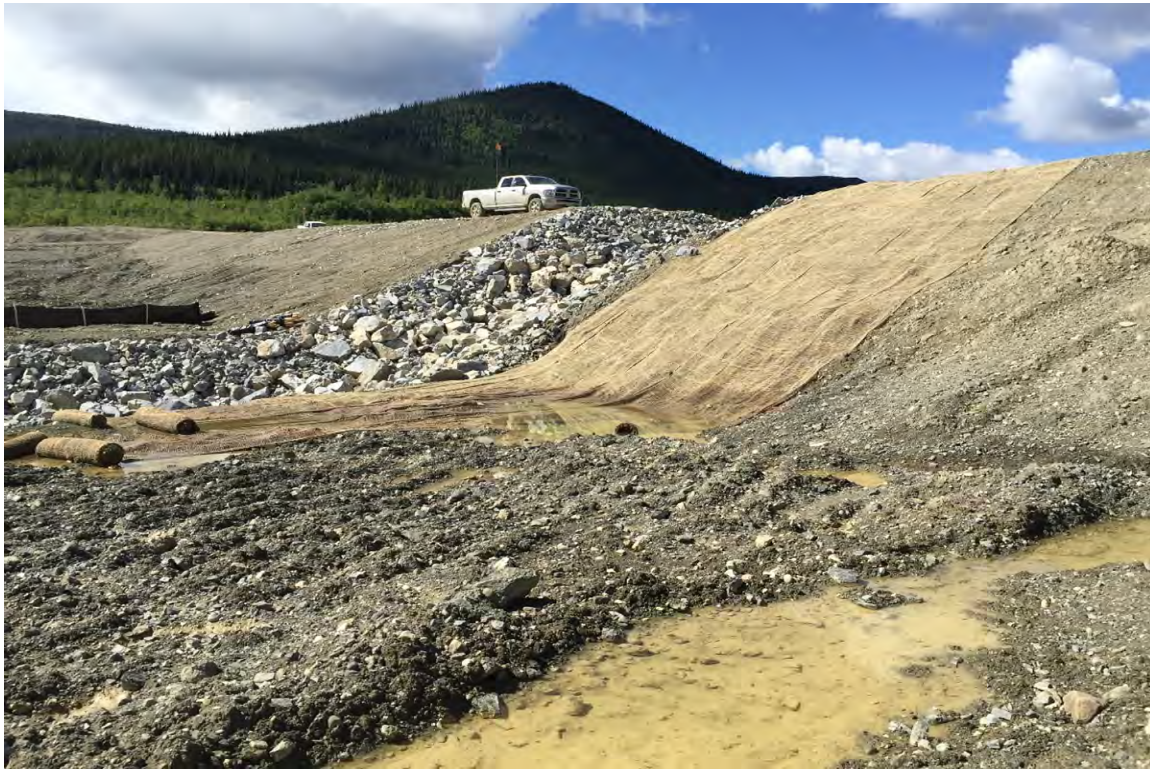
An inspection of the structure in June 2015 noted that a small subsidence had occurred on the lower portion of the exit chute from the spillway. The material displaced was retained by the geotextile filter fabric and some of the riprap had moved. Furthermore seepage from the hillside to the east had created a channel along the downstream toe of the SRS which caused some erosion to occur at the toe of the slope adjacent to the spillway. Remedial action completed after the inspection involved constructing a riprapped channel along the downstream toe on the east side of the SRS and adding more riprap in the exit chute to stabilize the slopes. An erosion control blanket (GeoJute), a lightweight biodegradable net, was placed on the side slopes to add further erosion control (Photo 14).

Photo 14: View looking west of the spillway through the SRS.

An annual inspection of the spillway should be carried out to ensure the structural integrity of the dyke and the riprap erosion protection. The downstream sideslope of the SRS should be inspected for any sloughing, subsidence or bulging. The crest should also be inspected for tension cracks or settlement. The pond should be measured for depth and an assessment of silt buildup. Any sign of seepage along the downstream toe should also be noted. Any new seeps boils or soft areas at the toe of the dyke should be noted.

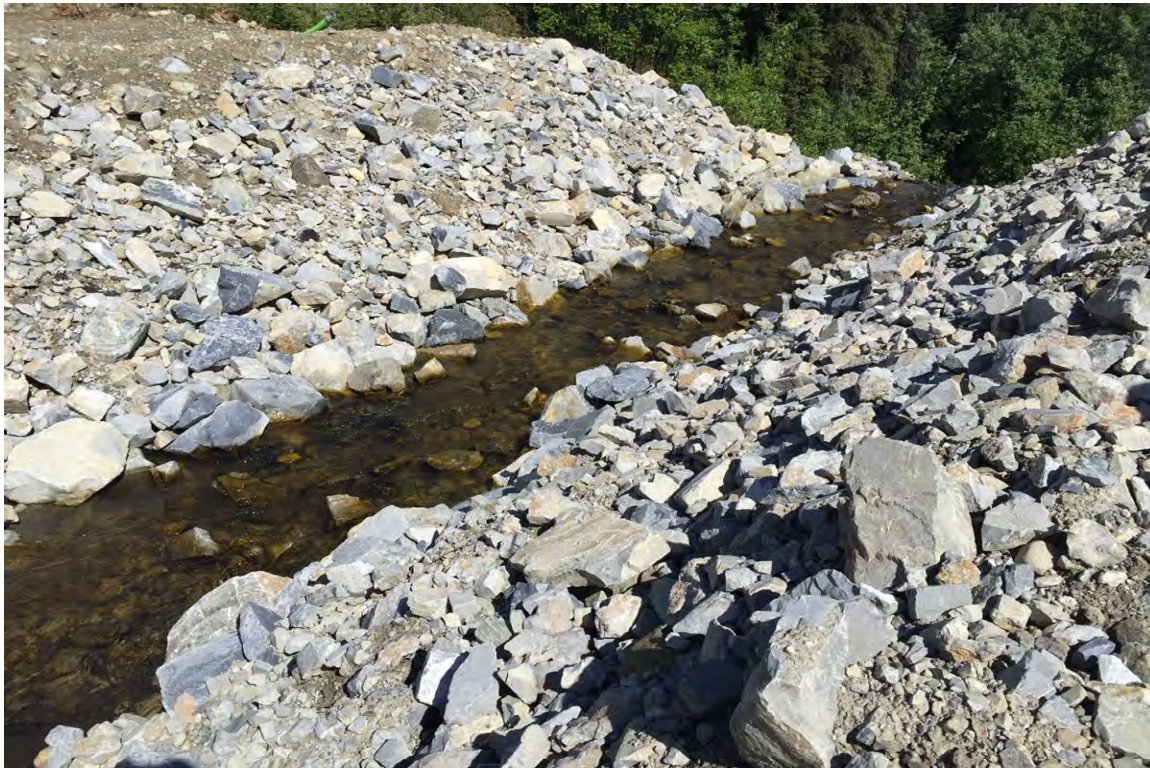
The North Creek dyke was removed in 2014 and the resulting channel was riprapped (Photo 17). Flow in the creek was conveyed through the decommissioned old dyke via a riprapped channel.

Photo 17: Channel through the North Creek Dyke following removal of the CMP culvert

Annual inspections should be made of the new North Creek channel to check on the condition of the riprap armouring and for any subsidence. Any debris that may have accumulated within the channel should be removed.

The sideslopes at the channel at the second crossing in North Creek should also be inspected to ensure there is no subsidence or movement of riprap.

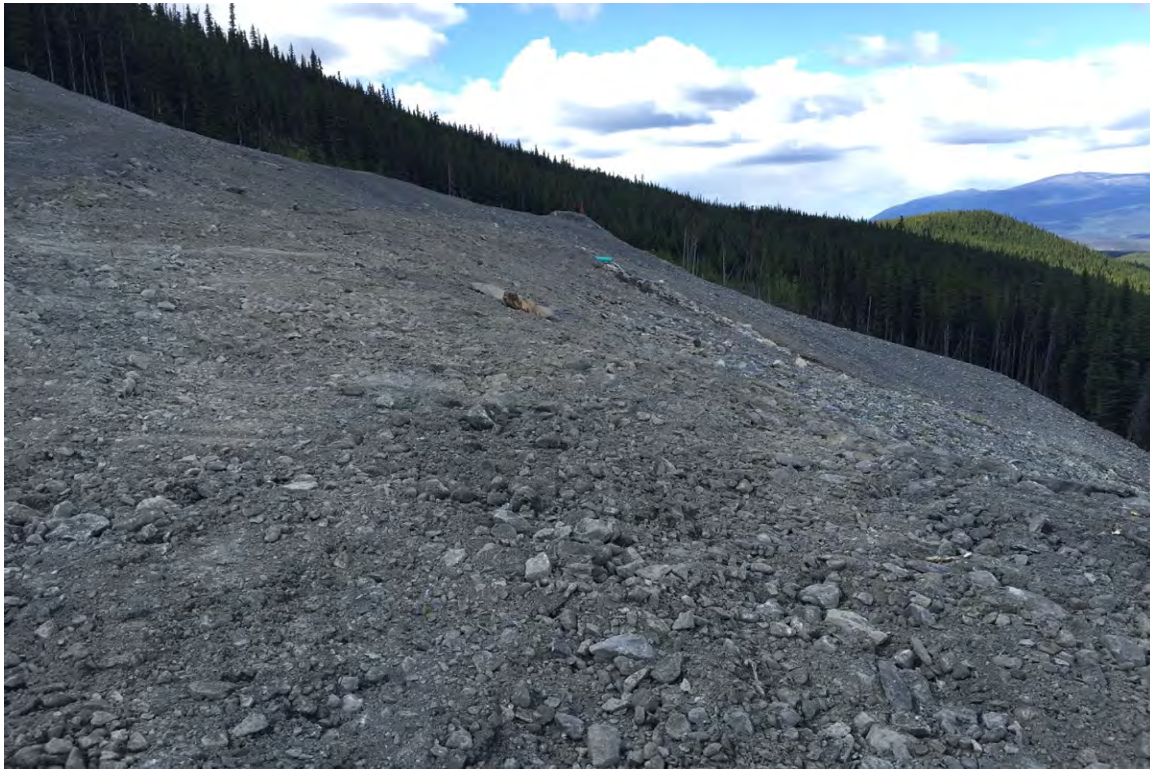
SRK inspected the Burnick waste dump at the 1200 portal and the Main Zone and Jewelbox waste dumps (Photo 18 and 19). The locations of these dumps are shown in Figures 8 and 9. The dumps were recontoured to provide added long-term stability. No subsidence of the slopes were noted. SRK did not inspect the dump at the 1300 portal (see Figure 8) because of restricted access.

Photo 18: Burnick Dump

SRK recommends that Teck continue to make annual inspections of Burnick 1200 dump slope, the dumps at Jewelbox and the Main Zone for any sign of vertical settlements, displacements or bulging.

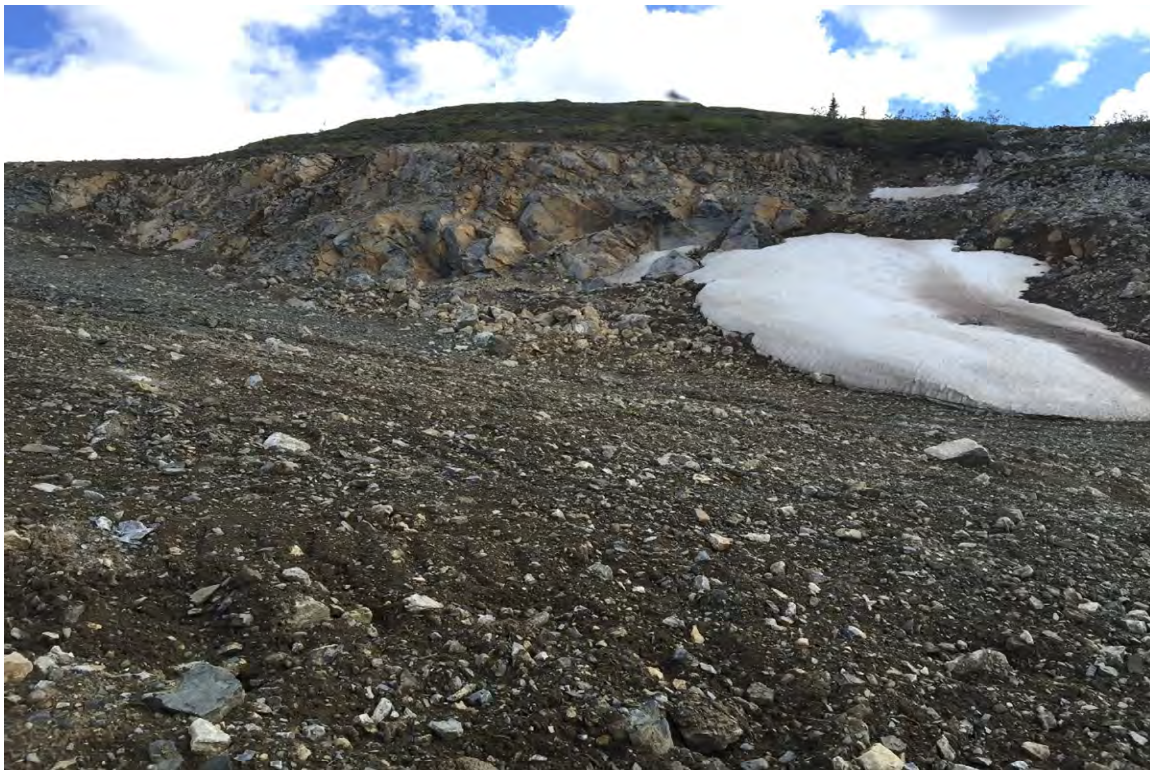
Photo 19: Main Zone dump

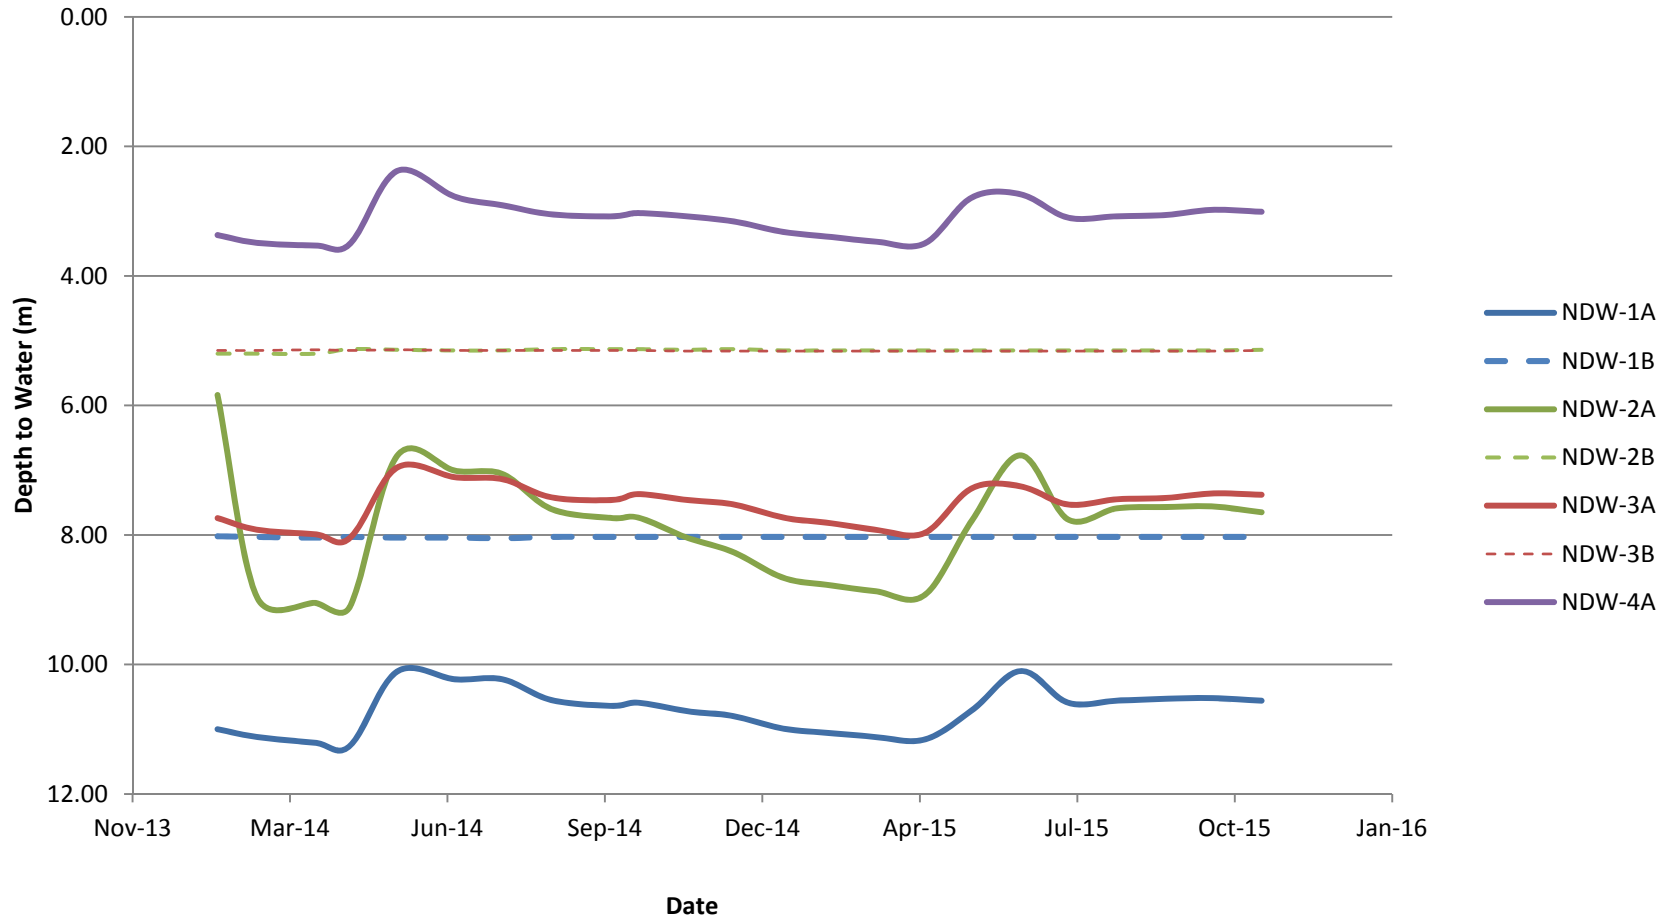
The water levels in the piezometers are recorded monthly and the 2015 data are presented in Appendix B. Figure B1 in Appendix B shows the seasonal water level fluctuation within the dam over the last two years. These levels preceded the completion of the till cover placement and reflect the water that seasonally ponded on the tailings surface during the freshet. Levels recorded in October, 2015 are plotted on the dam section shown on Figure 4. The seasonal fluctuations recorded this year in the piezometers are generally consistent with those in previous years and are within acceptable tolerance limits.
