## Sä Dena Hes Mine, Yukon Territory 2017 Dam Safety Inspection

SRK Consulting (Canada) Inc.  
December 2017

Project No: 1CT008.065

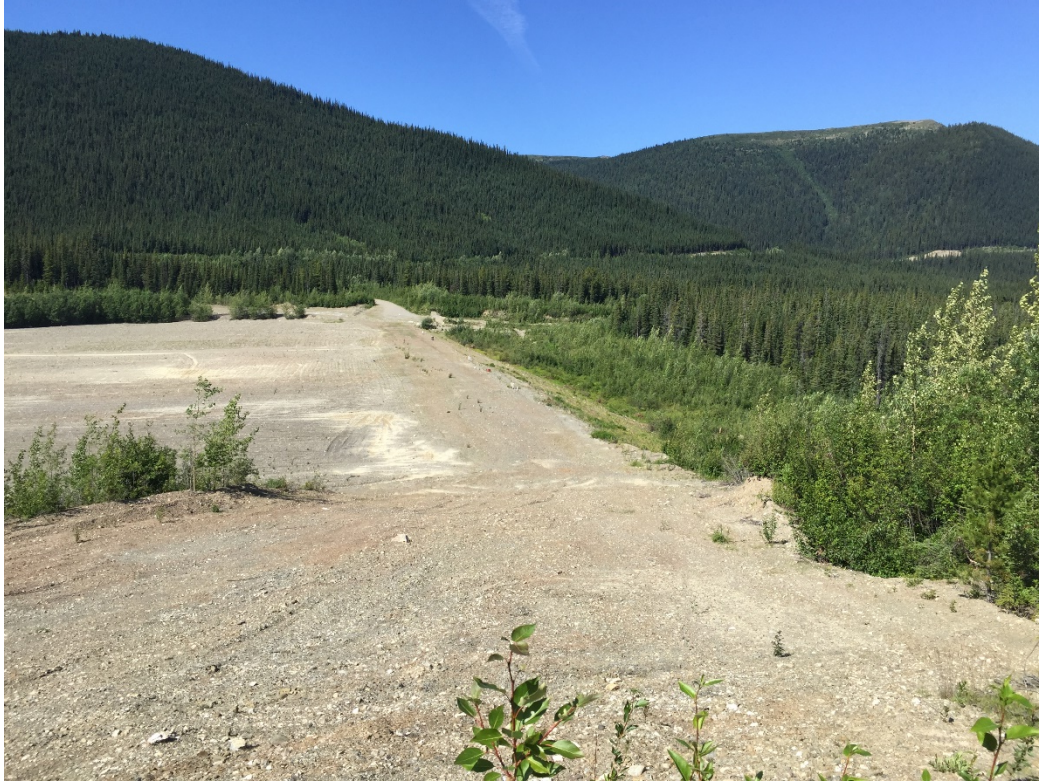
The crest of the North Dam (Photo 1), is in good condition. It shows no signs of deformation or abnormal settling. The downstream slope of the dam (Photo 2) shows no signs of surficial movement or erosion nor is there any sign of bulging at the downstream toe. Oversized trees observed during a previous dam safety inspection in 2015 had been removed in accordance with the routine maintenance specified in the OMS manual.

Photo 1: North Dam Crest looking west

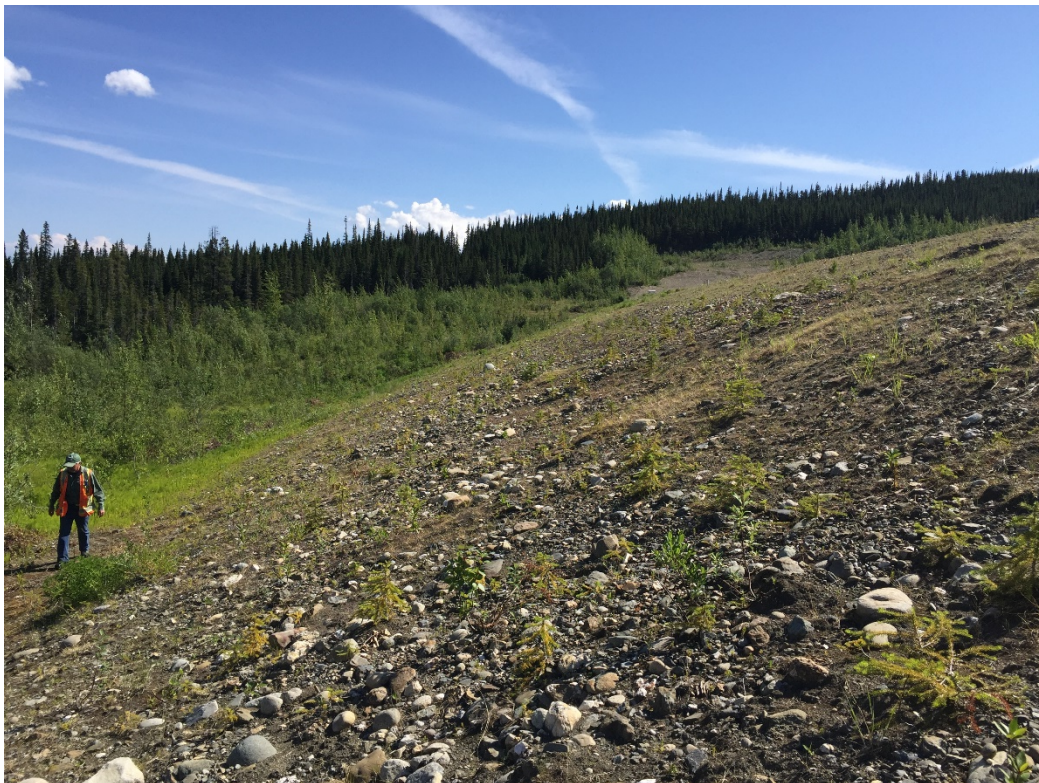
Photo 2: Downstream slope of the North Dam. Oversized trees have been removed

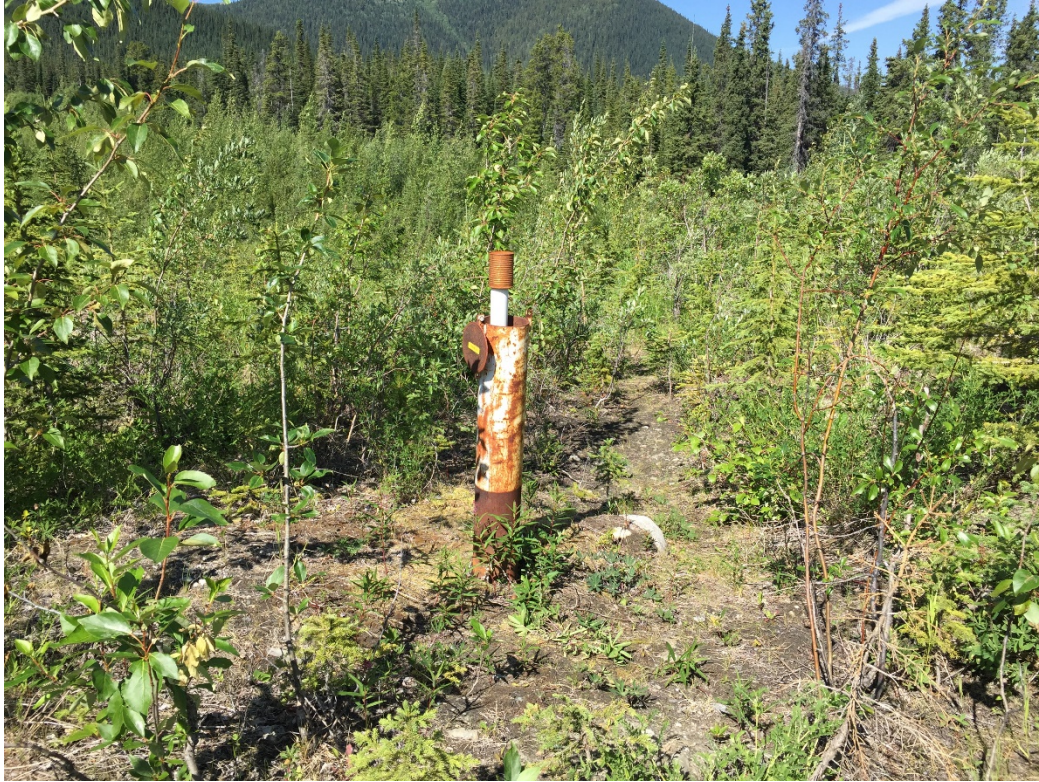
The piezometers and settlement gauges (Photos 3, 4 and 5) on the North Dam are in good condition and continue to function as designed. The orange coloured piezometer caps provide visible identification for the monitoring team. Piezometer 4A at the toe of the dam has not been updated with the new caps, and the steel protective cap has settled over time below the top of the PVC pipe.

Photo 3: North Dam Piezometer at toe NDW 4A

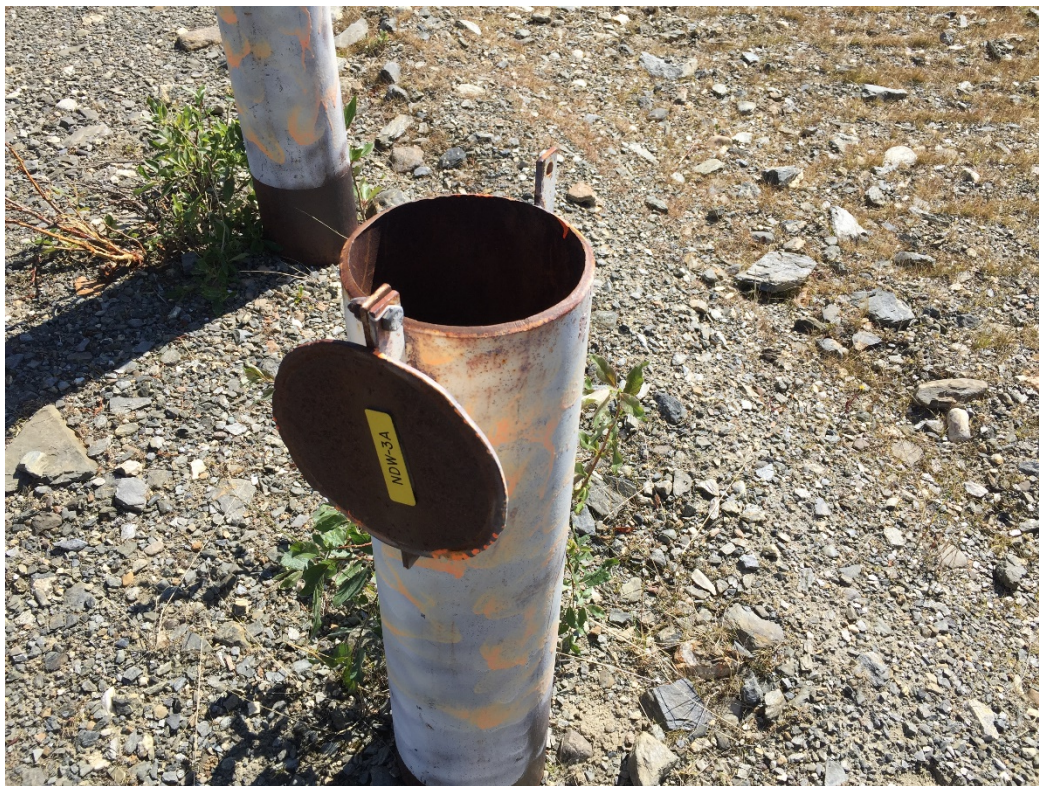
Photo 4: Well cover on NDW 3A

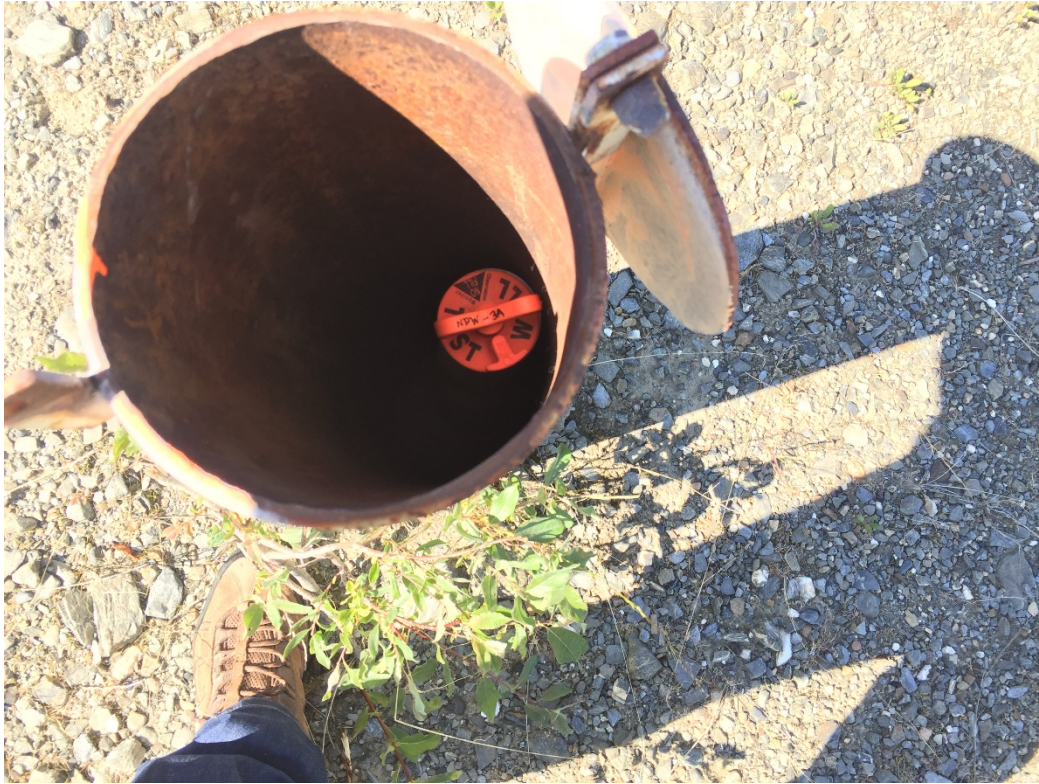
Photo 5: Plastic cap on the Piezometer NDW3A

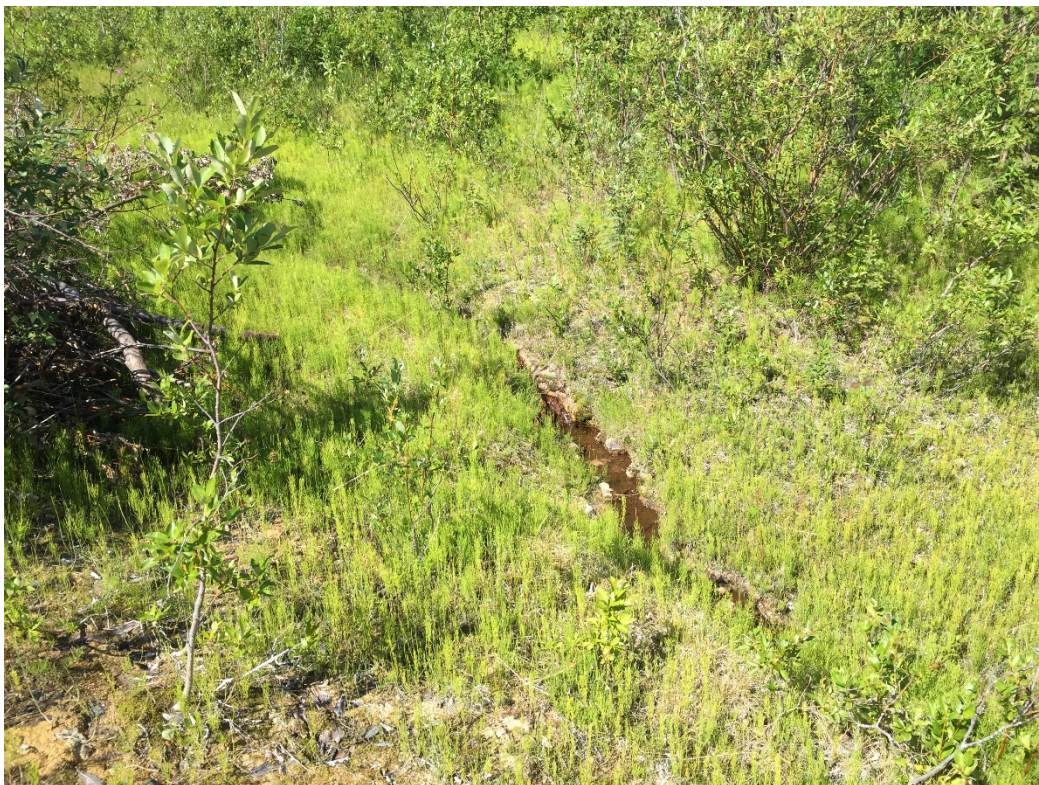
Along the downstream toe of the North Dam there is an 80 m long seepage zone (Photo 6). Seepage from this zone is collected at a monitoring station referred to as MH-02 and is a combination of groundwater discharge from the surrounding hillsides to the west and minimal seepage flow from the impoundment. The monitoring station consists of a 6-inch diameter steel pipe (Photo 7) embedded in sandbags. It was noted that the pipe had rotated and was not functioning as designed. Photo 8 shows the redundant slope displacement monitoring pins, which have survived the elements.

Photo 6: Hillside Seepage at toe of North Dam

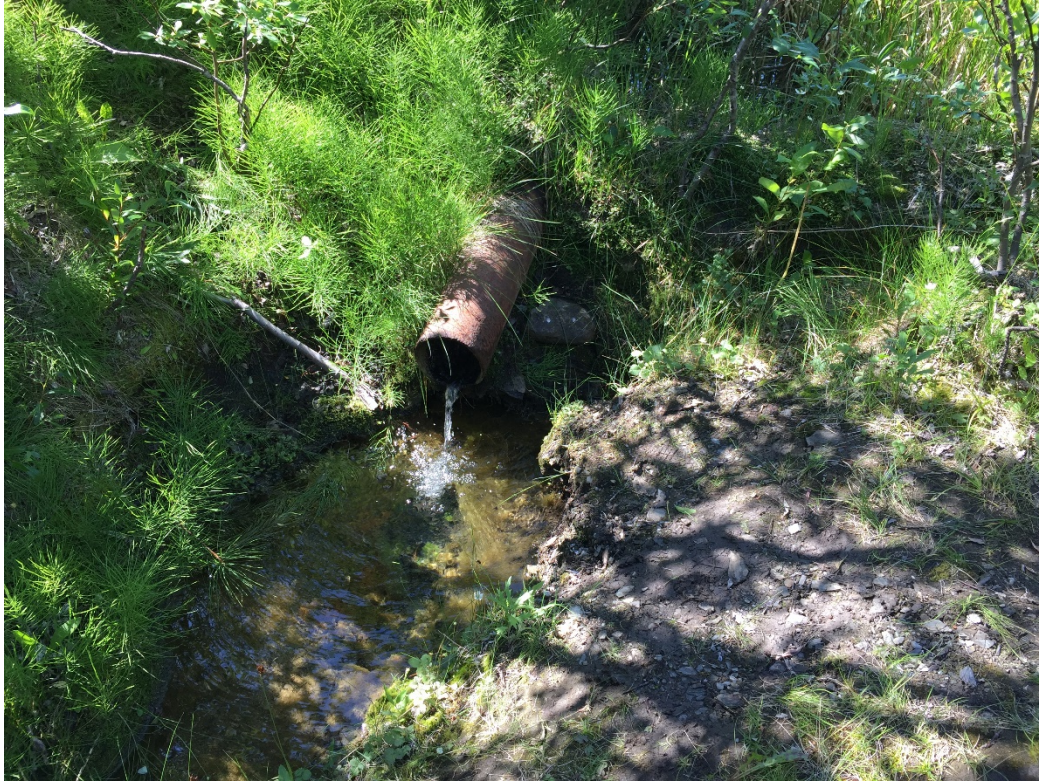
Photo 7: rotated pipe weir at MW 02

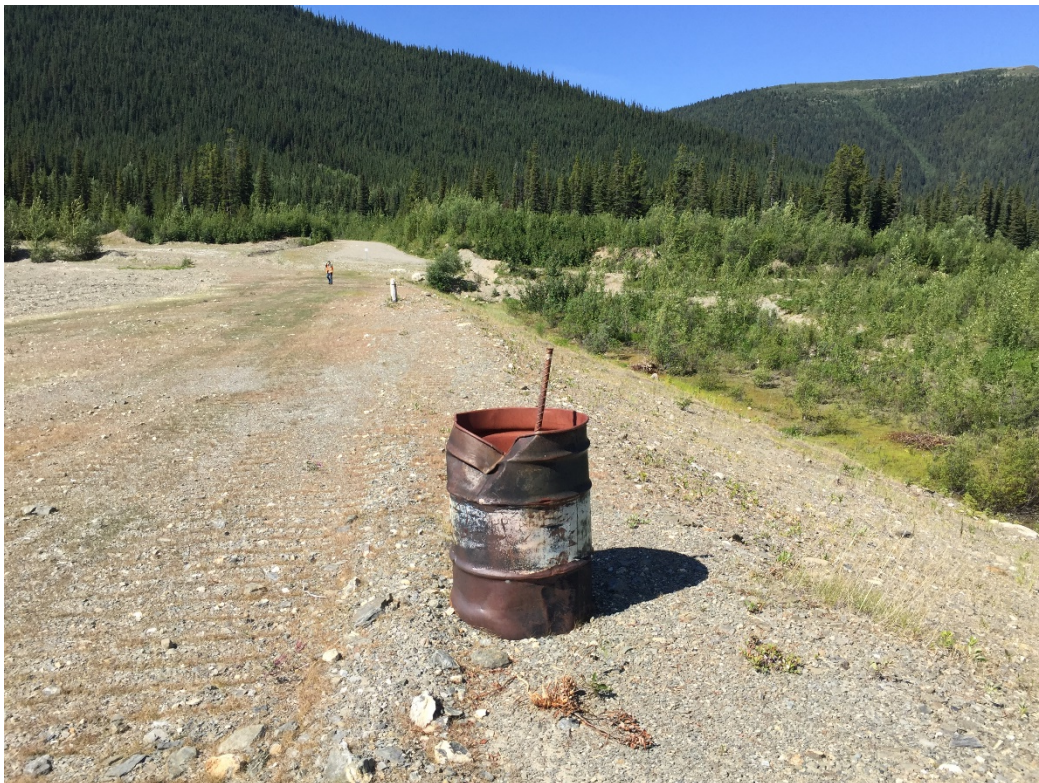
Photo 8: Slope Displacement pin on north edge of Dam (redundant)

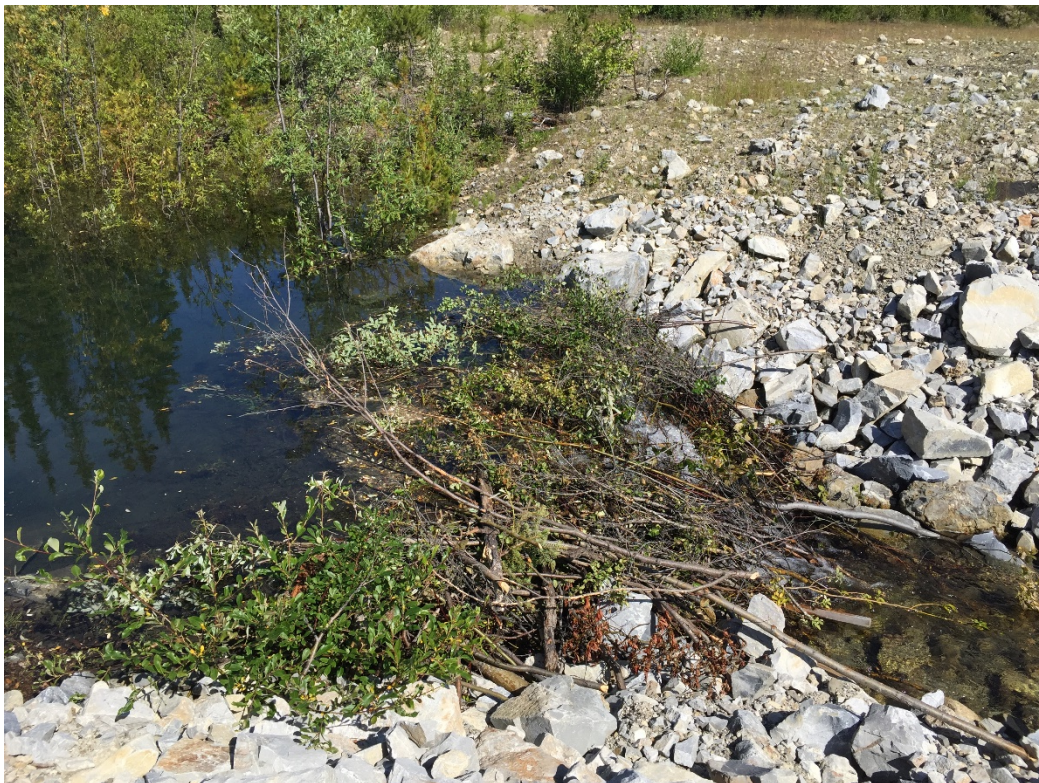
The riprapped channel conveys the North Creek over the location of the decommissioned North Creek Dyke. It was noted at the inlet of the channel that beavers had built a dam (Photo 12). Photo 13 shows a view downstream of the channel. At the outlet of the channel (Photo 14) some of the riprap has been dislodged by the flow, exposing a small area of the underlying filter fabric. This was noticed during last year's inspection and it has not deteriorated. The channel remains stable and no remediation is required. Photo 15 shows a view looking upstream along the channel.

Photo 12: Beaver dam at inlet to North Creek crossing

Structure	ID No.	Deficiency or Non Conformance	Applicable Regulatory or OMS Reference	Recommended Action	Priority (Teck 2014)	Recommended Deadline/ Status
North Creek Channel	2017-1	Beaver Dam at inlet to channel		Remove beaver dam in channel	3	End of 2017 / Completed July 27 Closed
Pipe Weir at MW-02	2017-2	6-inch pipe has rotated raising ponded water		Reconstruct weir to stabilise	3	End of 2017 / Completed July 27 Closed

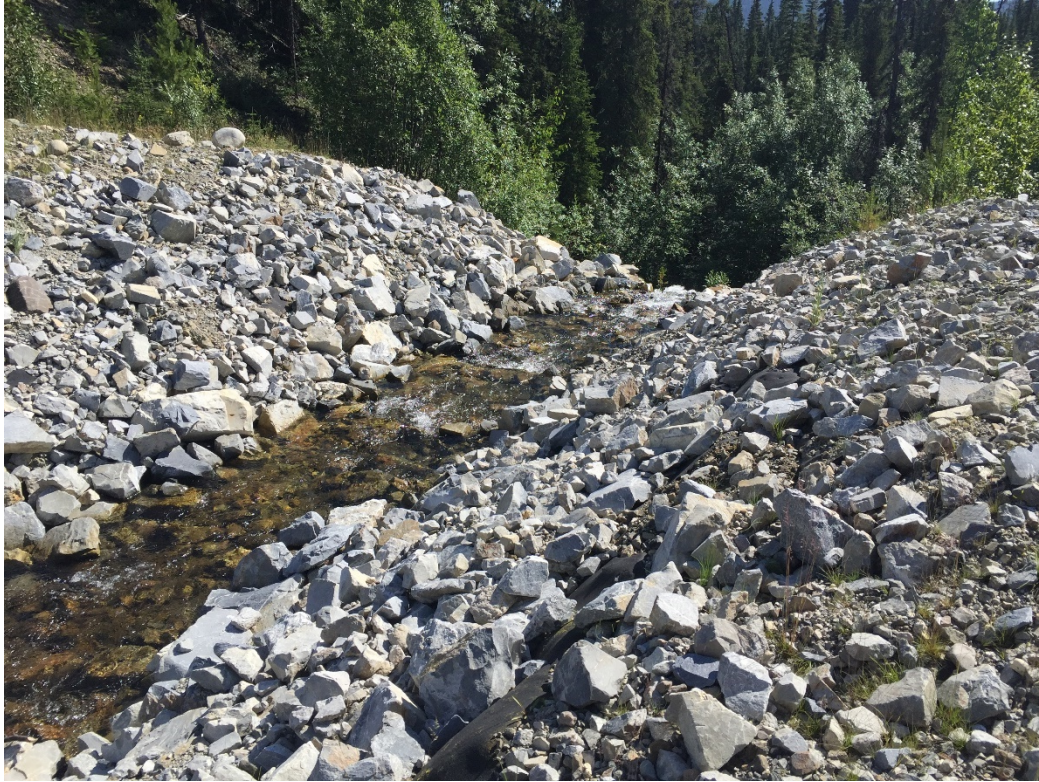
Photo 13: North Creek Crossing

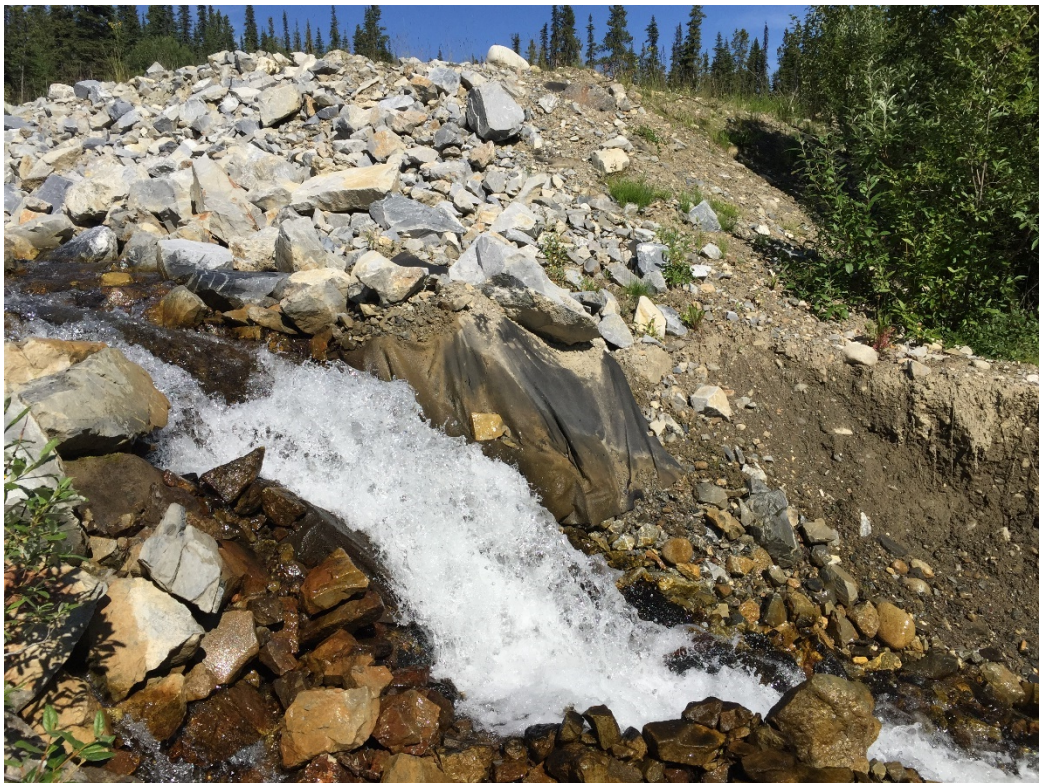
Photo 14: Outlet of North Creek crossing

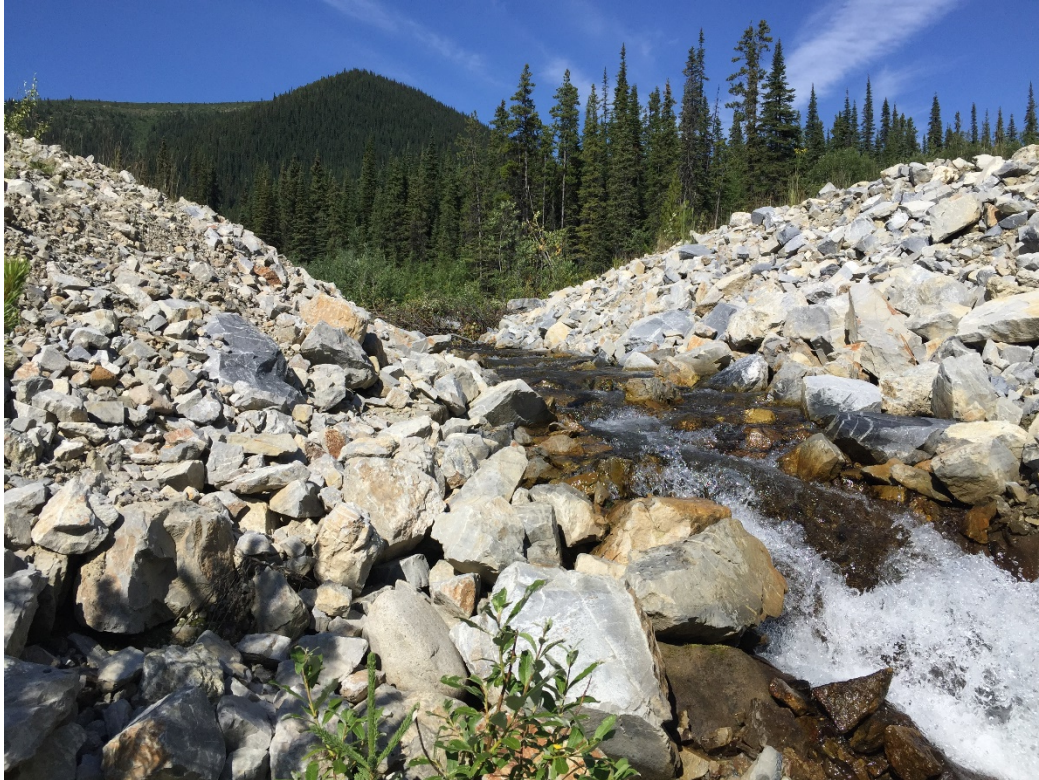
Photo 15: View looking upstream of the North Creek Dyke

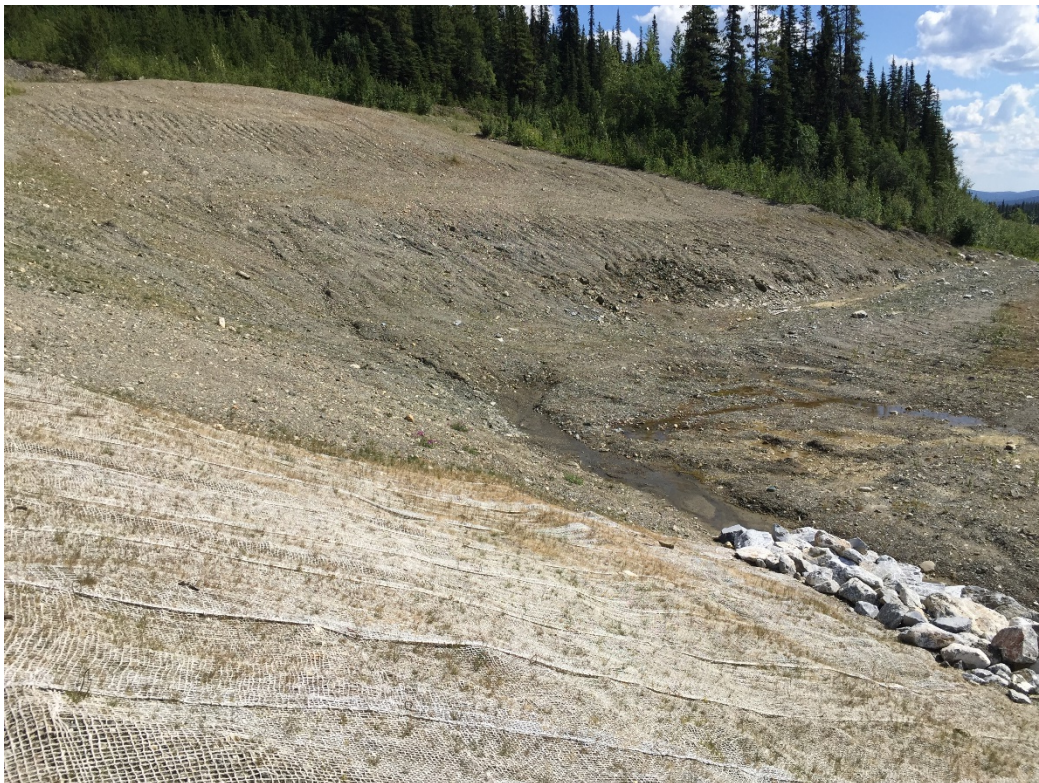
Photo 18: Hillside seepage along D/S toe of dyke

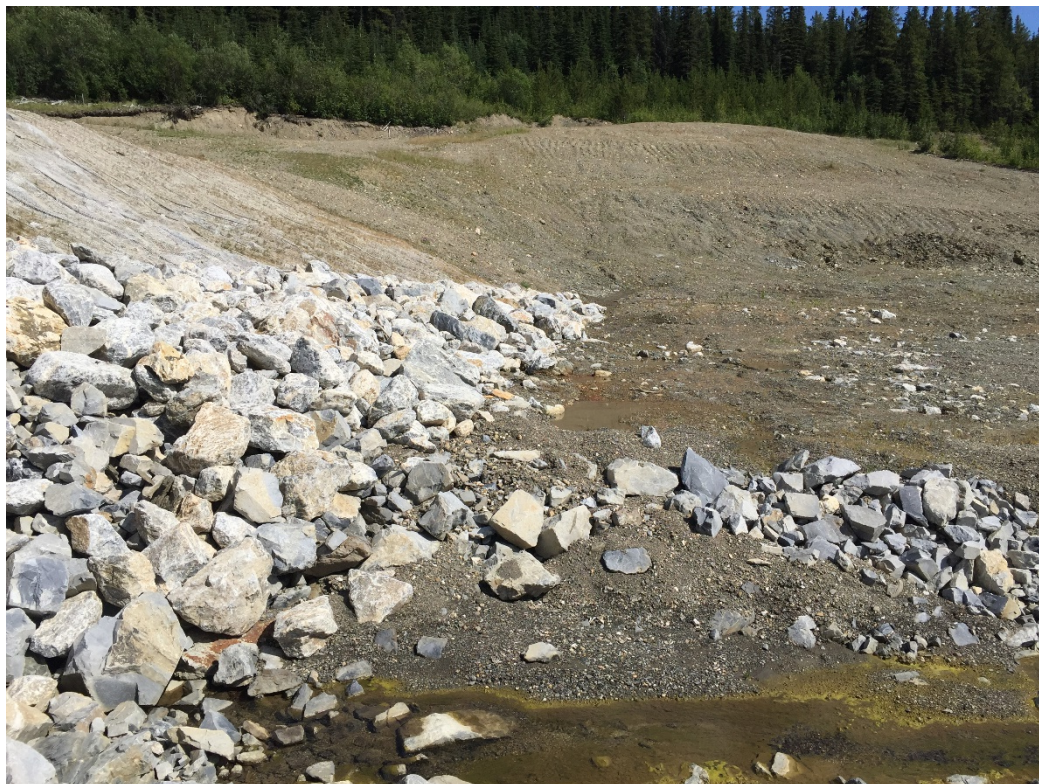
Photo 20 shows the riprap buttress along the toe of the dyke. A small boil was noted (Photo 21) at the toe of dyke which was also noted during last year's inspection. The activity is minor and no remediation is required.

Photo 20: View looking east of the riprap buttress along the D/S toe of the SRS dyke

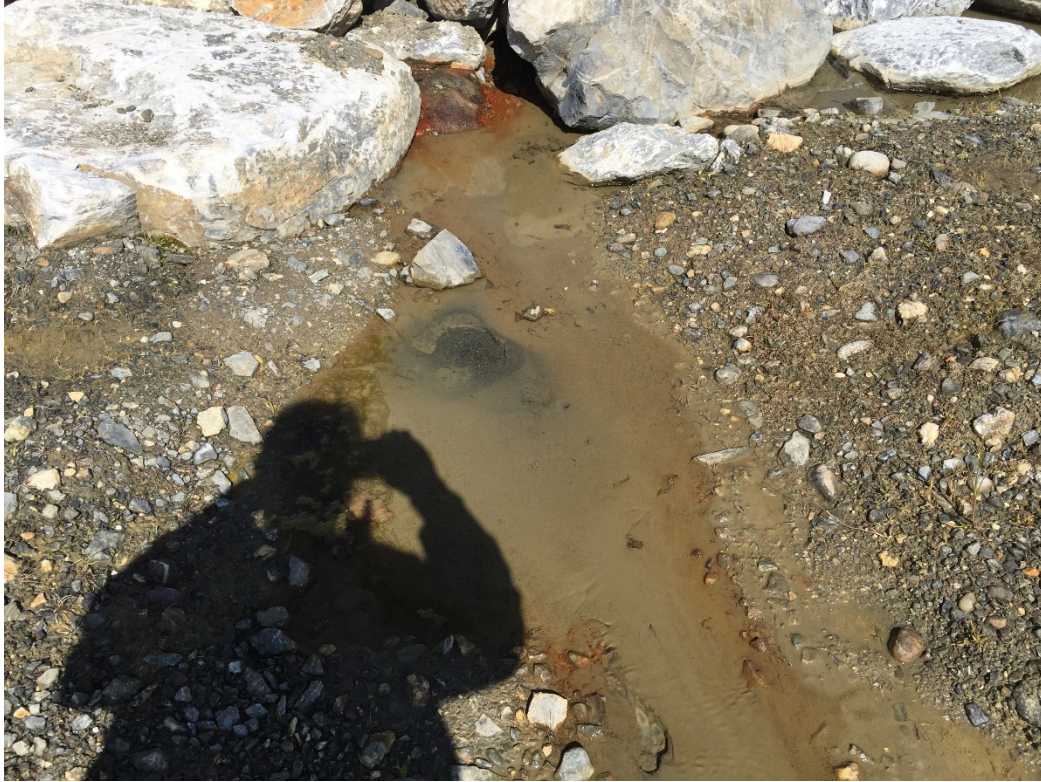
The pond behind the SRS has a maximum depth of about 1.5 m and the overall hydraulic gradient through the structure is low and corresponds to no piping potential. The seepage through the dyke is barely measurable. There is one small boil that has been noted at the downstream toe of the SRS dyke, but no loss of fines detected.

Photo 21: Single boil at toe of the SRS dyke

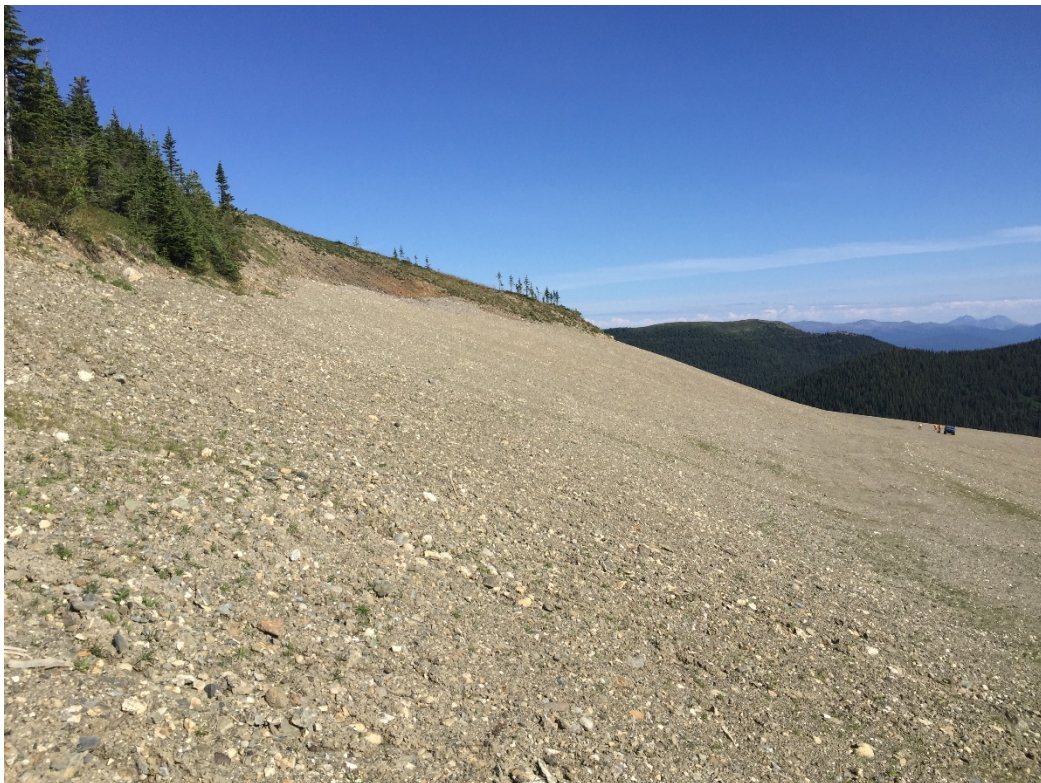
SRK inspected the resloped Main Zone and Jewelbox waste dumps (Photo 24 and Figure 12). It was noted that at the toe of the dumps, there was evidence of some erosion (Photos 25 and 26). While the erosion does not impact the stability of the dumps, SRK recommended that marked stakes be installed at the base of the erosion to monitor the erosion trend over time. Teck has installed the stakes and they will be inspected in 2018.

Photo 24: Regraded slopes of Jewelbox waste rock dump

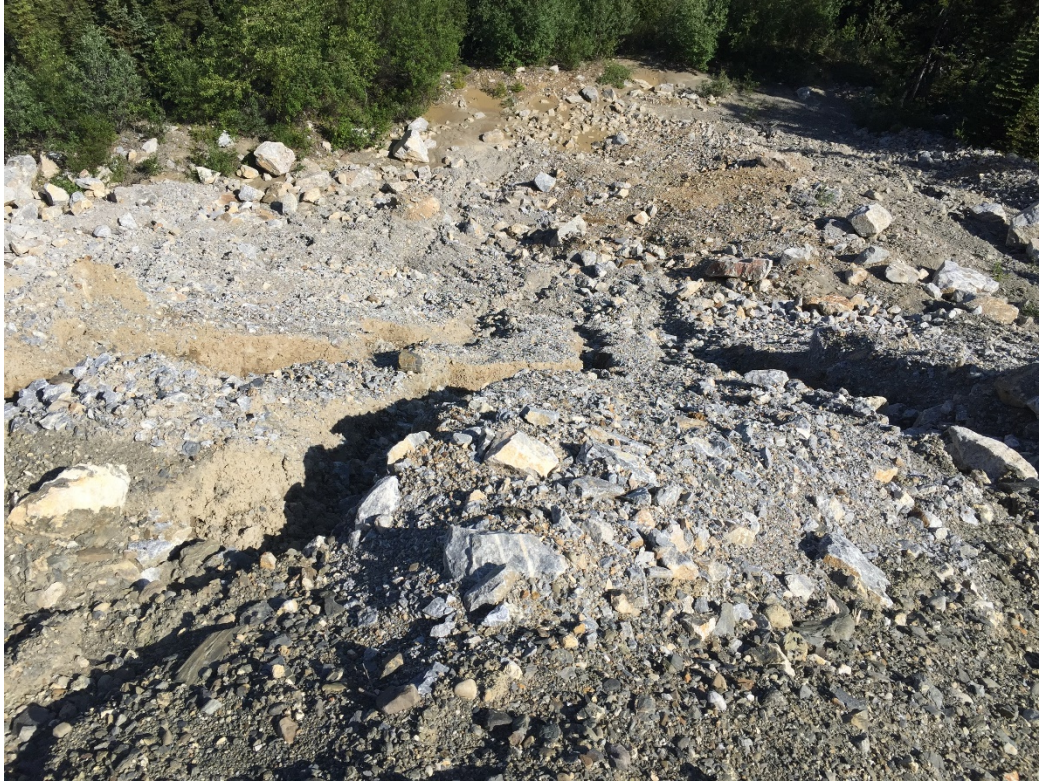
Photo 25: Erosion gullies at toe of Jewelbox Waste rock dump

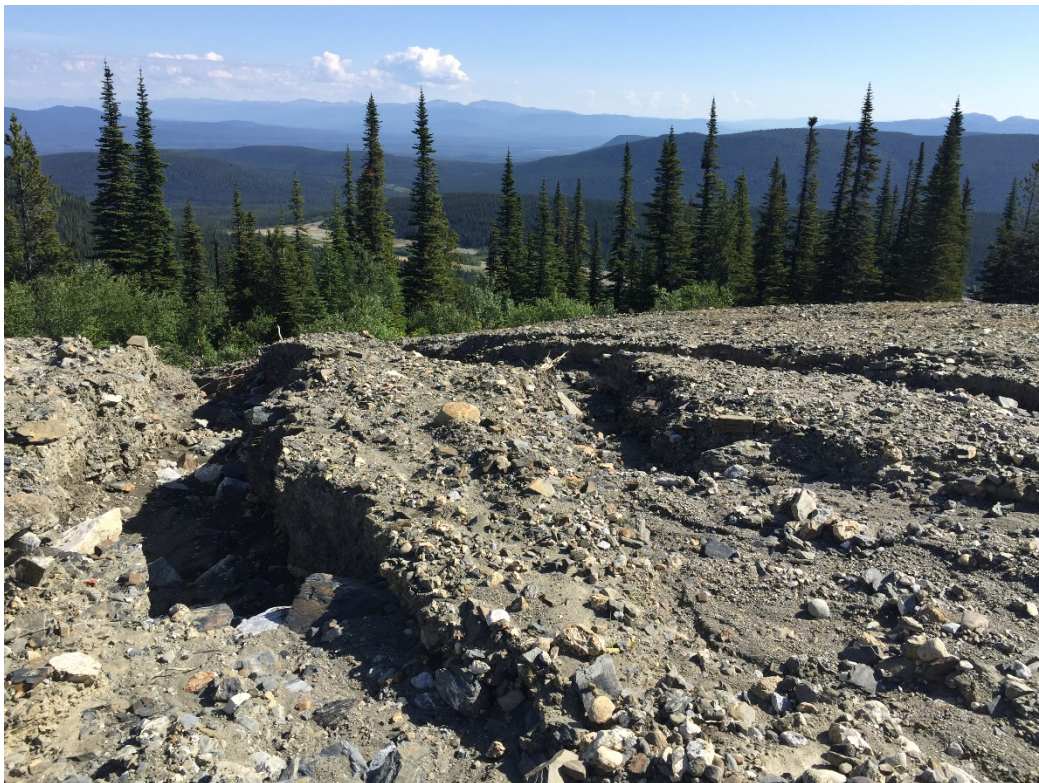
Photo 26: erosion gullies at toe of Jewelbox waste rock dump

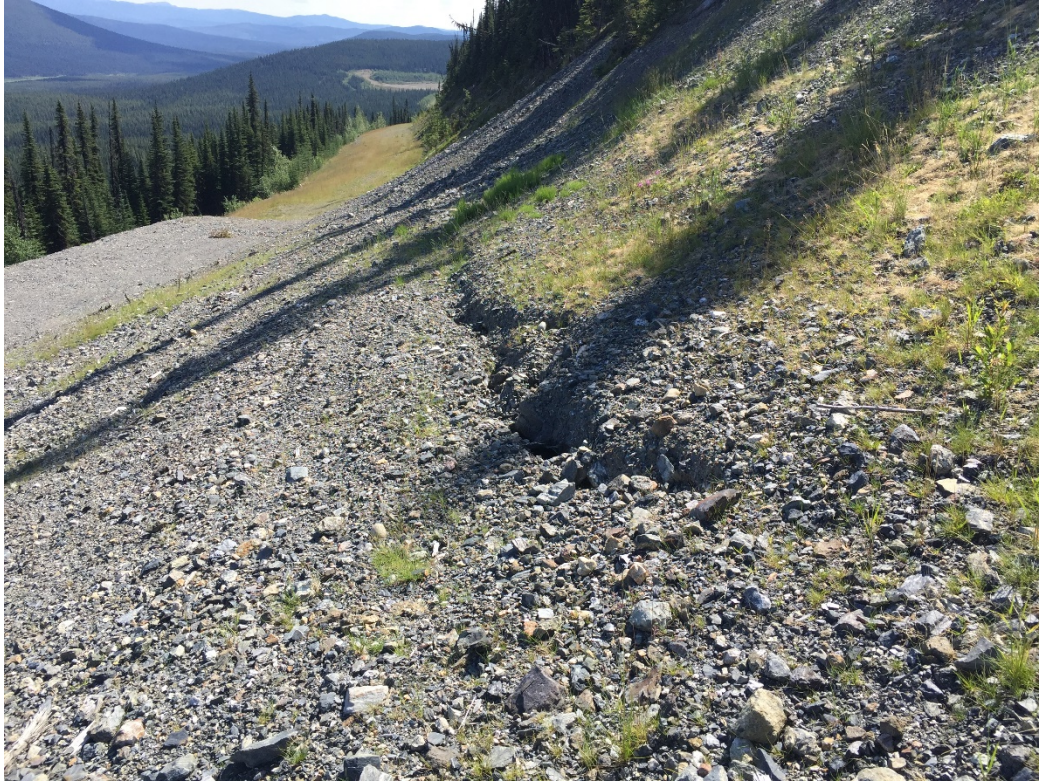
Minor settlement of the fill that was placed over the 1200 portal was noted (Photo 27). This settlement is to be expected and no remediation is required.

Photo 27 minor subsidence on the slope of the backfill at Portal 1200 on Burnick
