2024 Annual Facility Performance Report - SDH Tailings Management Area

Sä Dena Hes Mine, Yukon Territory, Canada
Teck Resources Limited

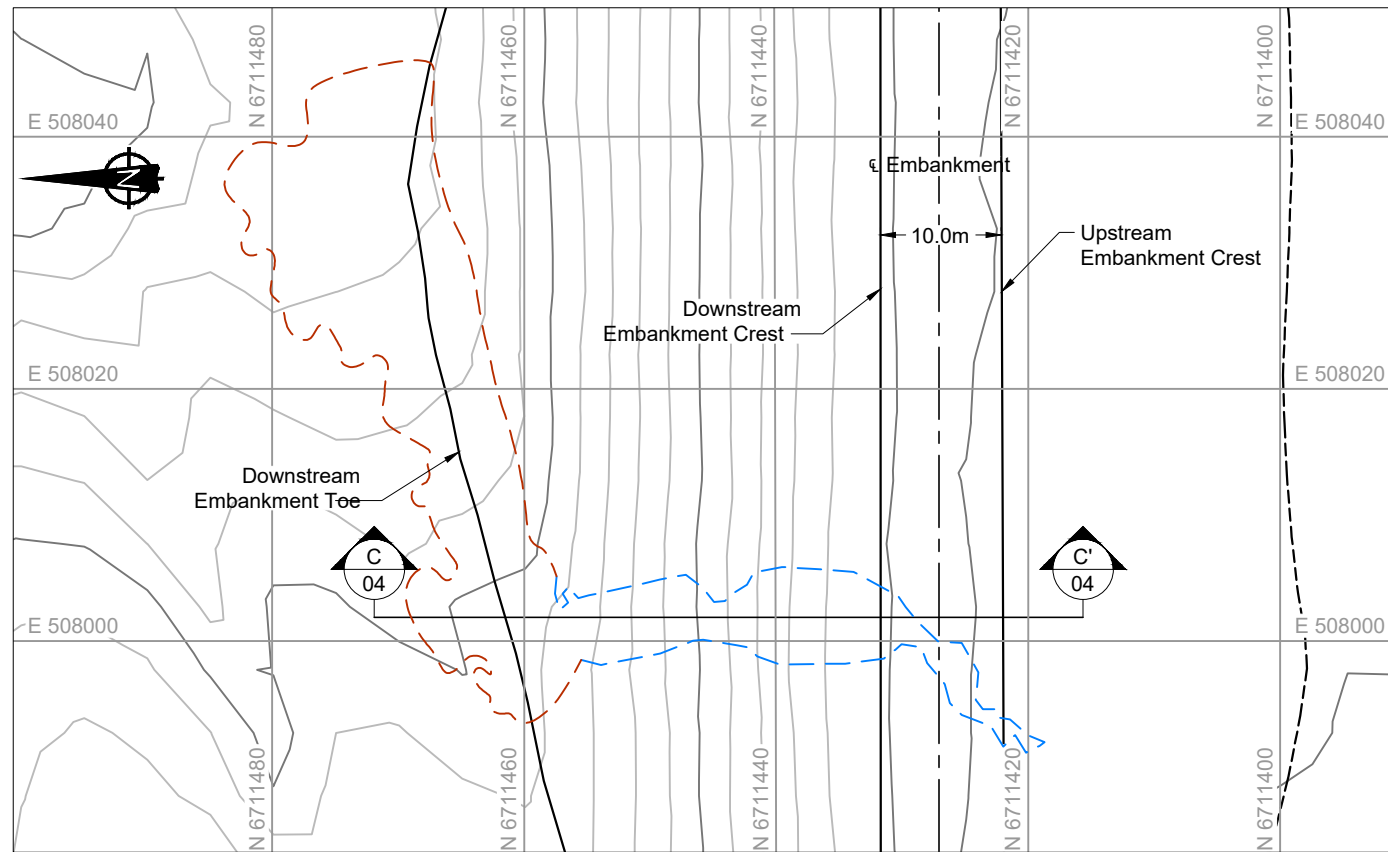
Plan View of Completed Repairs

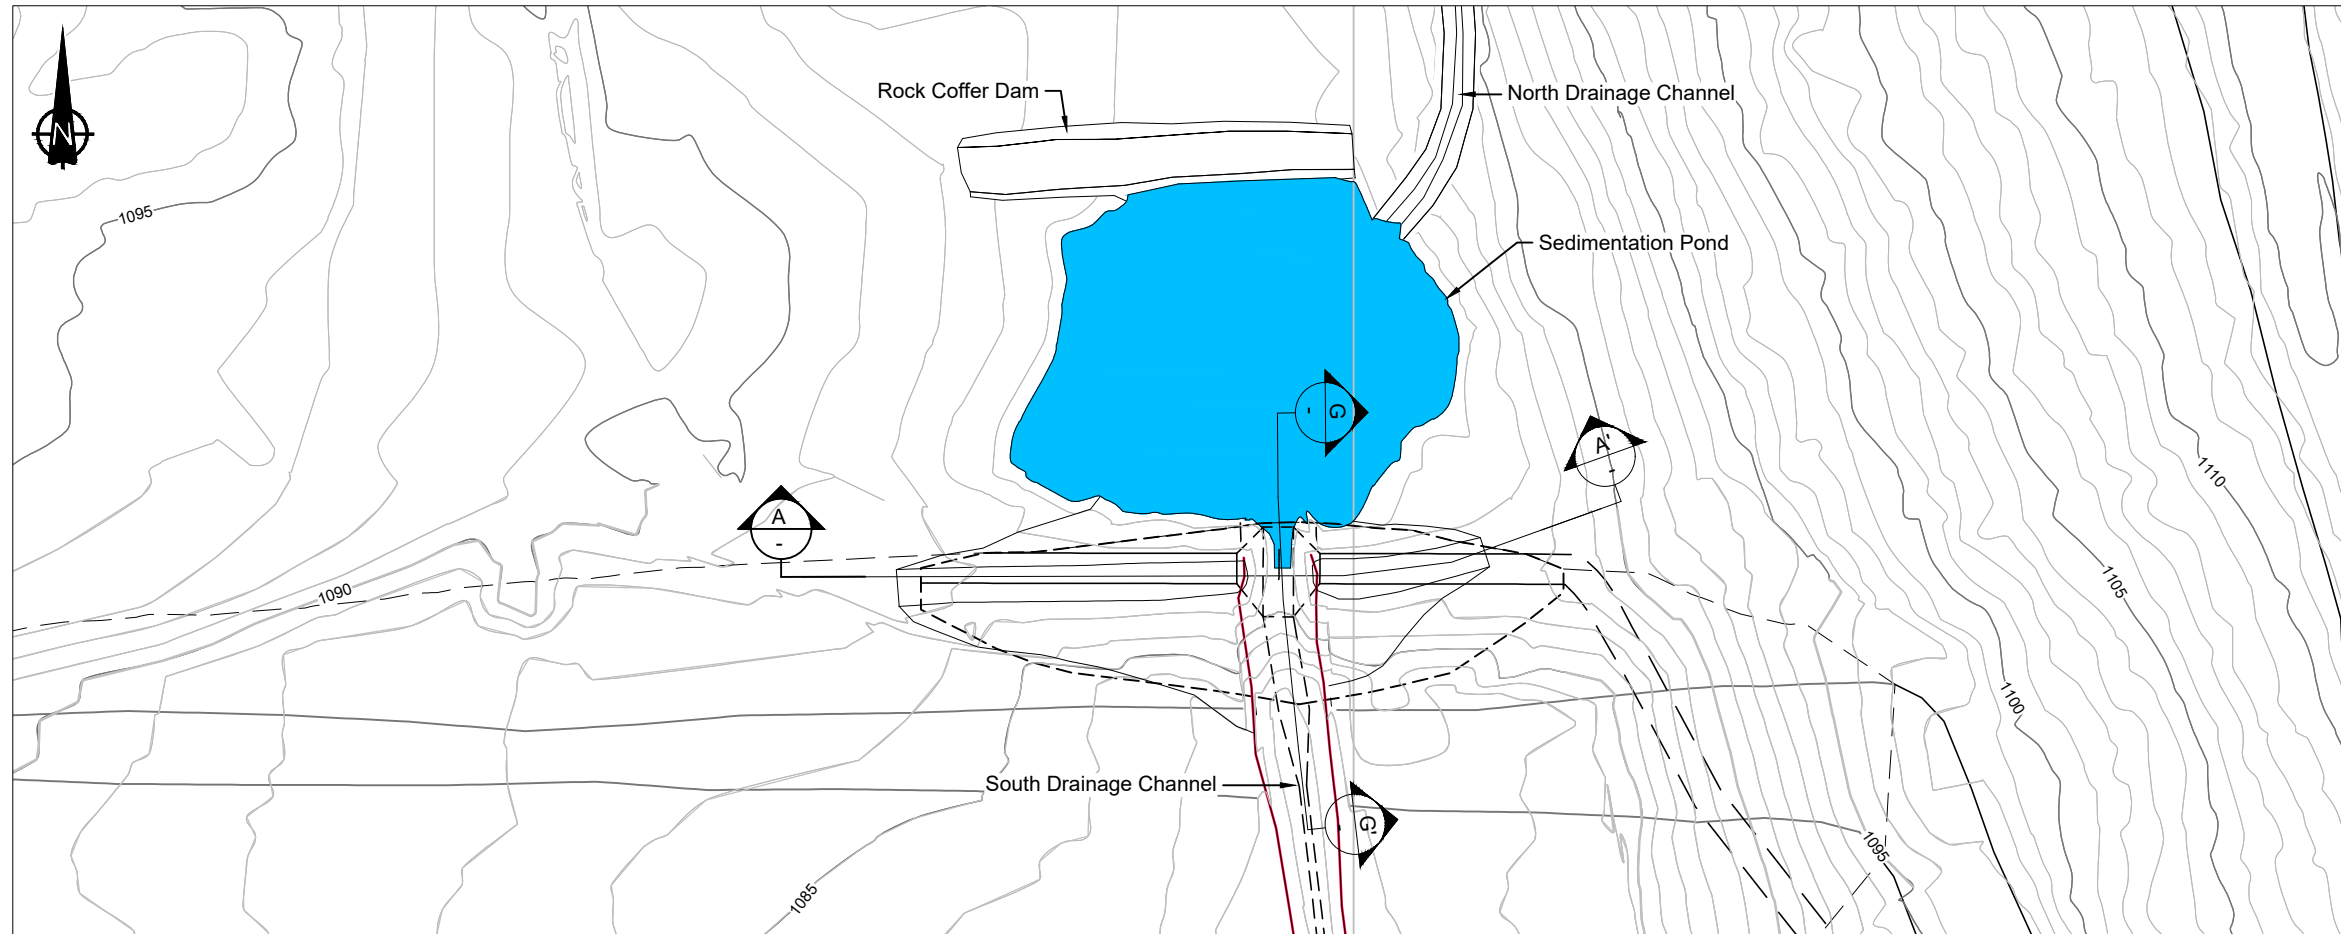
| FILE NAME: CAPR002559 - North Dam Repair.dwg | | DATE: August 2024 | APPROVED: PM | FIGURE: 04 |

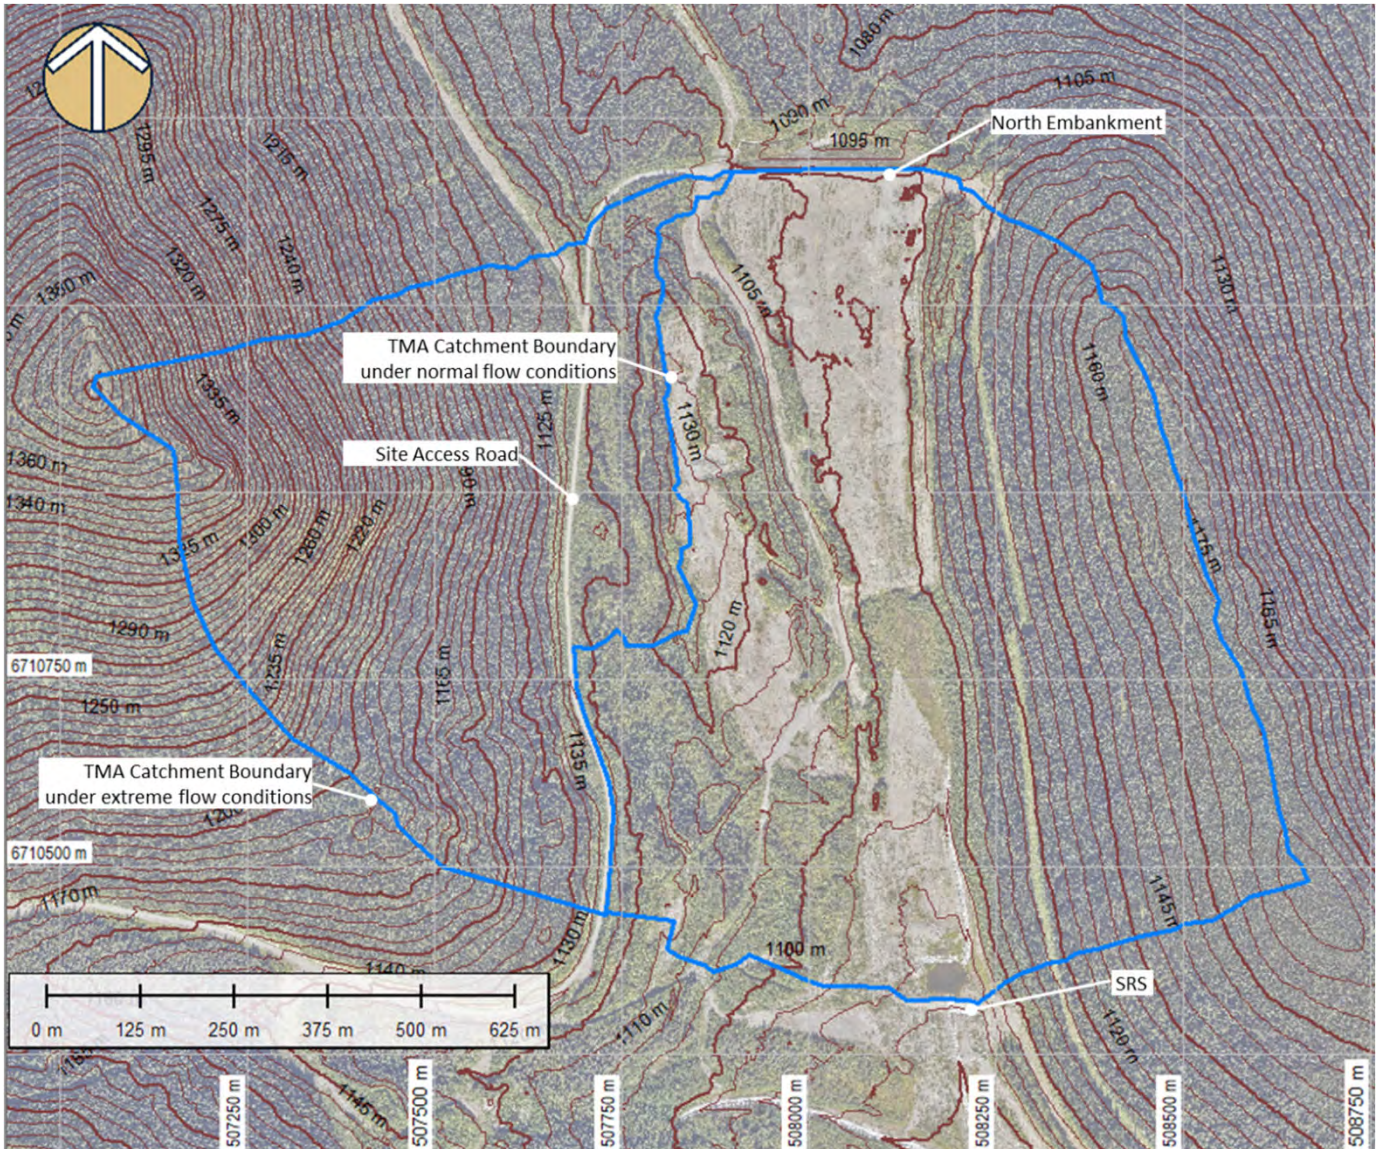
Sources : https://srk.sharepoint.com/sites/NA1CT008.075/Deliverables/Climate_Report/03_Figures/Fig2-3_TMA%20Catchment.pptx?web=1

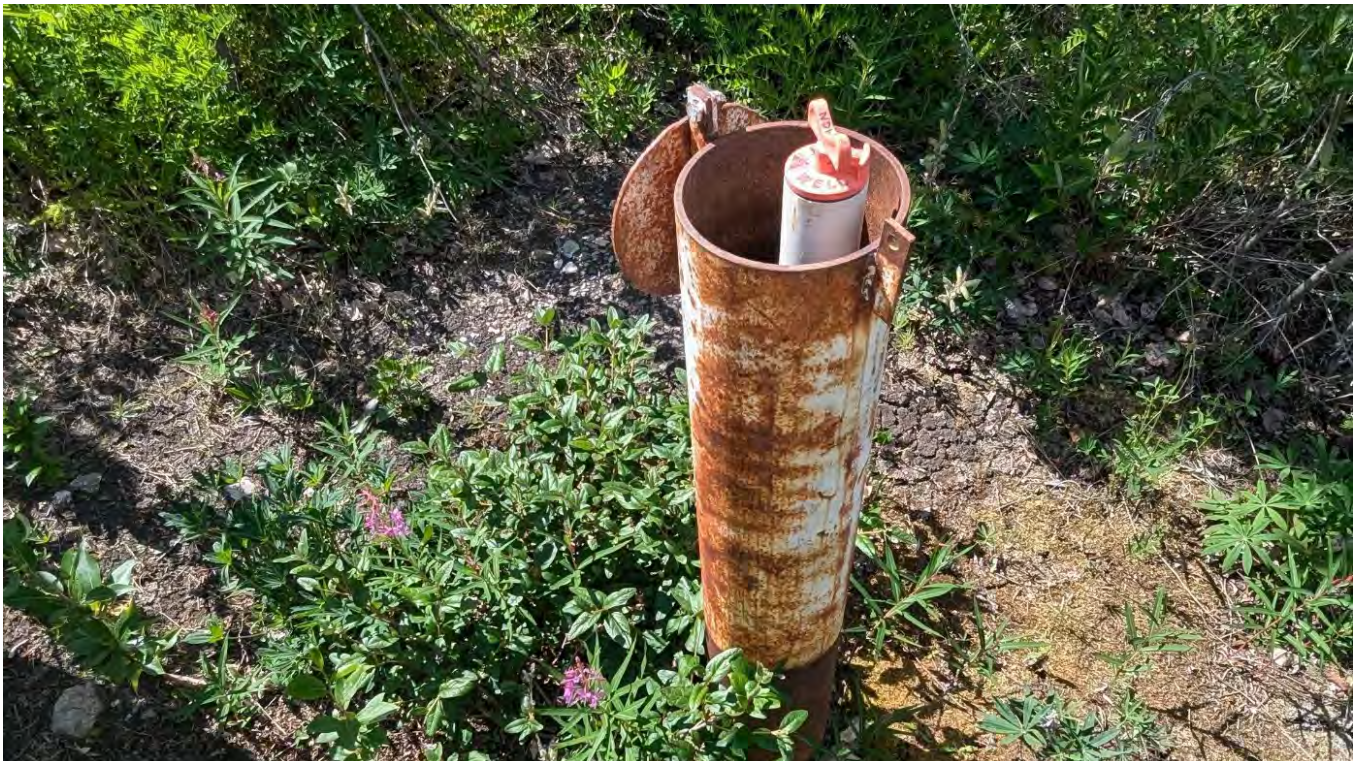
Photo NE-04: NDW-A4 Piezometer raised above the top of the protective casing due to frostjacking.

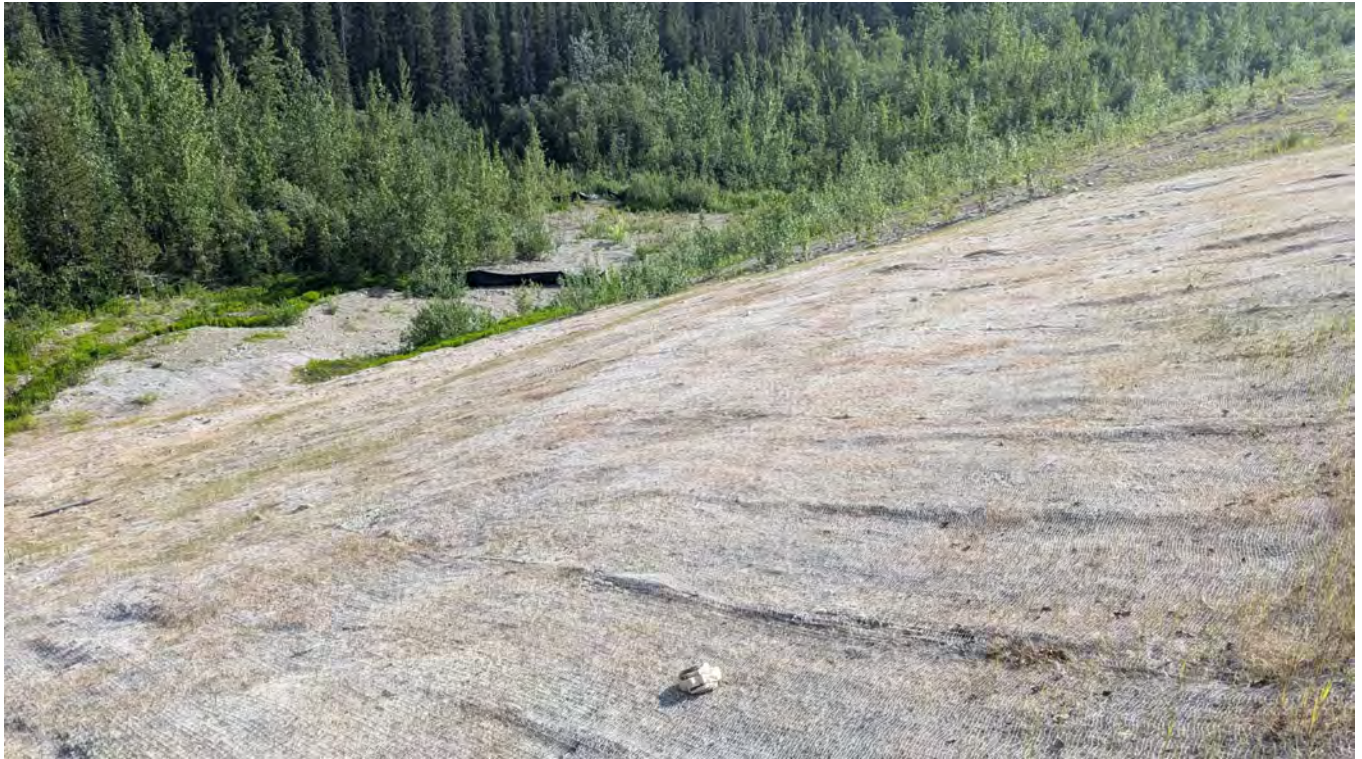
Photo NE-07: North Embankment gully repair erosion control blanket on the downstream slope.

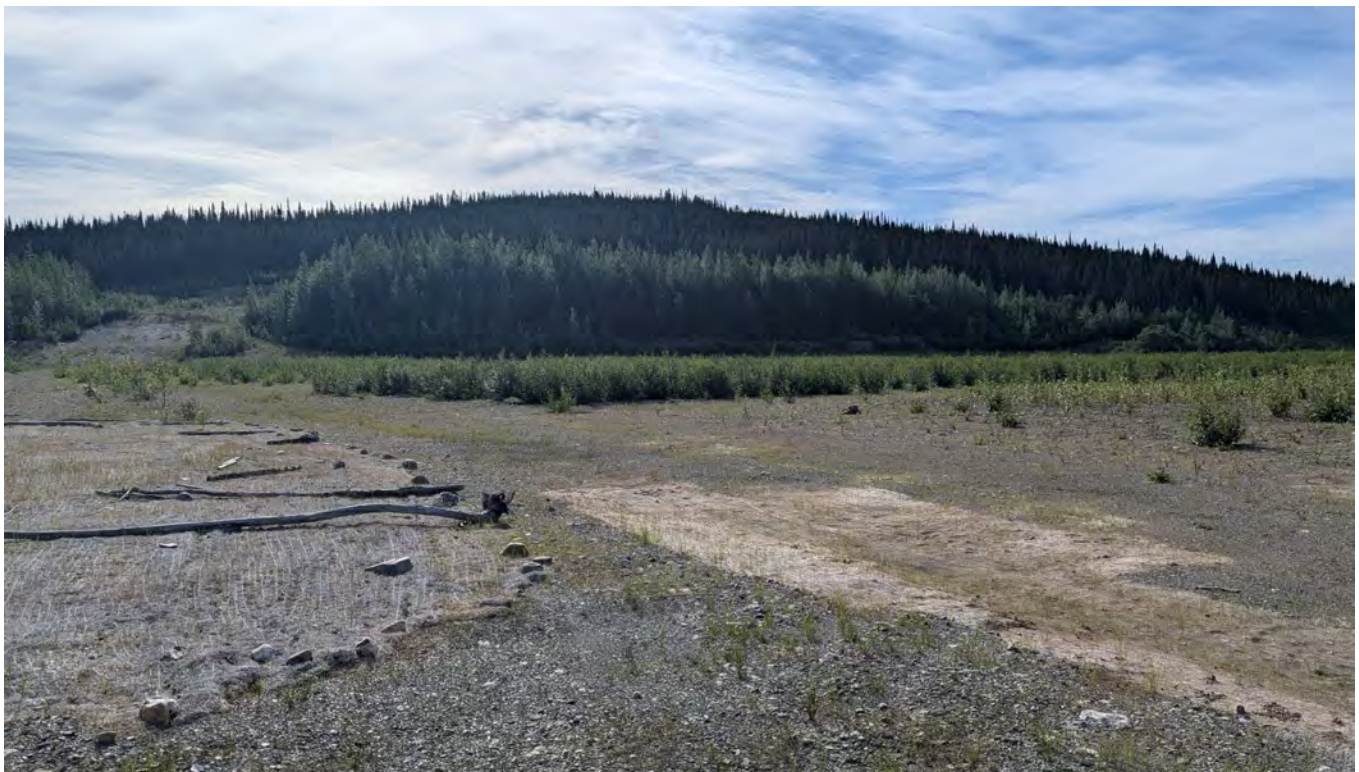
Photo NE-08: North Embankment gully repair erosion control blanket.

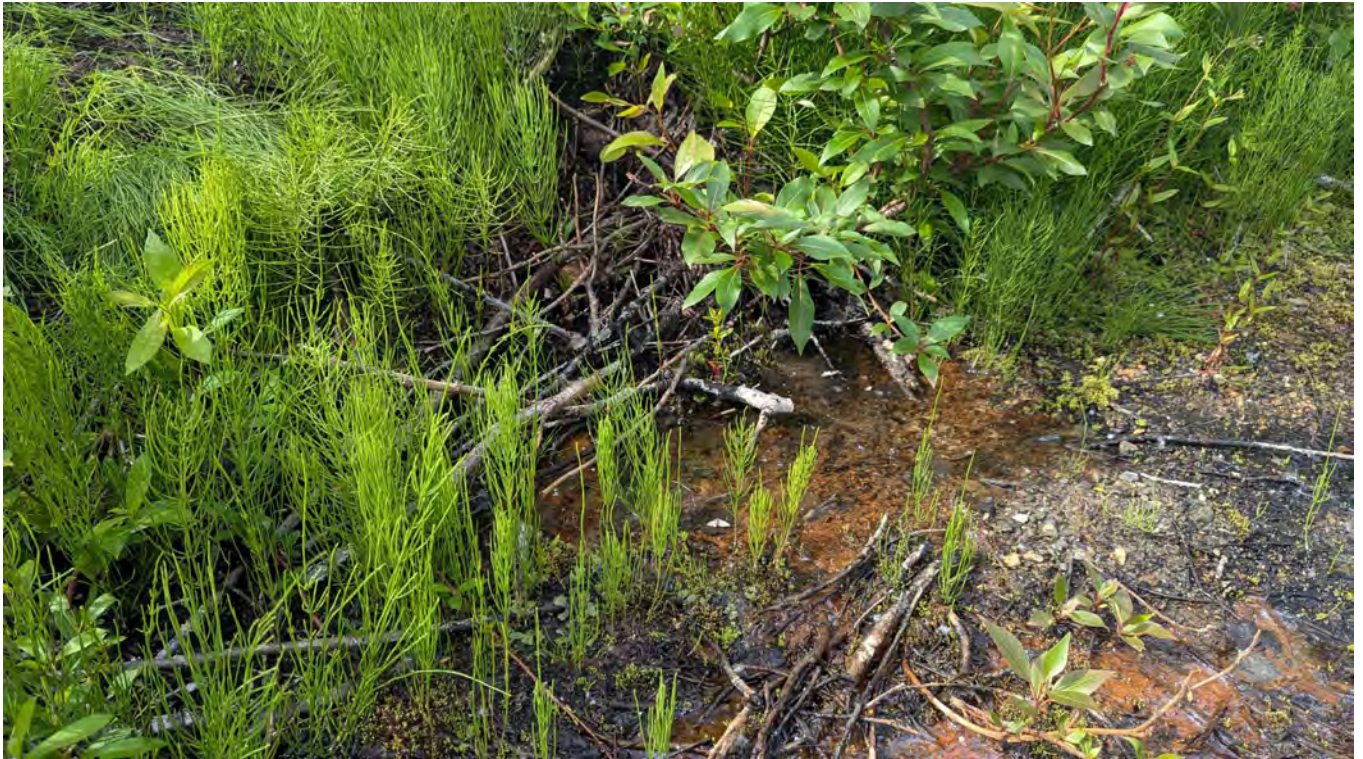
Photo NE-09: Seepage and soft ground observed at the embankment toe during the inspection 10 m west of the French Drain outlet.

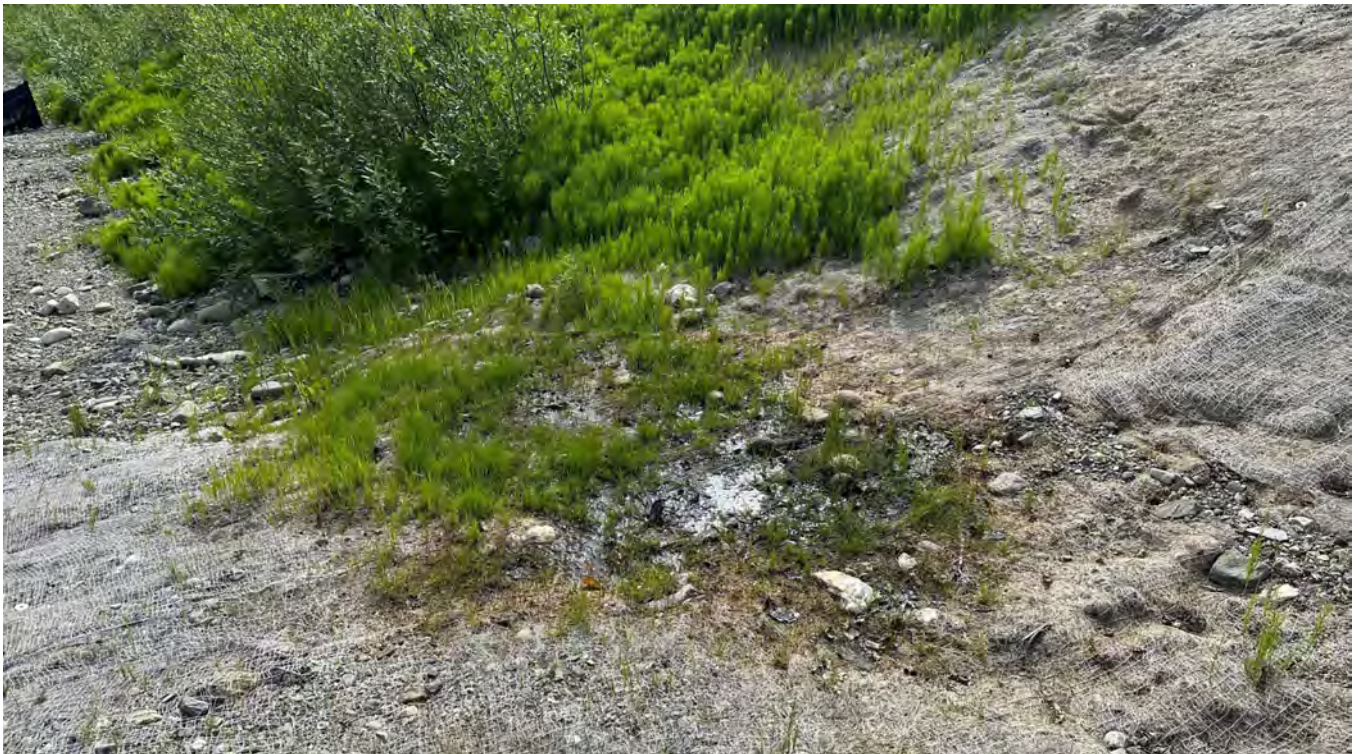
Photo NE-10: Seepage emerging from the French Drain in the 2022 repair area.

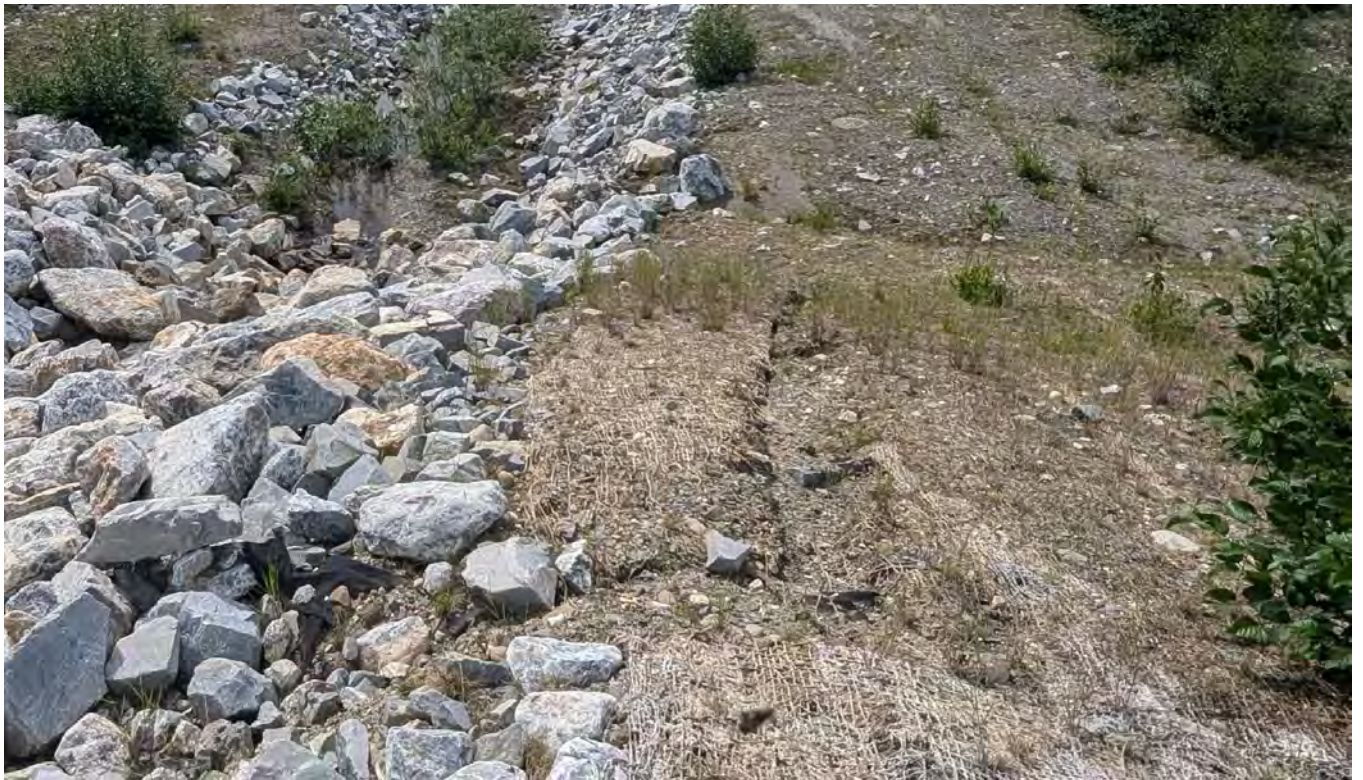
Photo SRS-02: Transverse crack across the dam crest approximately 1m east of the spillway seen from the crest of the SRS.

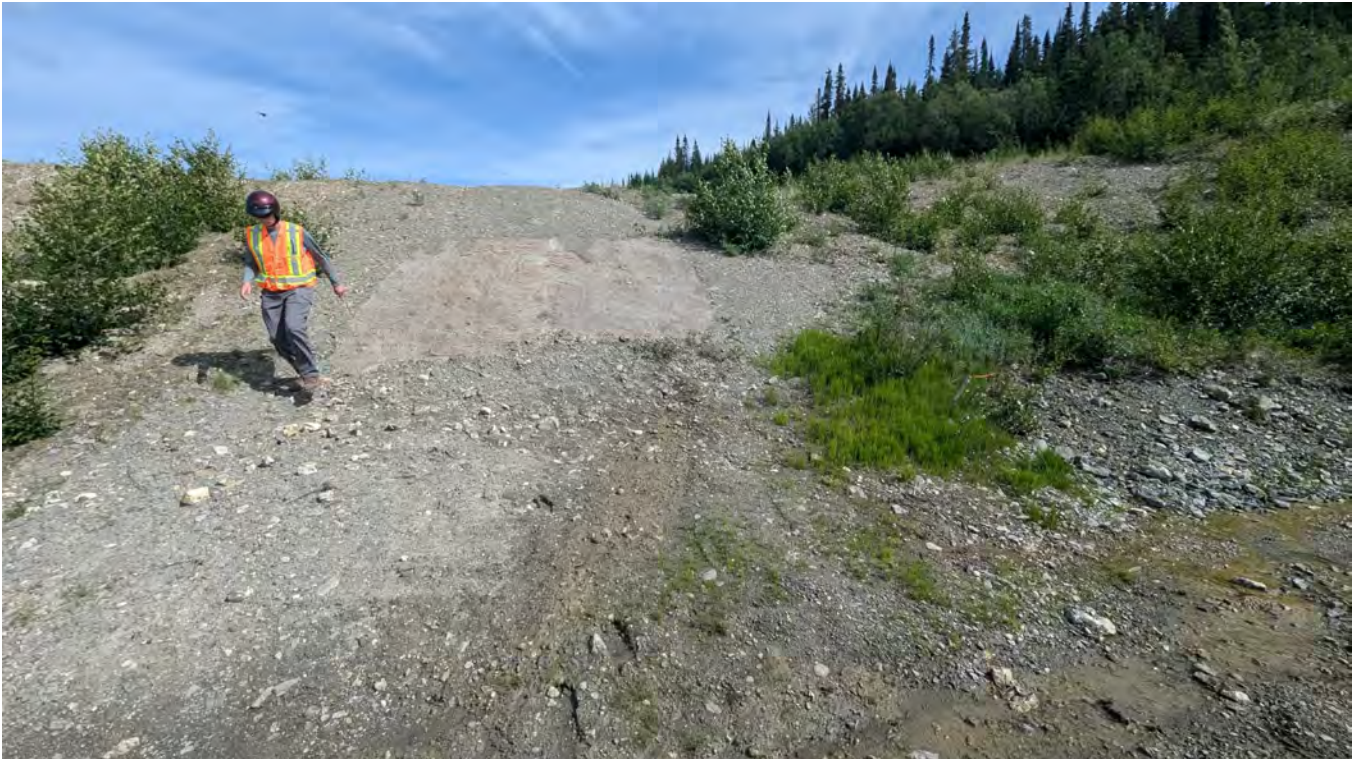
Photo SRS-05: Repaired sloughing area near the east abutment of the SRS. An erosion protection mat was installed on the slope as part of the repair.

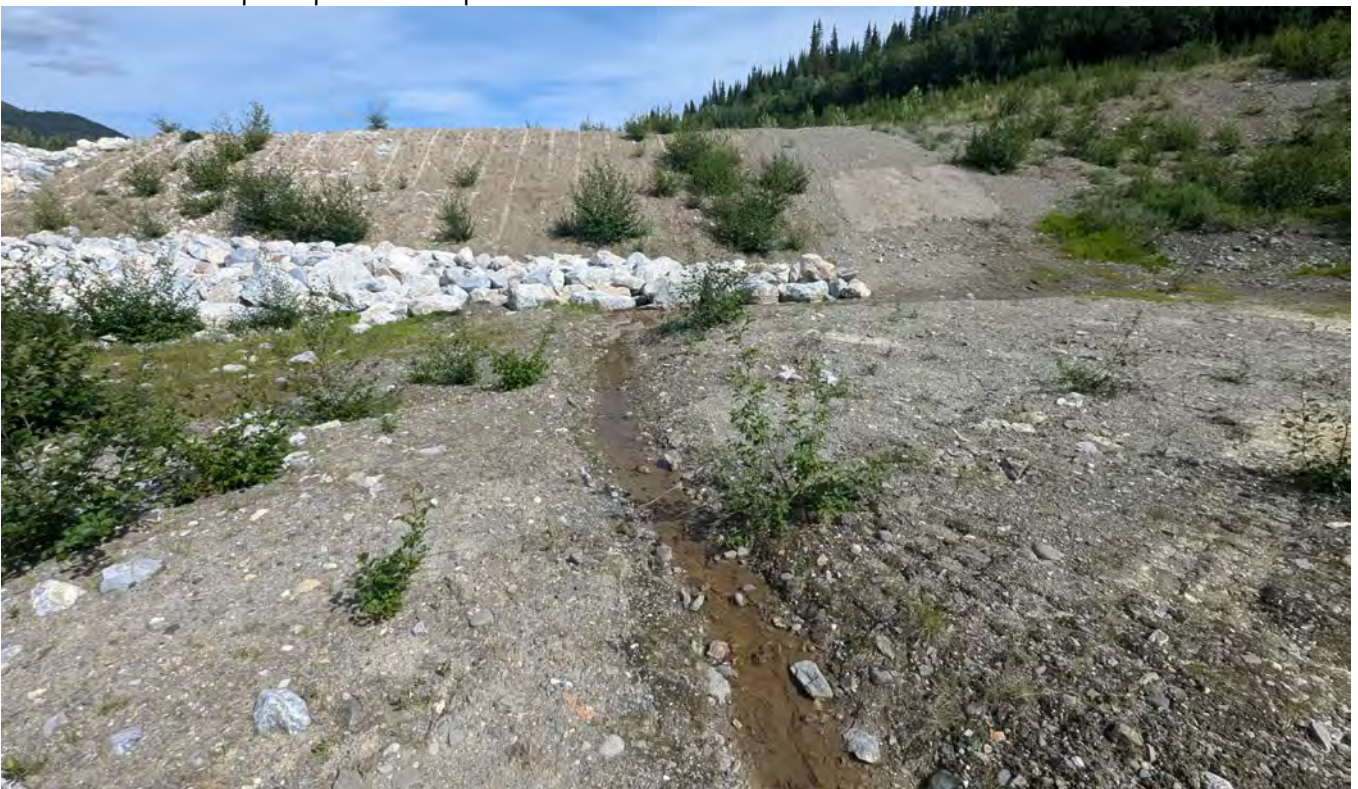
Photo SRS-06: Repaired slough area seen from downstream position. The area is away from the spillway and the ponded water area, and approximately 8 meters from the east abutment. Seepage is seen flowing from the SRS toe on the east side of the spillway.

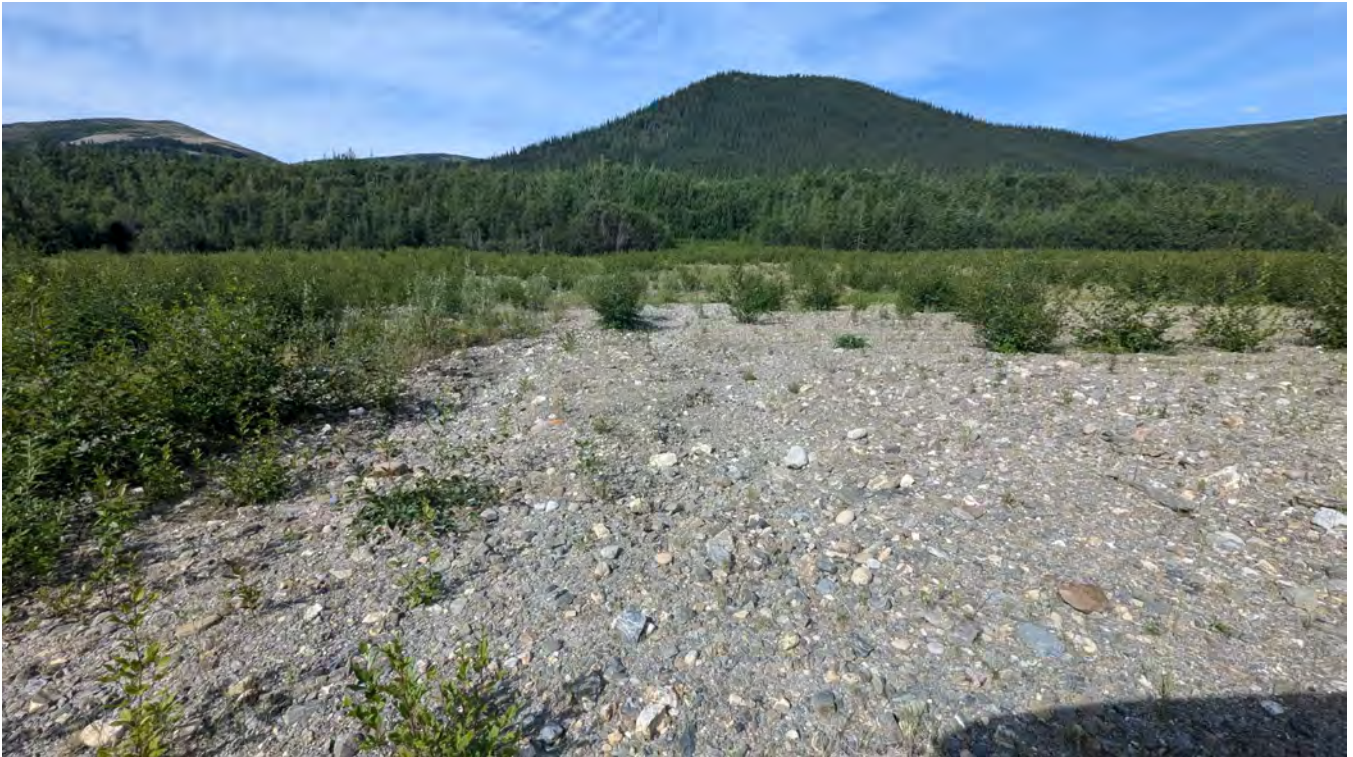
Photo TC-03: Eroded area of the cover where a drainage swale east of the main drainage swale of the cover flows to the west into the main drainage swale. No change in condition compared to the 2023 inspection.

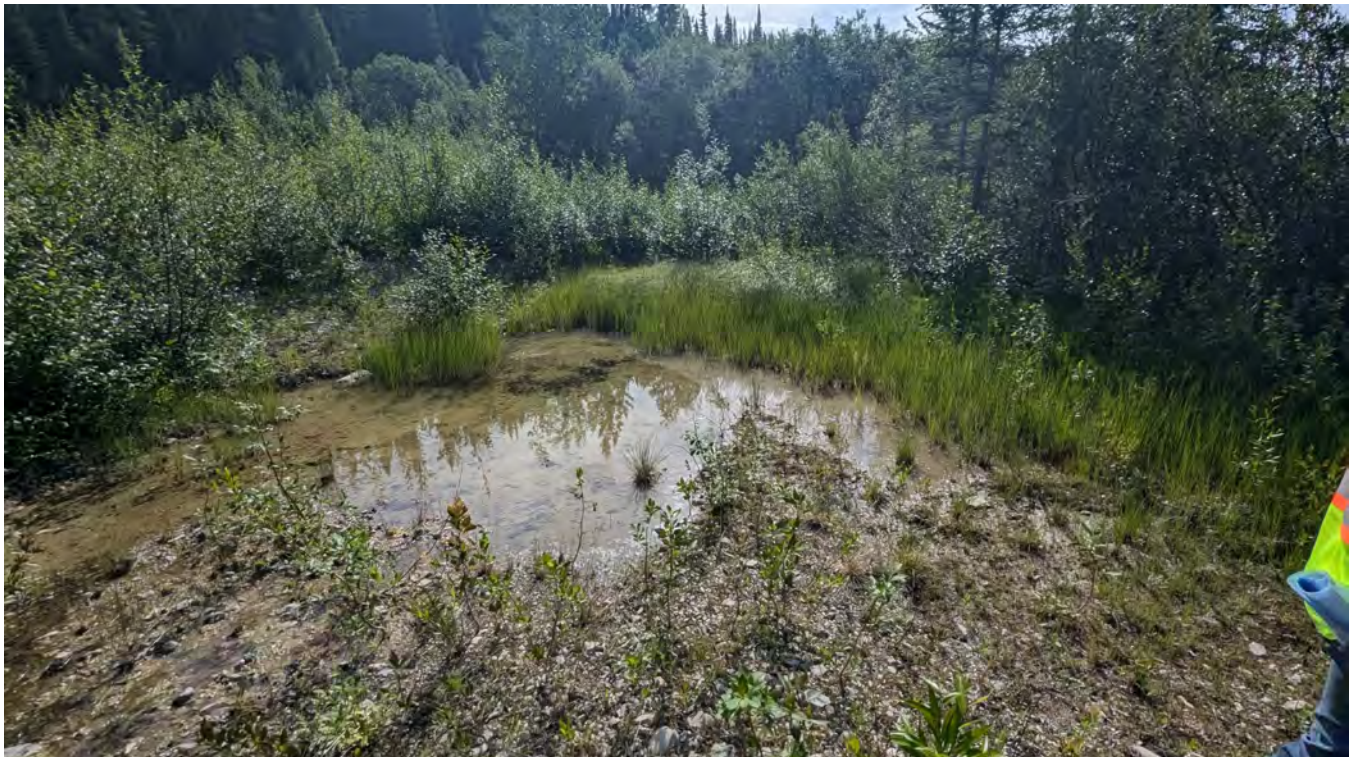
Photo TC-04: Outlet of the main drainage swale at the former coffer dam.

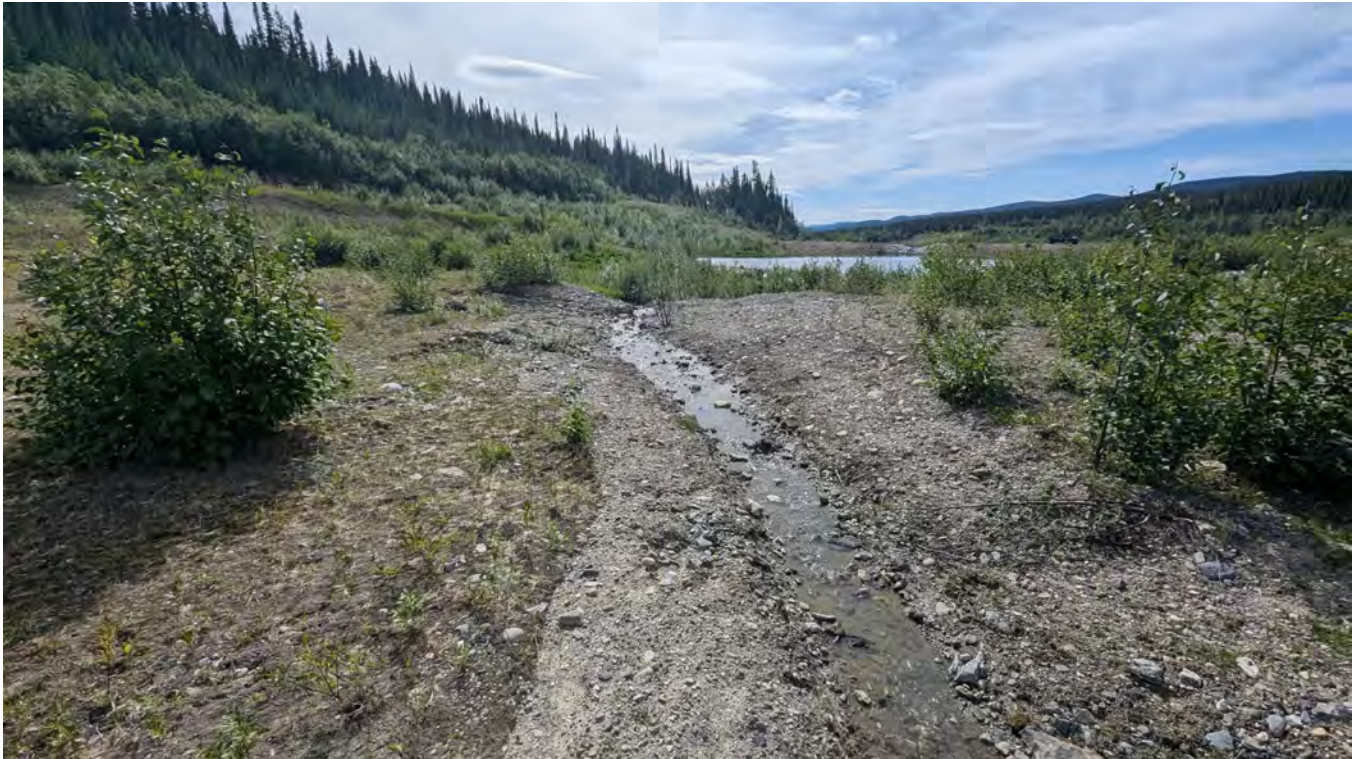
Photo TC-05: Repaired erosion area (repaired in August 2023). Looking downstream towards the SRS.

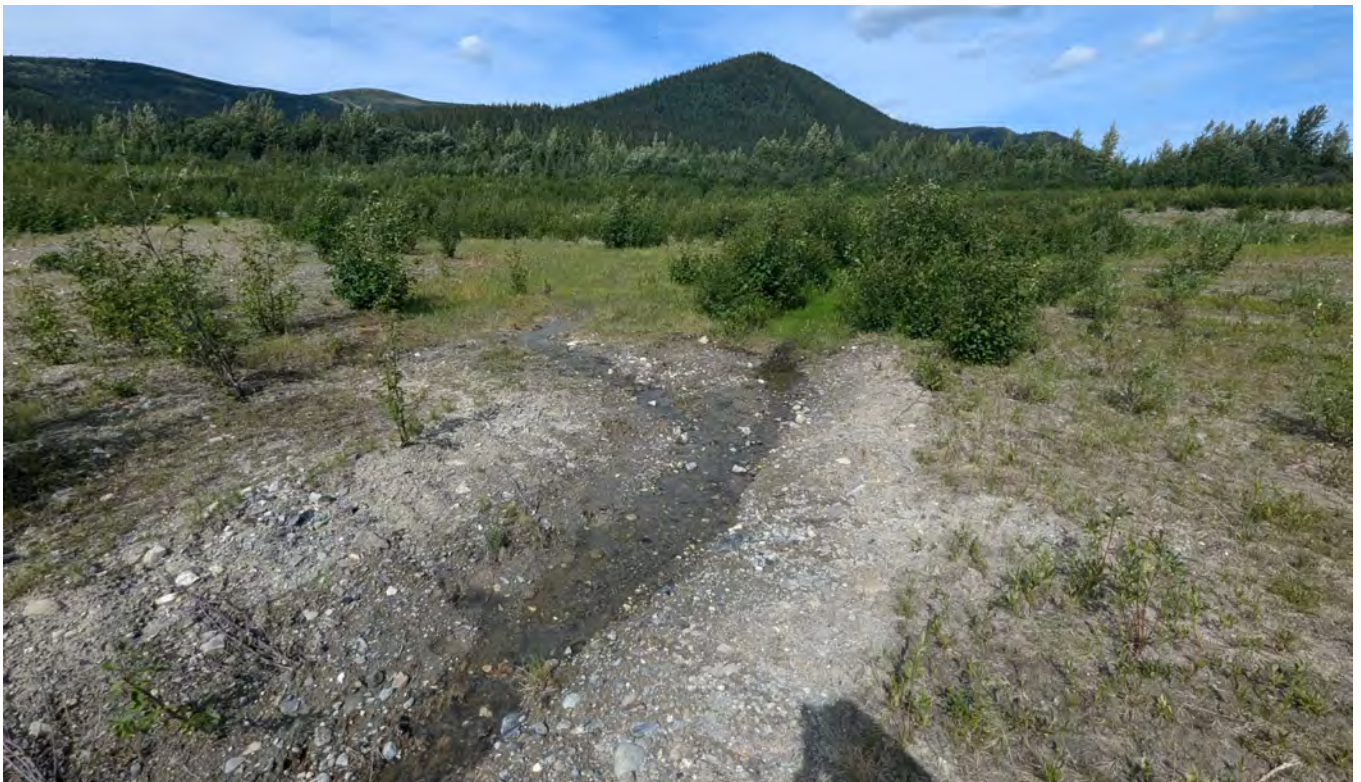
Photo TC-06: Repaired erosion area near the south end of the main tailings area (repaired in August 2023). Looking upstream to the northwest.

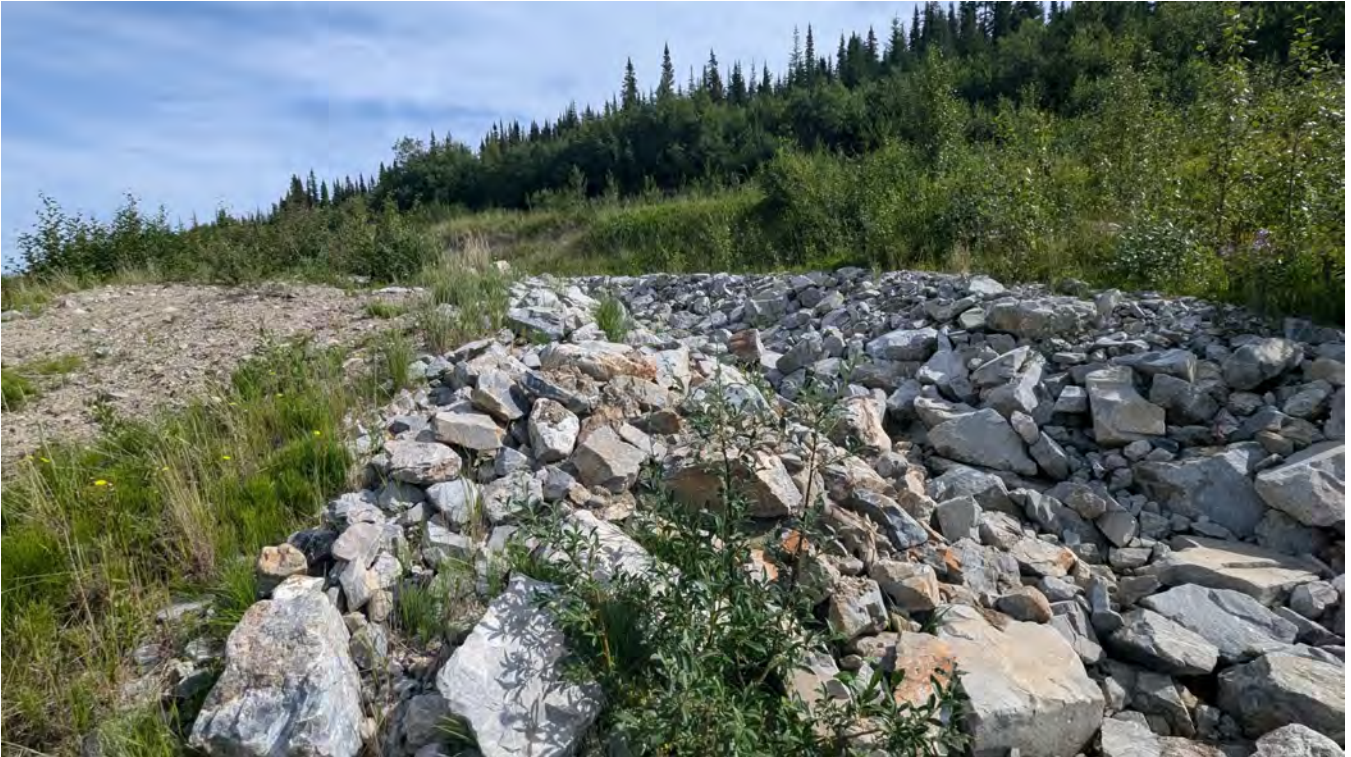
Photo NDC-01: Repaired area at the North Drainage Channel outlet where riprap movement was observed during the 2023 inspection.

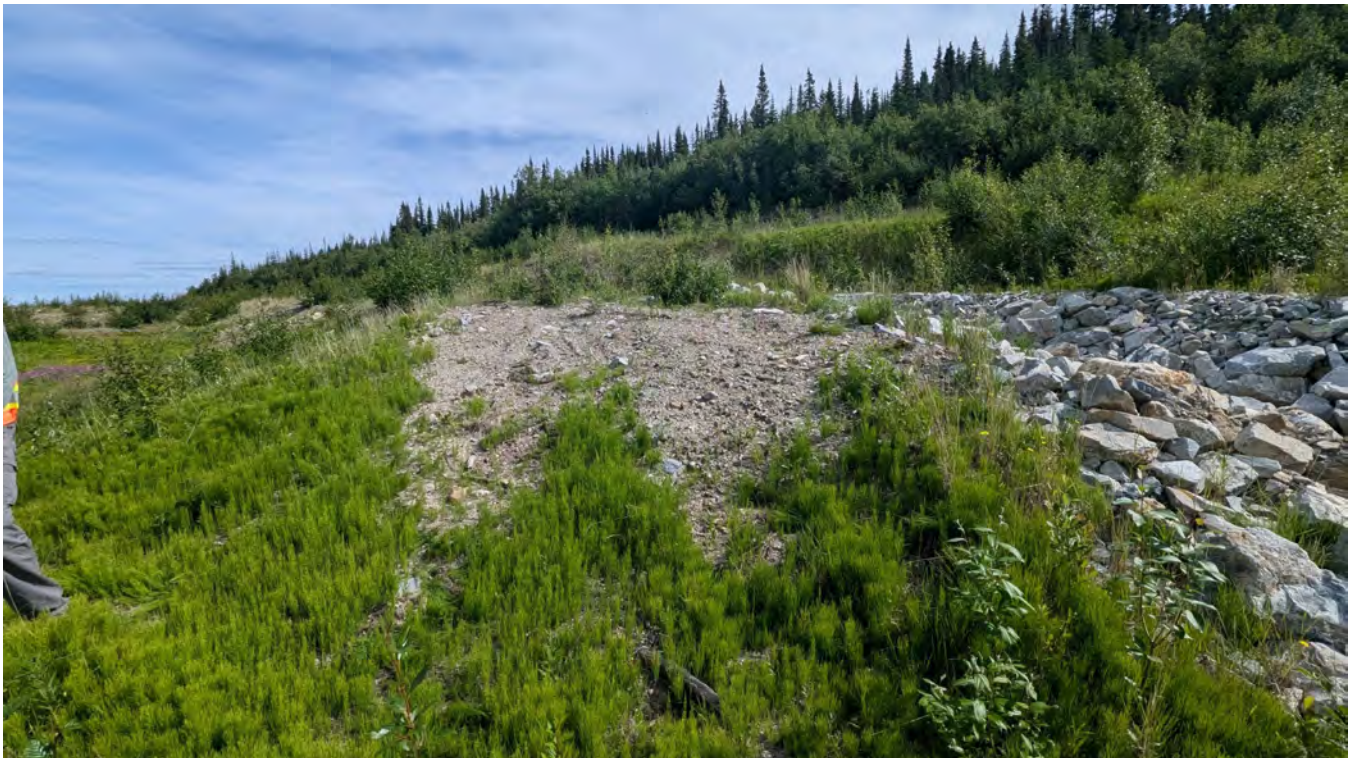
Photo NDC-02: Repaired erosion gully immediately to the west of the riprap movement area.

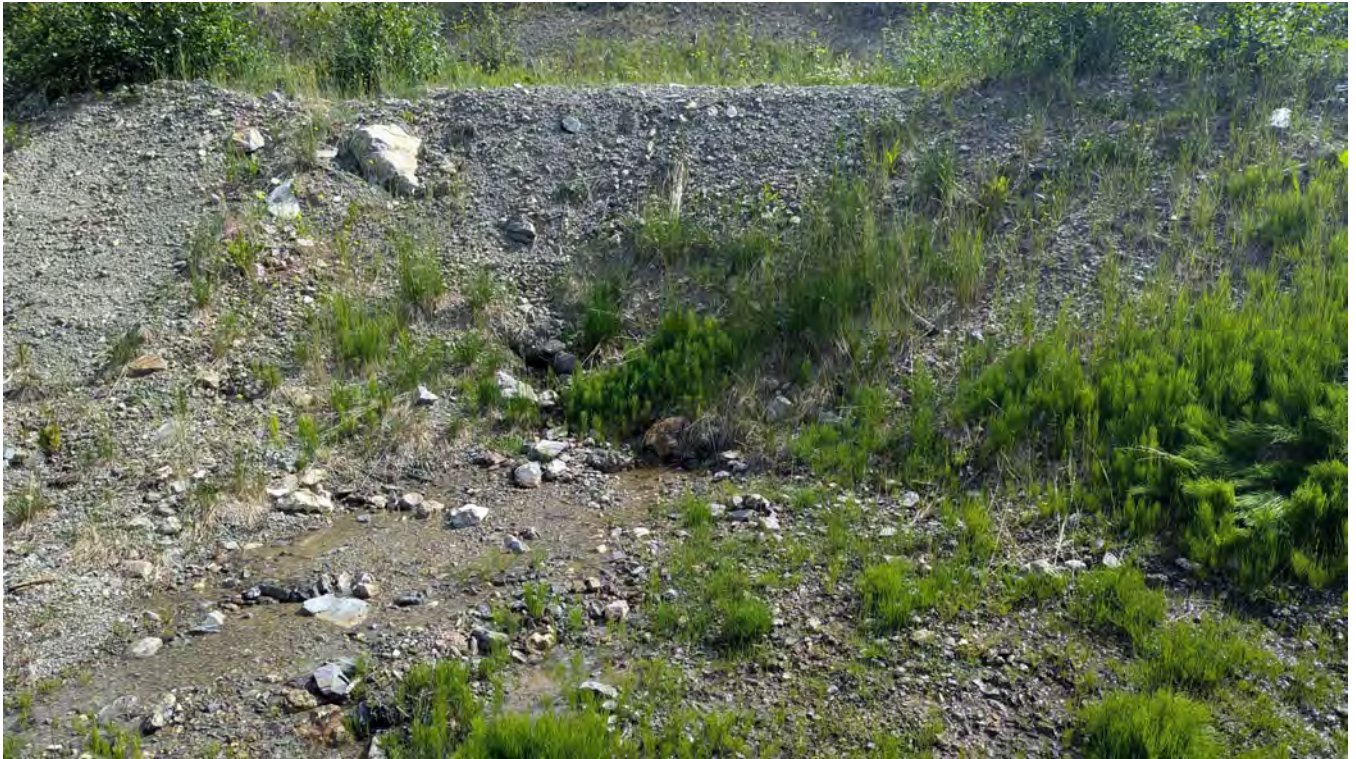
Photo NDC-03: Repaired area of the North Drainage Channel Berm where a slough was repaired in 2020 with a French Drain. Clear seepage was flowing through the base of the drain.

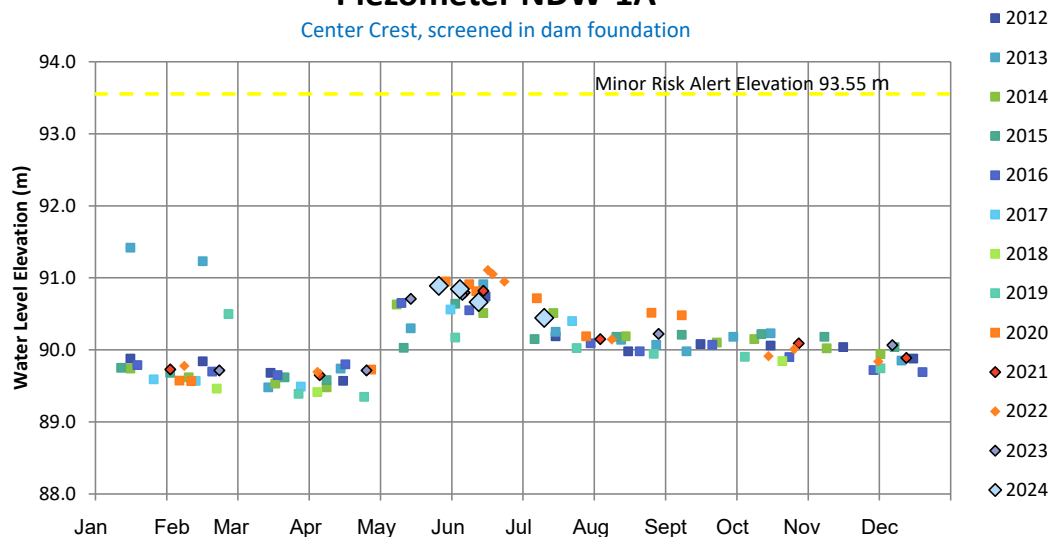
Center Crest, screened in dam foundation

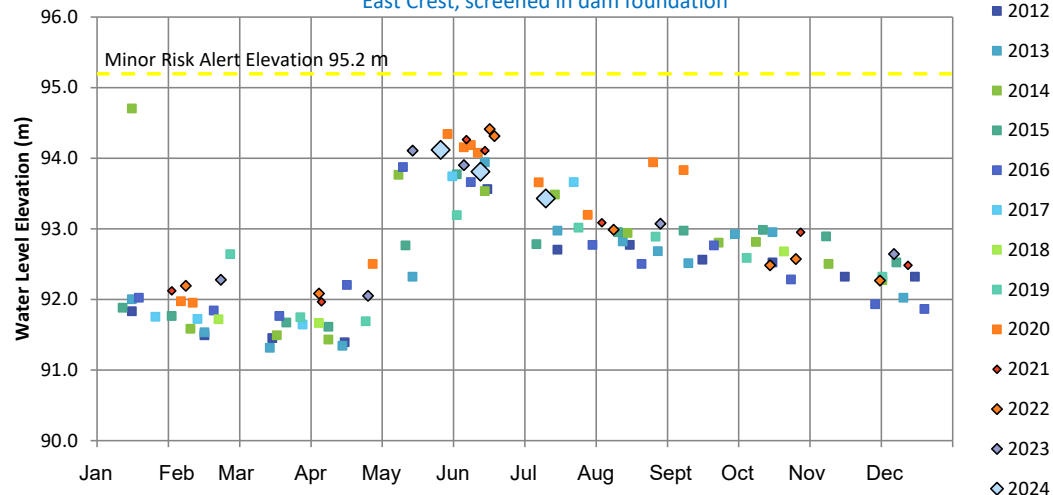
East Crest, screened in dam foundation

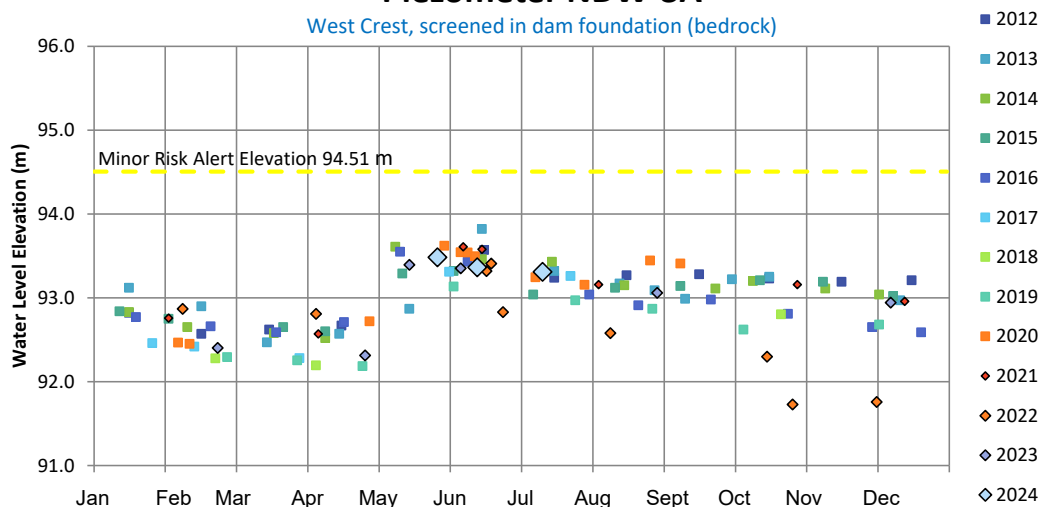
West Crest, screened in dam foundation (bedrock)

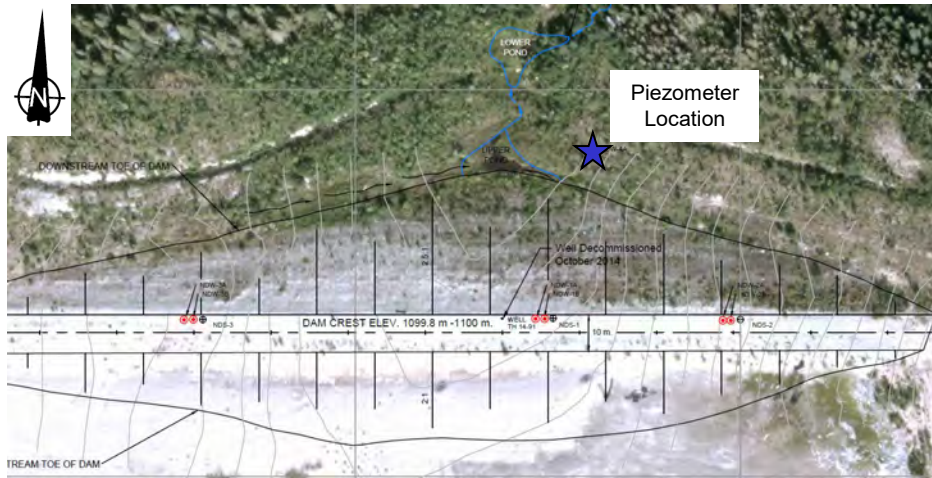
NOTE: In the spring of 2024, the PVC pipe was observed to have rose due to frost jacking and the top elevation of the pipe is uncertain. As a result, water level readings in 2024 are not accurate.
