2024 Annual Facility Performance Report - SDH Tailings Management Area

Sä Dena Hes Mine, Yukon Territory, Canada
Teck Resources Limited

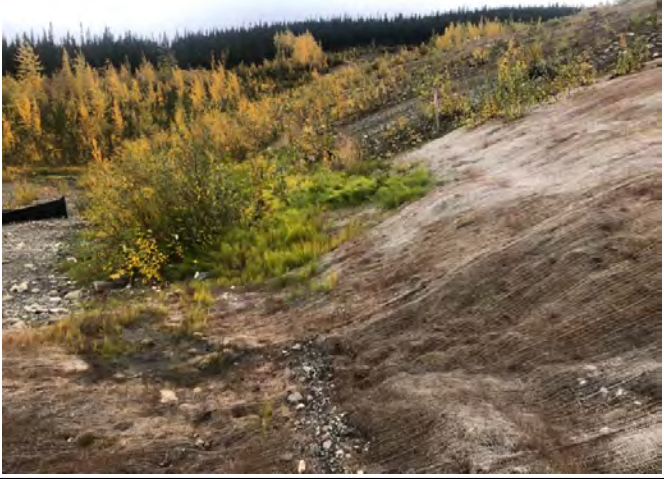
| Photo Discription | Photo | Photo Location |
|---|---|--|
| East side of downstream dam face. Seepage from area where french drain installed during repairs | | Latitude: 60.538864 Longitude: -128.854385 |

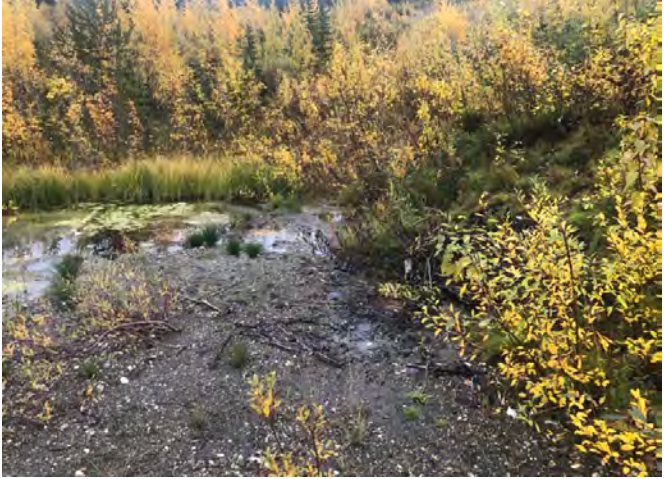
| Photo Discription | Photo | Photo Location |
|---|---|--|
| Center East side ponding and seepage | | Latitude: 60.538895 Longitude: -128.853729 |

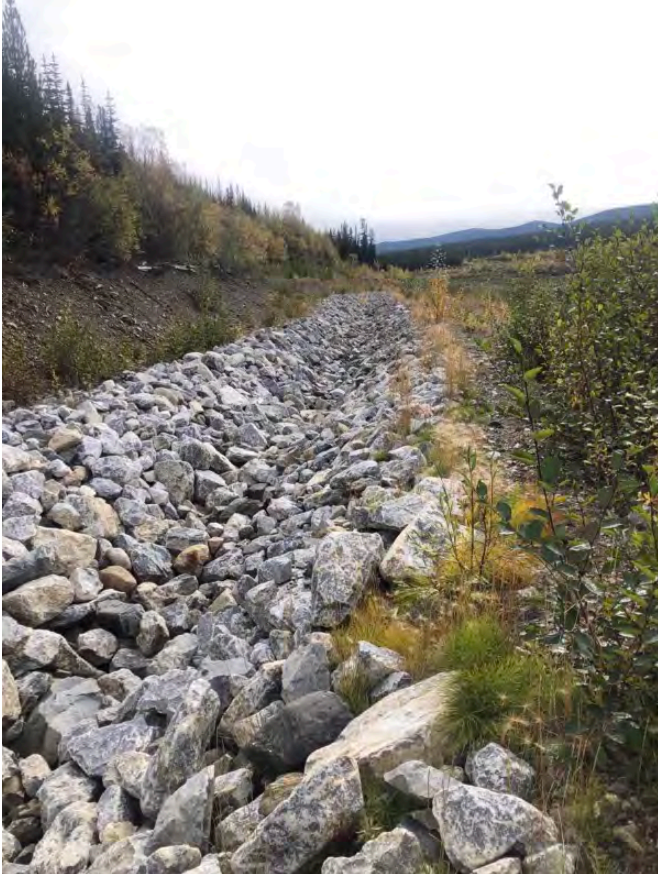
| Photo Discription | Photo | Photo Location |
|---|---|--|
| Midway-Looking south | | Latitude: 60.530994 Longitude: -128.850998 |

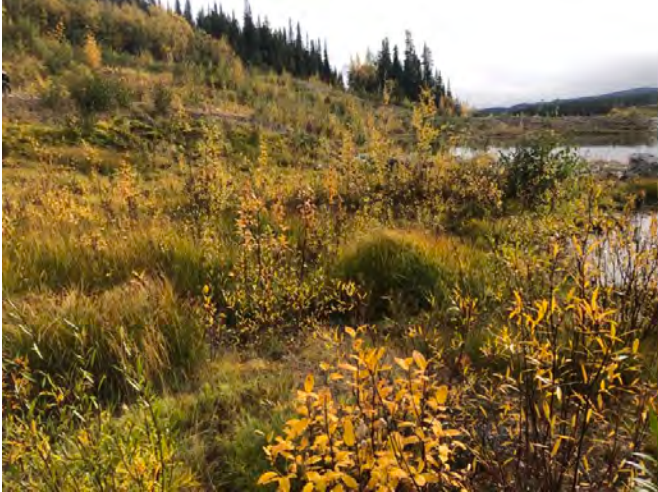
| Photo Discription | Photo | Photo Location |
|---|---|--|
| Hillside seepage into SRS | | Latitude: 60.529564 Longitude: -128.850861 |

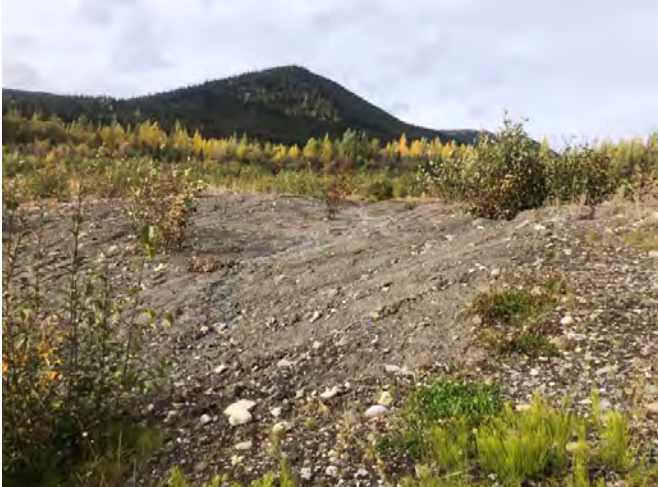
| Photo Discription | Photo | Photo Location |
|---|---|--|
| Cover repair of geotextile above SRS | | Latitude: 60.529686 Longitude: -128.850967 |

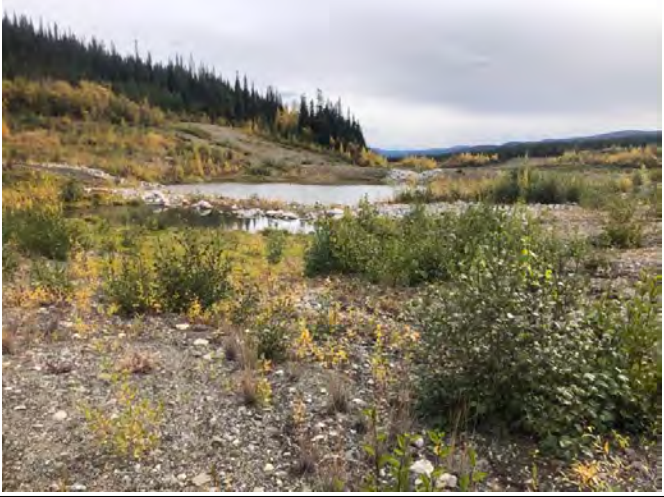
| Photo Discription | Photo | Photo Location |
|---|---|--|
| Pond | | Latitude: 60.529705 Longitude: -128.851562 |

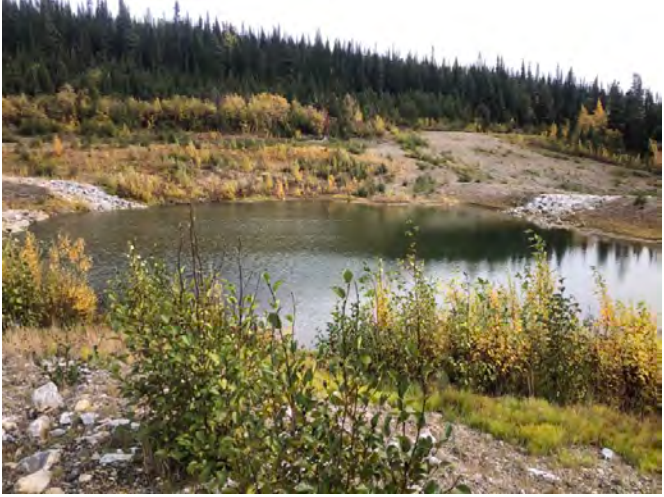
| Photo Discription | Photo | Photo Location |
|---|---|--|
| Overview | | Latitude: 60.529255 Longitude: -128.851639 |

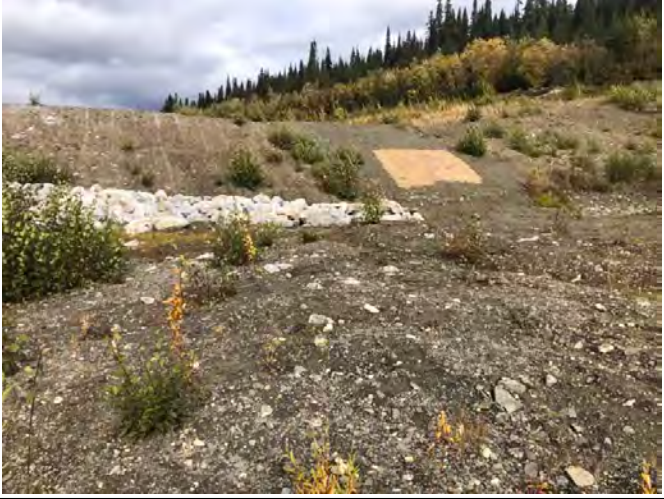
| Photo Discription | Photo | Photo Location |
|---|---|---|
| Downstream face repair | | |

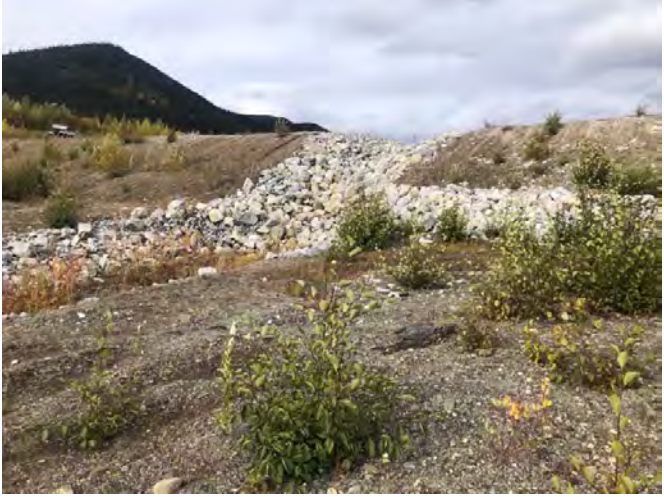
South Drainage Channel

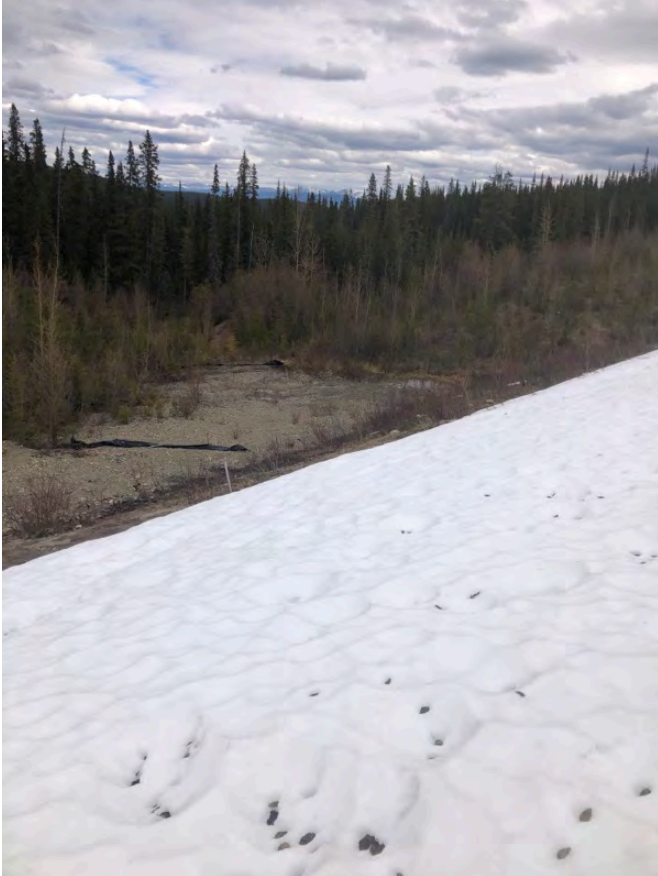
| Photo Discription | Photo | Photo Location |
|---|---|--|
| Toe seepage | | Latitude: 60.538918 Longitude: -128.854279 |

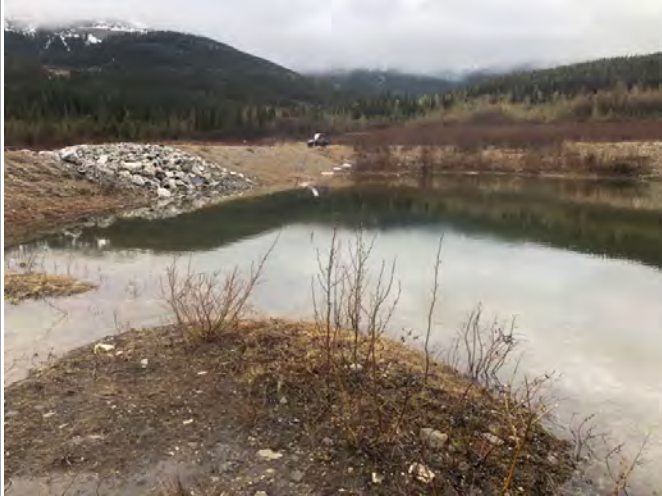
| Photo Discription | Photo | Photo Location |
|---|---|---|
| Upstream SRS | | |
