2024 Annual Geotechnical Inspection

Sä Dena Hes Mine, Watson Lake, Yukon
Teck Resources Ltd.

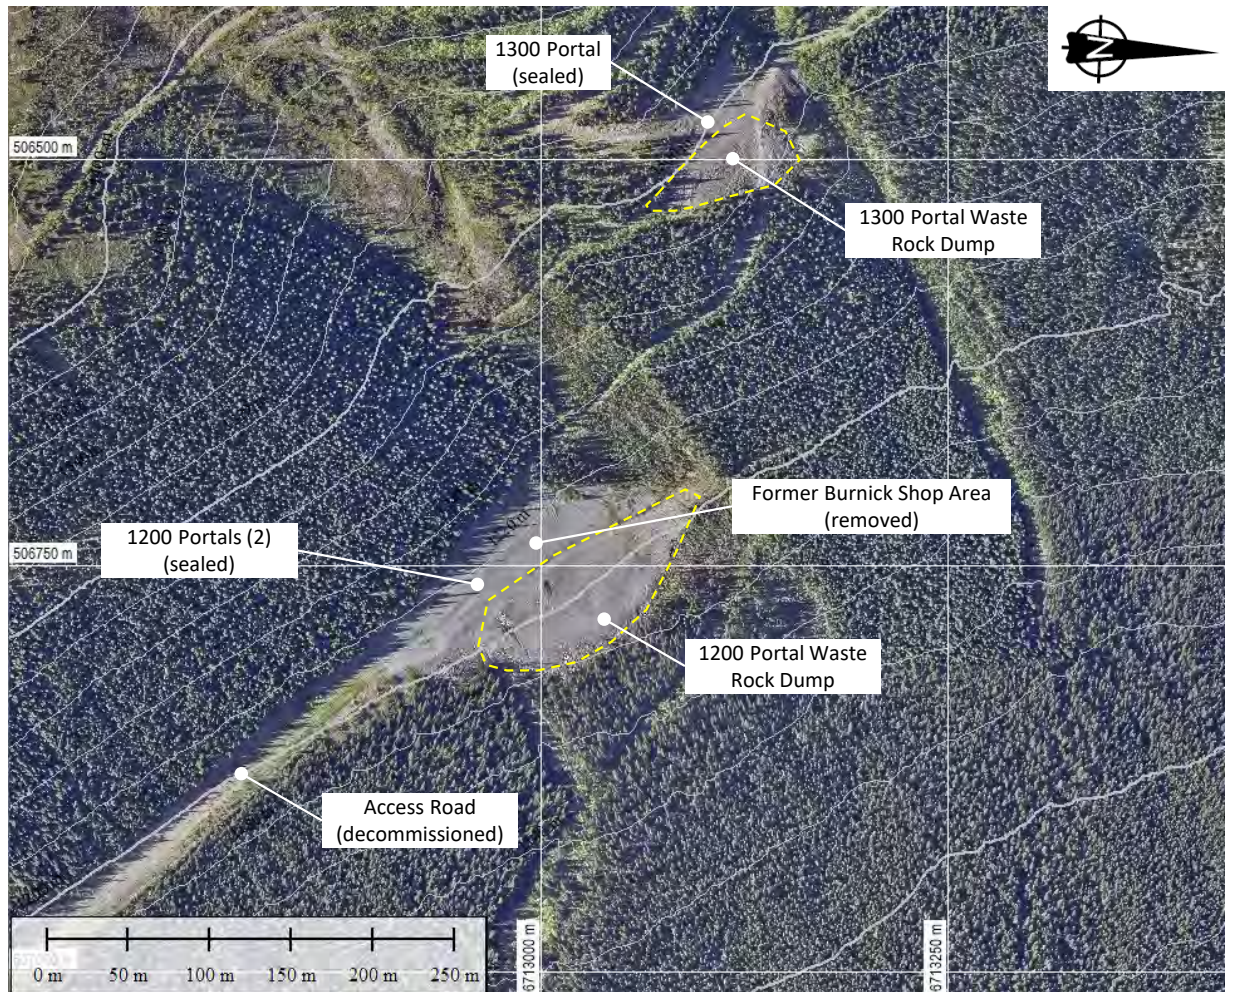
Sources: https://srk.sharepoint.com/sites/NACAPR003248/Deliverables/03_MineArea_Geotech_Inspection/040_Figures/SDH_Mine_Area_In-text_Figures.pptx

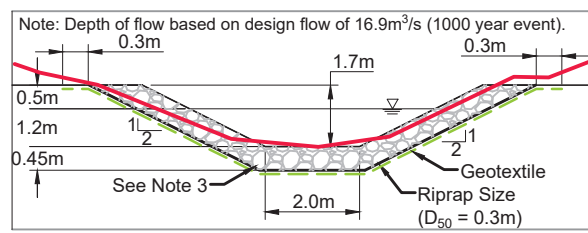
U
09 DESIGN SECTION U - U'
Camp Creek Drainage Channel
N.T.S.

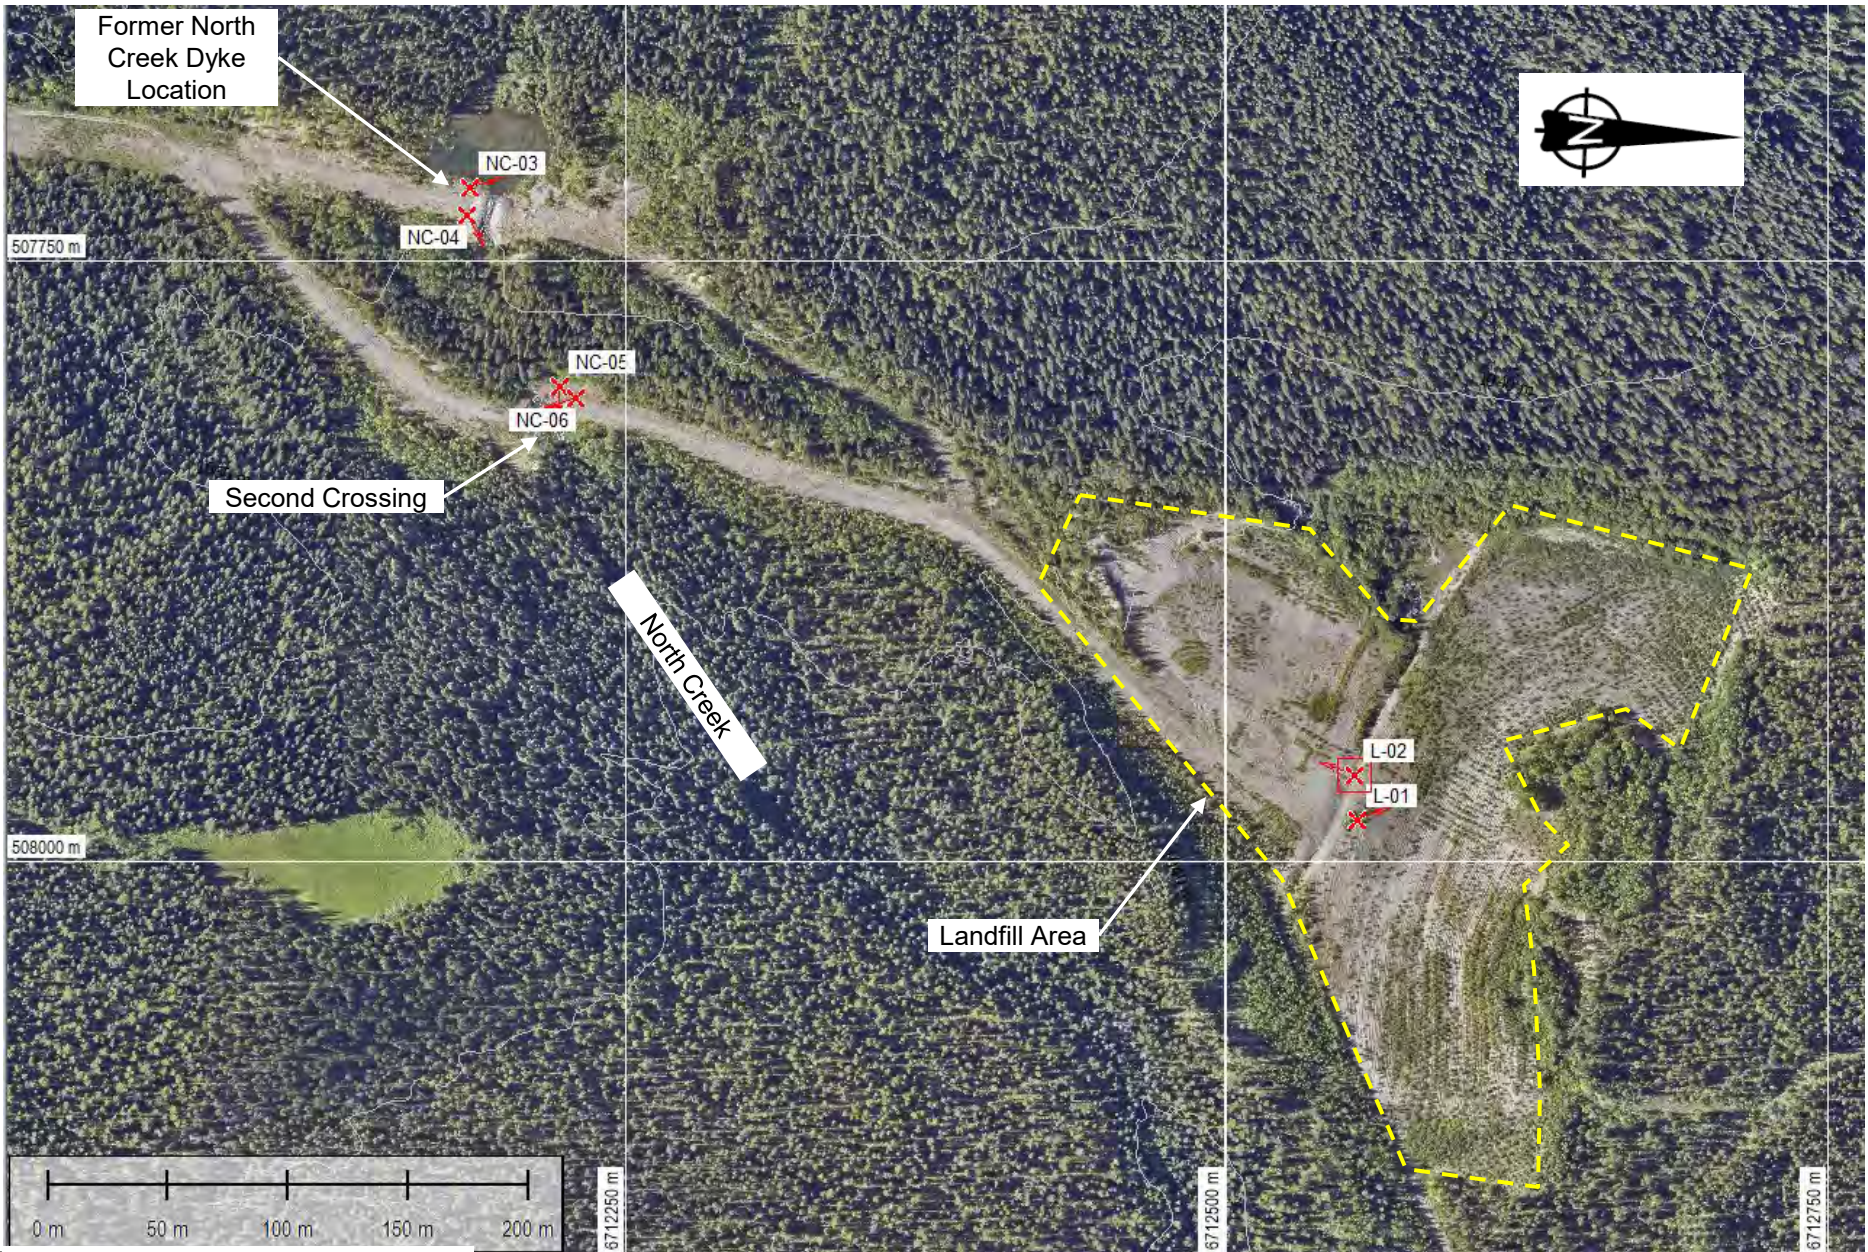
- Notes:
1. 2022 orthographic photo.
 2. Coordinate system is UTM NAD83 Zone 9.
 3. GlobalMapper file "SaDenaHes_2021.gmw" stored at:
 C:\Users\pmikes\SRK Consulting\F5261 Sa Dena Hes
 - Internal\040_CAD_GIS\GlobalMapper

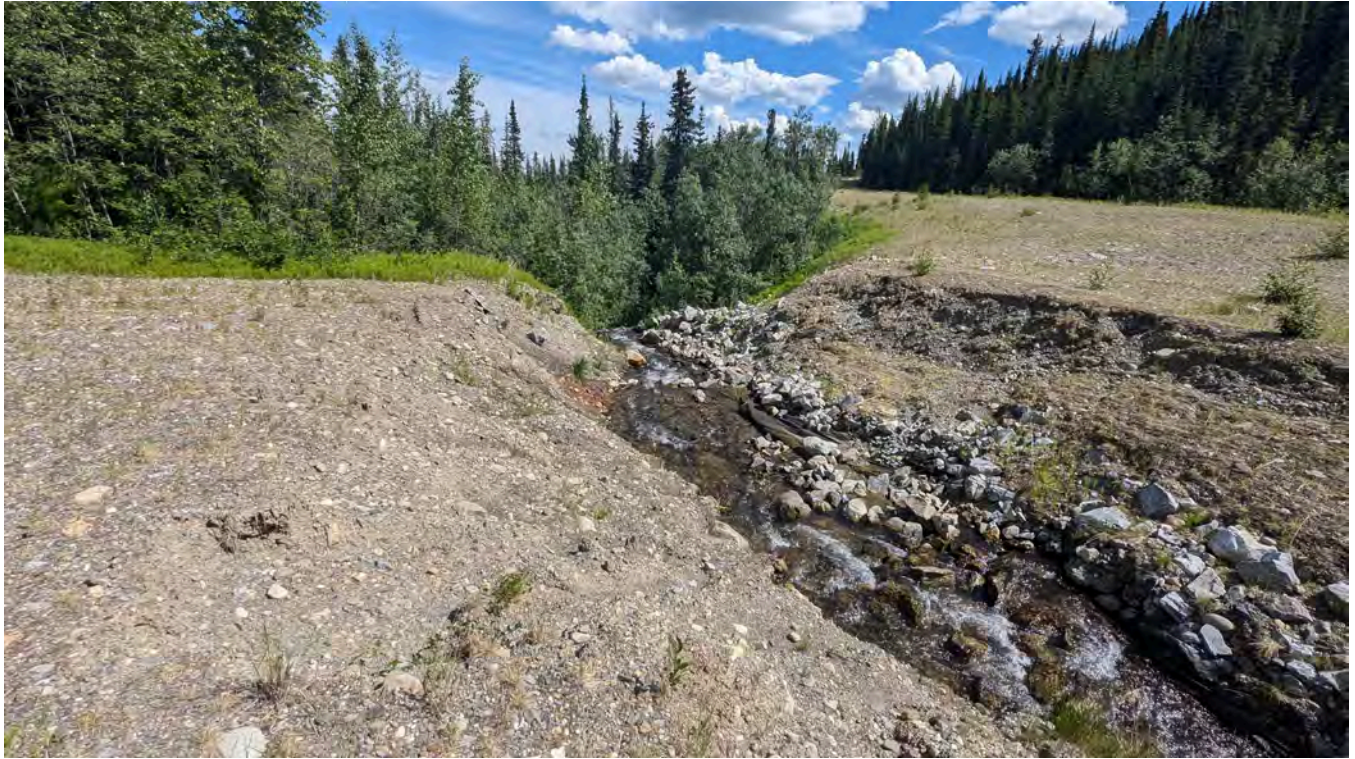
Photo NC-01: Decommissioned Access Road Crossing to Burnick Zone looking south.

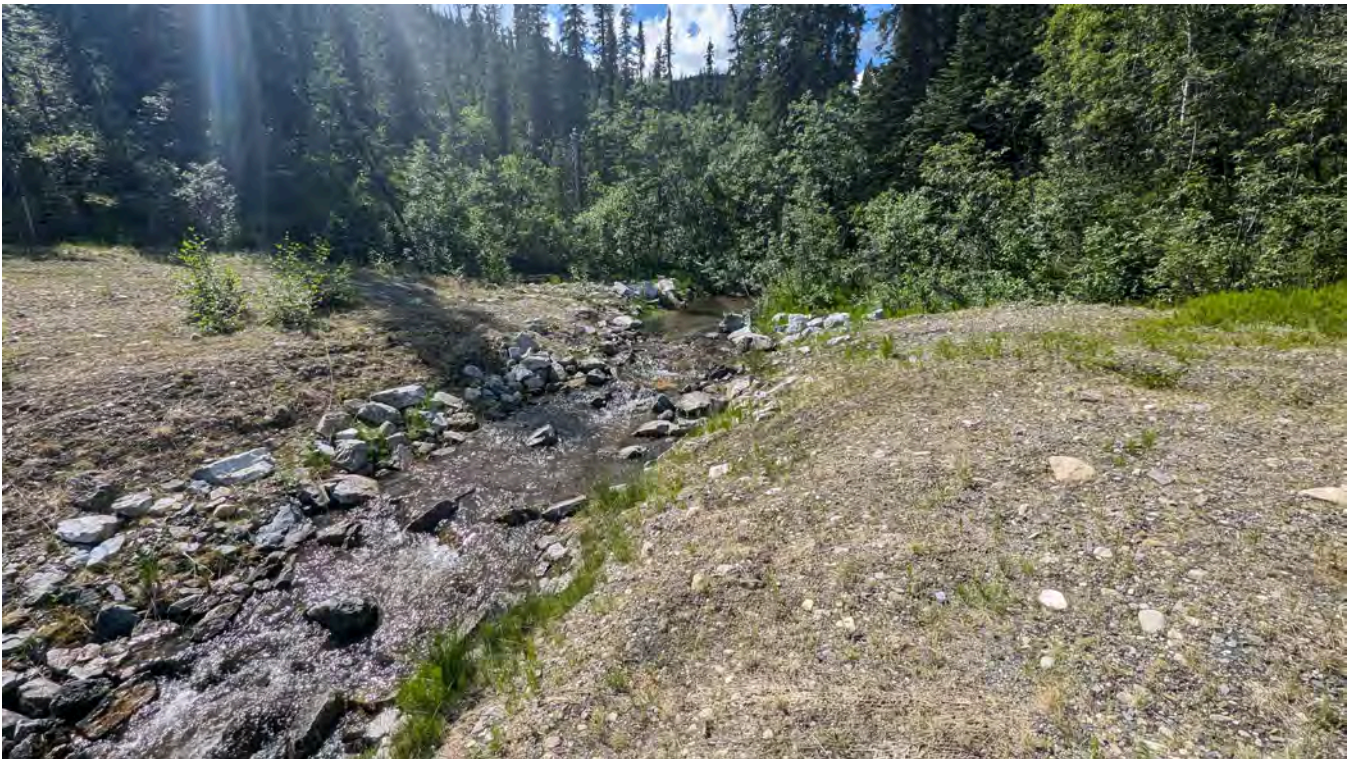
Photo NC-02: Decommissioned Access Road Crossing to Burnick Zone looking upstream.

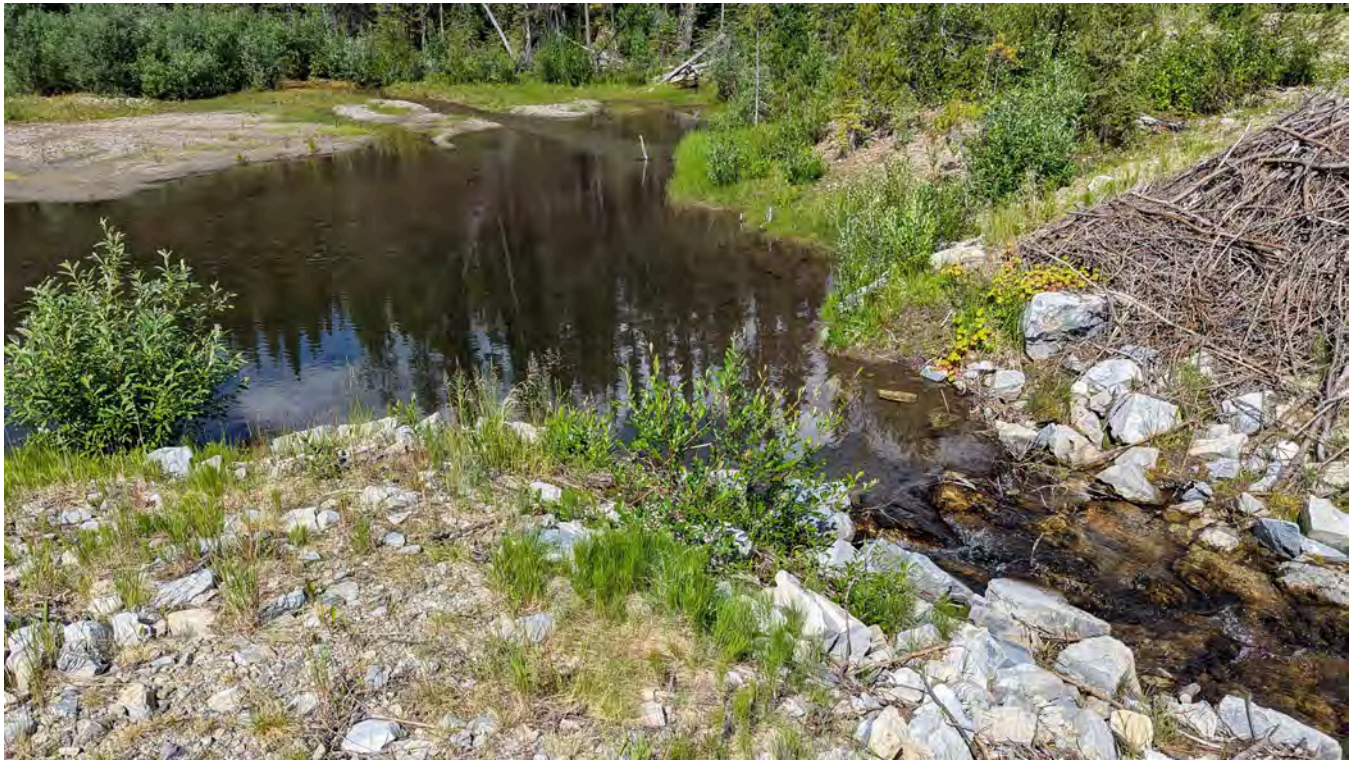
Photo NC-03: Former North Creek Dyke area. Inlet to the decommissioned dyke.

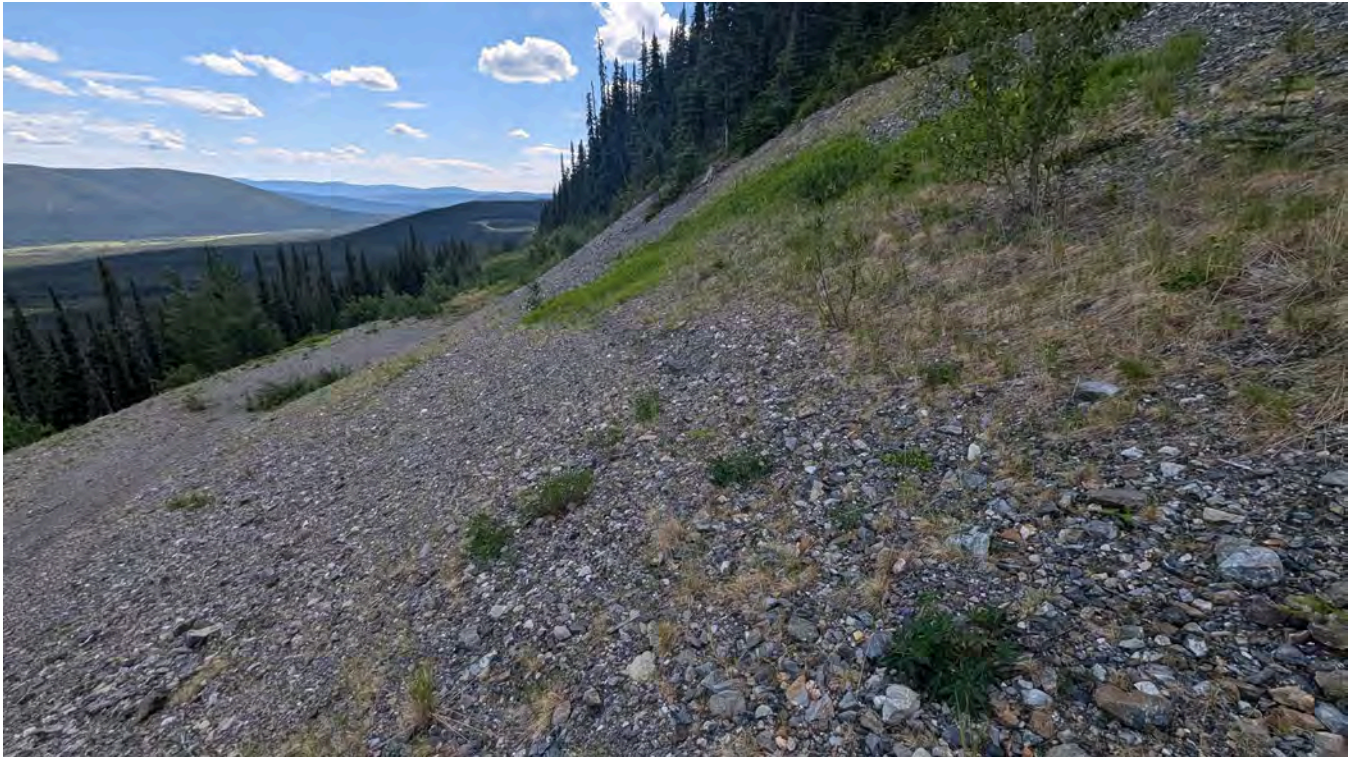
Photo WR-13: Regraded Burnick Waste Dump at the 1200 Portal. The minor settlement cracking observed during the 2023 inspection has partially filled with fine sediment.

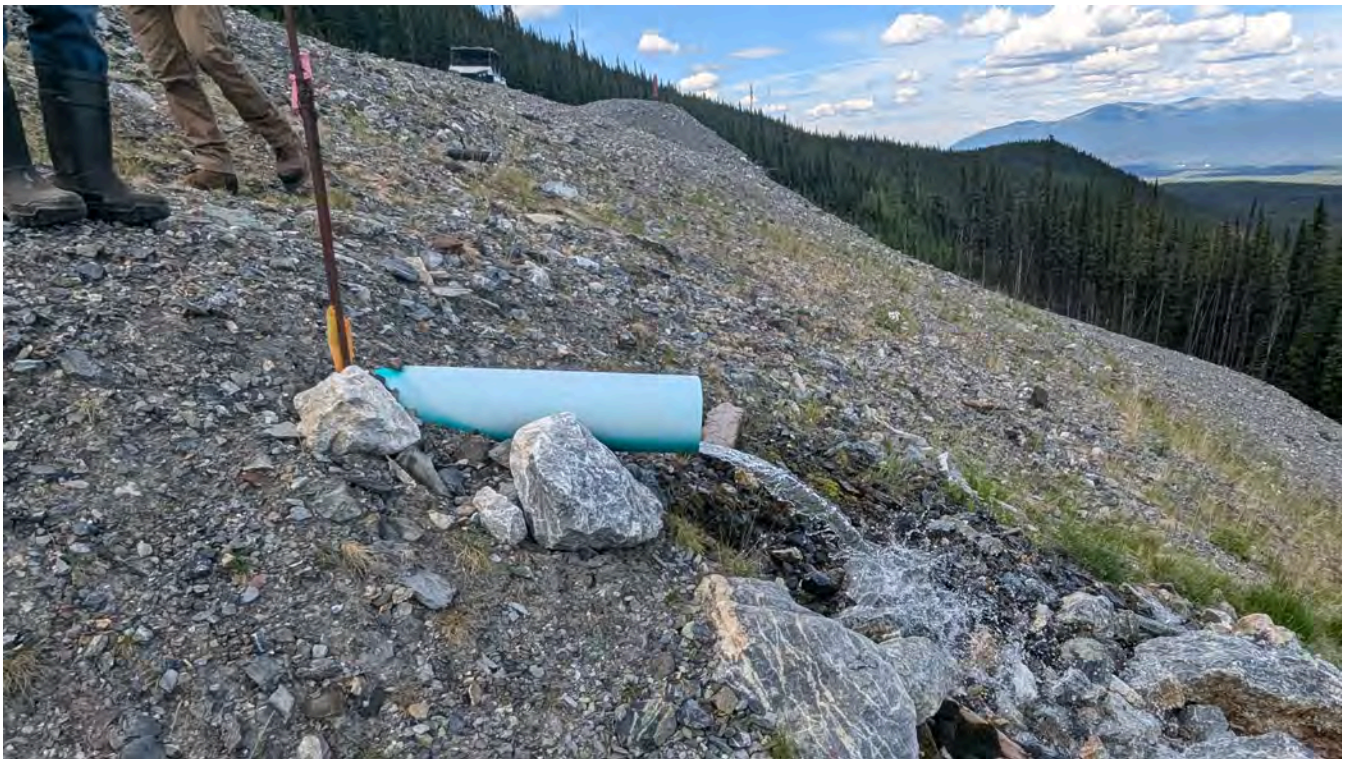
Photo WR-14: Drainage pipe at the Burnick 1200 Portal.

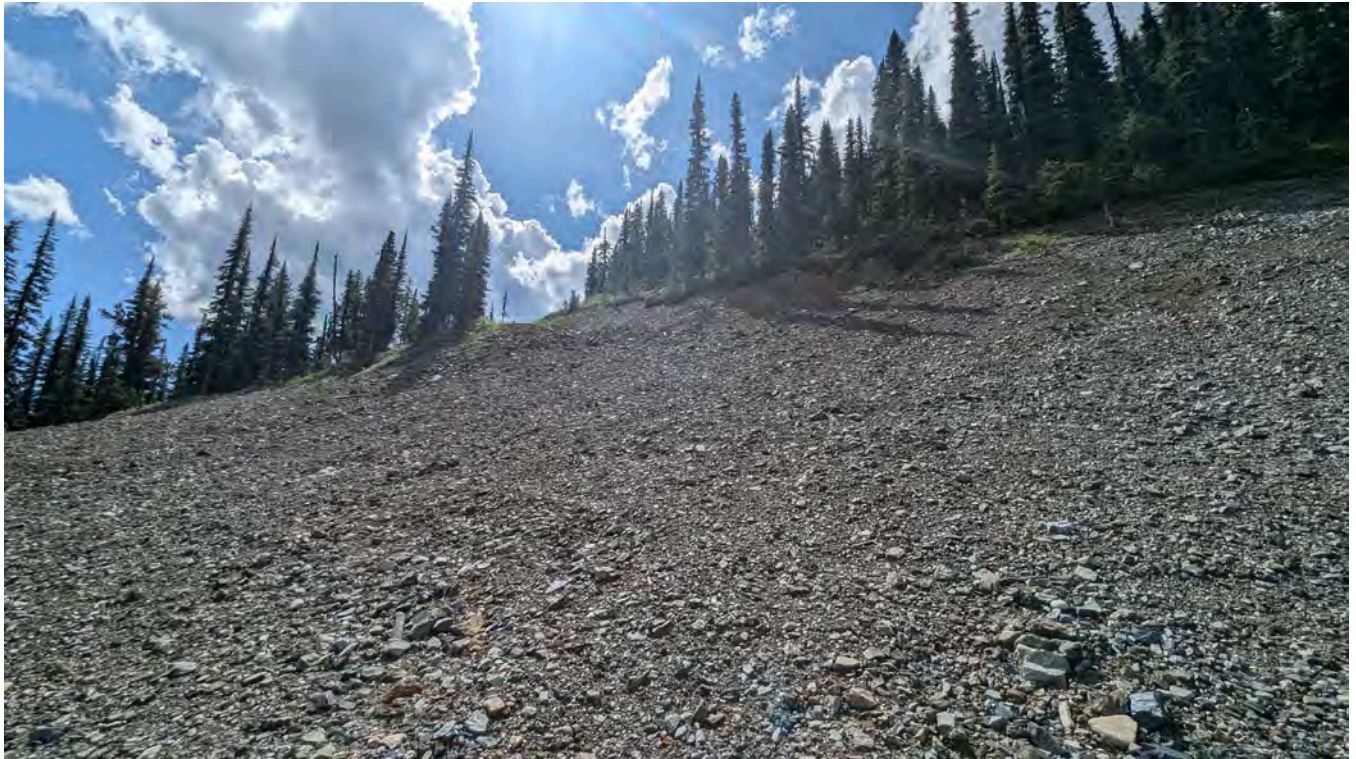
Photo WR-15: Regraded 1300 Portal Waste Rock Dump and 1300 Portal area.

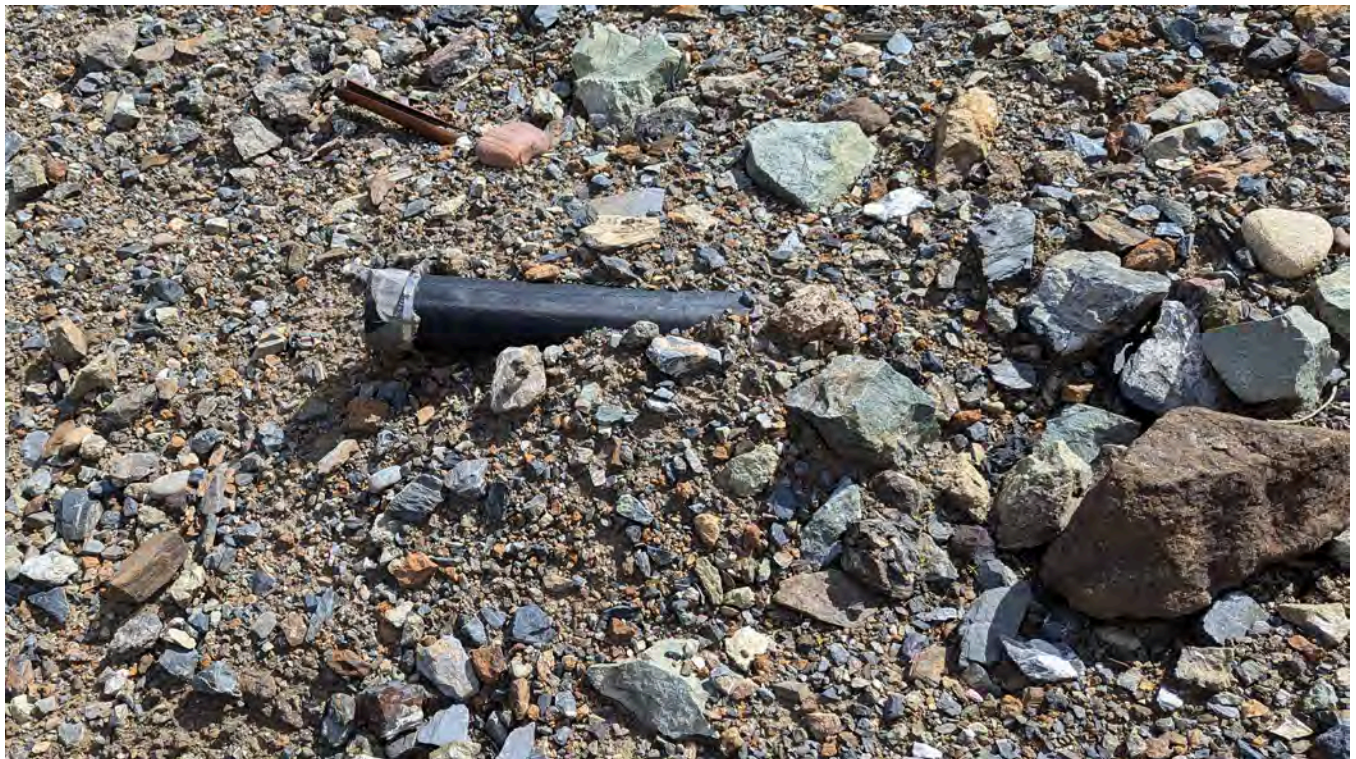
Photo WR-16: 1300 Portal drainpipe.

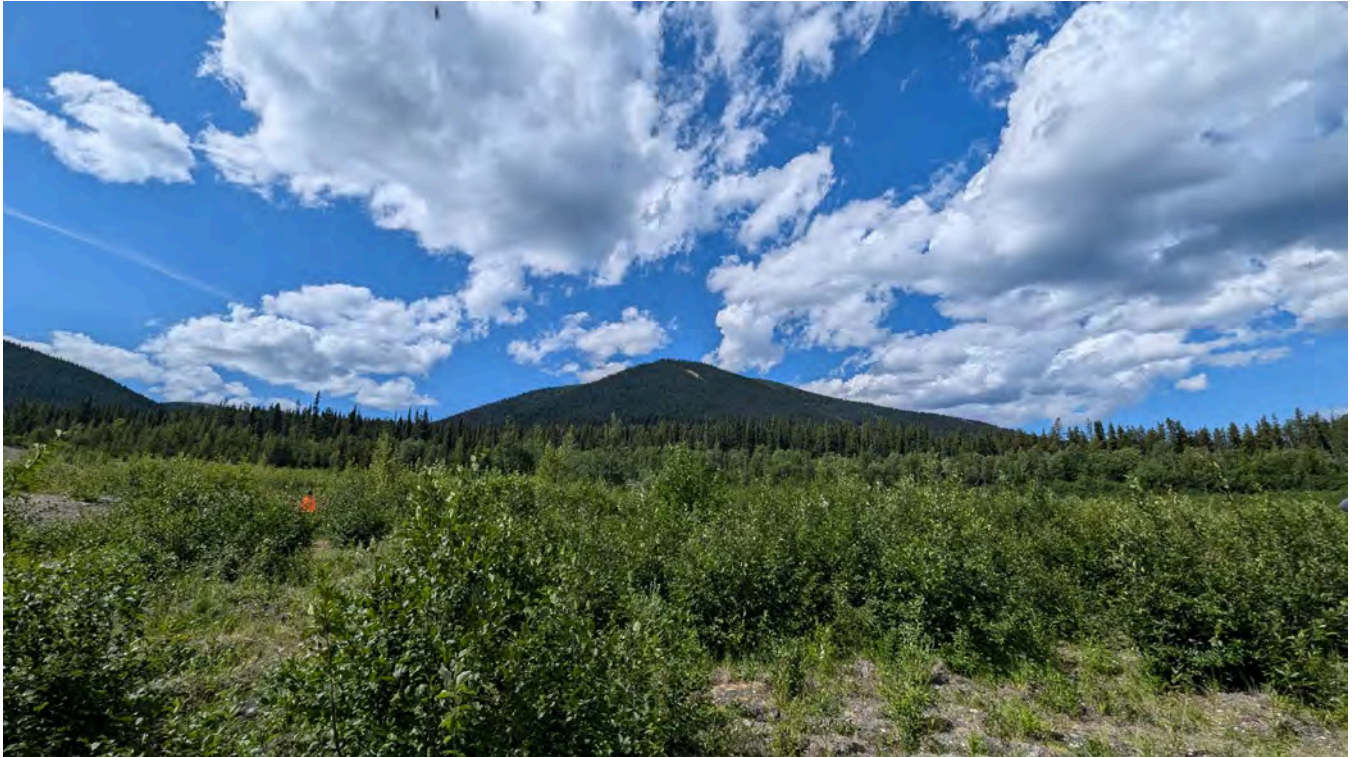
Photo L-01: Vegetation established on the Landfill cover.

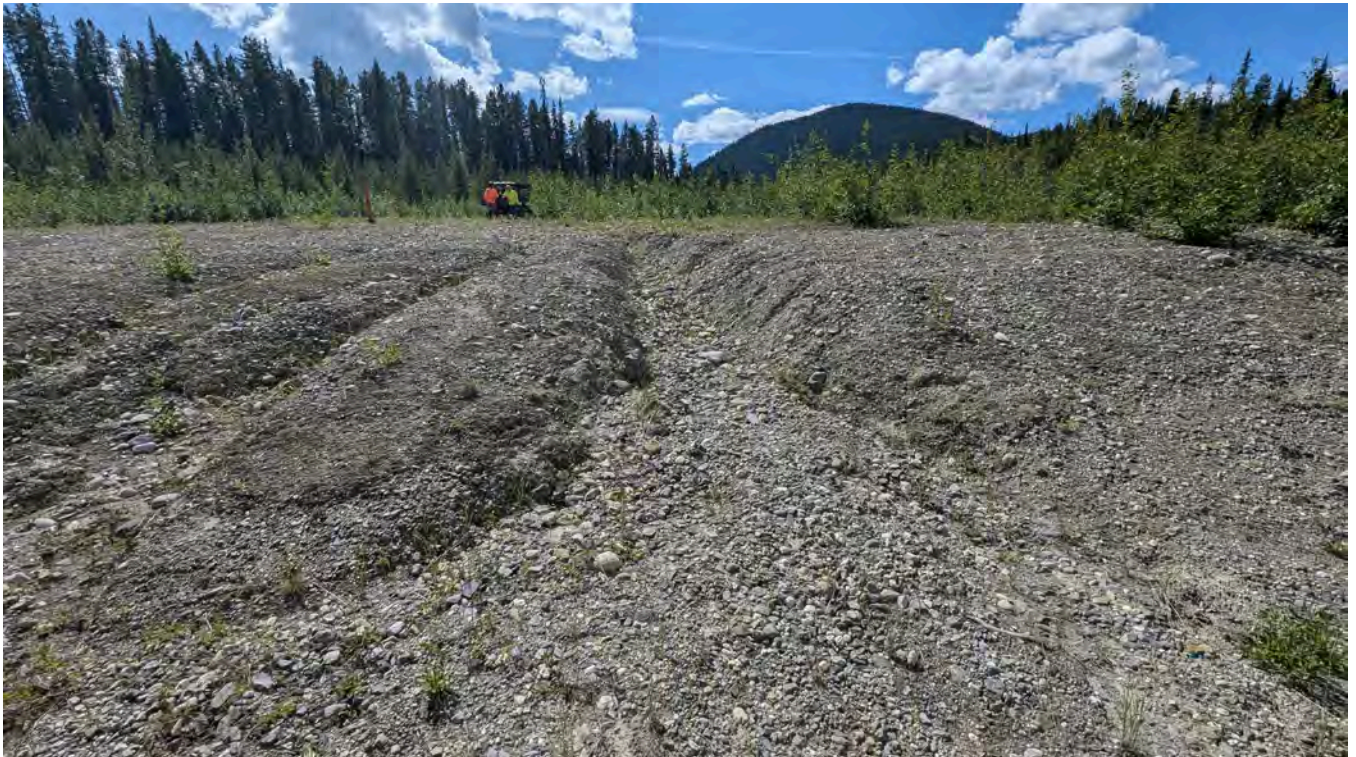
Photo L-02: Erosion channel that enters the Landfill drainage channel. The condition of the channel is unchanged compared to the 2023 inspection and no signs of debris were observed.

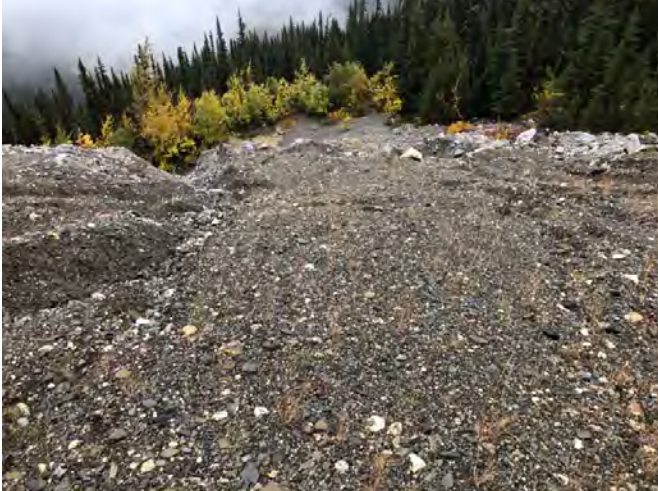
Photo Discription	Photo	Photo Location
Erosion rills and washout increased in size but appears to be to bedrock

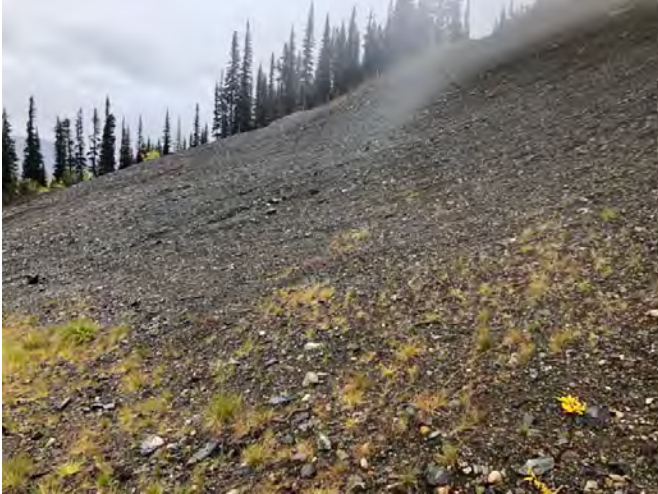
1200 portal waste rock dump , West.

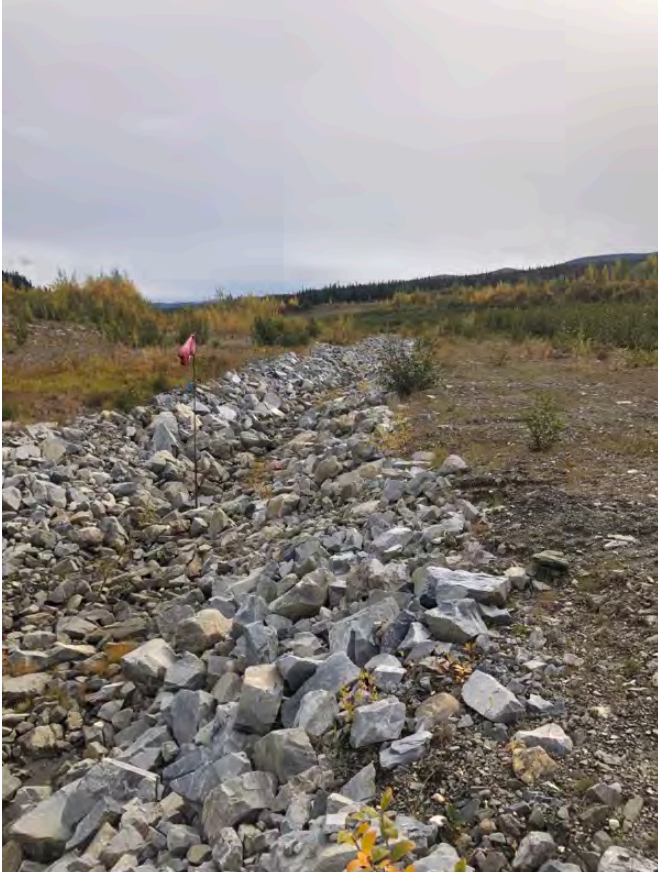
Latitude: 60.528454 Longitude: -128.850677

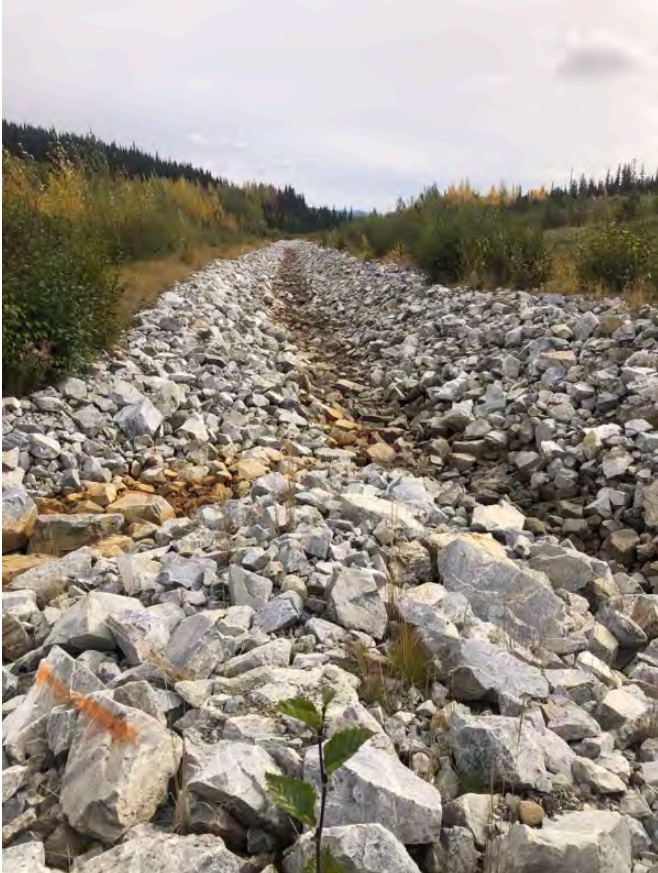
Camp Creek Drainage Channel

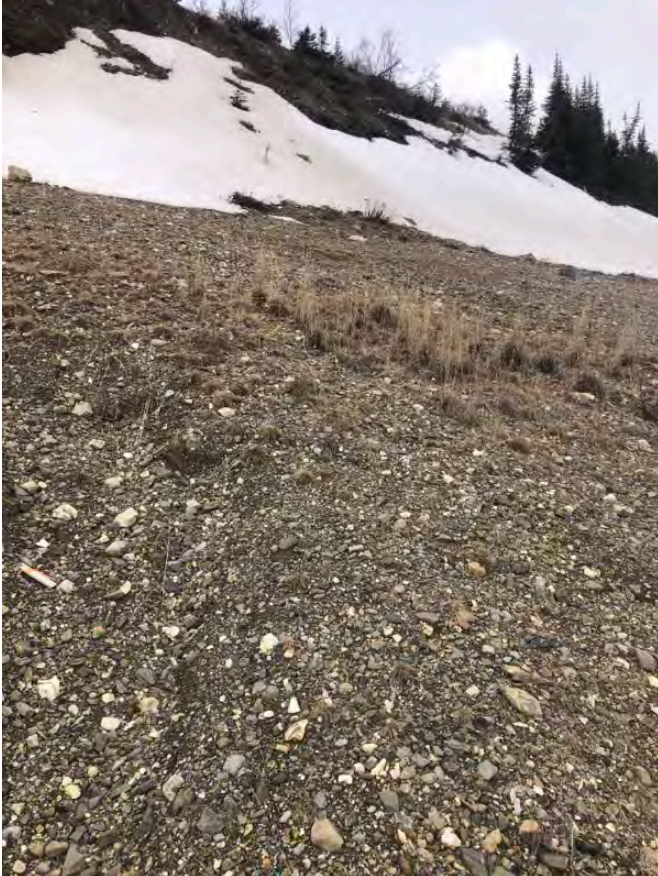
A photograph showing a steep, rocky slope. The foreground is covered in loose, grey and brown rocks and gravel. Sparse, dry, yellowish-brown grasses are scattered across the slope. In the upper portion of the image, there are patches of white snow or ice, particularly on the left side. The background shows a line of evergreen trees under a cloudy sky.	Latitude: 60.519615 Longitude: -128.877563

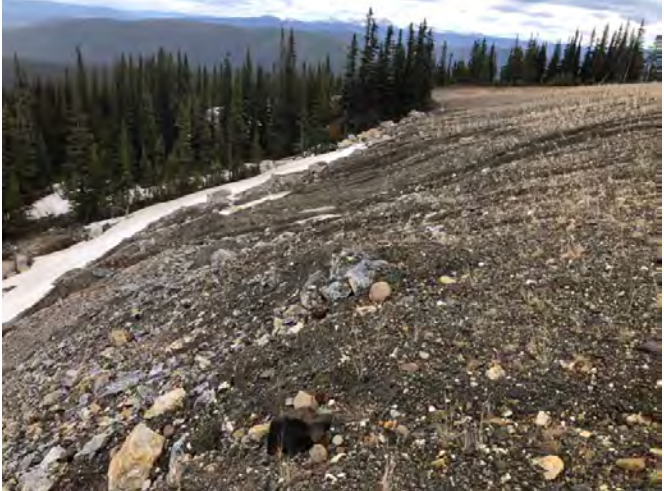
Photo Discription	Photo	Photo Location
Slumping along waste rock dump

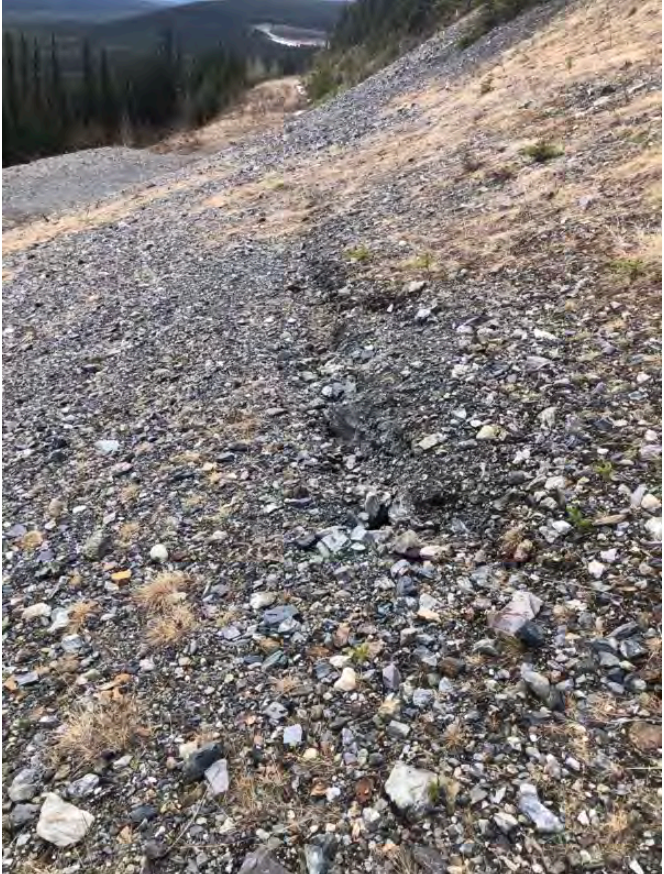
Latitude: 60.552460 Longitude: -128.876755

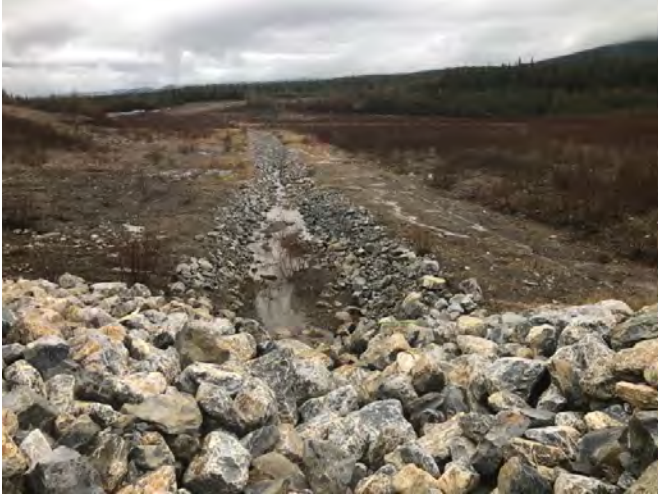
Iron staining in south channel, looking south.

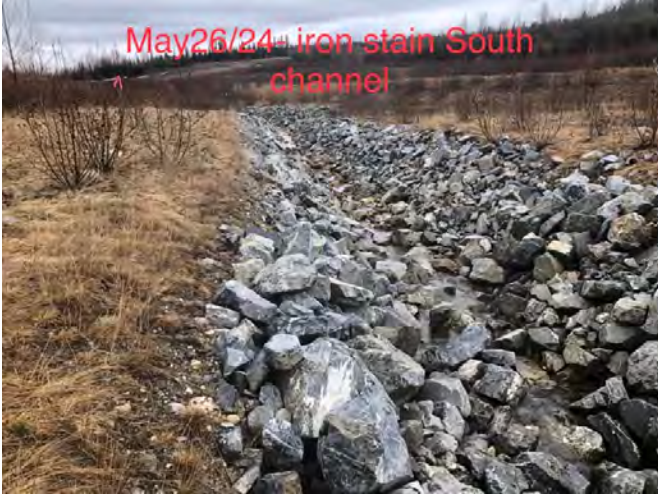
Camp Creek Drainage Channel

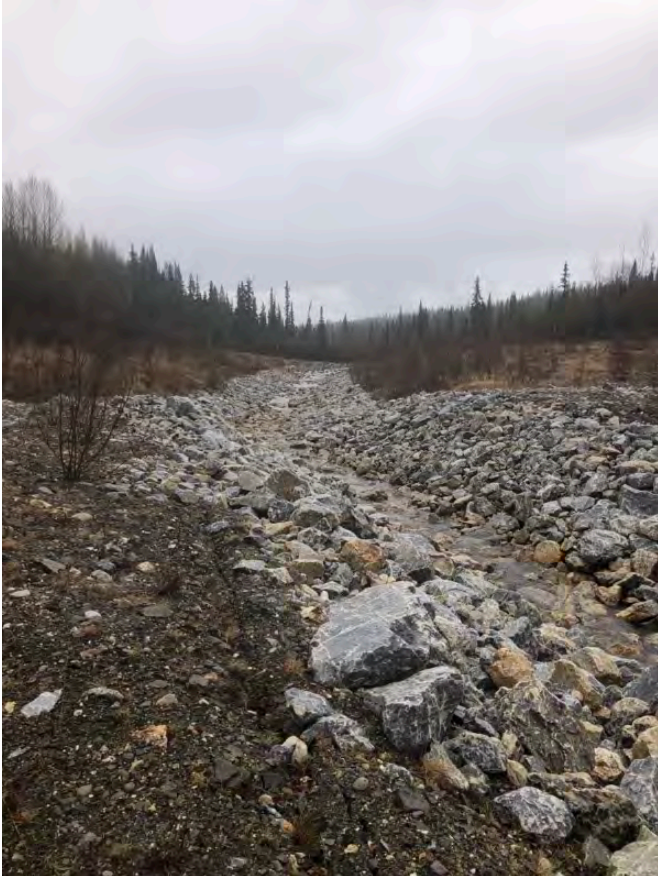
Photo Discription	Photo	Photo Location
Cracks along southern end of Camp creek channel

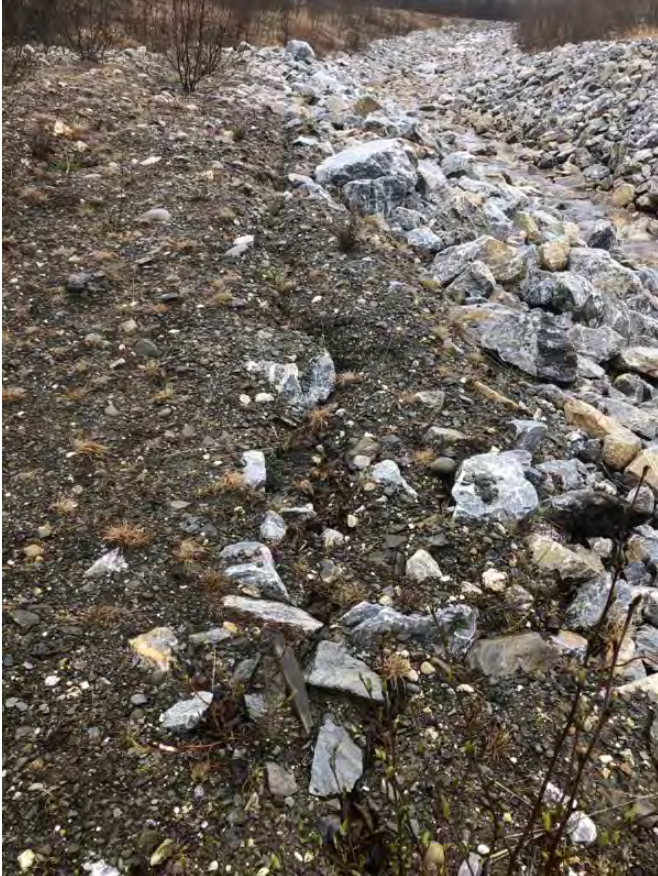
A photograph showing a rocky, gravelly channel, likely a creek bed, with visible cracks along its length. The channel is filled with various sized rocks and gravel, and the surrounding area appears to be a natural, somewhat overgrown site.
