Government of Yukon, Water Resources Branch

Former Whitehorse Copper Mine Geotechnical Assessment

November, 2010

Project No: 60160522 (402.19.2.2)
Regarding: Former Whitehorse Copper Mine – 2010 Geotechnical Inspection Report

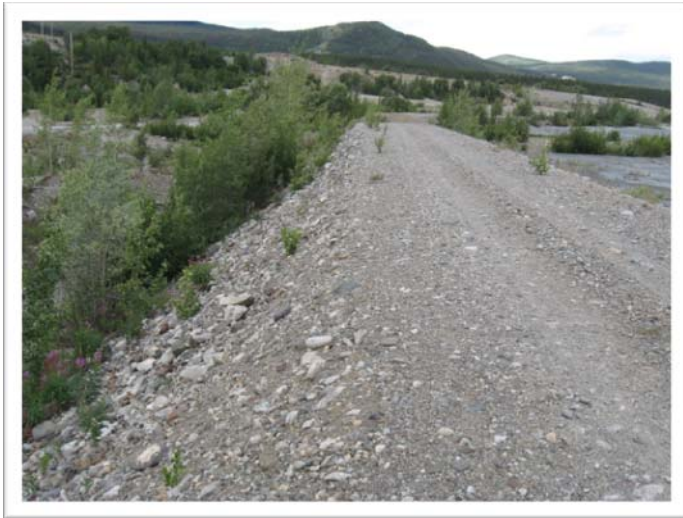
Figure 02 D/S Face at WP 116 (View NW)

The South Extension Dyke is about 400 m long, extending west from Spillway 7 to natural high ground at the access road into the former mill site. The dyke crest is about 5 to 6.5 wide and comprised of rounded gravel and cobbles up to 100 mm diameter. The dyke height varies from 1.5 m at WP 111 to 4.4 m at WP 116 (Figure 02 and 03). Upstream and downstream sideslopes are typically about 1.5 horizontal to 1 vertical (1.5H:1V). Small clusters of vegetation including saplings have become established along sections of the upstream face (Figure 04). A 1 m wide bench has been constructed along the downstream toe from WP 117 to Spillway 7 (Figure 05). The tailings are typically about 1 to 2 m below the dyke crest. The dyke appears stable with no visible signs of cracking or deformations. Seepage was not observed along the toe.

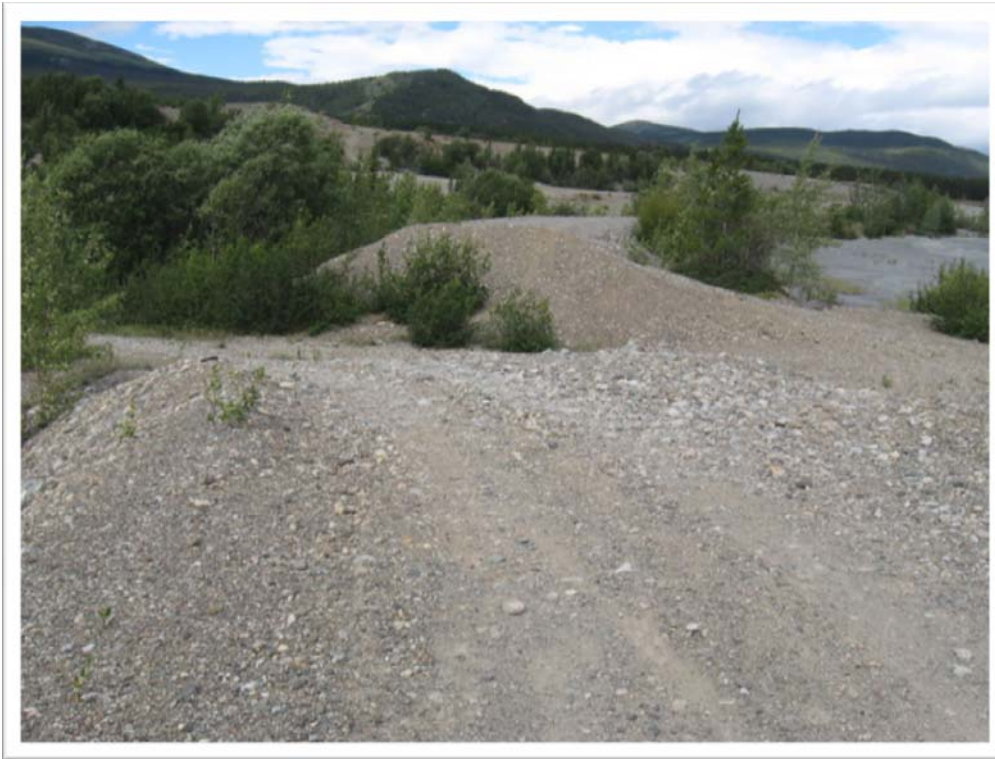
A section of the dyke has been removed at WP 113. It appears that gravel from the dyke fill at this location was used to construct a gravel pad about 30 m by 30 m by 0.3 m thick on the upstream side of the opening. The opening is about 5 m wide with 4H:1V transition slopes back onto the dyke on either side of the opening (Figure 06). The purpose of the opening is not clear although it could be for equipment access into the tailings area. It does not appear that the opening serves as a spillway. A gravel pile on the west side of the opening prevents vehicle access along the dyke, however, vehicle ramps have been constructed on the upstream sides of the dyke to gain access as seen on Figure 08.

**Figure 06 Opening in Dyke
at WP 113**

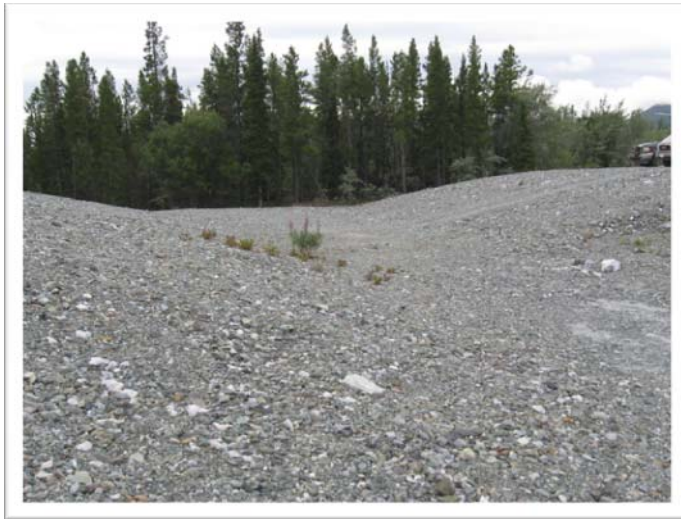
Figure 07 Spillway 7

Spillway 7 is located at the east end of the South Extension Dyke where it transitions into the Perimeter Dyke. The spillway was constructed to drain water from the impoundment into the Crater Lake watershed following the 1982 Abandonment Plan described as Alternative 3 (Thompson Geotechnical Consultants, 1982). The spillway is about 2 m deep and 6 m wide with 5H:1V (approximately) sideslopes to the dyke crest on either side (Figure 07). The spillway is connected to the pond shown on Drawing 03 with a drainage swale although there was no water entering the spillway at the time of the inspection (Figure 08). The spillway has been constructed with a crushed coarse granular fill which is grey in colour compared with the brown dyke fill. The maximum size is estimated to be 300 mm although the majority of the visible granular material is smaller sized. A spillway discharge pad on the downstream side of the dyke grades into the high ground to the southeast. Drainage from the pad is to the low ground to the east. There are no signs of erosion of the spillway channel or pad.

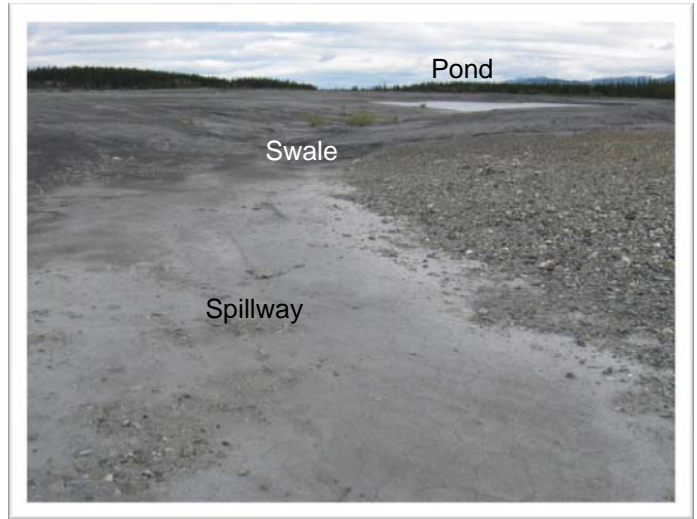
Figure 08 Entrance to Spillway from Tailings

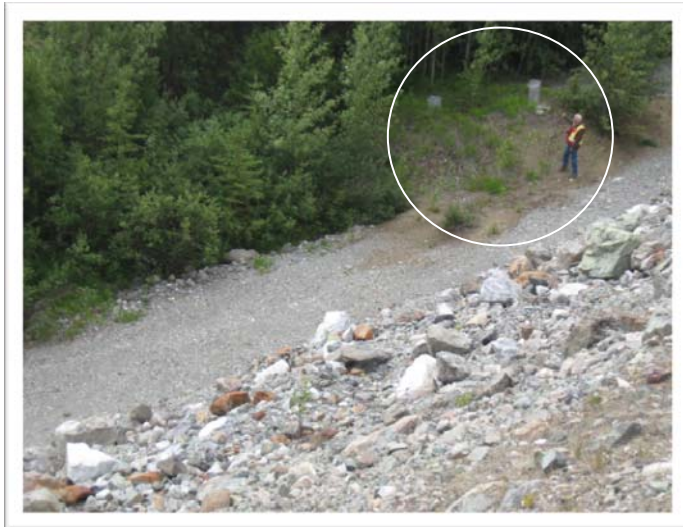
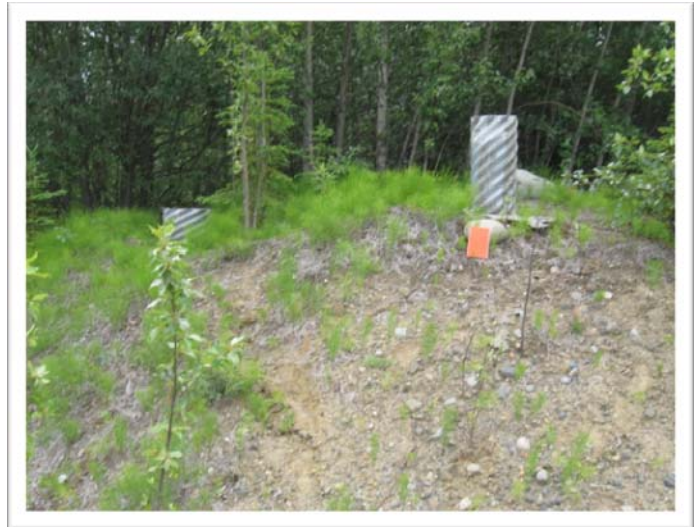
dyke at WP 155 (Figures 10 and 11). Both pipes appear to have been backfilled with concrete. There are also two PVC riser pipes behind the pad. Based on mine site drawings, the CMPs are the remnants of a decant structure abandoned as part of decommissioning (Gadsby, Drawing 10, 1991). There was no evidence of any seepage in the vicinity of the CMPs.

Figure 10 View of CMPs at Toe of Dyke from Crest

Figure 11 CMPs at Toe of Dyke

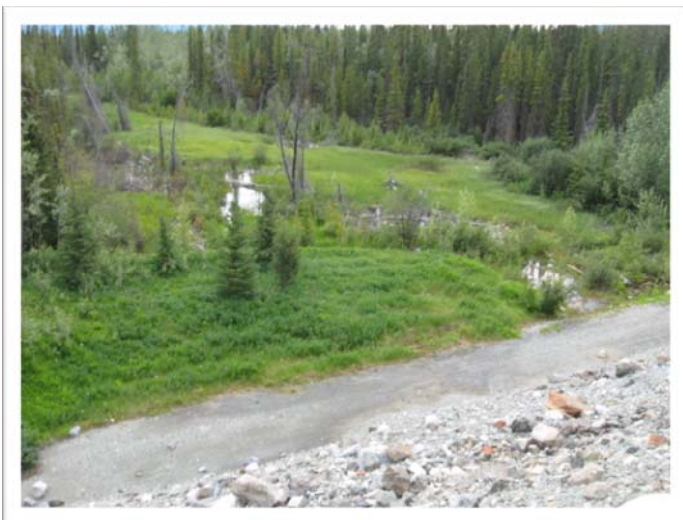
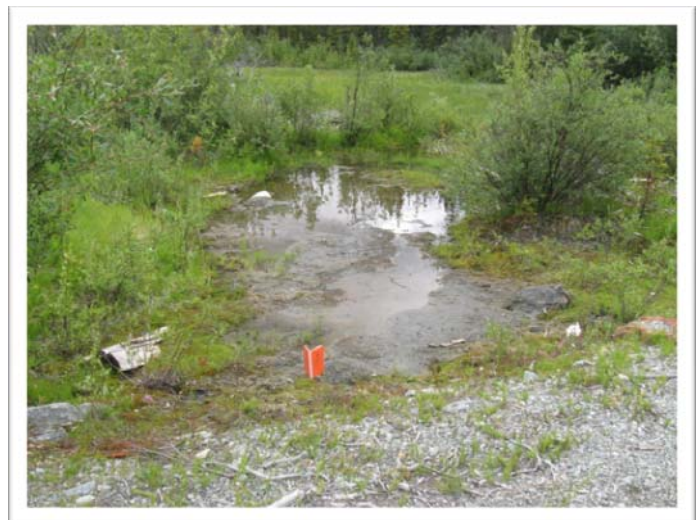
There is an area of ponded water at the edge of the road near the center of the valley at the location shown on Drawing 03 (WPs 157-159) and Figures 12 and 13. Although the water is clear, tailings extend some distance out into the water. There was no active seepage visible although it appears that the area is perpetually wet. Coincident with this ponded water are minor depressions in the tailings surface on the upstream side of the dyke (Figure 14). The depressions are about 300 to 500 mm in diameter and about 250 mm deep. Ponded water was previously reported at the downstream toe in 1987 but the area was dry at the time of development of the decommissioning plan by Gadsby in 1981 (Drawing 11 in Gadsby 1981). Geo-Engineering (1988) noted localized undrained depressions with seasonally ponded water that apparently recharged seepages occurring at several locations on the main dyke.

Figure 12 Ponded Water at Toe of Dyke

Figure 13 Tailings in Ponded Water

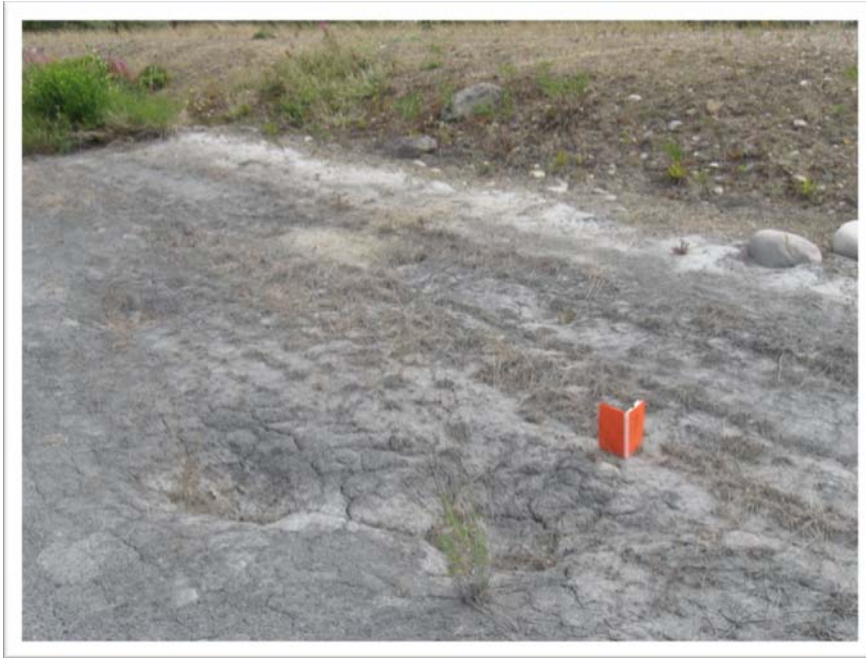
**Figure 14 Depressions
in Tailings Surface**

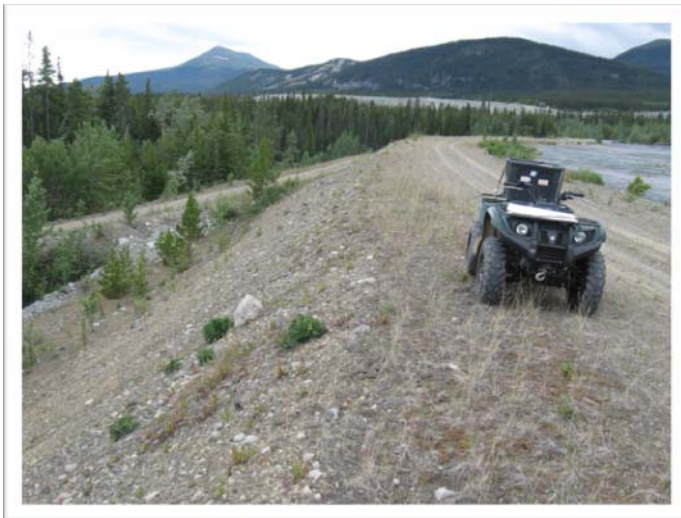
Figure 15 Downstream Face at WP 160

At WP 160, the dyke height is in the order of 6 m with a downstream slope of about 1.7H:1V (Figure 15). The tilted dyke crest is still visible at this location and the freeboard above the tailings is only about 0.4 m (Figure 16). There is no berm at this location nor is there any evidence of seepage at the downstream toe. The dyke is in good condition from WP 160 to 161 at which point the height decreases towards Spillway 6. The dyke height increases to about 18 m at the narrow valley northwest of Spillway 6 at WP 168 (Figure 17). The freeboard is less than 0.5 m at this location and wind-blown tailings have flattened out the upper portion of the downstream slope face to about 3H:1V (Figure 18). The slope face below the wind-blown tailings is at about 1.7H:1V.

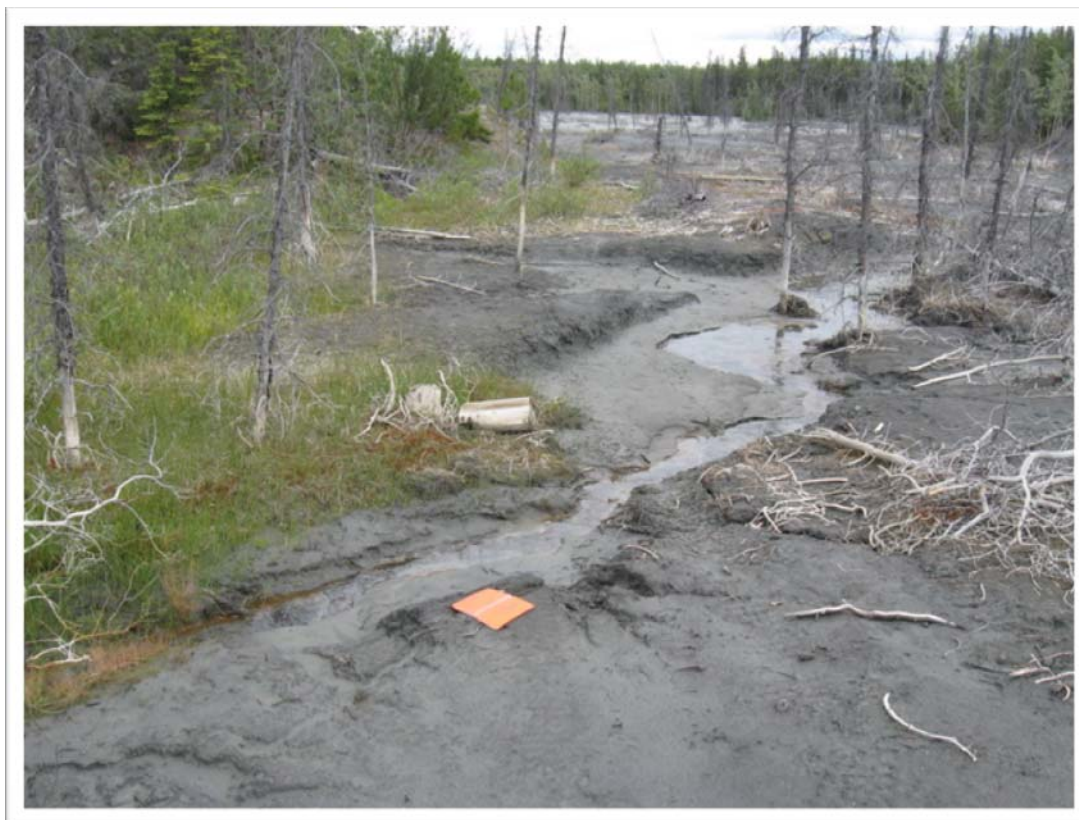
Seepage water accumulates along the toe of the dyke on the west side of the constriction. Flow from this area across the tailings and to the north was estimated to be at a rate of about 0.3 l/sec (Figure 23). The water appeared to be slightly turbid (cloudy) in the pond at the toe of the dyke. The toe of the dam above the A-Valley impoundment was reported as damp, suggesting seepage in previous inspection reports (Gadsby, 1992).

Figure 23 Seepage Water Downstream of Perimeter Dyke at WP 167, View N

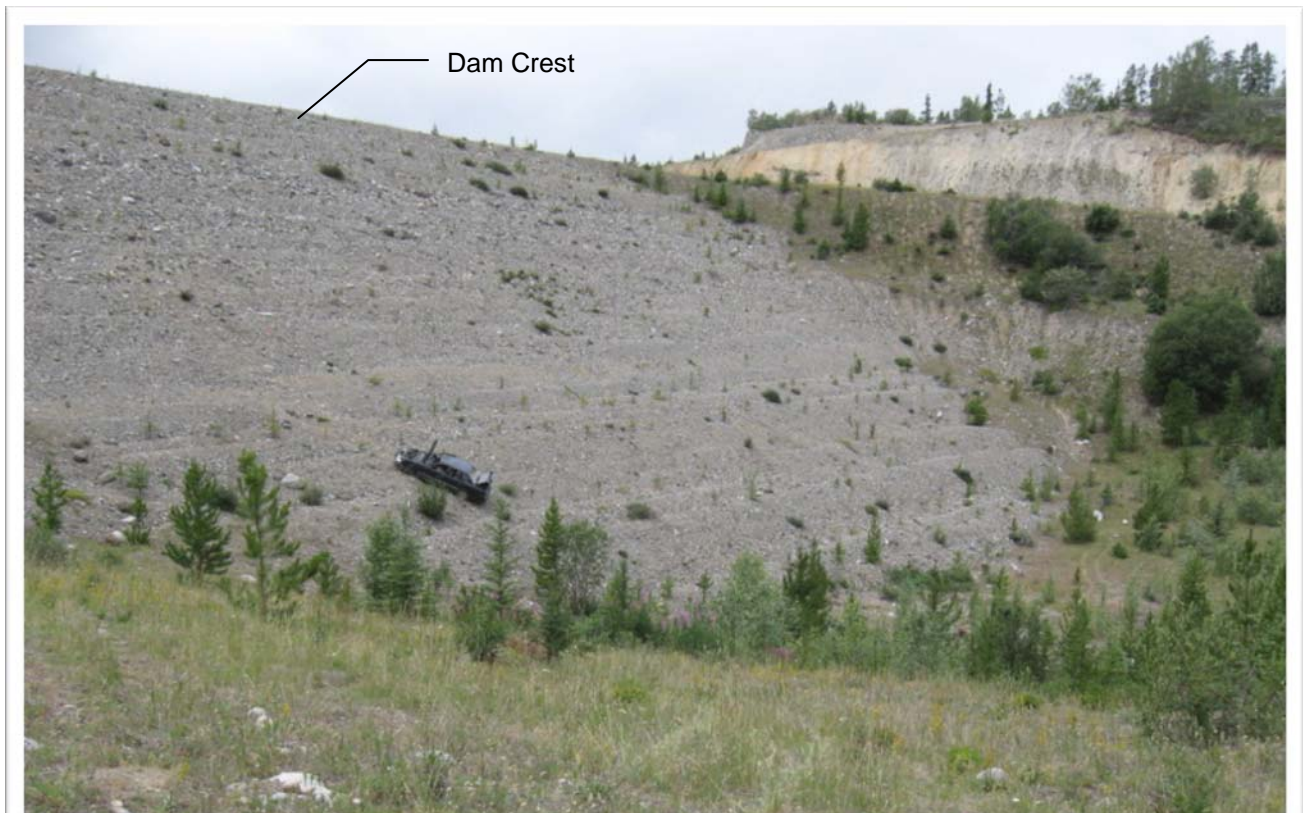
Figure 24 View at Downstream Slope from East Abutment at WP 170

The A-Dam is located at the downstream (west) end of the A-Valley Impoundment as shown on Drawing 02. The dam is about 150 m long and 34 m high (Figure 24). The dam crest is about 8 m wide and there is about 4 m of available freeboard between the tailings and the crest on the upstream side. There is no water impounded on the upstream side of the dam (Figure 25). The downslope side of the dam is about 2H:1V with coarse gravel, cobbles and boulders visible on the surface. For scale, a derelict vehicle can be seen on the downstream slope on Figure 24. There are a number of narrow benches on the downstream face for the full width of the dam which appears stable with no visible signs of cracking or deformations. There was no evidence of seepage at the downstream toe of the dam. The former decant culverts at the downstream toe of the right abutment were not visible, having been plugged and grouted as part of decommissioning (Geo-Engineering, 1996).

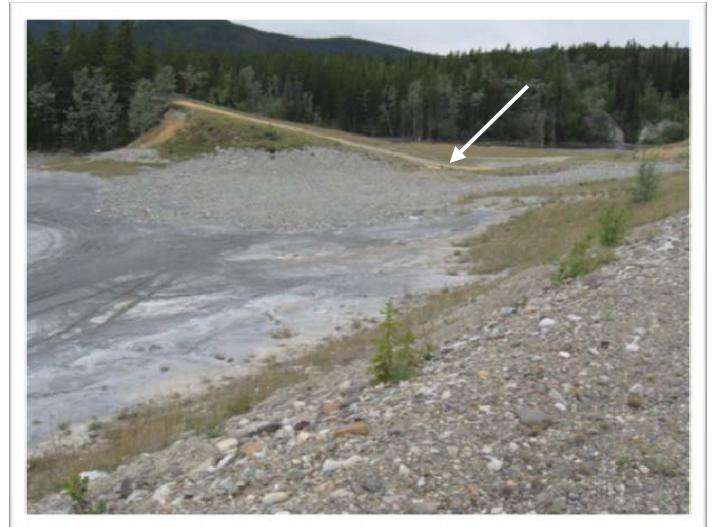
Figure 26 Saddle Spillway from WP 169

A saddle spillway is located on the access road to the west abutment as shown on Drawing 02. The spillway is about 8 m wide across the bottom with 2H:1V sideslopes (Figure 26). The entrance to the spillway and the spillway channel are well armoured with 100 mm down crushed rock and there is no evidence of erosion of this material. There was no water passing through the spillway at the time of the inspection.

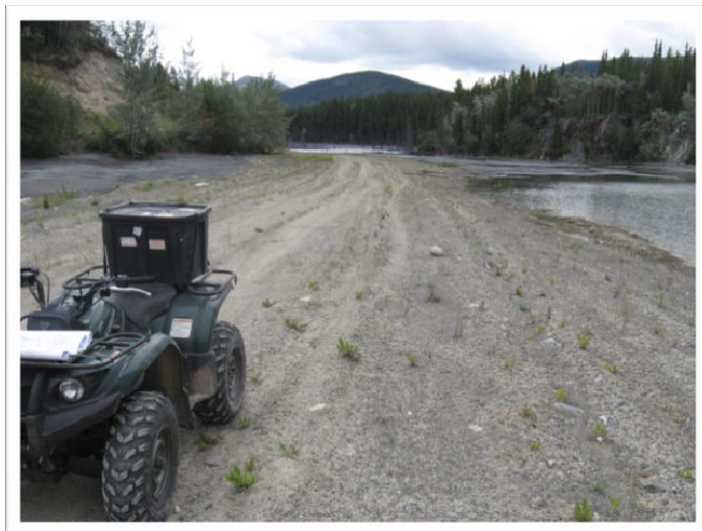
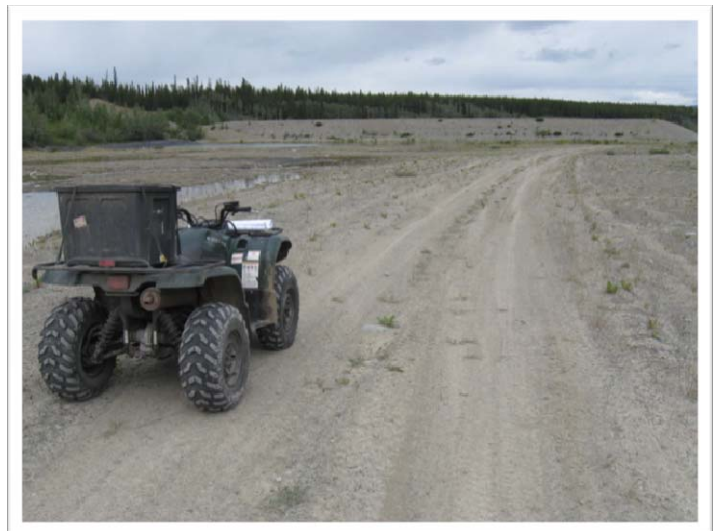
Figures 27 and 28 show the road through the B-Valley Impoundment that leads from the A-Dam to the B-Dam. Figure 27 is looking south while Figure 28 was taken looking north. There is some ponded water in the impoundment on the east side of the road at this location although the road is sufficiently elevated and in good condition.

Figure 27 View S from WP 174

Figure 28 View N from WP 174

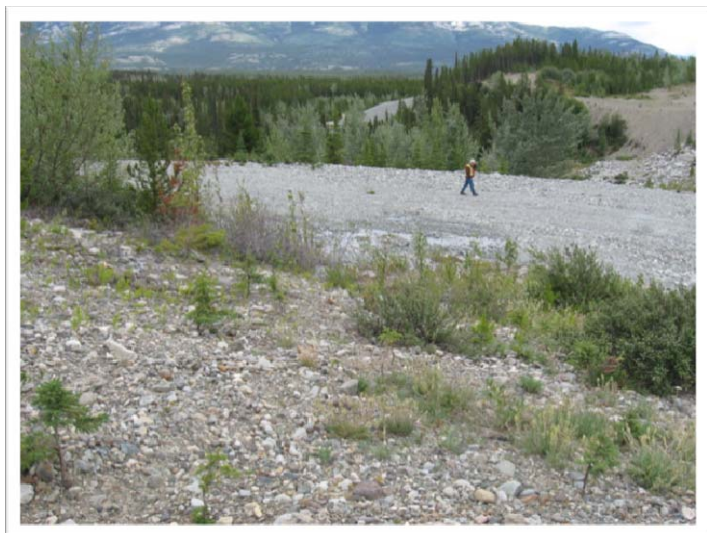
Water was seeping from the left downstream abutment at the locations shown on Drawing 03. Seep A is immediately upslope of the inverted filter constructed in 1996 on the left downstream abutment. Water from Seep A flows overland where it infiltrates the filter. Seep B is located about 30 m farther west at the upstream end of a drainage ditch on the left abutment above the B-Dam (WP 179). Seepage water from Seep B is conveyed along the ditch where it discharges into the tailings pond at WP 183 as shown on Figure 32. Flow from Seep B was estimated to be in the order of 2-3 l/sec. Seep C is located along the edge of the pond where the ground is very soft with iron staining visible (Figure 33). Flow was estimated to be in the order of 0.25 l/sec. Flow into the pond from the drainage channel was estimated to be in the order of 4-5 l/sec indicating additional seepage water enters the drainage channel downstream of Seep B.

Figure 30 Water Ponded on Filter from Seep A at WP 177

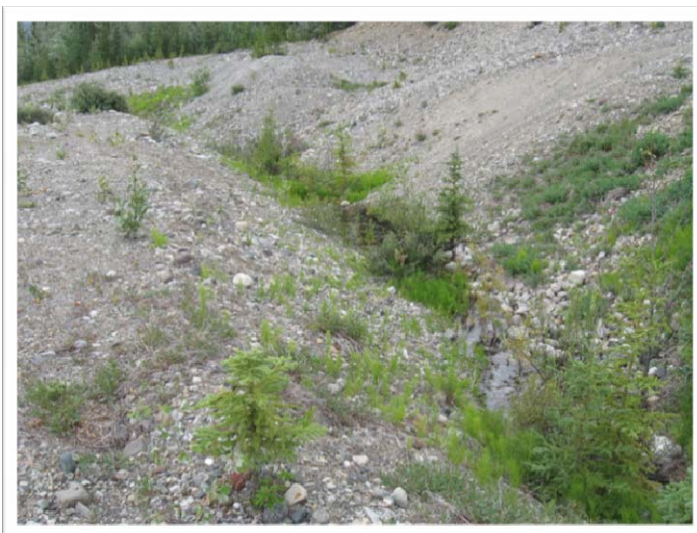
Figure 31 Seep B at WP 179

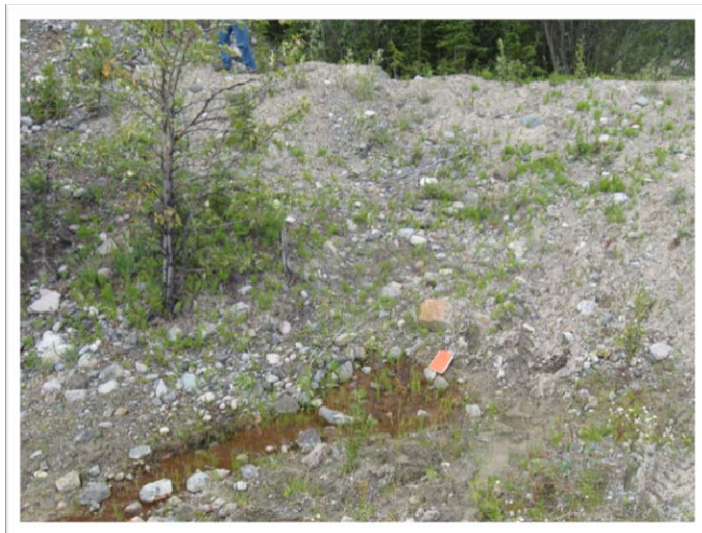
Figure 33 Iron Staining at Seep C at WP 182

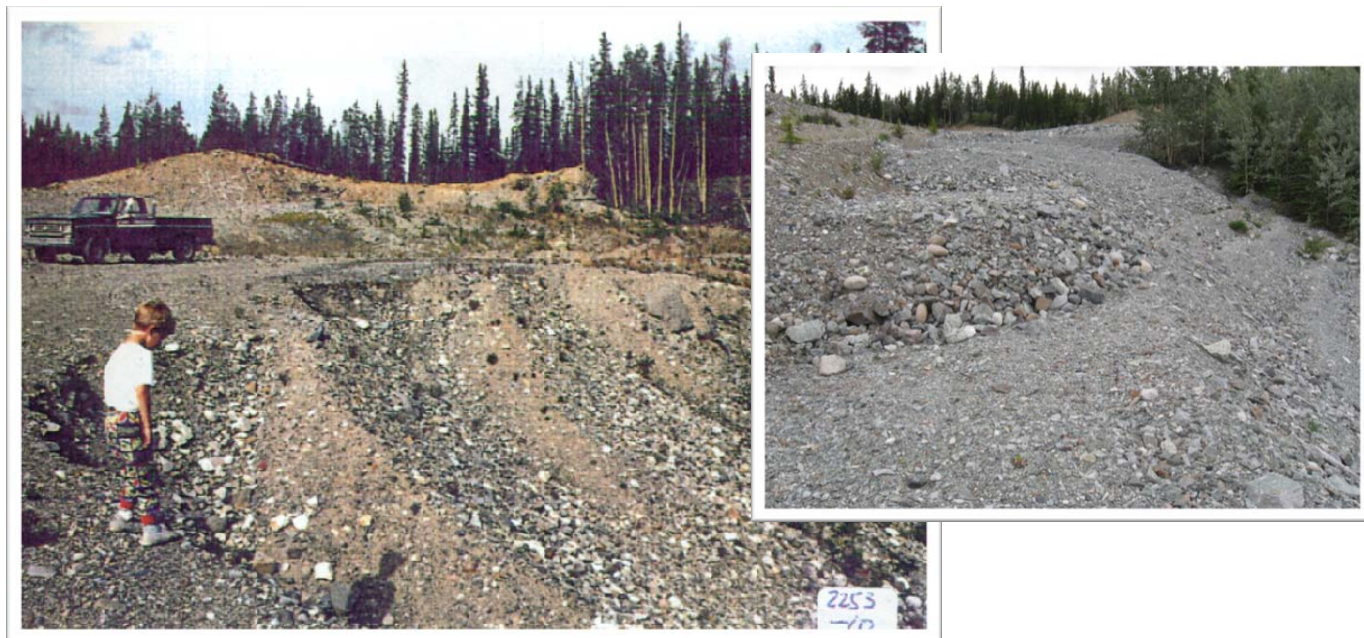
An inverted filter was constructed during mine decommissioning to guard against potential piping failures on the left downstream abutment. Previous inspection reports described gullies formed on the downstream slopes of the abutment above the pond elevation (Figure 34). The filter, seen on the left abutment in Figure 29 consists of 8 to 10 terraces, each 1-3 m wide consisting of cobbly gravel with 300mm diameter maximum size. Seepage at the abutment has been previously documented and is believed to be a consequence of seepage from a shallow lake about 800 ft west of the abutment (Gadsby, 1992). There was no visible seepage water at the toe of the filter. A spring is located in the densely vegetated area about 50 m north of the filter as shown on Drawing 03. The spring

Figure 34 Erosion Gullies on Left Abutment in August 1991 (Gadsby, 1992) and Repaired Area in 2010 (right photo)

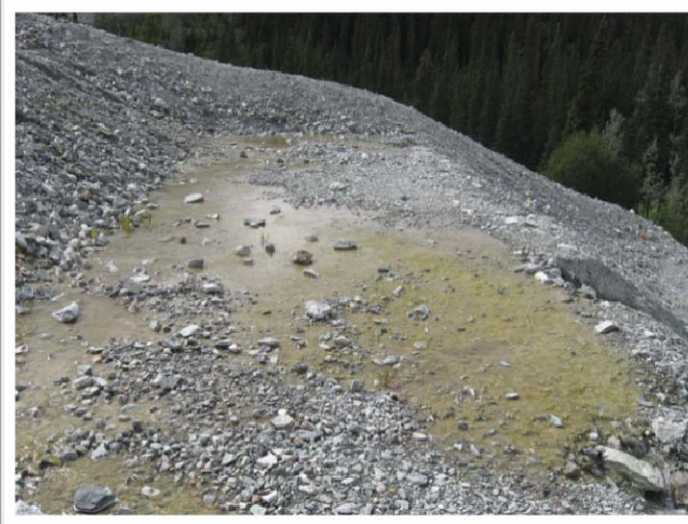
Discharge over the spillway was estimated to be in the order of 5 l/sec. Water discharges through the end of the chute over two benches and then onto a spillway apron about 50 m by 50 m and 11 m high. The first (upper) bench shown on Figure 37 and 38 is about 5 m below the end of the spillway chute. Water was flowing over the upper bench and had ponded on the second bench about 2.5 m lower. The water infiltrates into the bench at this location where flow become subterranean. There was no evidence of seepage at the toe of the spillway pad. Erosion gullies have formed on the sloped surfaces between the benches as seen on Figures 39 and 40. The material on the benches and spillway pad is a cobbly gravel with trace boulders up to a maximum size of about 400 mm. This material is smaller in size than originally specified (Geo-Engineering, 1996).

**Figure 39 Water Flowing Over First Bench
at WP 210**

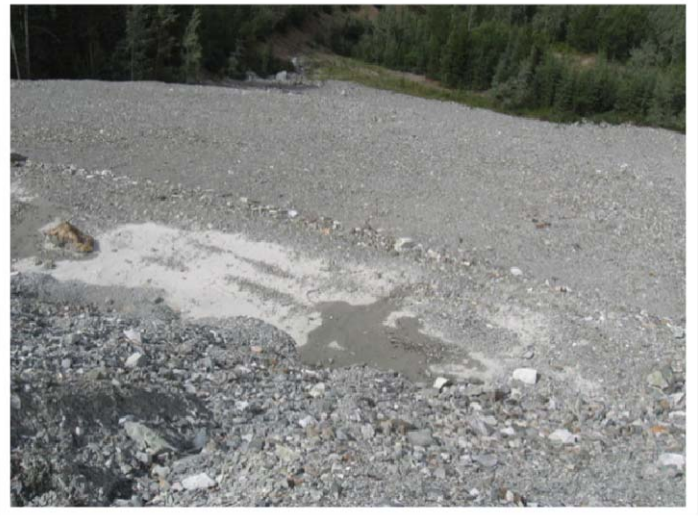
**Figure 40 Erosion Gully on Slope Between Upper
and Lower Benches and Water on Second Bench
from Top (from WP 210)**

The B-Spillway is generally in good condition although some erosion gullies have developed between the benches, indicating that the armouring material may not be adequate. The spillway and drop structure may require additional armouring in the future.

- improve wind erosion protection in the tailings in the Old Pond Impoundment by establishing vegetation or covering layer of gravel and cobbles (as originally recommended by Gadsby(1992))
- provide and maintain additional armouring along spillways including Spillway 6, 7 and the B-Spillway
