**YUKON ZINC CORP.  
WOLVERINE MINE**

**TAILINGS STORAGE FACILITY AND ON-SITE  
EARTH STRUCTURES 2016 INSPECTION**

VA101-677/1-1  
Rev 0  
December 2, 2016

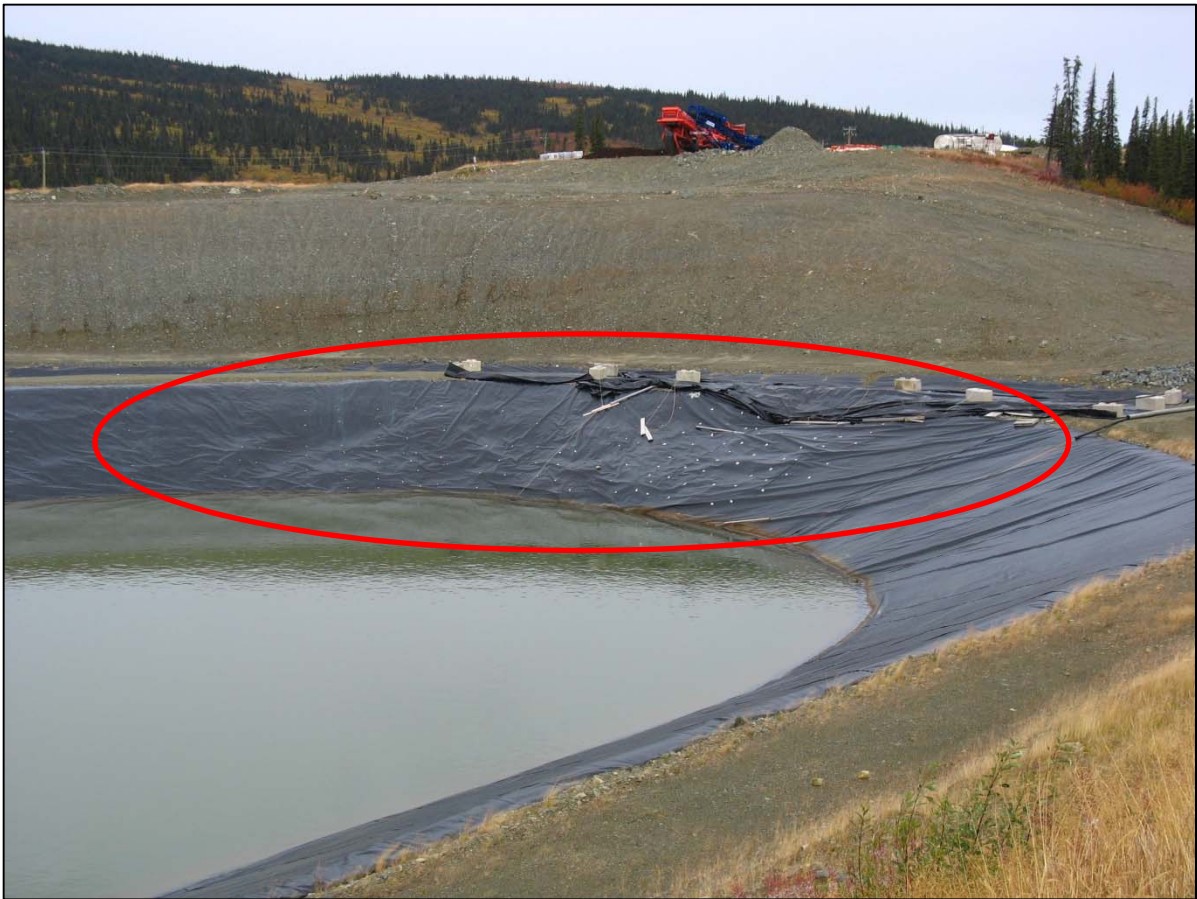
**Figure 3.1 Slump at North End of TSF**

The north end of the TSF has slumped as reported in previous DSIs. The slump has resulted in a loss of the liner anchor trench and a lowering of the crest by approximately 1.5 m (KCB 2015a). A short-term remediation plan was presented by KCB in August 2015 (KCB 2015b) which included covering the crest in this area with LLDPE liner material to prevent surface water from entering the tension cracks. The covering liner was in place during the 2016 inspection.

The liner at the north end of the TSF where the slump is occurring (discussions with mine staff indicate the slope has continued to progress based on a 2016 survey of this area) was inspected to the water line using a safety rope and harness. Although the bedding material beneath the liner has slumped in this area, the liner appears to be in good condition, with the exception of a few defects near the top of the slope which have been previously reported. The welds appeared to be intact. There was loose debris on the liner in this area which should be removed as discussed with Kevin Unrau. The slumped area is shown on Figure 3.1.

The slump is likely attributed to groundwater flow eroding the subsurface materials. The 2015 DSI reported a number of seeps were observed along the impoundment slope during construction (this was a cut slope) indicating this is an area of groundwater flow/discharge. Ditch A, which routes runoff around the north side of the TSF, was lined with a LLDPE geomembrane to reduce groundwater infiltration; however, the upstream Stilling Basin which drains into Ditch A is unlined and is likely a source of groundwater inflow towards the TSF. It is recommended Yukon Zinc engage KCB to evaluate the groundwater flow in this area and develop a plan to mitigate the on-going erosion of the slope.

- The slump is likely attributed to groundwater flow which has eroded the subsurface materials. It is recommended Yukon Zinc engage the EoR to evaluate the groundwater flow in this area and develop a plan to mitigate the on-going erosion of the slope to protect the liner from further deterioration.

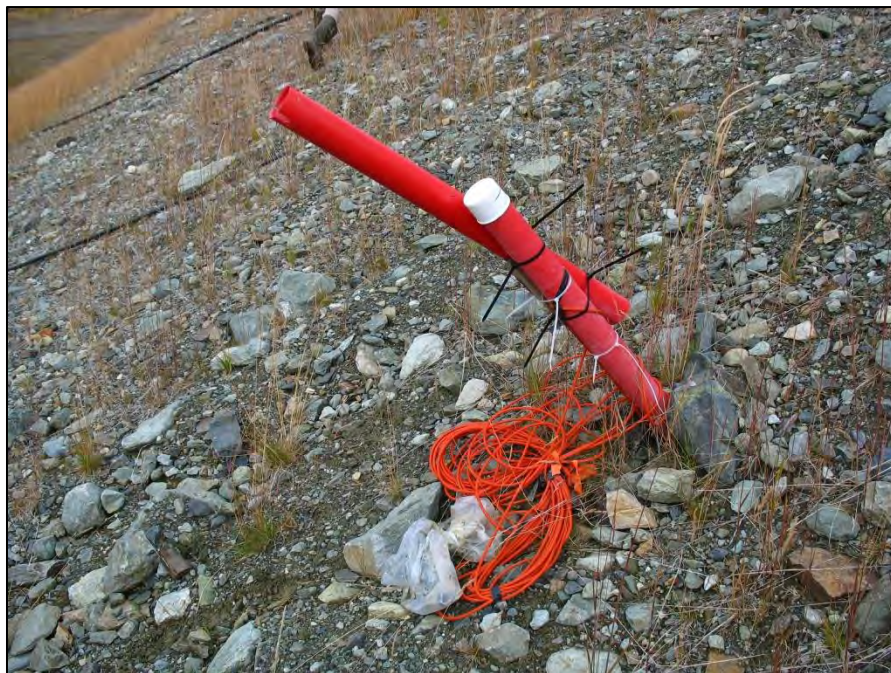
There are currently two inclinometers installed at the south end of the TSF. The inclinometers were installed downstream of the Stage 1 dam during the Stage 1 construction program. The location of the inclinometers was within the Stage 2 dam footprint resulting in the need to extend the casing through the Stage 2 embankment fill material. Access to the inclinometers is approximately midway up the downstream embankment slope. Both inclinometers have been damaged, are no longer functioning and are likely not repairable. It is recommended Yukon Zinc discuss the requirement for maintaining functioning inclinometers with KCB and develop a replacement plan if required, or alternative method for measuring potential slope deformations.

**PHOTO 6** – TSF South Embankment – Damaged inclinometer – no longer functioning.

There are five survey monuments installed along the embankment crest. The survey monuments were measured monthly until January 2015 but have not been measured since. It is recommended the measurement of the survey monuments be re-started and a regular schedule be developed especially in lieu of the damaged inclinometers.

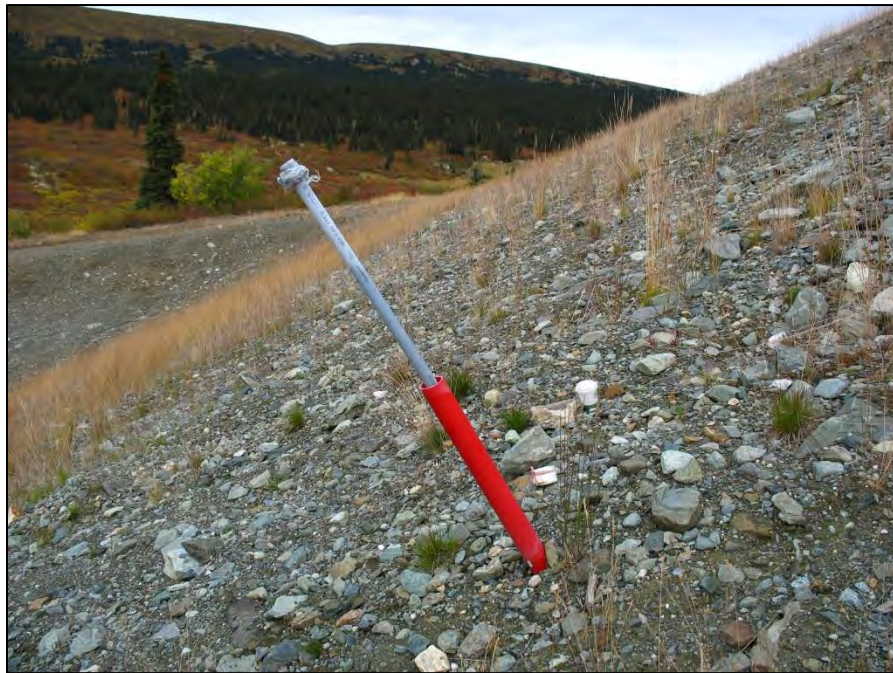
**PHOTO 8** – TSF South Embankment – Pipe stuck in inclinometer – no longer functioning.

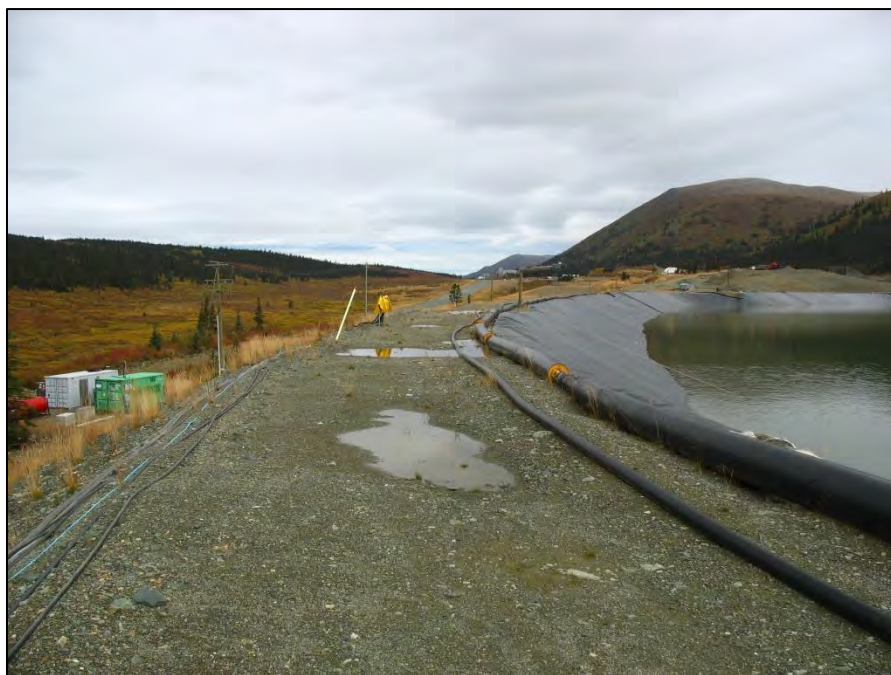
The embankment crest appeared to be relatively level although ponding from precipitation was observed in low spots or ruts at a few locations. Grading of the embankment crest would alleviate ponding. There was no evidence of animal burrowing.

**PHOTO 10** – TSF West Embankment – Ponding on crest

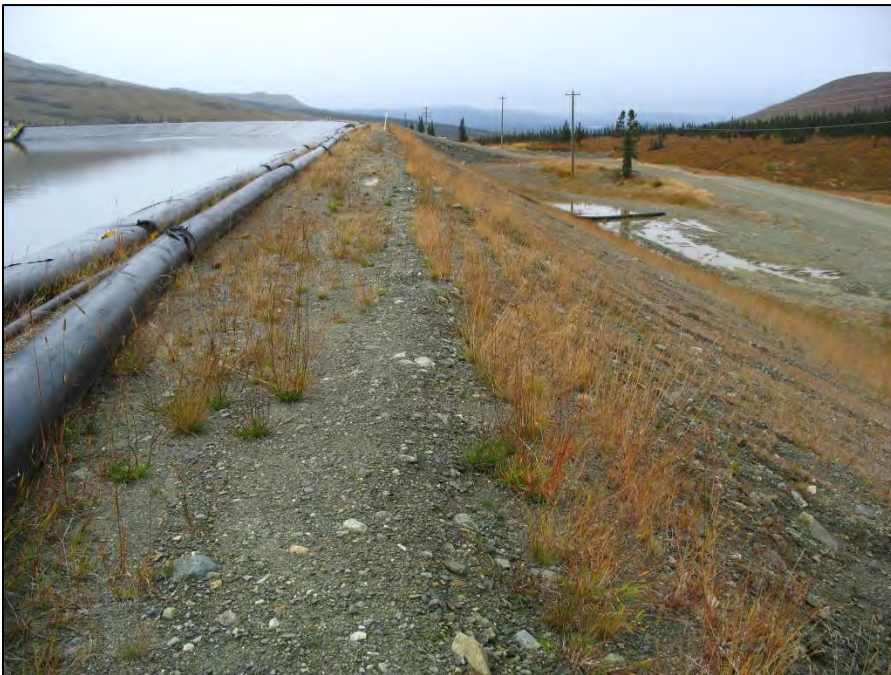
**PHOTO 12** – TSF West Embankment crest looking south. Ponded water at toe.

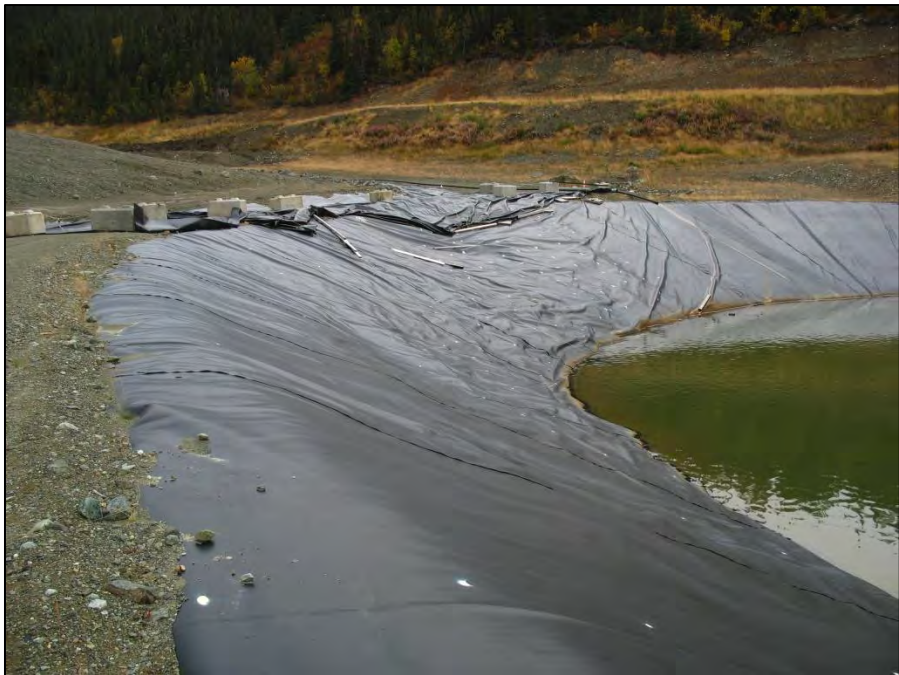
**PHOTO 14** – North TSF Upstream Slope – Slump area.

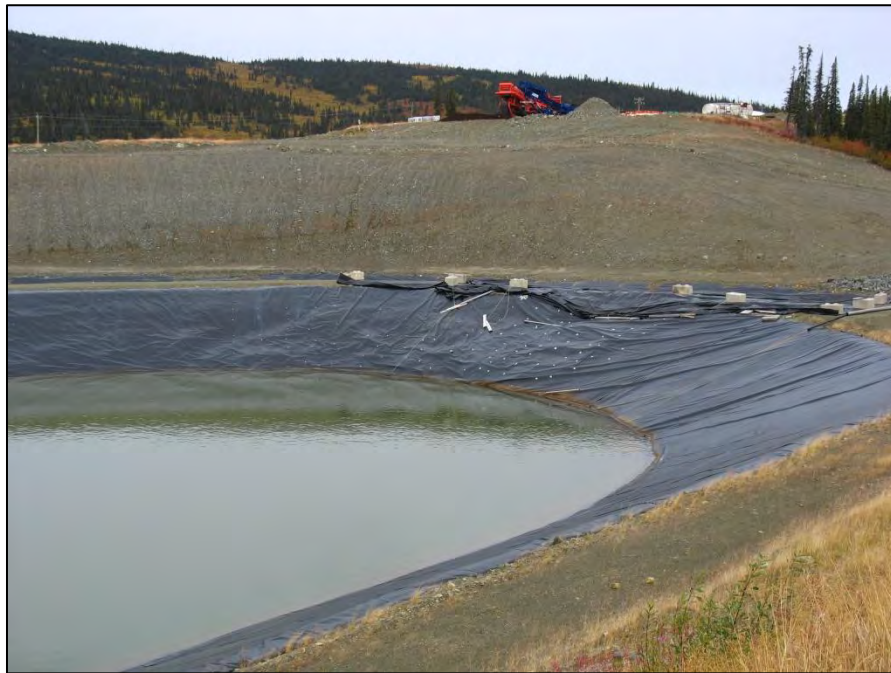
**PHOTO 15** – North TSF Upstream Slope – Slump area.

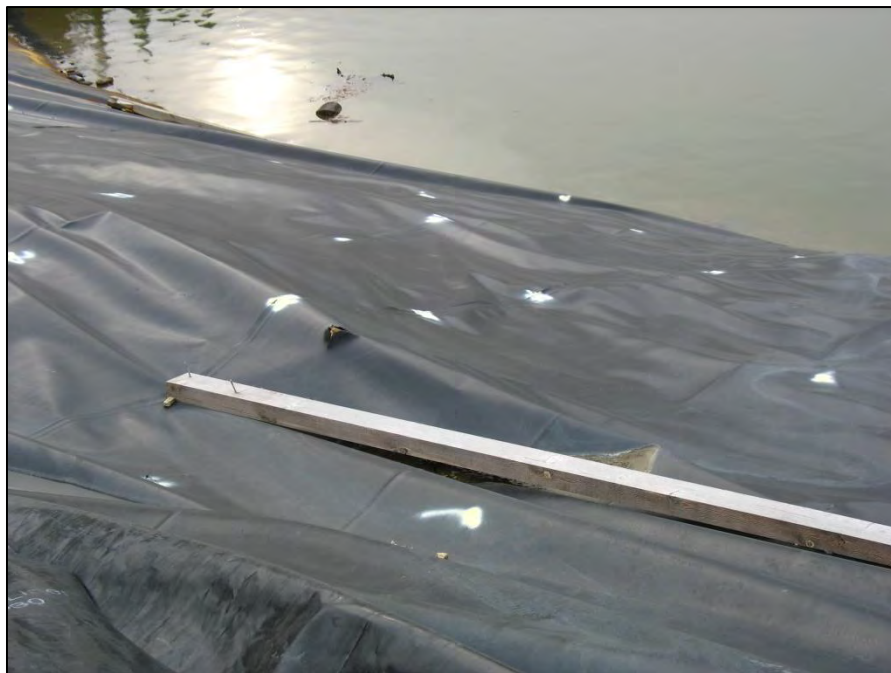
**PHOTO 16** – TSF slump area – Liner damage

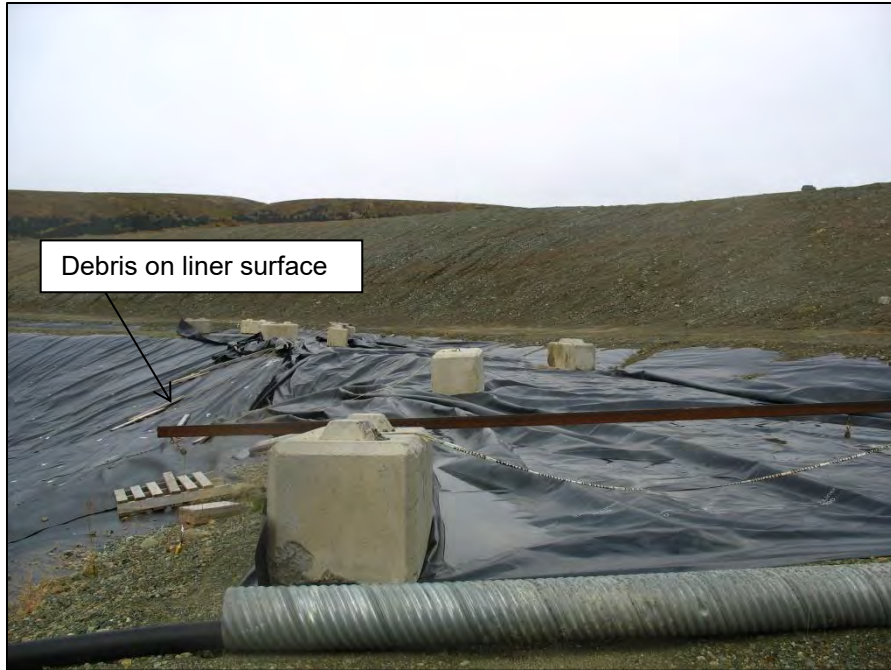
**PHOTO 17** – TSF slump area cover material.

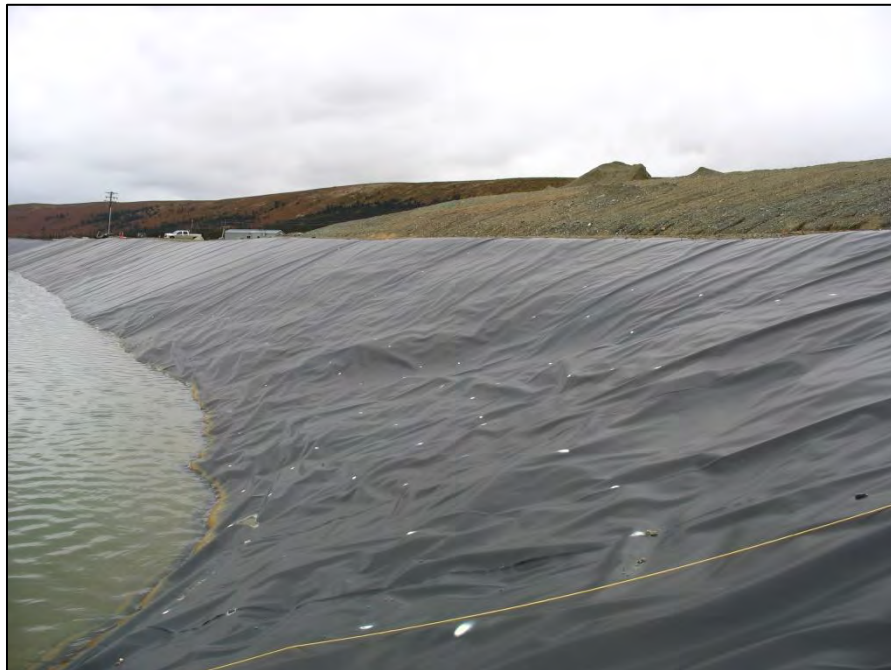
**PHOTO 18** – TSF slump area – Deformation of underlying fill material.

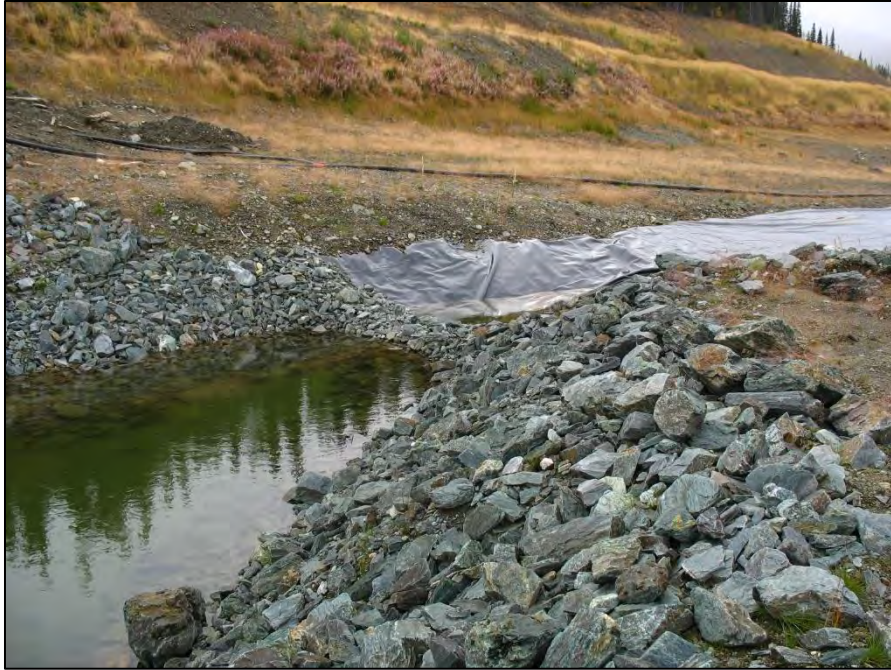
The northern inlet to Ditch A is at the south end of the stilling basin. Although the ditch is lined, the stilling basin is not. There is the potential for water from the stilling basin to flow under the lined ditch towards the TSF (in the direction of the slump). This may be a contributing factor to the deterioration of the fill material at the TSF slump area. Consideration should be given to reducing potential seepage flow in this area.

**PHOTO 31** – Stilling Basin and upstream end of Ditch A. Stilling Basin unlined.

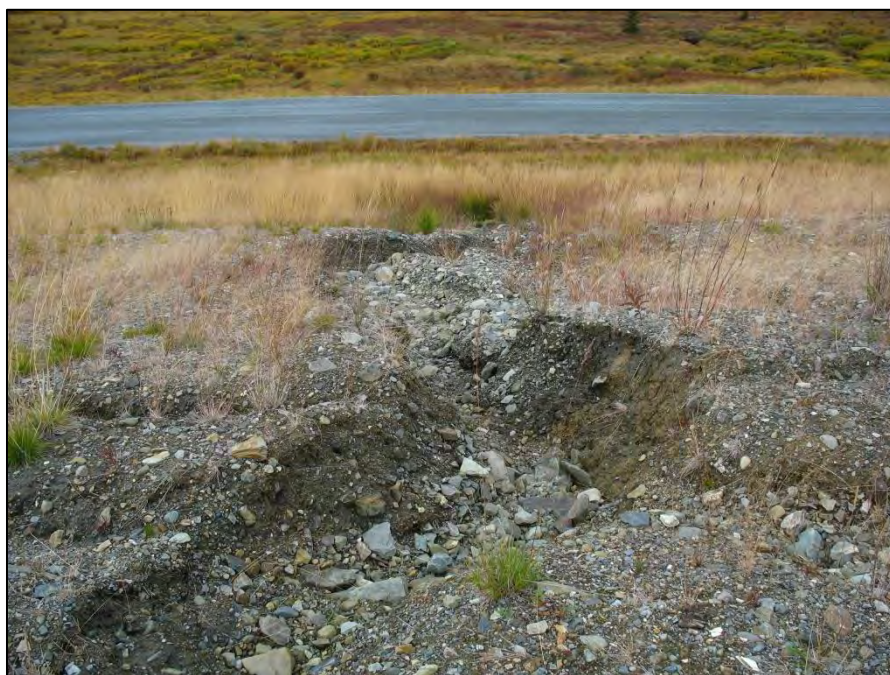
The presence of large erosions gullies on some slopes can be an indication that upstream surface runoff is not being managed properly. A number of the previously reported erosion gullies have been repaired, however, ongoing monitoring of the repaired erosion gullies is recommended as this is likely the preferred pathway for storm water runoff which may result in ongoing erosion in some areas.

**PHOTO 38** – NW waste pile erosion gullies

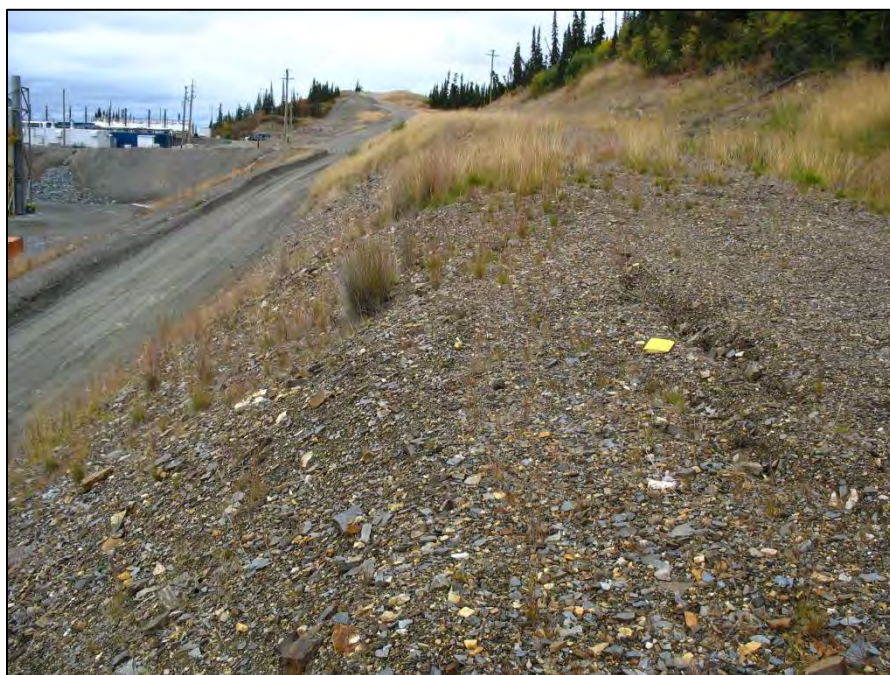
- Ditch 1 – Ditch 1 is located on the eastern side of the Mill Building. Ditch 1 is unlined. A tension crack approximately 20 m long was observed on the crest of the downstream berm for Ditch 1. This was documented in the 2015 DSI report. The tension crack still exists, although there was no other sign of distress observed for this slope.

**PHOTO 46** – Ditch 1 – Tension crack in berm fill material.

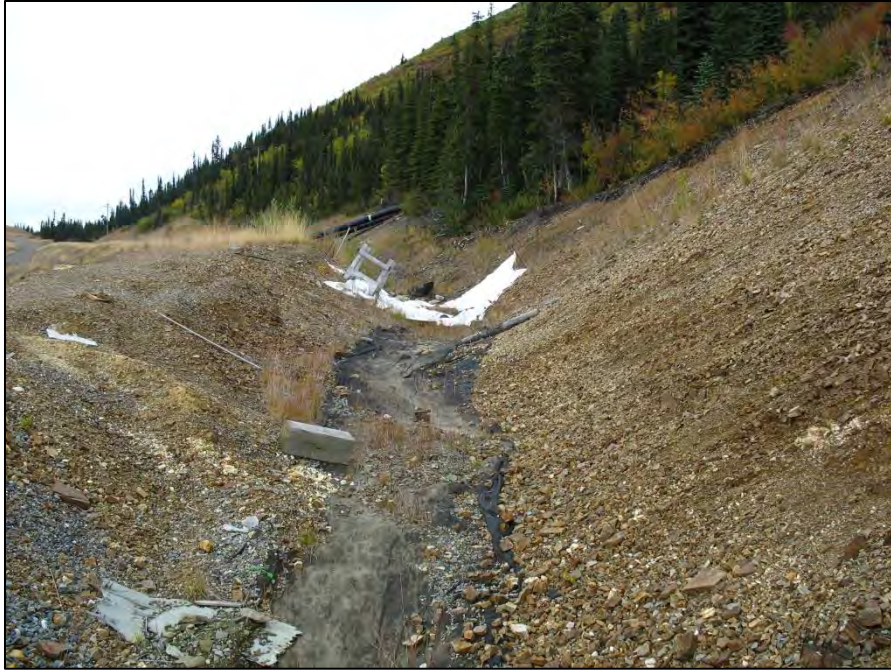
**PHOTO 47** – Ditch 1 – Minor debris in ditch bottom.

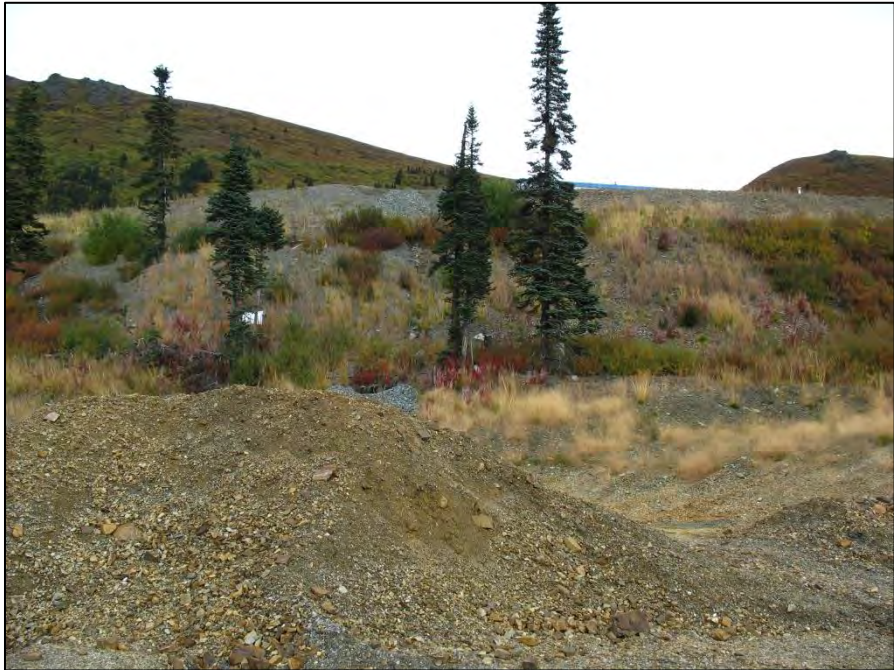
- Camp Pad – Erosion gullies from the Camp Pad have previously been observed and repaired.
- MSE Wall – The MSE wall was inspected and no signs of deformation or bulging were observed. Small tension cracks were observed on the downstream side of the road above the MSE wall which will require monitoring.

**PHOTO 52 – Camp Pad with repaired erosion gully**

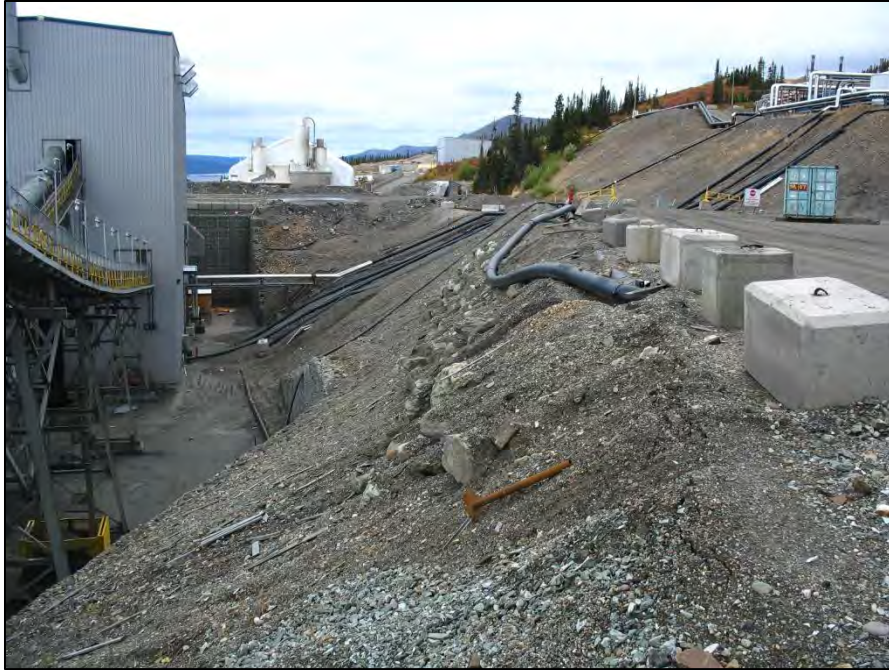
**PHOTO 57** – Slope upstream of MSE Wall – Small tension cracks observed on downstream site of access road.

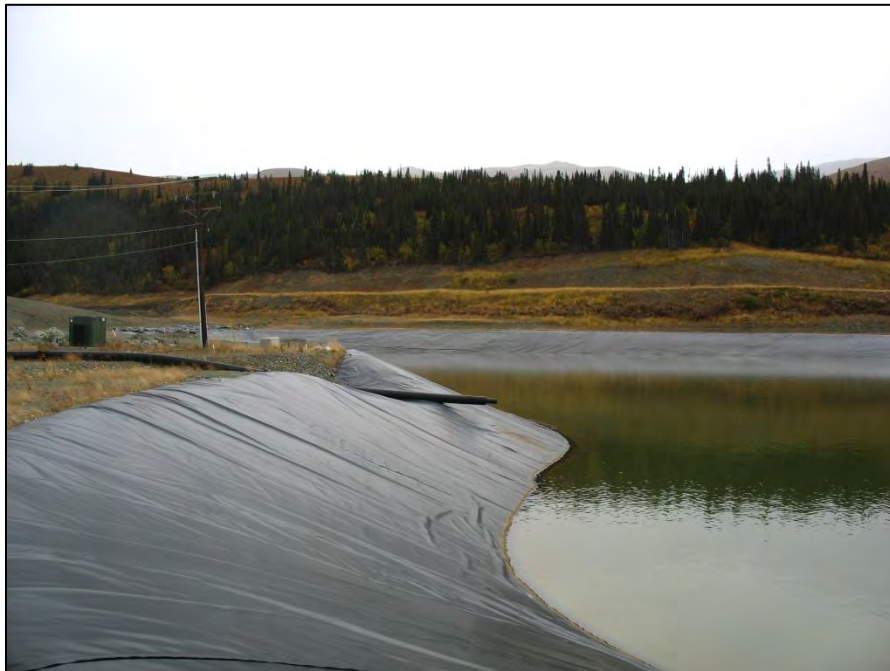
The TSF is fully lined with a LLDPE liner. The TSF inspection included walking around the crest and visually inspecting the liner for obvious defects. No liner defects were observed during the inspection outside of the slumped area. Diagonal lines/bulges are evident along the east side of the TSF which may indicate differential stress on the liner resulting from creeping subgrade materials.

**PHOTO 58** – East slope of lined TSF. Note diagonal lines on the liner which may be an indicator of liner stress.
