Aug 24th, 2017

Our File: ES00078

**Re: 2017 Wolverine Annual Physical Inspection
Evaluation of earth structures, works and installations**

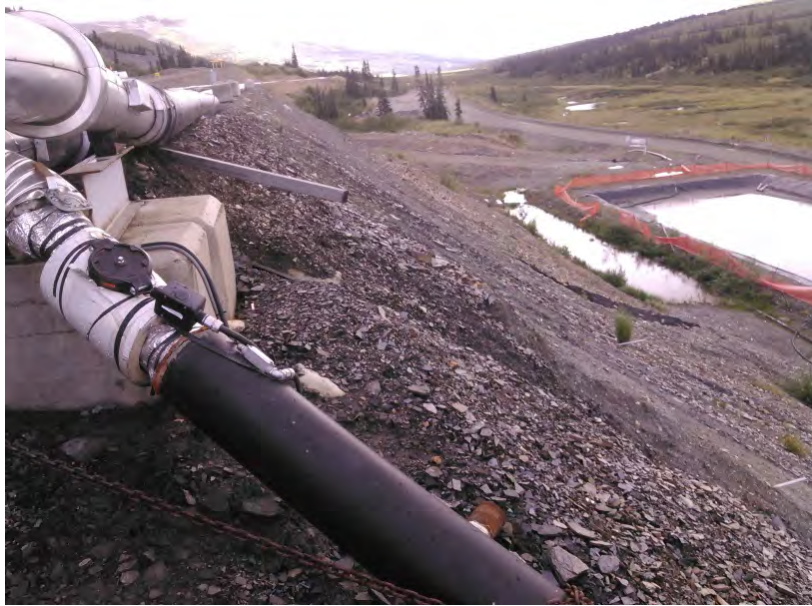
Figure 1 – Erosion down slope of mill pad. Repairs from previous years using rip rap and non-woven geotextile can be observed in the background.

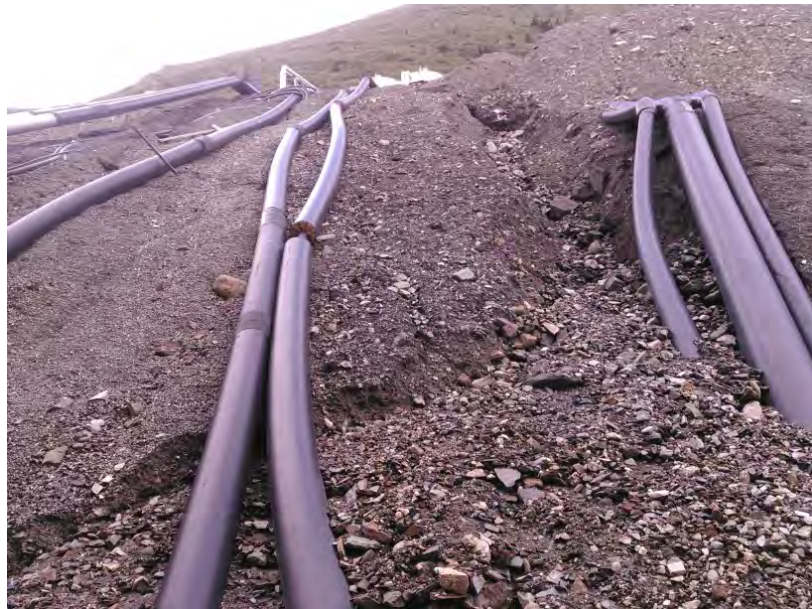
- Erosion at the crest of the mill pad slope above the crusher pad which had undermined piping infrastructure was observed at the North West corner of the mill pad next to fire hydrant #10;
- The culvert at the crest of the mechanical stabilized earth (MSE) wall was covered with fines due to the year's precipitation events;
- Erosion down slope of the Mill Pad was observed and appeared to be associated with pipes running along crest of the embankment. Past repairs using rip rap and non-woven geotextile have been instituted;
- A constant flow of water was observed to be flowing from the ground water collect culvert buried under the south west portion of the mill pad; and
- Water was observed seeping out of the toe of the fuel/generator pad access road and running

Figure 2 - Base of erosion from North West corner of Mill Pad.

- **Mill Pad** – Figure 2, erosion at the North West corner of the Mill Pad around hydrant #10 should be repaired with rip rap as reasonably as possible;

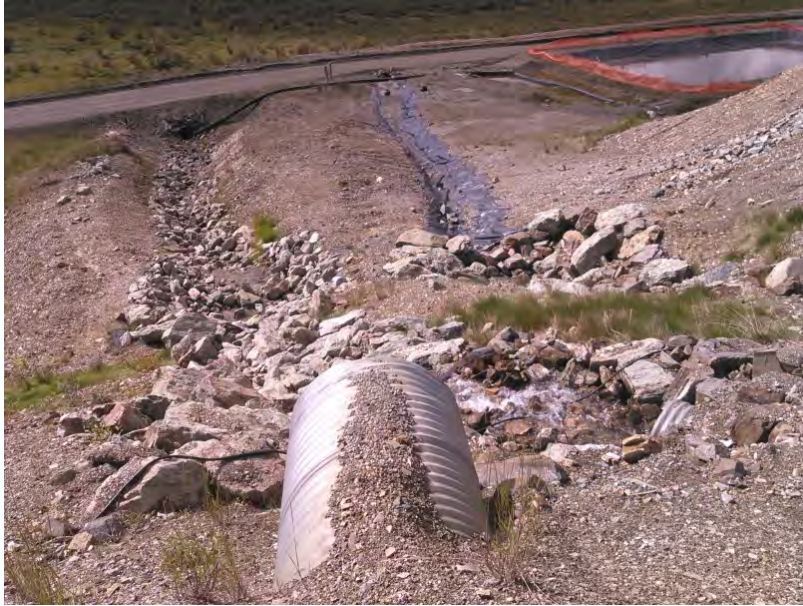
Figure 3 – Outlet of culverts draining to the environment and Ditch #3. Culvert outlet at the right with running water connected to groundwater collection and was observed with significant flows.

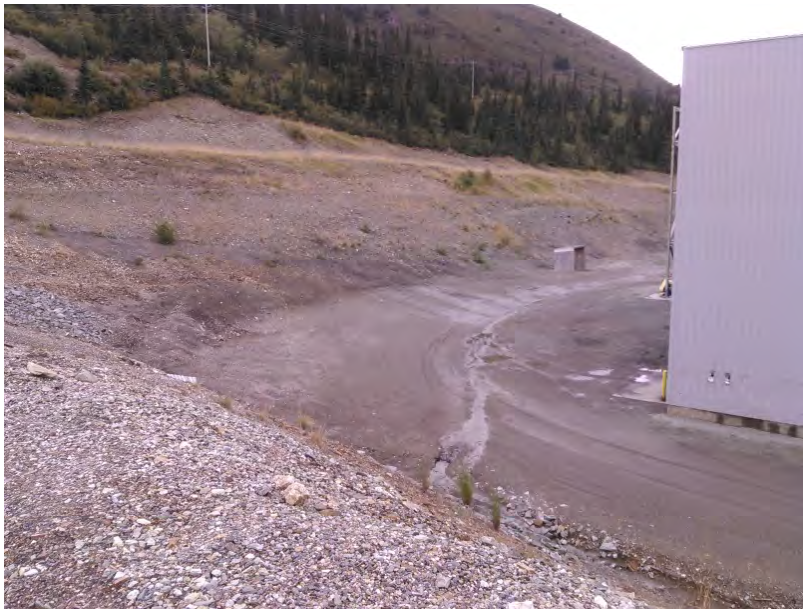
Figure 4 – Embankment seepage from North West corner of the Mill Pad. Toe of the embankment paralleling Diversion Ditch #1, water flows to Ditch #5, shed at centre of photo contains vertical sump pump.

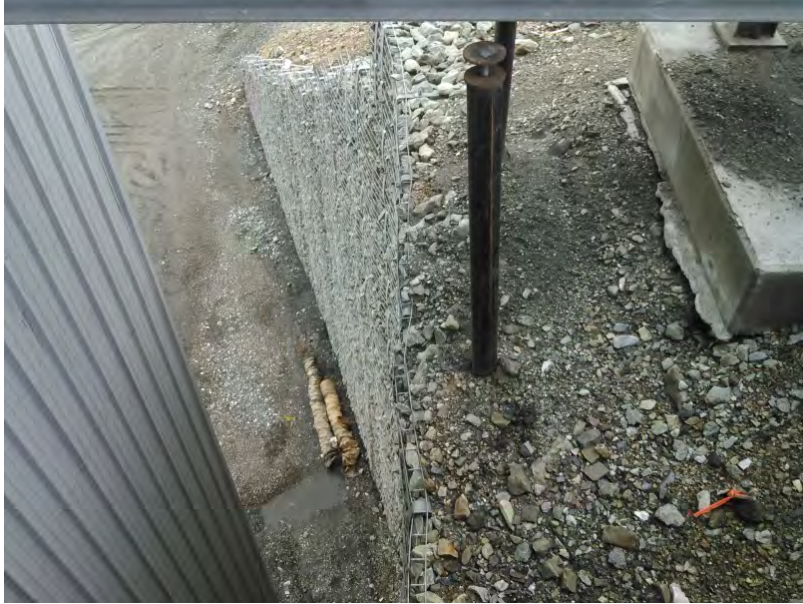
- At the South West corner of the crusher building, the telepost below the walkway was noted to be offset from vertical; and
- The culvert located at the bottom of the wall connected to Ditch #5's manhole was partially submerged by fines due to the yearly precipitation events.

Figure 5 – MSE wall at south west corner of crusher building, post offset from vertical, possible indication of movement.

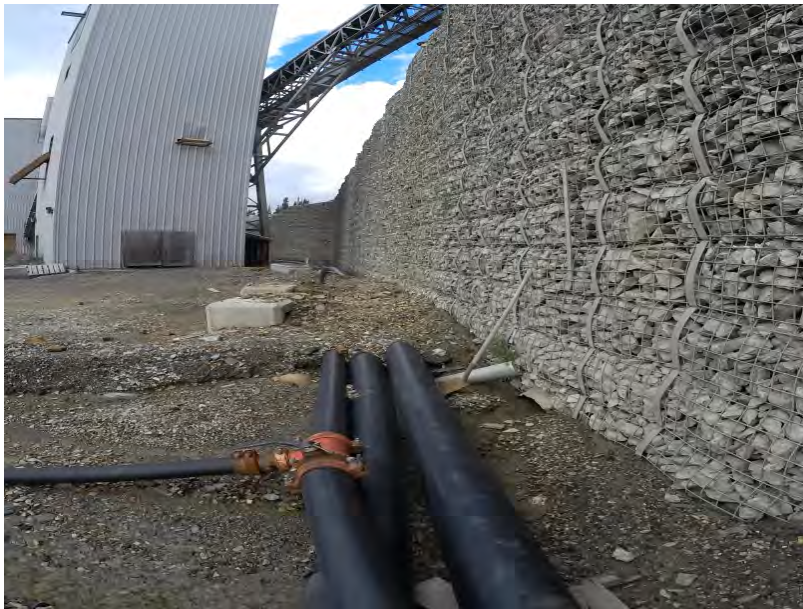
Figure 6 – MSE wall facing North West towards the crusher and conveyor belts. Culvert from Ditch #5 can be seen in the lower right section of the photo.

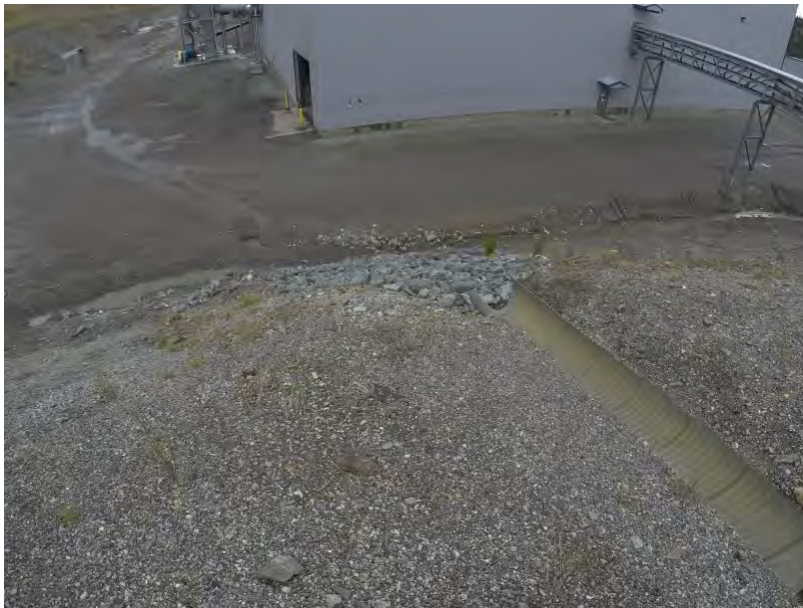
Figure 8 – Culverts and rip rap leading from Generator Pad to Ditch #5.

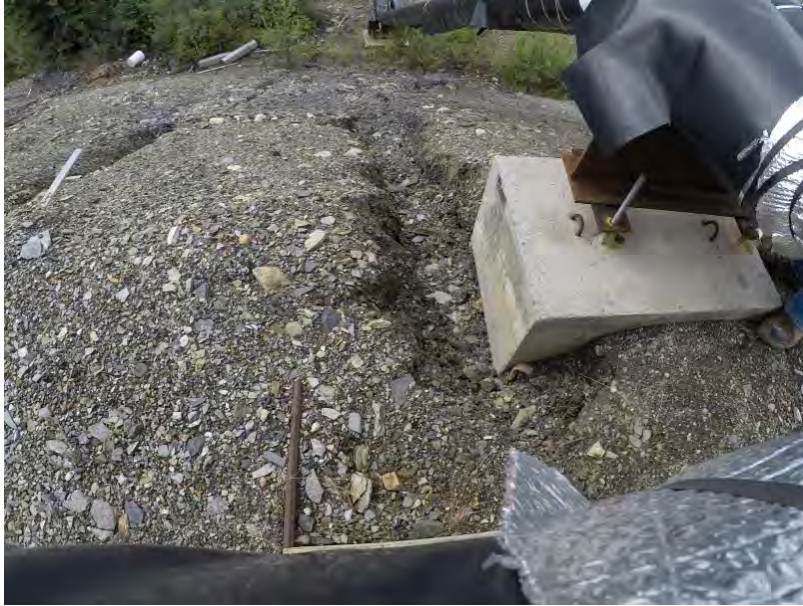
- Small rill erosion present on the old exploration roadway embankment behind the fuel tank and generator pad;
- The two erosion gullies that had been previously repaired with rip rap were still in good condition and have withstood the annual melt and precipitation events; and
- A small erosion gully at the North West portion of the fuel pad has begun to undermine a concrete support block.

Figure 9 – Erosion undermining concrete anchor at the North West side of the Fuel Pad.

- **Fuel Pad** – Figure 9, erosion undermining the concrete anchor should be repaired as best as possible;
- **Waste Rock Pad #1** – Figure 26, construct a berm between the waste rock pad access ramp. This will fully enclose the waste rock pad and help contain runoff water; and

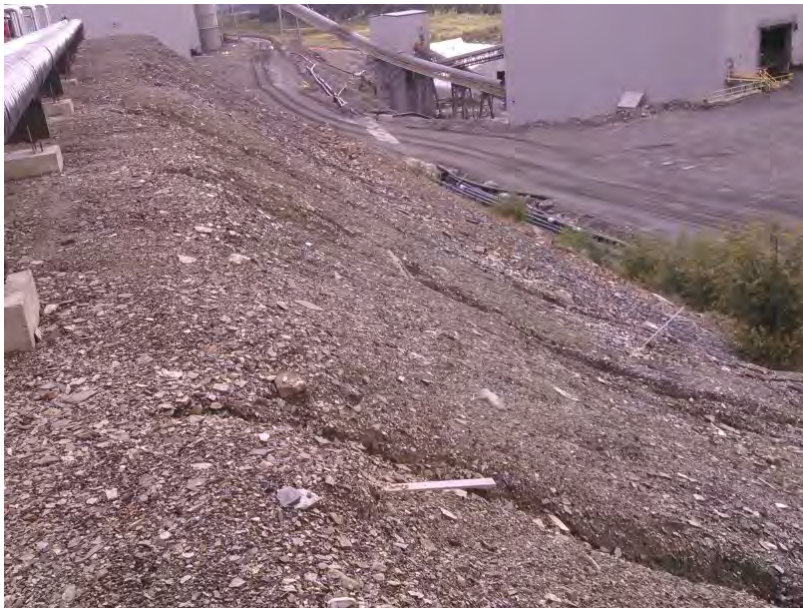
Figure 10 – Embankment slope below Generator Pad, small rill erosion can be observed.

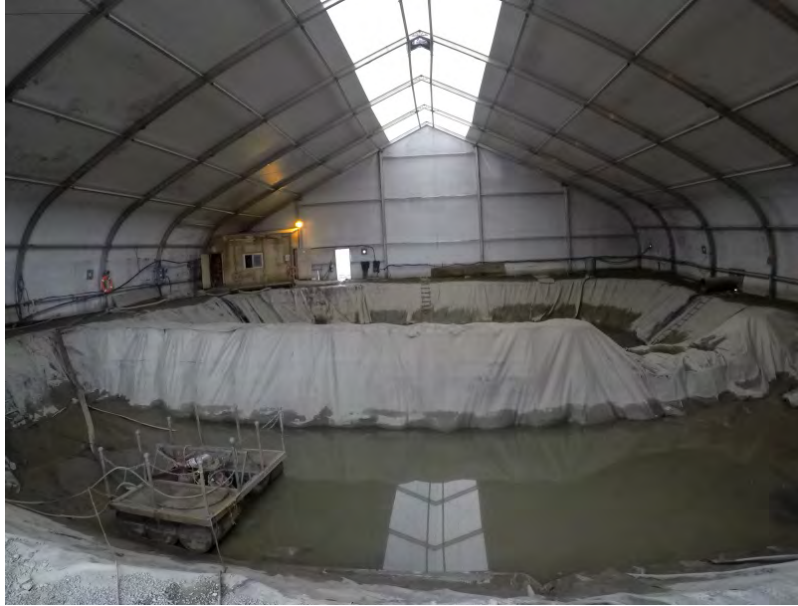
Figure 11 – Sump #2 being drained for replacement of liner, drainage from Ditch #3 visible at the right of the photo.

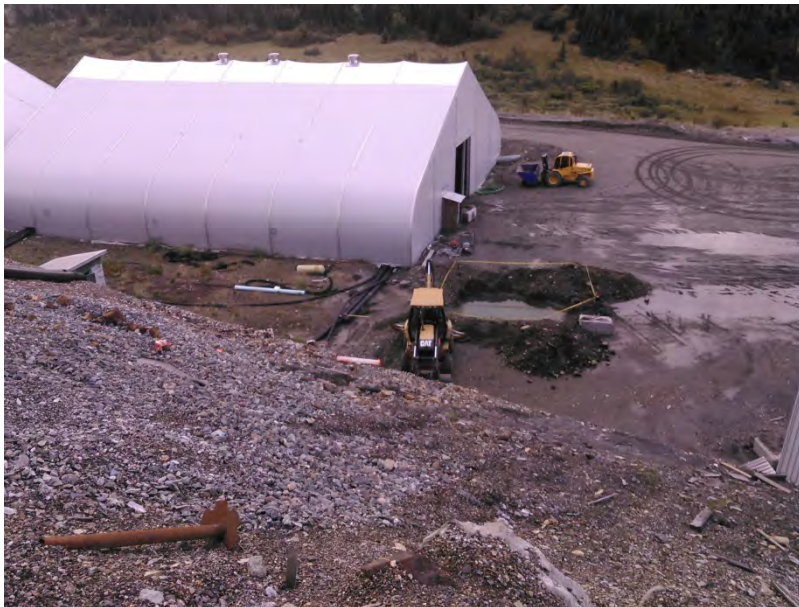
Figure 12 – Recently constructed sump excavated upstream of Sump #2 in order to control flow during the relining of Sump #2.

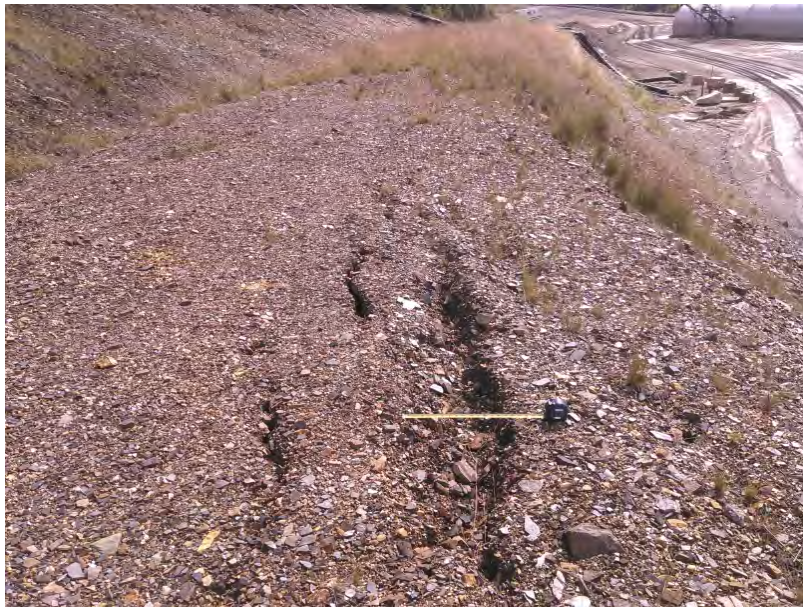
Diversion Ditch 1 located above the Fuel and Generator Pad access road and east of the Mill Pad was observed to be in good condition. As reported in the previous year's inspection reports the large approximately 20 m long tension or settlement crack was observed on the crest of the downstream berm of Ditch 1. There were no signs of distress or movement during the site investigation. The culvert located at the end of Ditch 1 running under the Mill Pad was observed to be damaged.

Figure 14 – Settlement/tension cracks observed in berm adjacent to Ditch #1. Area has been noted in previous reports and no new indication of soil distress was noted.

- **Site Erosion and Cracks** – Continue monitoring and repairing erosion rills and gullies as they appear throughout the year. Tension and settlement cracks can be visually monitored by backfilling the crack with soil and spray painting over the filled soil.

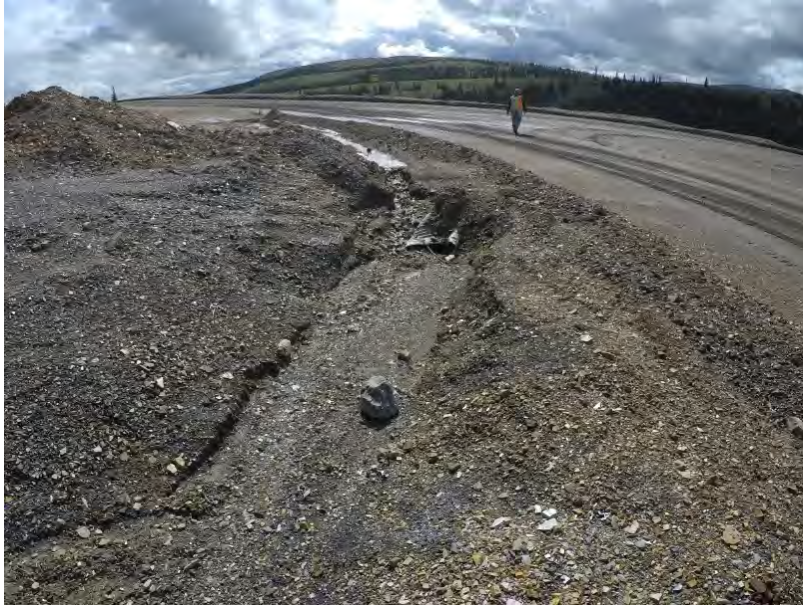
Figure 15 - Ditch #1 culvert at the south end of the Mill Pad. Buildup of sediments and damage to the culvert can be seen.

- **Site Culverts** – It is recommended that all culverts on site should be cleaned of all fines and sediment. Additionally, if culverts are damaged repairs should also be completed;

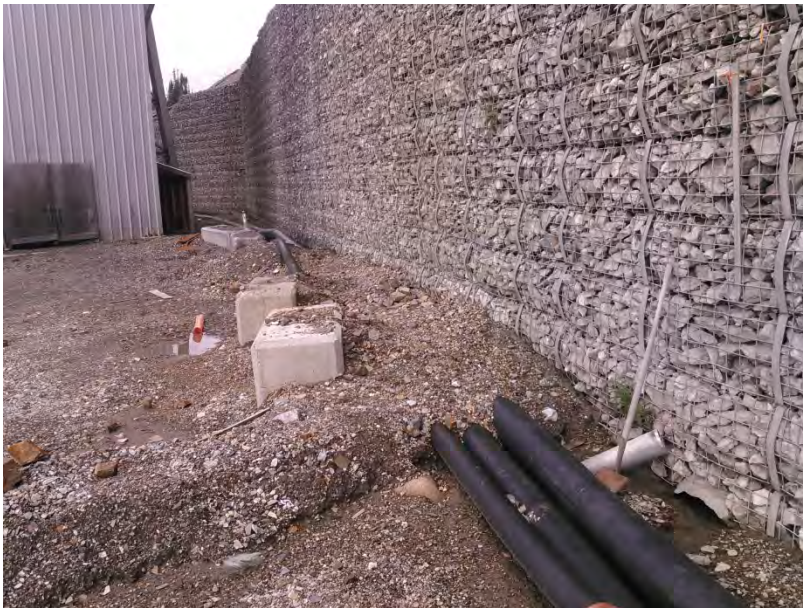
Collection Ditch 5 and outlet culvert appeared to be in good working condition. The Ditch 5 appears to be working properly as water was seen to be flowing and diverting correctly during the inspection. As mentioned above the outlet culvert at the bottom of the MSE has had some sediment and fine materials accumulated over the year, and the manhole was covered with fines and sediment as well.

Figure 18 – Outfall of Ditch #5 at base of MSE wall.

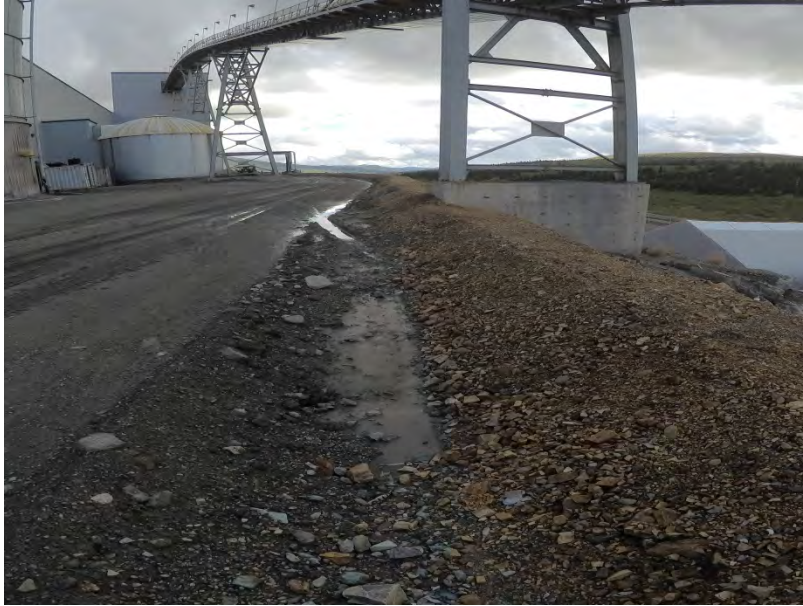
Figure 19 – Ditch #5 manhole located at the top of the MSE wall on the west side of the Mill Pad.

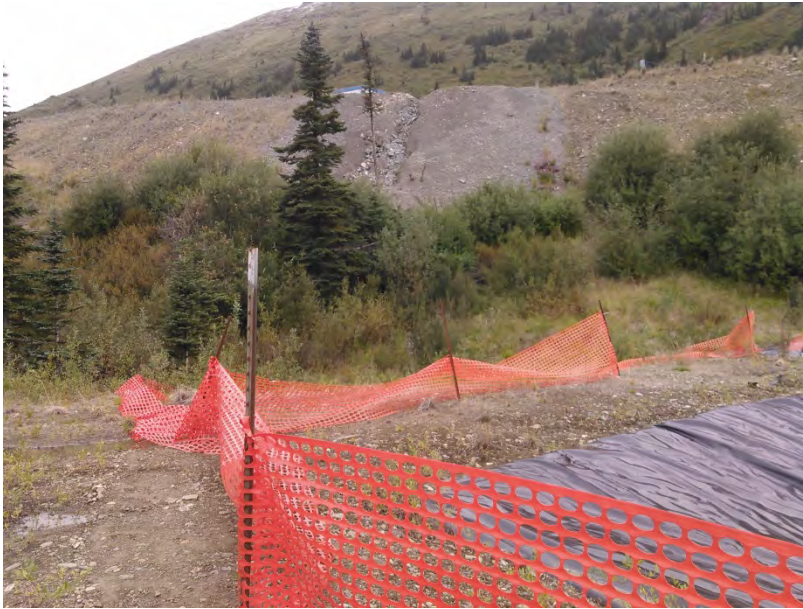
Figure 20 – Previously repaired erosion along the Camp Pad as seen from the Sewage Pond.

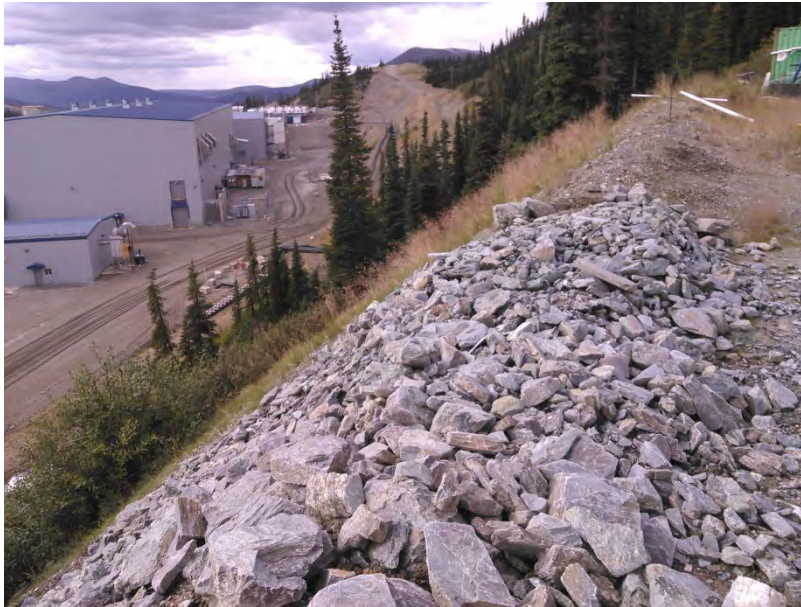
- Due to the recent high precipitation a small section of berm had been washed away in the North West corner of the Camp Area which caused an erosion gully leading down to the mill pad and Ditch #1. Upon inspection the berm had been repaired; and
- Erosion repair on past erosion areas have withstood the yearly precipitation.

Figure 22 – Recently repaired erosion rill due to heavy rainfalls located in the North West corner of the Camp Pad facing north.

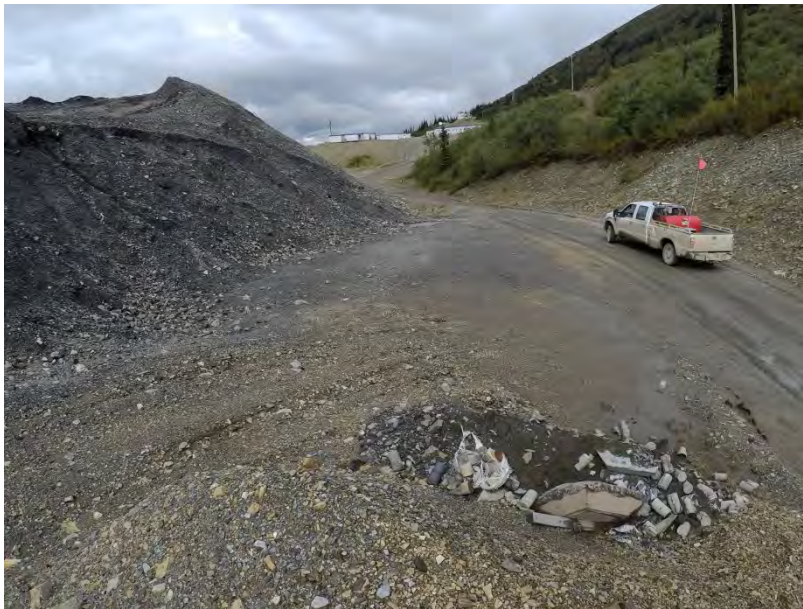
Waste Rock Pad #1, sumps, and liner located south of the Mine Camp Area were observed to be in good condition. Minor surface erosion on the steep portion of the access South East of Waste Rock Pad area was observed on approach. Additionally, a berm across the stockpile ramp appeared to be missing, this could potentially lead to portions of runoff flows to the nearby culvert, see Figure 26.

Figure 26 – Waste Rock Pad #1 berm isn't continued past the waste pad access ramp.

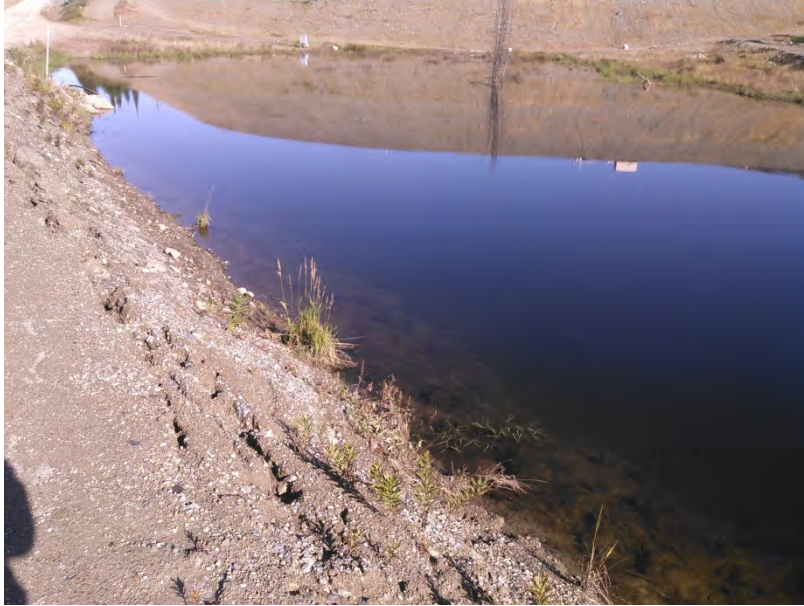
The TSF Seepage Pond located south of the TSF appeared to be in good condition. The Mine Access Roadway serves as the Seepage Pond dam and the embankment slope has settled which has caused over steepening of the slope as well as tension cracks which were visible along the shoulder of the road.

Figure 29 - Seepage Pond downstream of the TSF. Wolverine access roadway serves as dam. Embankment slope has settled causing over steepening of slope as well as tension cracks.

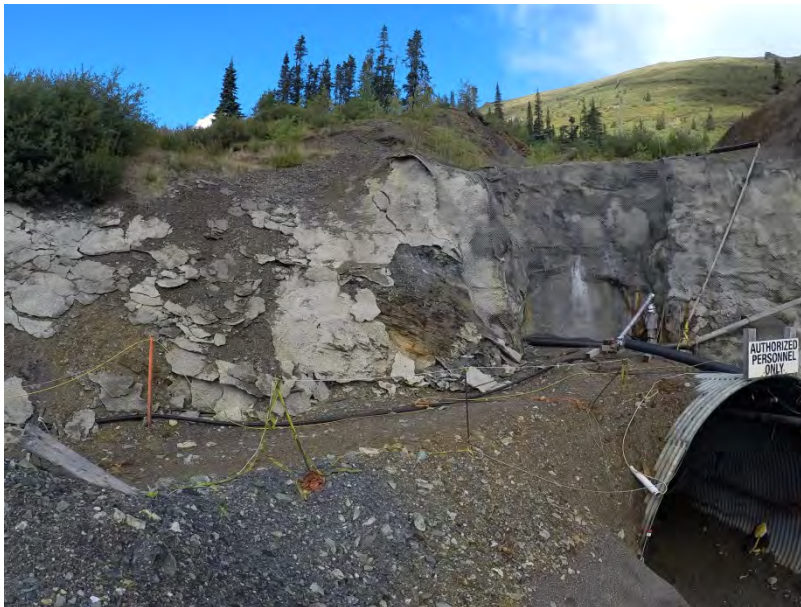
The cut slope and supported ground around the Mine Portal appeared to be in okay condition with minor defects. It was observed that sections of shotcrete have come loose and fallen from the slope around the portal. The exposed bedrock appears to be relatively stable, although it may become erodible under flow and/or weathering.

Figure 38 – Mine Portal, some shotcrete has come loose and fallen from the slope. Exposed bedrock appears relatively stable, but could be erodible under flow and/or weathering.

- **Mine Portal** – Figure 38, monitor the shotcrete at the mine portal for additional peeling and bedrock erosion.
