WOLVERINE MINE

QUARTZ MINING LICENSE QML-0006

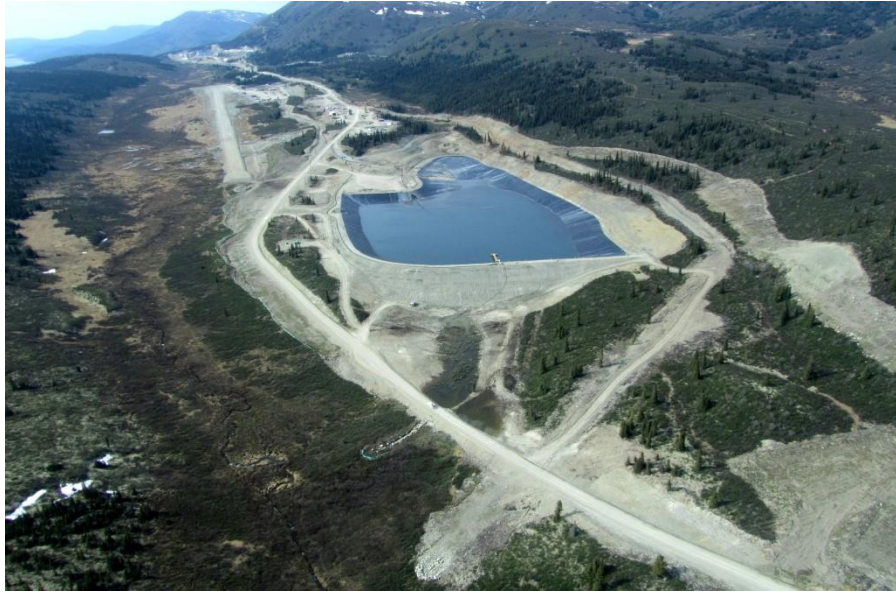
Picture 2-4: Tailings storage facility and mine access road.

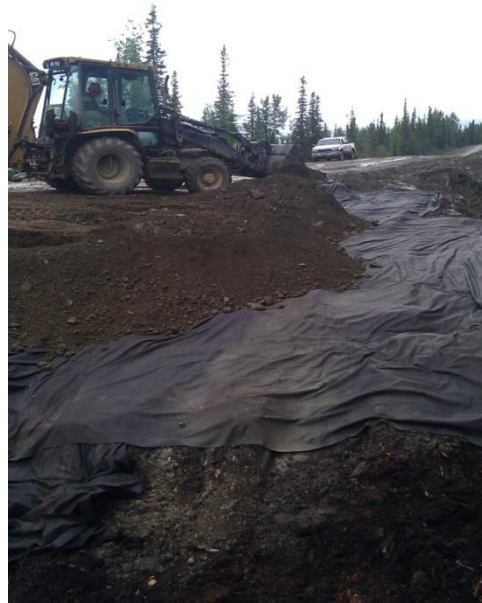
Picture 7-2: Installation of geotextile and re-grading at KM 4.5 where permafrost was an issue

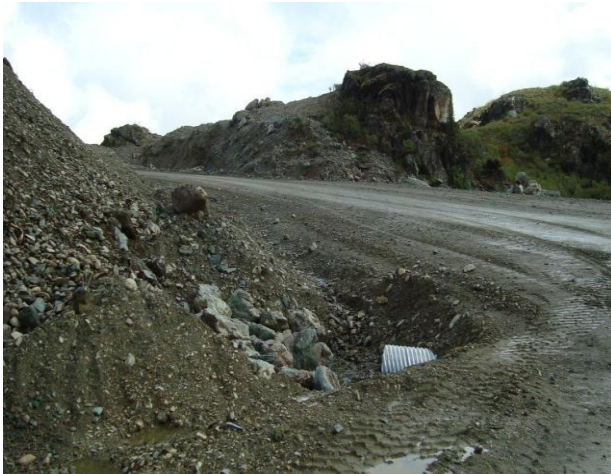
Picture 7-3: Installation of a culvert at KM 19 to divert heavy flow

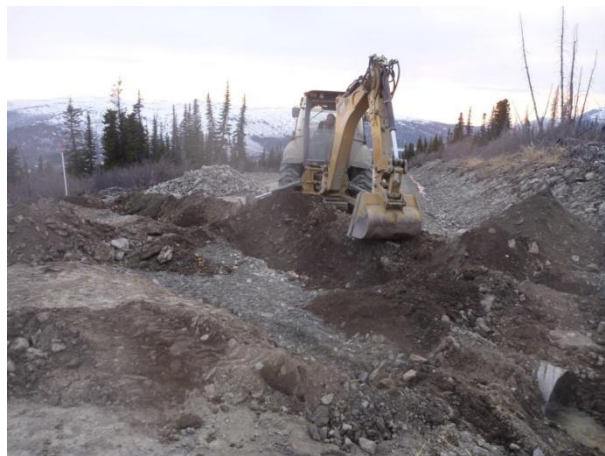
Picture 7-4: Repair of undermined culvert at KM 21

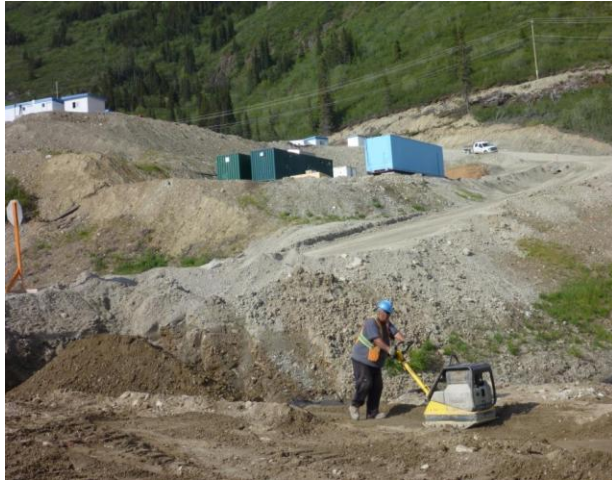
Picture 7-5: Initial stages of road improvement measures at KM 27 + 200

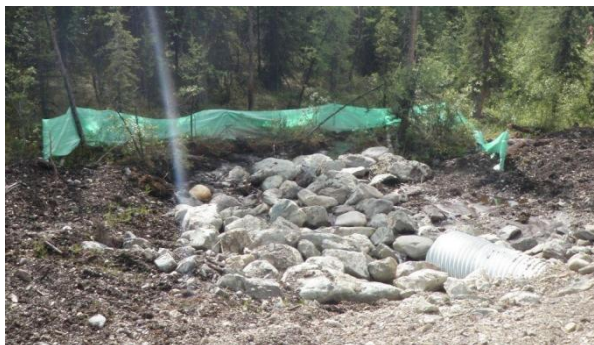
Picture 8-3: Installation of large rocks and silt fence to reduce flow energy and sediment load, respectively

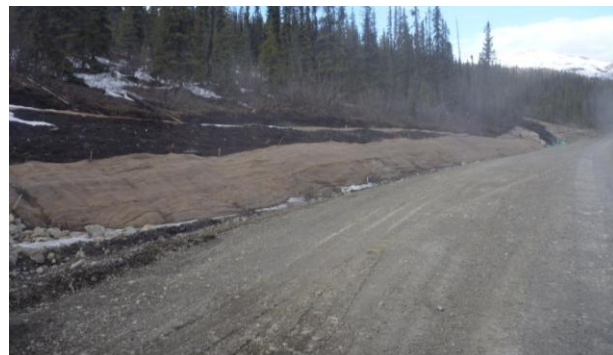
Picture 8-4: Installation of coconut matting and seeding along side of road where permafrost was evident

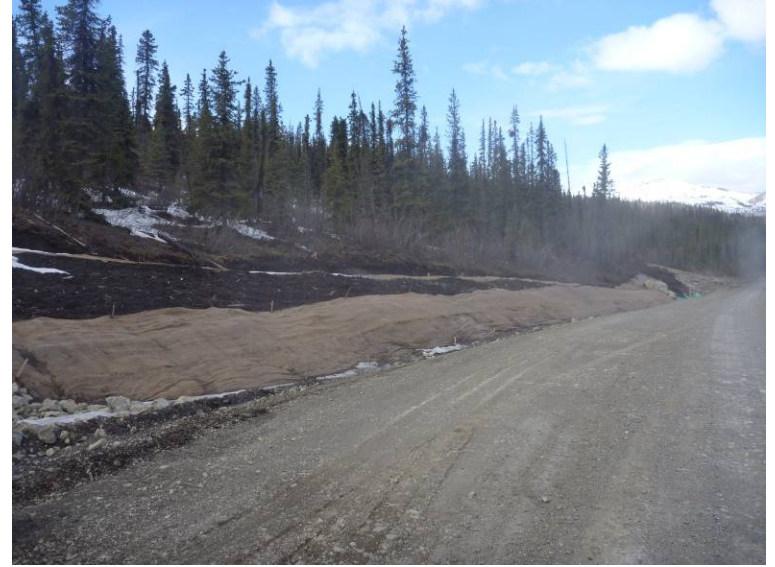
11/04/30 Coconut matting in good repair, monitor for revegetation in summer

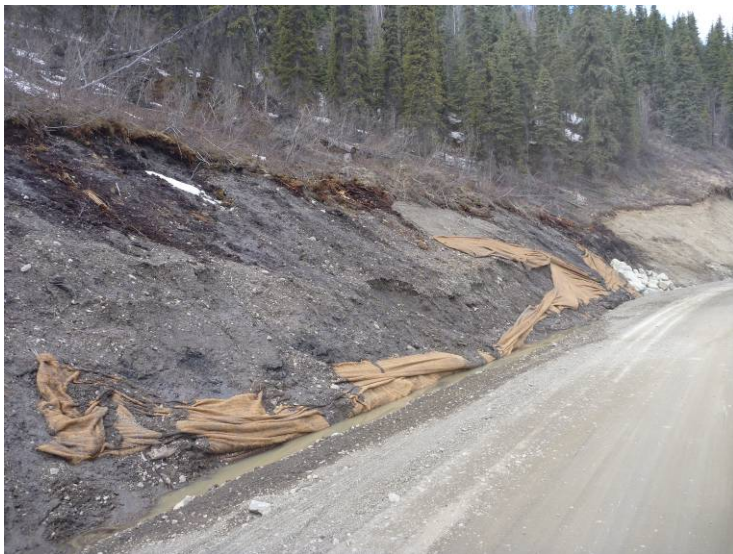
11/04/30 Km 9+500 Sloughing on bank, matting needs repair and reseeded.

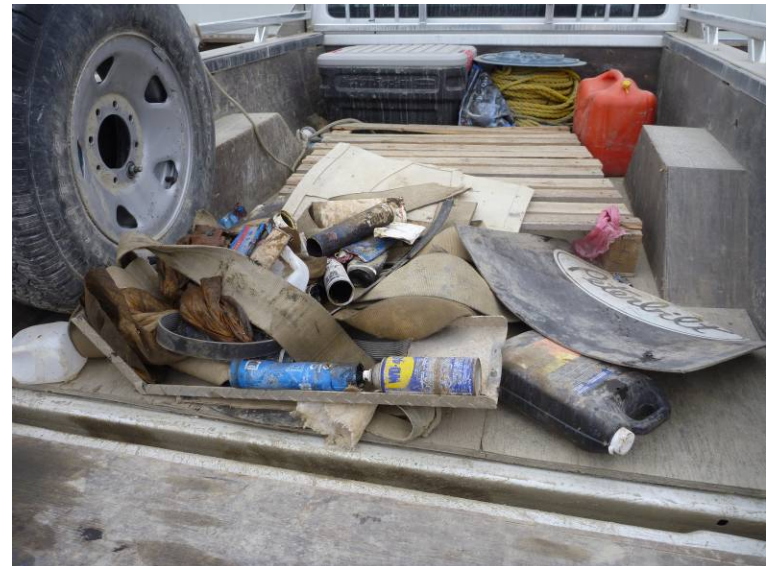
11/05/04 Trash left at gate laydown and cleaned up

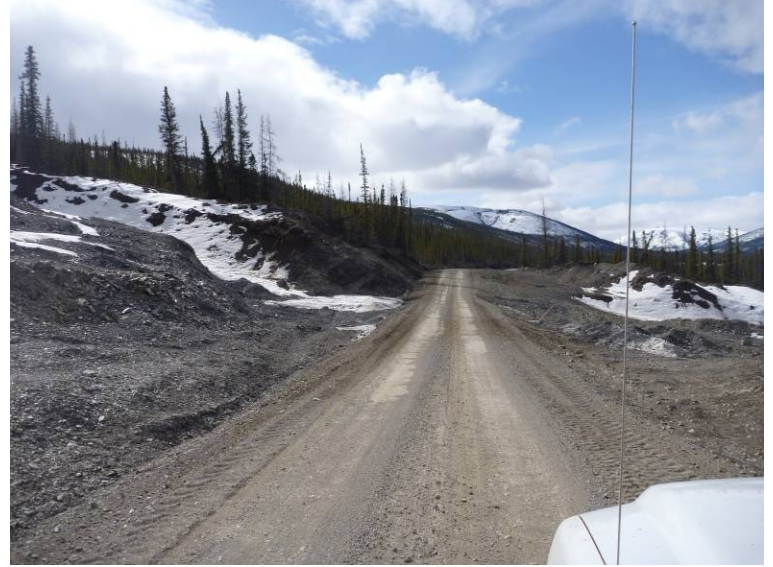
11/05/05 Road conditions dry and in good shape

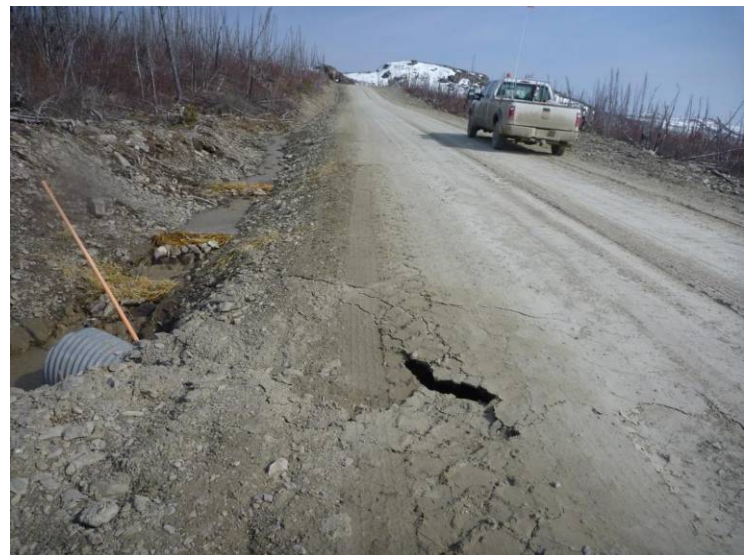
Photo 4 (11/05/18) Cave-in on road caused by culvert being undermined by high water flow

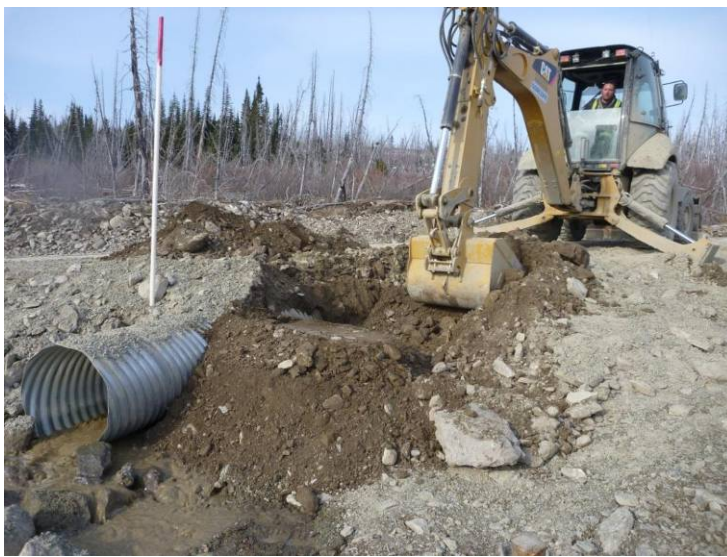
Photo 7 (11/05/18) Initiation of excavation and backfill to support culvert repair at KM 19.5

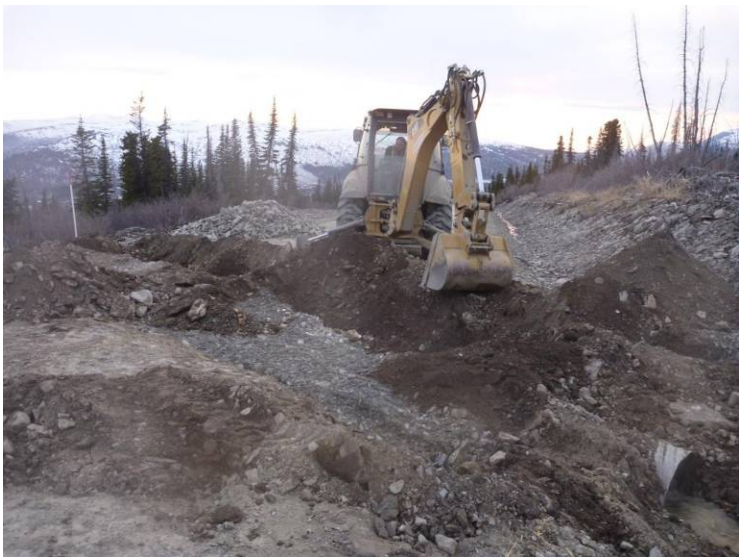
Photo 8 (11/05/18) Excavation and backfill to support culvert repair at KM 19.5

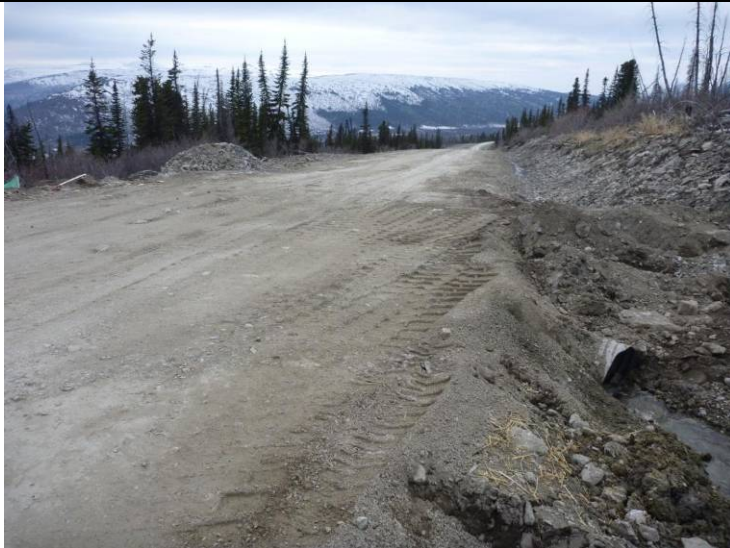
Photo 9 (11/05/18) Culvert repair at KM 19.5 completed

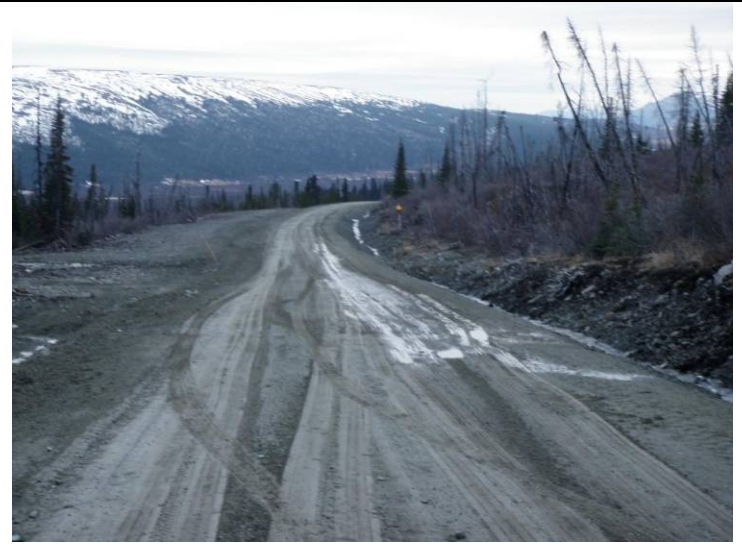
Photo 10 (11/05/20) Water seeping from middle of road at KM 20

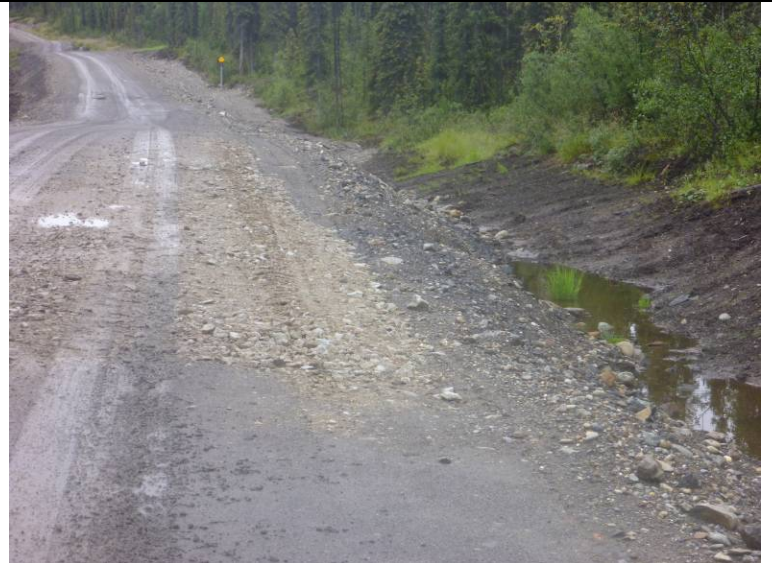
KM6.2 Repairs to the road

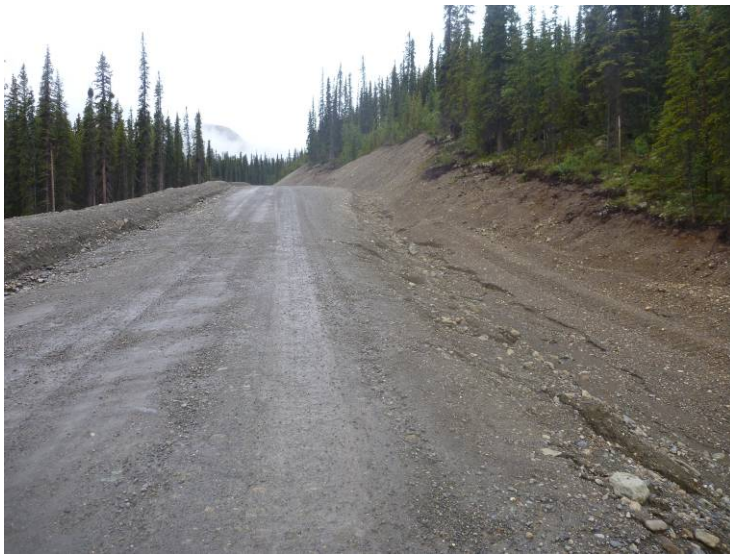
KM11 Water rills throughout the road going into the ditch across road, loose sandy material

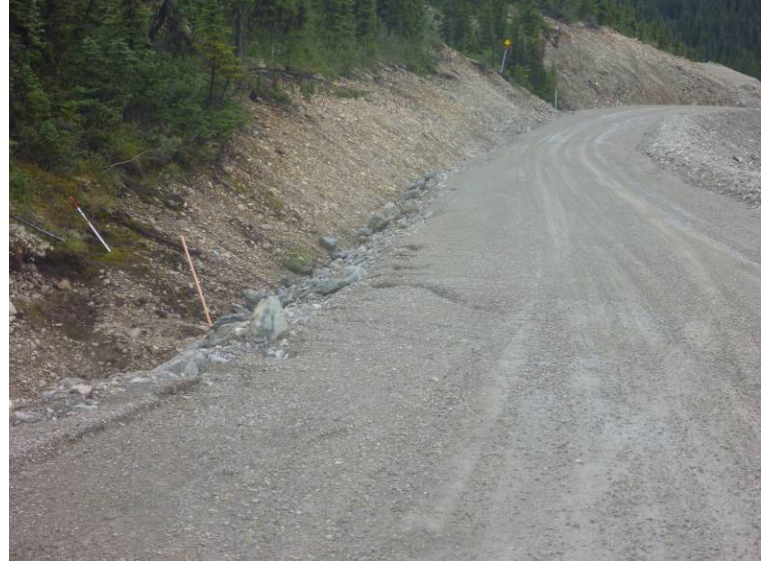
KM17 Erosion into the road

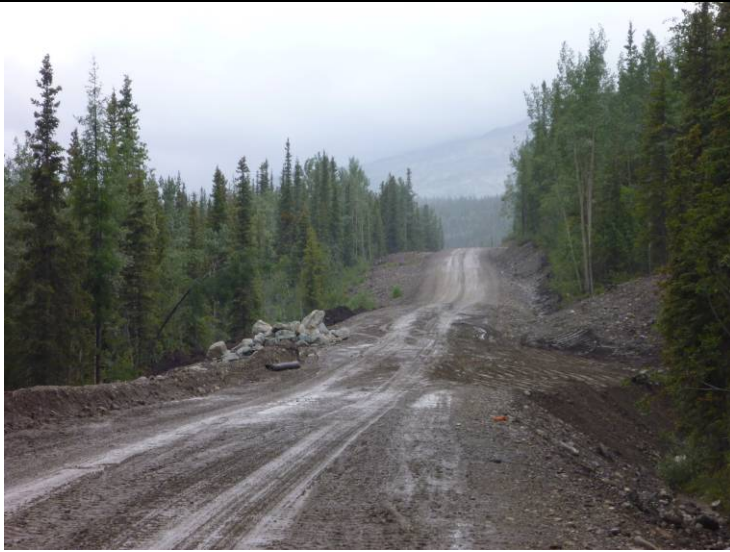
KM 4.1 Road repair with Backhoe, culvert repair and ditch was stabilized.

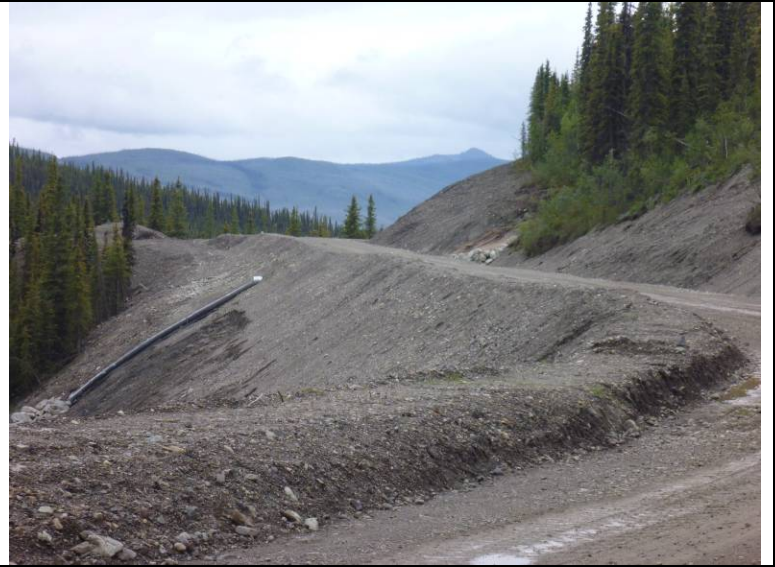
KM 9.5 Sediment and erosion control needs repair, and needs permafrost stabilized upslope and down slope.

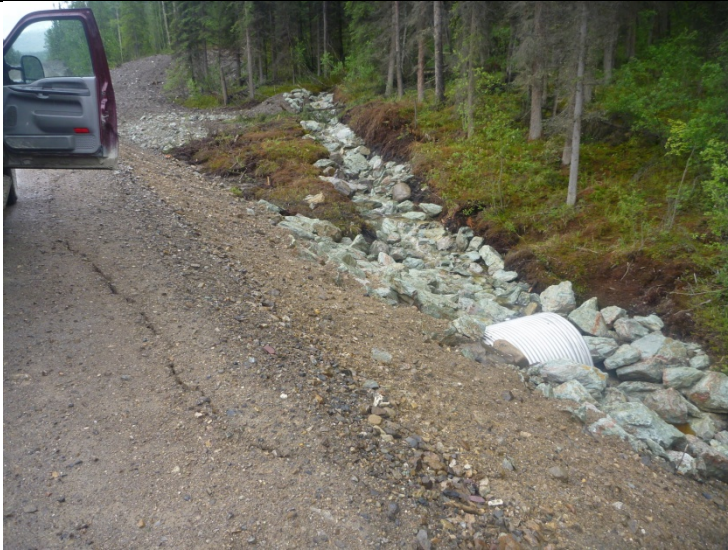
Photo 1 (July 1, 2011): km 4.6 Looking north - tension crack on east side of road.

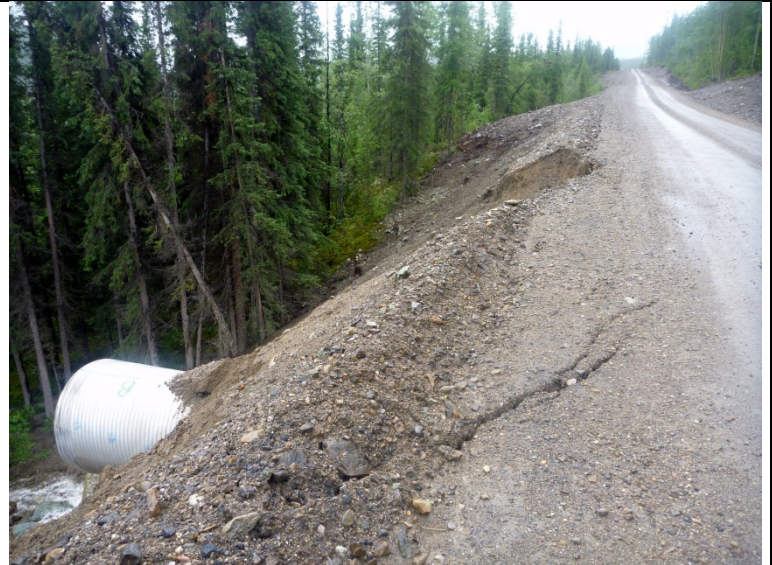
Photo 2 (July 1, 2011): km 4.6 Looking north - tension cracks & erosion channels on west side of the road.

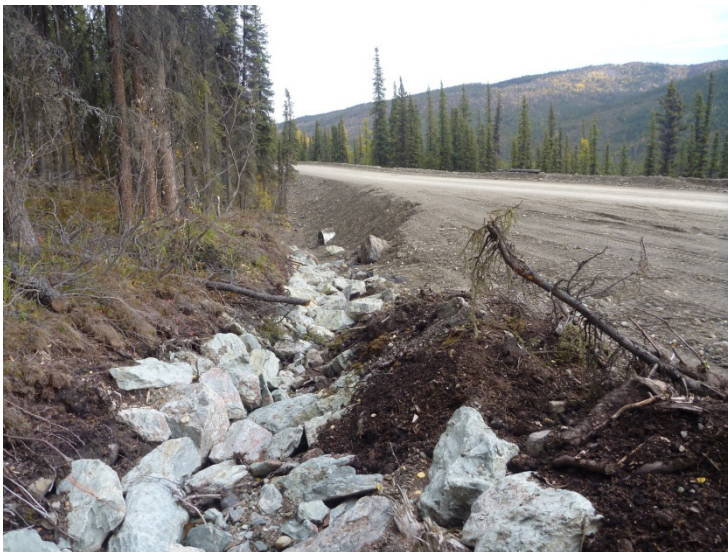
Photo 3 (Sept 13, 2011): km 4.6 Looking south - fill-in tension cracks; laid geo-membrane and placed rip rap on east side of road fill slope.

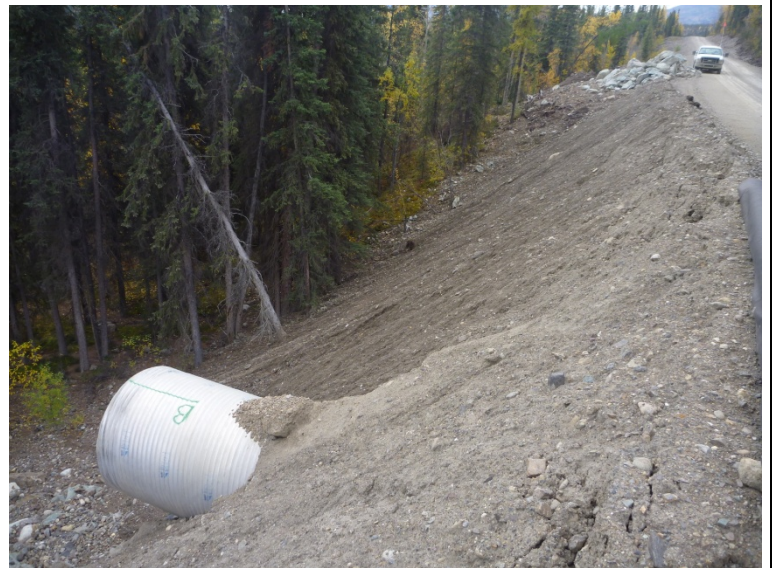
Photo 4 (Sept 13, 2011): km 4.6 Looking north - fill-in tension cracks and erosion channels along west side of the road cut and fill slope.

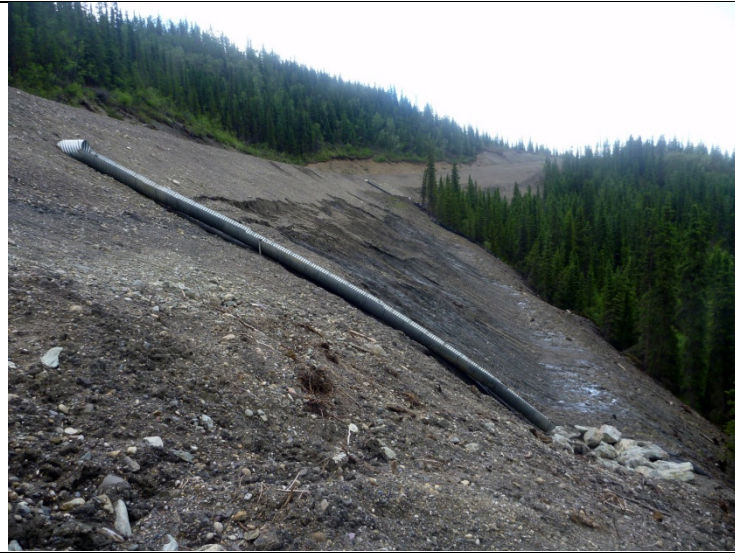
Photo 5 (July 1, 2011): km 9.5 Looking south - tension cracks & erosion channels down slope of the road. Note: Visible water seepage through sand/gravel.

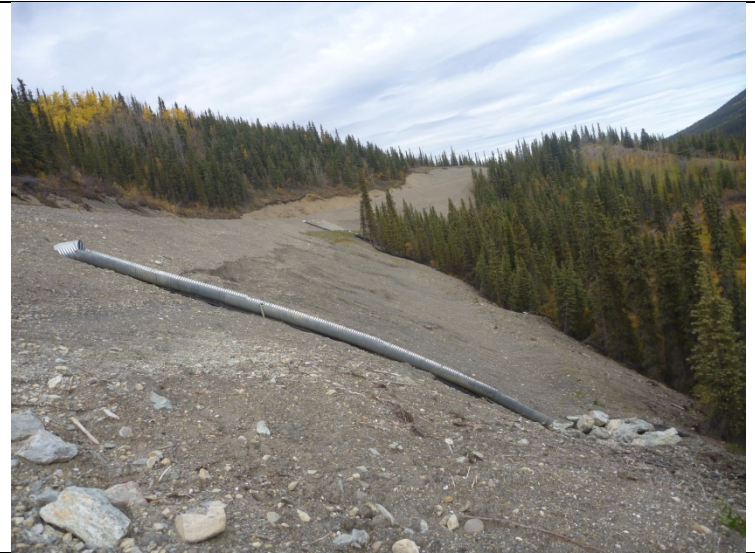
Photo 6 (September 13, 2011): km 9.5 Looking south - tension cracks & erosion channels down slope of the road. Note: No visible water seepage.

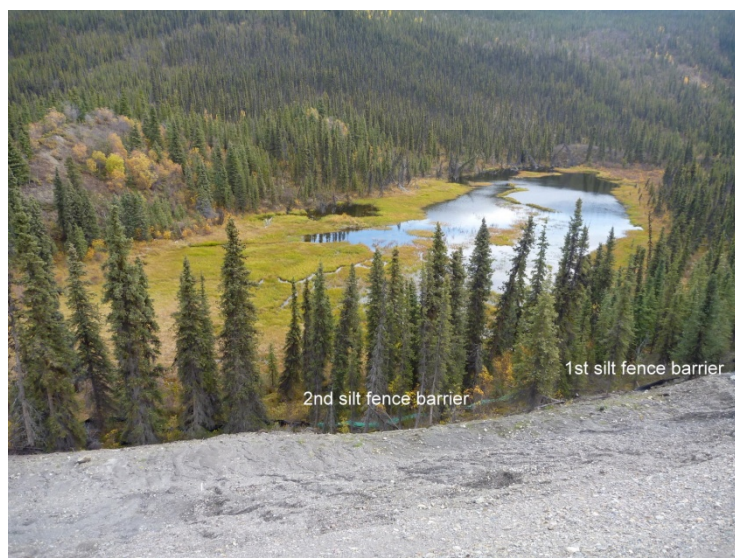
Photo 7 (September 13, 2011): km 9.5 Looking west – portion of 1st silt fence barrier covered by moving sand/gravel. 2nd silt fence still in place at the toe.

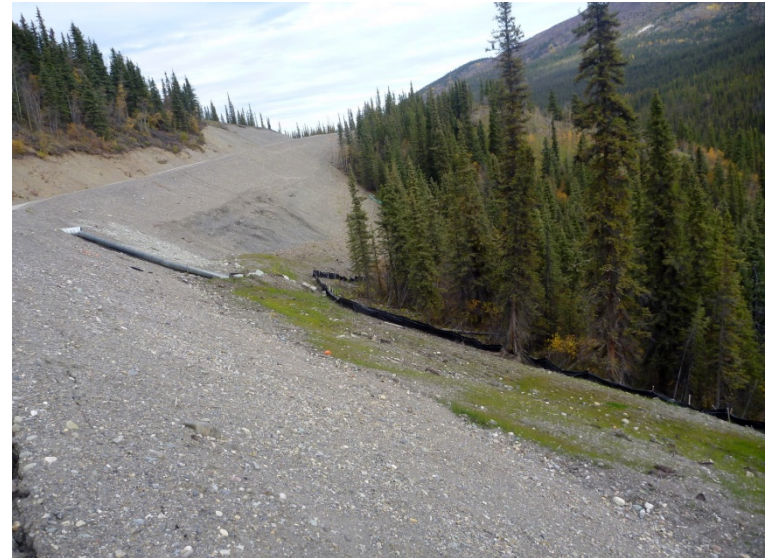
Photo 8 (September 13, 2011): km 9.5 Looking south - roadside seeds growing where the ground is moist. Note: 1st silt fence barrier intact at toe.

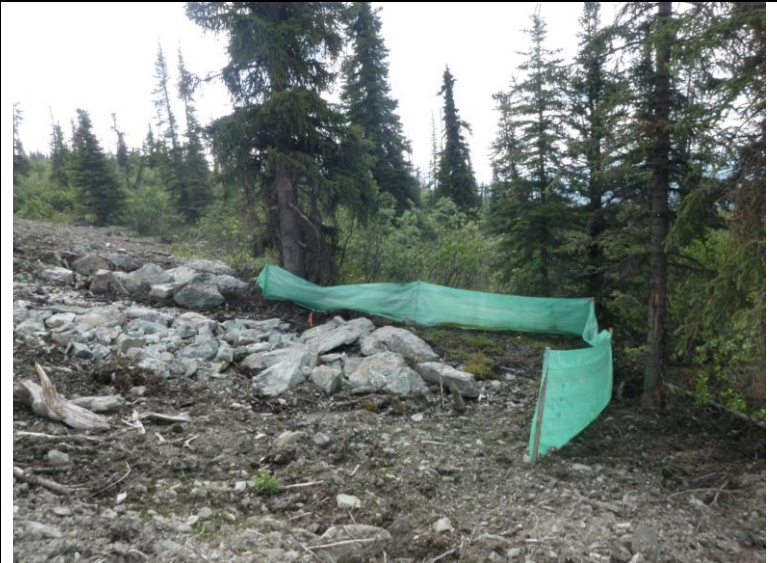
Photo 2 (11/06/17) After (silt fence has been repaired)

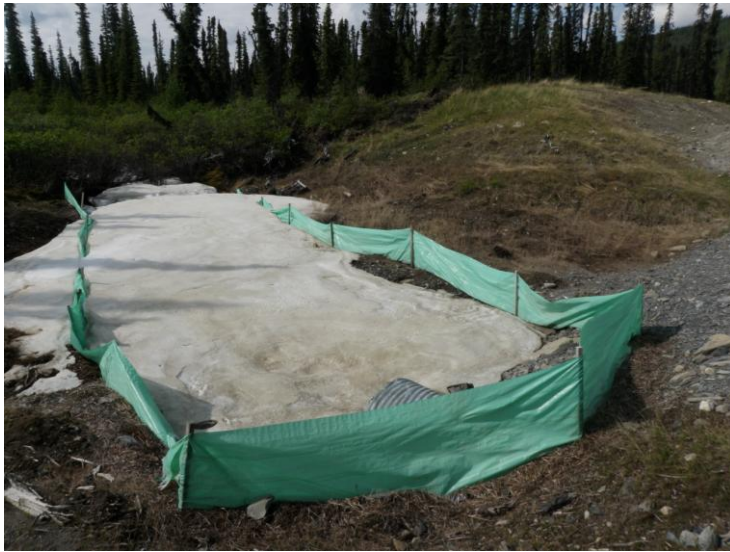
Photo 3 (11/06/17) Sediment control at Pitch Creek.

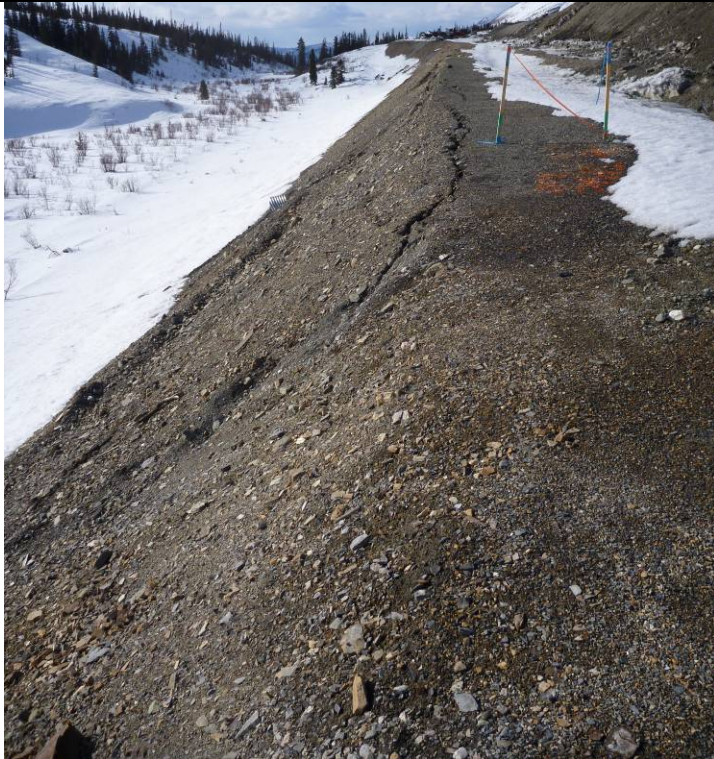
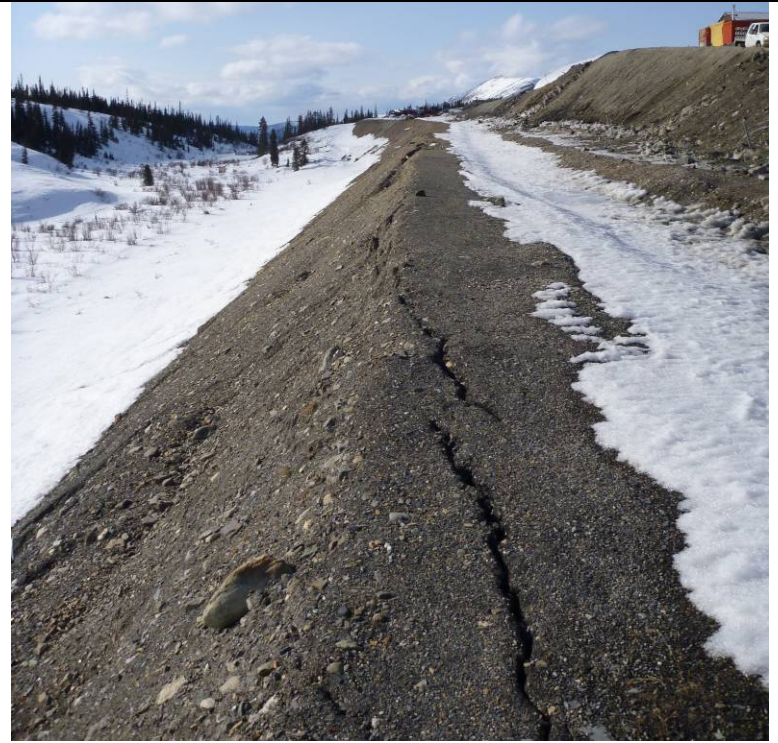
11/04/08 Ditch # 4 (facing NW) evidence of cracking. Some pre-existing from last year.

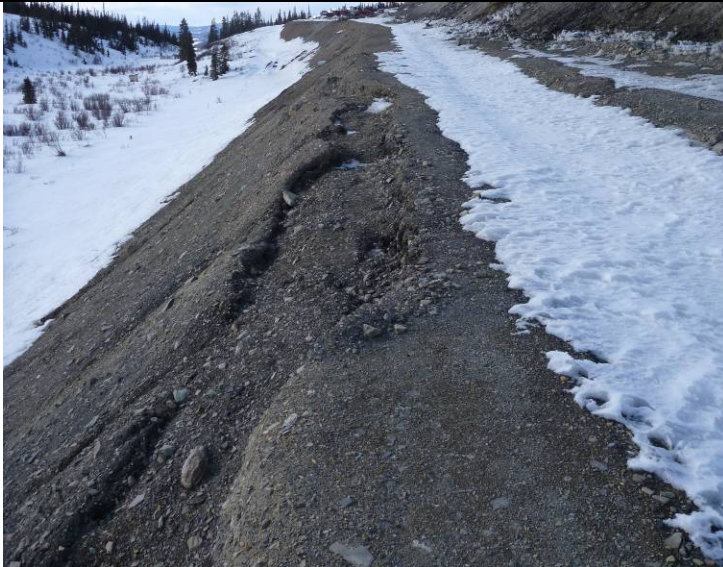
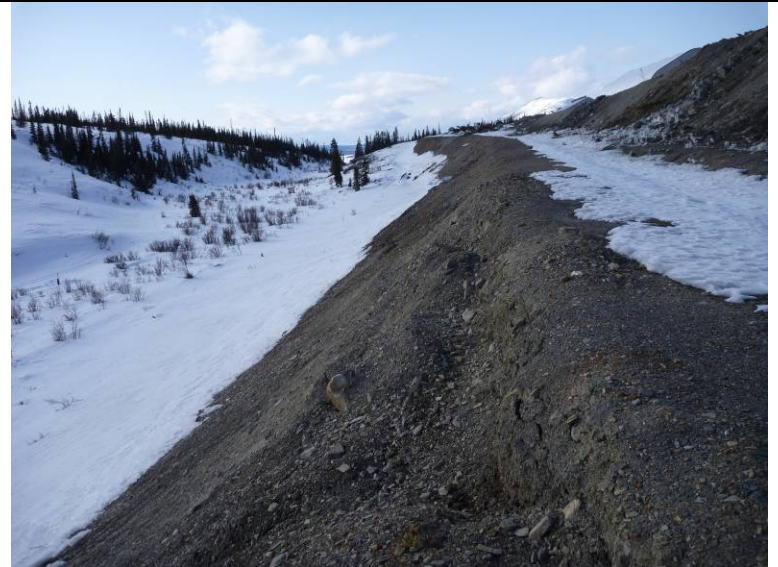
11/04/08 Ditch # 4 (facing NW) evidence of cracking and sloughing. Some pre-existing from last year.

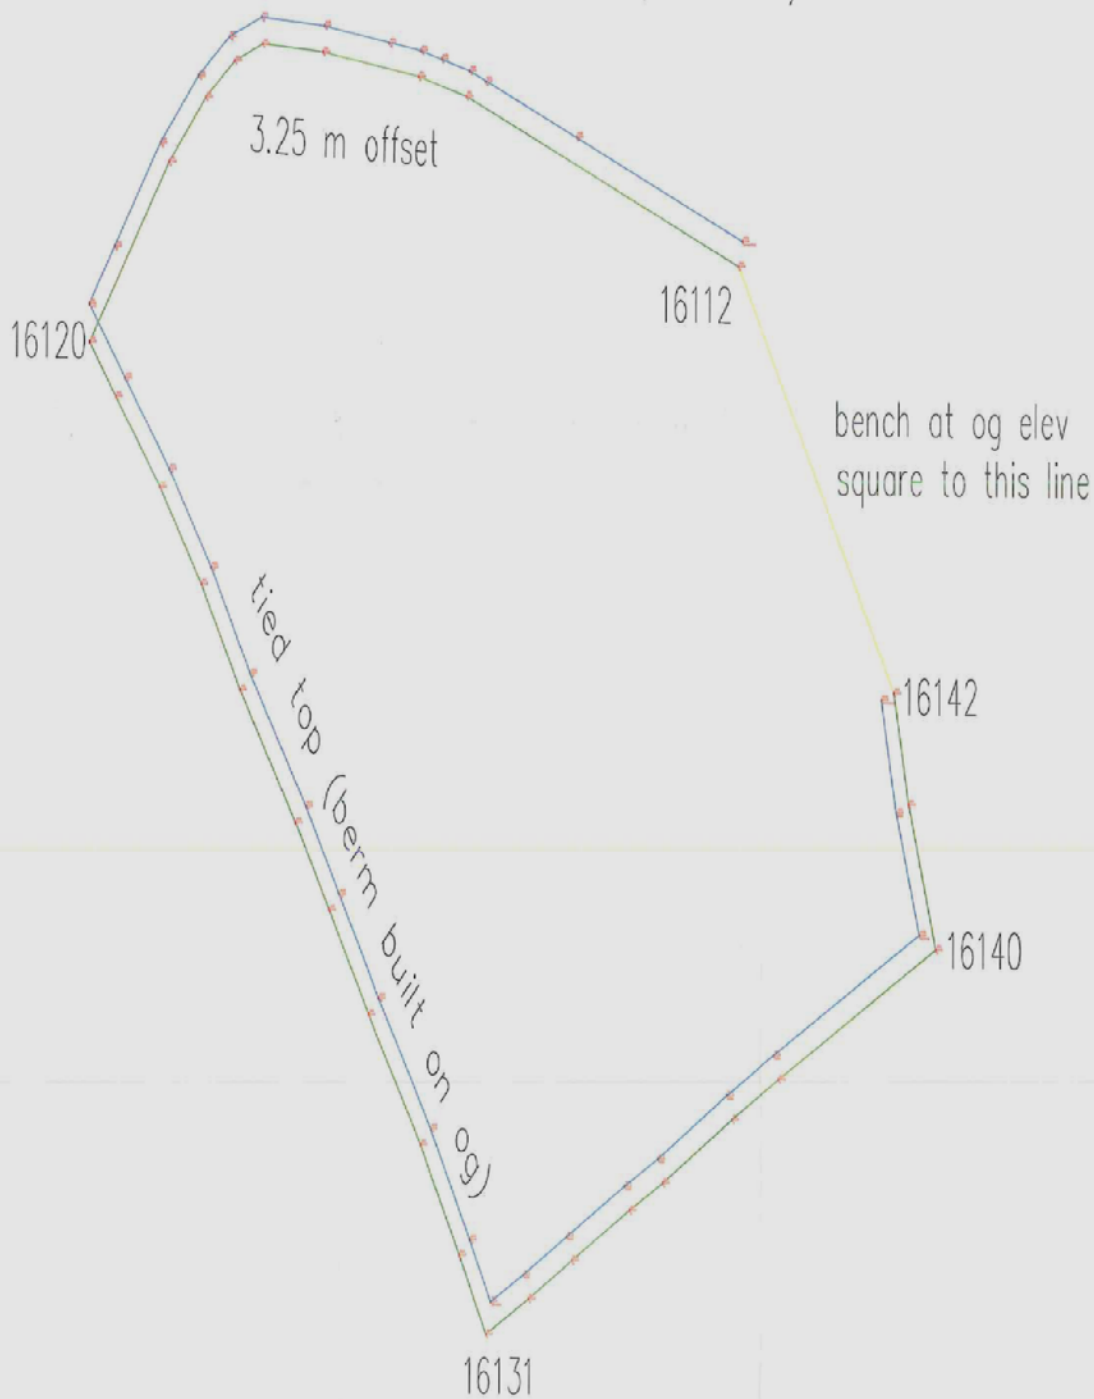
Wolverine Project Environmental Inspection Form

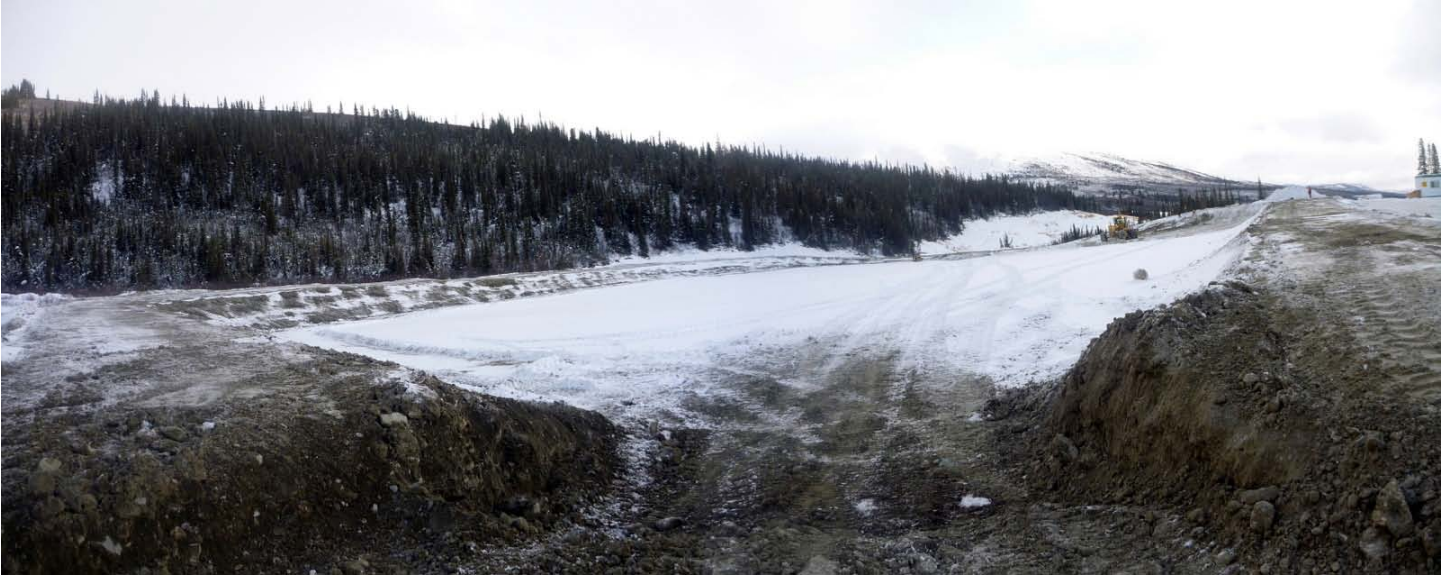
Photo 3 (11/10/29): Looking east – removing loose rocks along southeast berm.
