WOLVERINE MINE

QUARTZ MINING LICENSE QML-0006

2014 ANNUAL REPORT

Prepared by:
Yukon Zinc Corporation
Vancouver, British Columbia

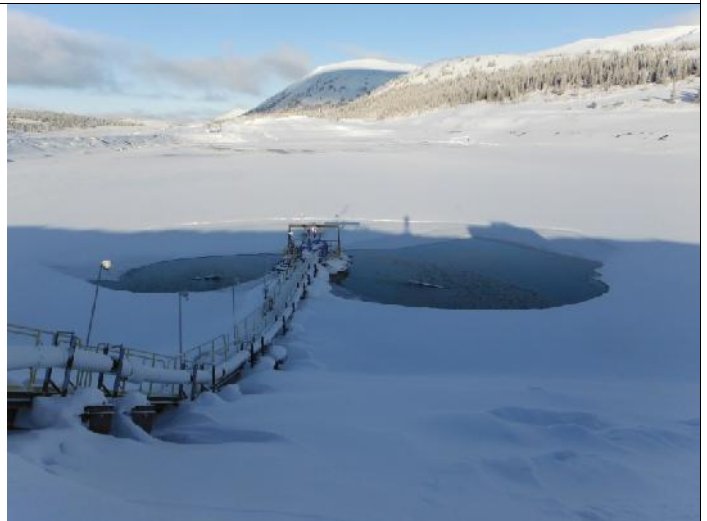
Photo 4: Barge with new de-icing pump effectively opening up the area around barge

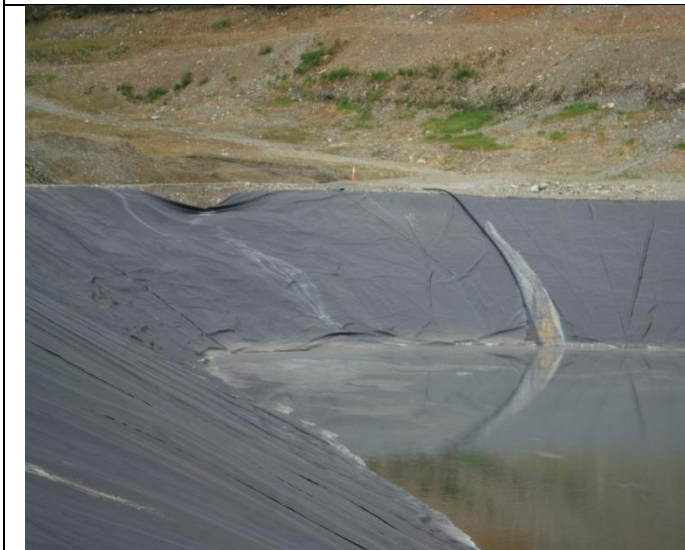
Photo 3: West wall view with slough at upper crest of west wall & disturbance/movements underneath the liners.

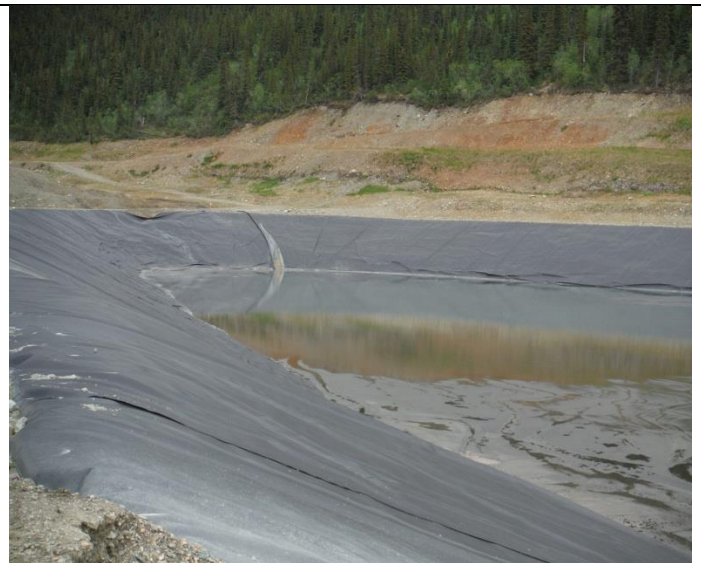
Photo 4: Expanded view of the Photo 3- West wall & South Wall at fore ground.

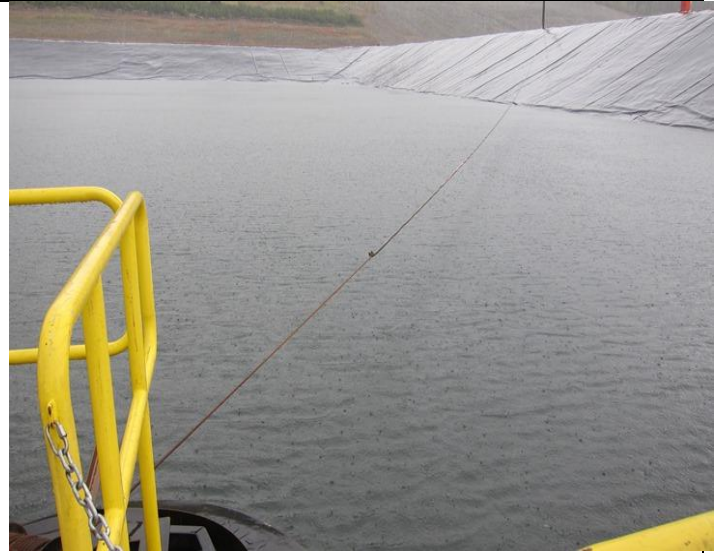
Photo 2: Looking at north-east corner of TSF from Barge, with only one-cable attached at north side of barge.

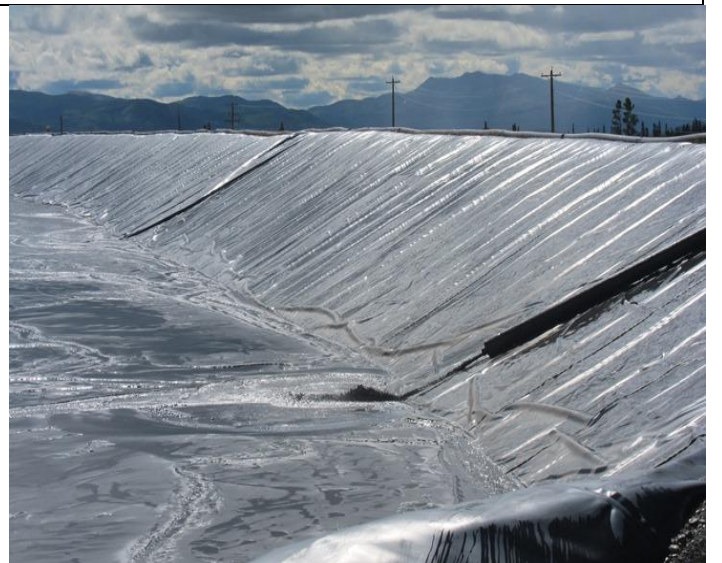
Photo 4: View of South Wall with tailing slurry discharging- enough room for the tailings.

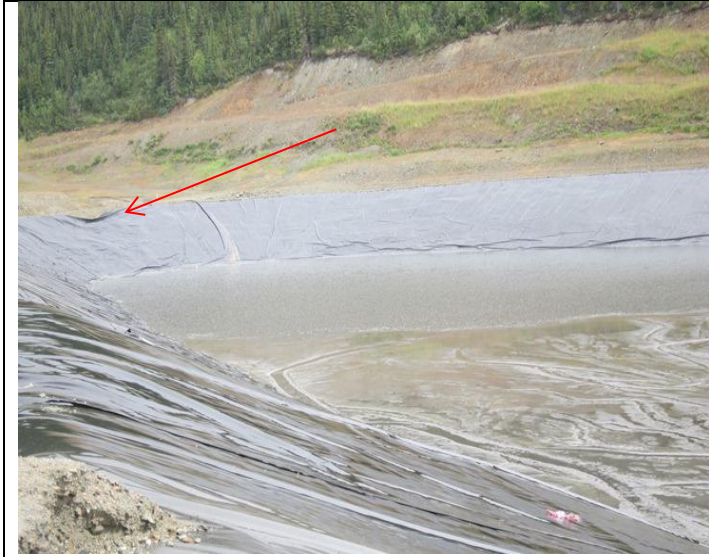
Photo 5: looking at south-west corner bank showing distorted liner at left corner of west wall.

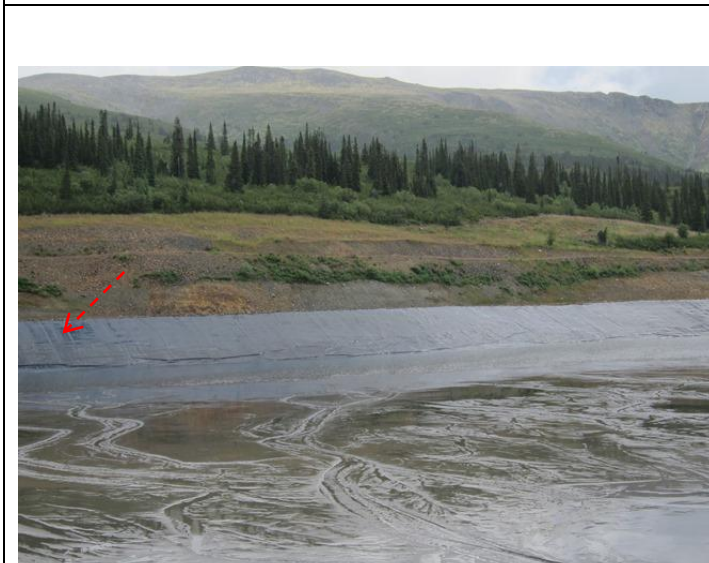
Photo 7: looking at north side of TSF showing ripples on the left corner liner of wall.
