**Mayo Lake Generating Station Re-Development**  
**Mollard Memo November 17, 2008**

**Re: Yukon Energy Corporation -- Mayo Lake Generating Station Re-development**

To provide preliminary thoughts on shore erosion changes that may result from lowering the Mayo Lake minimum drawdown level by 1m or raising the maximum full supply level by 1m.

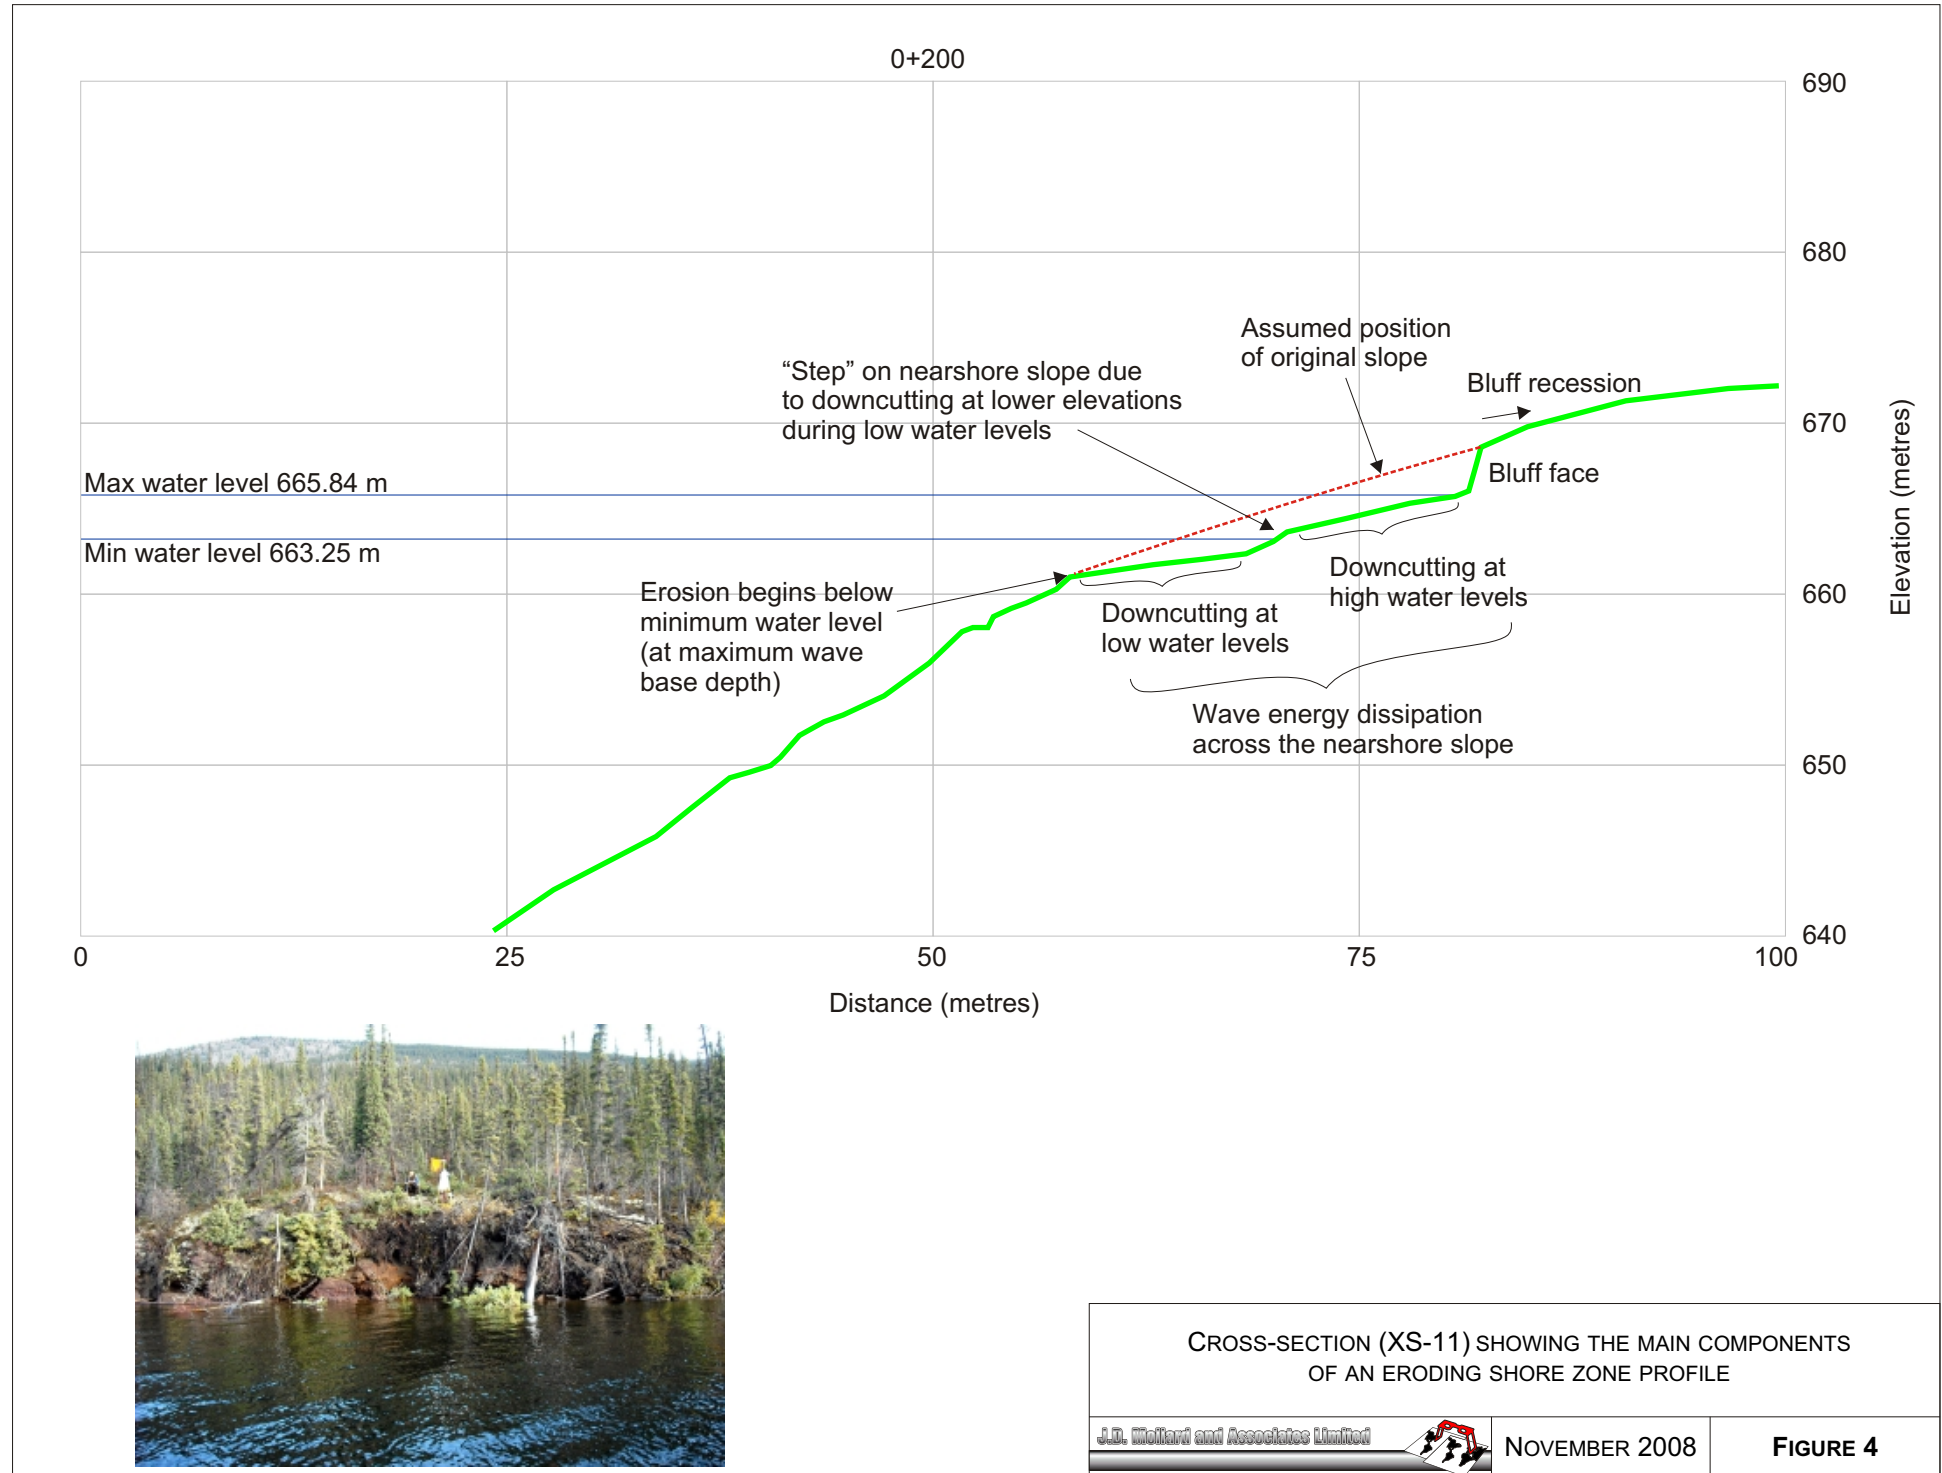
J.D. Mollard and Associates Limited NOVEMBER 2008 **FIGURE 4**

\*Field photographs of transect 11 suggest that this site is located in a low till (moraine) bluff with low-moderate erosion activity

Figure 4 shows an enlarged view of the shore zone profile at cross-section 11, located on the east shore of the southeast arm of Mayo Lake. This cross-section serves as a good example to illustrate the main components of an eroding shore zone profile. The maximum and minimum water levels under the current Mayo Lake operational scheme are shown on the cross-section. The two main geomorphic components of an eroding shore zone are the bluff face and the nearshore slope. As waves approach the shoreline, wave shear stresses are transferred to the lake bottom where water depths are shallower than the wave base depth. If lake bottom sediments are erodible, these shear stresses erode the lake bottom in the nearshore zone (*i.e.*, where water depths are less than the wave base depth). This process is referred to as nearshore downcutting.

CROSS-SECTION (XS-11) SHOWING THE MAIN COMPONENTS OF AN ERODING SHORE ZONE PROFILE

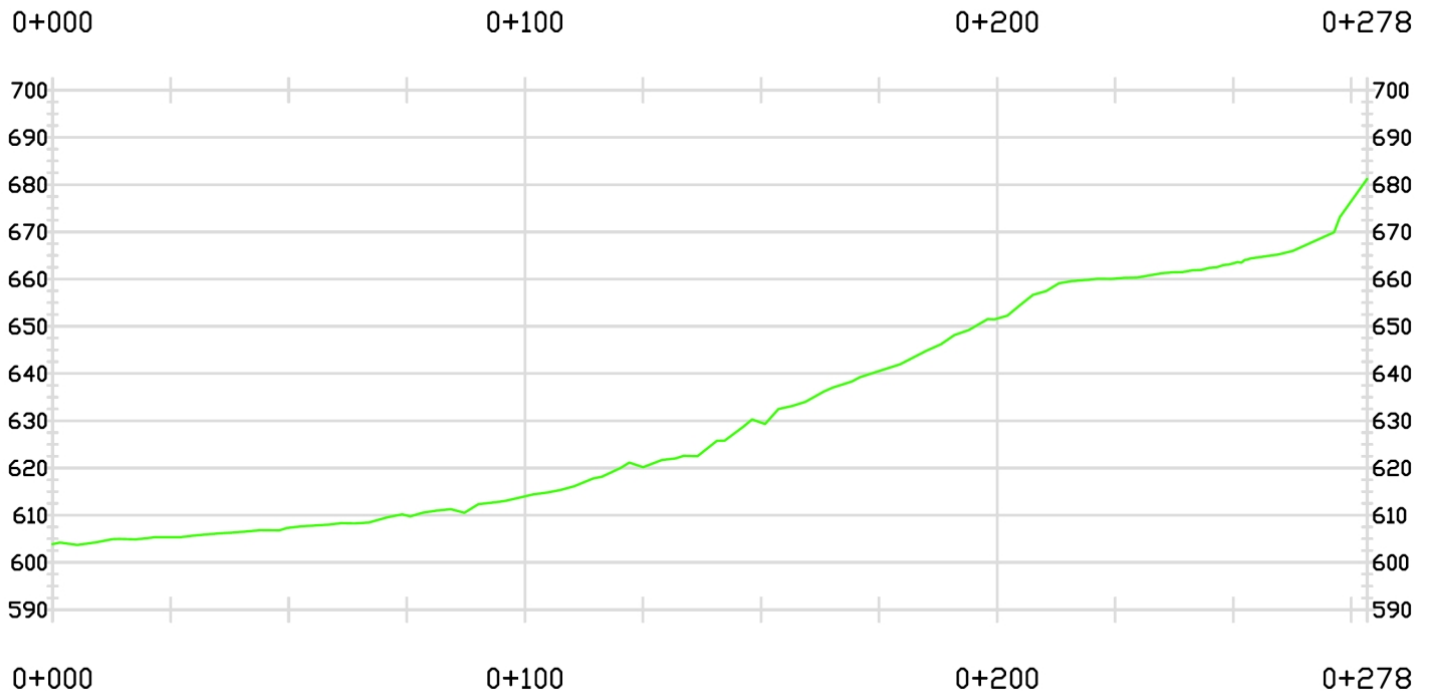
FIGURE 5A

**Cross-section 1 (Figure 5a,b):** This cross-section is located in morainal terrain and experiences low to moderate erosion activity under existing conditions.

Surficial Geology: Moraine  
 Erosion Activity: Low-Moderate  
 Grain Size: coarse sand - fine gravel  
 (re-worked?)

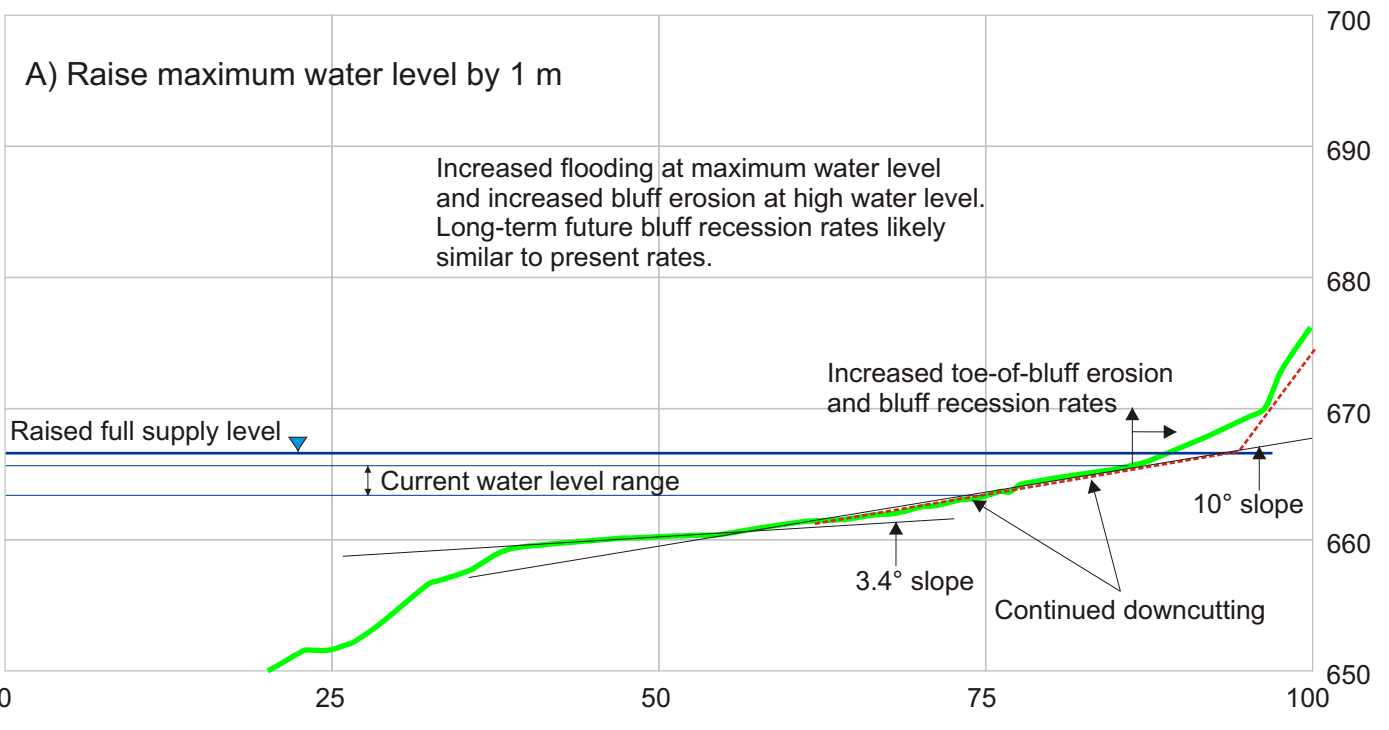
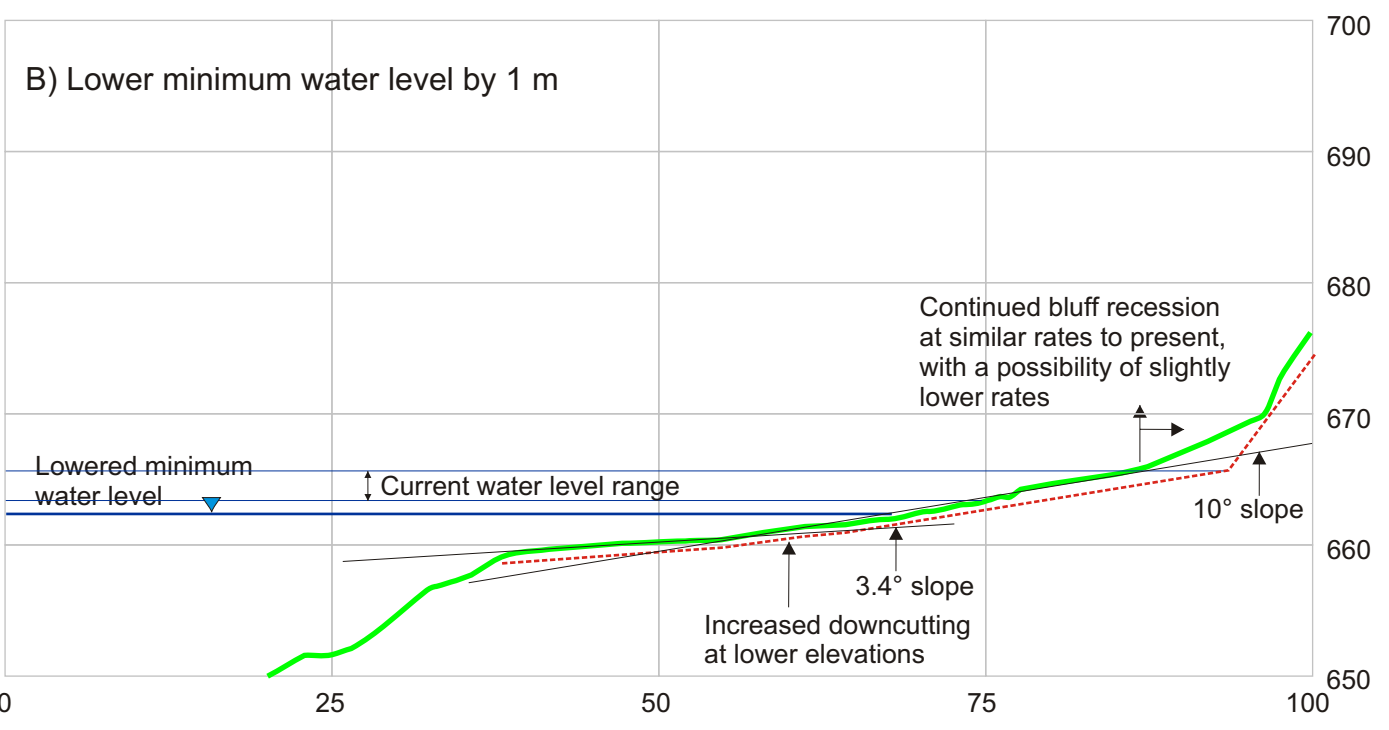
Under an increased full supply level bluff recession at this site is expected to increase due to increased wave action on the steep bluff face. Increased bluff recession rates are expected to eventually return to rates that are similar to existing rates, with a possibility that future rates might be lower than existing rates due to increased wave energy dissipation (due to an increased fluctuation range) in the nearshore. Future bluff recession rates will also depend on the duration of full supply water levels in the future.

Under a lower minimum water level increased downcutting is expected to occur on the lower nearshore slope. Bluff recession rates may decrease initially but increased downcutting will likely result in long term bluff recession rates that are similar to existing rates.

Surficial Geology: Moraine  
 Erosion Activity: Low-Moderate  
 Grain Size: coarse sand - fine gravel  
 (re-worked?)

CROSS-SECTION PROFILE AT SITE XS-1, MAYO LAKE. QUALITATIVE ASSESSMENT OF CHANGES TO EROSION FOR TWO OPERATION SCENARIOS		
J.D. HOLLAND and Associates Limited		NOVEMBER 2008
		<b>FIGURE 5B</b>

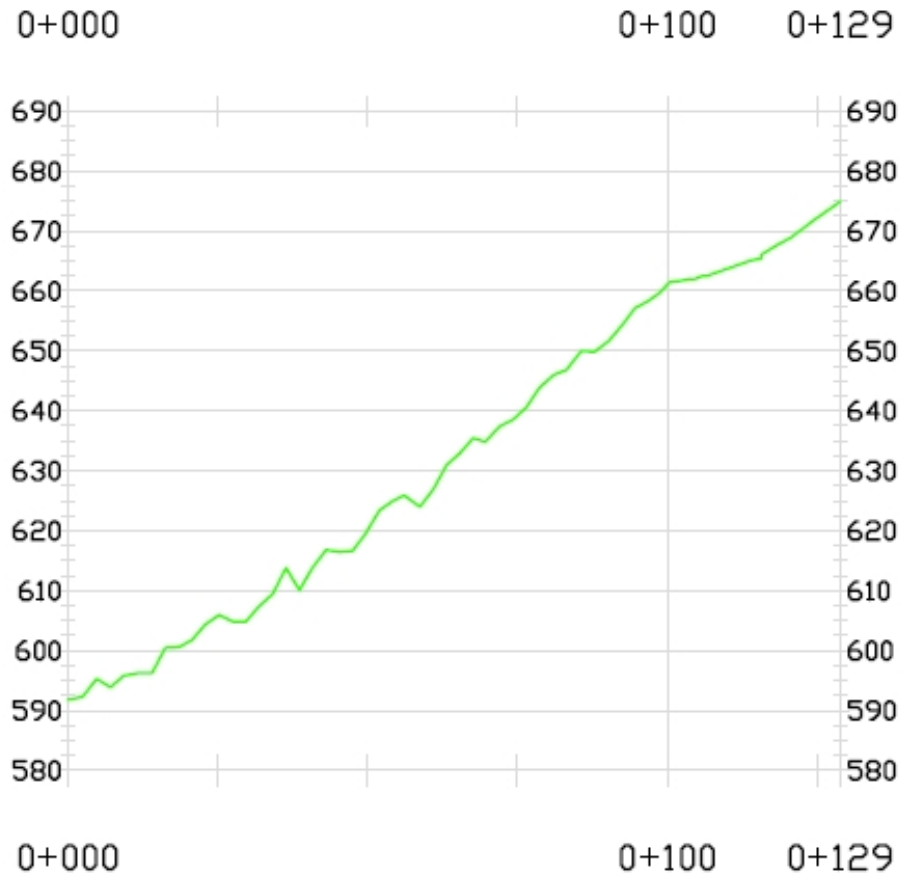
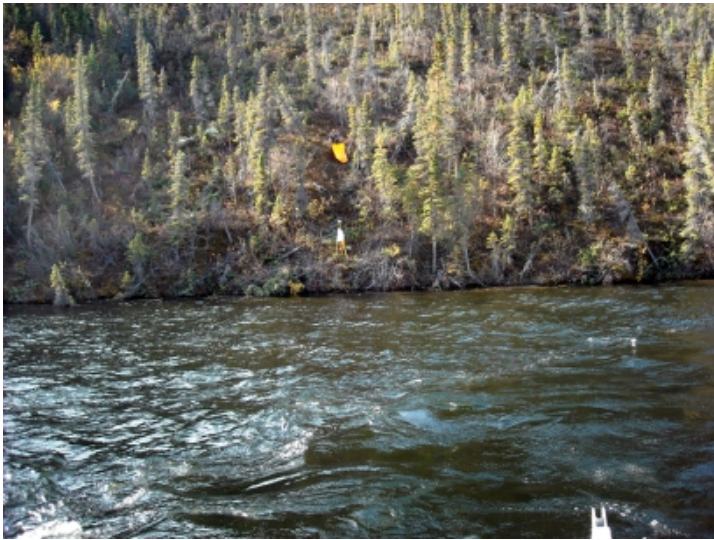
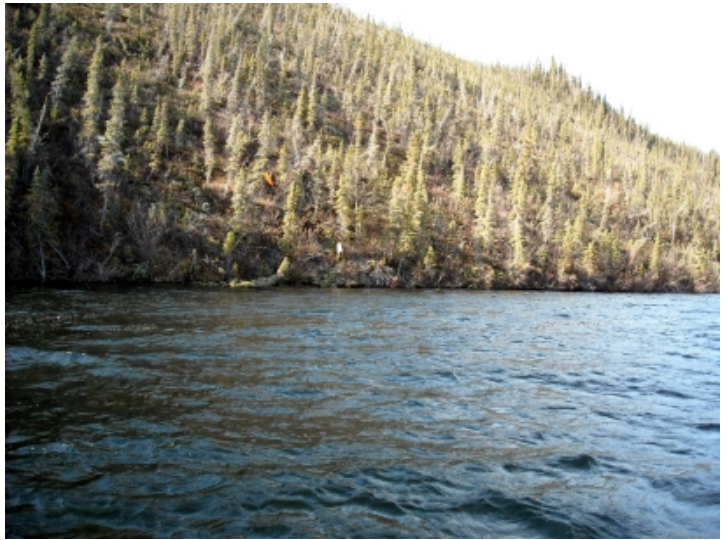
FIGURE 6A

**Cross-section 13 (Figure 6a,b):** This cross-section is located in morainal terrain that experiences low erosion rates under existing conditions.

Surficial Geology: Moraine  
 Erosion Activity: Low  
 Grain Size: clay, organics, rock fragments

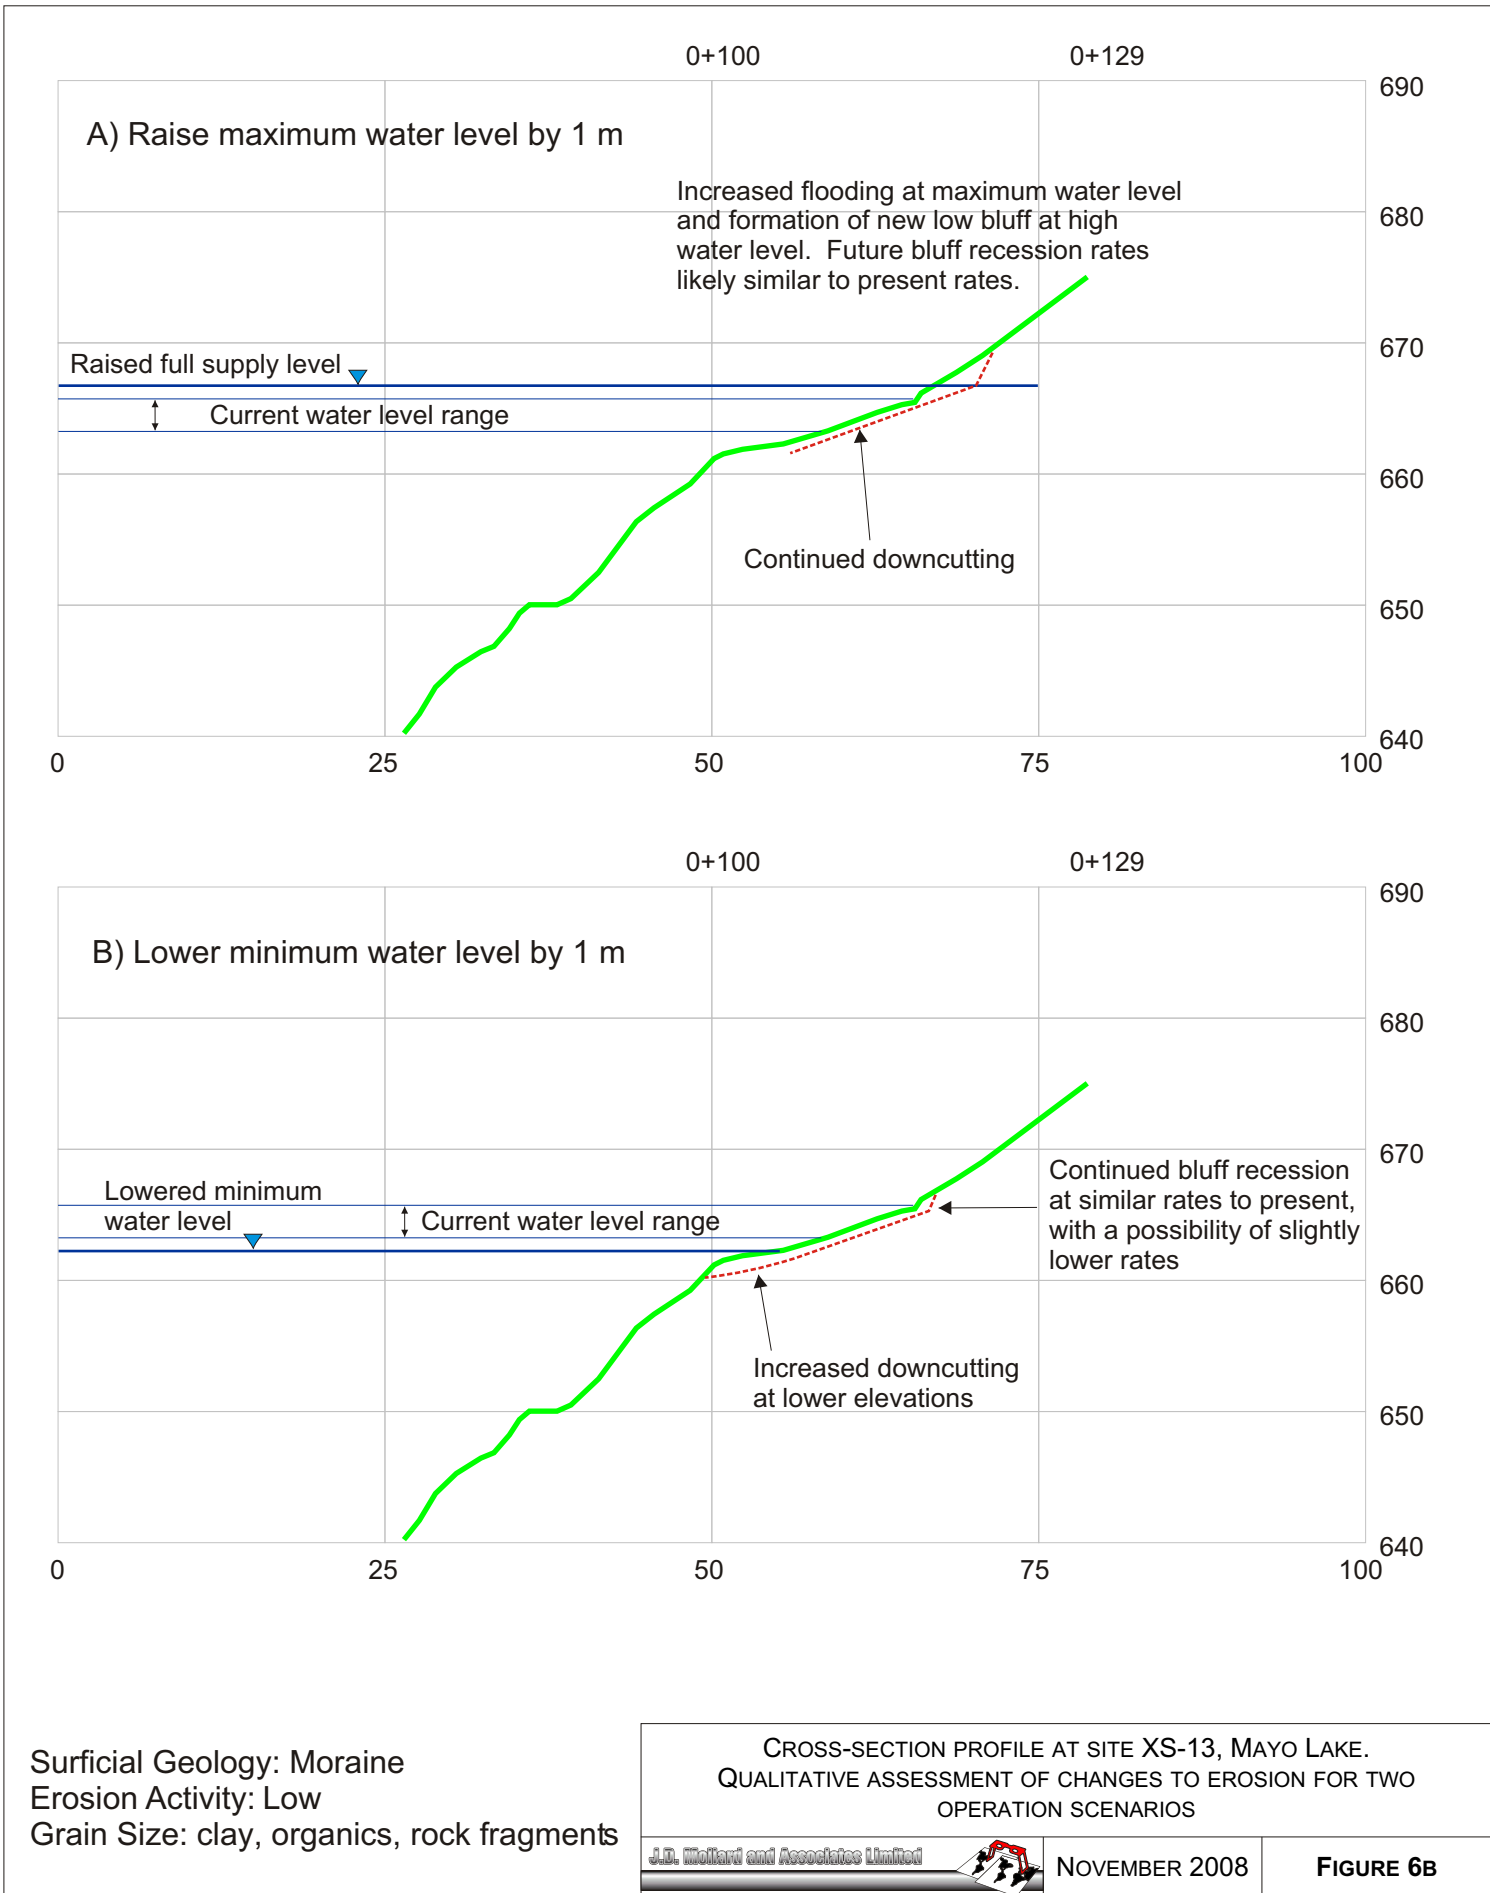
Under an increased full supply level it is expected that a new low bluff will gradually develop about 1m above the current maximum water level. Bluff recession and nearshore downcutting rates are expected to continue to be low.

Under a lower minimum water level increased downcutting is expected to occur on the lower nearshore elevations. Bluff recession rates will likely continue to be similar to existing rates, with a possibility that future rates might be even lower than existing rates due to increased wave energy dissipation (due to an increased fluctuation range) in the nearshore. Future bluff recession rates will also depend on the duration of full supply water levels in the future.

Surficial Geology: Moraine  
 Erosion Activity: Low  
 Grain Size: clay, organics, rock fragments

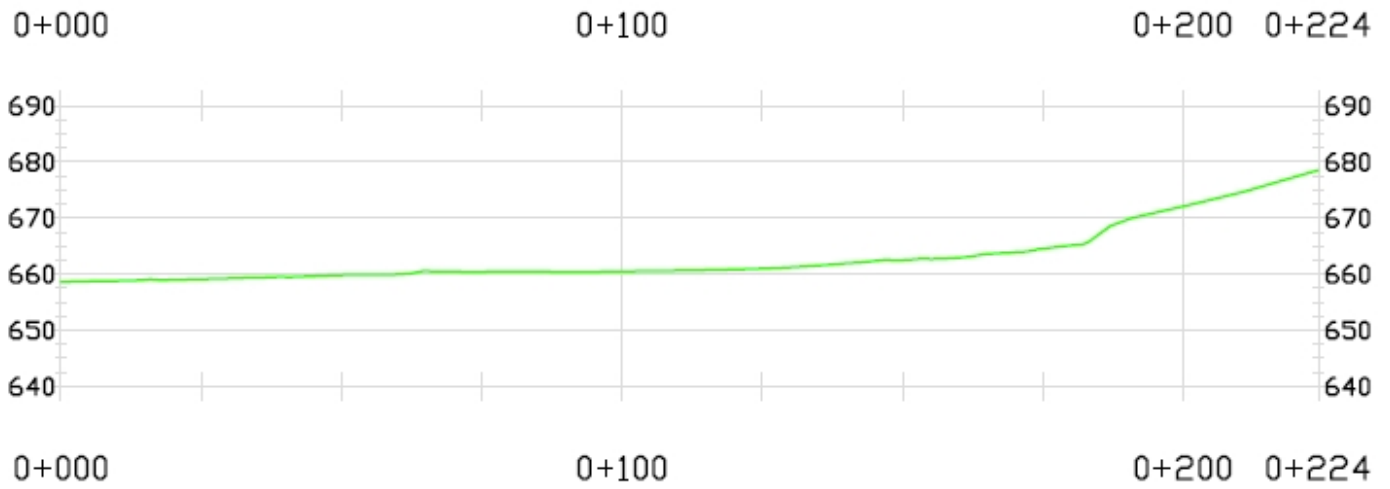
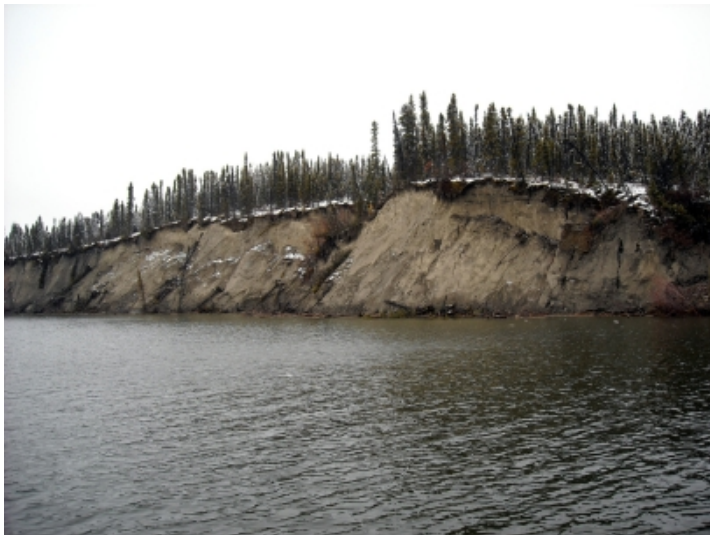
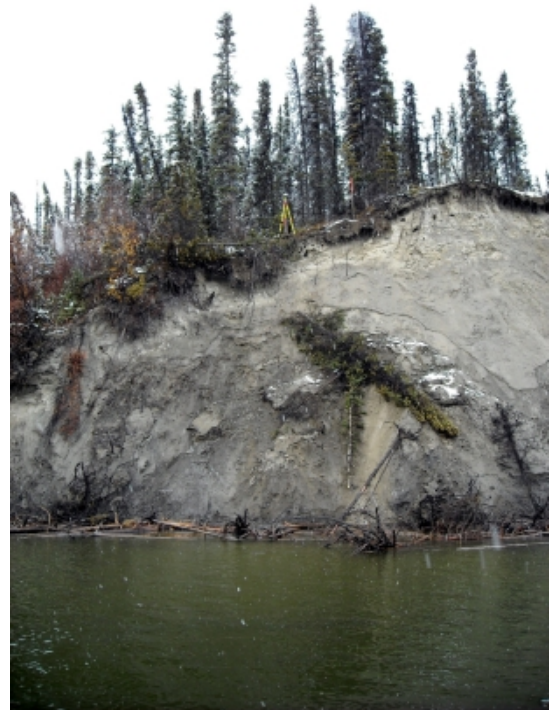
FIGURE 8A

**Cross-section 19 (Figure 7a,b):** This cross-section is located in glaciolacustrine terrain that experiences moderate to high erosion rates under existing conditions.

Surficial Geology: Glaciolacustrine  
Erosion Activity: Moderate-High  
Grain Size: clay, silt, fine sand

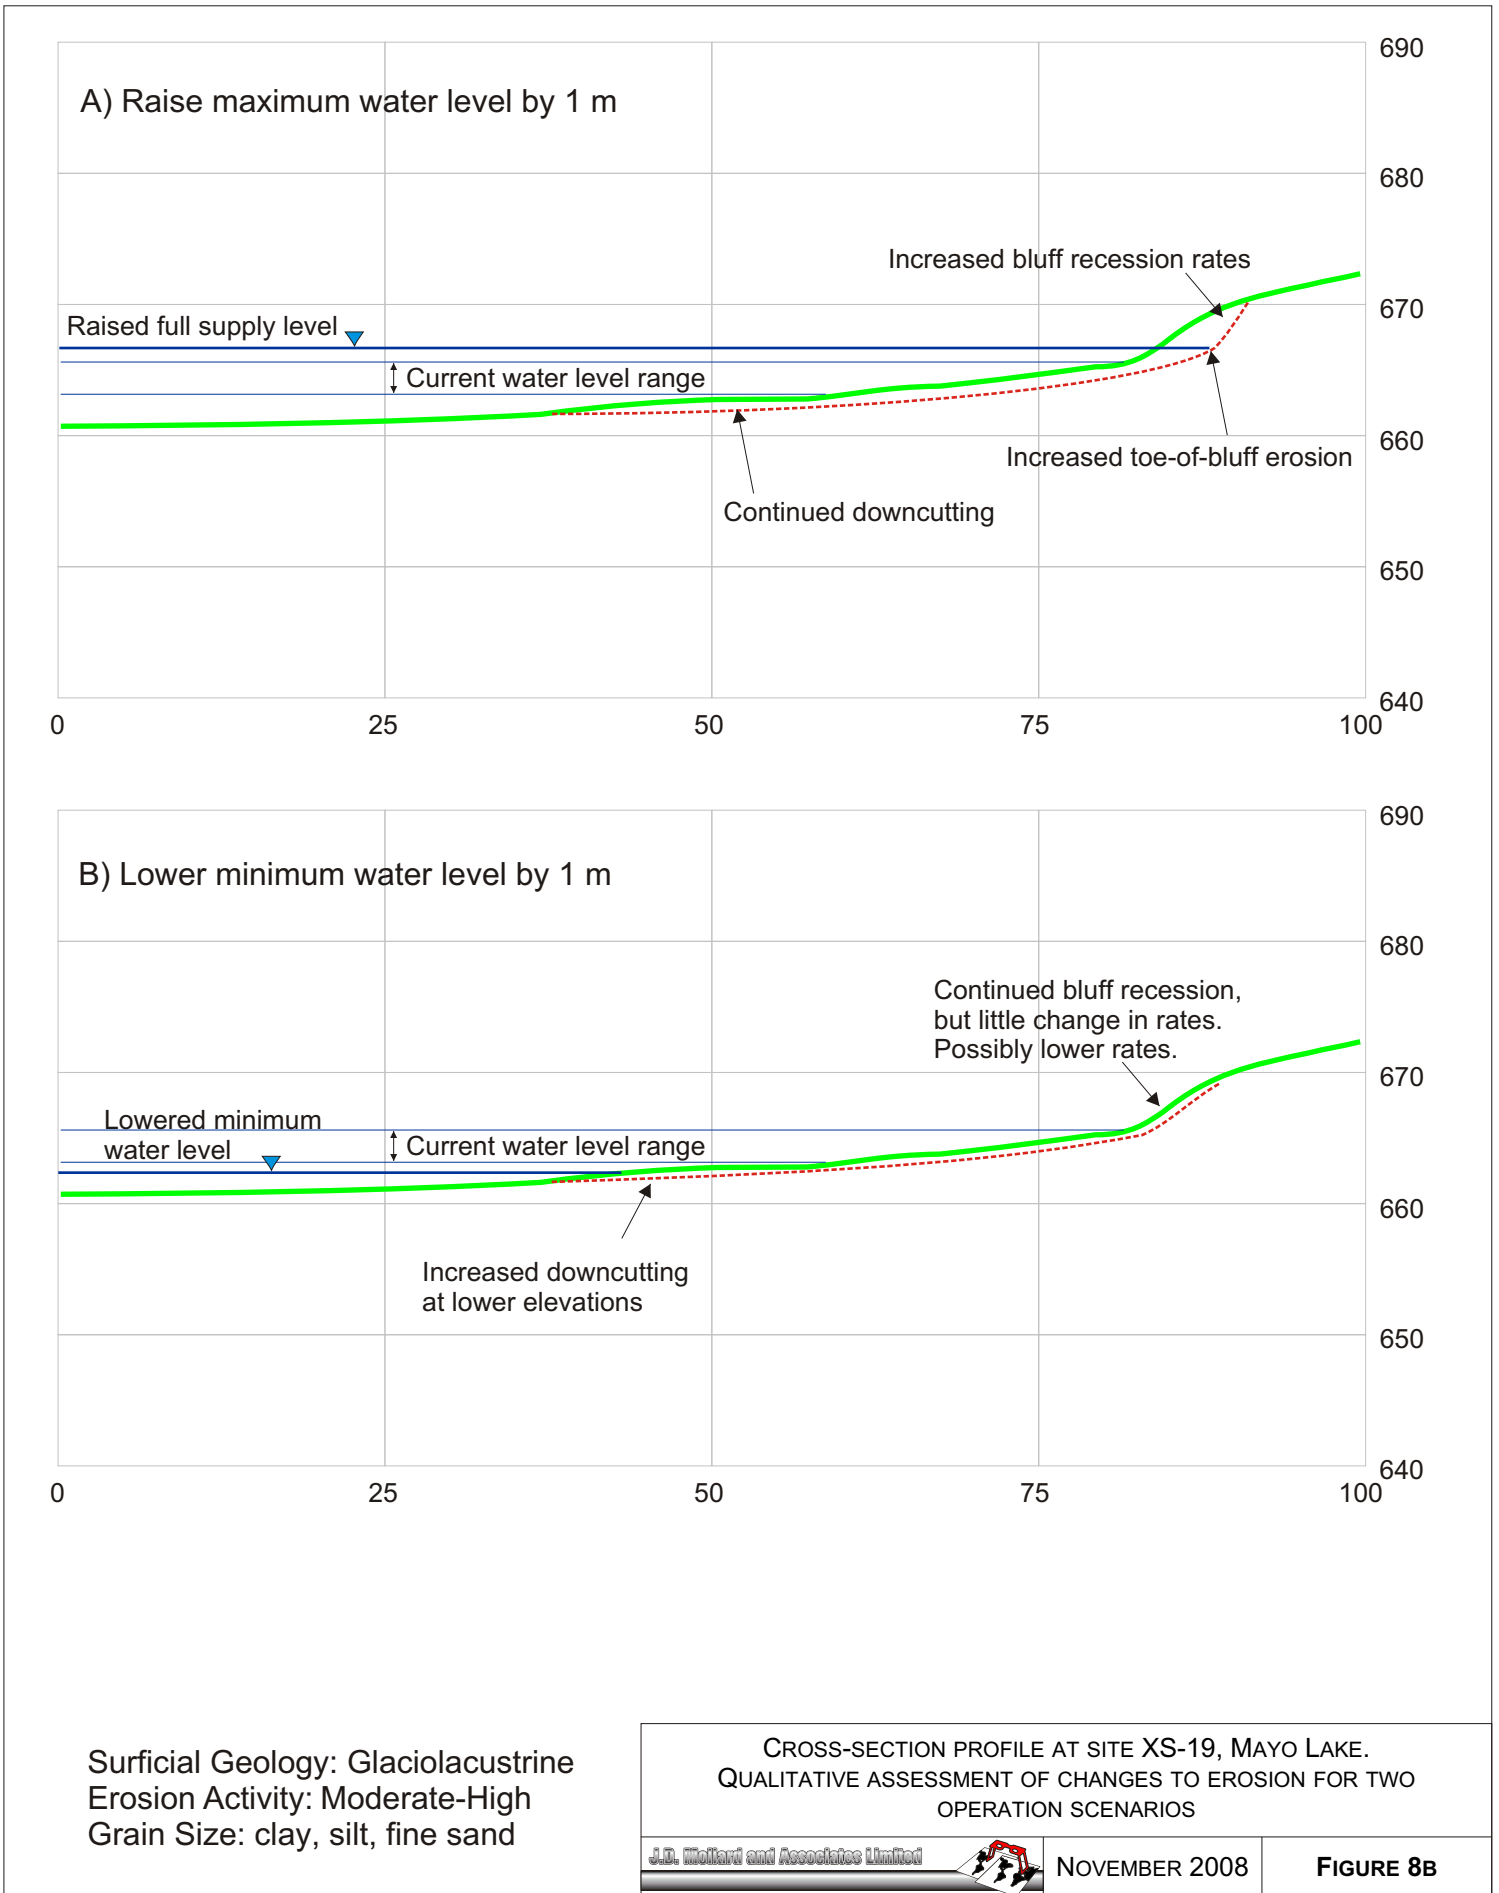
Under an increased full supply level bluff recession at this site is expected to increase due to increased wave action on the steep bluff face. Increased rates are expected to eventually return to rates that are similar to existing rates, with a possibility that future rates might be lower than existing rates due to increased wave energy dissipation (due to an increased fluctuation range) in the nearshore. Future bluff recession rates will also depend on the duration of full supply water levels in the future.

Under a lower minimum water level increased downcutting is expected to occur on the lower nearshore slope. Bluff recession rates may decrease initially but increased downcutting will likely result in continued bluff recession at rates similar to present rates over the long term.

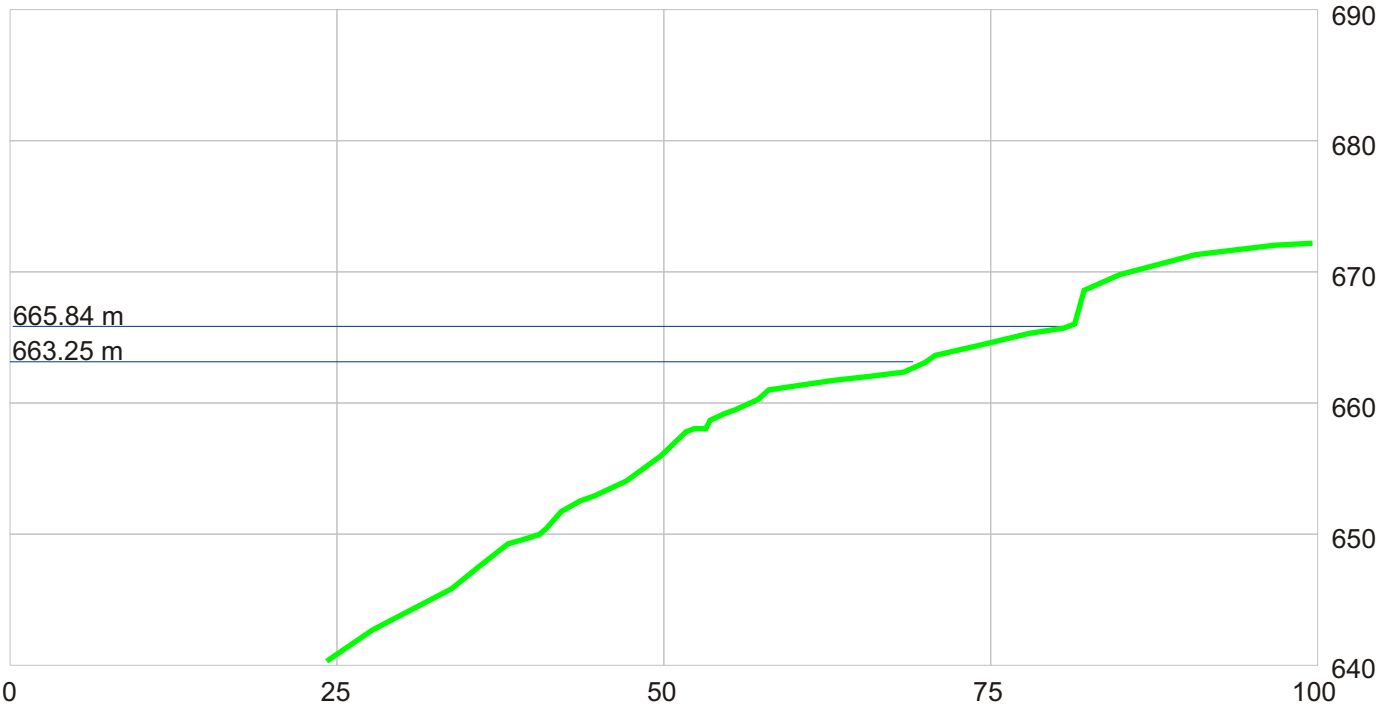
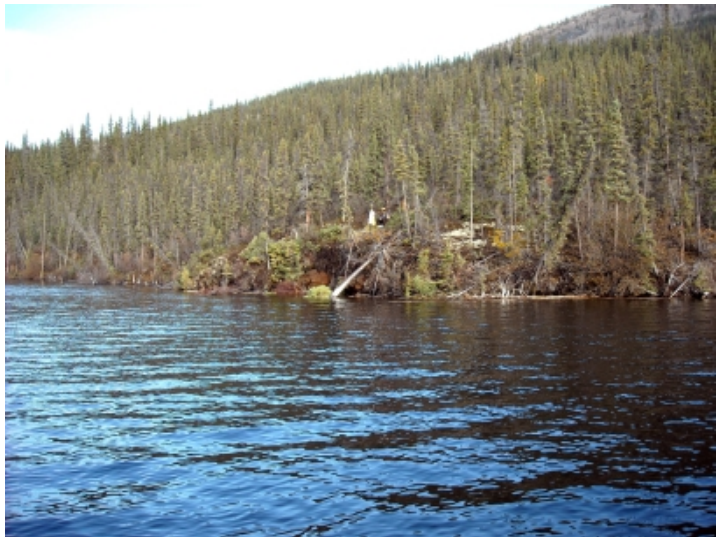
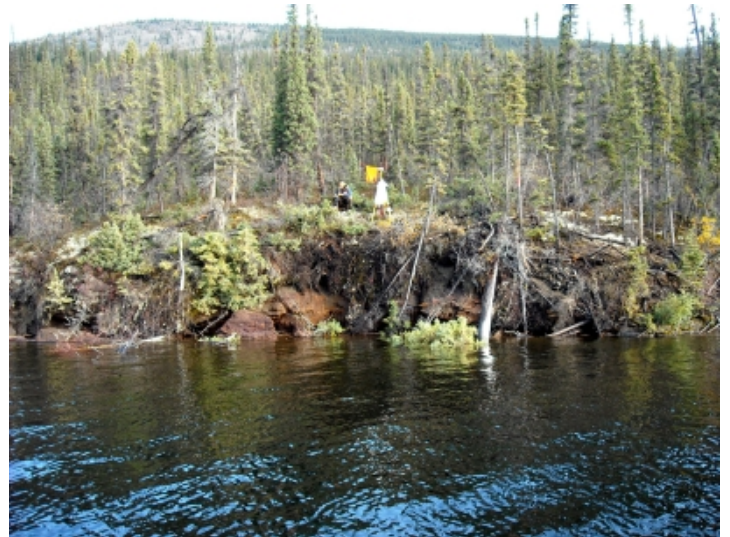
FIGURE A11

Surficial Geology: Colluvium/Bedrock (map) looks like till bluff  
 Erosion Activity: Low-Moderate  
 Grain Size: sand, gravel, clay, till blocks (reworked?)

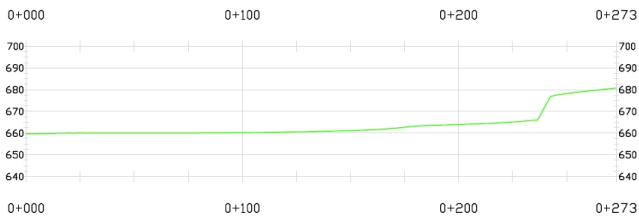
FIGURE A22

Surficial Geology: Glaciolacustrine  
 Erosion Activity: Moderate-High  
 Grain Size: clay, silt  
 (excess water - permafrost?)
