MERG Report 2004-3

# Reconnaissance Survey of Erosion Site At Gold Run Creek

By Laberge Environmental Services

March 2004

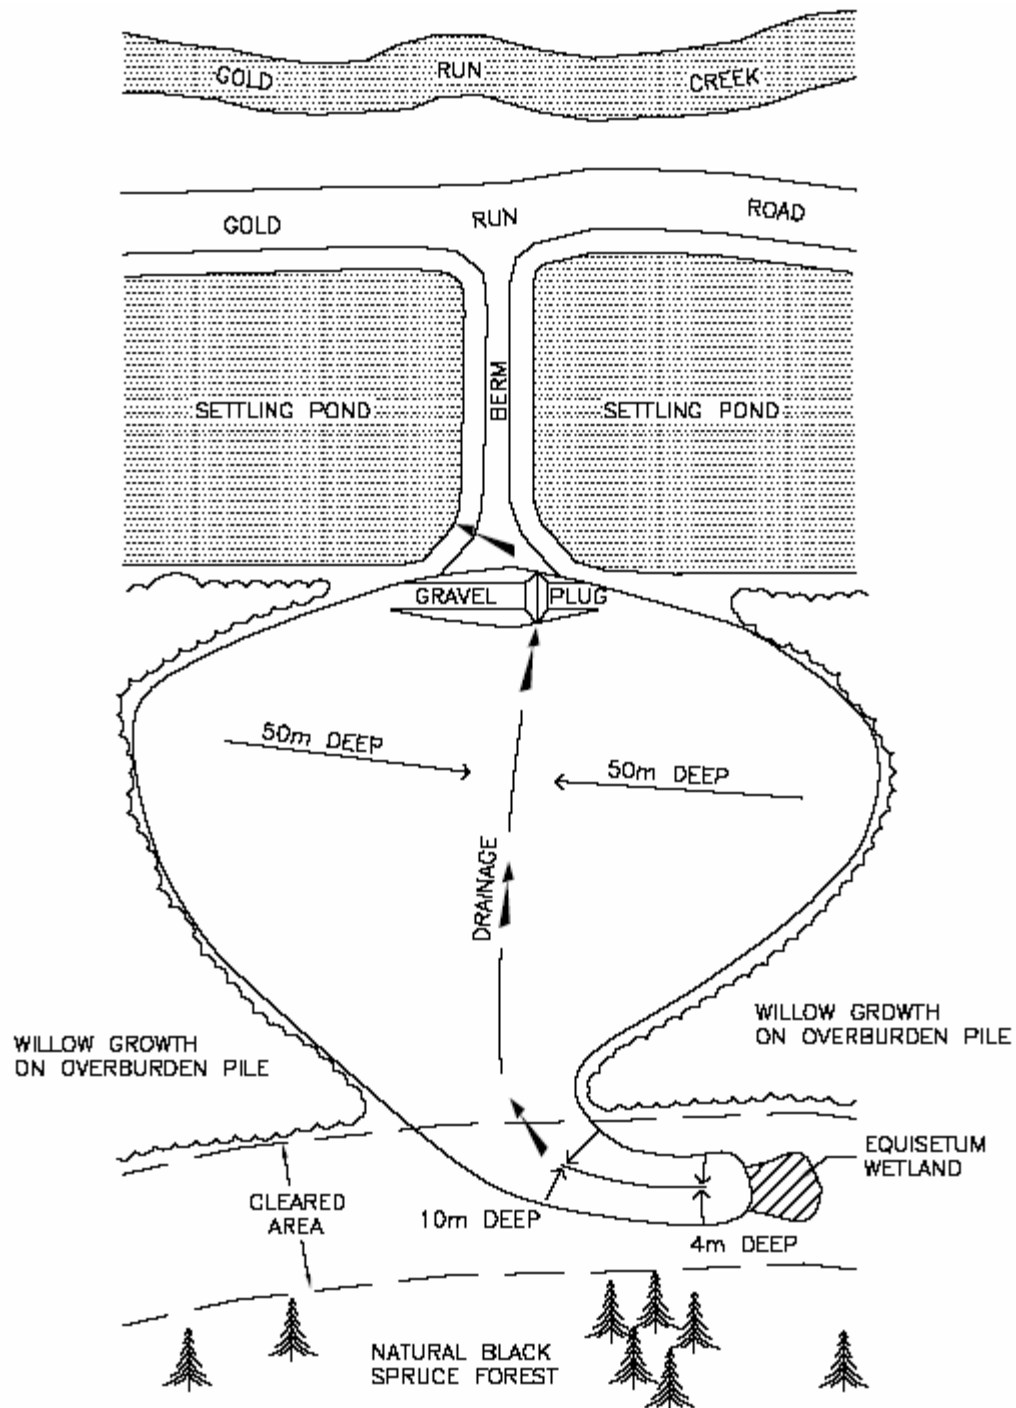
Figure 1 – Slope Failure Near Gold Run Creek  
(Not To Scale)

It is unclear just when the slope failure first occurred. By July 2003, soil had slumped back to a point about 300 metres from the creek bank (see Figure 1). The width of the slumped-in area ranged from about 4 metres at its apex to about 60 metres at its centre. The maximum depth was estimated to be about 50 metres. The walls of the gully were nearly vertical in places.

Vertical cracks in the soil about one metre deep had formed up to 20 metres back from the sidewalls at various locations, indicating the instability of the thawed overburden. The depth to frost in mid-July ranged from 20 cm near the apex of the slope failure to about one metre at the top of the overburden stockpile. Water was discharging from the base of the erosion cut at a rate of about 0.1 litres / second. Photographs of the site are presented in Appendix A.

The side-slopes of this cut are very steep and should be recontoured prior to the installation of any bank stabilization systems. This could either be done by hand labour or with the use of heavy equipment. Late summer/early fall, when the ground has thawed to its maximum depth, would be the best time of year for doing this work.

A combination of standard bioengineering techniques could be used for restoring slope stability at this site. These could include well-tried methods such as contour wattling, brush layering and live staking. A good supply of plant material is available. The overburden stockpile, with its dense growth of willows, would be a handy donor site. The existing slumping soils should be a good growth medium. A light seeding of locally occurring grasses and forbs would also be beneficial.

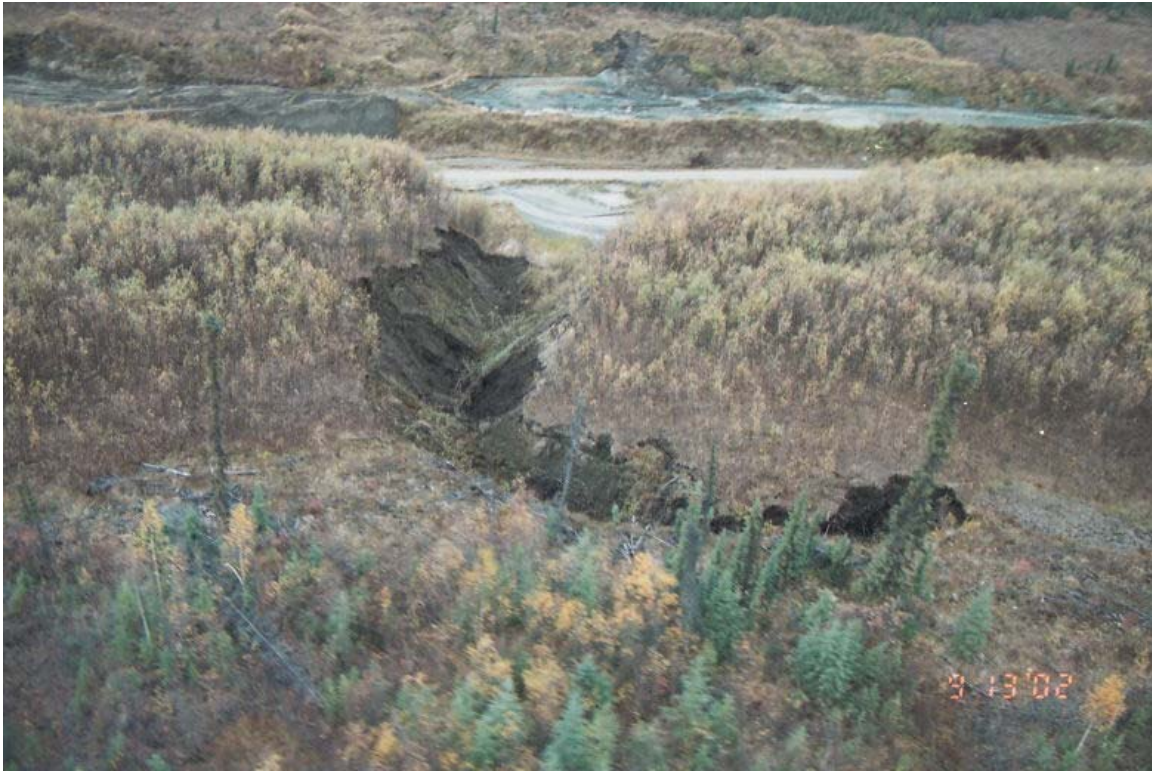
Aerial view of slope failure at Gold Run Creek photographed by Dawson Client Services, September 13, 2002.

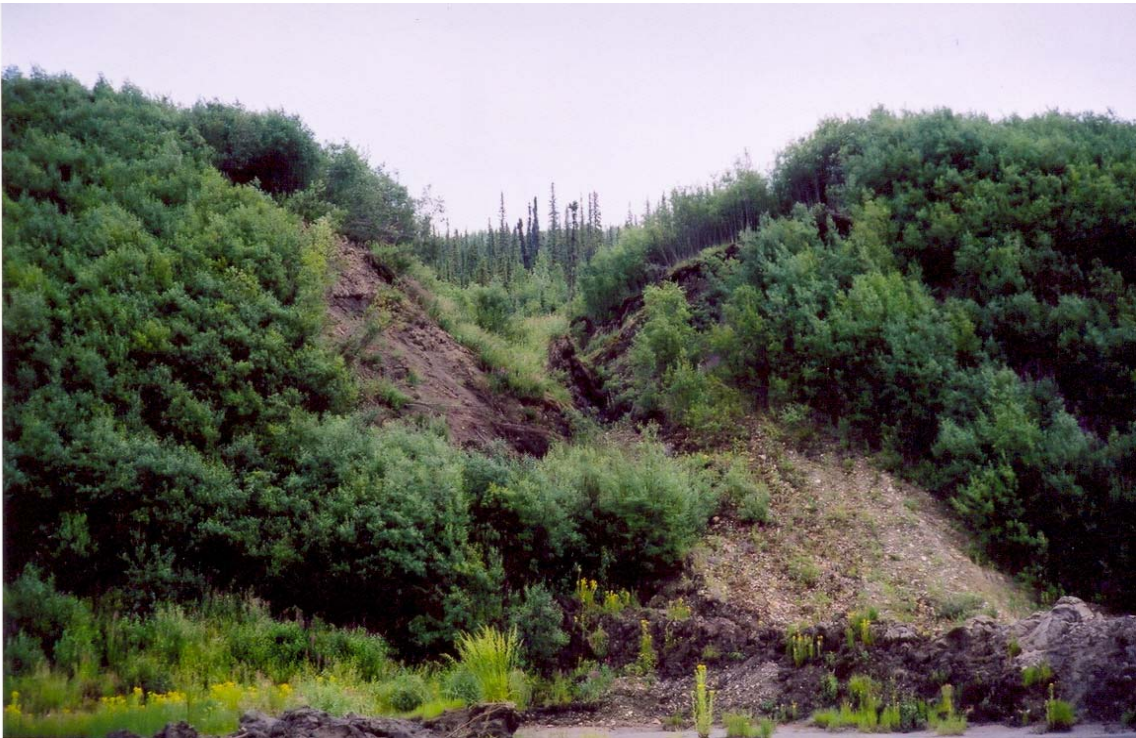
View of the slope failure from Gold Run Road. Note the gravel plug. July 14, 2003.

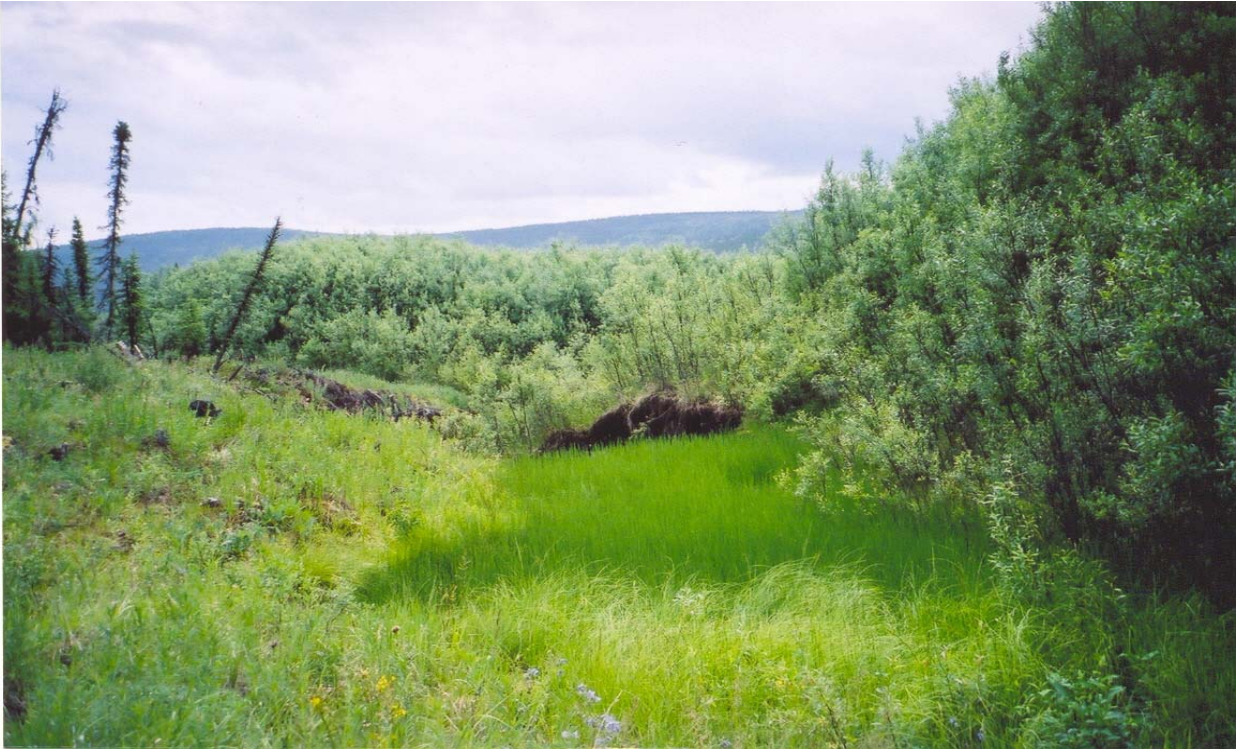
The small stand of water horsetail (*Equisetum fluviatile*) located at the apex of the slope failure, July 14, 2003.

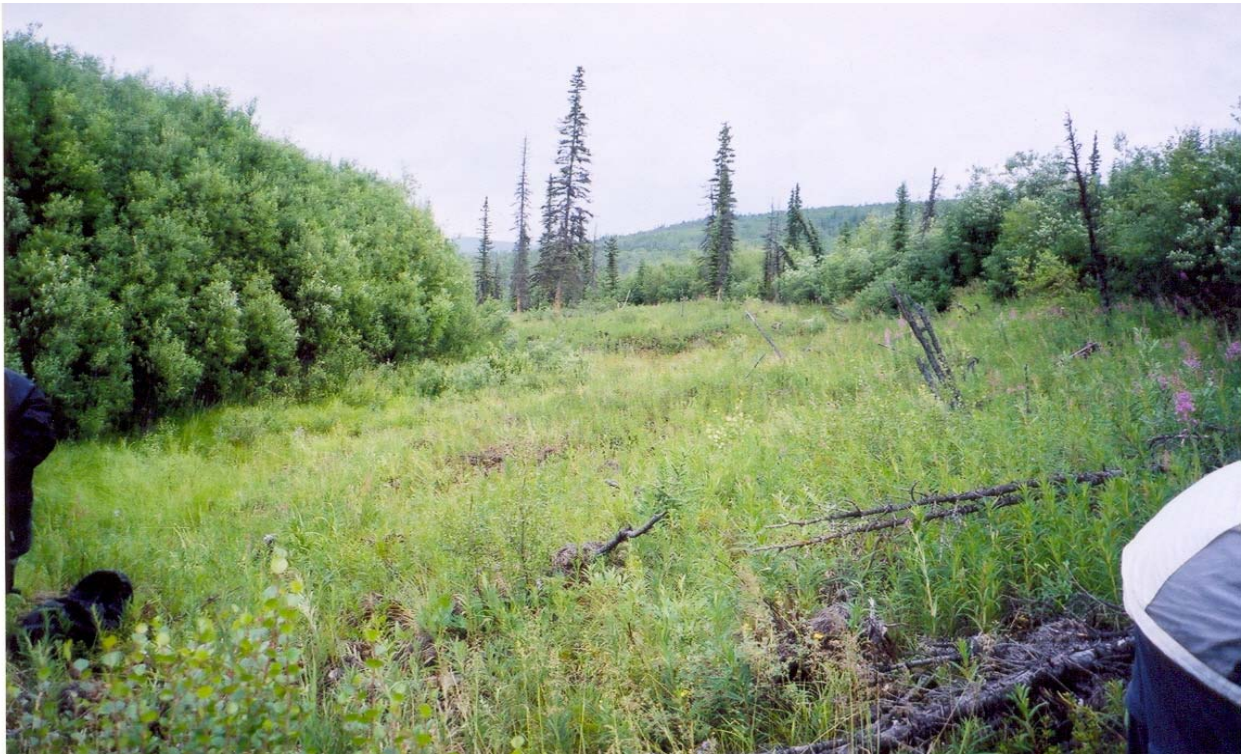
The cleared area looking north from the wetland. The re-vegetated overburden pile is on the left, the undisturbed black spruce forest is on the right. July 14, 2003.

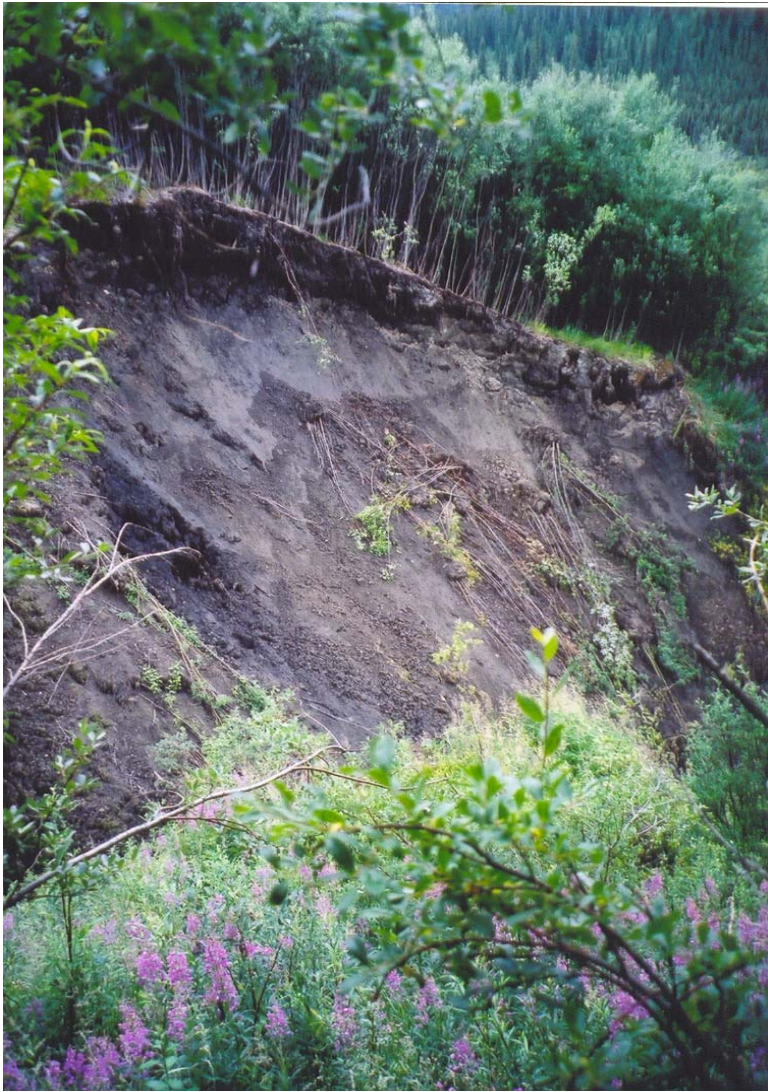
The actively eroding north-west facing wall of the slope failure, July 14, 2003.

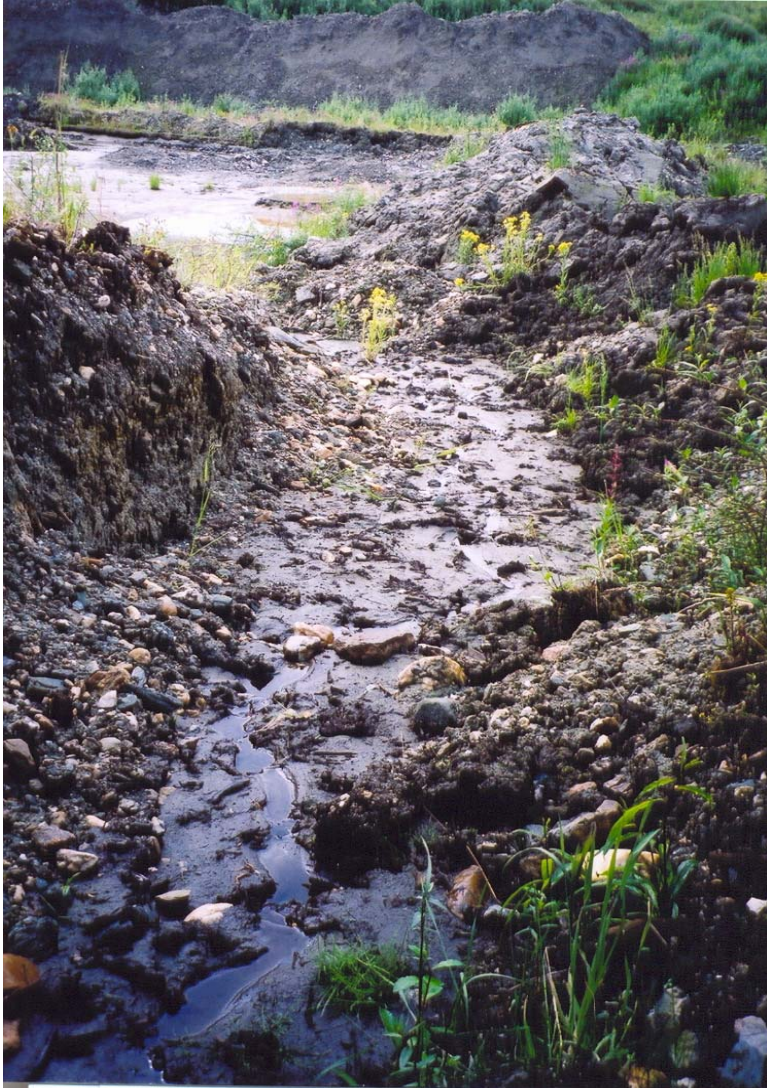
Drainage (melting permafrost) flows to Gold Run Creek via settling ponds from the base of the cut, July 14, 2003.
