MERG Report 2005-2

Upgrades to the Bioengineering Installations at Noname Creek 2003/2004

**Upgrades to the Bioengineering
Installations at Noname Creek
2003 / 2004**

**Submitted By
LABERGE ENVIRONMENTAL SERVICES
February, 2005**

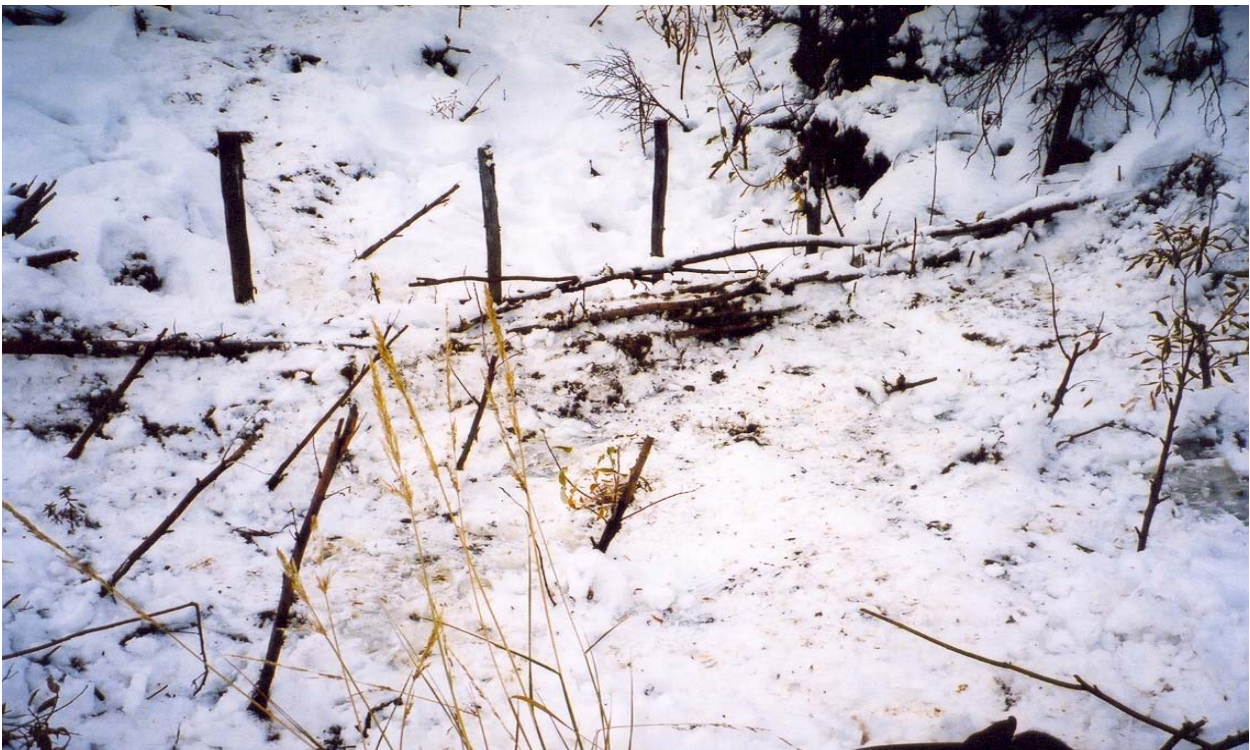
PLATE # 2: First gully break prior to upgrades. September 24, 2004.

Attempts were made to rehabilitate the first gully break. A small trench was hand dug upstream of the break and biodegradable geotextile (coconut fiber mat) was laid over the upstream side of the gully break including the breached channel. The geotextile was held in place with live willow cuttings and backfilled. This upgrading work had to be discontinued as the ground was too frozen to be workable with hand tools. The week before and the week of the fieldwork were unseasonably cold resulting in snow cover and frost penetration of approximately one foot. This slowed down the progress of the physical work considerably (which was all manual labour) that was necessary in order to construct the remediation structures. Ideally, several more gully breaks were to be fortified with the biodegradable geotextile. Backfilling was also hampered as the excavated material consisted of frozen clumps of earth that resisted compaction around the pole drains and the gully break. Remediation work was suspended until May 2004.

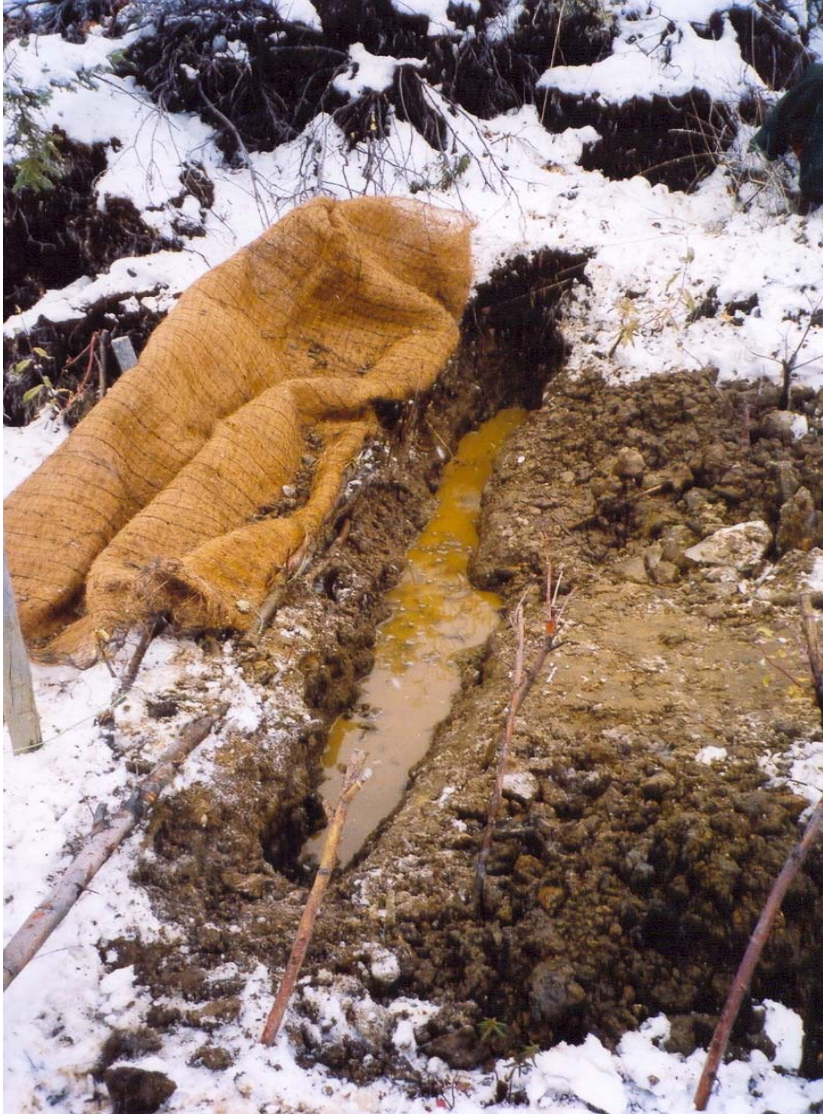
PLATE #3: First gully break under construction, Sept. 24/03.

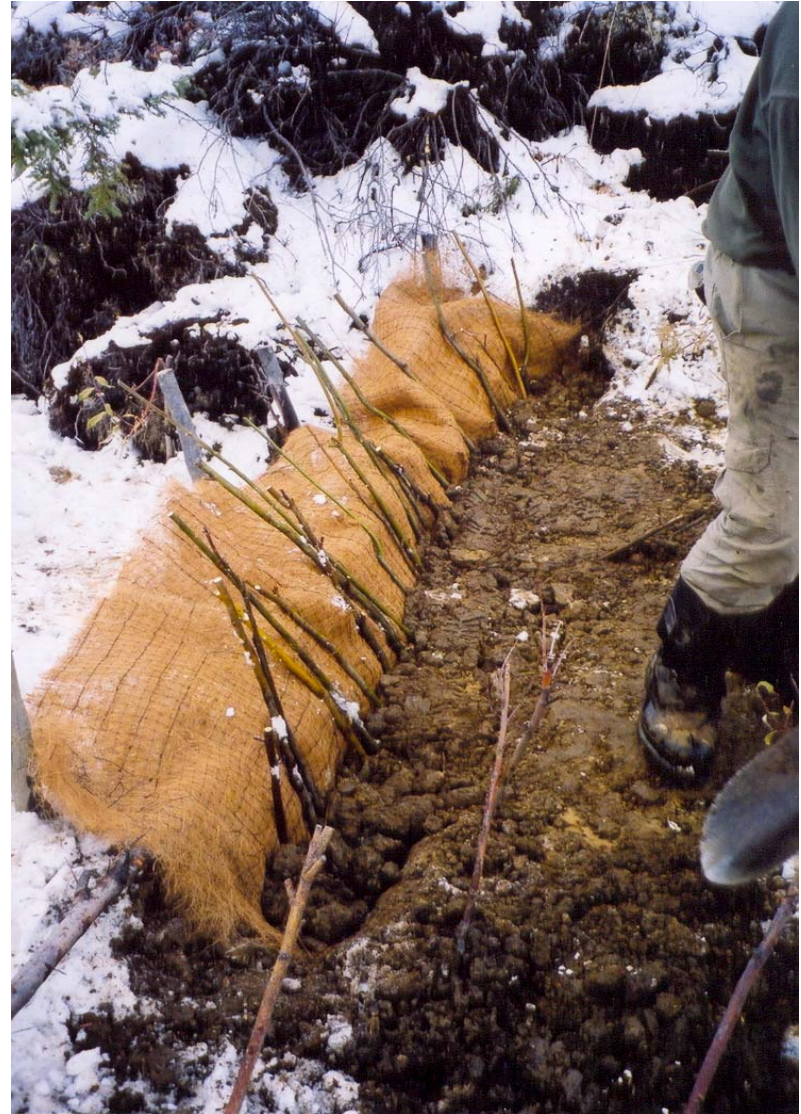
PLATE #4: First gully break repairs completed, Sept. 24/03

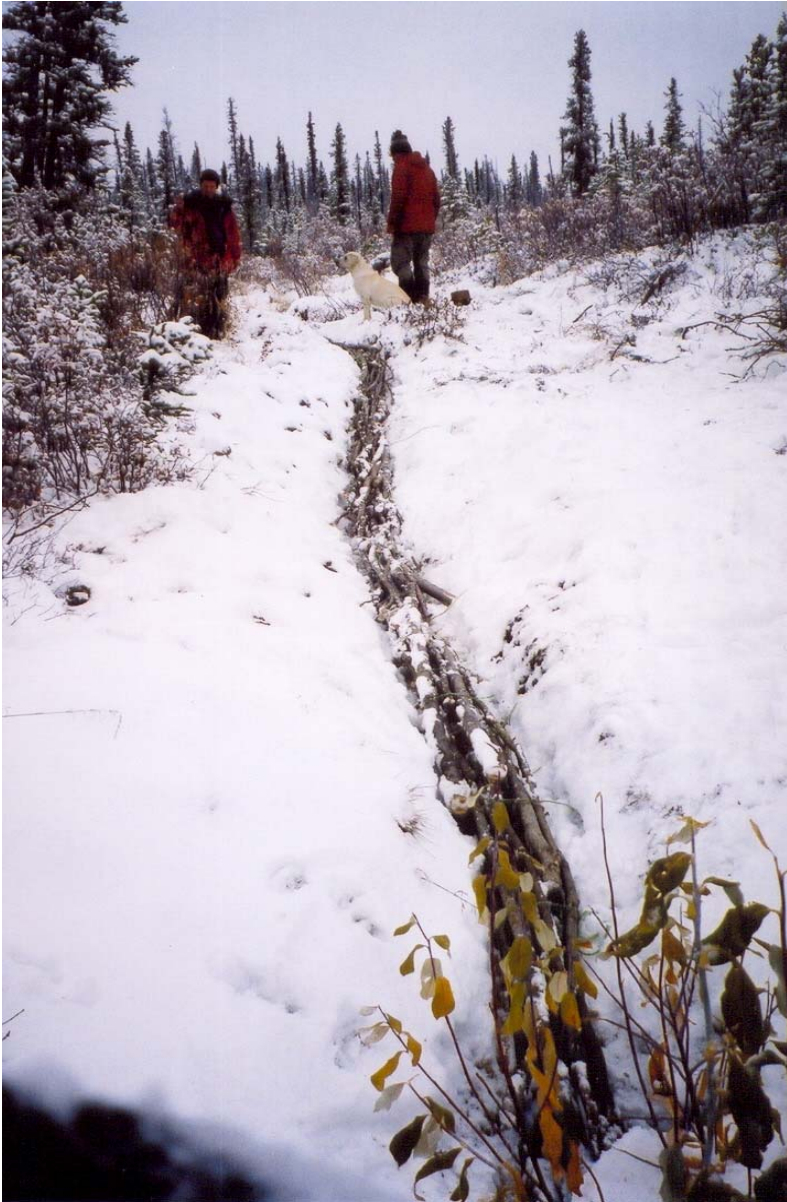
PLATE #5: Installing new pole drain into frozen trench.

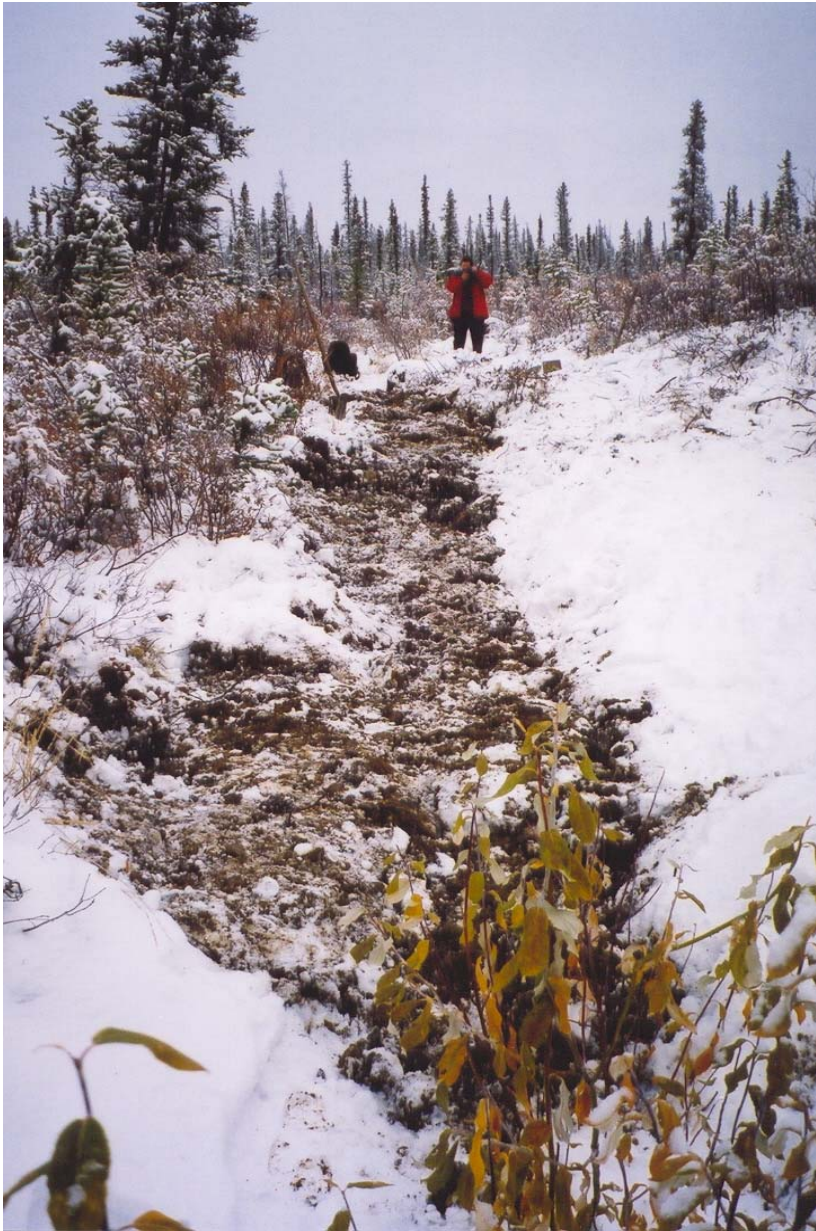
PLATE #6: Backfilling pole drain with frozen material.

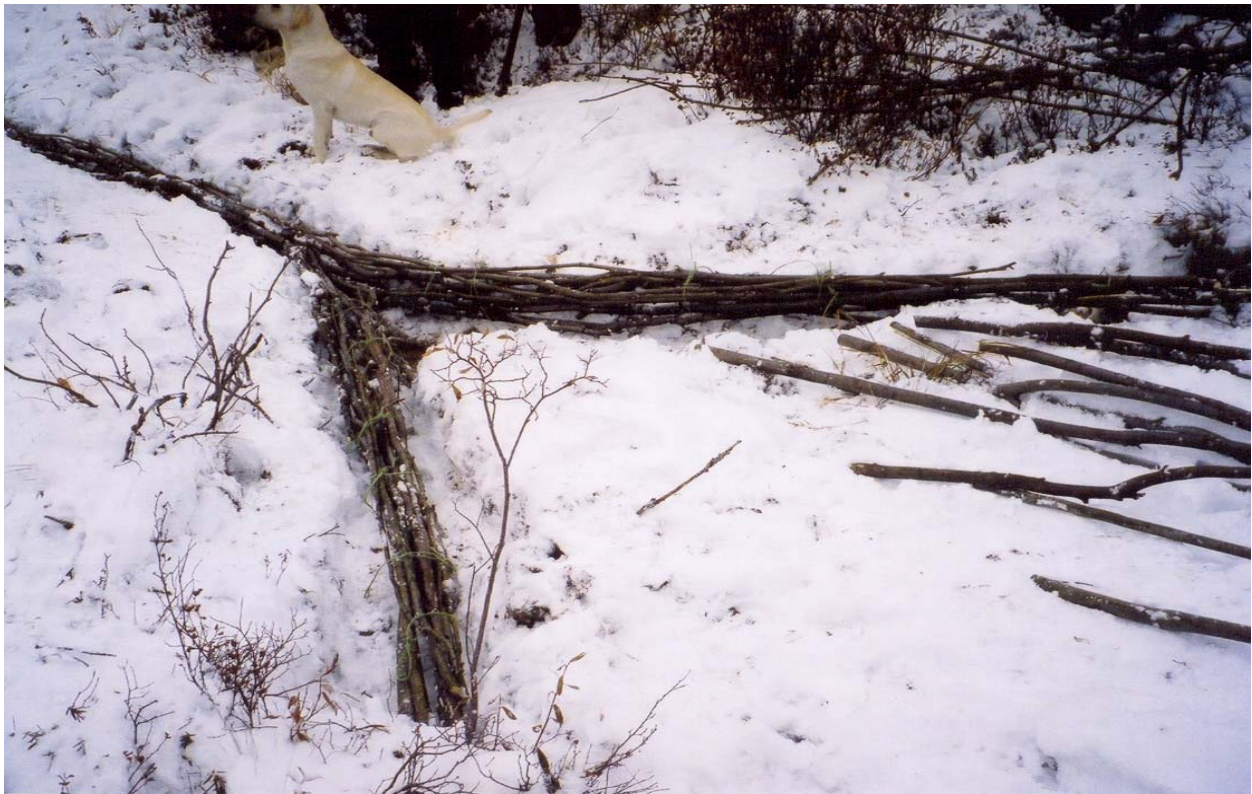
PLATE #7: "Y" pole drain at top of new pole drain, September 24, 2003.

An extension was constructed to the upper pole drain, creating approximately 70 meters of continuous live pole drain. The pole drain was branched at the upper end to help capture potentially separate seepages. A short span of the lower pole drain was covered with a single layer of biodegradable geotextile prior to backfilling, to determine if this would aid in controlling erosion along the sides. The geotextile material is of a loose enough weave that sprouting plants should have no problem penetrating it. Backfilling of the erosion cuts around the drain was also completed.

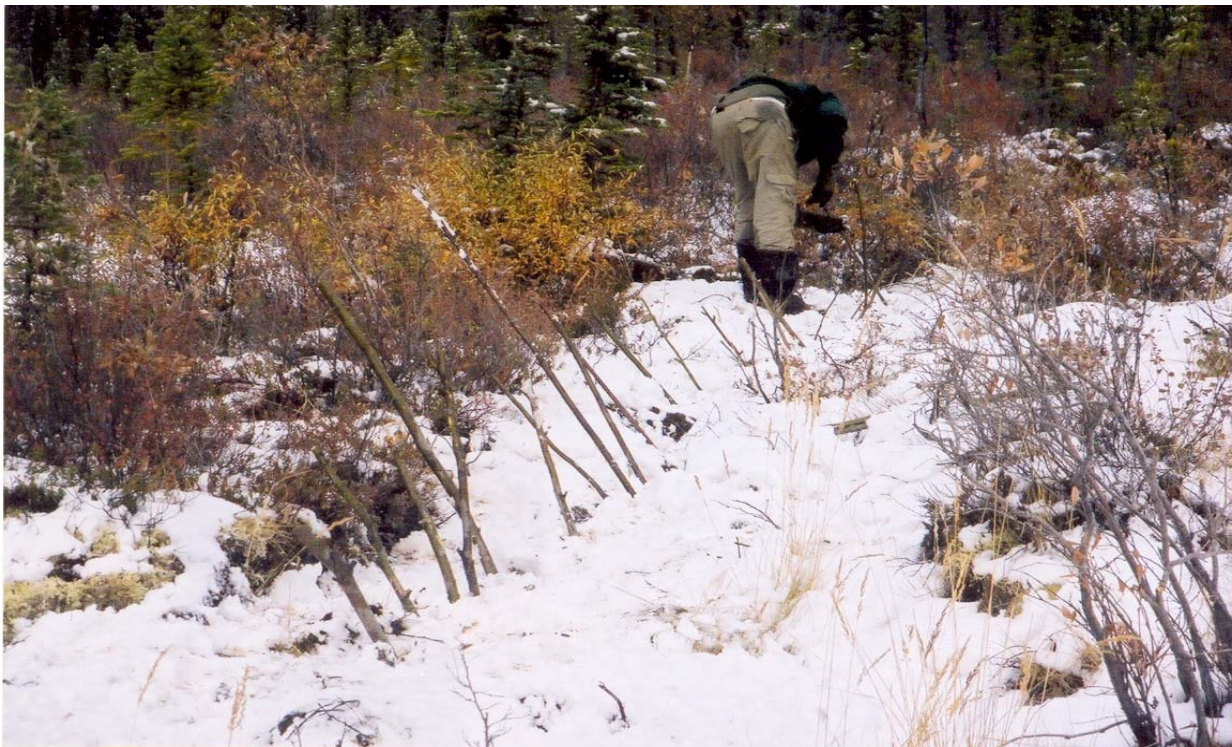
PLATE #8: Live staking up slope of "Y" pole drain, September 24, 2003.

Live willow cuttings were randomly staked along both sides of the drain. Live cuttings were also staked in the areas between the gully breaks.

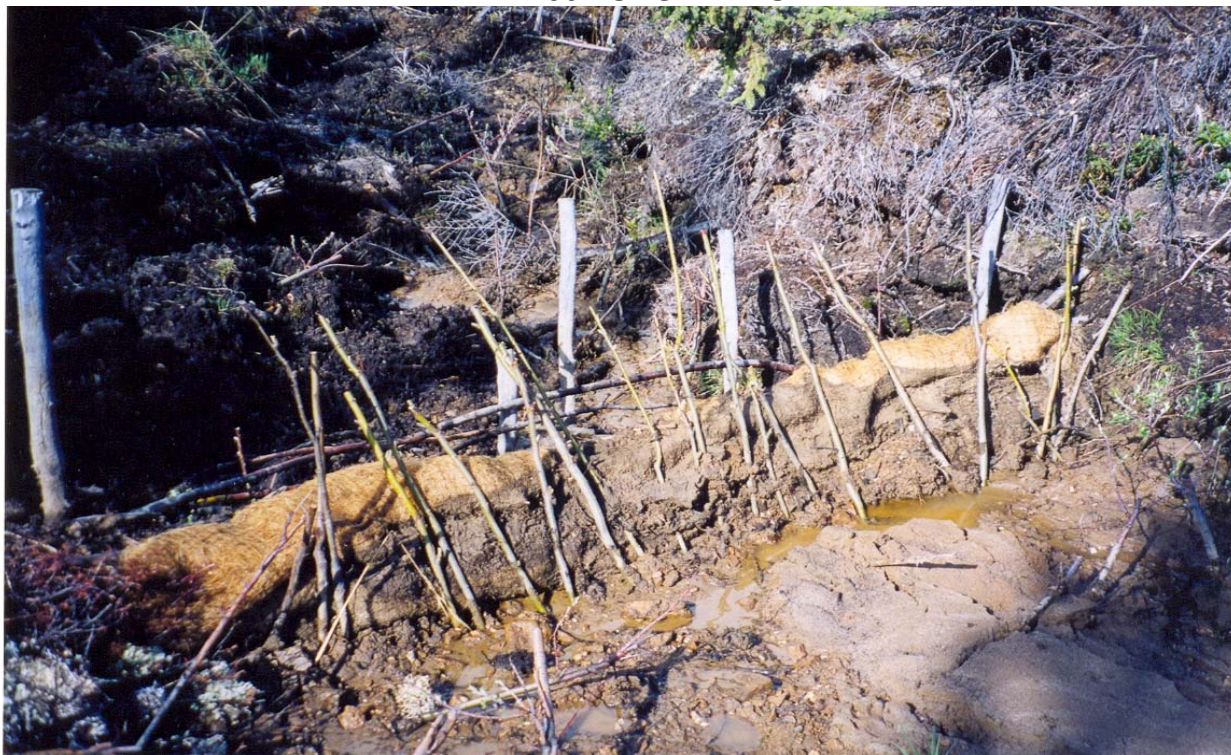
The upgrades made to the first gully break in September 2003 appear to be successful as no erosion has occurred. Sediment has been trapped upstream of the gully break.

PLATE #9: Gully break #1 repaired in Sept '03 has not breached and has trapped sediment. Note mud layer on geotextile indicating where water level had been earlier in May 2004.

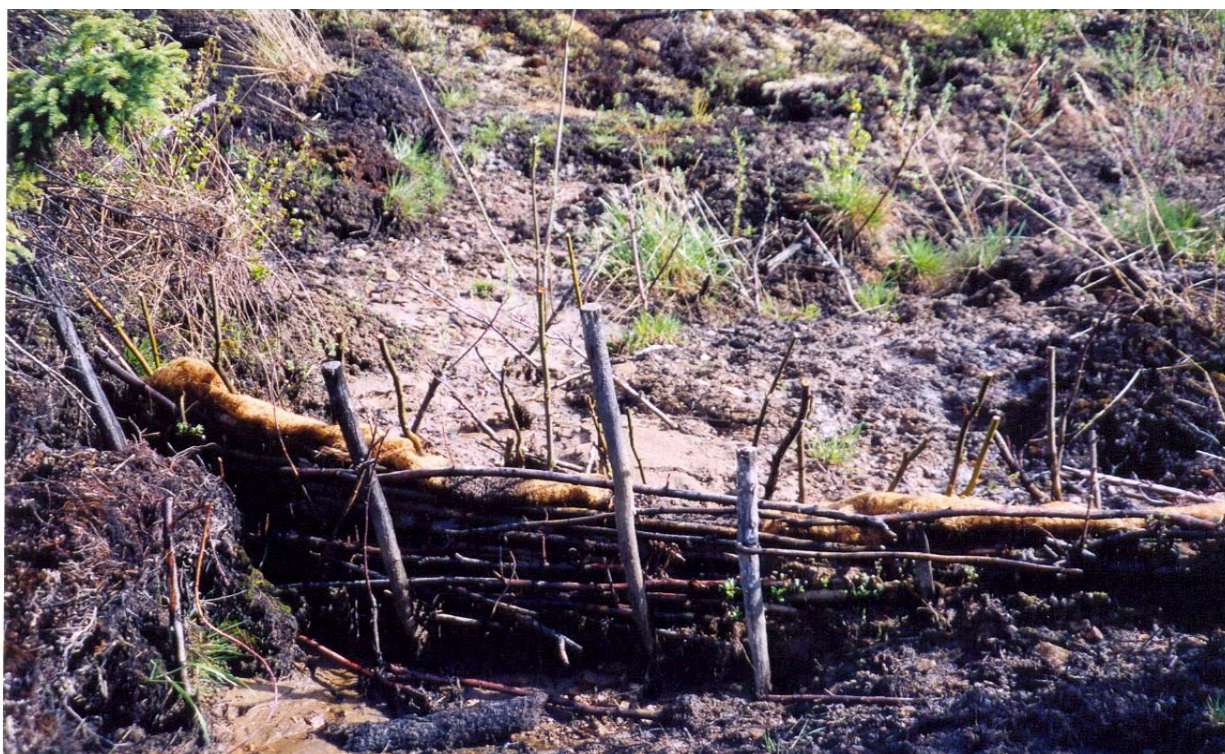
PLATE # 10: Downstream side of gully break #1, May 27, 2004.

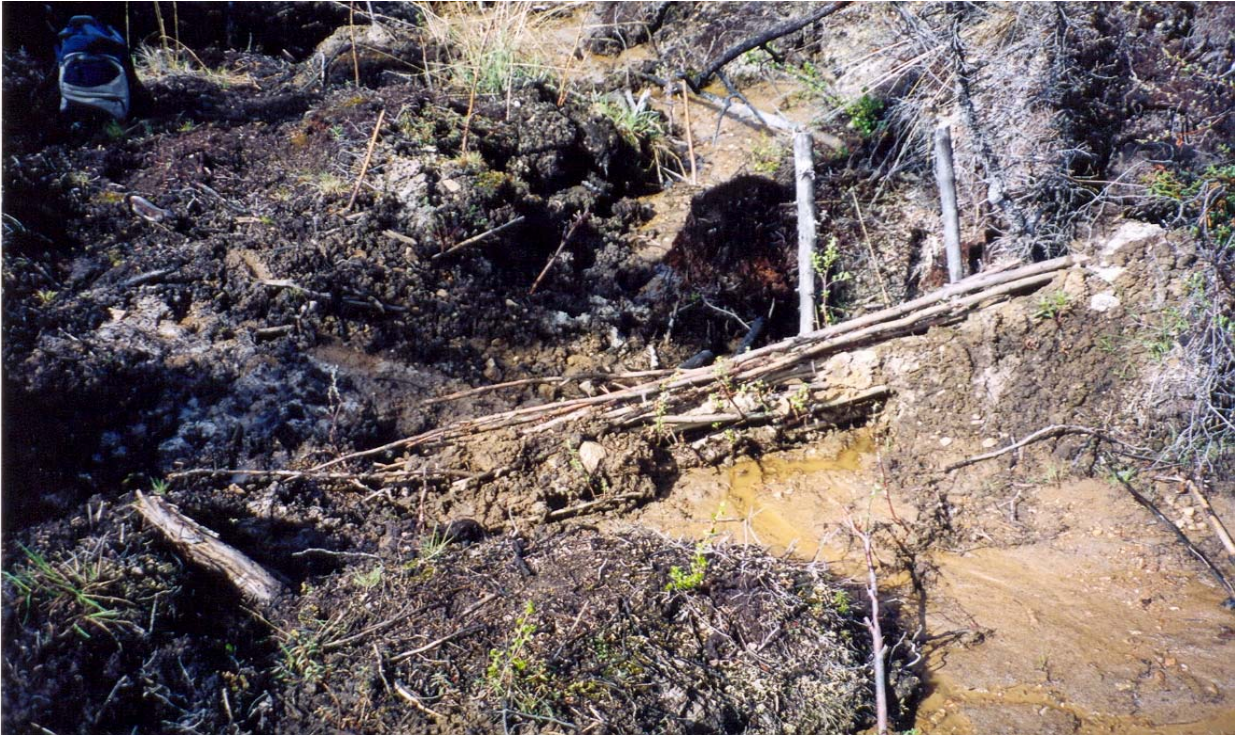
PLATE #11: Gully break #3 prior to repairs, May 27, 2004.

Biodegradable geotextile was laid over the erosion cuts at cross-gully breaks 2, 3, 5, 6, 8 and 9. At each gully break, the geotextile was secured with live willow stakes on the upstream side and then backfilled. Structural repairs also included replacing or resetting several of the stakes (black spruce) that support the gully breaks.

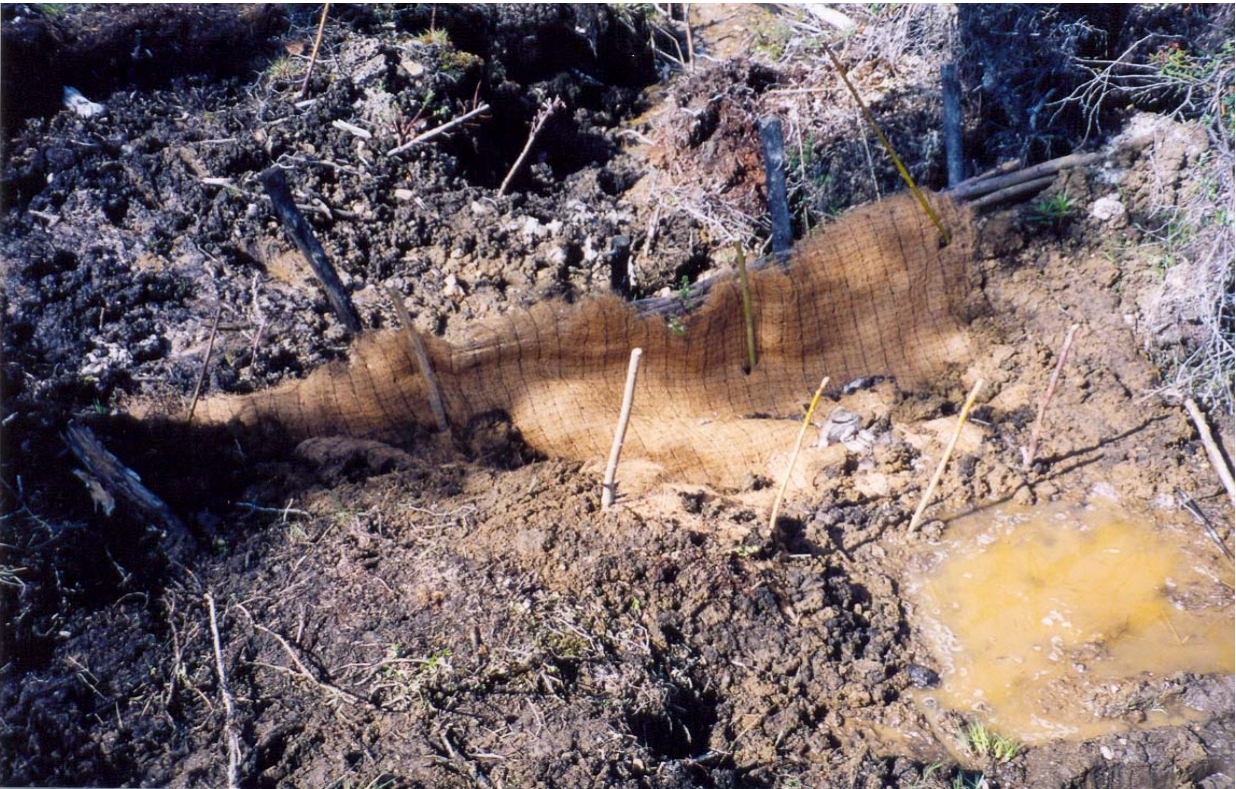
PLATE #12: Gully break #3 after placement of geotextile, May 27, 2004.

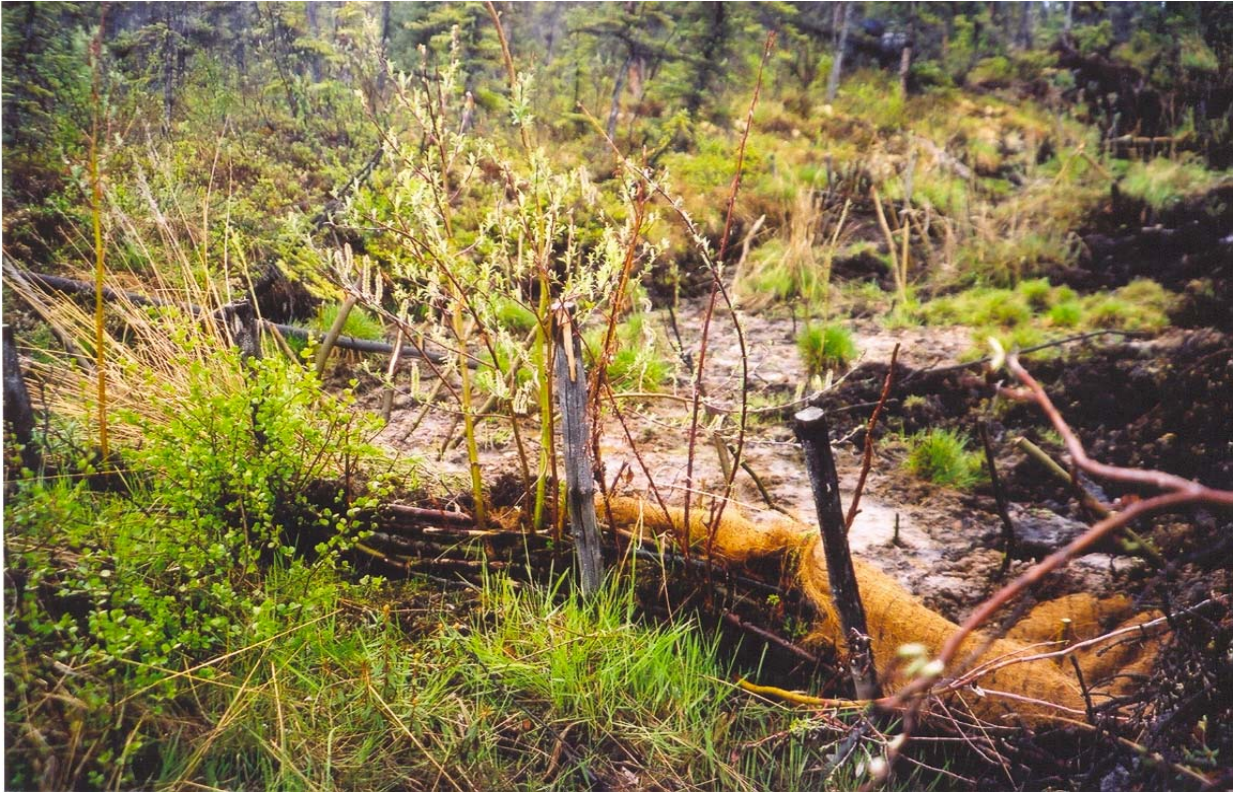
PLATE #13: Repaired gully break #8. Note spring shoots of willow growing from wattle fence.

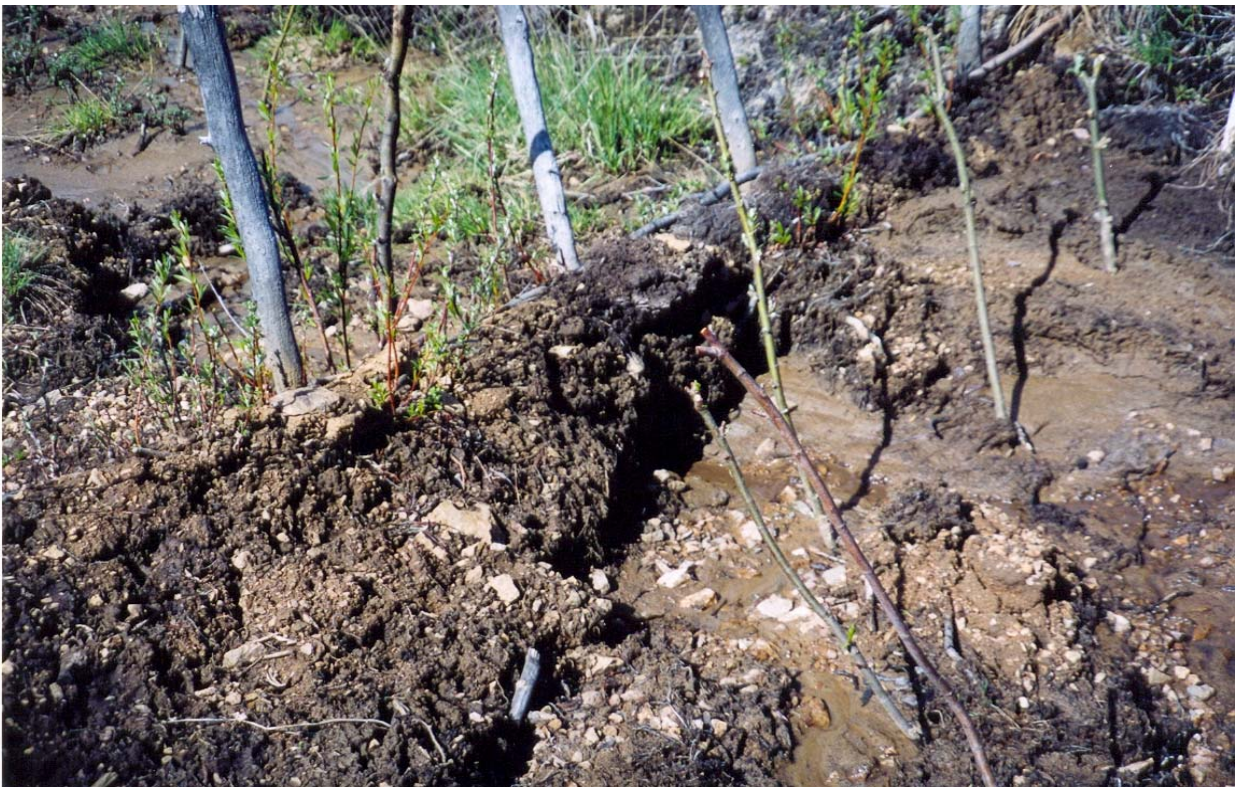
PLATE #14: Gully break #6 prior to upgrades, May 27, 2004.

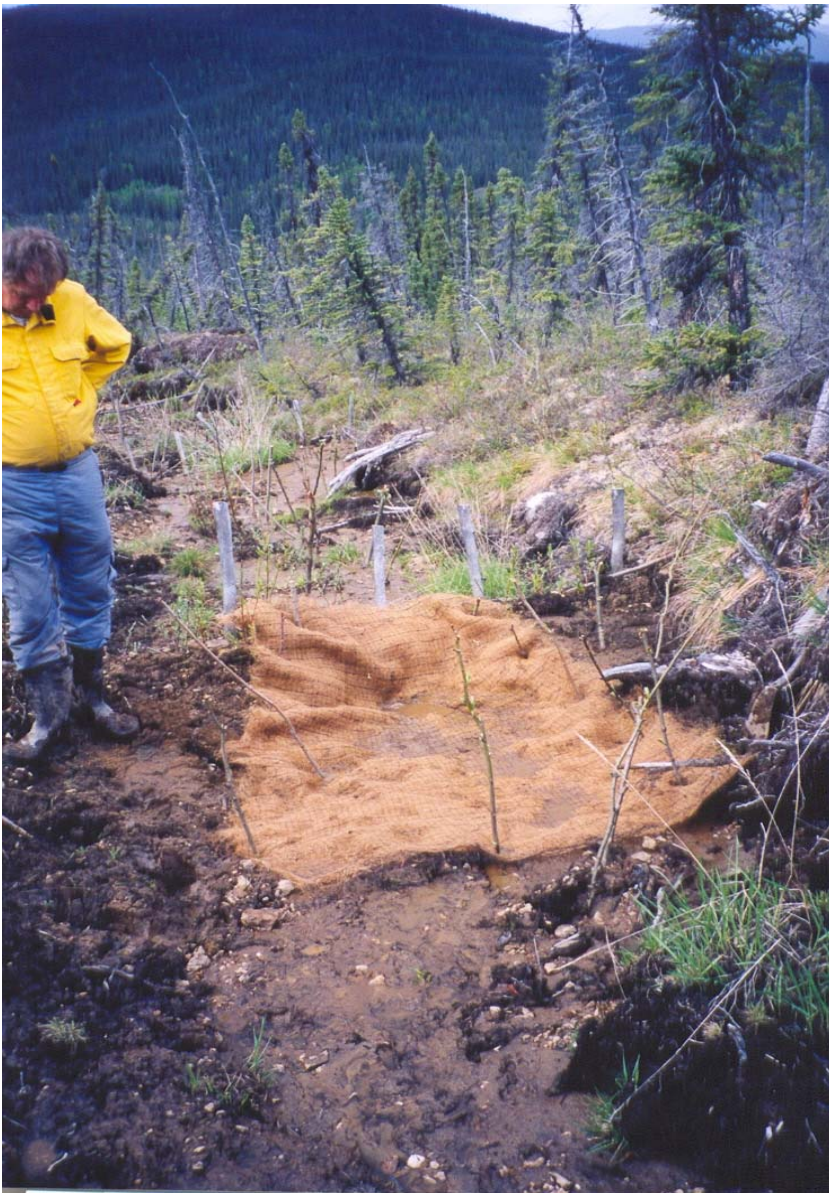
PLATE #15: Gully break #6 after upgrades. May 27/04.

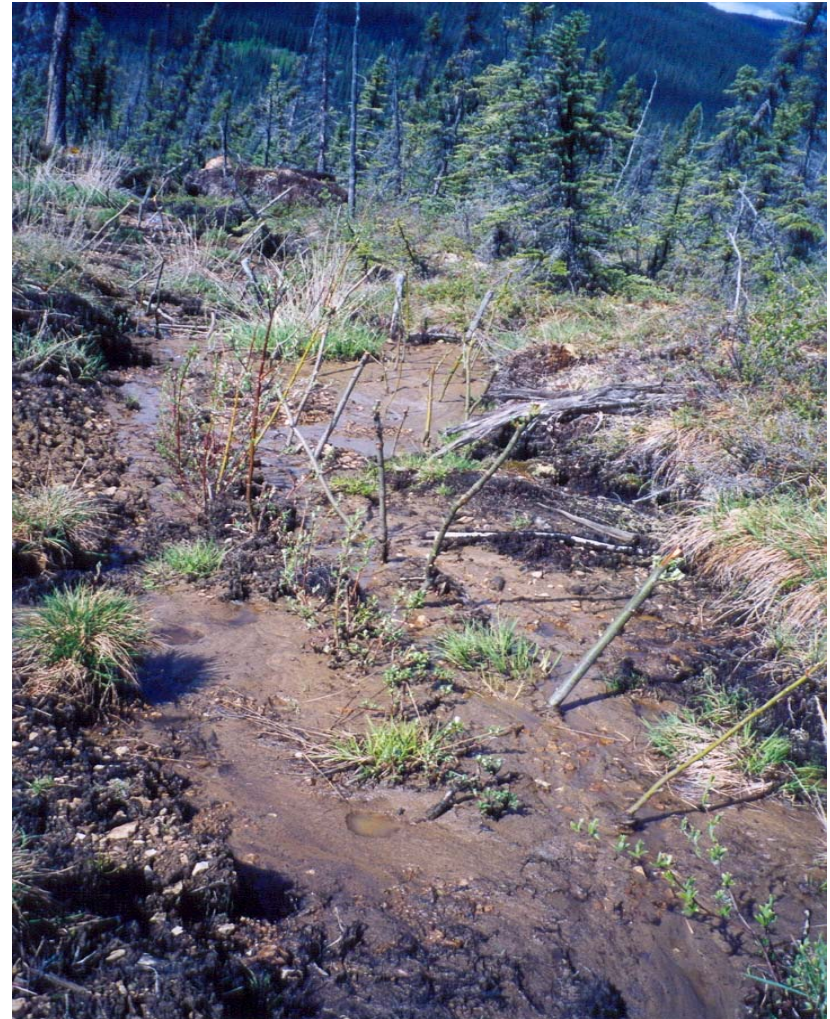
The erosion cuts around the upper pole drain were backfilled and compacted at points where the ground had been too frozen to work in September 2003. The lower pole drain (between gully breaks 6 and 7) was also re-backfilled. The area of pole drain that was covered by a geotextile layer displayed no signs of erosion. No above ground willow growth was observed yet from the recently installed (September 2003) sections of pole drain.

PLATE #16: Pole drain between gully breaks 6 and 7. Note sprouting and continued growth from pole drain, and trapped sediment. May 27/04.

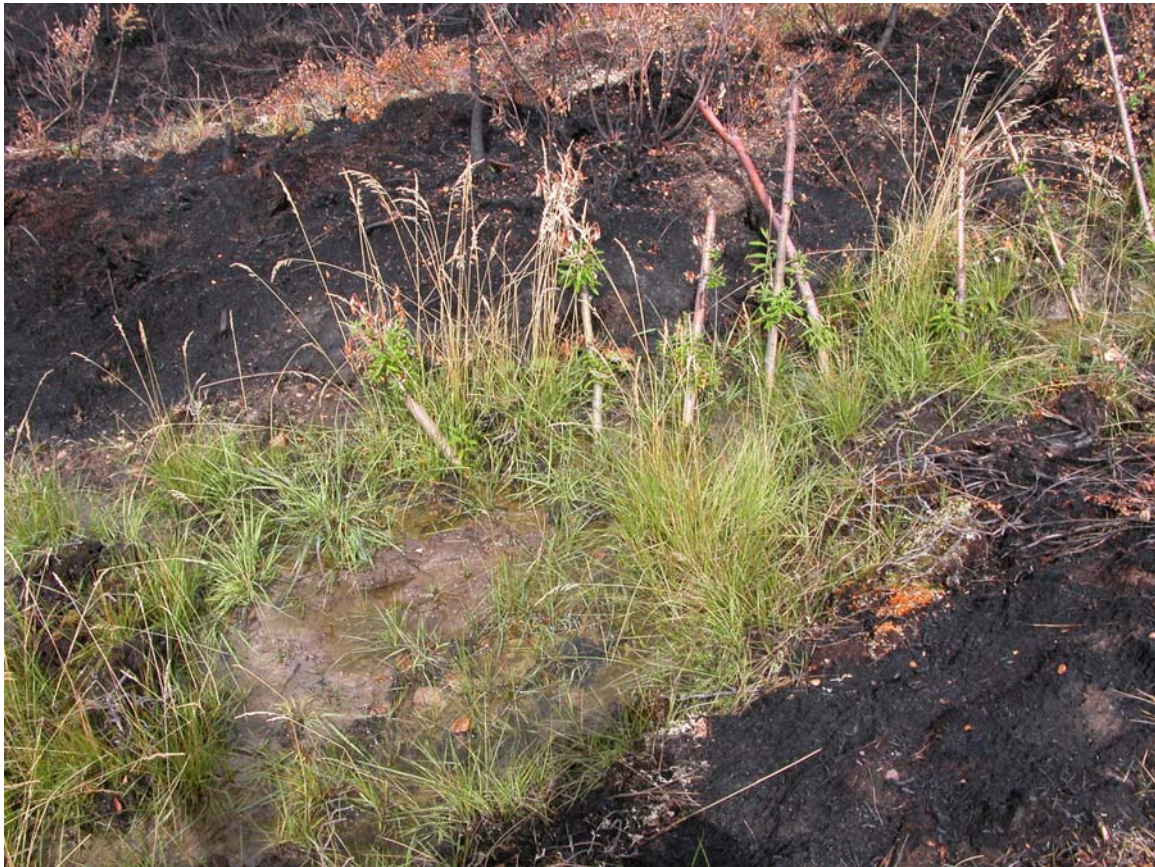
PLATE #18: Live staking from Sept /03 (see PLATE #8) sprouting good growth although surrounding area is burnt. Grasses in gully appear unaffected as well. Aug 4/04.

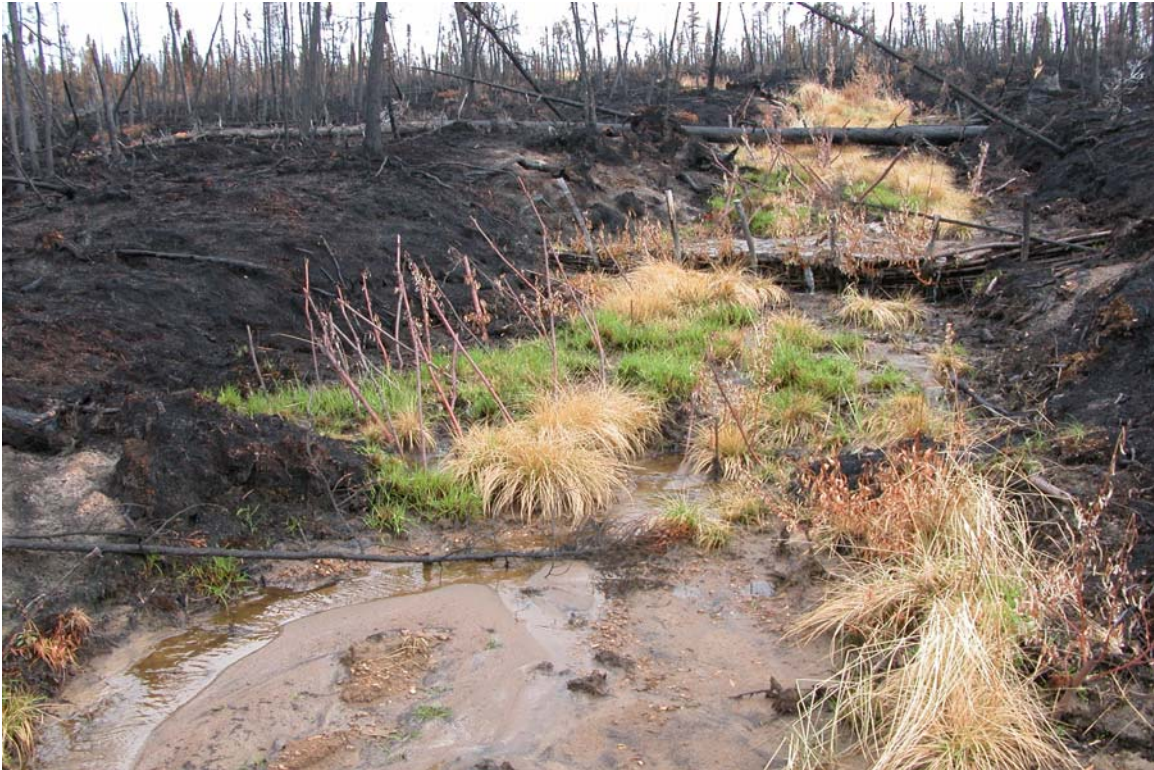
PLATE #19: Looking up to gully break #10 from intact gully break #11 (not in picture) Break # 10 is effectively holding back sediment terrace. Live staking of willows appear scorched but not dead. Most grasses are viable.

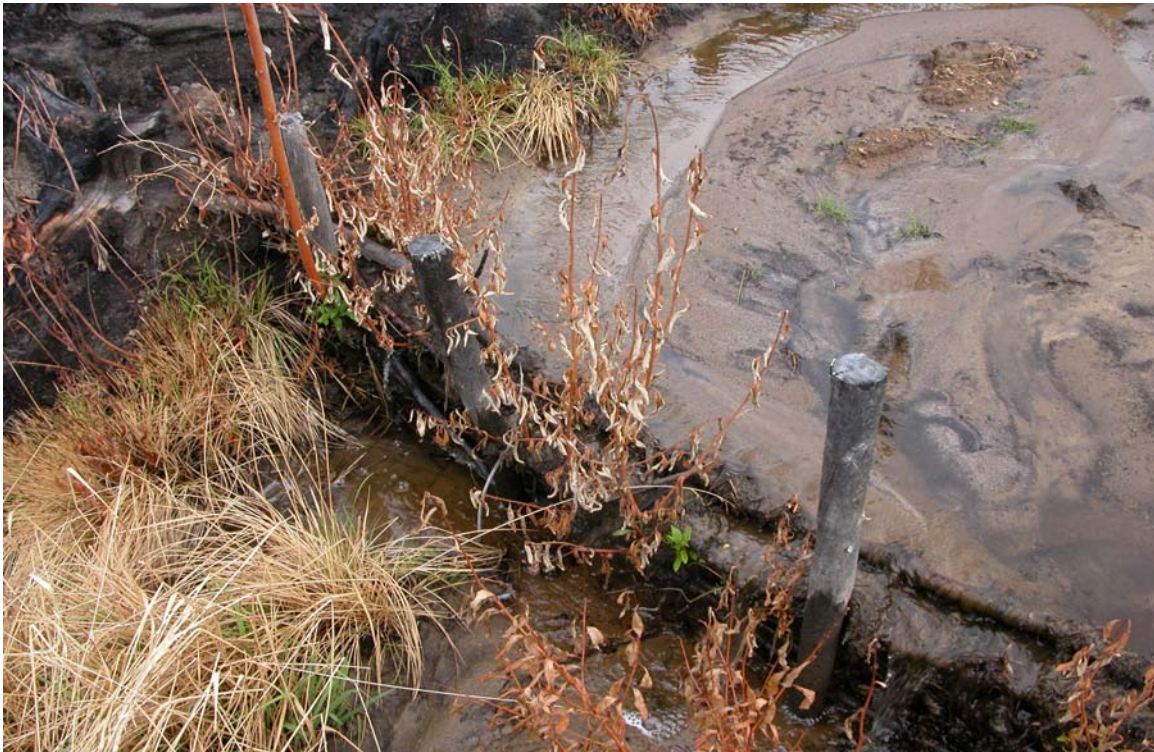
PLATE #20: Close up of gully break showing correct decanting of surface flow. Note new willow shoots on wattle fence.

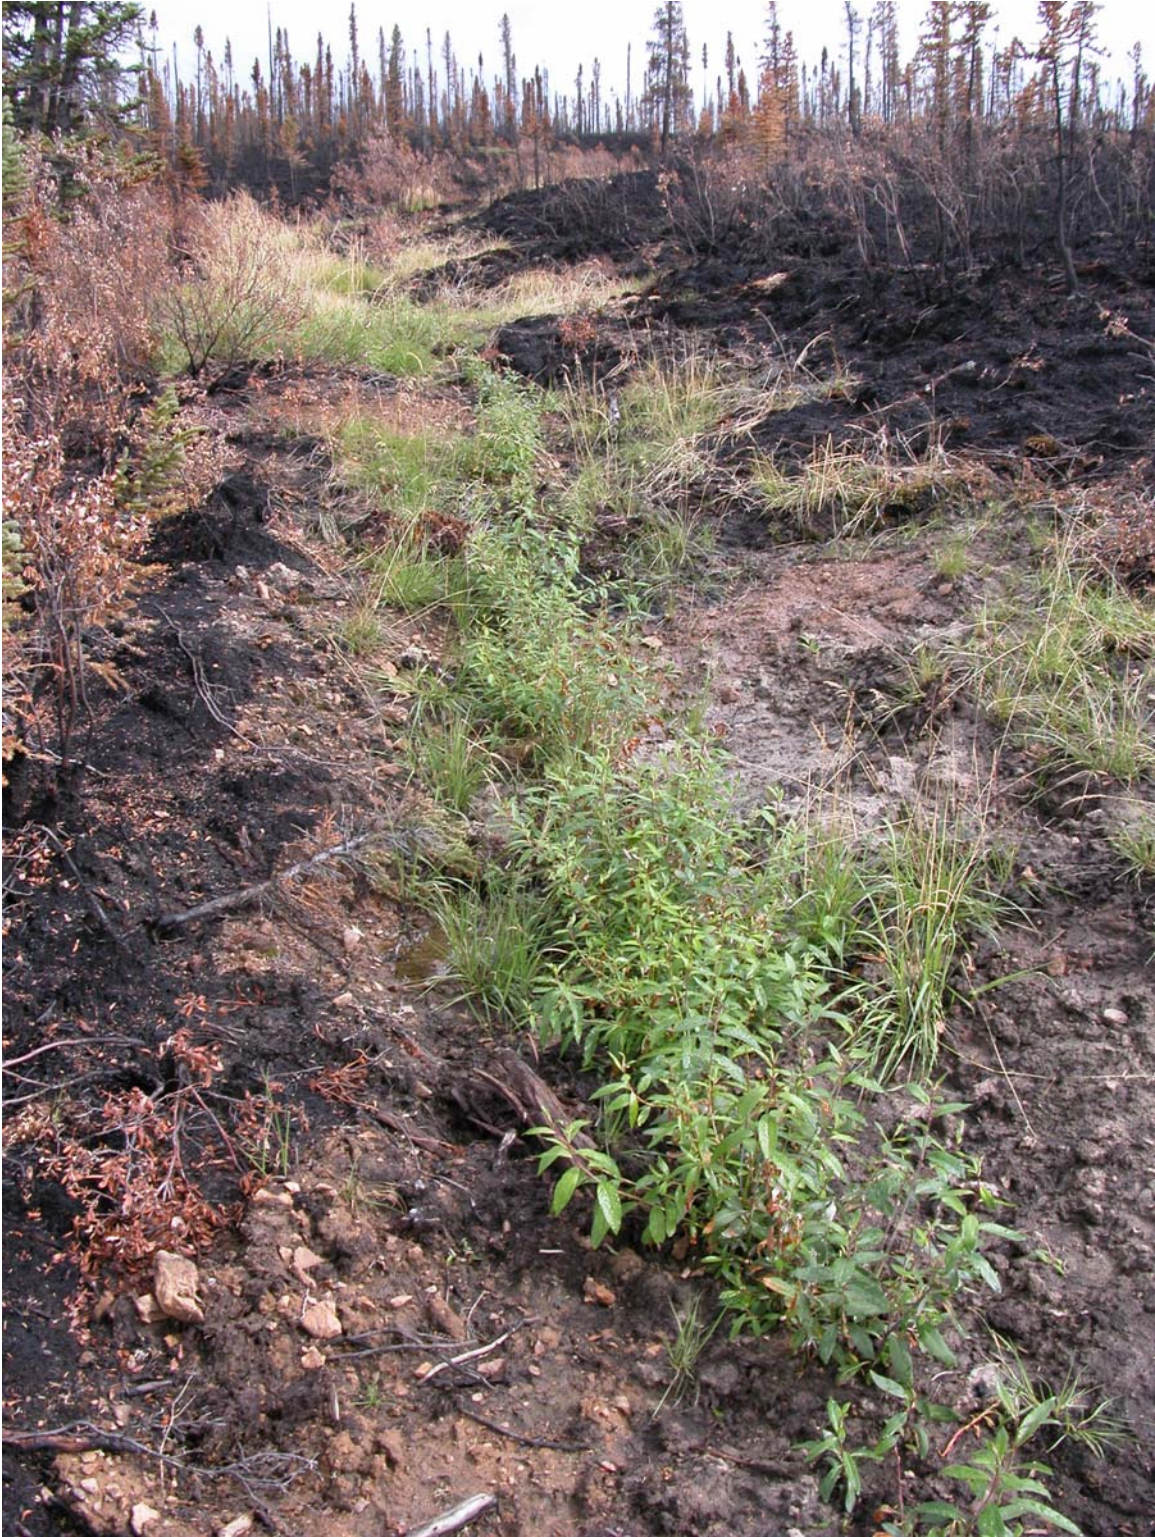
PLATE #21: Pole drain showing robust willow growth despite burnt and scorched surroundings.
