MPERG Report 2009-4

**Brewery Creek:
From Assessment and Permitting
Through Production to Post Closure:
A Post Closure Analysis of a
Northern Heap Leach Mine**

Access Consulting Group

2010

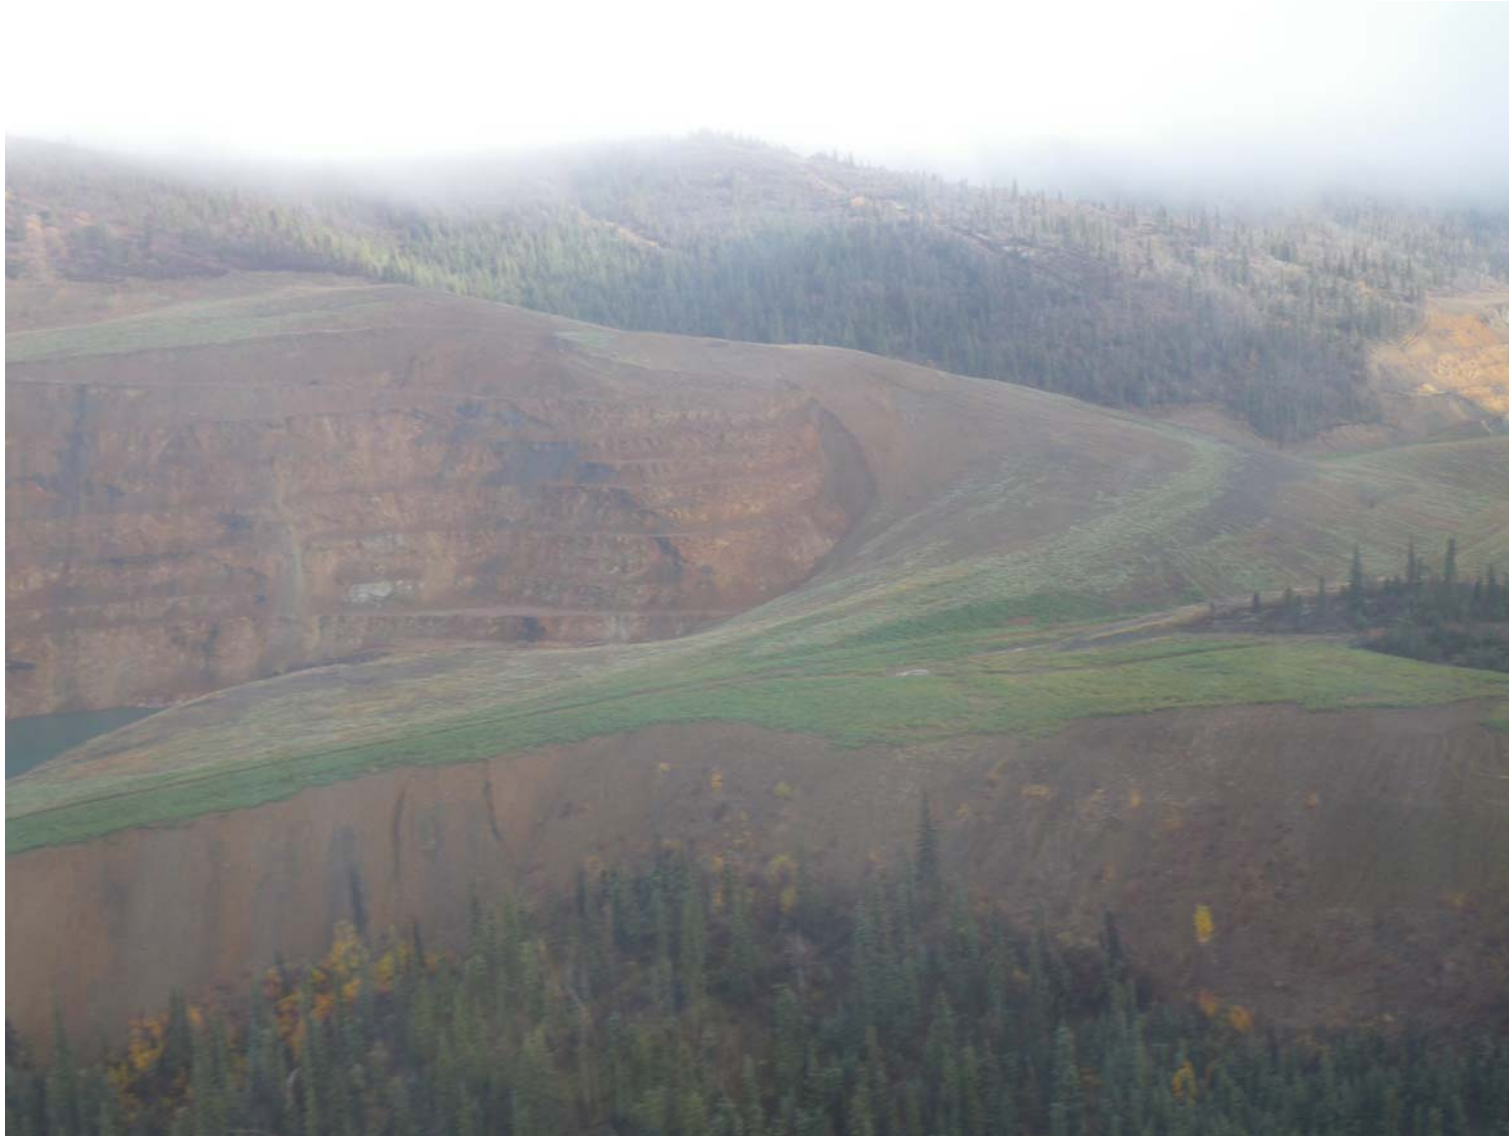
Extensive revegetation on level slopes looking north towards the Kokanee pit (2008)

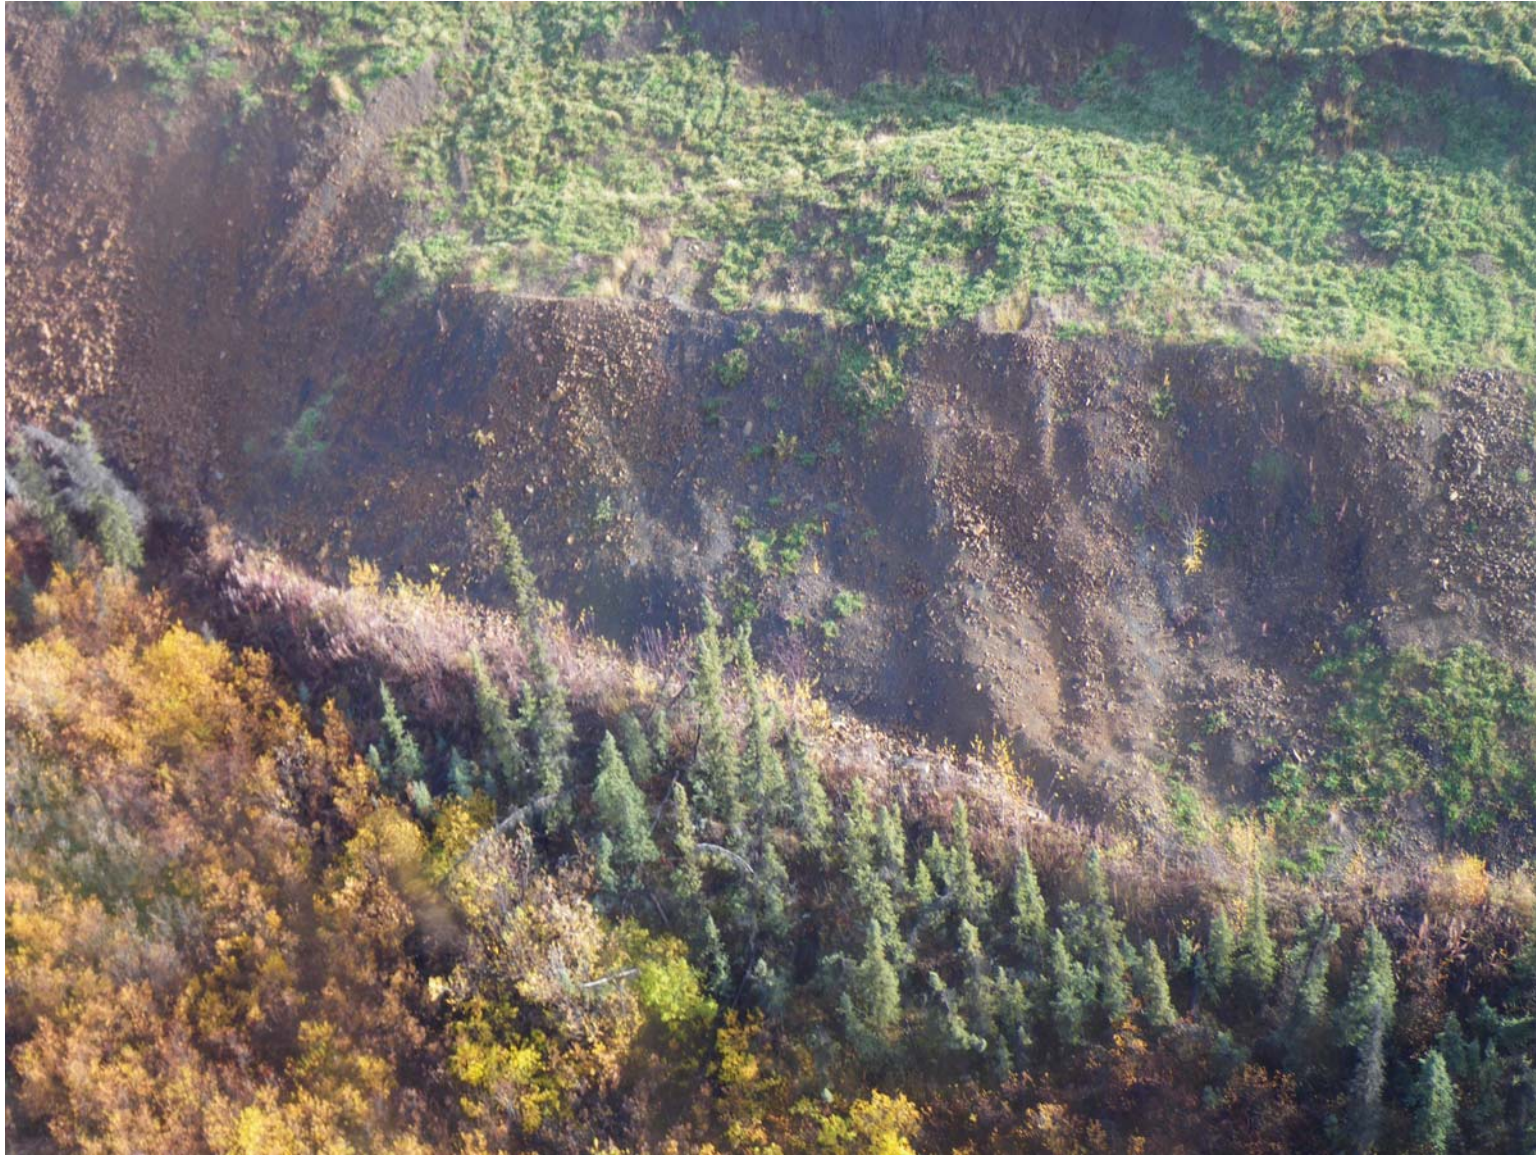
Steep slopes with minimal revegetation (2008)

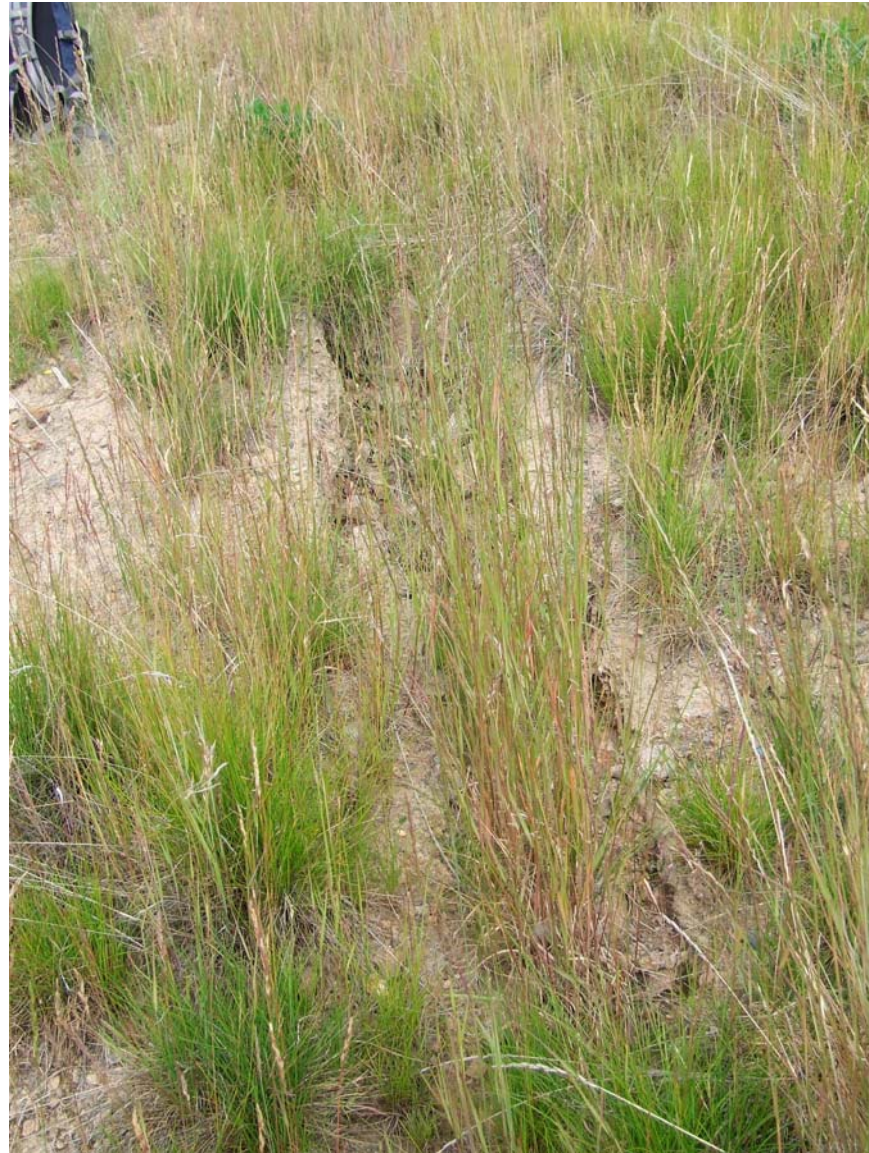
Photo #2: Gully in Plot 3 of the Blue Zone WRSA supporting thick growth of grasses.

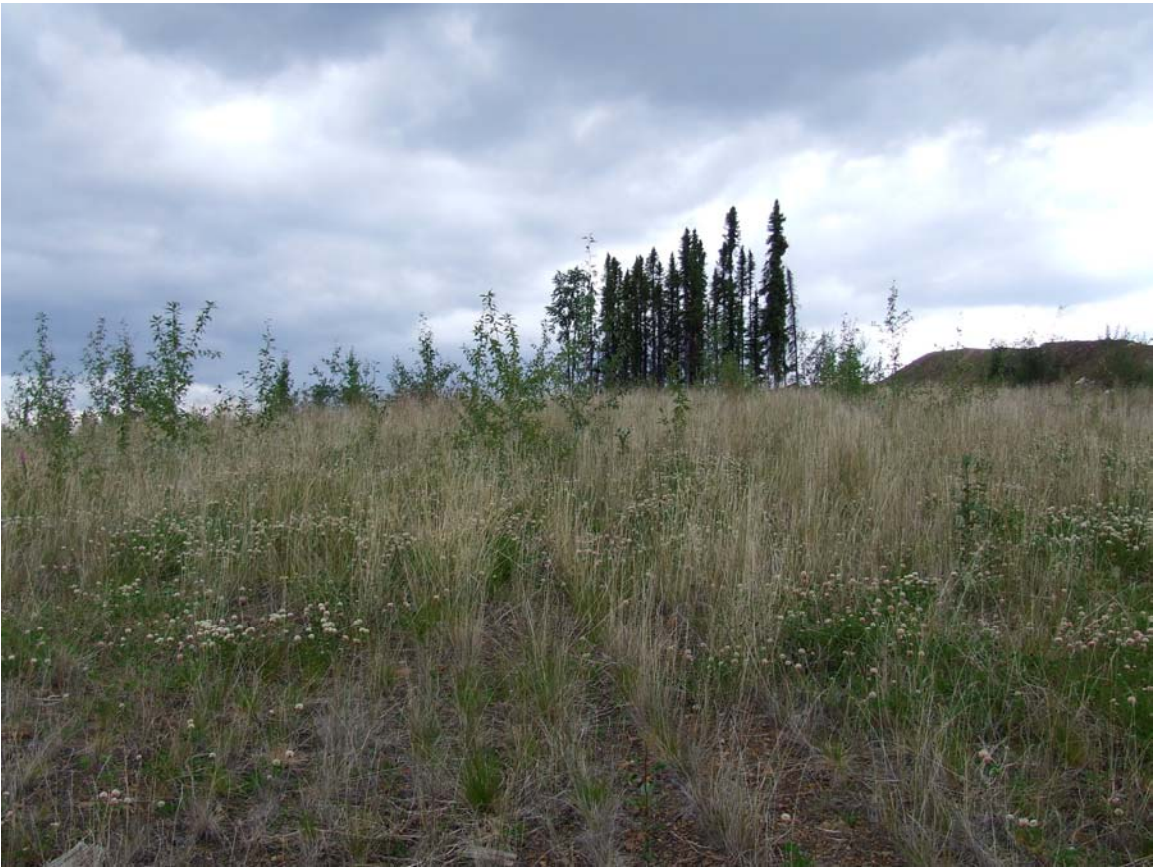
Photo #5: Moosehead – willows and poplars are colonizing and becoming established in parts of this zone.

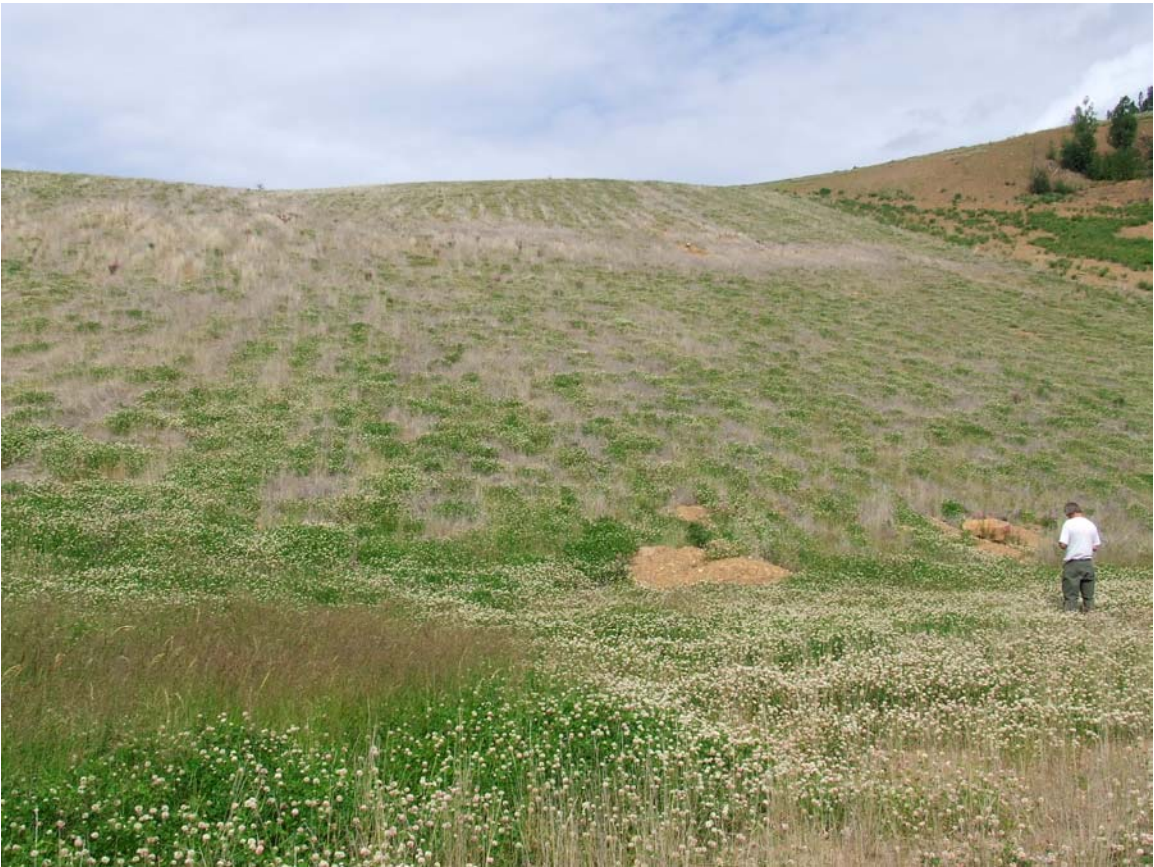
Photo #7: White Clover dominates the vegetation of the Canadian Stockpile area.
