MPERG Report 2010-3

Alternative Methods for the Reclamation of an Exploration Trail off the Dempster Highway, Yukon

Laberge Environmental Services

March 2010

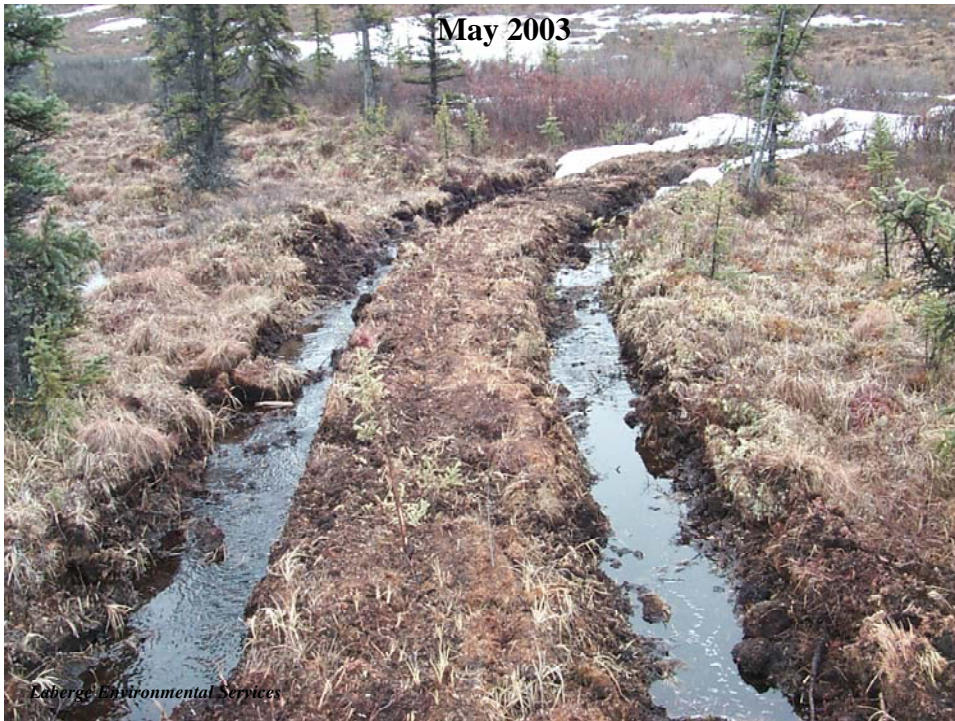
This section encompasses Sites 1 through 7. During the inspection conducted by Energy, Mines and Resources in May 2003, deep ruts were filled with water from the commencement of spring melt (Photo #1, Appendix A) at the top of the trail, Site 1. The damage to the trail had occurred in November 2002, so this represents the first melt following the impact. The water was running in the ruts and continued intermittently down to the upper creek crossing (Site 6), a small tributary to Engineer Creek. This runoff had eroded several sections down to the underlying gravels within this segment.

Photo #1: Site #1, in May 2003 snowmelt is actively flowing in the ruts that were created by tracked equipment in November 2002. Photo credit: Al Rothwell, EMR, YG, Dawson City.

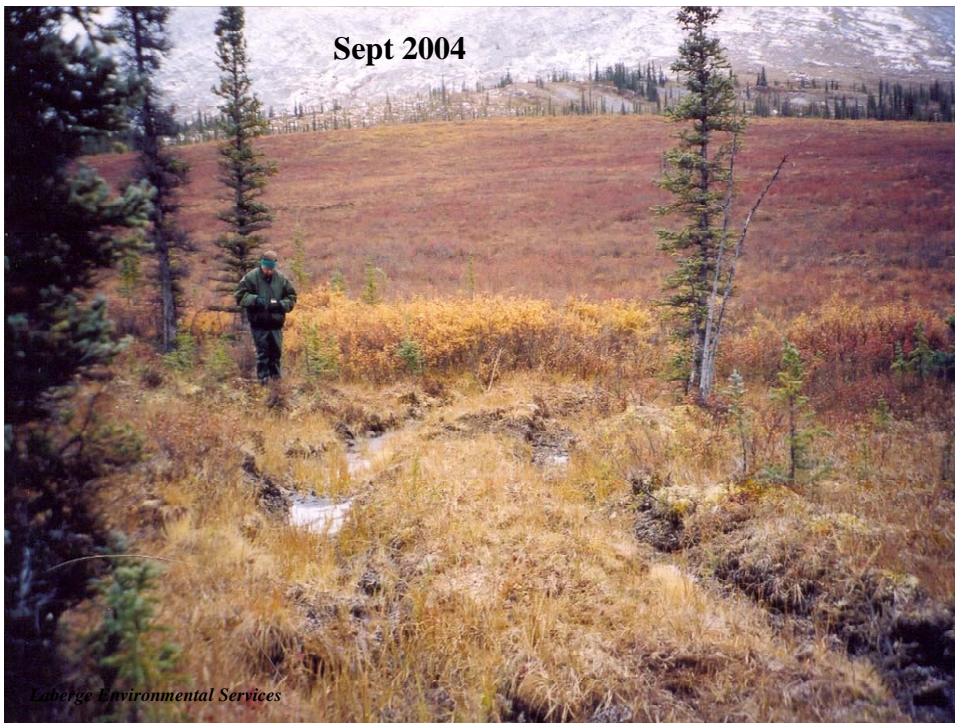
Photo #2: Site #1; on September 13th, 2004, water within the ruts was frozen.

During the inspection by LES on September 13th, 2004, the ruts contained frozen water (Photo #2). These trenches were filled in with local material from the sides using hand picks (Photo #3). Inspections of Site 1 during July 2005, July 2006 and July 2009, showed that grasses were growing within the ruts, with the presence of a small amount of standing water (Photos # 4 to # 6) and no evidence of flowing water. No further treatments were applied after the initial effort in 2004.

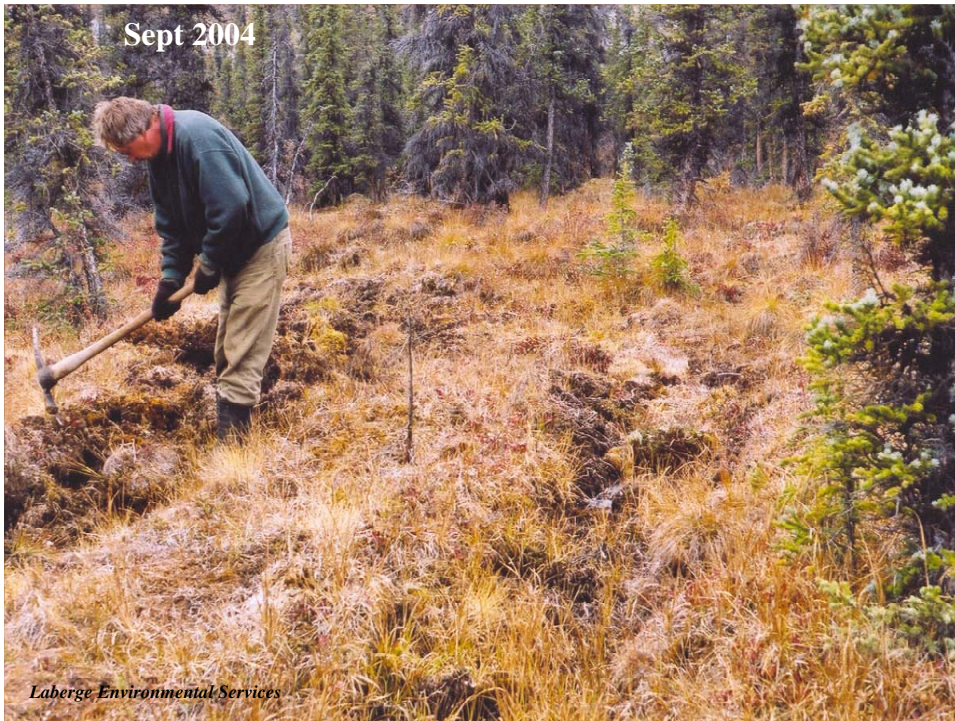
Photo #3: Site #1; the ruts are backfilled with local material, September 2004.

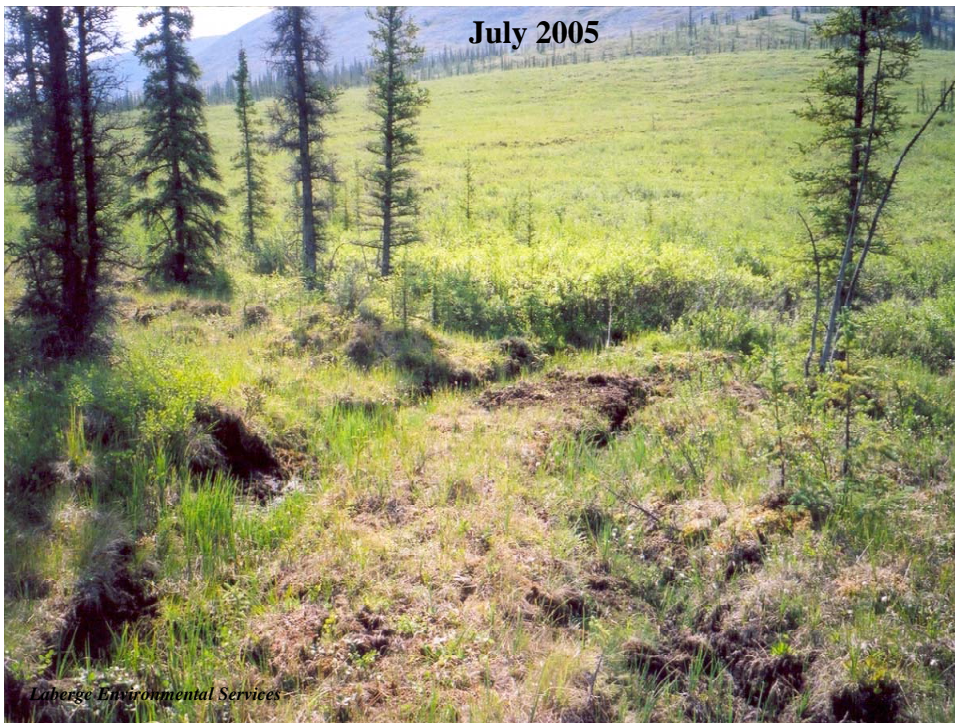
Photo #4: Site #1; grass is growing within the ruts creating stability by July 2005. There are localized spots of standing water but no evidence of running water.

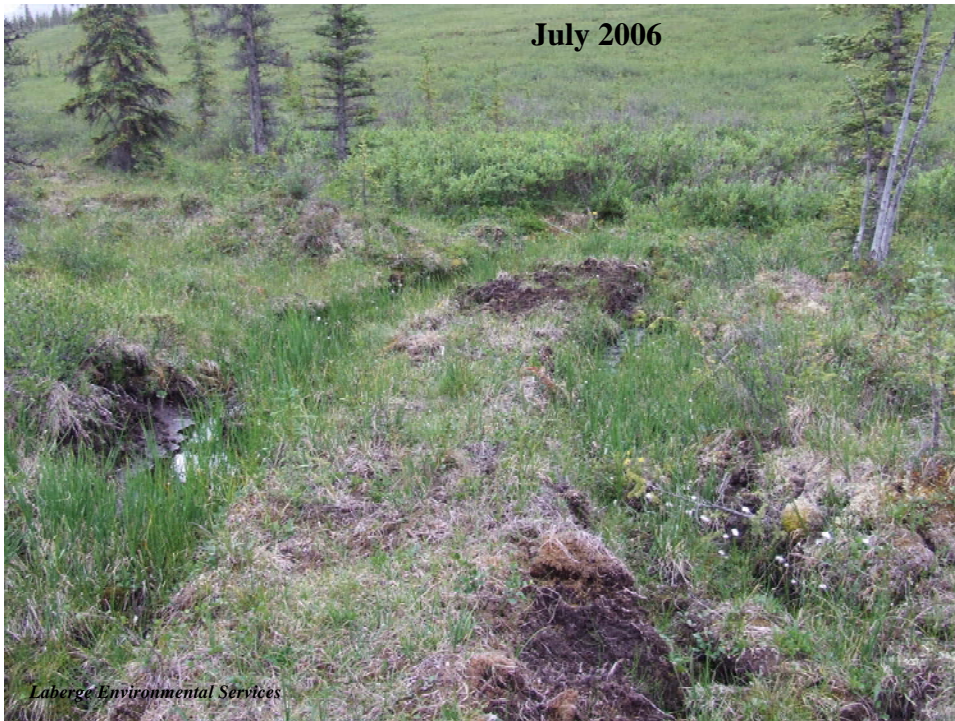
Photo #5: Site #1; grass growth is thicker in the ruts by July 2006. Some standing water remains.

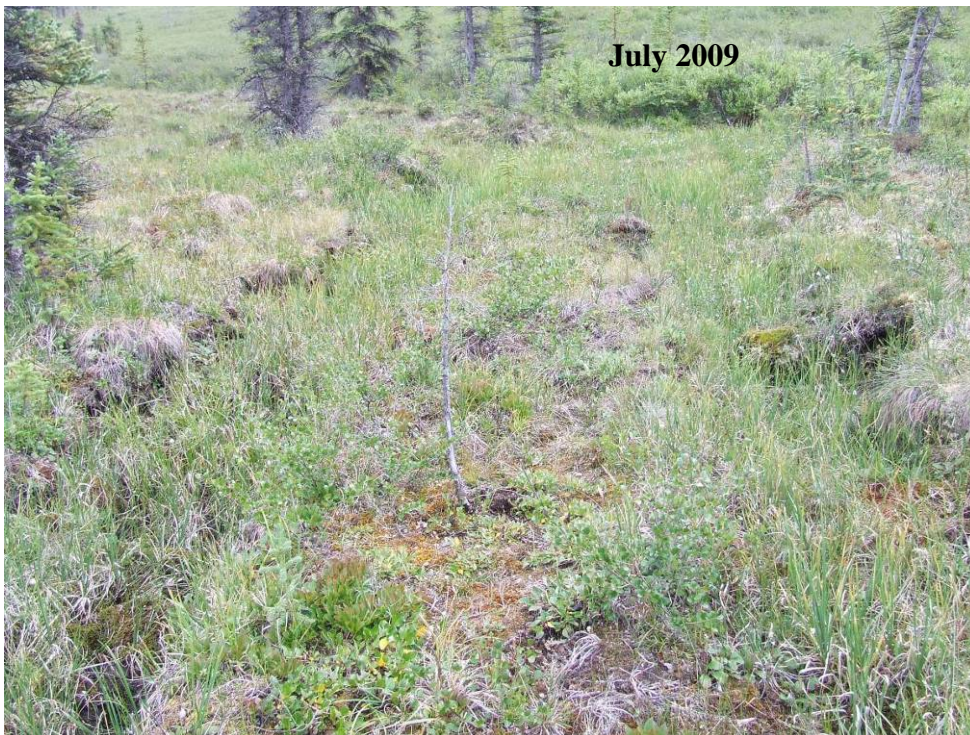
Photo #6: Site #1; grass and plant growth continues to populate the ruts in July 2009. No standing water present.

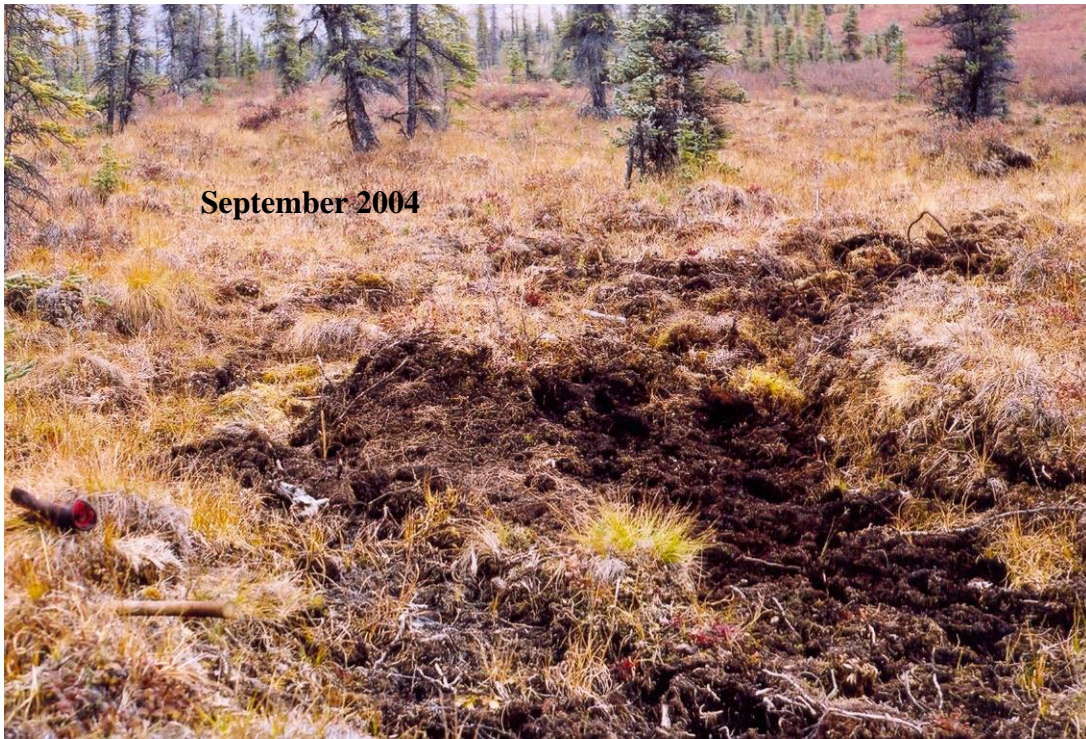
Site 2 is approximately 20 m below Site 1 where the trail curves south. The runoff in 2003 had eroded the groundcover here down to the underlying gravels. As well as using side material for filling in the ruts, some small plugs of vegetation from the adjacent forest were used. This area was revegetating nicely and no standing or running water was present in 2005, 2006 or 2009 (Photos 7 to 9).

Photo #7: Site #2; the eroded and rutted corner has been backfilled with local material, Sept 13, 2004.

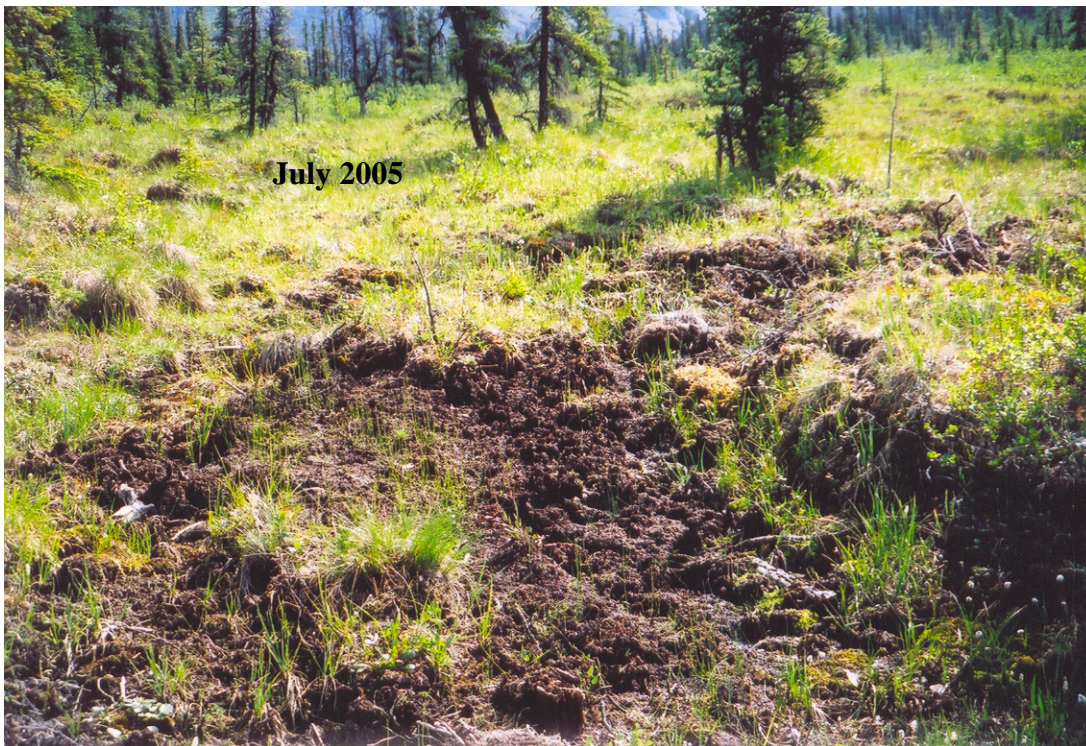
Photo #8: Site #2; the section remains stable with new grass growth sprouting on the exposed soils, July 2005.

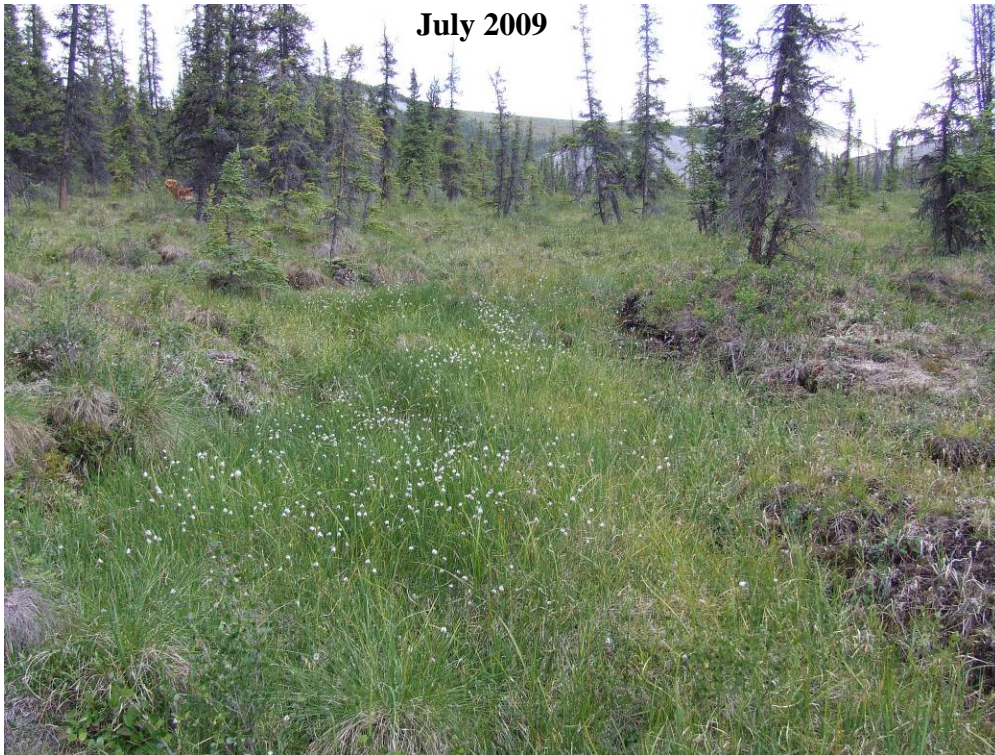
Photo # 9: Sedges and grasses have colonized Site #2 by July 2009.

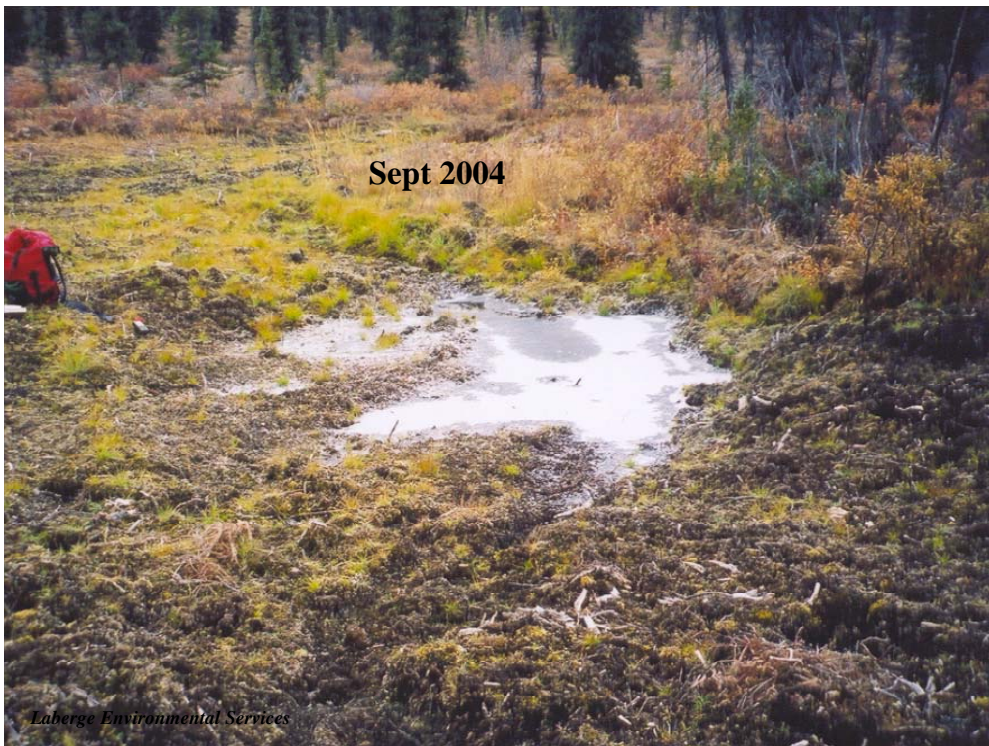
There were two existing sumps at the drill site, both of which were frozen during the September 2004 inspection. Remediation work was carried out in July 2005. The first sump (Site 4) was shallow and small, and contained some standing water. Efforts were concentrated on the second larger and deeper sump (Site 5). Local ground material that had been ripped up by the equipment, as well as dead vegetation, were used as fill. As of 2009, the surface of the sump was revegetating efficiently and contained small quantities of standing water, but no erosion had occurred since the remediation work in 2005 (Photos 10 to 14).

Photo #10: Site #5; the standing water in the second sump was frozen on September 13th, 2004.

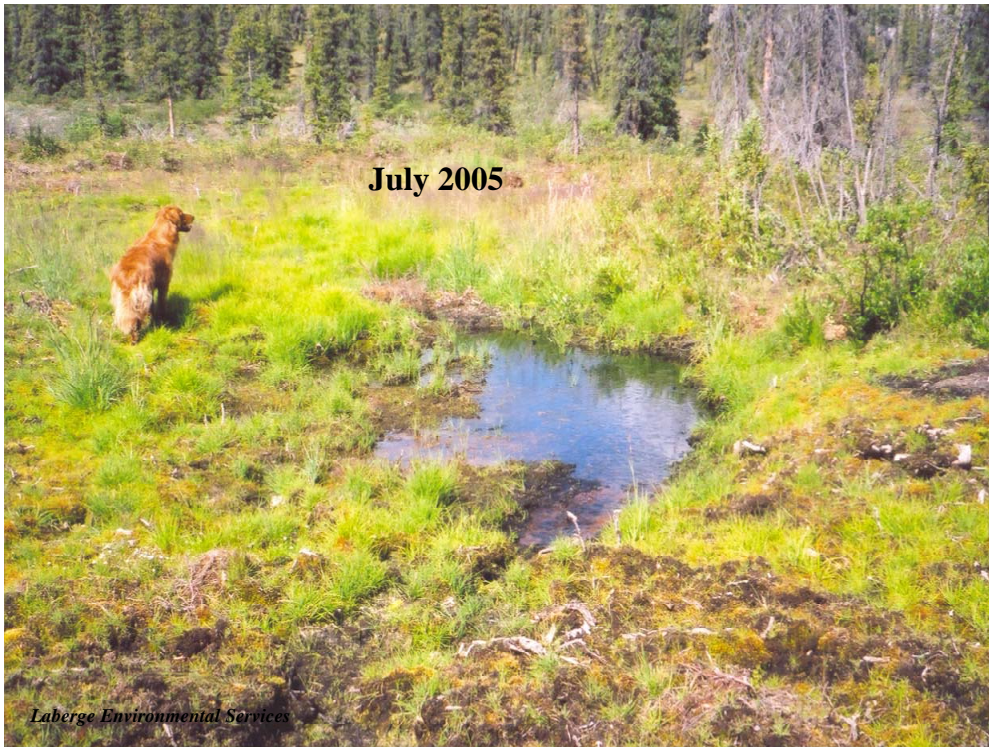
Photo #11: Site #5; prior to any treatments, July 2005.

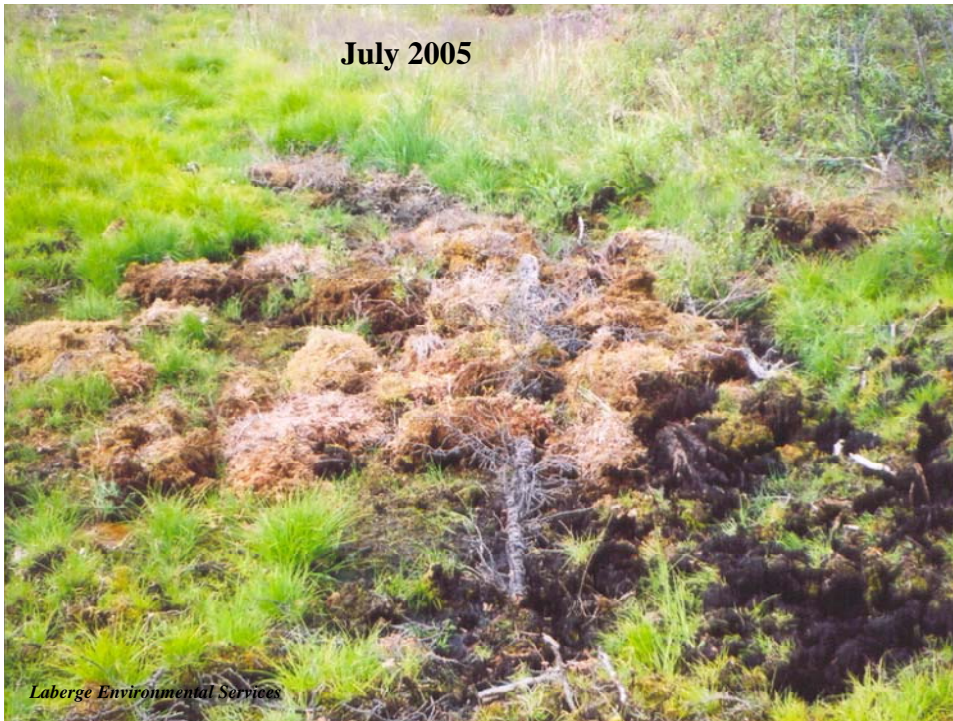
Photo # 12: Site #5; following backfilling with local material, July 2005.

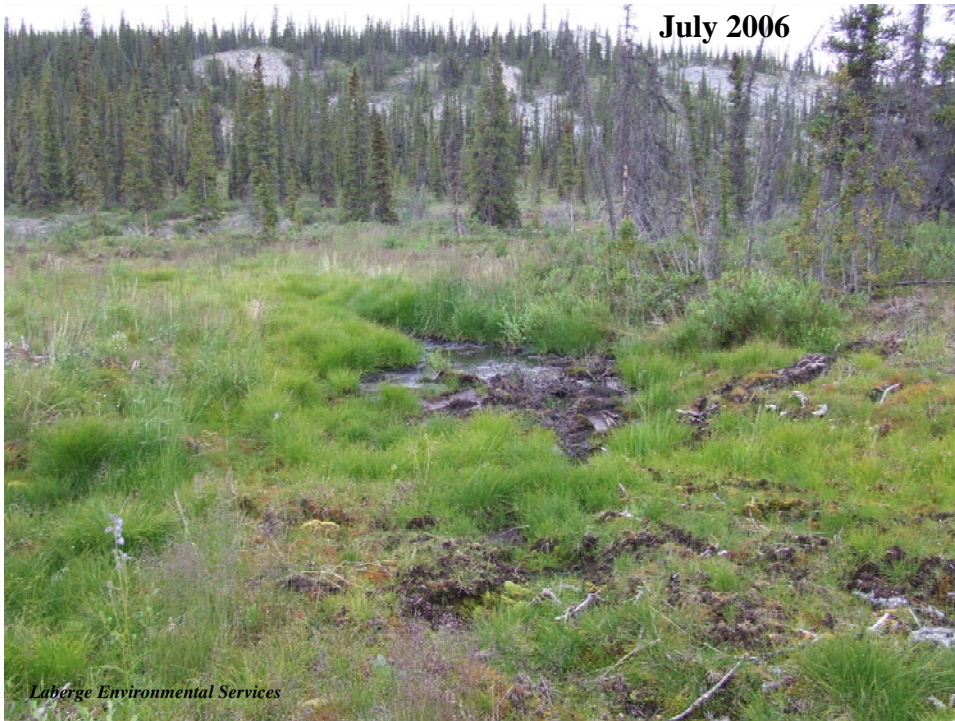
Photo #13: Site #5; the organic material had absorbed the water with some standing water present over the northern half, however no water movement or erosion was evident, July 21, 2006.

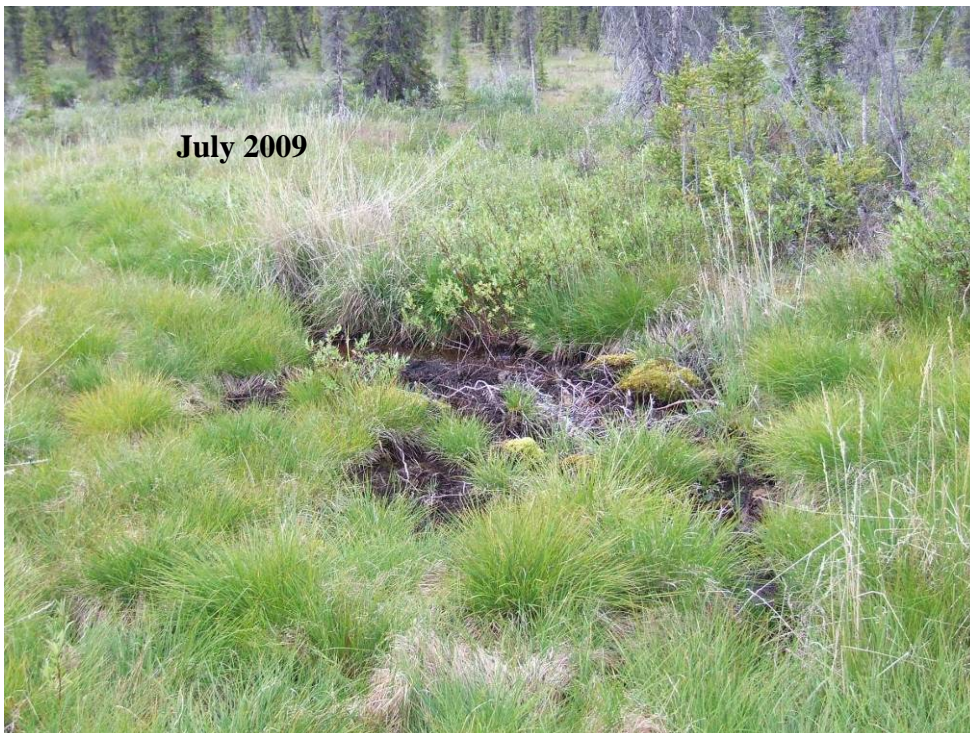
Photo #14: Site #5; plant growth has increased by July 2009 and little standing water is evident.

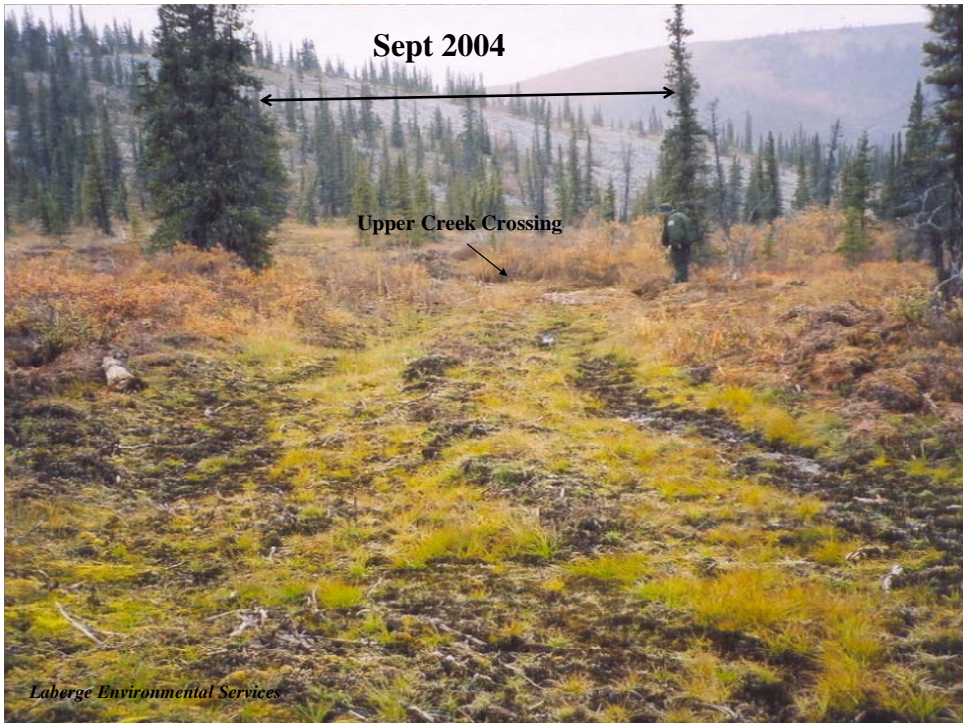
During the September 2004 inspection, the trail between the second sump and the upper creek crossing was rutted and flowing water had previously eroded some sections, but was frozen at the time. These ruts were backfilled with soil and peat that had been pushed aside by the heavy tracked vehicles, and blue-joint reed-grass seeds (*Calamagrostis canadensis*) were also scattered on September 13th, 2004. No further treatments were applied in 2005. Photos 15 to 19 show how the area has recovered over time. By 2009, the colonizing bluegrass documented in 2006 has become well established. Appendix B lists the species that were colonizing the various mitigated areas.

Photo #15: The section of trail from the second sump (Site 5) to the upper creek crossing (Site 6) required backfilling, September 2004.

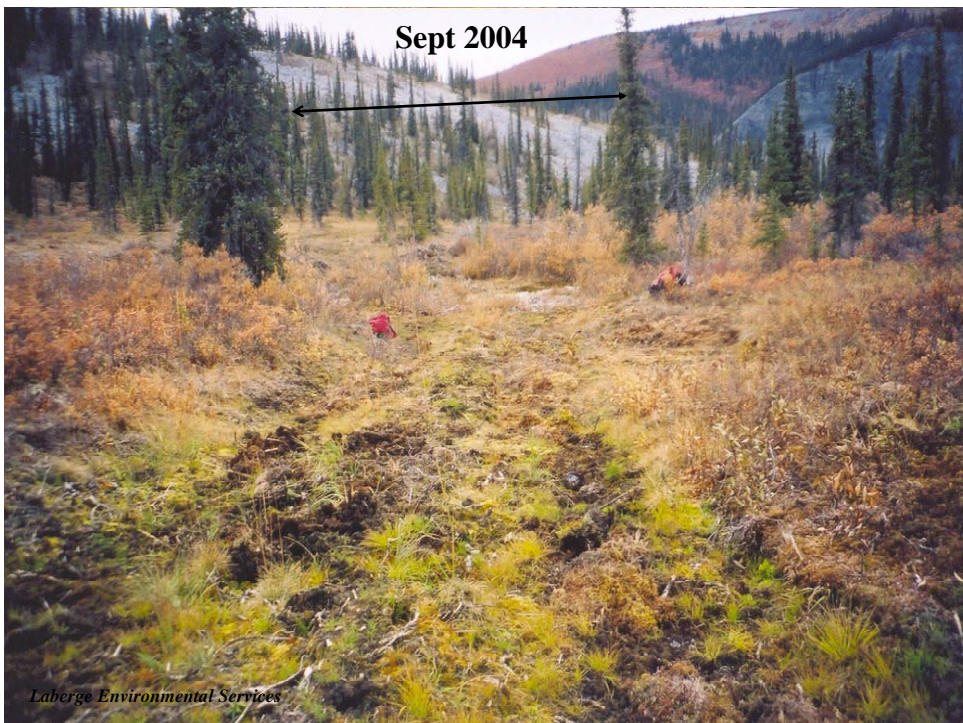
Photo #16: Completion of backfilling the problem areas, September 13th, 2004.

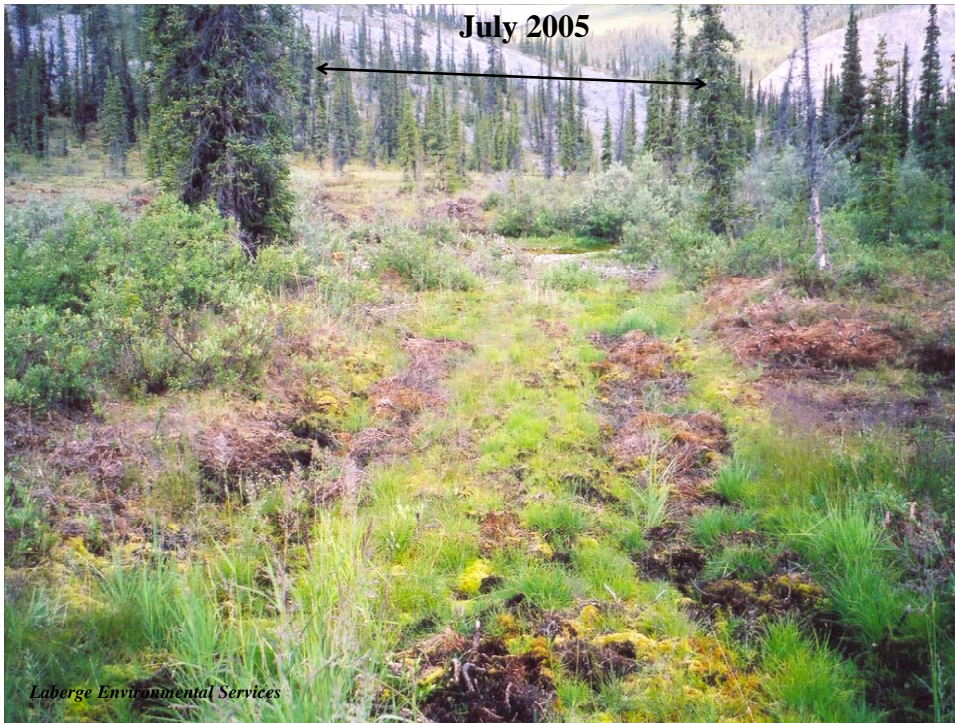
Photo #17: By July 2005 grass is growing within the rutted areas and no water, standing or flowing is evident.

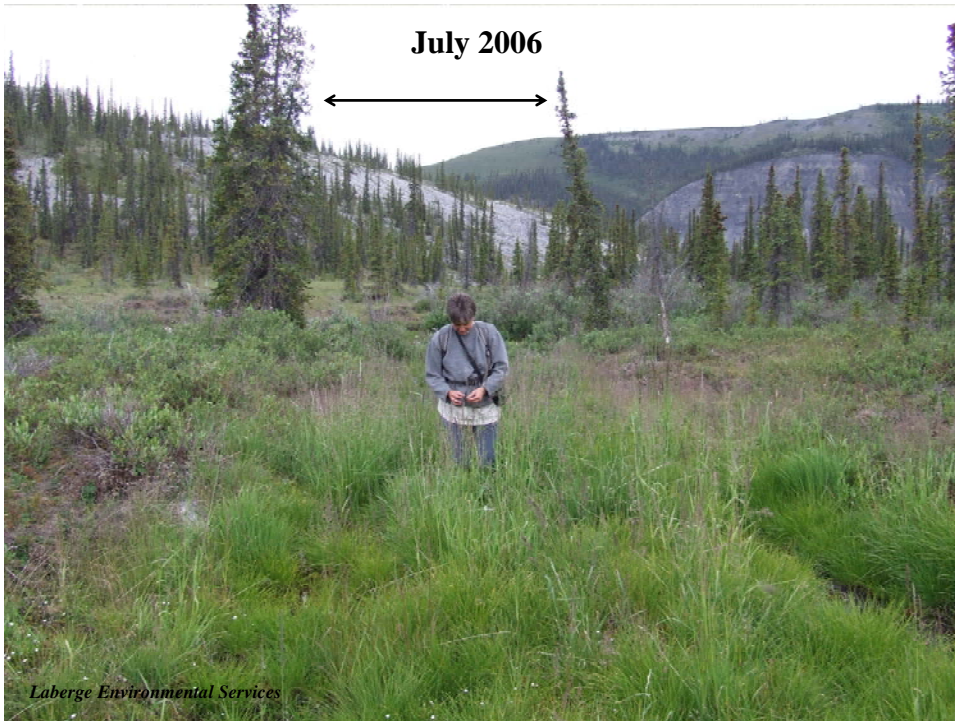
Photo #18: By July 2006, a robust growth of *Calamagrostis canadensis* is apparent.

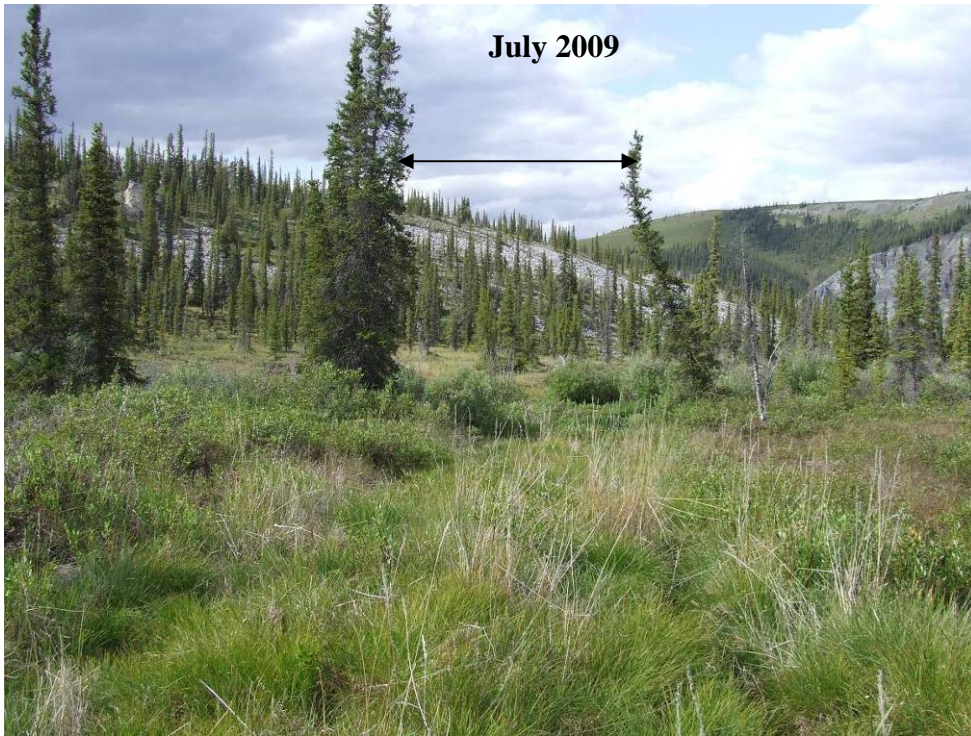
Photo #19: By July 2009, vegetation has continued to invade and propagate, and the ruts are barely perceptible.

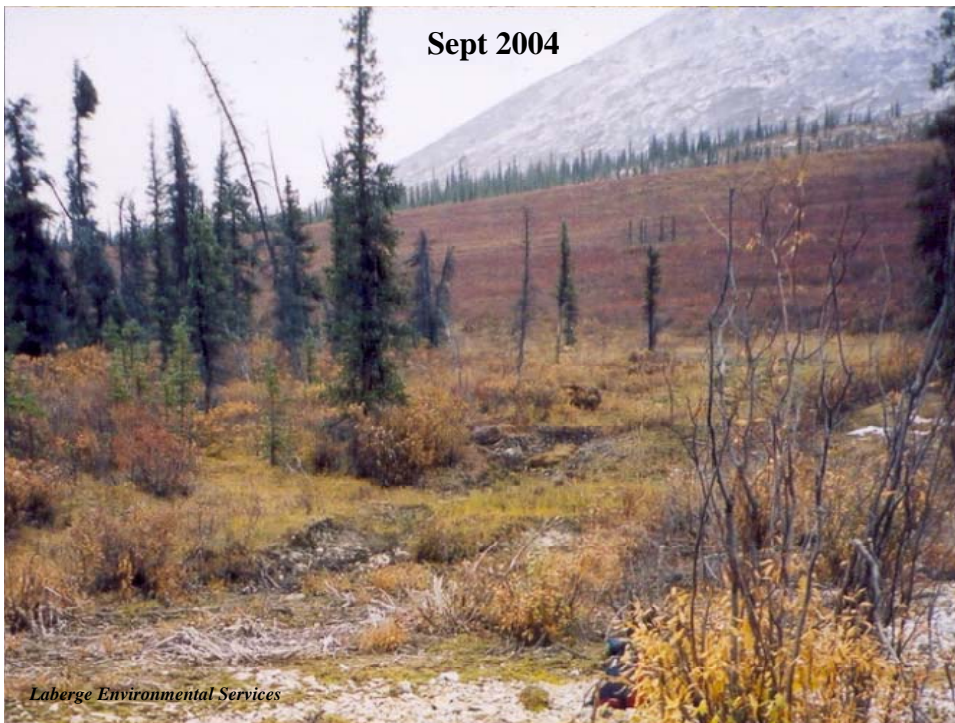
The channel of the upper creek crossing (Site 6) appeared stable during the September 2004 visit, however both approaches had suffered damaged, notably the upslope portion. The repeated

traversing of equipment accessing this slope had exposed some of the underlying material and this was further exacerbated following the spring melts. Ground material that had been scraped aside during the mechanical activities was placed over the exposed roots and gravels on September 13th, 2004. This procedure was effective at reducing and eliminating erosion and no further work was required in July 2005. Photos 20 through 23 show the initial problem, the site following the treatment and the recovery in the ensuing years.

Photo #20: Site 6; the upper approach of the upper creek crossing had been damaged with most of the ground layer having been removed and/or worn down by the action of the tracked equipment, September 13th, 2004.

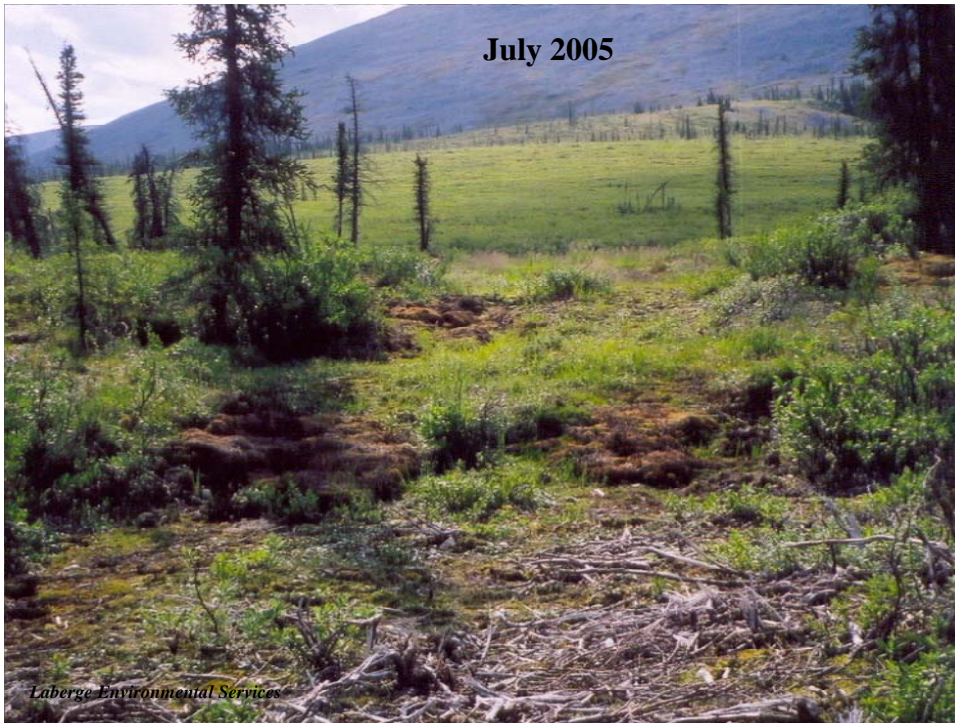
Photo #21: Site 6; less than one year later no erosion has occurred on the upslope approach, gravels remained covered with material laid down in 2004 and grasses have begun to grow in some areas, July 21, 2005.

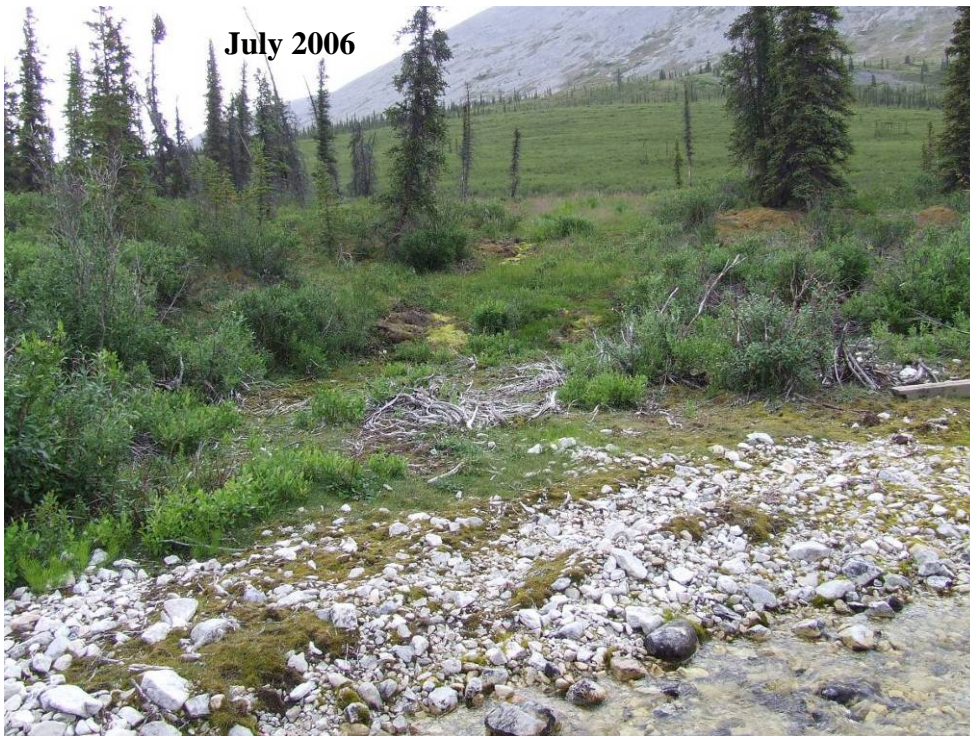
Photo #22: Site 6; on July 21, 2006, increased growth appears to be creating more stability. No signs of any erosion.

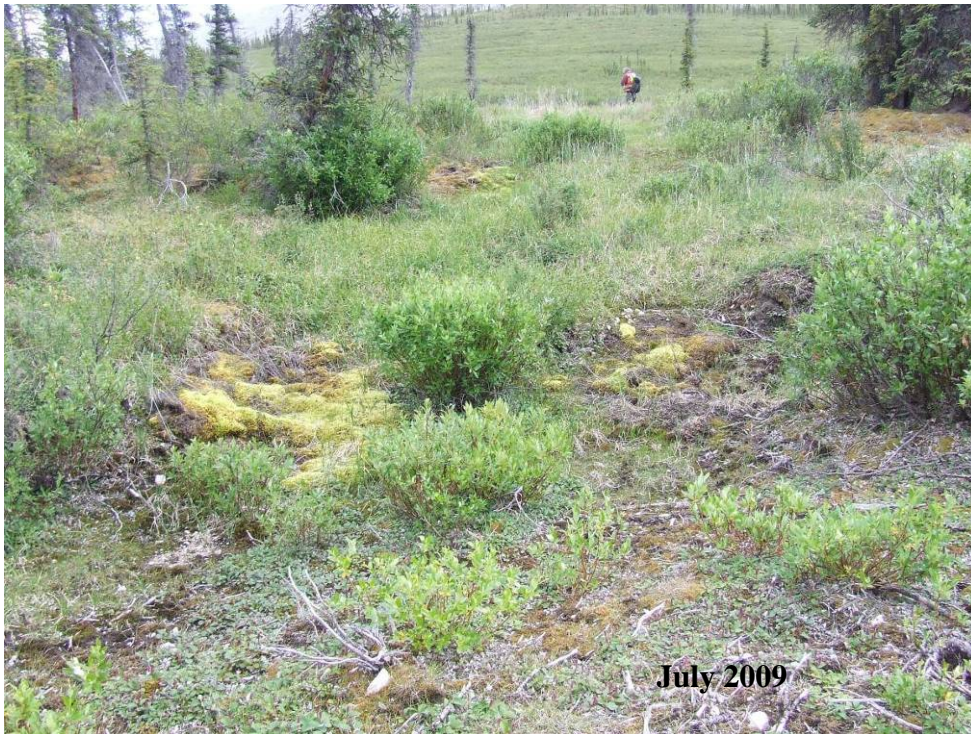
Photo #23: Site 6; The remediated site has well established plant growth and the upper approach is stable, July 24, 2009.

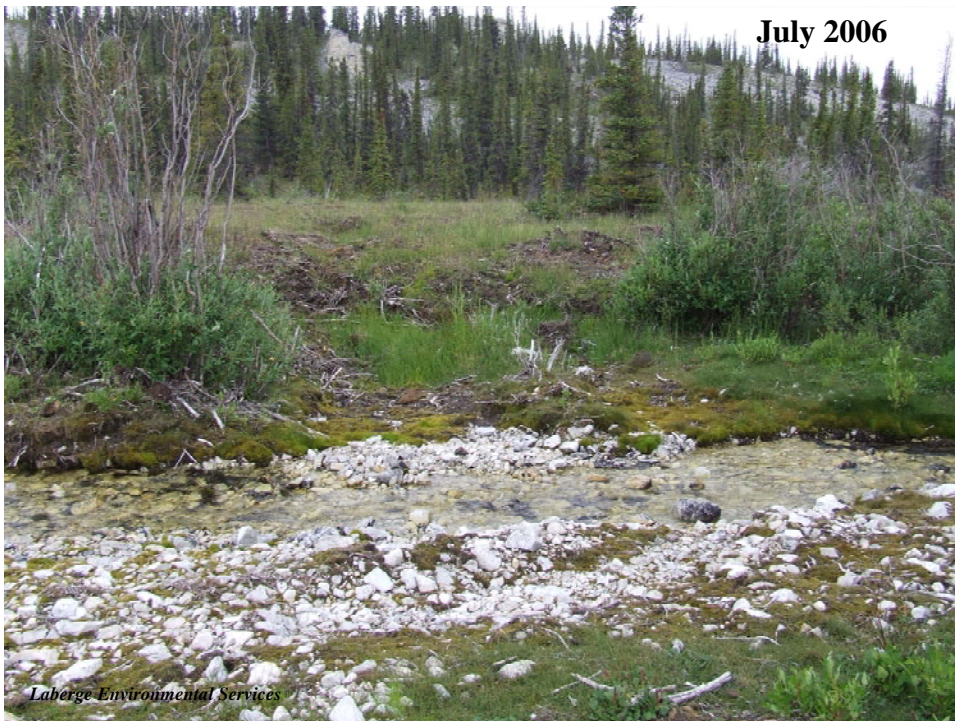
Photo # 24:Site 6; grasses are becoming established on the lower approach to the upper creek crossing on July 12th, 2006.

Some levelling of the downslope approach was conducted with hand tools on July 21st, 2005, which has increased the stability and enhanced the return to original conditions. (Photos 24 and 25).

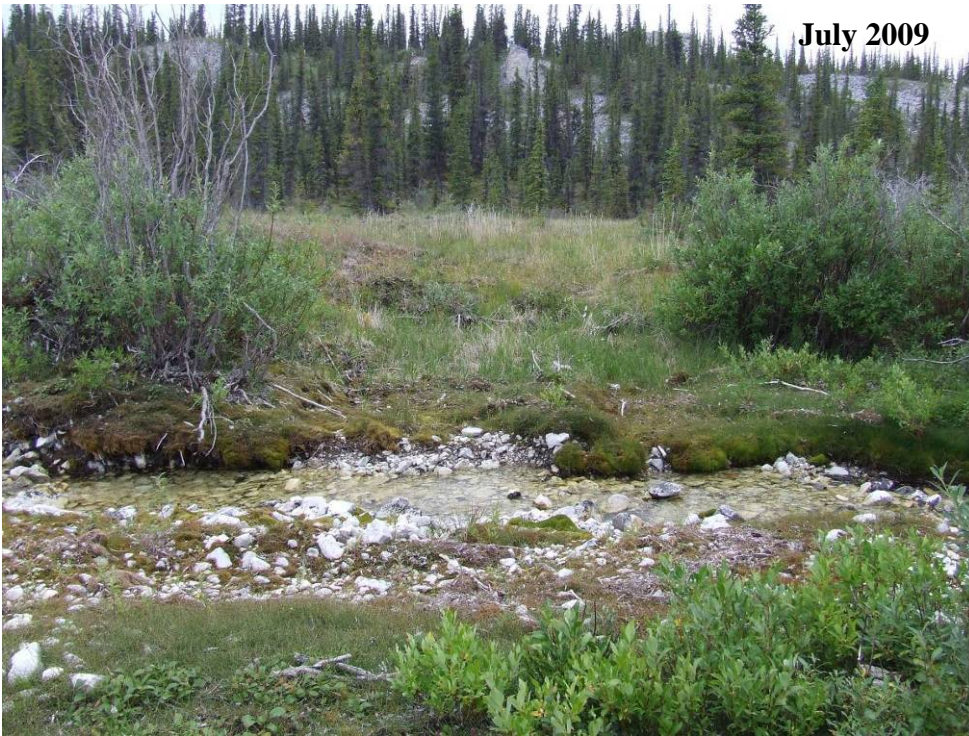
Photo # 25: Site #6; the lower approach continues to revegetate naturally, July 24, 2009.

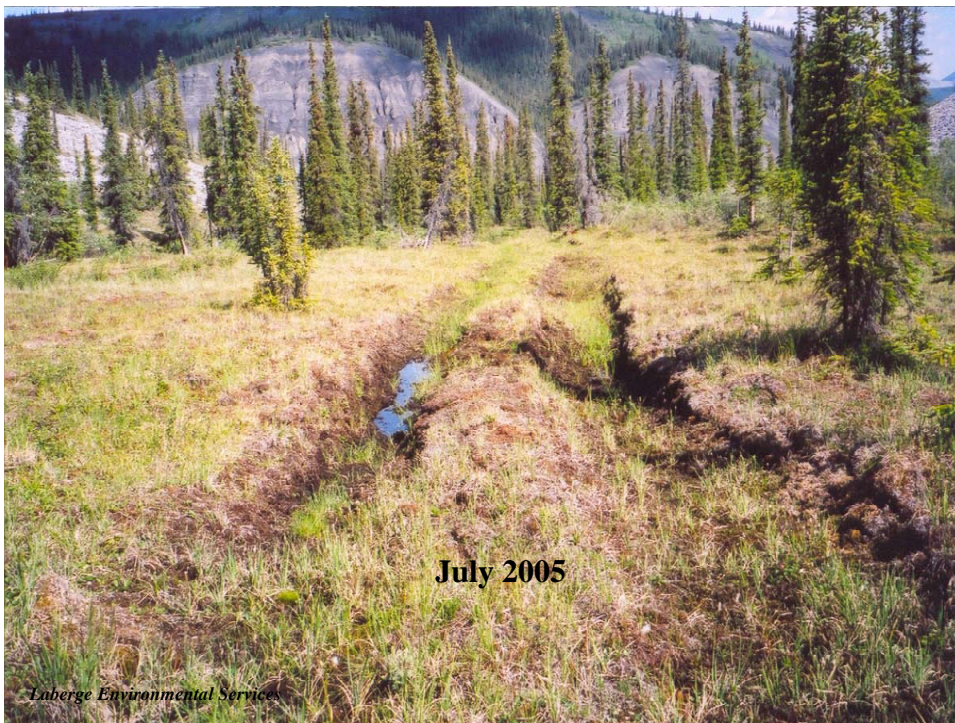
The trail was relatively unaffected for approximately 50m from the upper creek crossing to a set of fairly deep ruts (Site 7). The standing water within the ruts was frozen on September 14th and as the terrain was level no action was taken. During July, some time was spent in backfilling these ruts to ensure that they would not create a problem in the future (Photos 26 to 30).

Photo # 26: Site 7 prior to any amendments, July 13, 2005.

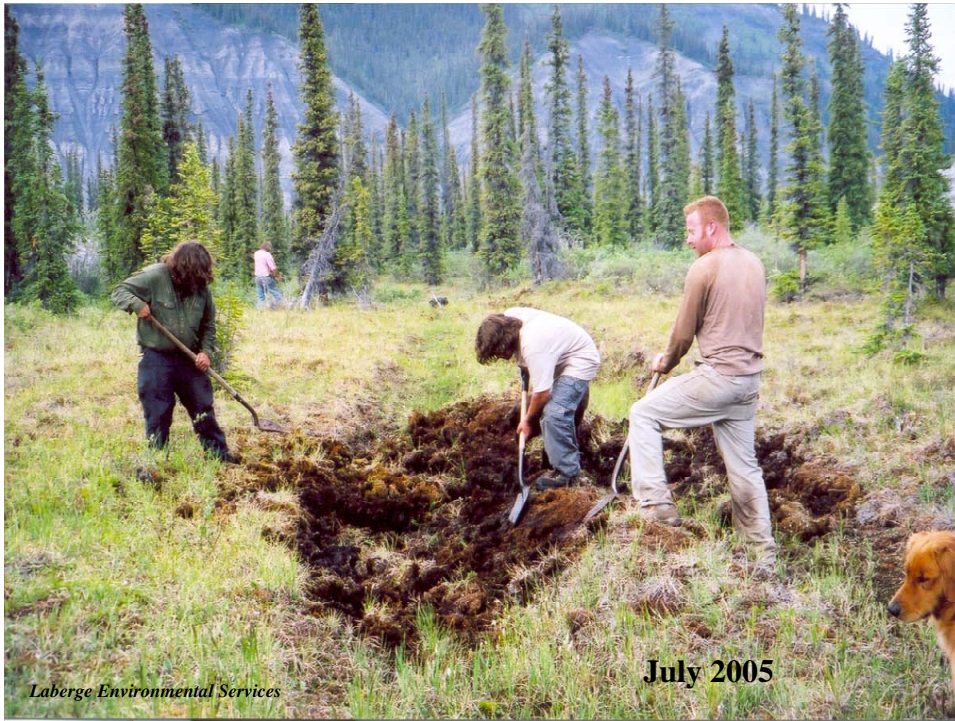
Photo # 27: Leveling and backfilling Site 7, July 13, 2005.

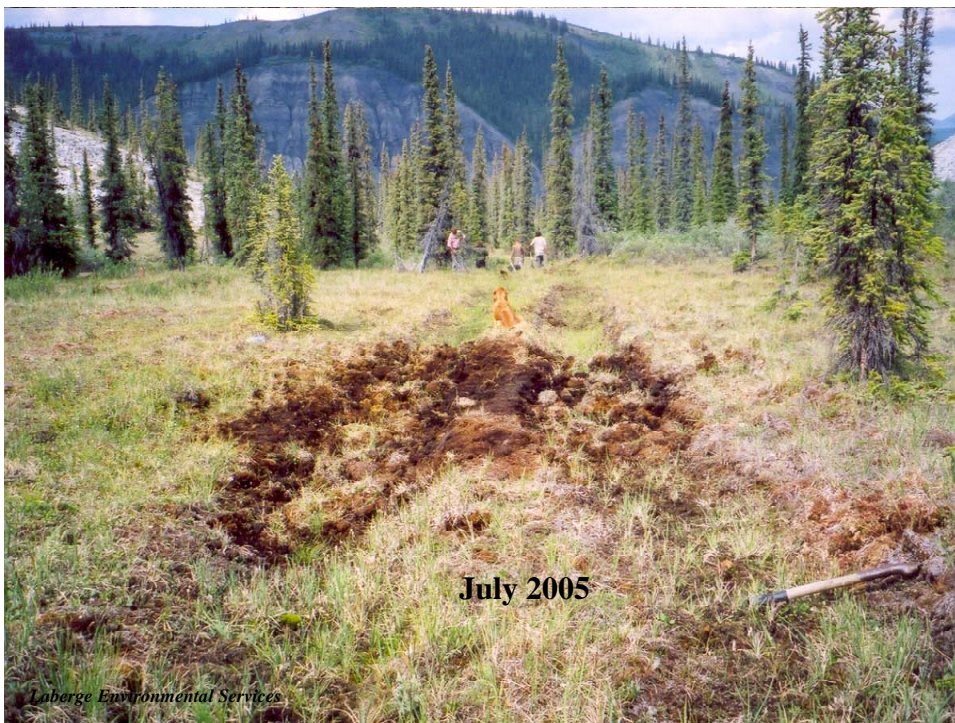
Photo #28: The completion of the remediation work at Site 7 on July 13, 2005.

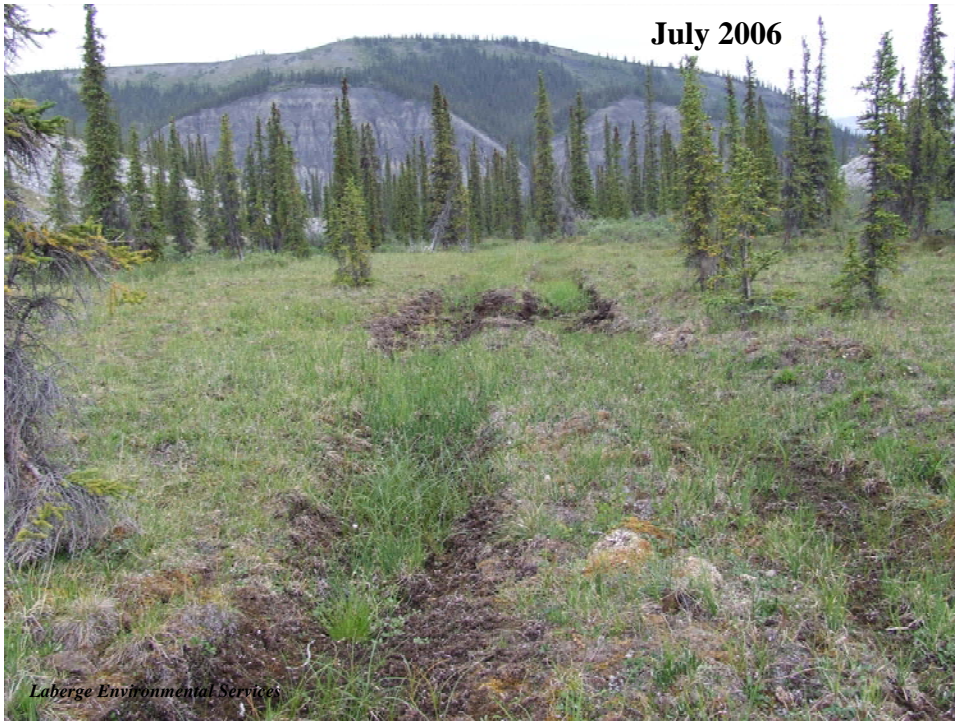
Photo #29 : Grasses are colonizing most of the backfilled ruts at Site 7, July 2006.
