MPERG Report 2010-3

Alternative Methods for the Reclamation of an Exploration Trail off the Dempster Highway, Yukon

Laberge Environmental Services

March 2010

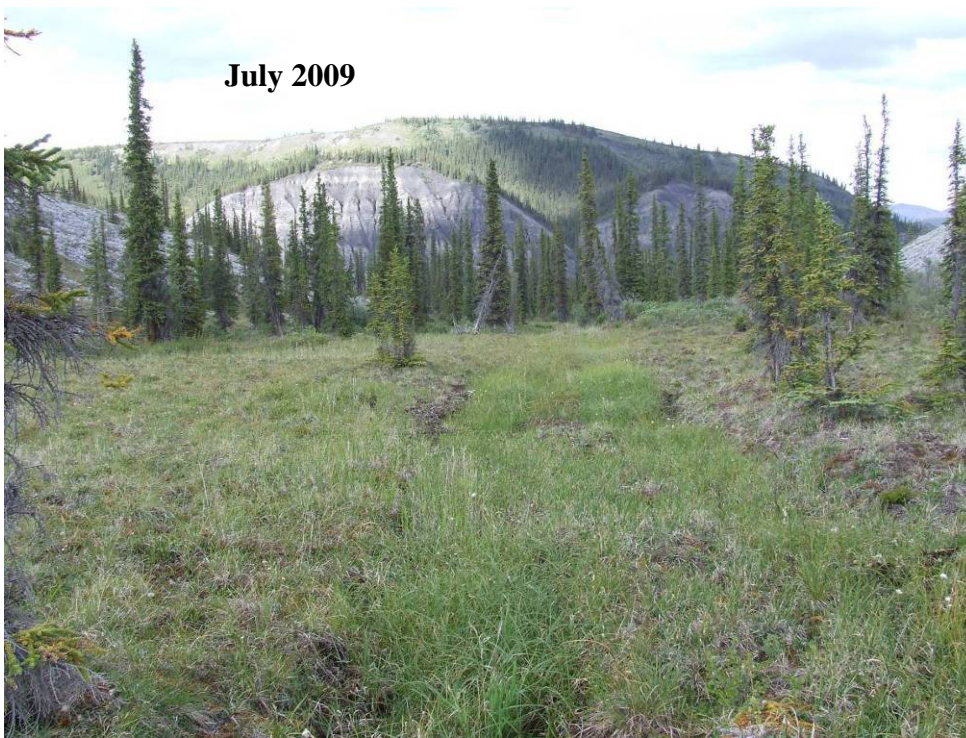
Photo # 30: Grasses have continued to propagate throughout the rutted areas so that on July 24, 2009, the ruts are barely discernible at Site 7.

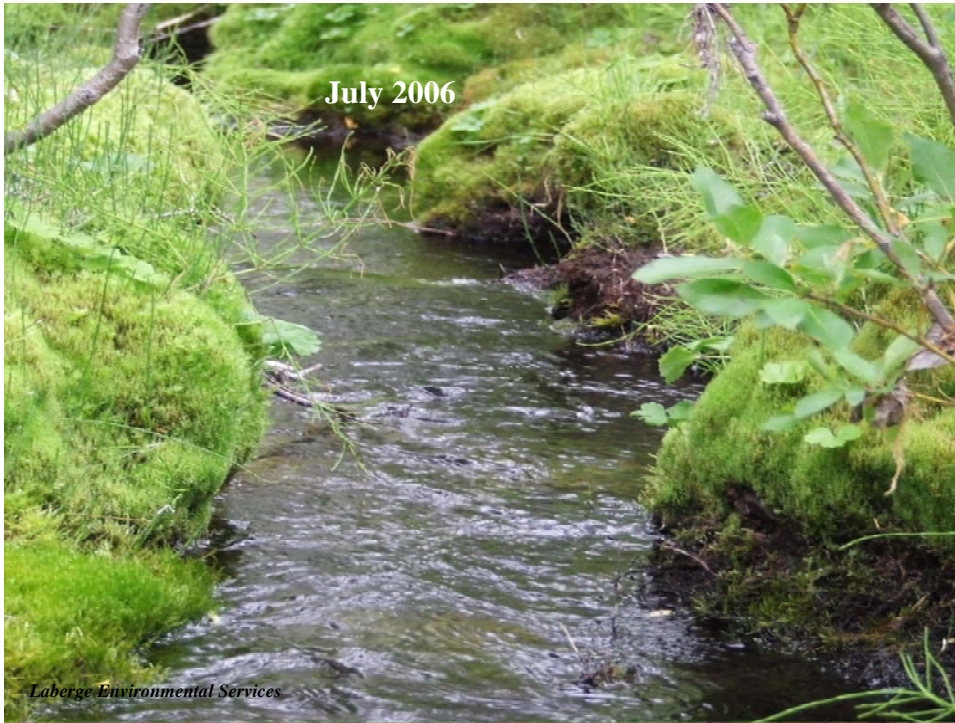
The drilling company appeared to have had problems with the lower creek crossing as there were two separate areas where fords had been created. The original creek channel here is very narrow with willows (predominantly *Salix arbusculoide* and *Salix pulchra*) growing immediately on the banks (Photo). Both fords had created wide shallow areas with the potential for flooding. A great deal of energy was spent live-willow staking along these two fords on September 14th, 2004. Dormant willow cuttings were collected from the streamside and immediate area, and staked along both banks at both of the lower crossings. The intention was that the live cuttings would produce new roots and shoots during the following growing seasons, leading to the re-establishment of a riparian band of willows at these sites. This would confine the channel to control the flow.

Photo #31: Site 10; The original creek channel at the lower creek crossing is approximately 80 cm wide and 20 cm deep.

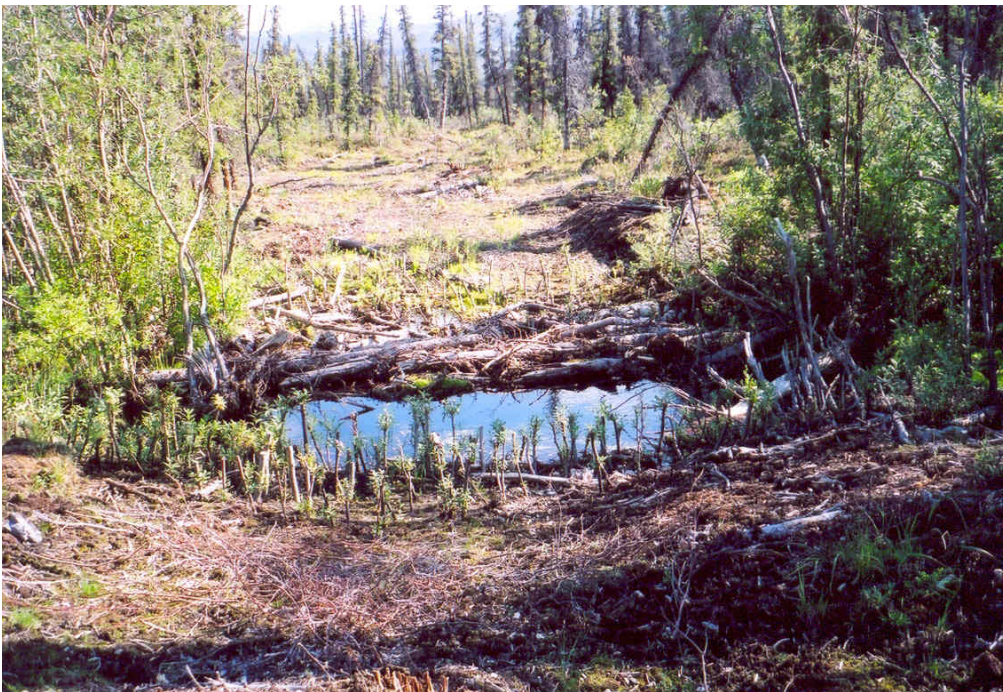
The live staking was very successful and no further stabilization work was conducted at Site 10 when assessed in July 2005. Subsequent inspections in 2006 and 2009 showed a high success rate of survival. No evidence of flooding or erosion was apparent (Photos 32 to 34).

Photo #32: Site 10; the live willow staking that was installed in September 2004 shows good survival rates in July 2005.

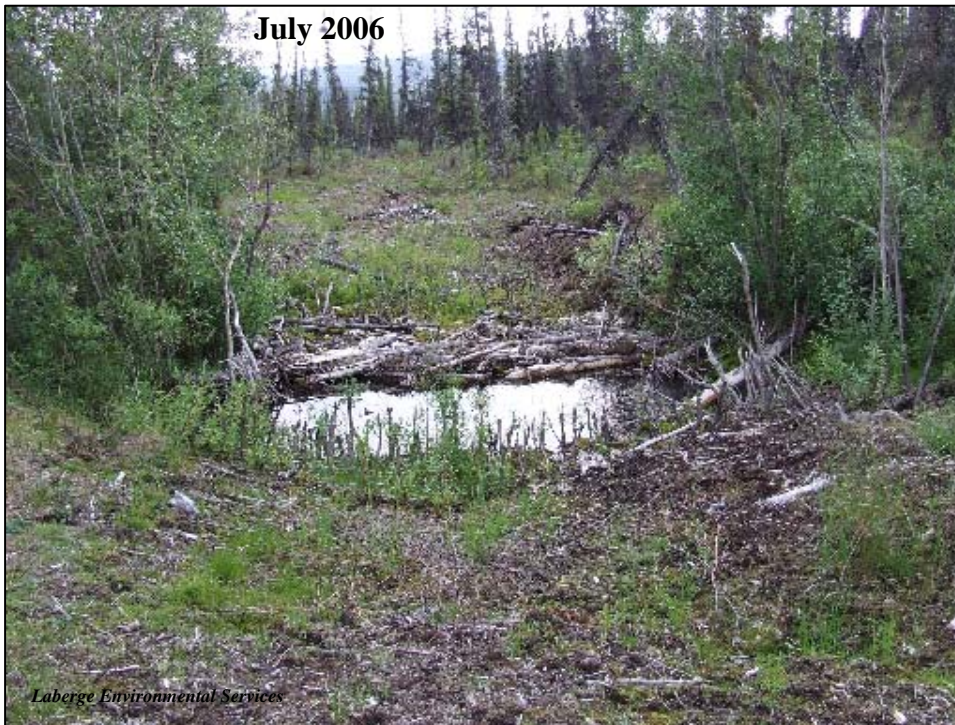
Photo # 33: Site 10; The upper ford of the lower creek crossing shows continued good survival rates of the live staked willows in July 2006.

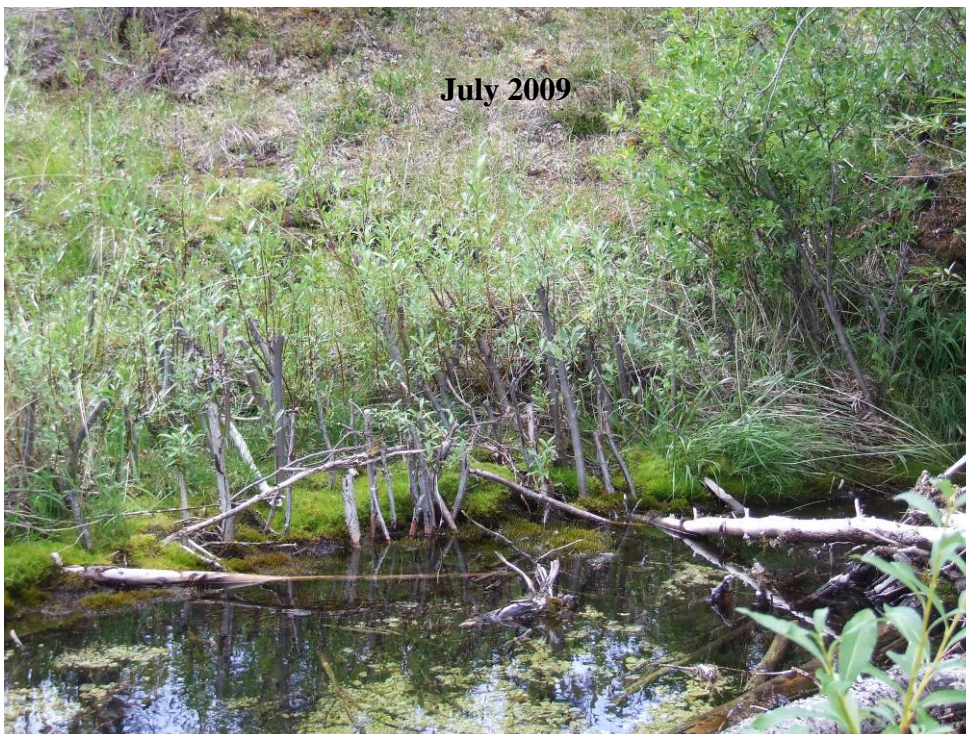
Photo # 34: Site 10; The willow stakes at the lower ford of the lower creek crossing are thriving in July 2009.

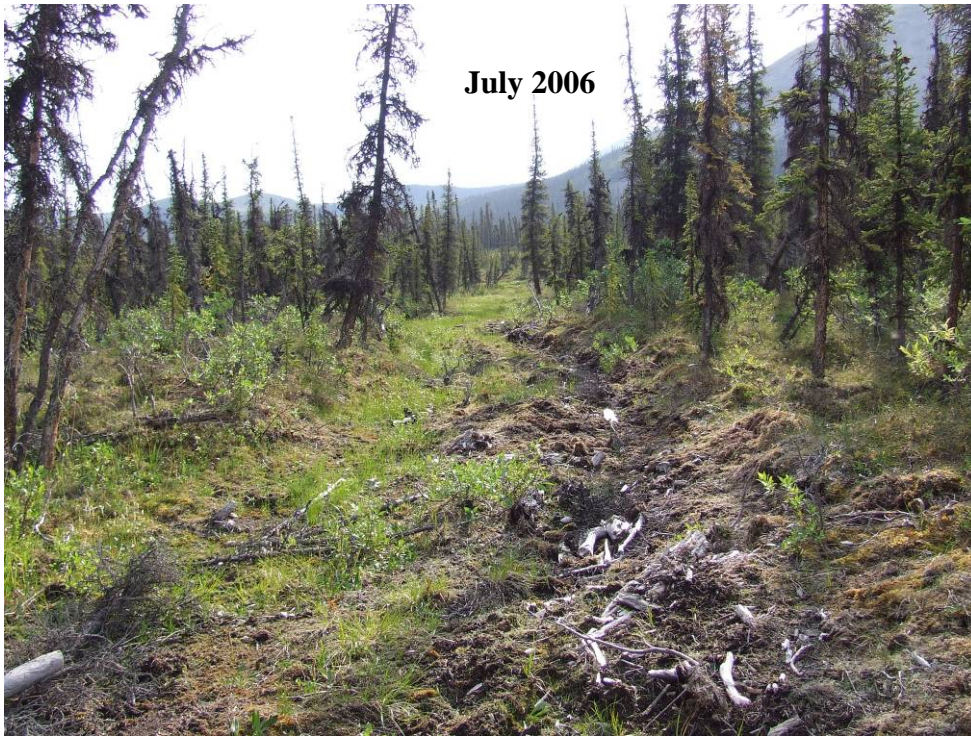
This section encompasses Sites 11 through to 16. There were a couple of dry and wetted rutted segments of the trail below the lower creek crossing. These ruts were backfilled with adjacent material including dead portions of spruce trees in July 2005 (Photos 35 and 36).

Photo # 35: Site 12; The bottom of the rutted section below the lower crossing that was mitigated in July 2005. This photo was taken on July 21, 2006. Portions of dead spruce trees as well as the removed material were used as fill.

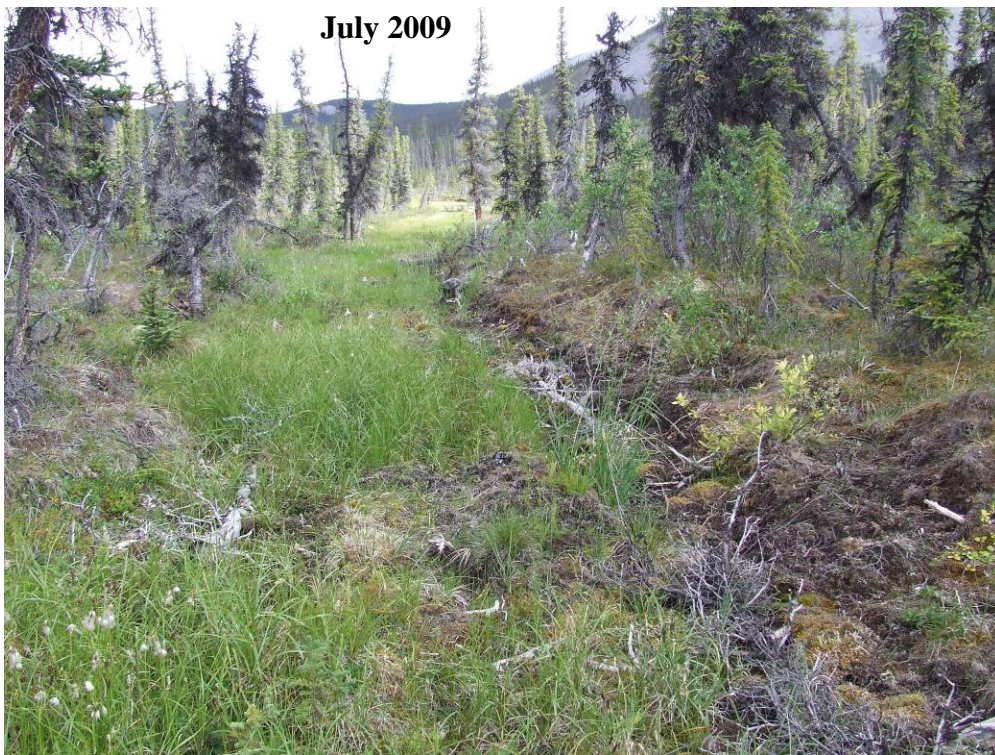
Photo # 36: Site 12 in July 2009 showing increased grass and sedge growth, and stabilized condition.

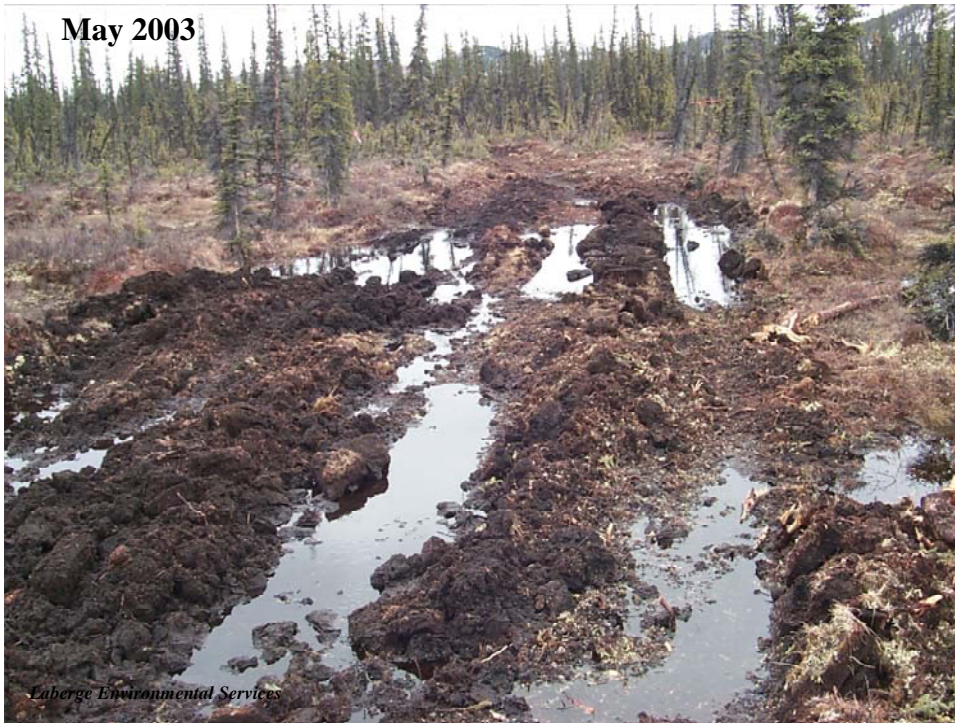
A very wet boggy problem area commenced at Site 15 through to a set of very deep ruts at Site 16. It appears that this large boggy area presented difficulties for vehicles as quite a wide section was disturbed. In September 2004, portions of the surface layer that had been scrapped off that previous winter were placed onto the wetter sections. Sedge seeds (*Carex ssp*) were collected from the immediate vicinity and scattered over the mitigated portions.

Photo #37: A section of Site 15 in May 2003. Photo credit: Al Rothwell, EMR, YG, Dawson City

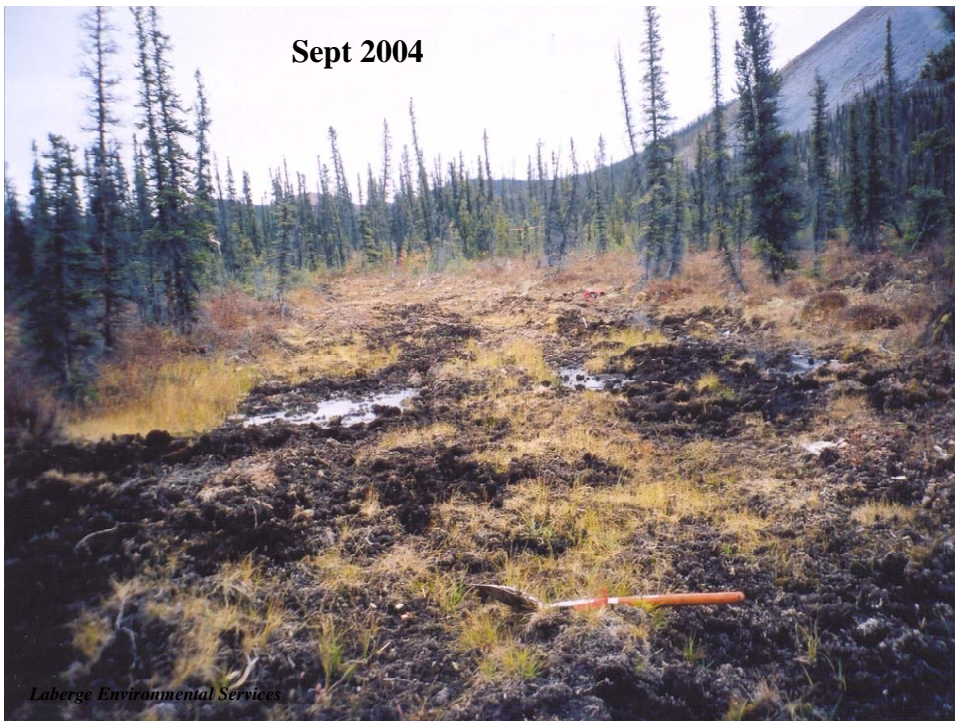
Photo #38 : The same general area of Site 15 in September 2004 after initial remediation.

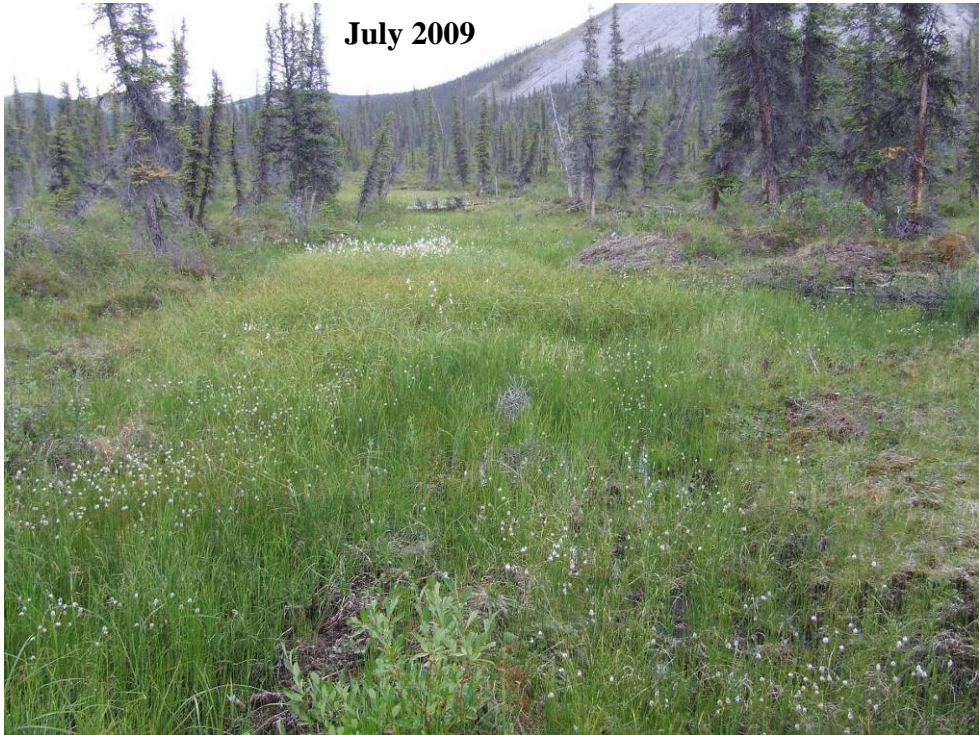
Photo #39 : The same general area of Site 15 in July 2009 showing excellent results from the amendments applied in July 2005.

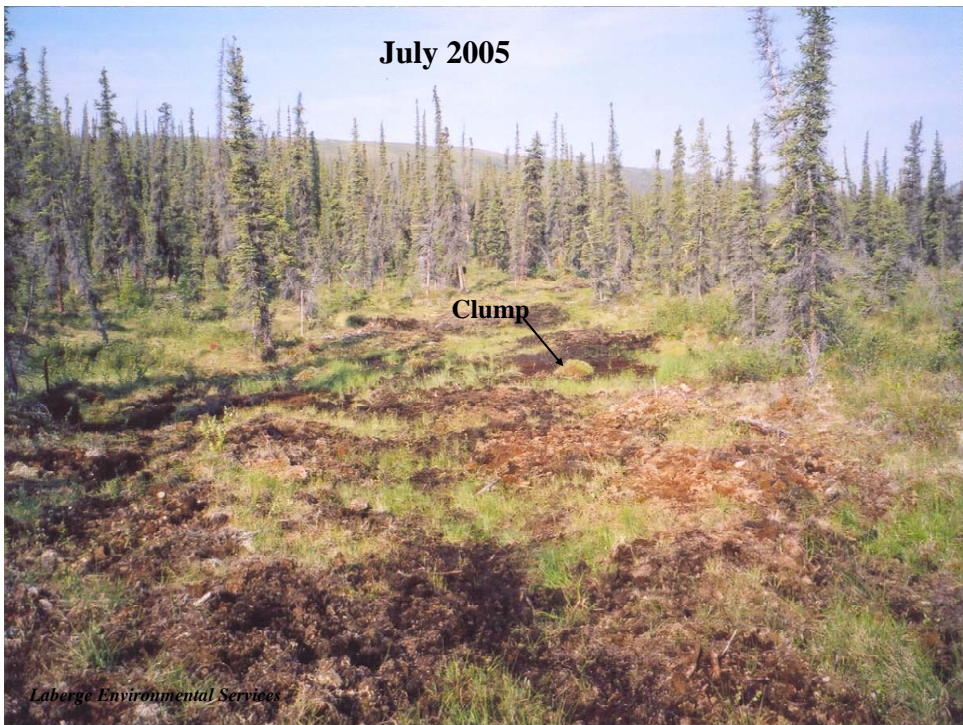
In July 2005 a great deal of standing water was present and efforts were concentrated throughout this area. Following recommendations by EMR, loads of peat collected from a stockpile at Km 187, were brought in on July 24th to assist in the absorption of the moisture and hopefully build up the insulation layer again. This method had been used the previous day to fill in the deep ruts at Site 16, described in detail below. It was becoming apparent that this method was far too labor intensive and time consuming and would not permit completion of the mitigation project within the given budget and time constraints. Alternatively, clumps of moss and vegetation were harvested from the undisturbed areas nearby and placed into the disturbed area. This had the added advantage of introducing mature plants to the site that could then spread over time. During the July 21st 2006 visit, areas of standing water were still present, but is typical of this vicinity and pockets of standing water exist in the undisturbed areas adjacent to the trail. Lush areas of sedges were colonizing portions of the treated areas. Increased growth was observed in July 2009. Photos 37 through to 42 display the site before any mitigation methods were employed plus the site over time.

Photo # 40: A section of Site 15 looking west, after the site had been mitigated with clumps of vegetation and peat moss, July 2005.

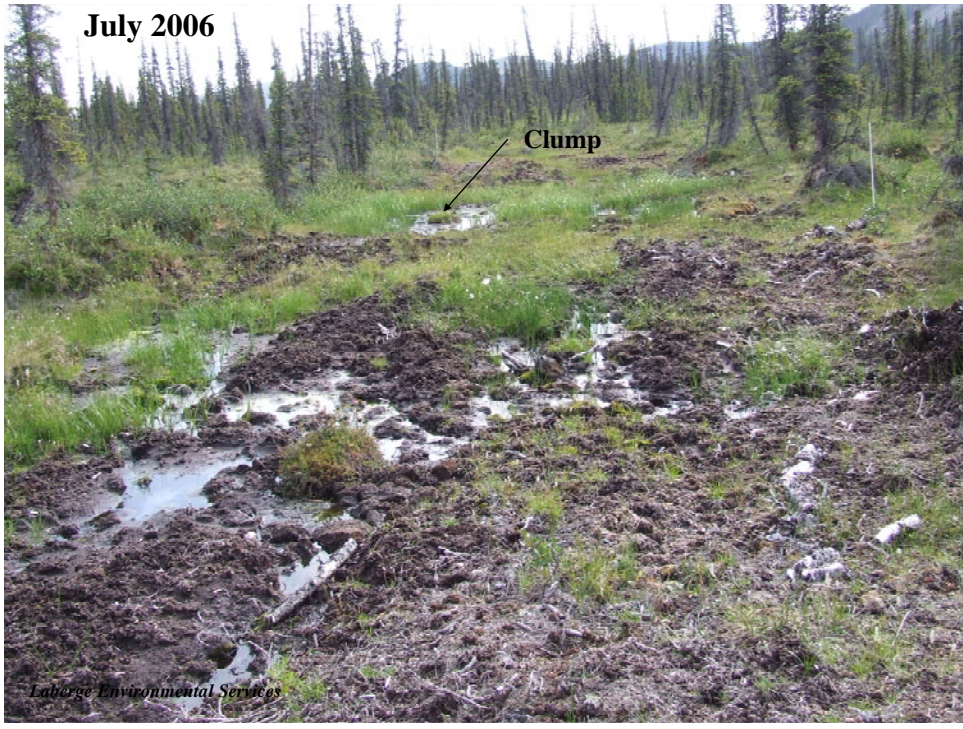
Photo # 41: Site 15; looking east along the mitigated trail toward the large clump in July 2006. Standing water is present, however this is typical of this particular area.

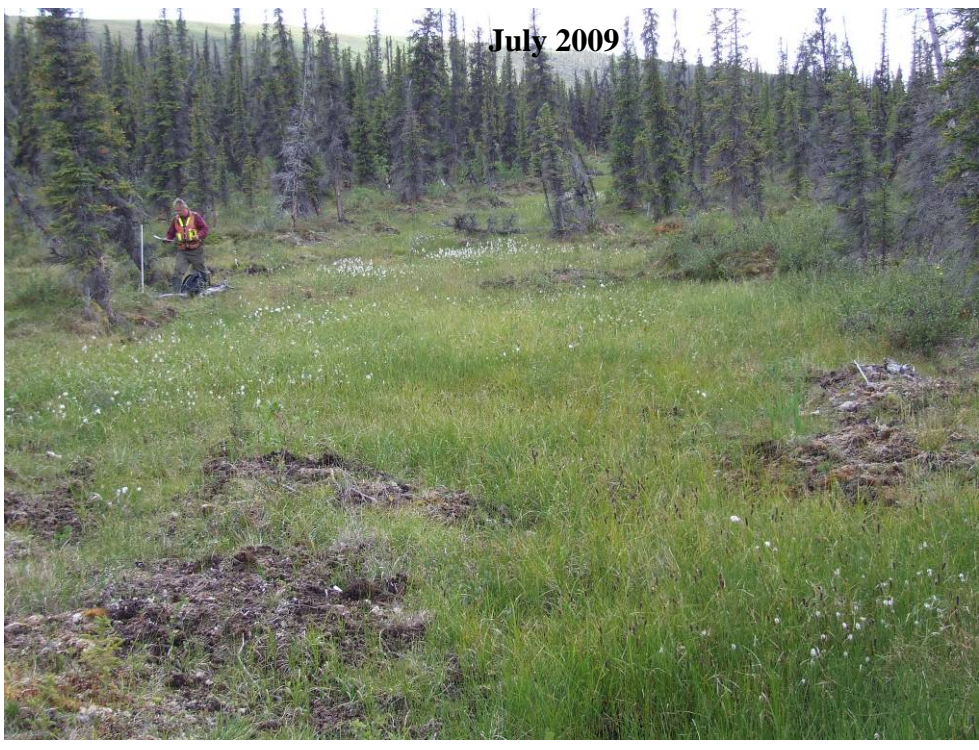
Photo #42 : Site 15 looking west, July 2009. Significant cover of grasses and sedges.

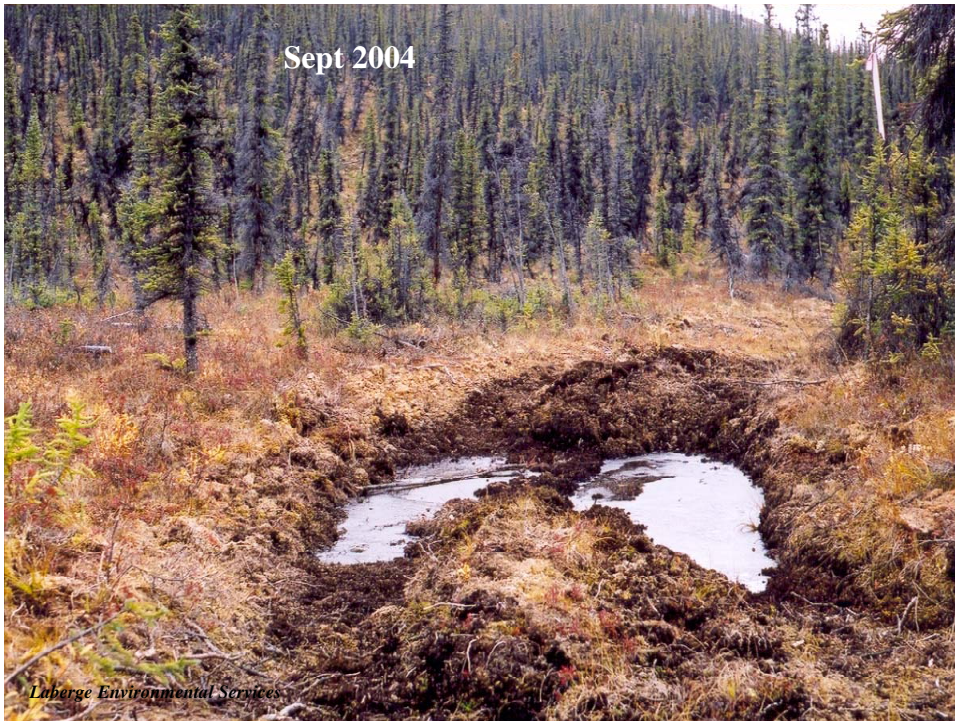
The very deep set of ruts, Site 16, was frozen during the initial inspection in September 2004 (Photo 43). The only mitigation that could be performed at this time was the placing of dead trees on top of the ice to help absorb and slow down flow during the following spring melt. This was the first site where the application of peat to aid in the absorption of the standing water was employed as a mitigation method that had been recommended by EMR. Truckloads of peat were hauled as close to the trailhead as possible over the rocky dry riverbed. The peat was shoveled onto tarps and then carried to the site by four people with one at each corner (Photo 44). After approximately 25 tarp loads, the set of ruts appeared to be covered (Photos 45 and 46). However, this process took one full day and only one impacted site had been repaired. It was important not to introduce any mechanical disturbance to this sensitive area, and the use of all terrain vehicles for moving the peat was rejected. It is interesting to note, that the numerous trips made by foot were creating an impact from the trailhead to Site 16.

Photo #43: The deep ruts at Site 16 were frozen in September 2004.

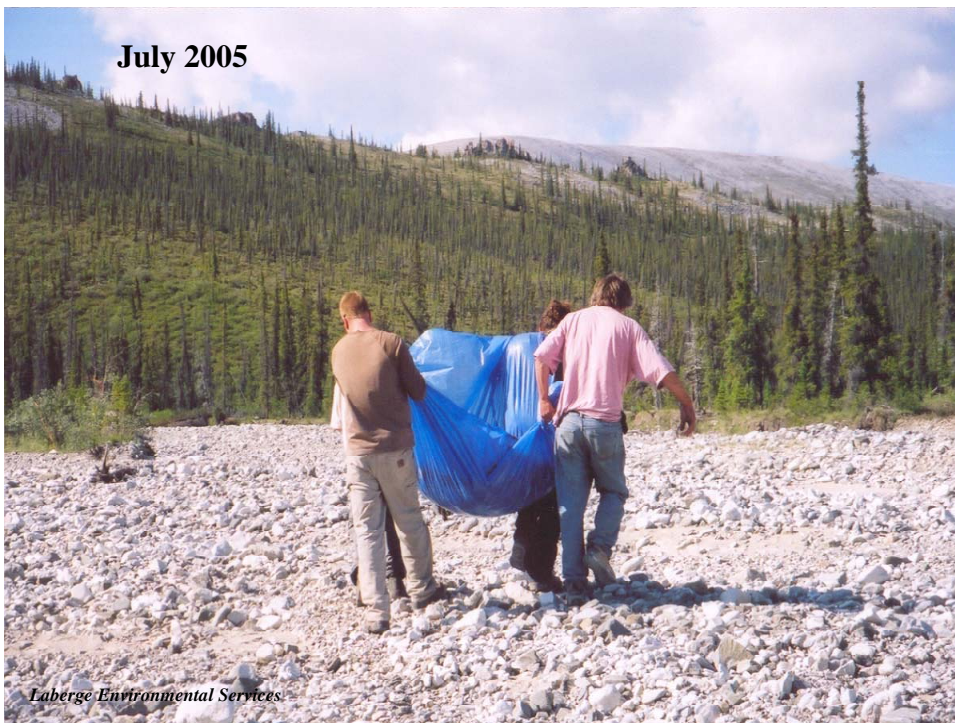
Photo # 44: Tarp loads of peat are hauled across the dry river bed to the trail head to be deposited into the ruts at Site 16.

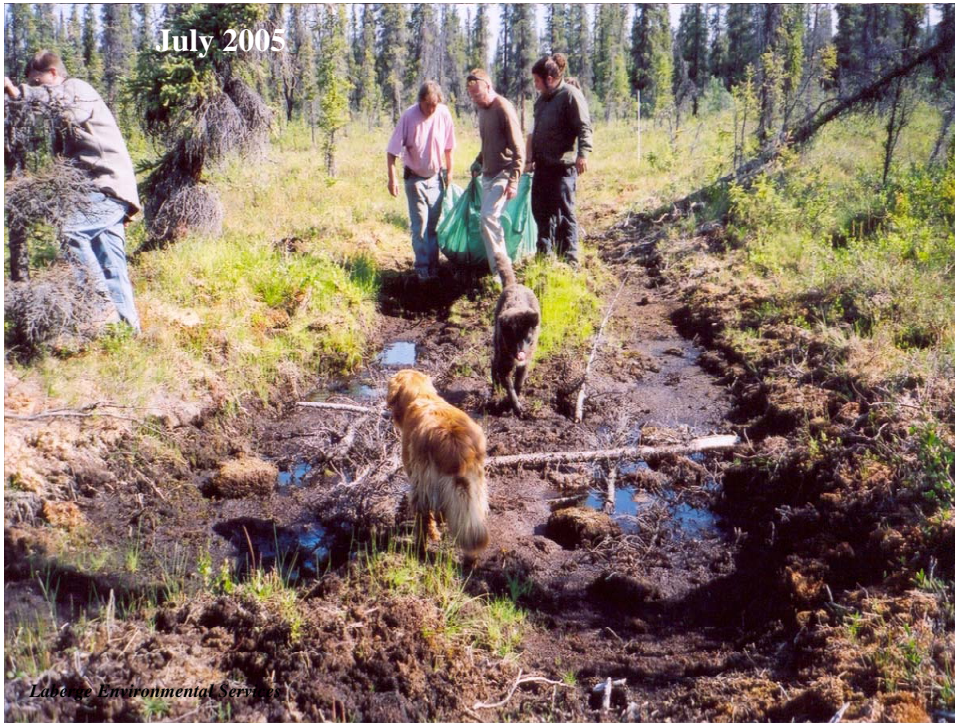
Photo #45: The peat and dead trees were used as fill to remediate the deep ruts, July 2005.

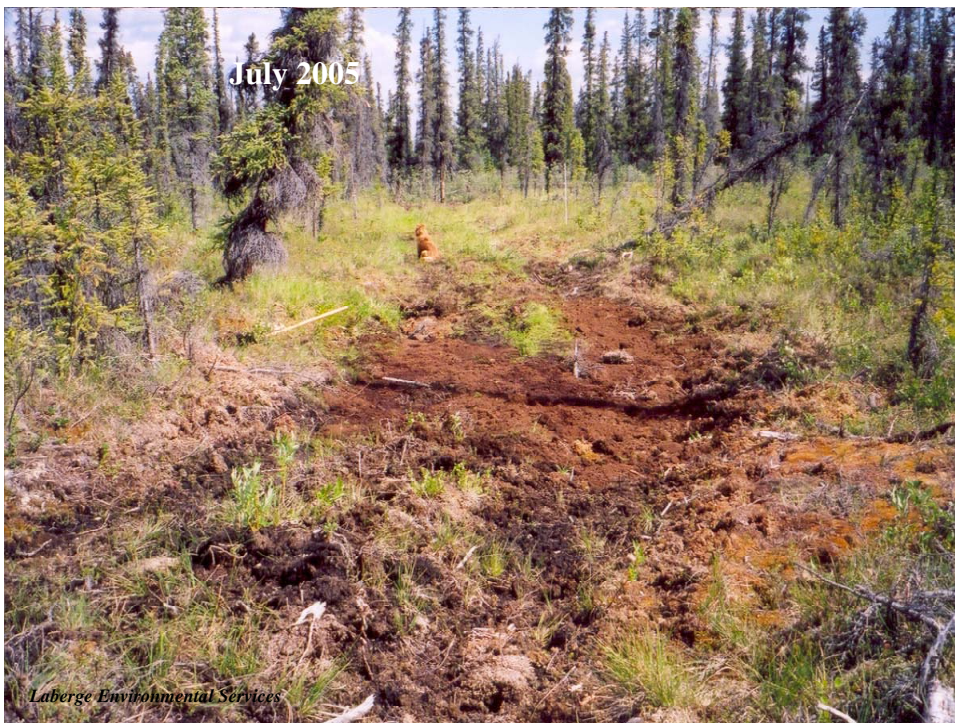
Photo #46: Site 16 appears to be mitigated following 25 tarp loads of peat on July 19th, 2005.

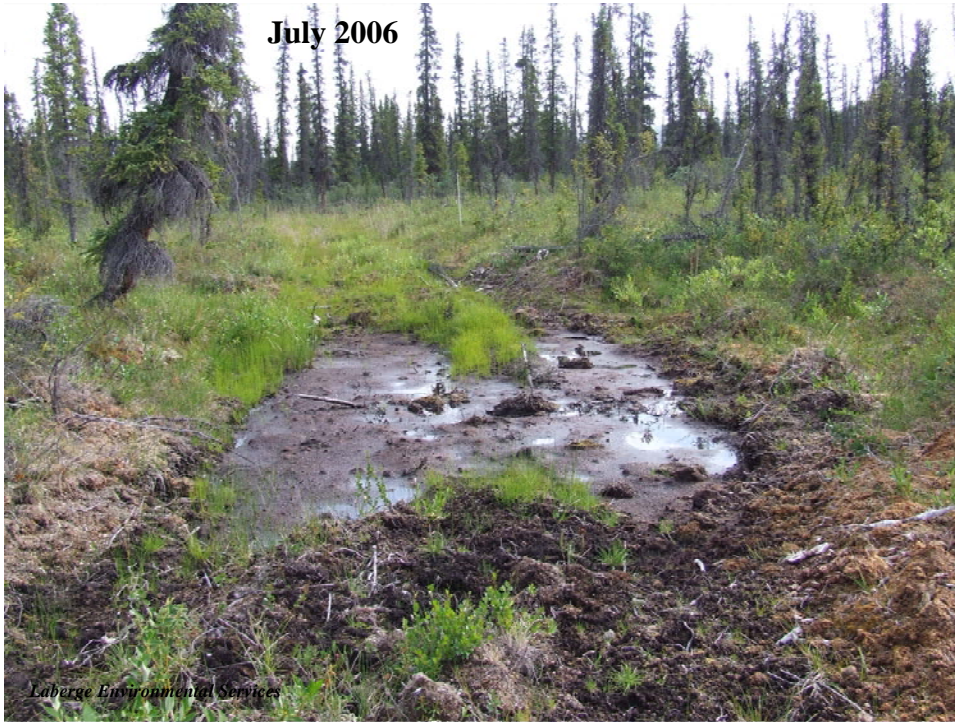
A year later, the applied loads of peat were not sufficient to absorb the water and the presence of pooling was observed (Photo 47). Clumps of vegetation had not been added to this area as they had been at Site 15, but it is probable that if this had been done, some invasion of plants may have commenced. By 2009 significant colonization had occurred however the site was still soft and spongy (Photo 48).

Photo #47: A year later the applied loads of peat were insufficient to absorb the water and Site 16 was boggy in July 2006.

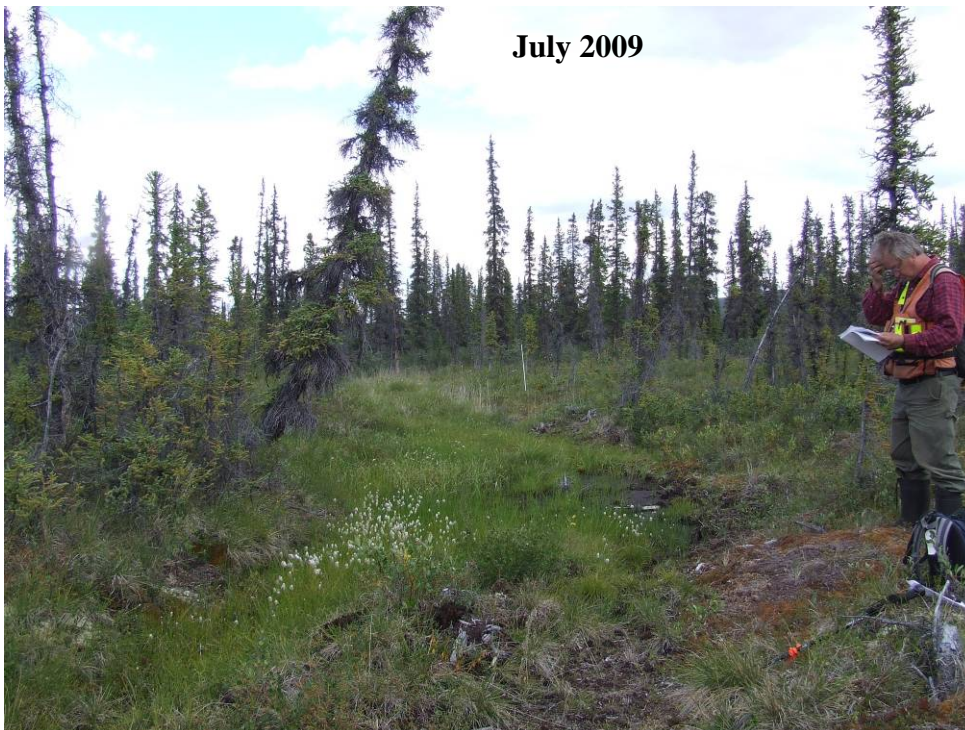
Photo #48: By July 2009 however, a significant cover of sedges was established although the site was still soft.

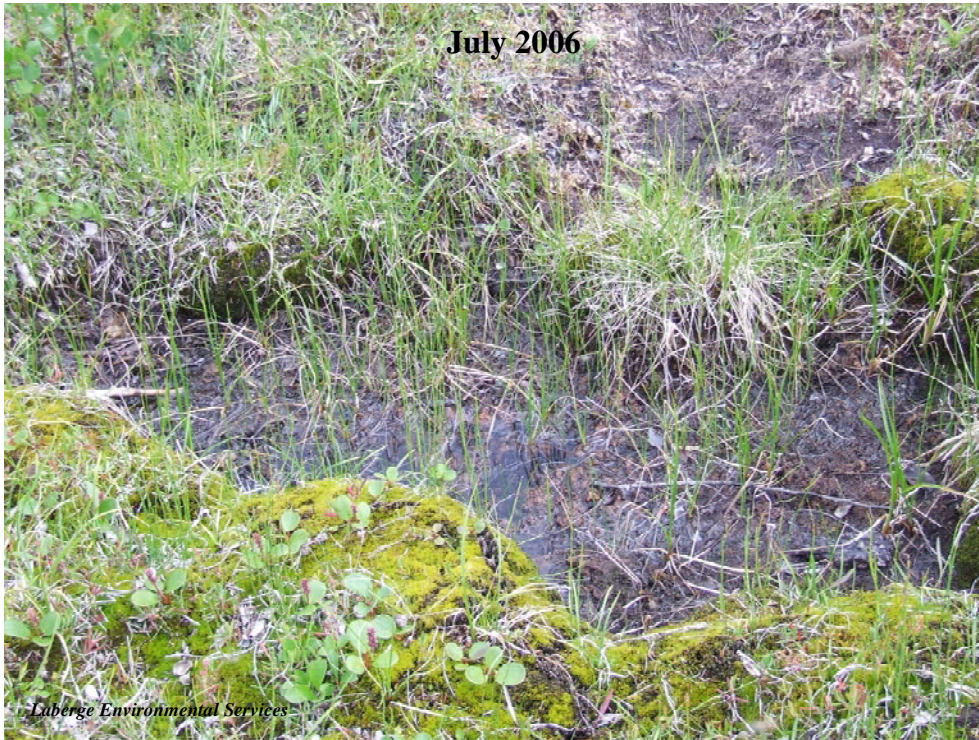
Attempts were made in 2009 to locate these donor sites to determine if they had recovered over the ensuing years. Some of the donor sites were not obvious and others were slower to recover. It appeared that those removed from the wetter areas recovered faster than those collected from drier zones (Photos 49 and 50).

Photo # 49: By July 2006, less than a year from removing the material from this donor site, grasses and sedges have begun to colonize the cavity.

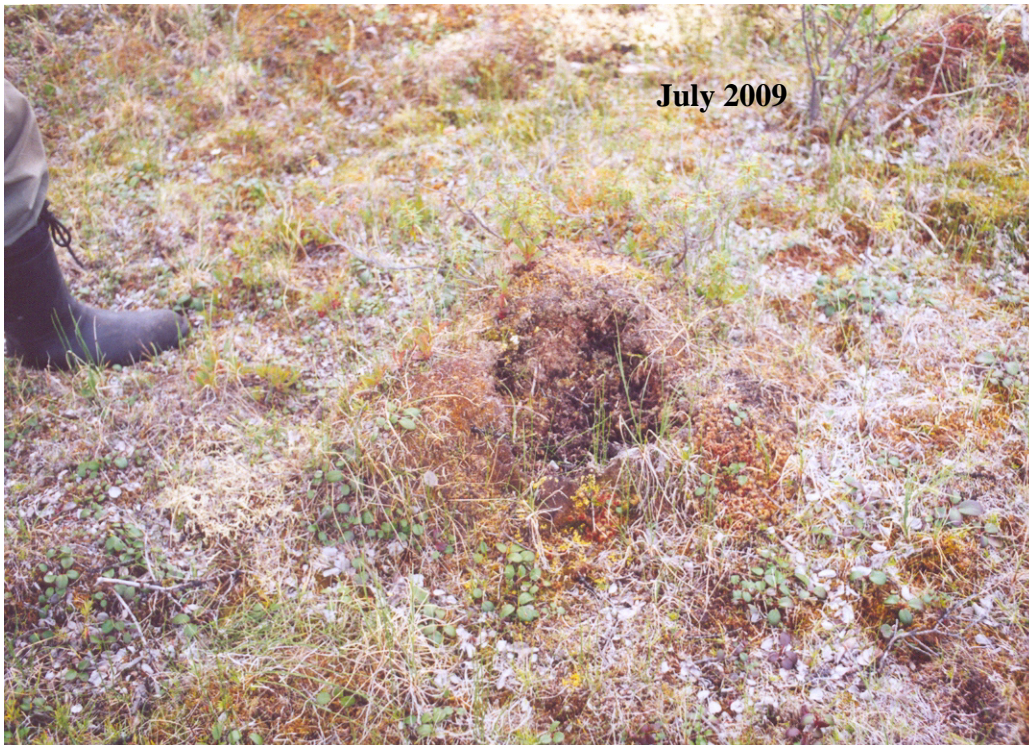
Photo #50: A donor site from one of the drier areas has shown slow recovery by July 2009 with just a few blades growing.
