Yukon Geological Survey Miscellaneous Report 17

Inventory of mass movement geohazards along the Dempster Highway, Yukon

Robin J. McKillop, Courtenay E. Brown, Daniel J. McParland and David A. Sacco
Palmer Environmental Consulting Group Inc.
and Jim Coates
Kryotek Arctic Innovation Inc.

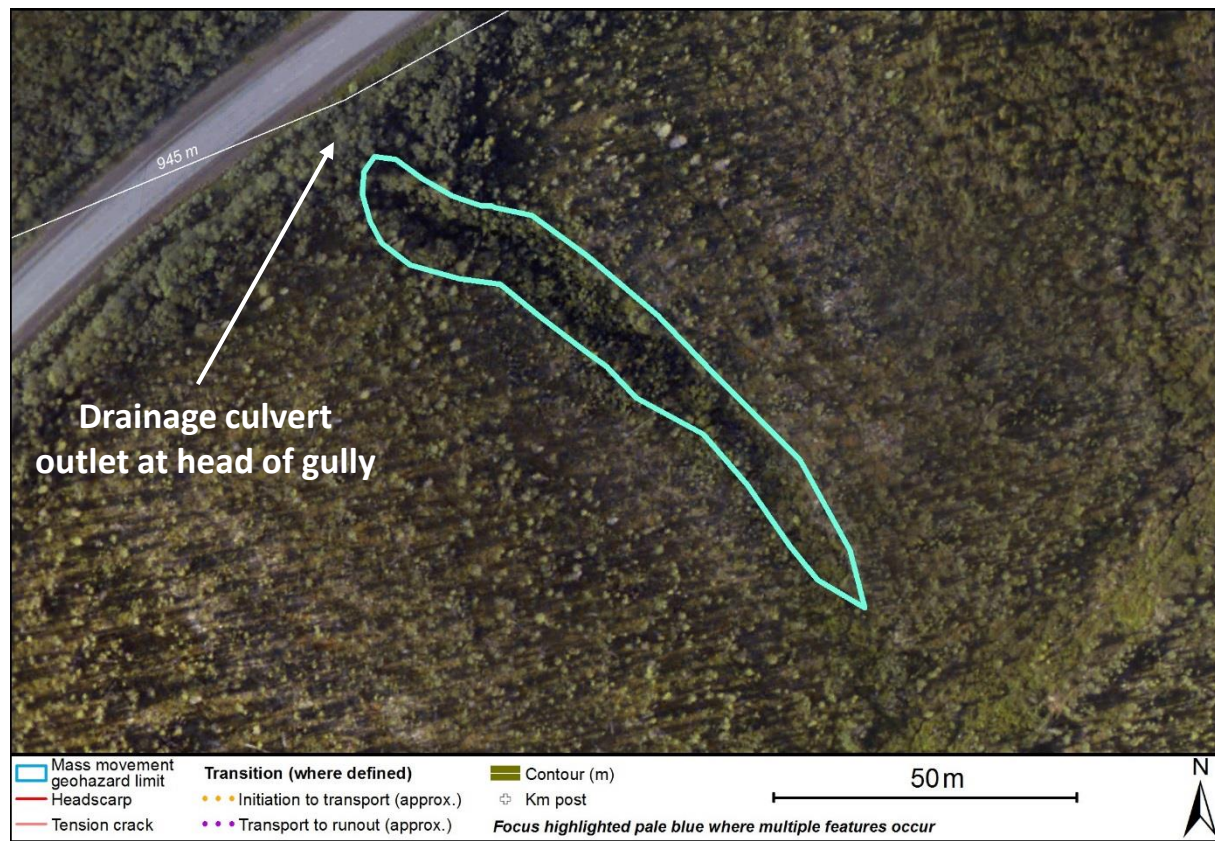
Project: Dempster Geohazard Investigation Project number: 14132 Client: Yukon Government
		KM 60.7

SITE	PROCESS	GEOMETRY	IMPLICATIONS
Section	Type	Elevation (m)	Likelihood
Klondike	thermokarst gully	933	L
Proximity (m)	Position	Length (m)	Consequence
10	below	113	M
Aspect (°)	Causes	Width (m)	Risk
120	concentrated drainage	12	L
Surficial material	Triggers	Depth (m)	Mitigation
szcFa	intense rainfall/snowmelt	3	Management of surface runoff from culvert
Permafrost	Timing	Average slope (°)	Comments
Shallow permafrost, likely locally ice-rich	Ongoing/episodic, likely initiated following highway construction	4

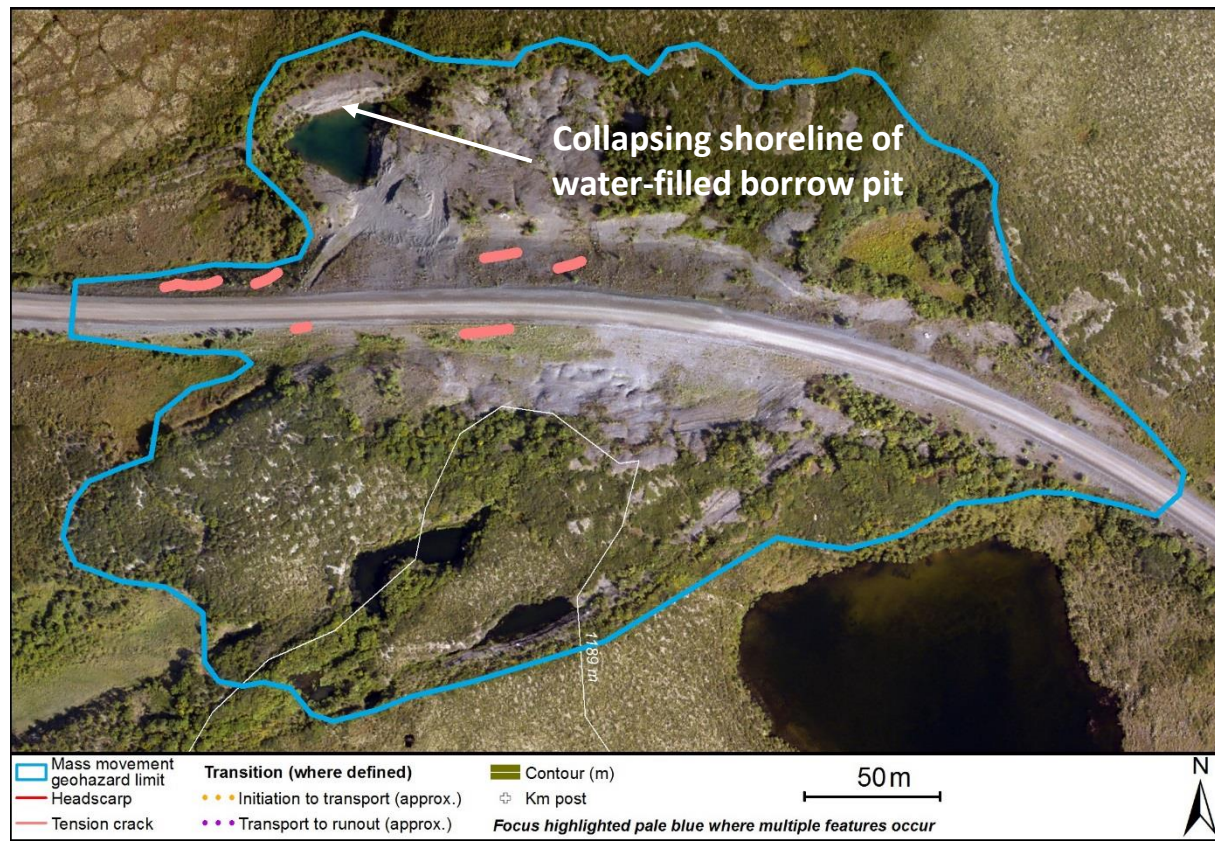
Project: Dempster Geohazard Investigation Project number: 14132 Client: Yukon Government
		KM 85.5

SITE	PROCESS	GEOMETRY	IMPLICATIONS
Section	Type	Elevation (m)	Likelihood
Klondike	thermokarst subsidence	1180	M
Proximity (m)	Position	Length (m)	Consequence
0	beneath	360	L
Aspect (°)	Causes	Width (m)	Risk
240	alteration to surface organic cover, alteration to drainage, permafrost degradation	235	L
Surficial material	Triggers	Depth (m)	Mitigation
dszMu	intense rainfall/snowmelt or heat	<2	Management of ground settlement
Permafrost	Timing	Average slope (°)	Comments
Shallow, ice-rich permafrost in area of degrading ice-wedge polygons	Ongoing/episodic, likely exacerbated by highway construction	3	Differential settlement expected to continue affecting hwy embankments

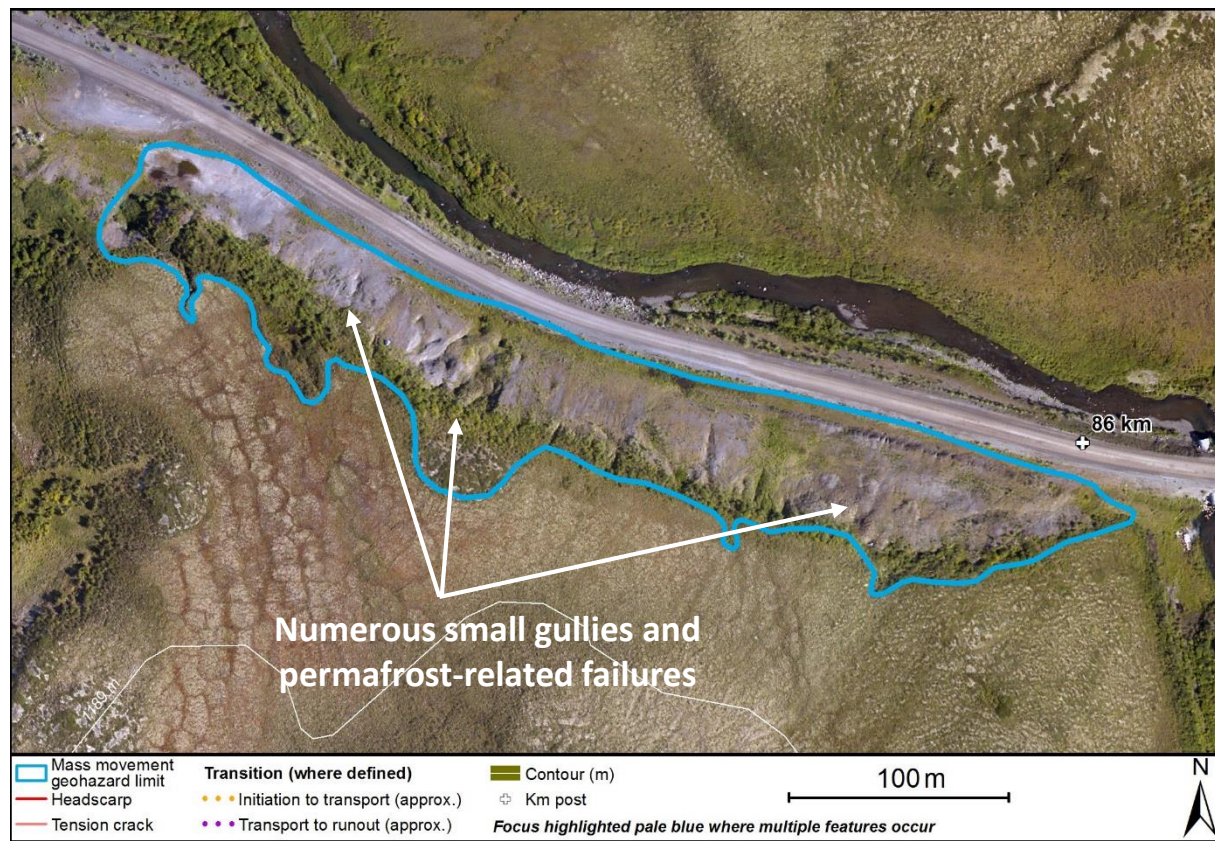
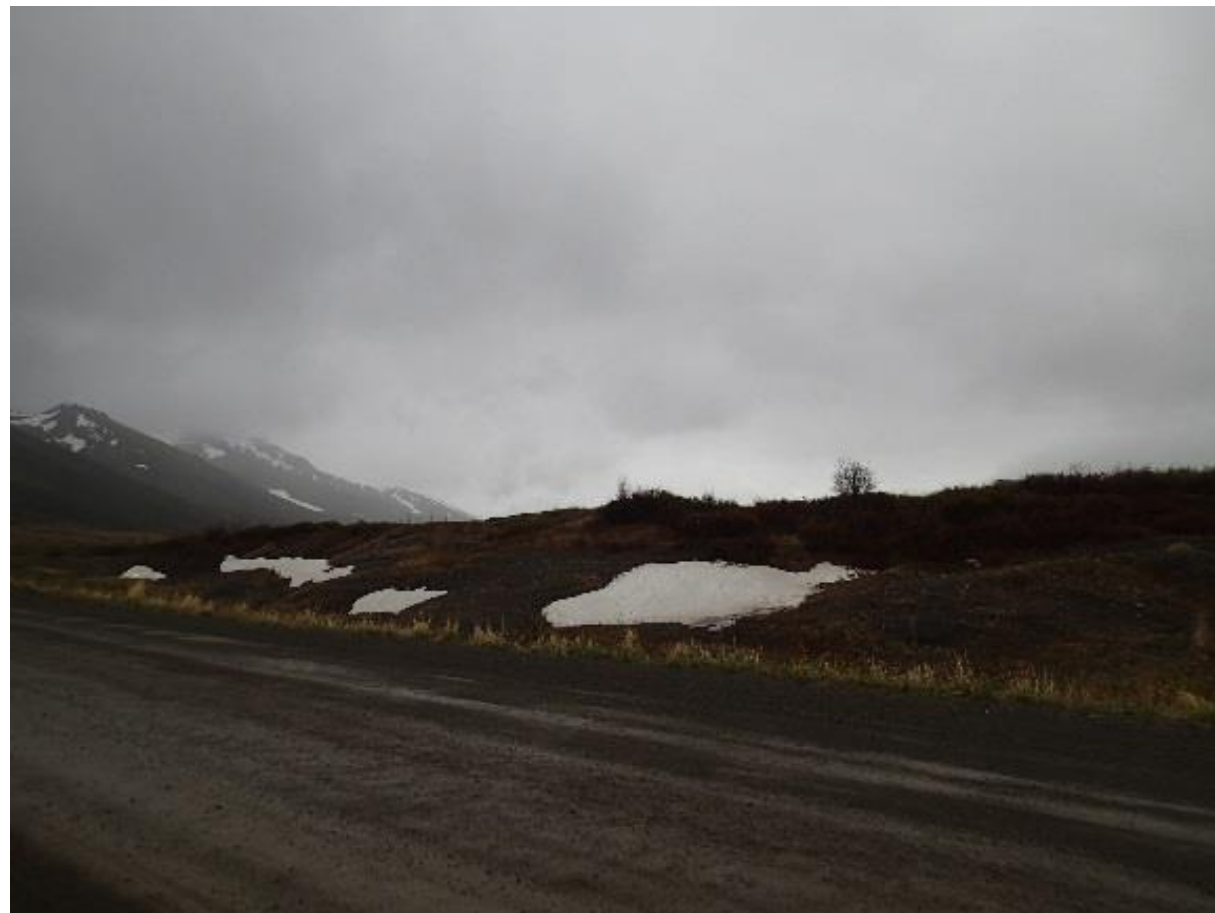
SITE	PROCESS	GEOMETRY	IMPLICATIONS
Section	Type	Elevation (m)	Likelihood
Klondike	debris slide (active layer detachment) & thermokarst gully	1170	M
Proximity (m)	Position	Length (m)	Consequence
0	above	55	L
Aspect (°)	Causes	Width (m)	Risk
15	disturbance and possible over-steepening of slope toe, permafrost degradation	420	L
Surficial material	Triggers	Depth (m)	Mitigation
dszMa	intense rainfall/snowmelt or heat	2	Management of runout debris
Permafrost	Timing	Average slope (°)	Comments
Shallow, ice-rich permafrost in area of degrading ice-wedge polygons	Ongoing/episodic, likely exacerbated by highway construction	14	Minor slope deformation expected to continue as ice-wedge polygons thaw

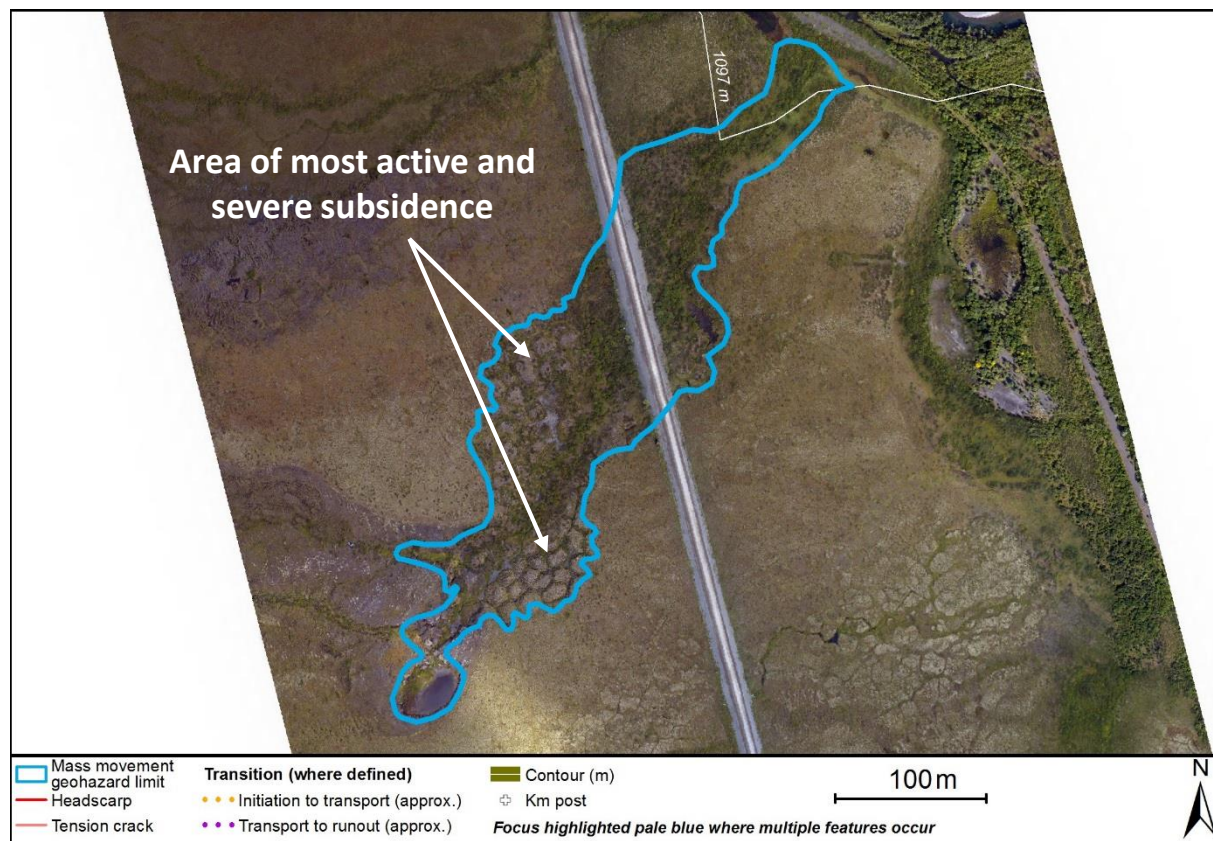
SITE	PROCESS	GEOMETRY	IMPLICATIONS
Section	Type	Elevation (m)	Likelihood
Klondike	thermokarst subsidence	1106	L
Proximity (m)	Position	Length (m)	Consequence
0	beneath	518	M
Aspect (°)	Causes	Width (m)	Risk
55	permafrost degradation	95	L
Surficial material	Triggers	Depth (m)	Mitigation
zsgFf	intense rainfall/snowmelt or heat	2.5	Management of ground settlement
Permafrost	Timing	Average slope (°)	Comments
Shallow, ice-rich permafrost (silt/organics) in area of degrading ice-wedge polygons	Ongoing/episodic, possibly exacerbated by highway construction	1	Area of severest subsidence activity southwest of hwy

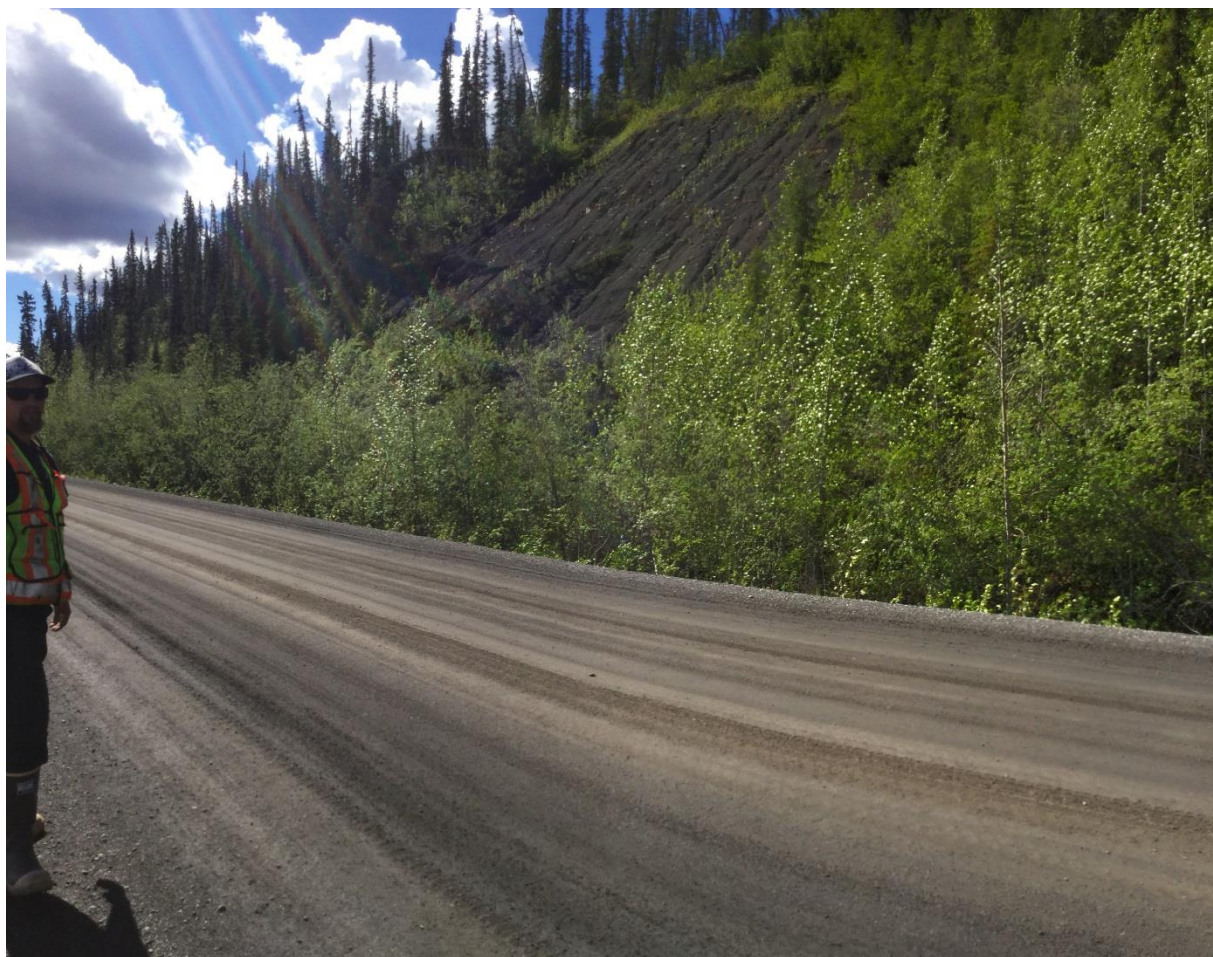
KM 205

SITE	PROCESS	GEOMETRY	IMPLICATIONS
Section	Type	Elevation (m)	Likelihood
Ogilvie	debris slide (active layer detachment)	578	M
Proximity (m)	Position	Initiation slope (°)	Consequence
0	above	29	M
Aspect (°)	Causes	Runout slope (°)	Risk
70	disturbance and possible over-steepening of slope toe, permafrost degradation	24	M
Surficial material	Triggers	Average slope (°)	Mitigation
dszCv	intense rainfall/snowmelt or heat	35	Management of runout debris
Permafrost	Timing	Dimensions (L/W/D) (m)	Comments
Shallow permafrost	Single event (2007-2013) with potential for post-failure sloughs/flows	52 / 52 / 1	Runout limits approximate due to clearing of former debris accumulation

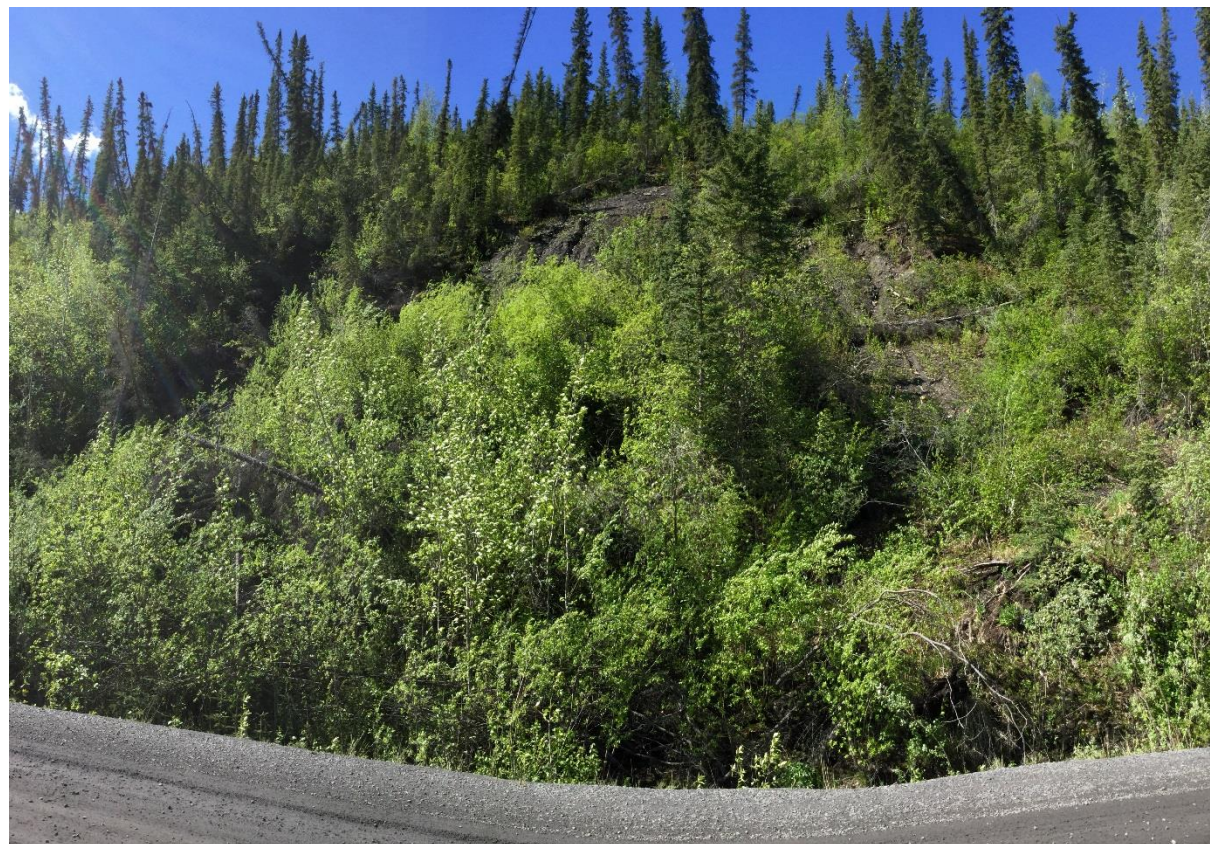
Project: Dempster Geohazard Investigation Project number: 14132 Client: Yukon Government
		<h2>KM 209.5</h2>

SITE	PROCESS	GEOMETRY	IMPLICATIONS
Section	Type	Elevation (m)	Likelihood
Ogilvie	debris slide (active layer detachment)	569	M
Proximity (m)	Position	Initiation slope (°)	Consequence
0	above	42	M
Aspect (°)	Causes	Runout slope (°)	Risk
80	disturbance and possible over-steepening of slope toe, permafrost degradation	17	M
Surficial material	Triggers	Average slope (°)	Mitigation
dszCv	intense rainfall/snowmelt or heat	28	Management of runout debris
Permafrost	Timing	Dimensions (L/W/D) (m)	Comments
Shallow permafrost	Single event (2007-2013) with potential for post-failure sloughs/flows	67 / 63 / <1	Runout limits approximate due to clearing of former debris accumulation

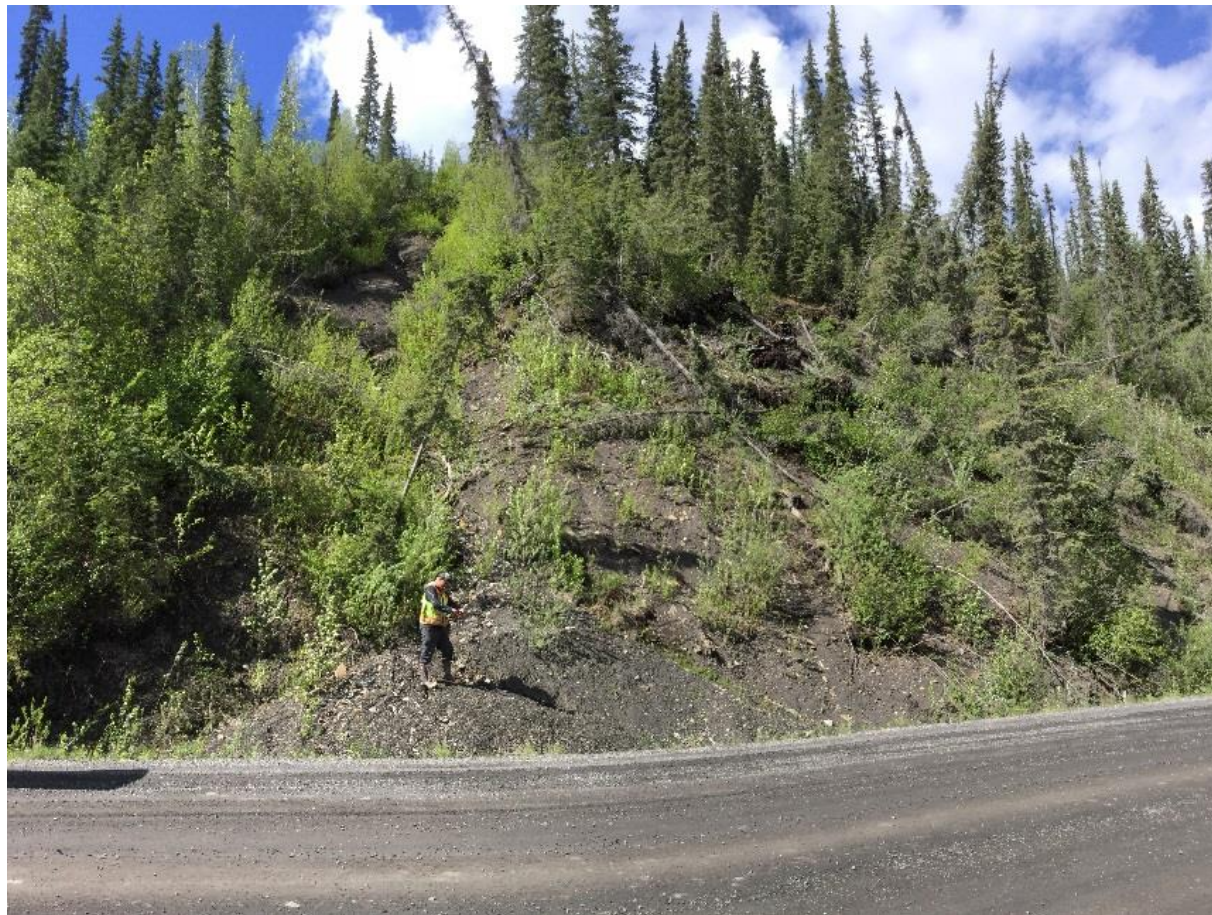
Project: Dempster Geohazard Investigation Project number: 14132 Client: Yukon Government
		<h2>KM 209.6</h2>

SITE	PROCESS	GEOMETRY	IMPLICATIONS
Section	Type	Elevation (m)	Likelihood
Ogilvie	debris slide (active layer detachment)	566	M
Proximity (m)	Position	Initiation slope (°)	Consequence
0	above	50	M
Aspect (°)	Causes	Runout slope (°)	Risk
85	disturbance and possible over-steepening of slope toe, permafrost degradation	14	M
Surficial material	Triggers	Average slope (°)	Mitigation
dszCv	intense rainfall/snowmelt or heat	37	Management of runout debris
Permafrost	Timing	Dimensions (L/W/D) (m)	Comments
Shallow permafrost	Single event (2007-2013) with potential for post-failure sloughs/flows	66 / 54 / <1	Runout limits approximate due to clearing of former debris accumulation

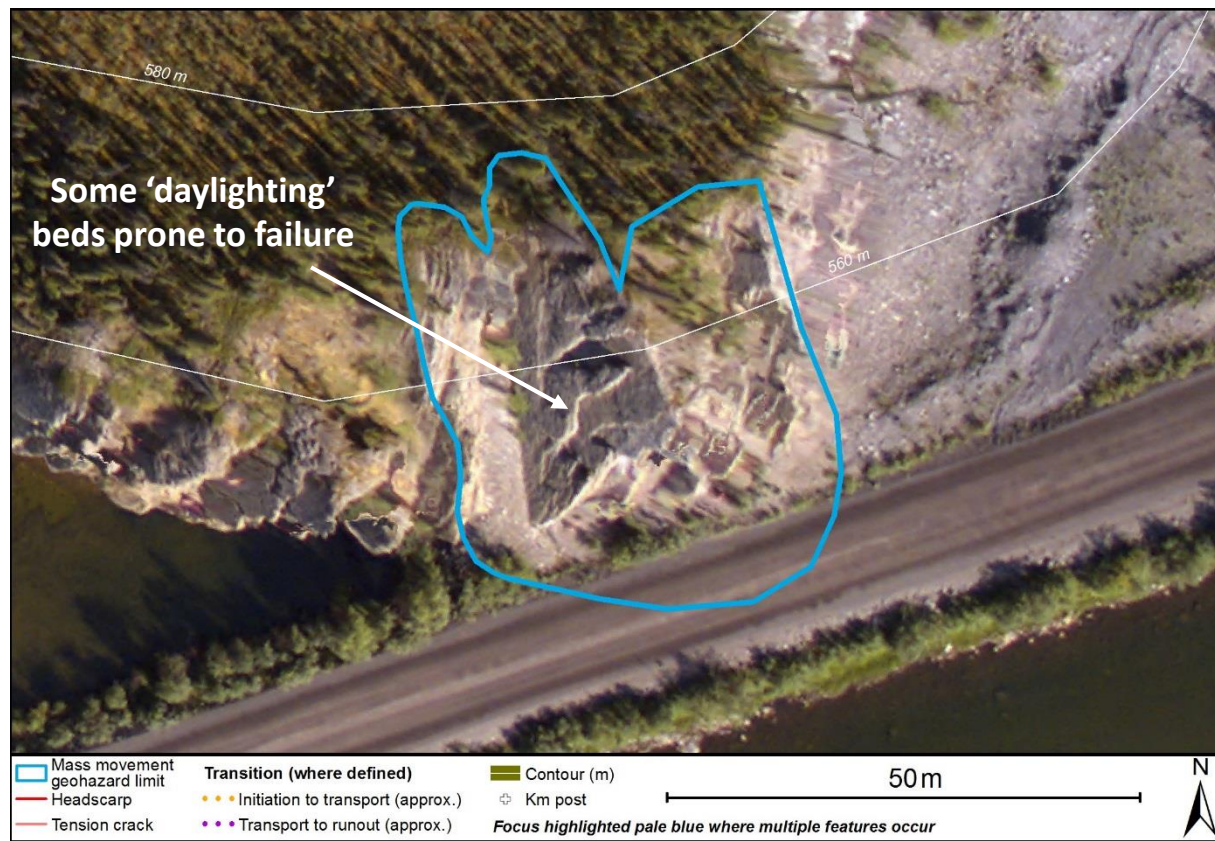
Project: Dempster Geohazard Investigation Project number: 14132 Client: Yukon Government
		<h2>KM 209.7</h2>

SITE	PROCESS	GEOMETRY	IMPLICATIONS
Section	Type	Elevation (m)	Likelihood
Ogilvie	rockfall	590	H
Proximity (m)	Position	Initiation slope (°)	Consequence
0	above	46	L
Aspect (°)	Causes	Runout slope (°)	Risk
165	steep rock bluff	17	M
Surficial material	Triggers	Average slope (°)	Mitigation
R	freeze/thaw	42	Management of rockfall initiation and/or debris in ditch and on hwy
Permafrost	Timing	Dimensions (L/W/D) (m)	Comments
Permafrost, likely ice-poor, deep within bedrock	Recurrent (likely annual)	45 / 41 / n/a	Runout limits approximate due to clearing of former debris accumulation

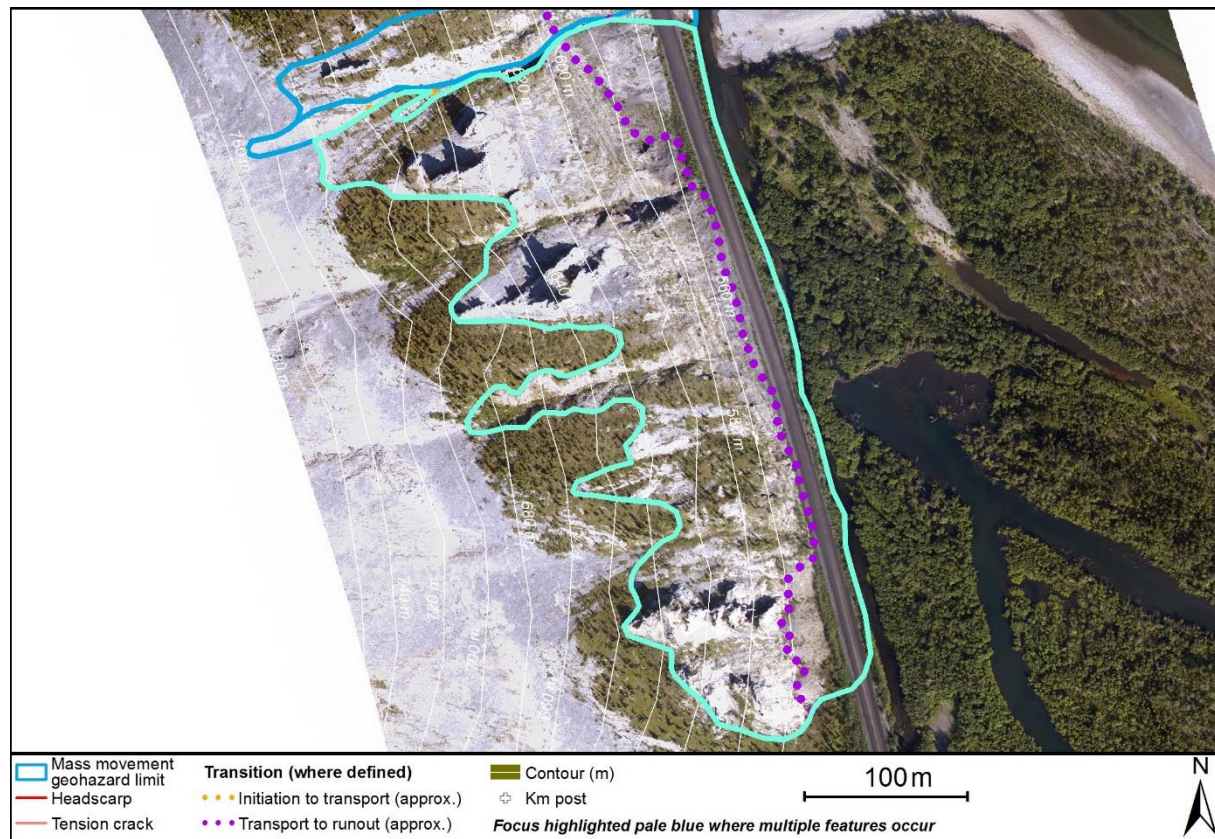
Project: Dempster Geohazard Investigation Project number: 14132 Client: Yukon Government
		<h2>KM 210.9</h2>

SITE	PROCESS	GEOMETRY	IMPLICATIONS
Section	Type	Elevation (m)	Likelihood
Ogilvie	rockfall & debris slide	622	H
Proximity (m)	Position	Initiation slope (°)	Consequence
0	above	35	M
Aspect (°)	Causes	Runout slope (°)	Risk
70	steep rock bluffs	27	H
Surficial material	Triggers	Average slope (°)	Mitigation
R	freeze/thaw, intense rainfall/snowmelt	42	Management of rockfall/debris slide debris in ditch and on hwy
Permafrost	Timing	Dimensions (L/W/D) (m)	Comments
Permafrost, likely ice-poor, relatively deep within colluvial rubble or weathered bedrock	Recurrent (likely annual)	208 / 453 / n/a	Runout limits approximate due to clearing of former debris accumulation; risk greatest downslope of prominent rock bluffs; small debris slides

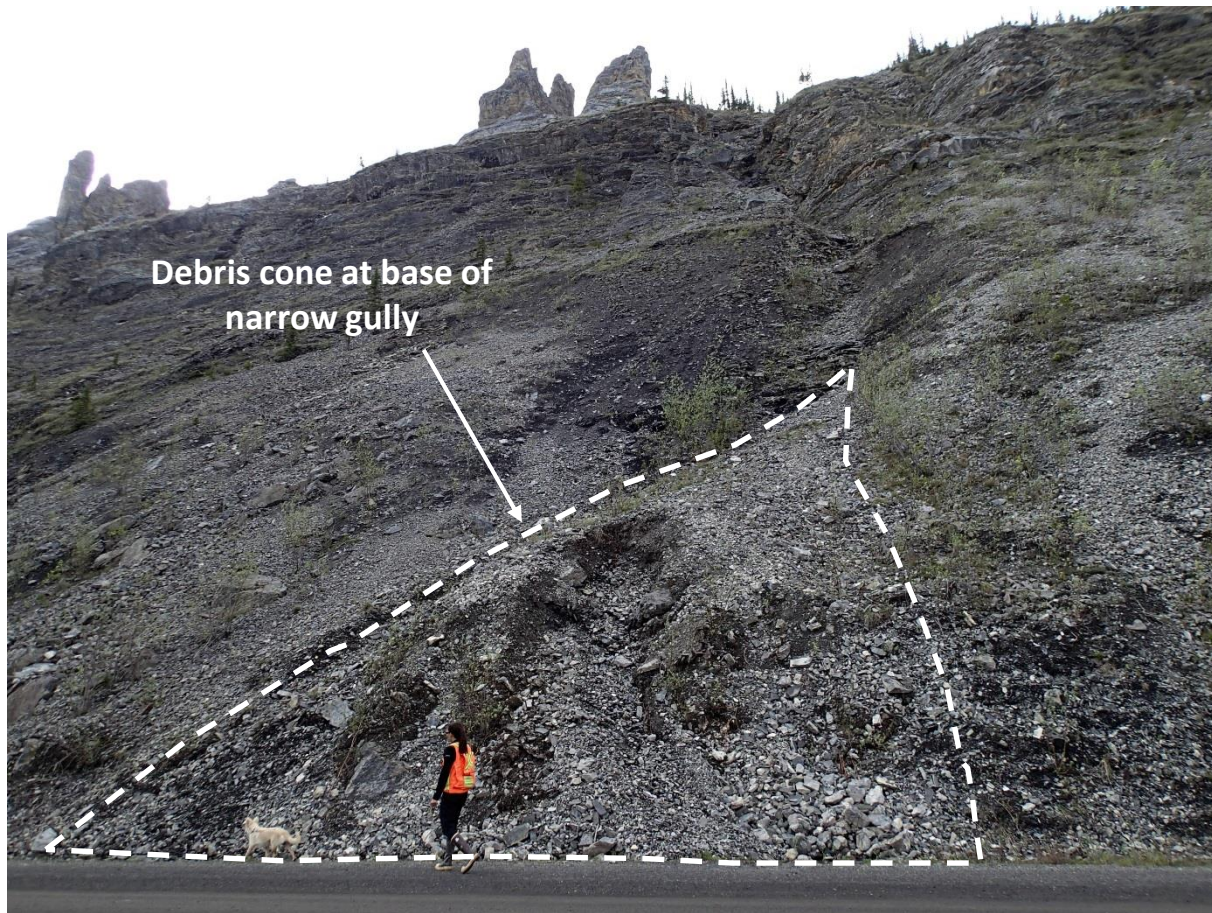
Project: Dempster Geohazard Investigation Project number: 14132 Client: Yukon Government
		<h1>KM 212.5</h1>

SITE	PROCESS	GEOMETRY	IMPLICATIONS
Section Ogilvie	Type debris flow	Elevation (m) 652	Likelihood L
Proximity (m) 0	Position above	Initiation slope (°) 32	Consequence H
Aspect (°) 70	Causes saturation of colluvial debris in headwater basin, gully channelization	Runout slope (°) 19	Risk M
Surficial material rszCv	Triggers intense rainfall/snowmelt	Average slope (°) 34	Mitigation Management of runout debris
Permafrost Permafrost, likely ice-poor, relatively deep within colluvial rubble or weathered bedrock	Timing Recurrent (likely decadal)	Dimensions (L/W/D) (m) 294 / 38 / n/a	Comments

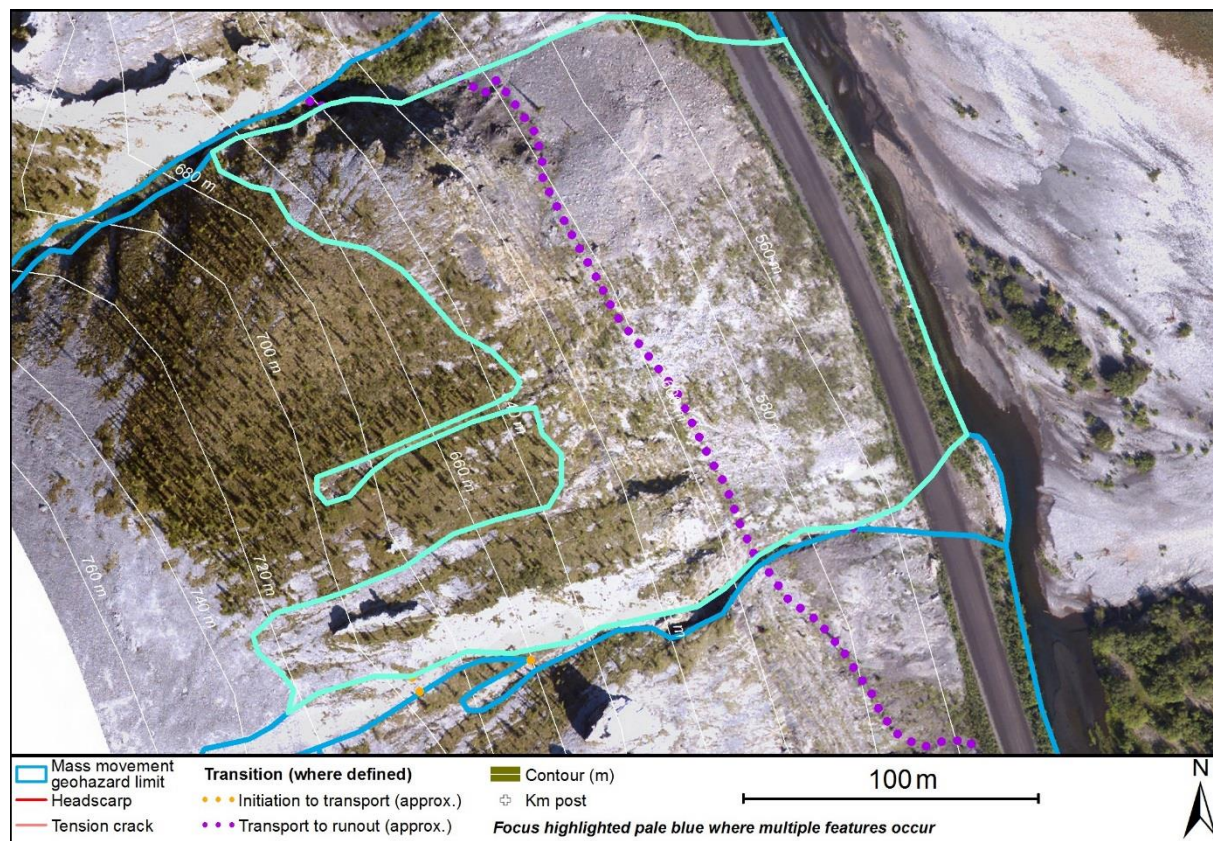
KM 212.7

SITE	PROCESS	GEOMETRY	IMPLICATIONS
Section	Type	Elevation (m)	Likelihood
Ogilvie	rockfall & debris slide	615	H
Proximity (m)	Position	Initiation slope (°)	Consequence
0	above	36	M
Aspect (°)	Causes	Runout slope (°)	Risk
65	steep rock bluffs	31	H
Surficial material	Triggers	Average slope (°)	Mitigation
R/rszCb	freeze/thaw, intense rainfall/snowmelt	40	Management of rockfall/debris slide debris in ditch and on hwy
Permafrost	Timing	Dimensions (L/W/D) (m)	Comments
Permafrost, likely ice-poor, relatively deep within colluvial rubble or weathered bedrock	Recurrent (likely annual)	220 / 165 / n/a	Runout limits approximate due to clearing of former debris accumulation; small debris slides

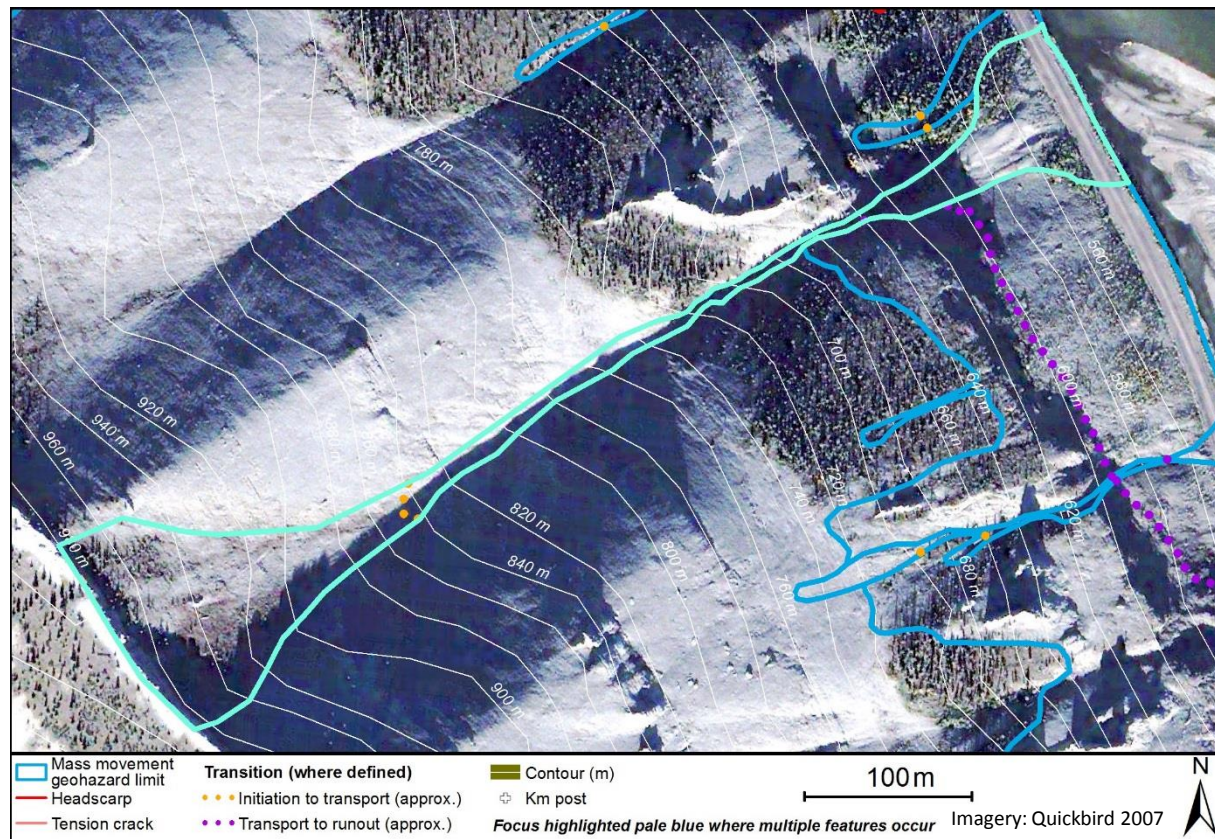
Project: Dempster Geohazard Investigation Project number: 14132 Client: Yukon Government
		<h2>KM 212.8</h2>

SITE	PROCESS	GEOMETRY	IMPLICATIONS
Section	Type	Elevation (m)	Likelihood
Ogilvie	debris flow & rockfall	805	L
Proximity (m)	Position	Initiation slope (°)	Consequence
0	above	36	H
Aspect (°)	Causes	Runout slope (°)	Risk
60	saturation of colluvial debris in headwater basin, gully channelization	30	M
Surficial material	Triggers	Average slope (°)	Mitigation
rszCv	intense rainfall/snowmelt, freeze/thaw	33	Management of runout debris
Permafrost	Timing	Dimensions (L/W/D) (m)	Comments
Permafrost, likely ice-poor, relatively deep within colluvial rubble or weathered bedrock	Recurrent (likely decadal)	666 / 105 / n/a

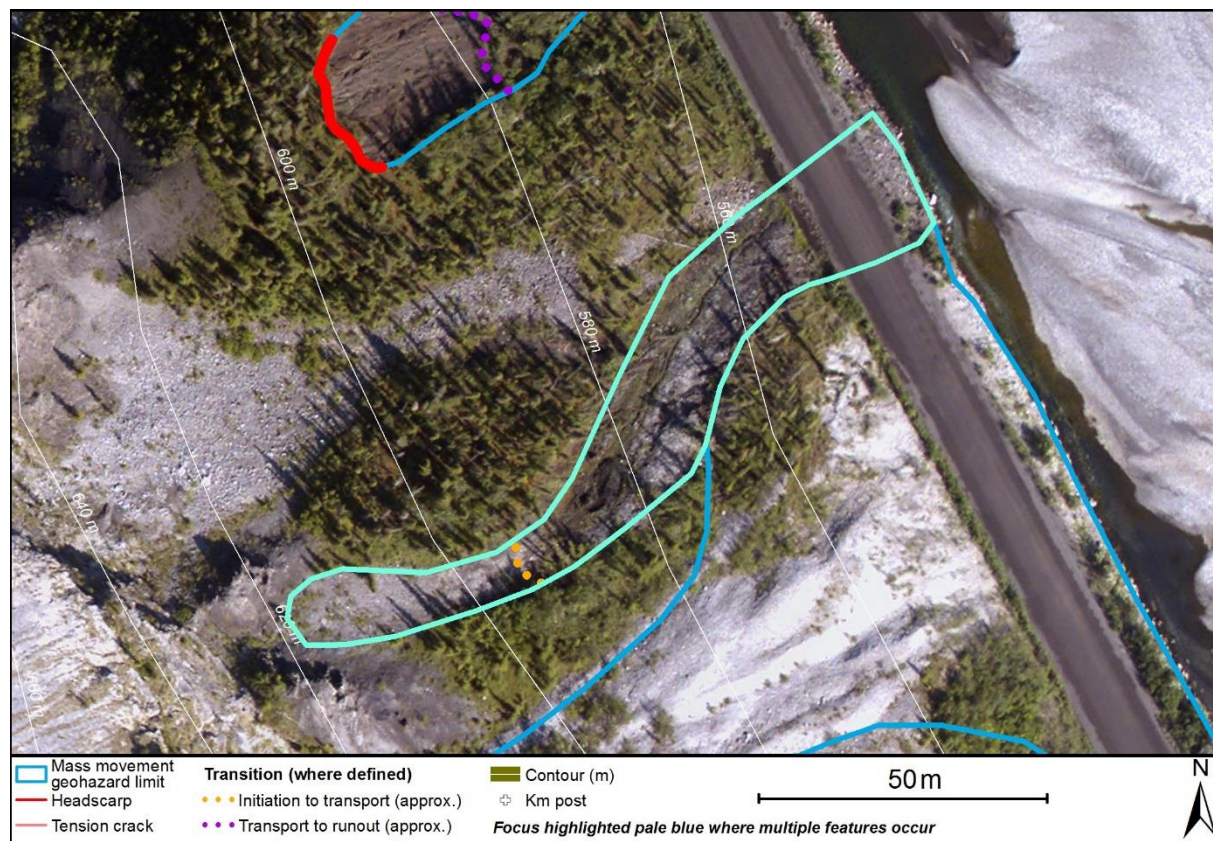
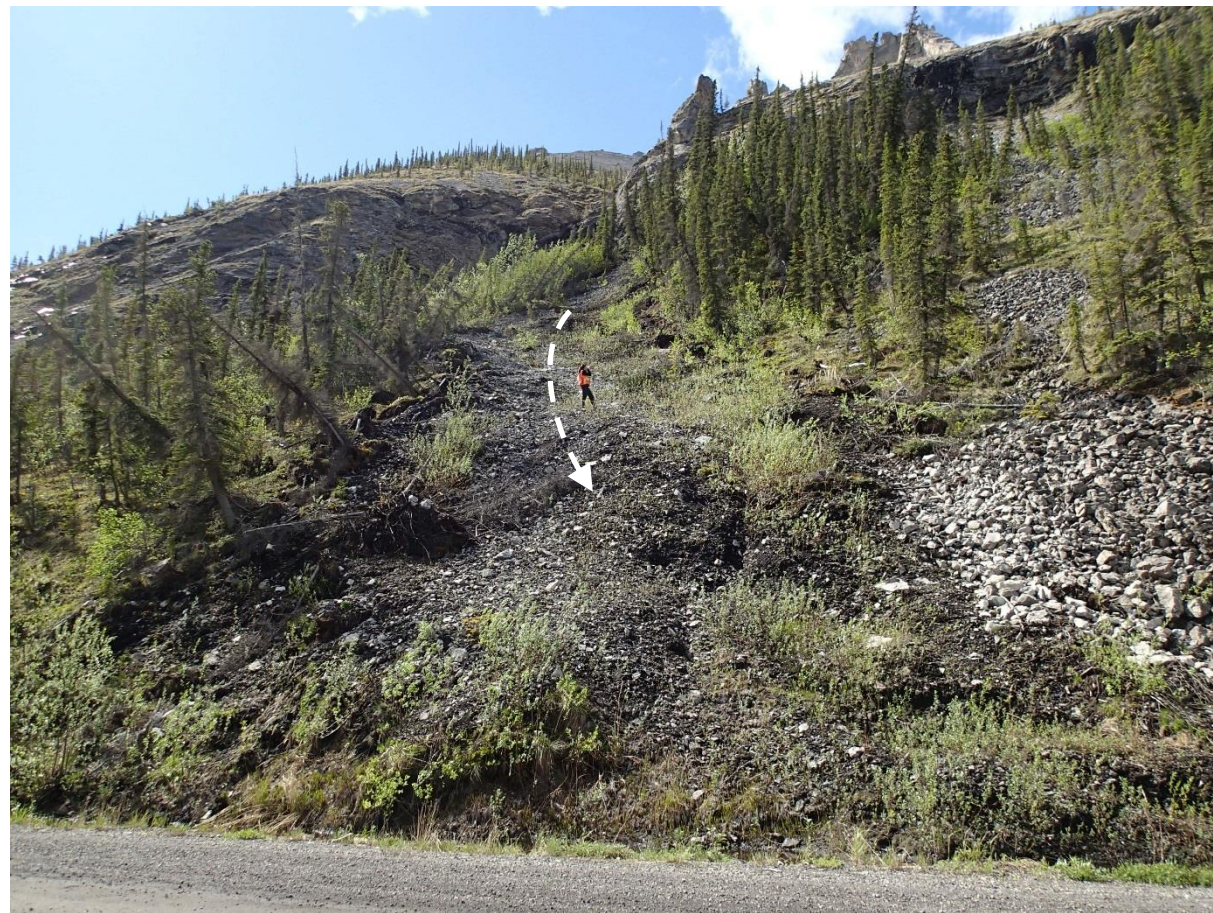
Project: Dempster Geohazard Investigation Project number: 14132 Client: Yukon Government
		<h2>KM 212.95</h2>

SITE	PROCESS	GEOMETRY	IMPLICATIONS
Section	Type	Elevation (m)	Likelihood
Ogilvie	debris slide (active layer detachment)	575	M
Proximity (m)	Position	Initiation slope (°)	Consequence
0	above	38	L
Aspect (°)	Causes	Runout slope (°)	Risk
60	permafrost degradation	10	L
Surficial material	Triggers	Average slope (°)	Mitigation
rszCv	intense rainfall/snowmelt or heat, possible rockfall onto slope	29	Management of debris accumulation in ditch
Permafrost	Timing	Dimensions (L/W/D) (m)	Comments
Permafrost, likely ice-poor, relatively deep within colluvial rubble or weathered bedrock	Single event (2007-2013) with potential for post-failure sloughs/flows	142 / 22 / 0.5	Runout limits approximate due to clearing of former debris accumulation

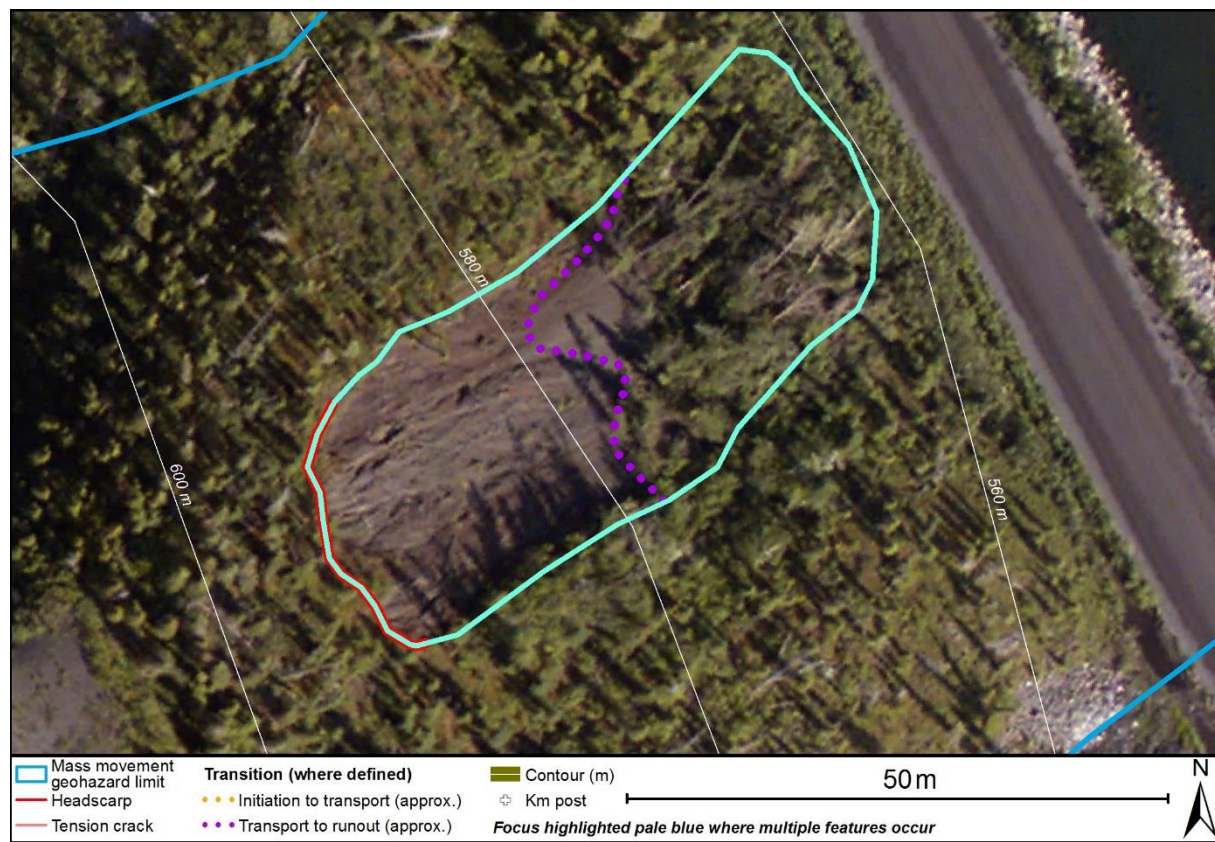
Project: Dempster Geohazard Investigation Project number: 14132 Client: Yukon Government
		KM 213

SITE	PROCESS	GEOMETRY	IMPLICATIONS
Section	Type	Elevation (m)	Likelihood
Ogilvie	debris slide (active layer detachment)	573	M
Proximity (m)	Position	Initiation slope (°)	Consequence
10	above	48	L
Aspect (°)	Causes	Runout slope (°)	Risk
55	permafrost degradation	33	L
Surficial material	Triggers	Average slope (°)	Mitigation
rszCv	intense rainfall/snowmelt or heat	37	Management of debris accumulation in ditch
Permafrost	Timing	Dimensions (L/W/D) (m)	Comments
Shallow permafrost	Single event (2007-2013) with potential for post-failure sloughs/flows	64 / 28 / <1

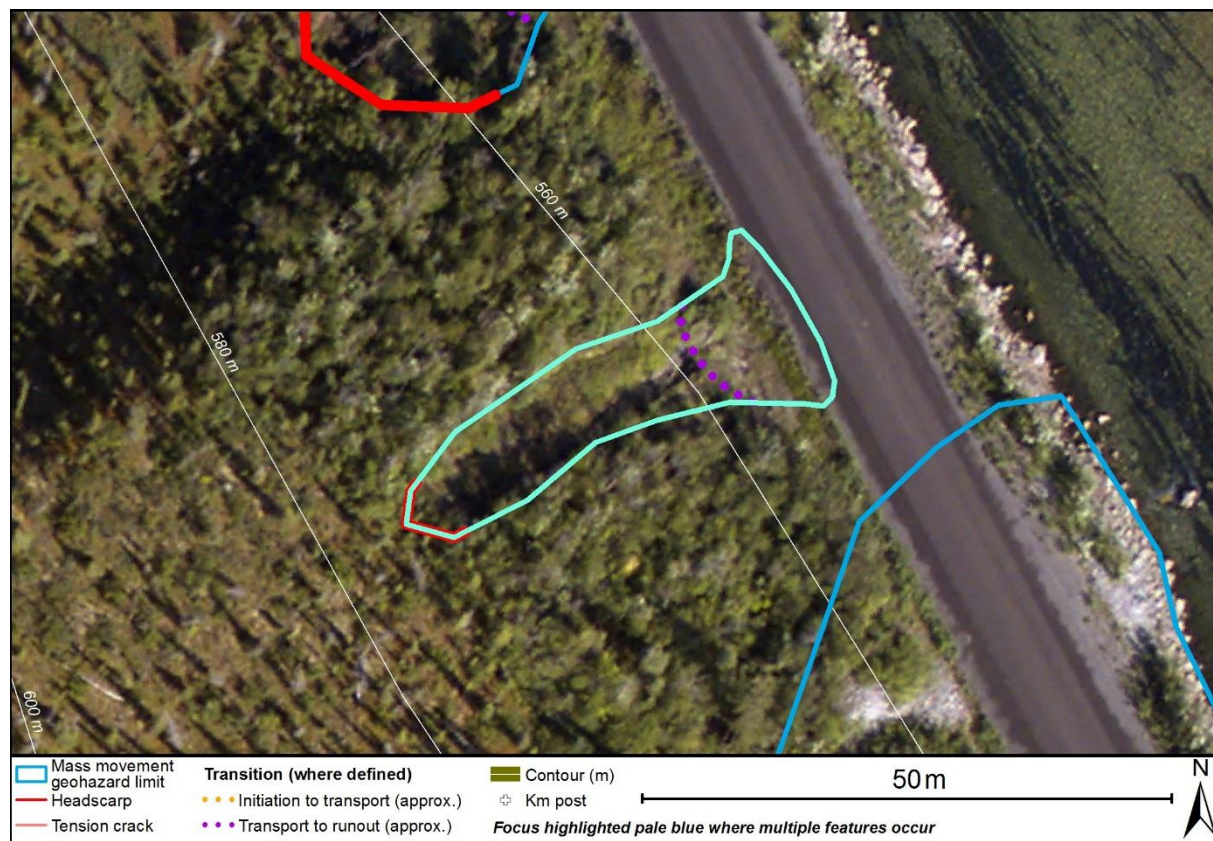
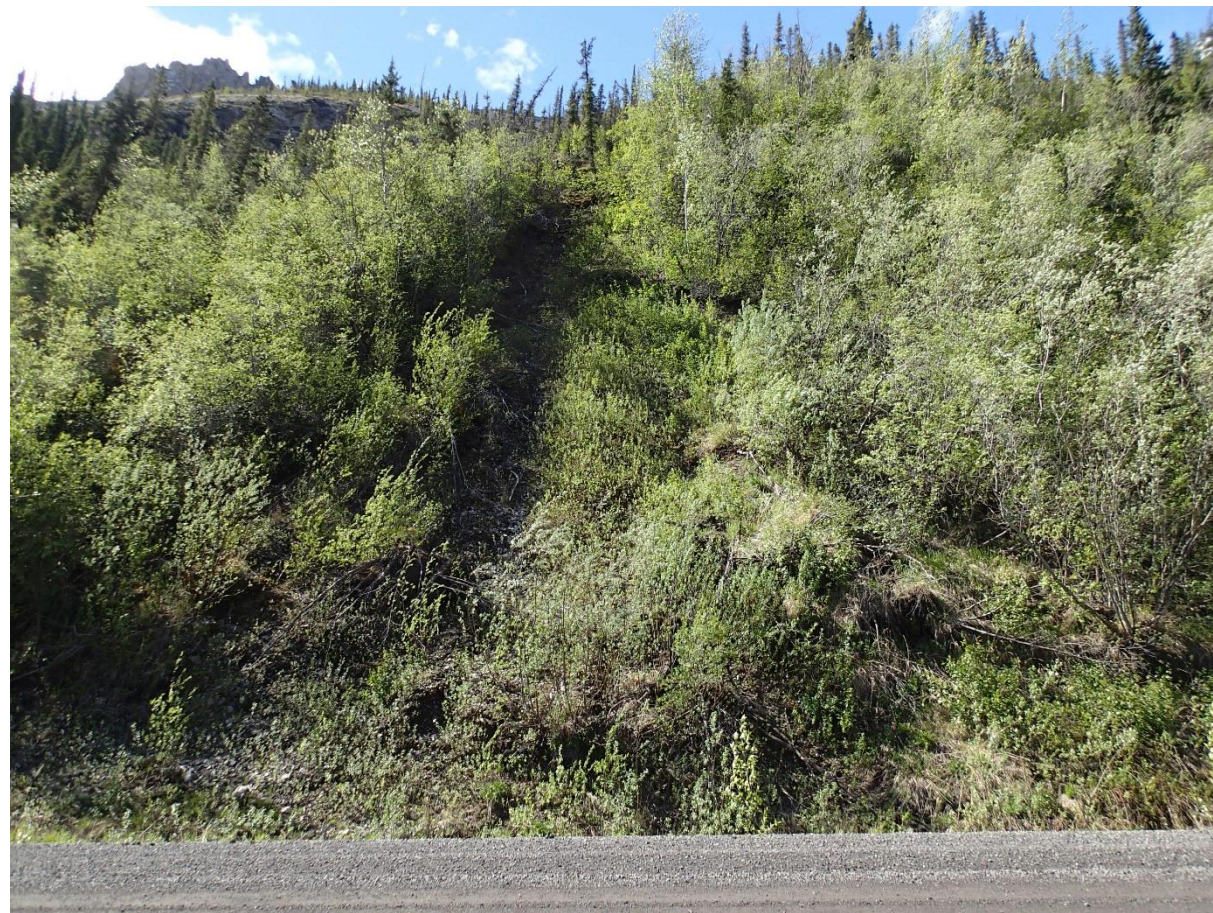
KM 213.1

Ogilvie	debris slide (active layer detachment)	564	M
<hr/>			
Section	Type	Elevation (m)	Likelihood
Ogilvie	debris slide (active layer detachment)	564	M
Proximity (m)	Position	Initiation slope (°)	Consequence
0	above	37	L
Aspect (°)	Causes	Runout slope (°)	Risk
60	disturbance and possible over-steepening of slope toe, permafrost degradation	15	L
Surficial material	Triggers	Average slope (°)	Mitigation
rszCv	intense rainfall/snowmelt or heat	35	Management of debris accumulation in ditch
Permafrost	Timing	Dimensions (L/W/D) (m)	Comments
Shallow permafrost	Single event (2007-2013) with potential for post-failure sloughs/flows	43 / 19 / 0.5	Runout limits approximate due to clearing of former debris accumulation
