Yukon Geological Survey Miscellaneous Report 17

Inventory of mass movement geohazards along the Dempster Highway, Yukon

Robin J. McKillop, Courtenay E. Brown, Daniel J. McParland and David A. Sacco
Palmer Environmental Consulting Group Inc.
and Jim Coates
Kryotek Arctic Innovation Inc.

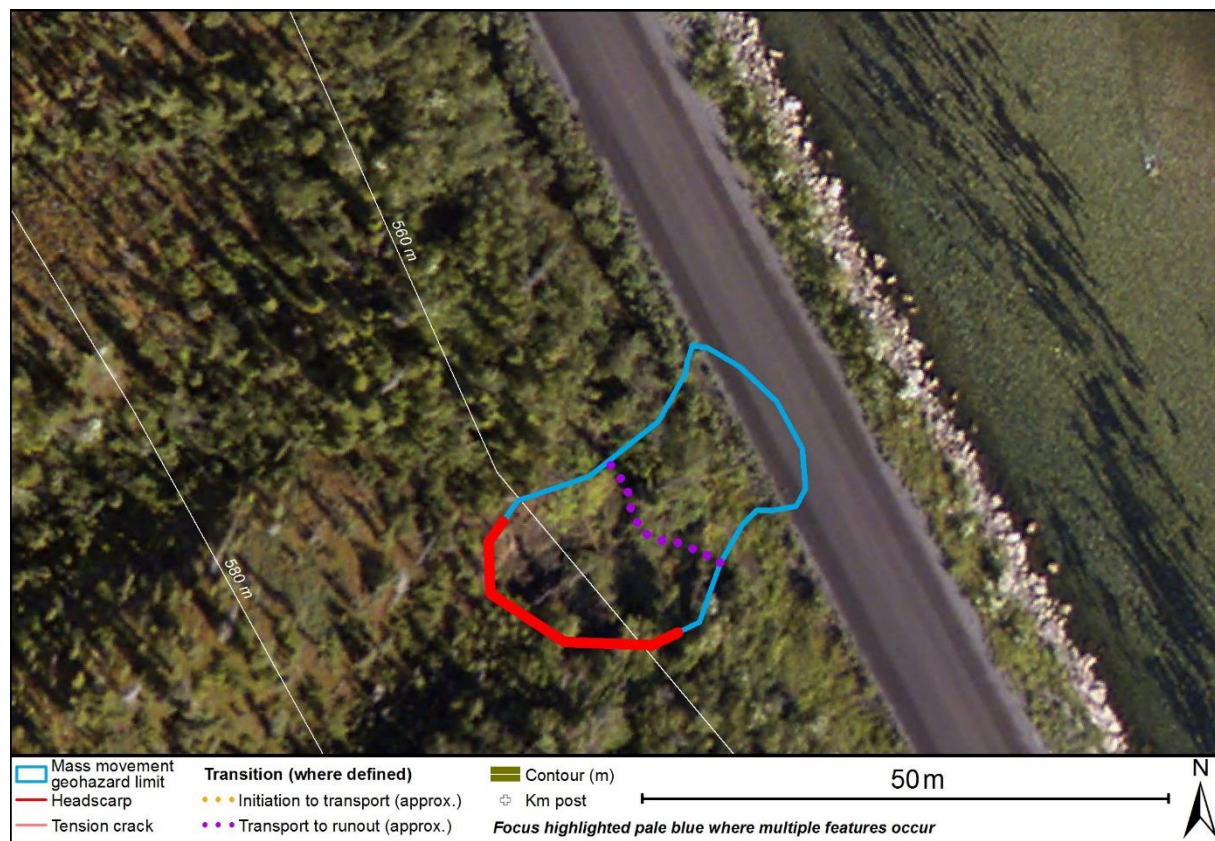
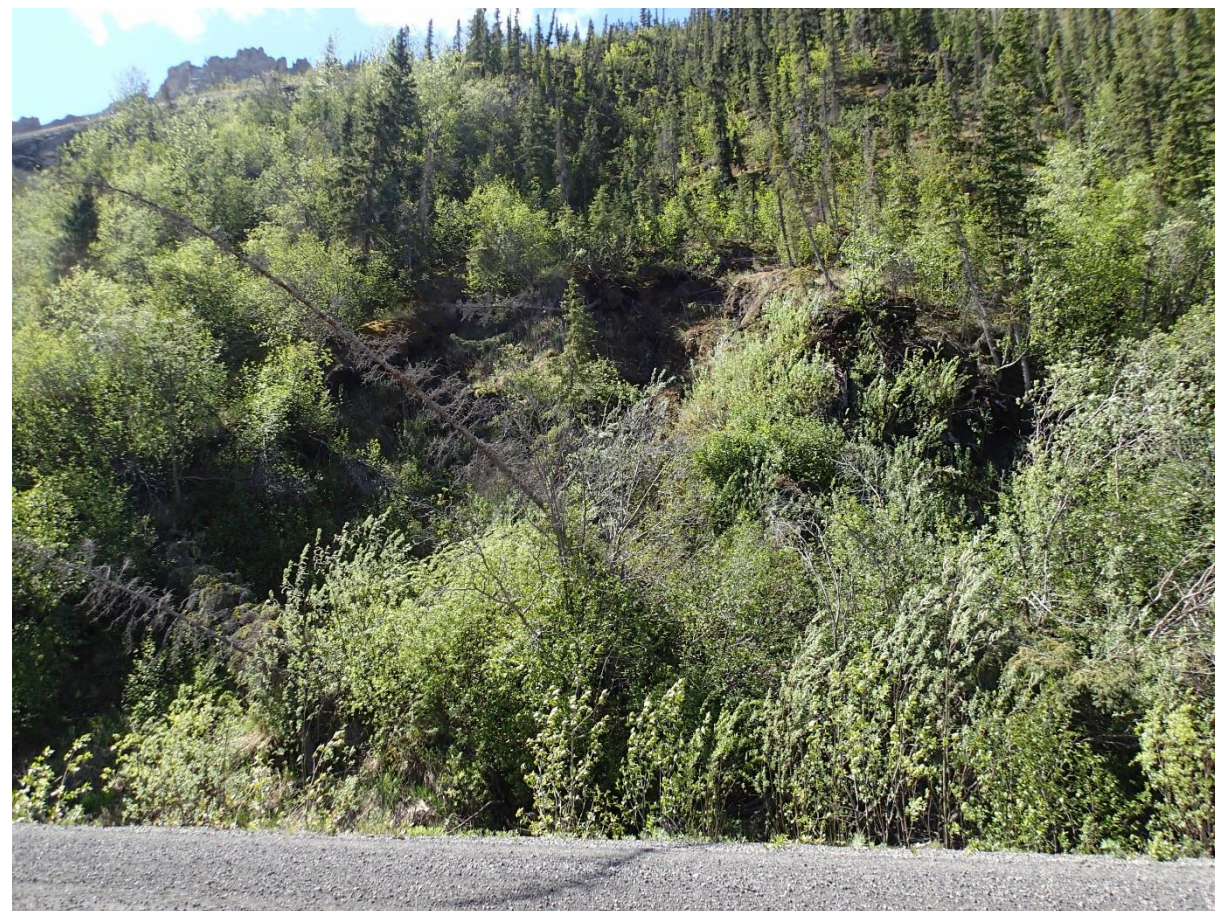
SITE	PROCESS	GEOMETRY	IMPLICATIONS
Section	Type	Elevation (m)	Likelihood
Ogilvie	debris slide (active layer detachment)	556	M
Proximity (m)	Position	Initiation slope (°)	Consequence
0	above	43	L
Aspect (°)	Causes	Runout slope (°)	Risk
45	disturbance and possible over-steepening of slope toe, permafrost degradation	5	L
Surficial material	Triggers	Average slope (°)	Mitigation
rszCv	intense rainfall/snowmelt or heat	25	Management of debris accumulation in ditch
Permafrost	Timing	Dimensions (L/W/D) (m)	Comments
Shallow permafrost	Single event (2007-2013) with potential for post-failure sloughs/flows	33 / 17 / <1	Runout limits approximate due to clearing of former debris accumulation

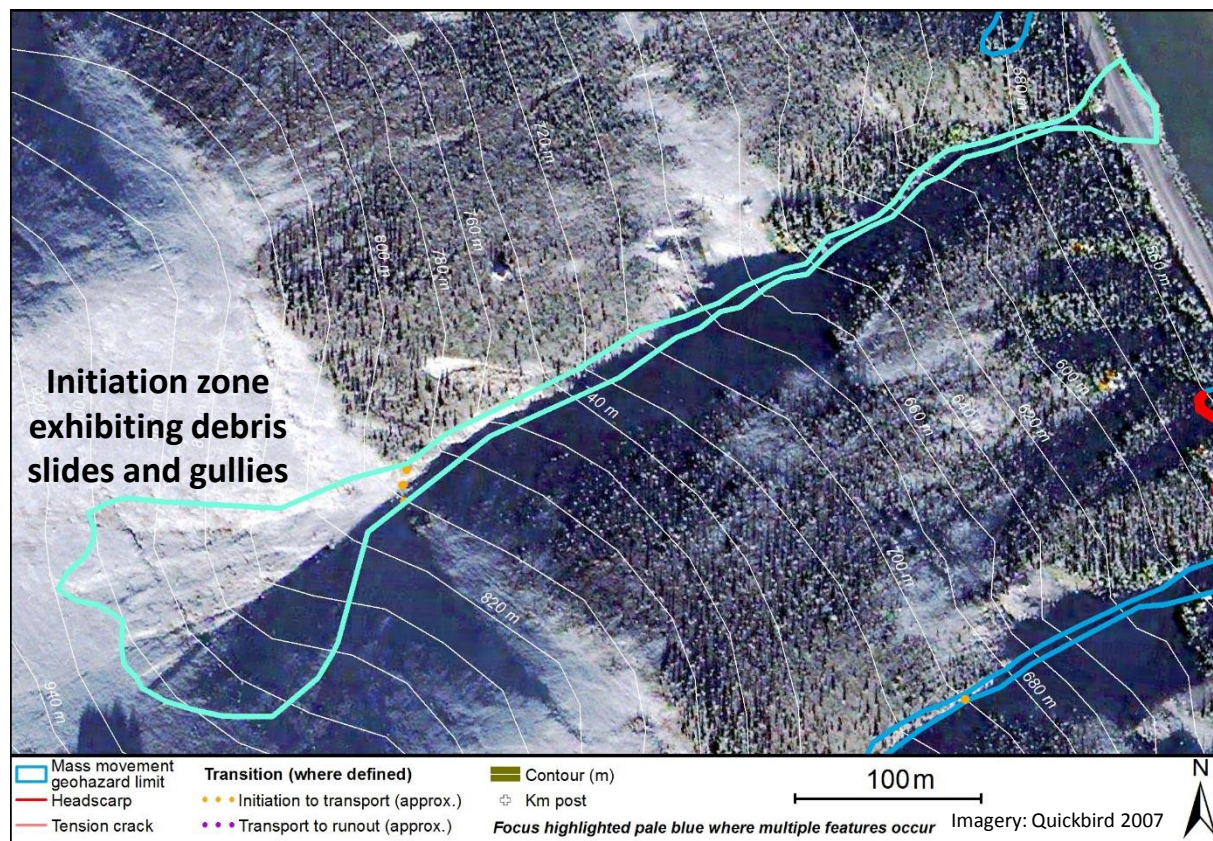
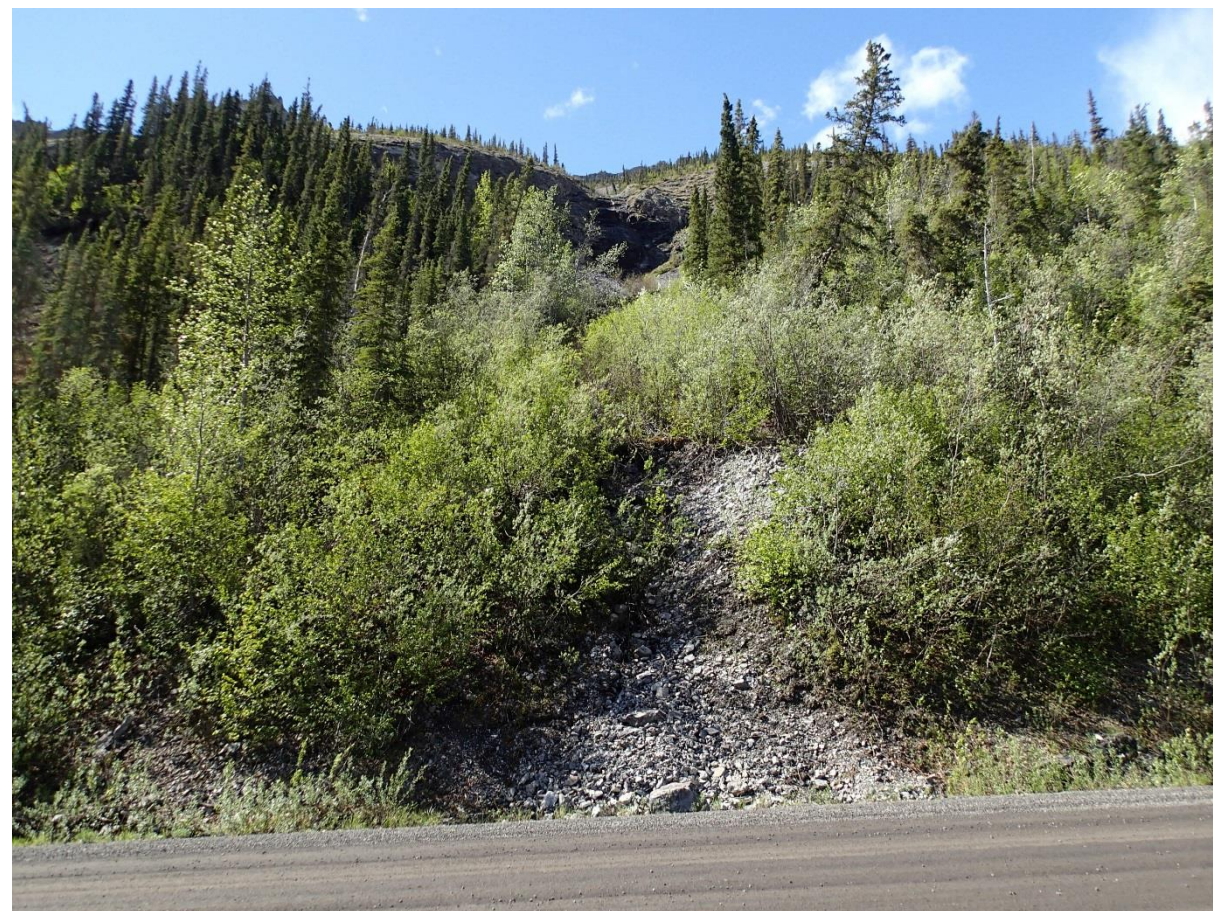
Project: Dempster Geohazard Investigation Project number: 14132 Client: Yukon Government
		KM 213.2

SITE	PROCESS	GEOMETRY	IMPLICATIONS
Section	Type	Elevation (m)	Likelihood
Ogilvie	debris flow	810	L
Proximity (m)	Position	Initiation slope (°)	Consequence
0	above	36	H
Aspect (°)	Causes	Runout slope (°)	Risk
55	saturation of colluvial debris in headwater basin, gully channelization	16	M
Surficial material	Triggers	Average slope (°)	Mitigation
rszCv	intense rainfall/snowmelt	29	Management of runout debris
Permafrost	Timing	Dimensions (L/W/D) (m)	Comments
Permafrost, likely ice-poor, relatively deep within colluvial rubble or weathered bedrock	Recurrent (likely decadal)	654 / 45 / n/a

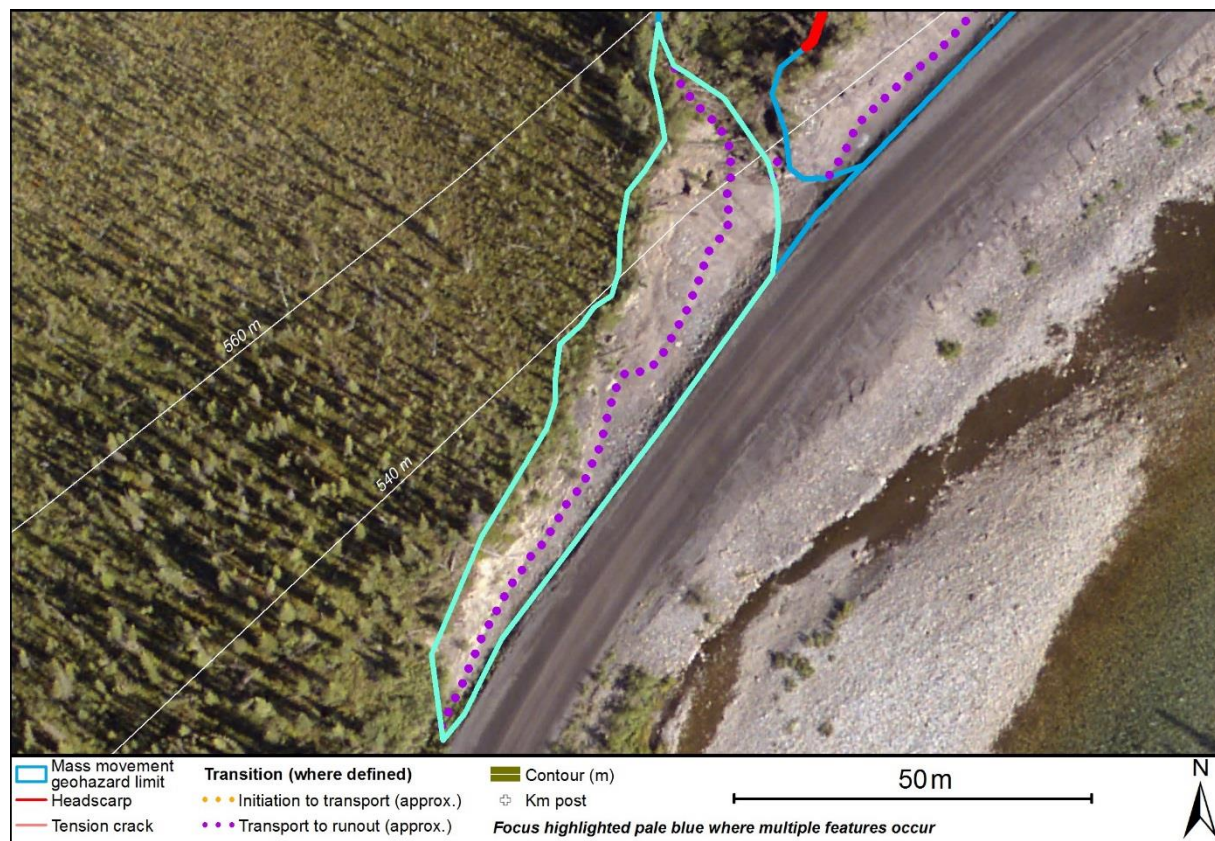
Project: Dempster Geohazard Investigation Project number: 14132 Client: Yukon Government
		<h2>KM 219.3</h2>

SITE	PROCESS	GEOMETRY	IMPLICATIONS
Section	Type	Elevation (m)	Likelihood
Ogilvie	rockfall	544	H
Proximity (m)	Position	Initiation slope (°)	Consequence
0	above	55	L
Aspect (°)	Causes	Runout slope (°)	Risk
120	steep rock bluff	14	M
Surficial material	Triggers	Average slope (°)	Mitigation
R	freeze/thaw, intense rainfall/snowmelt	51	Management of debris accumulation in ditch
Permafrost	Timing	Dimensions (L/W/D) (m)	Comments
Permafrost, likely ice-poor, relatively deep within colluvial rubble or weathered bedrock	Recurrent (likely annual)	17 / 86 / n/a	Runout limits approximate due to clearing of former debris accumulation

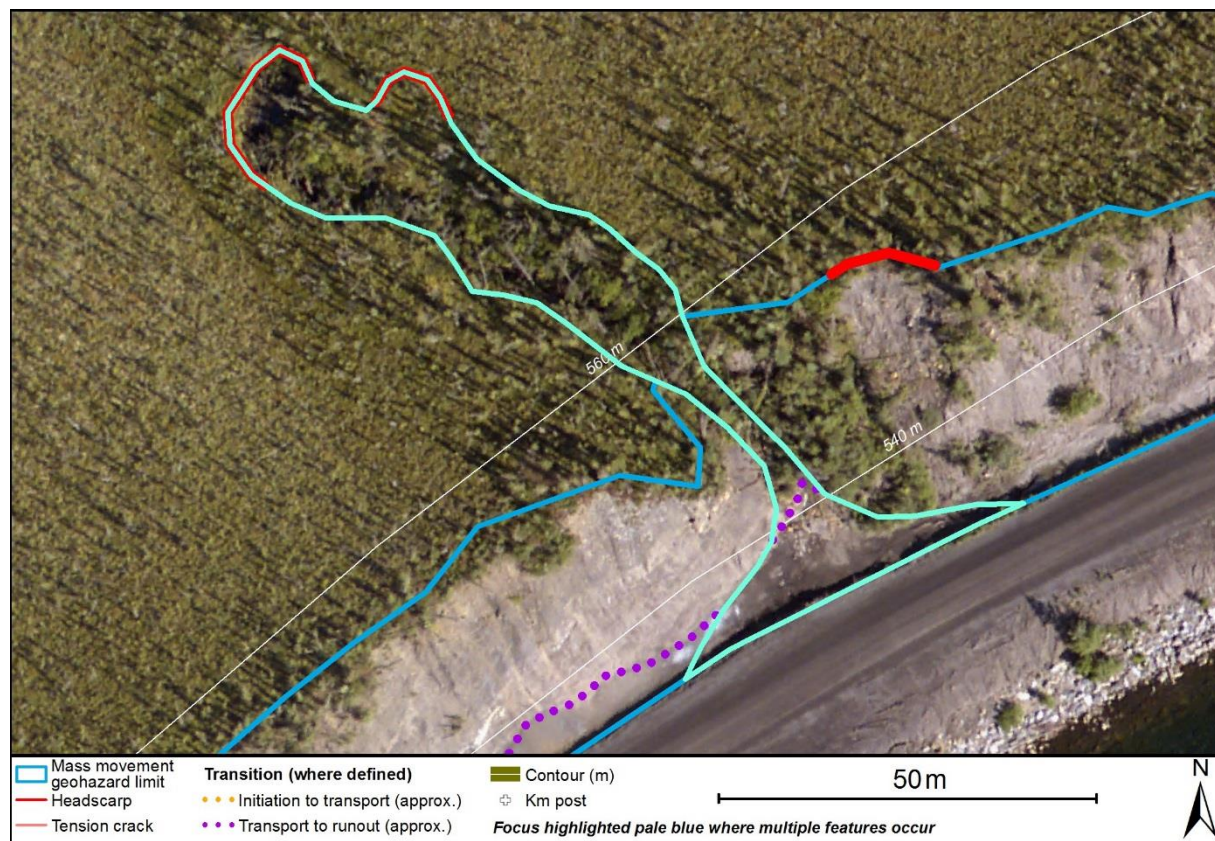
Project: Dempster Geohazard Investigation Project number: 14132 Client: Yukon Government
		KM 221.7

SITE	PROCESS	GEOMETRY	IMPLICATIONS
Section	Type	Elevation (m)	Likelihood
Ogilvie	retrogressive thaw slump	563	M
Proximity (m)	Position	Initiation slope (°)	Consequence
0	above	31	L
Aspect (°)	Causes	Runout slope (°)	Risk
110	natural concentration of runoff, permafrost degradation	12	L
Surficial material	Triggers	Average slope (°)	Mitigation
dszCv	intense rainfall/snowmelt or heat	18	Management of debris accumulation in ditch
Permafrost	Timing	Dimensions (L/W/D) (m)	Comments
Shallow, likely ice-rich permafrost above slope-toe scarp beside highway	Ongoing/episodic, possibly exacerbated by highway construction	99 / 45 / 3

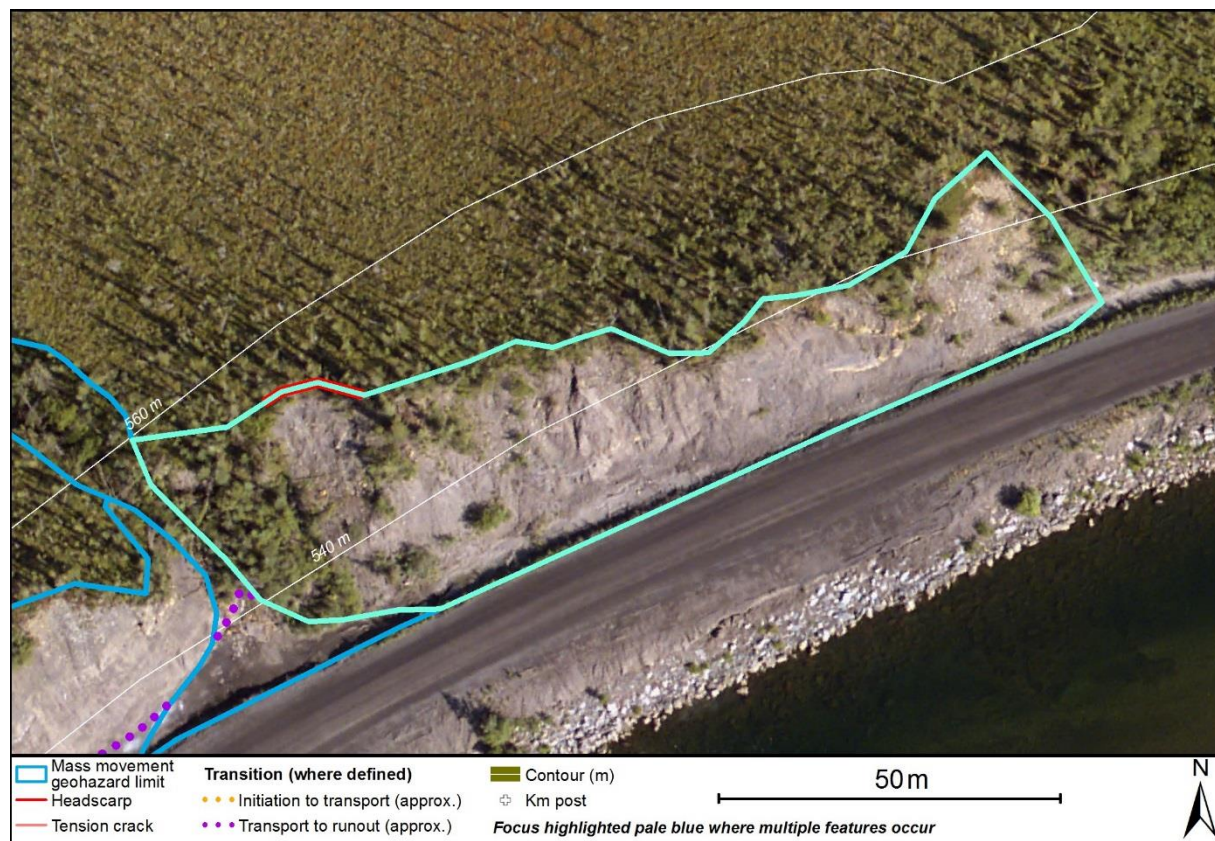
Project: Dempster Geohazard Investigation Project number: 14132 Client: Yukon Government
		KM 221.8

SITE	PROCESS	GEOMETRY	IMPLICATIONS
Section	Type	Elevation (m)	Likelihood
Ogilvie	debris slide & rockfall	549	H
Proximity (m)	Position	Initiation slope (°)	Consequence
0	above	33	L
Aspect (°)	Causes	Runout slope (°)	Risk
145	disturbance and possible over-steepening of slope toe, steep rock bluffs	10	M
Surficial material	Triggers	Average slope (°)	Mitigation
dszCv/R	freeze/thaw, intense rainfall/snowmelt	40	Management of debris accumulation in ditch
Permafrost	Timing	Dimensions (L/W/D) (m)	Comments
Shallow permafrost areas remaining within slope otherwise underlain by permafrost relatively deep within colluvium or weathered bedrock	Recurrent (likely annual)	30 / 130 / <1	Runout limits approximate due to clearing of former debris accumulation

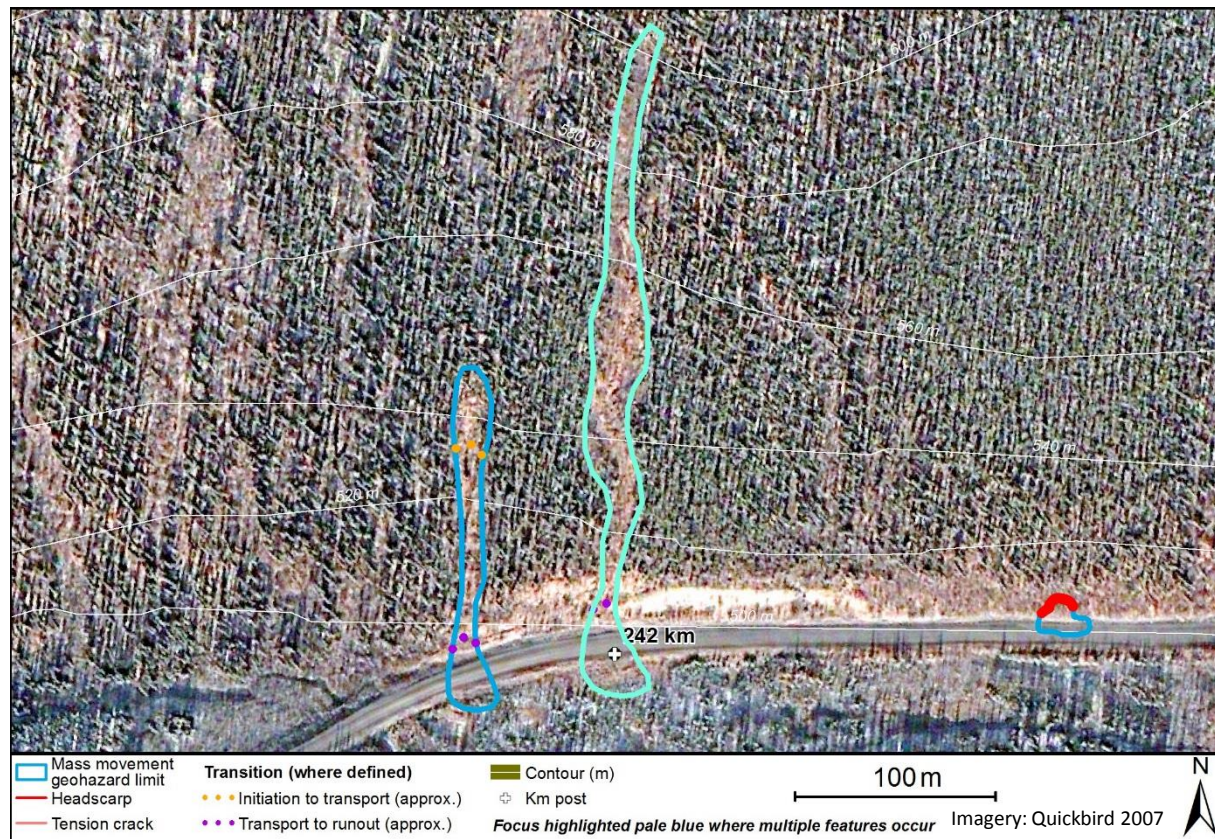
Project: Dempster Geohazard Investigation Project number: 14132 Client: Yukon Government
		KM 241.9

Stabilized sidewall of active layer detachment

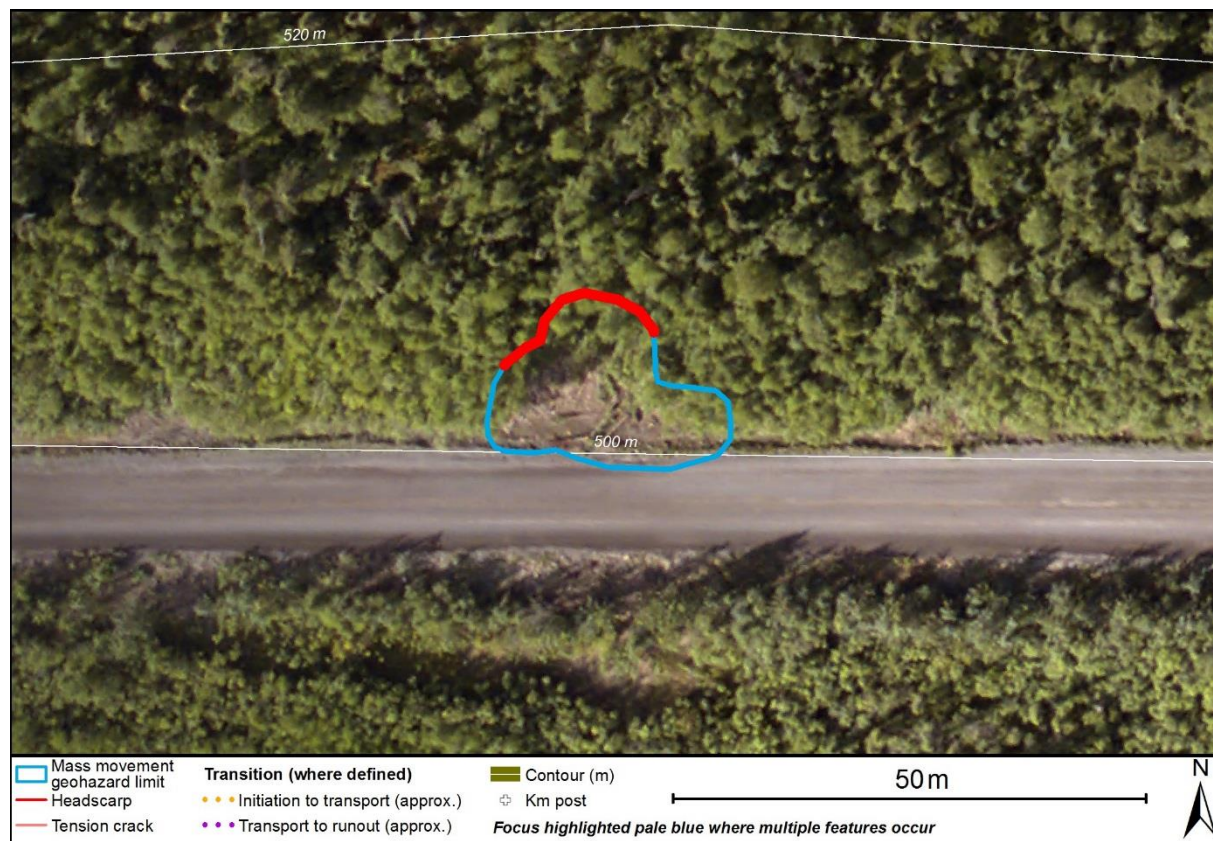
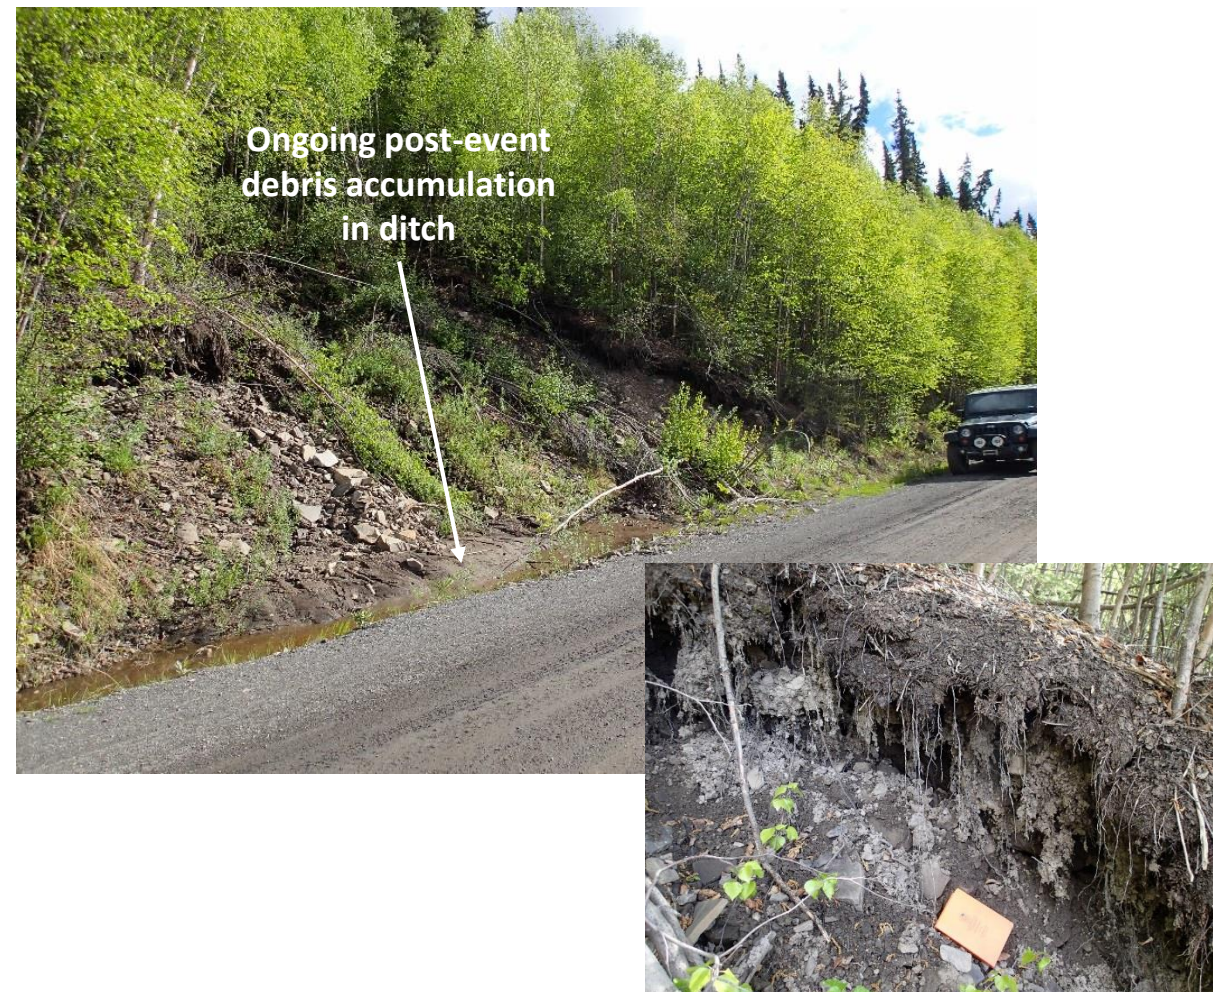
Project: Dempster Geohazard Investigation Project number: 14132 Client: Yukon Government
		KM 242

SITE	PROCESS	GEOMETRY	IMPLICATIONS
Section	Type	Elevation (m)	Likelihood
Ogilvie	debris slide (active layer detachment)	495	M
Proximity (m)	Position	Initiation slope (°)	Consequence
0	above	33	L
Aspect (°)	Causes	Runout slope (°)	Risk
170	oversteepened slope toe	4	L
Surficial material	Triggers	Average slope (°)	Mitigation
rszCb	intense rainfall/snowmelt or heat	23	Management of debris accumulation in ditch
Permafrost	Timing	Dimensions (L/W/D) (m)	Comments
Moderately deep permafrost in original road cut area	Single event (2007-2013) with potential for post-failure sloughs/flows	19 / 27 / 1	Runout limits approximate due to clearing of former debris accumulation

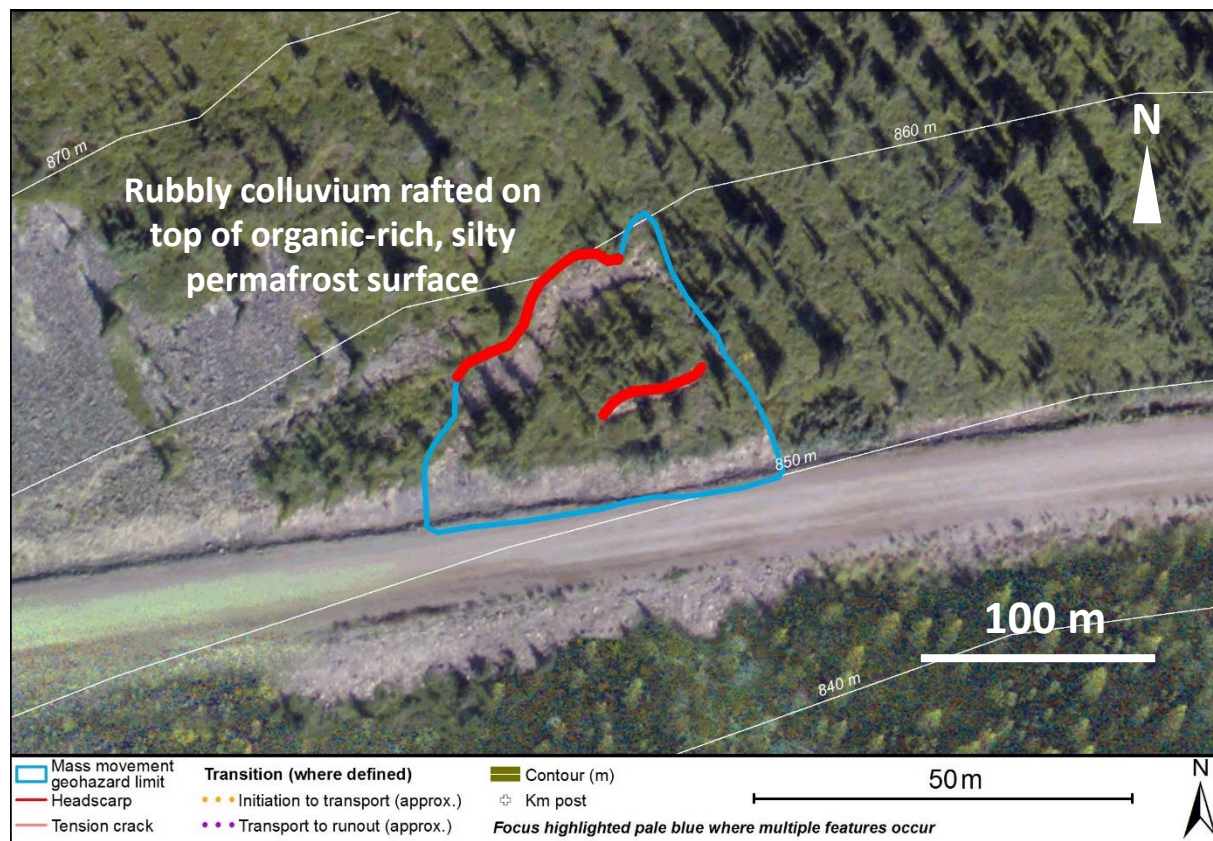
KM 244.3

SITE	PROCESS	GEOMETRY	IMPLICATIONS
Section	Type	Elevation (m)	Likelihood
Ogilvie	debris slide (active layer detachment)	854	M
Proximity (m)	Position	Initiation slope (°)	Consequence
0	above	17	M
Aspect (°)	Causes	Runout slope (°)	Risk
150	oversteepened slope toe, permafrost degradation	17	M
Surficial material	Triggers	Average slope (°)	Mitigation
rszCv	intense rainfall/snowmelt or heat	16	Management of runout debris
Permafrost	Timing	Dimensions (L/W/D) (m)	Comments
Shallow permafrost	Single event (2007-2013) with potential for post-failure sloughs/flows	33 / 49 / 0.3	Reactivation possible

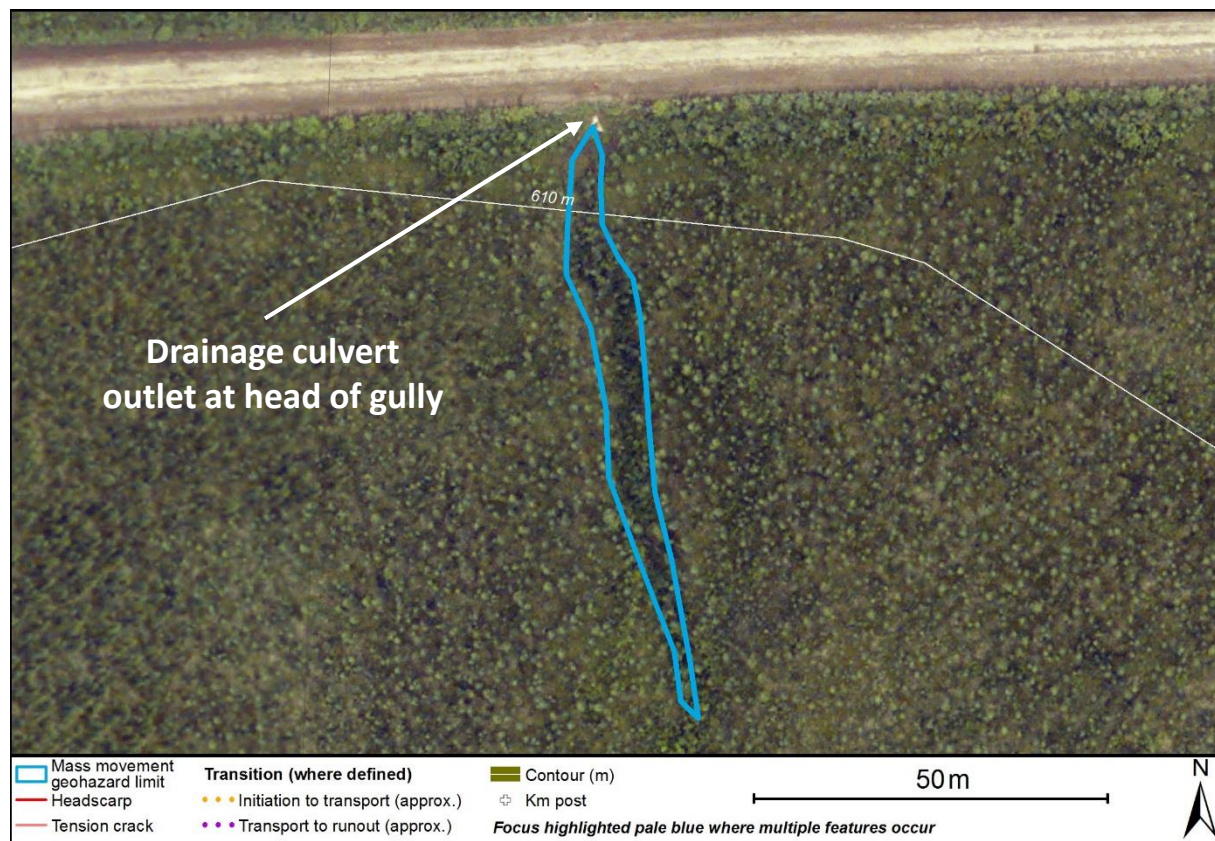
Project: Dempster Geohazard Investigation Project number: 14132 Client: Yukon Government
		<h2>KM 273.1</h2>

SITE	PROCESS	GEOMETRY	IMPLICATIONS
Section	Type	Elevation (m)	Likelihood
Eagle Plains	thermokarst gully	607	L
Proximity (m)	Position	Length (m)	Consequence
0	below	86	L
Aspect (°)	Causes	Width (m)	Risk
175	concentrated drainage	5	VL
Surficial material	Triggers	Depth (m)	Mitigation
rszCb	intense rainfall/snowmelt	1	Management of surface runoff from culvert
Permafrost	Timing	Dimensions (L/W/D) (m)	Comments
Shallow permafrost	Ongoing/episodic, likely initiated following highway construction	5

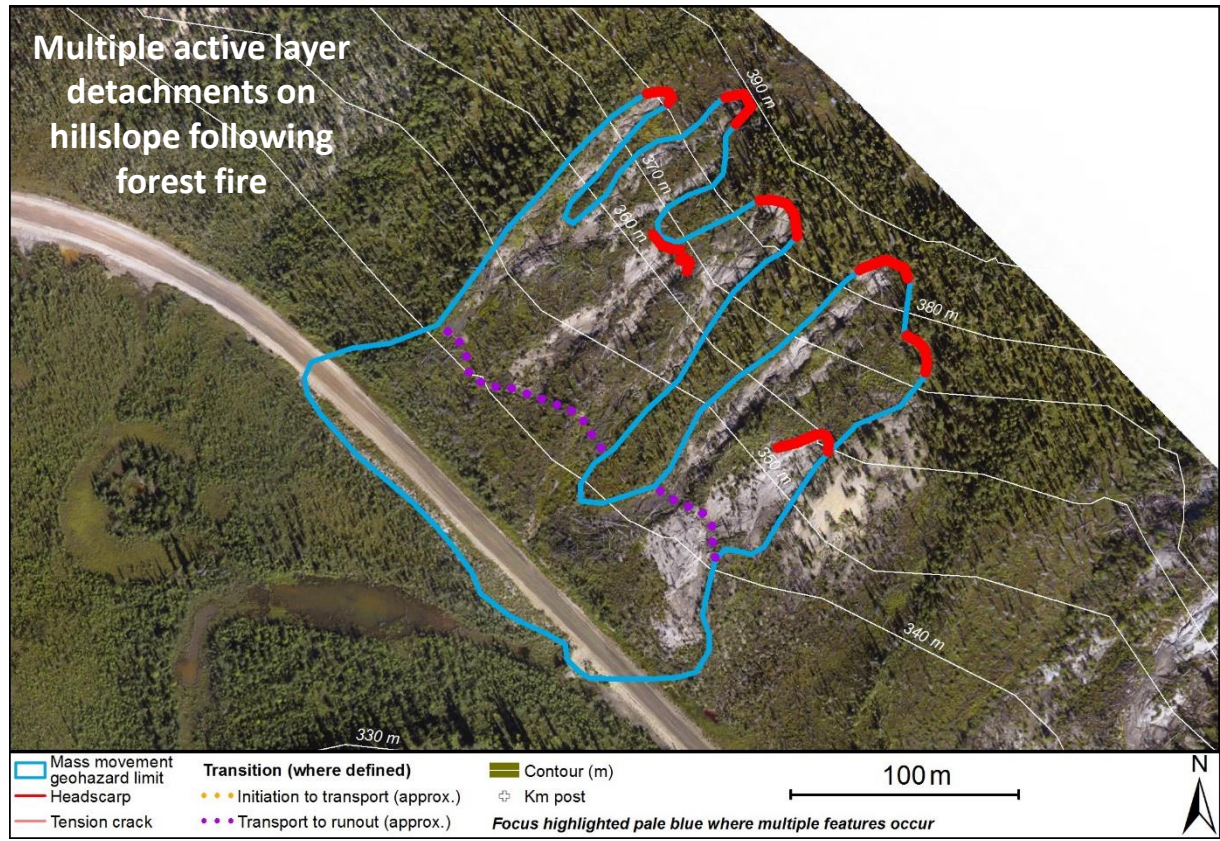
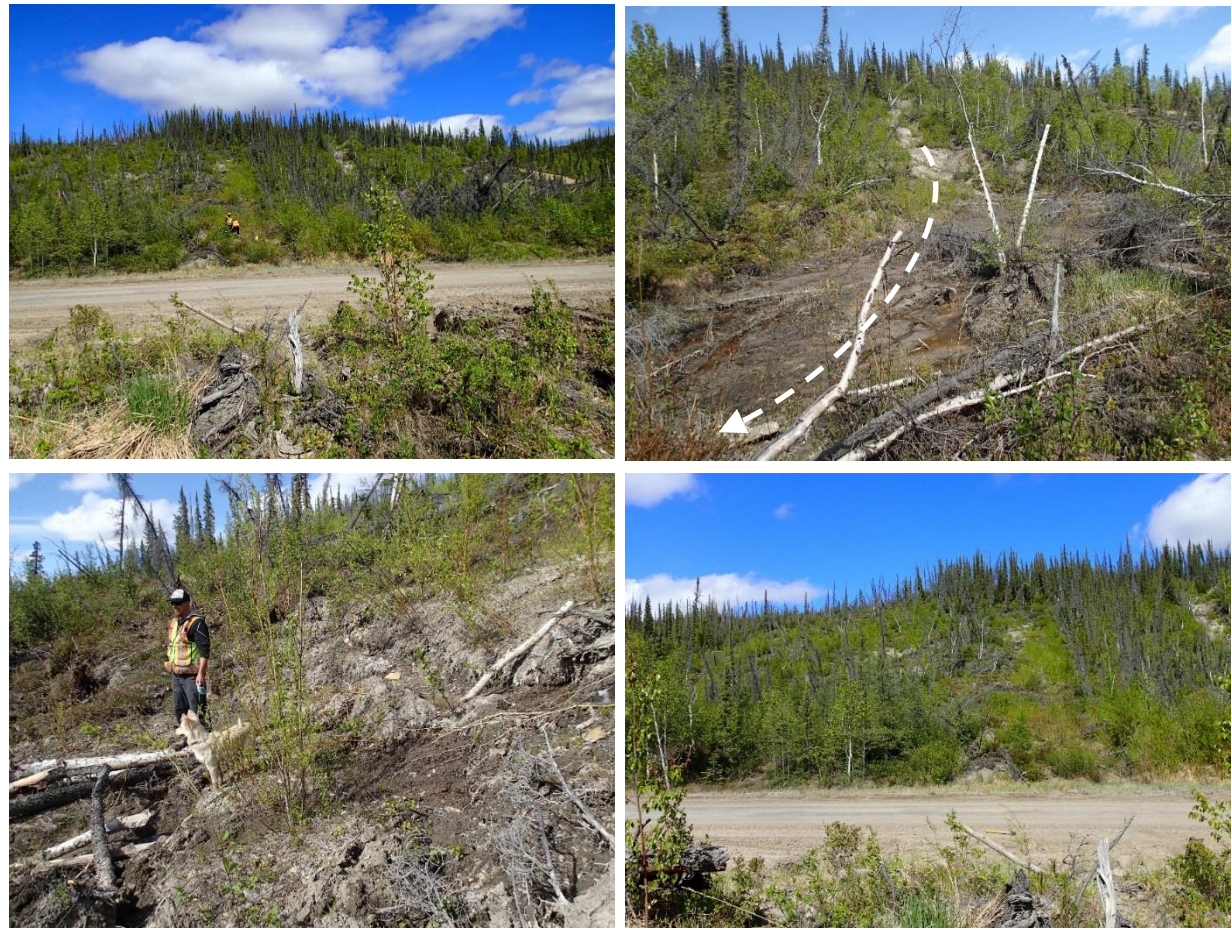
Project: Dempster Geohazard Investigation Project number: 14132 Client: Yukon Government
		KM 301.4

SITE	PROCESS	GEOMETRY	IMPLICATIONS
Section	Type	Elevation (m)	Likelihood
Eagle Plains	debris slide (active layer detachment)	339	M
Proximity (m)	Position	Initiation slope (°)	Consequence
0	above	20	M
Aspect (°)	Causes	Runout slope (°)	Risk
210	fire, permafrost degradation	5	M
Surficial material	Triggers	Average slope (°)	Mitigation
szdCv	intense rainfall/snowmelt or heat	15	Management of runout debris
Permafrost	Timing	Dimensions (L/W/D) (m)	Comments
Shallow, likely ice-poor permafrost	Single event with potential for post-failure sloughs/flows	217 / 217 / 1

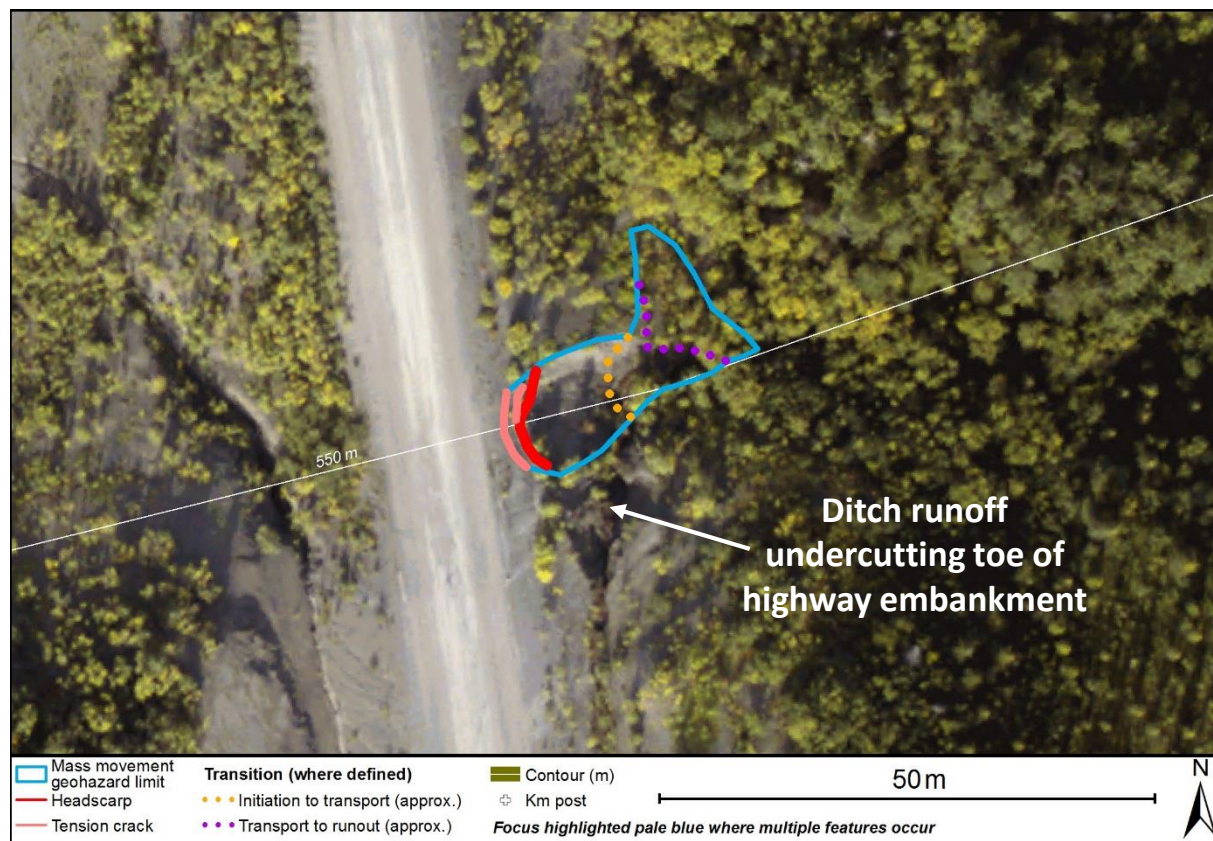
Project: Dempster Geohazard Investigation Project number: 14132 Client: Yukon Government
		KM 378.8

SITE	PROCESS	GEOMETRY	IMPLICATIONS
Section	Type	Elevation (m)	Likelihood
Eagle Plains	debris slide	549	M
Proximity (m)	Position	Initiation slope (°)	Consequence
0	below	30	M
Aspect (°)	Causes	Runout slope (°)	Risk
45	concentrated drainage in hwy ditch undercutting embankment	20	M
Surficial material	Triggers	Average slope (°)	Mitigation
A	intense rainfall/snowmelt	25	Management of runoff in hwy ditch
Permafrost	Timing	Dimensions (L/W/D) (m)	Comments
Permafrost likely relatively deep within highway embankment or underlying weathered bedrock	Single event with potential for post-failure sloughs and gradual retrogression	25 / 10 / 0.5
