Thermal imagery and lidar monitoring of ground instability on the Alaska Highway, southwestern Yukon

Roman, J., Stix, J., Kalacska, M., Lucanus, O., Arroyo-Mora, P. and Lipovsky, P.S., 2025. Thermal imaging and lidar monitoring of ground instability on the Alaska Highway, southwestern Yukon. In: Yukon Exploration and Geology Technical Papers 2024, L.H. Weston, A. Stuart, S.K. Schultz, A.D. Brubacher and D.C. Cronmiller (eds.), Yukon Geological Survey, p. 41–50.

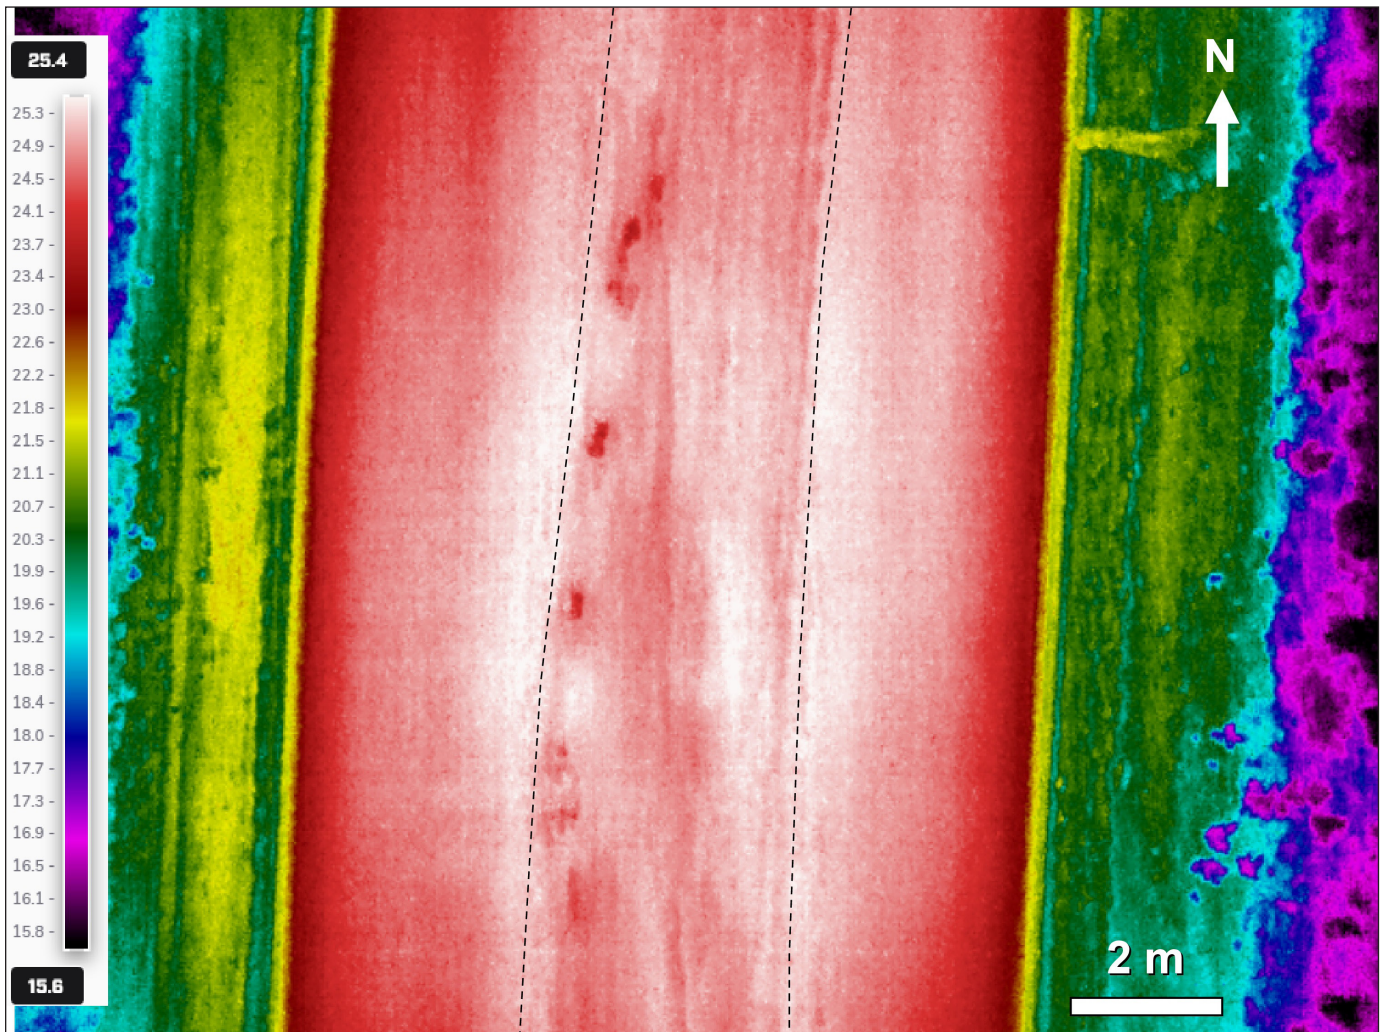
The thermal infrared image presented in Figure 2 was obtained on August 9, 2024, from Study Area B using the XT-R camera. The red to white colours represent the road, whereas the darker colours correspond to the embankment and an open area beyond, which are several degrees cooler. Due to the adjustment of the image's emissivity for asphalt ($\epsilon = 0.93$; Engineering Toolbox, 2024) to highlight variations in the road surface, the temperature displayed for the vegetation (which generally has an emissivity closer to 0.98) appears cooler than it actually is. The road surface is thermally heterogeneous. A main central depression is well displayed, characterized by numerous lineations that are parallel to subparallel to the road. These lineations represent fractures and cracks. The warmest areas of the road surface tend to be on either side of the central depression, although warm temperatures are also present within the depression itself. Small potholes within the depression are well displayed and are slightly cooler than the rest of the depression.

Figure 2. Thermal infrared image from the road deformation site acquired with the XT-R thermal camera from 25 m above ground level, indicating pronounced thermal heterogeneity in the middle section of the road corresponding with the irregular surface topography displayed in Figure 3. The black dashed lines define the main central depression. The red anomalies within the depression correspond to local depressions such as potholes. The left side of the diagram includes temperatures in degrees Celsius and the corresponding colours that are depicted on the image. Analytical parameters used: emissivity 0.93, air temperature 17°C, external optics temperature 17°C, reflected temperature -50°C, relative humidity 69%, and distance 25 m. Note: to prioritize the highway, the emissivity was set to 0.93 (general estimate for asphalt) and other materials with higher emissivity such as vegetation, will be underestimated in temperature.

The thermal infrared image in Figure 2 indicates that the areas of maximum highway damage, as manifested by relatively deep potholes, are reflected by slightly lower temperatures relative to the rest of the road surface. These preliminary results suggest that thermal infrared imaging may serve as a sensitive and early indicator of highway damage. Such surface changes can be valuable for identifying sections of the highway where more thorough investigations may be needed that penetrate deeper in the subsurface. This information could be crucial for road maintenance teams in prioritizing repairs in areas that are most at risk of further thawing.

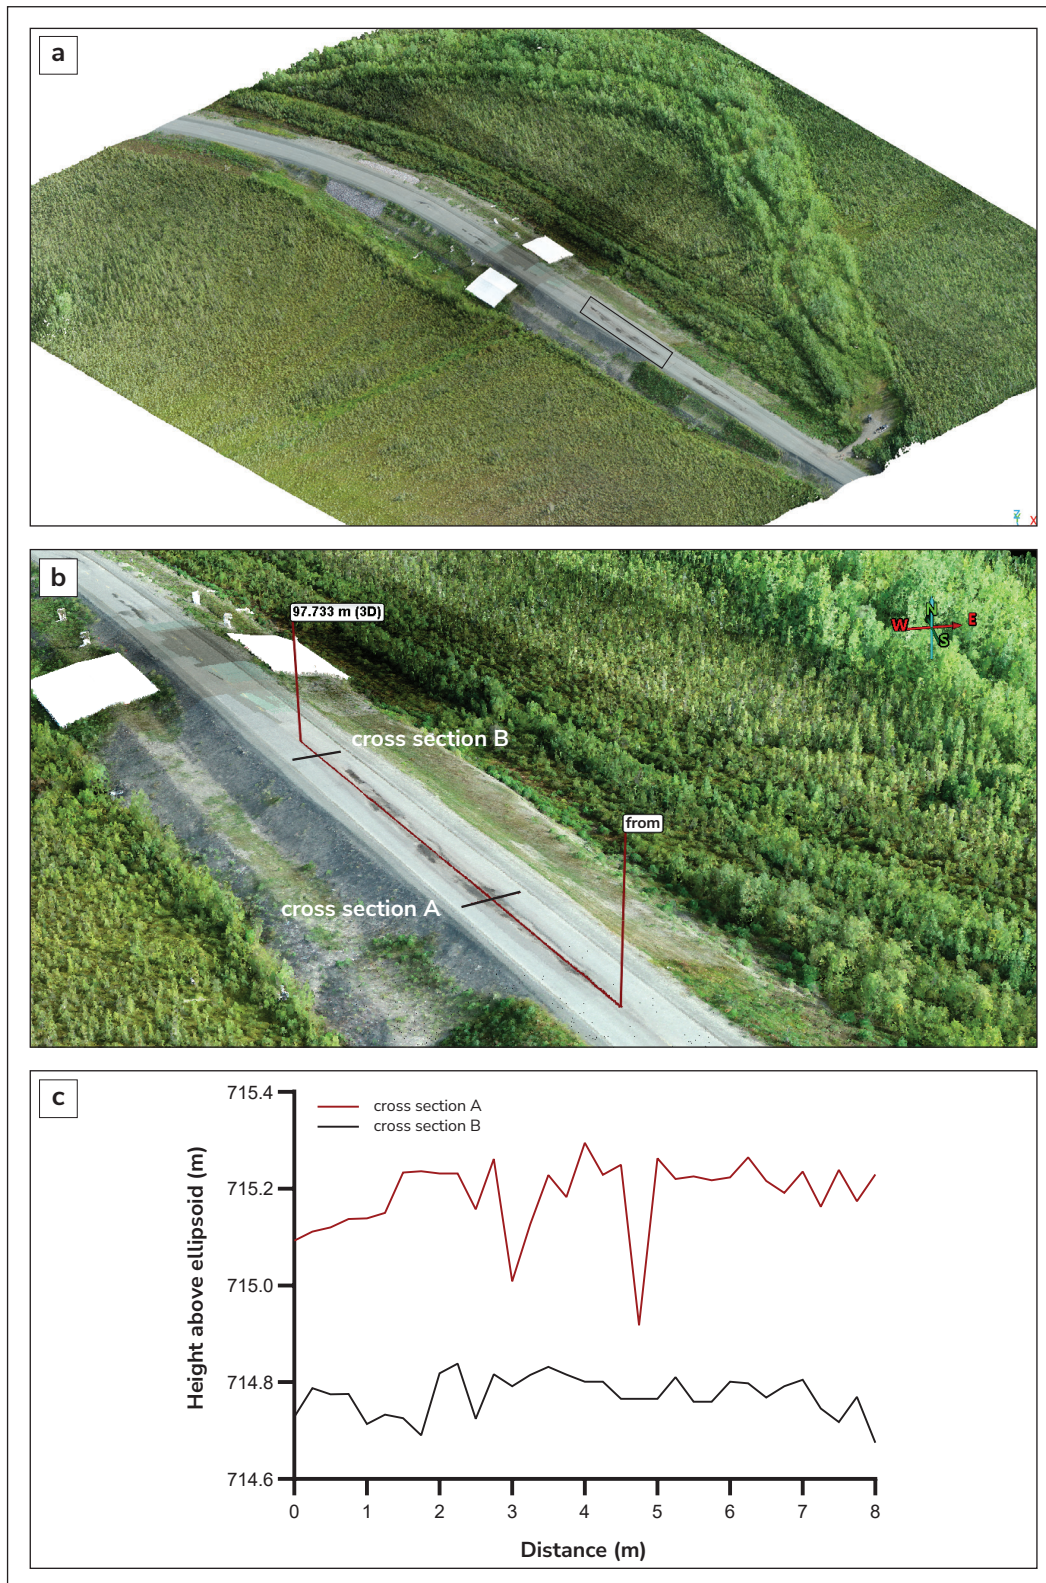
The lidar point cloud density ranged from 30 to 230 pts/m². Lidar data from the same locality as the thermal infrared imagery discussed above also reveals a central area of the road surface containing irregular features (Fig. 3). The main longitudinal depression feature, having a depth of 10 to 15 cm and width of 1 to 3 m, is clearly present in at least two areas of the point cloud. Within the depression, a series of smaller, darker features represent potholes and other locally deeper areas of the depression. The two cross sections contrast a 37 cm vertical difference in cross section A, and a 16 cm vertical difference in cross section B. Cross section A traverses one of the larger local depressions.

Figure 3. Lidar point cloud from Study Area B. **(a)** Overview of the 650 by 350 m area. The black rectangle is the area visible in **(b)**; **(b)** Close-up view of the highway with a 97.7 m centreline across which 8 m cross sections were extracted. Cross section B does not show major surface deformation. Cross section A traverses the central depression on the highway. **(c)** Elevation across the two cross sections at a resolution of 25 cm. Cross section A has a vertical difference of 37 cm, and cross section B has a vertical difference of 16 cm.

topographic view of the road surface. In this study, lidar data revealed cracks and other deformations along a central depression structure on the Alaska Highway (Fig. 3). Further spatial analysis of the point clouds will likely reveal that surface deformations are not uniform, but vary significantly in size and distribution, with certain areas displaying more pronounced instability than others. These can be particularly interesting in the context of highway management because the work can be focused on high-risk areas. These variations may be linked to differences in local permafrost conditions, soil composition or drainage patterns, all of which can influence how thaw affects ground stability (de Grandpré et al., 2012).

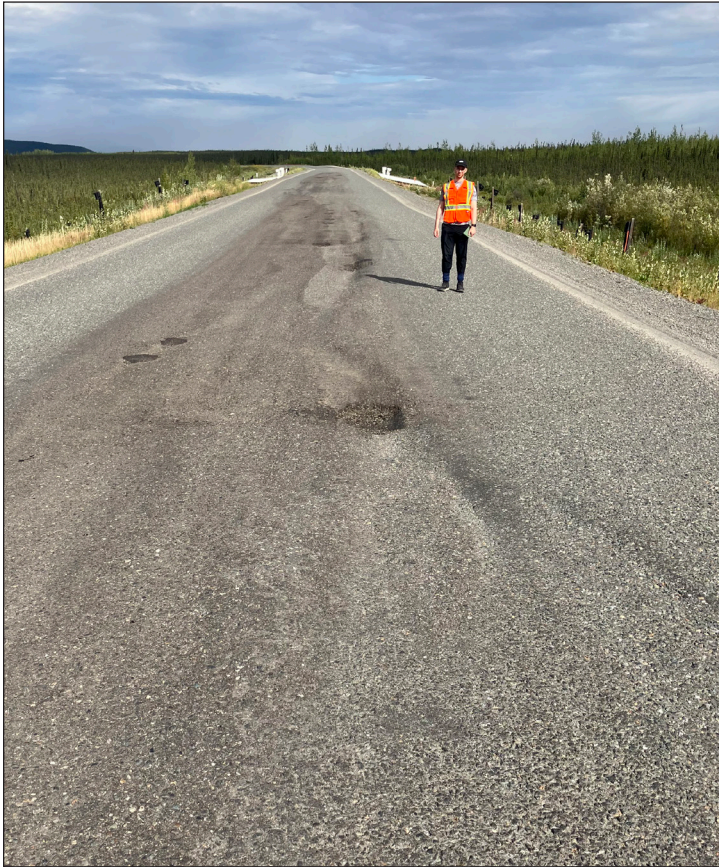
of each area, enabling detailed observations of the road surface. Figures 4 and 5 demonstrate the magnitude and variability of the road deformation at Study Area B, such as cracks and potholes within larger depression features. These features are all observed on the thermal infrared imagery and lidar point cloud. Other observations include features along the side of the road, such as cracks and drainage zones. These features may help to identify specific areas of weakness along the highway.

Figure 4. Site survey of Study Area B indicating a longitudinal depression in the central part of the highway (brown area), as well as potholes and other local depressions.

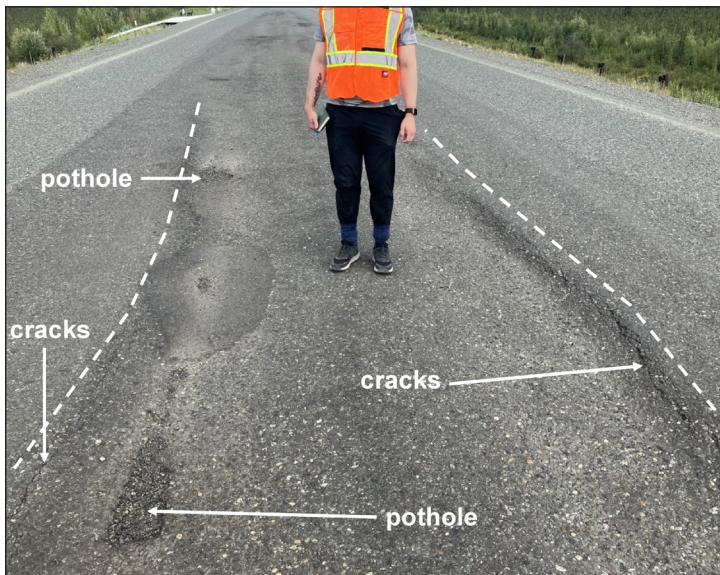
Figure 5. Close-up view of road deformation in Study Area B. A central depression feature is visible (outlined by the dashed white lines), along with potholes and cracks, which define the margins of the depression.
