Mapping geohazards to support climate adaptation on Yukon's transportation network

Emilie Stewart-Jones and Moya Painter*
Yukon Geological Survey

Stewart-Jones, E. and Painter, M., 2026. Mapping geohazards to support climate adaptation on Yukon's transportation network. In: Yukon Exploration and Geology 2025, A. Stuart, L.H. Weston and S.K. Schultz (eds.), Yukon Geological Survey, Government of Yukon, p. 207–219.

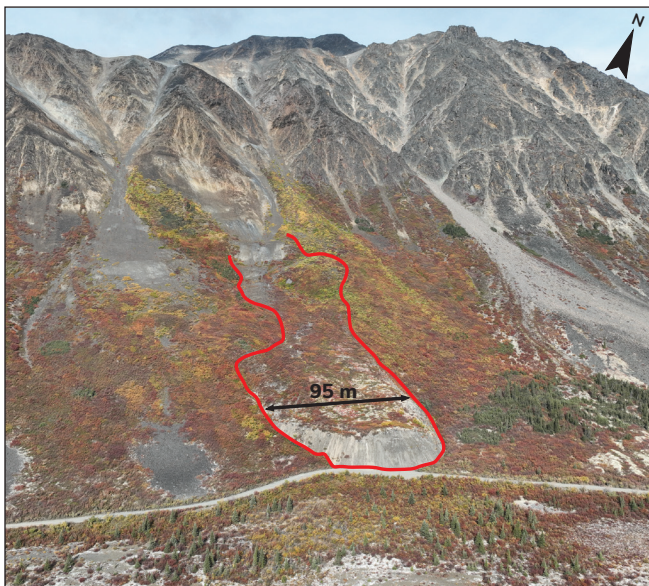
The toe of the rock glacier on the North Canol Road has encroached onto the road, and regular debris clearing is required by maintenance crews to ensure

Figure 4. North Canol Road rock glacier, outlined in red.

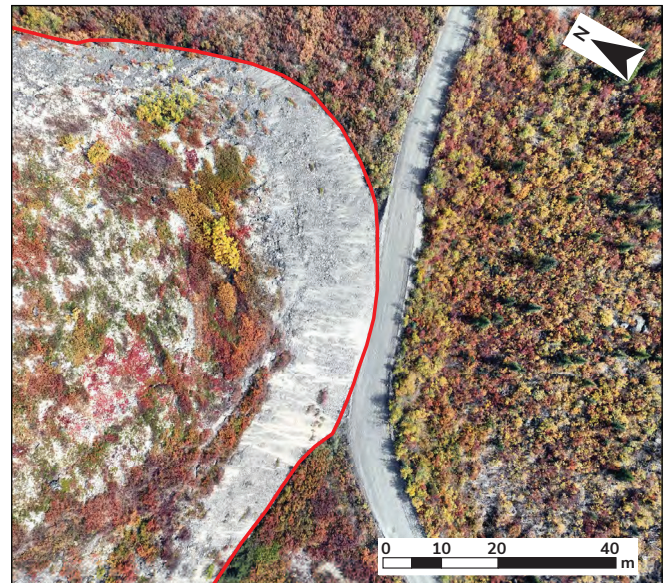
the road is passable (Fig. 5). The toe of the rock glacier is up to 18 m thick on the road surface. Old tension cracks were visible in the 1949 and 1974 air photos near the top of the rock glacier; however, more recent tension cracks were captured in 2013 satellite imagery and formed sometime between 1974 and 2013; these are shown in lidar imagery from 2019 (Fig. 6).

Figure 5. Birdseye view of the toe of the rock glacier (outlined in red) and its relative position to the North Canol road in September 2025.

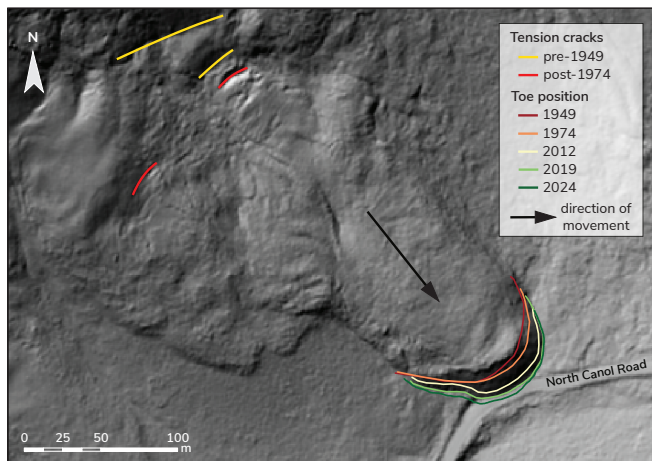
Figure 6. Lidar image from 2019 of the North Canol rock glacier outlining the maximum toe positions from 1949 to 2024; tension crack locations are also delineated.

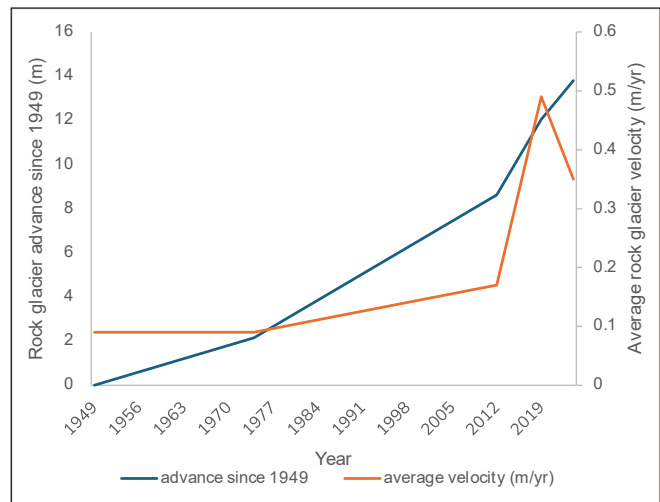
Average displacement rates can be tracked using available lidar, satellite imagery and historic air photos. Two historic air photos of this area were available for 1949 and 1974, lidar was flown for 2012 and 2019, and high-resolution satellite imagery was available for 2013 and 2024. Using these we were able to calculate mean movement rates for each period bracketed by the imagery. From 1949 to 2024 the toe of the rock glacier advanced toward the road by a total of 13.8 m, on average. Advance is not uniform across the front of the rock glacier. In recent years there is greater advance on the western side of the toe, while there is little or no movement on the eastern side. Total displacement from 1949 to 1974 of the centre of the toe of the rock glacier was 19 m. From 1949 to 1974, the displacement across the toe of the rock glacier was 2.15 m, or an average of 0.09 m/year. Between 1974 and 2012, the toe of the rock glacier moved 6.47 m, or an average of 0.17 m/year. From 2012 to 2019, the advance

of the rock glacier accelerated to an average of 0.49 m/year, and then dropped to an average of 0.35 m/year from 2019 to 2024 (Fig. 7).

The acceleration of the rock glacier in the last decade is likely related to increasing air temperatures in the Yukon, having a total mean annual air temperature increase of 2.5°C between 1948 and 2021, including notable increases beginning in the mid-1970s (Perrin and Jolkowski, 2022). The relationship between increasing air temperatures and accelerating rock glacier velocities has been observed for rock glaciers globally (Hu et al., 2025), suggesting that, with increasing air temperatures, this rock glacier may continue to accelerate and further encroach onto the road.

Figure 7. Average velocity and maximum advance of the toe of the North Canol Road rock glacier since 1949.

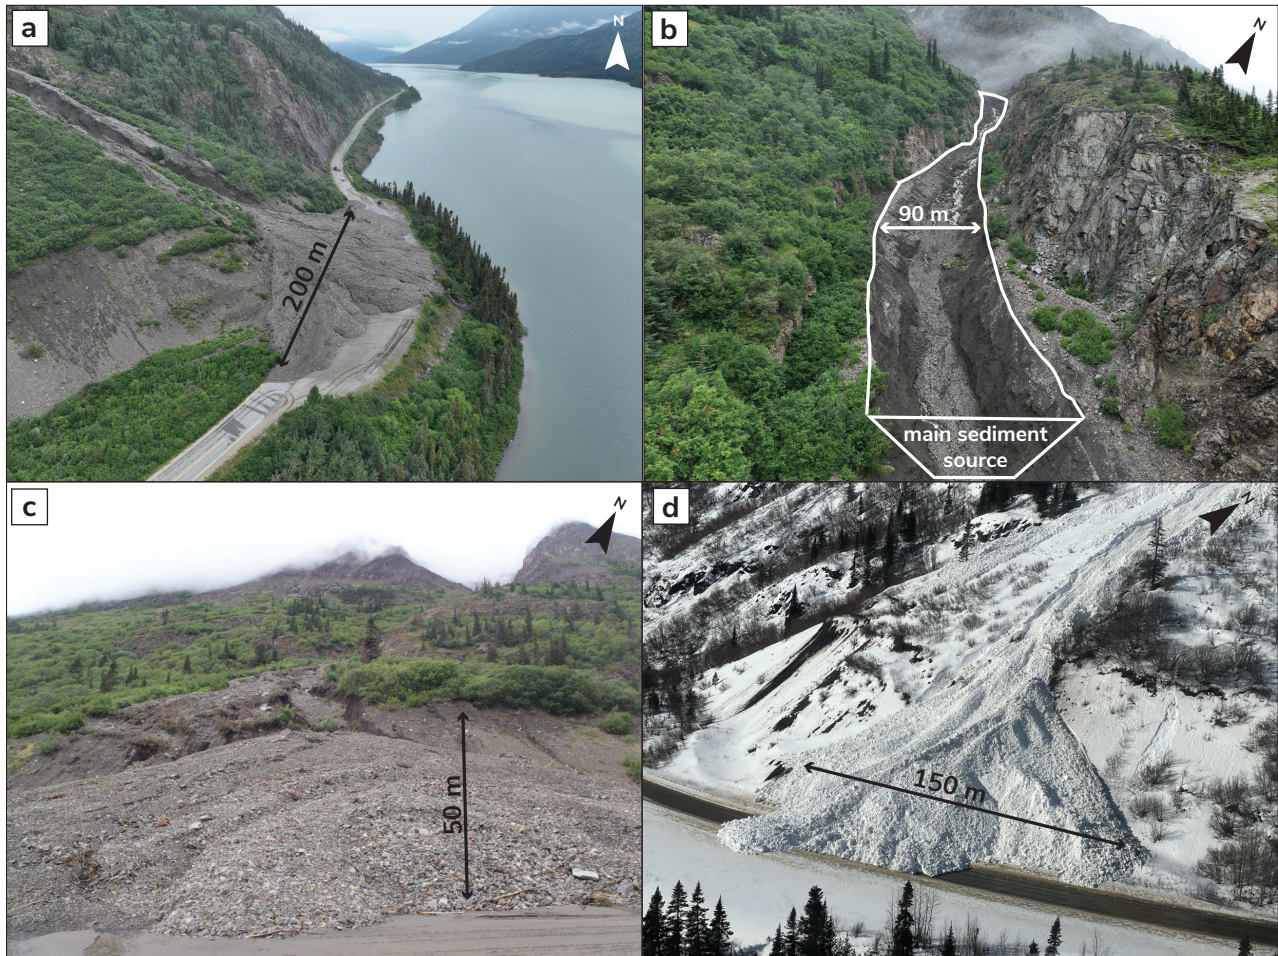
In July of 2024, a heavy rainfall event of approximately 50 mm of precipitation over 24 hours triggered a debris flow that covered a 200 m section of the South Klondike Highway at KM 58 (Figs. 1 and 8a). Similar rainfall across the region caused

This is the second major debris flow at this site in a decade. A smaller event occurred in July 2014 after heavy rainfall triggered a debris flow and resulted in a 2-day road closure (Fig. 8c). For another event of this magnitude to occur at this site, a build-up of material in the channel will be required, suggesting that large events in consecutive years are unlikely.

This site is also a common avalanche path in the winter (Fig. 8d), and 52 avalanches were recorded between 1991 and 2020, resulting in two road closures (Tse and Adams, 2024). Recent work has estimated the frequency of size 3 avalanches (large enough to bury and destroy a car or break a few trees) to be every year, and the frequency of size 4 avalanches (large enough to destroy a large truck or several buildings) to occur every 10 years (Sharp, 2025).

Figure 8. Photos of the South Klondike Highway KM 58 debris flow site. **(a)** A photo from July 2024 of the debris flow fan covering the entire width and affecting a 200 m stretch of the highway (photo: Derek Cronmiller). **(b)** A photo from July 2024 of the scoured drainage resulting from the debris flow; the photo was taken above the road and near the apex of the debris flow fan (photo: Derek Cronmiller). **(c)** A photo of the toe of the debris flow fan taken from the road in July 2014 (photo: Paul Murchison). **(d)** A photo of an avalanche triggered by explosives taken in the spring of 2024; the avalanche followed the same path as the debris flow (photo: Colin MacKenzie, Snowshoot Productions).

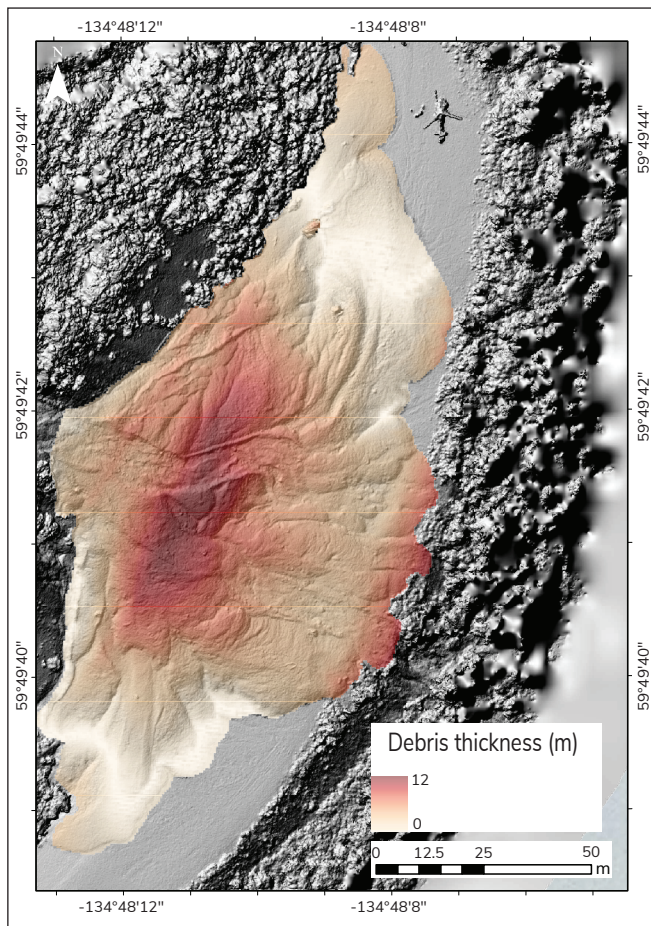
widespread flooding, debris flows and rockslides, and at least one of these events closed the White Pass rail line. At KM 58, the road was closed for less than a day; however, it took seven weeks to fully remove debris, requiring a pilot car to shuttle traffic during this time. Most material originated from the lower part of a pre-existing drainage and its channel deposits (Fig. 8b), resulting in an estimated 63 000 m³ of debris deposited across the road and colluvial fan (Fig. 9).

Figure 9. Lidar imagery of change detection illustrating the thickness of the 2024 debris flow fan on the South Klondike Highway.

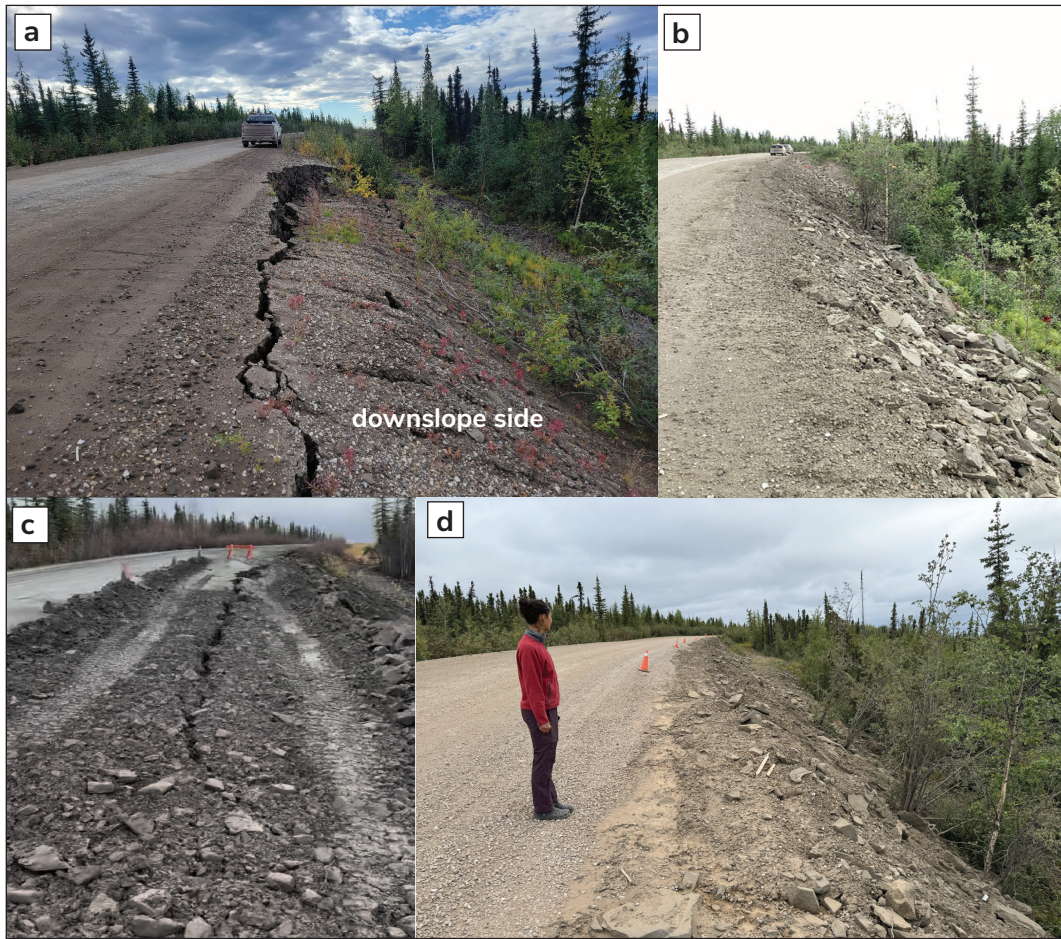
A road embankment failed at KM 312 of the Dempster Highway in August 2023 (Figs. 1 and 10a). A large crack initiated along the shoulder of the road, resulting in a vertical displacement of at least 1 m at one end. The embankment failure occurred on the downslope side of the road. At this location, the road intersects a small drainage where the embankment ranges in height from 2 to 4 m.

Prior to 2023, this embankment was stable. This section of the Dempster Highway is within the continuous permafrost zone and has historically shown little permafrost-related instability (Burn, 2015). The failure of the embankment at the end of summer (both in August 2023 and September 2024) suggests that the cause of failure is likely permafrost

Figure 10. The evolution of the embankment failure at KM 312 of the Dempster Highway: **(a)** the initial failure in August 22, 2023; **(b)** the repaired embankment in July 22, 2024 and minimal cracking; **(c)** the failed embankment in October 2024; and **(d)** the stabilized embankment in July 2025. Photo by Stephan Gruber.

Material was added to the road in the fall of 2023 to stabilize the embankment before winter. The embankment remained stable (Fig. 10b) until September 2024, when it failed again. That fall,

material was added to the toe to stabilize the slope; however, the embankment continued to fail with vertical displacement reaching up to 0.5 m (Fig. 10c). Repairs were not done until the following spring, resulting in a single lane closure at this location throughout the winter months. As of July 2025, there has been no significant movement observed at this site (Fig. 10d).

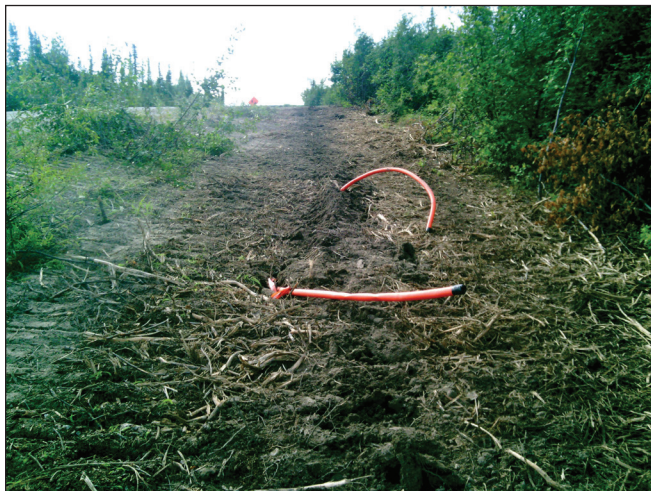
related, as the depth of thaw is greatest in the fall. A possible contributing factor to this failure is the installation of a fibre optic line at the toe of the embankment in July 2022. Stripping of vegetation and the subsequent compression of the organic mat in permafrost terrain accelerates thaw and can lead to visible surface disturbance where ice is present (Brown and Grave, 1979; Fig. 11).

Figure 11. An example of the installed fibre optic line in 2022 at KM 311.6 of the Dempster Highway. The photo was taken 100 m from the embankment failure, and the removal of vegetation is evident.

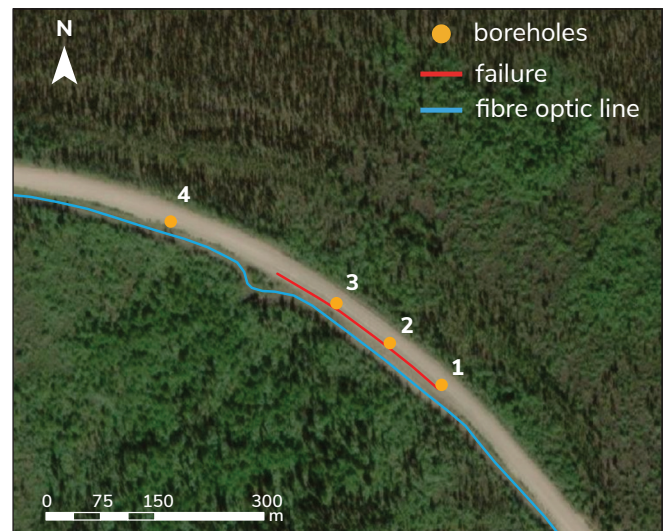
A geotechnical investigation was carried out at this site in the spring of 2025 (Singh and Ismail, 2025). The purpose of the work was to characterize soil, permafrost and geological conditions at the site to identify potential stabilization or mitigation options. Fieldwork included drilling four boreholes, three within the failure zone and one outside; depths ranged from 5.3 to 15.5 m (Figs. 12 and 13).

Figure 12. Aerial photo of the embankment failure at KM 312 of the Dempster Highway and the location of the four boreholes drilled during the investigation.

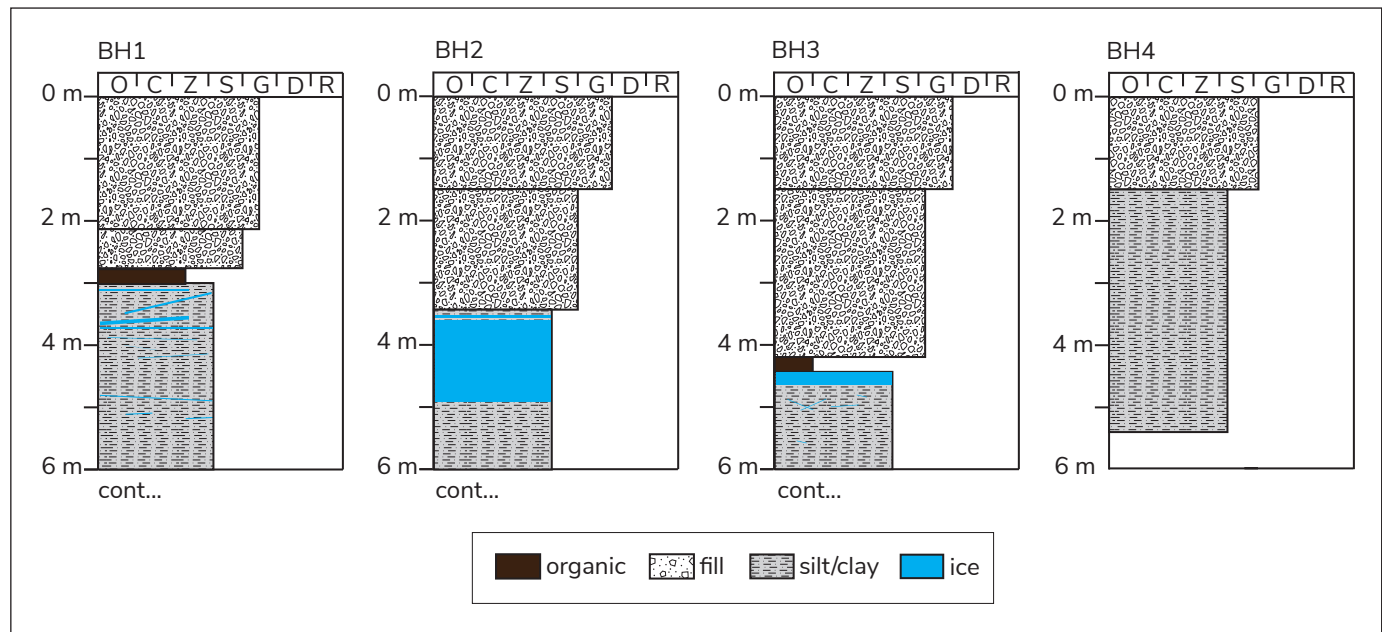
Subsurface conditions generally consisted of road fill overlying silt and clay (Fig. 13). The road fill in

the failure zone varied in thickness from 2.7 to 4.4 m. Visible ice was identified in several boreholes, particularly between 3 and 6 m depth, indicating ice-rich and potentially thaw-sensitive materials. Boreholes 2 and 3, both located within the failure zone, contained the most visible ice. Although total ground ice content is difficult to determine due to the disturbance of ice during drilling, an estimated excess ice measurement was taken from a sample from both boreholes. The sample from borehole 2 taken at a depth of 4.2 m had a volumetric ice content of 58%, whereas the sample from borehole 3 taken at a depth of 4.9 m had a volumetric ice content of 55%.

1. High ground ice content, as was evidenced by greater ice content in the failure zone compared to outside of the failure zone.
2. Disturbance of vegetation and the ground surface during the installation of the fibre optic line, which likely caused ground ice melting and subsidence of the embankment toe.
3. A thick, steep embankment on a slope, which would have exacerbated the effects of the reduced soil strength at the toe as ground ice melted.

Figure 13. Stratigraphic logs of the uppermost 6 m for the four boreholes drilled at KM 312 of the Dempster Highway. Borehole logs from Singh and Ismail (2025).
