2005 Village of Mayo Well Rehabilitation and Resource Assessment on PW1 and PW2

Prepared for
Energy Solutions Centre

Submitted by
Gartner Lee Limited

January 2006

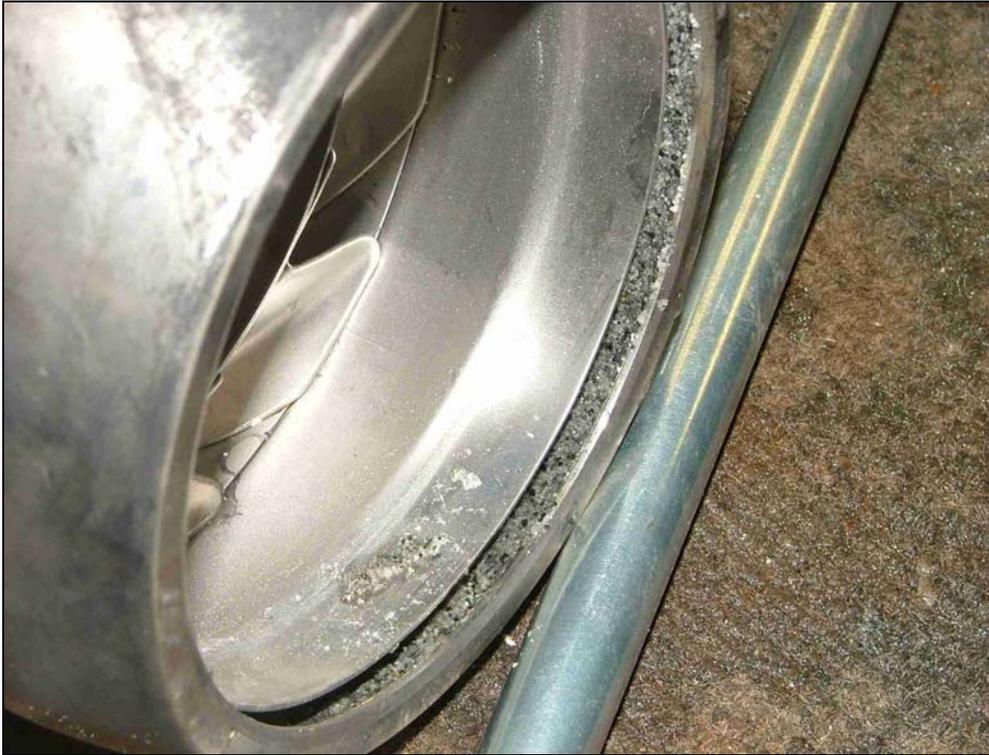
Given these observations, it is likely that the holes in the casing are the likely source of the silica sand observed in the pump that was pulled from PW1. Appendix B provides a photo of the sand observed in the PW1 pump impellers. The mechanical wear was so extensive that the pump required replacement.

Photograph 2: Silica sand was found within the impellers from pump PW1. Silica sand was NOT found in PW2. Both pumps however were removed and replaced as it was determined the pumps had lost efficiency due to mechanical wear.

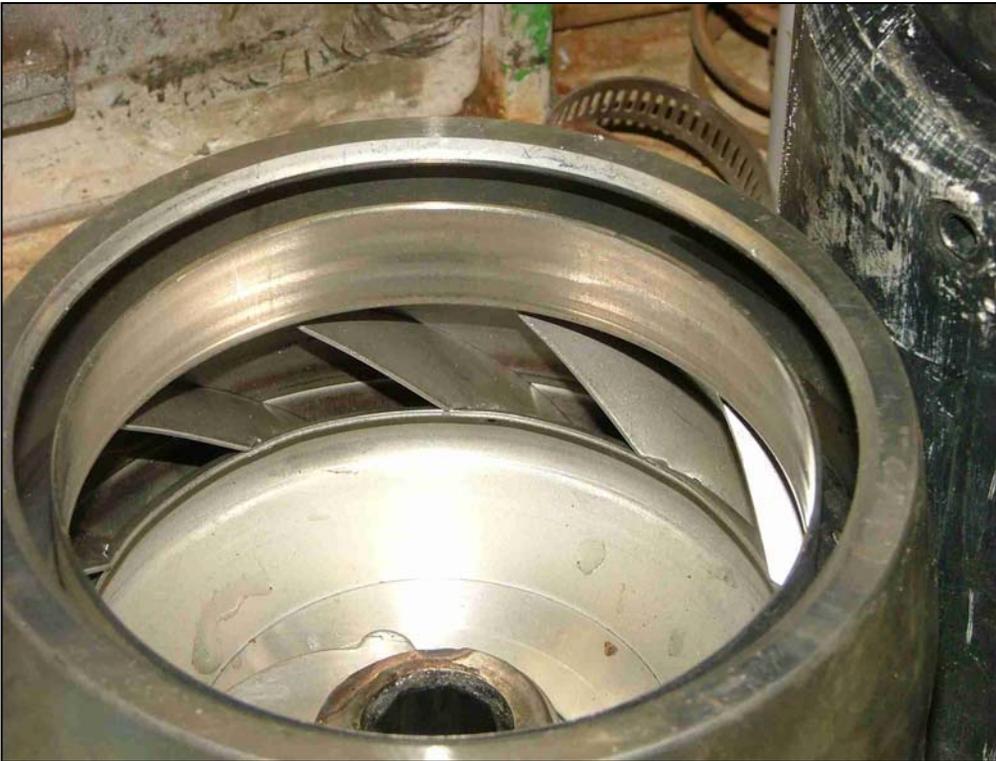
The pump from PW1 exhibited significant signs of mechanical wear as a result of pumping sand. The mechanical wear was so extensive that the pump was replaced. PW1 should *not* be used as a primary

Photograph 3: A close-up of the pump impellers from PW1. Note the mechanical wear at the base of the impeller.

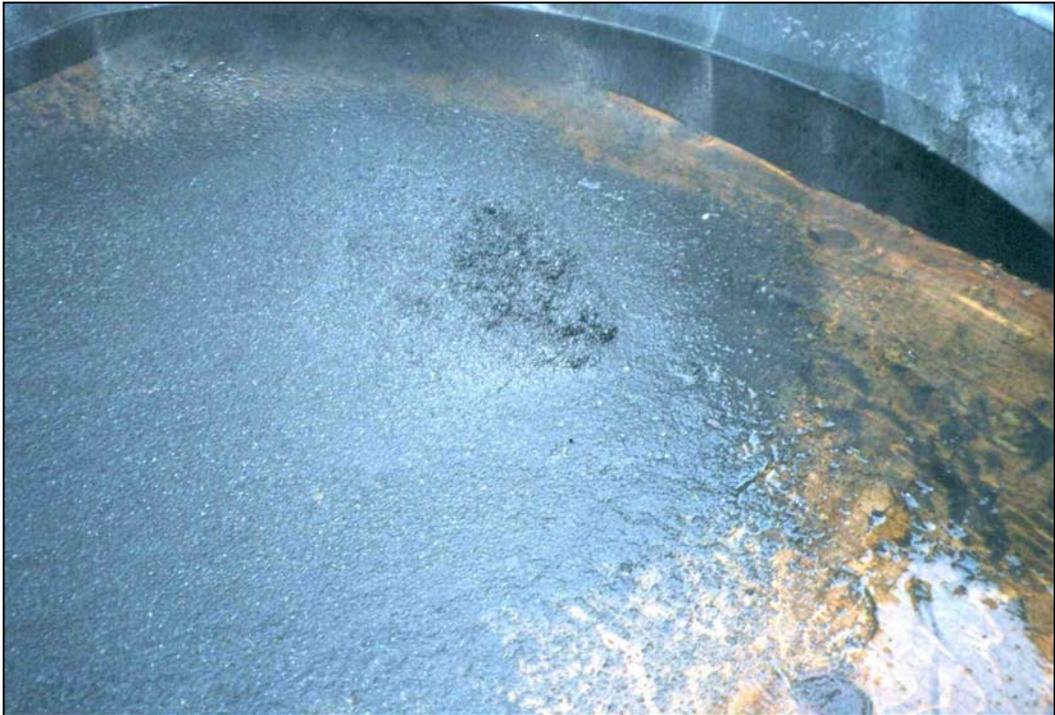
- The observed features of this sample are consistent with the deposition of iron (Fe) and calcium (Ca) within the well as a poorly consolidated scale.
- It seems probable that much of the Fe is derived by corrosive dissolution of the steel well casing and subsequent precipitation in hydroxide form.
- Microbial activity most likely plays a part in this process and in the formation of the minor co-precipitated Fe sulfides in the scale.
- The estimated composition of the scale material is as follows:
 - Quartz, (Quartzite) 15%
 - Carbonate (CaCO₃) 25%
 - Limonite (FeO(OH)·nH₂O) 60%
 - Pyrite (FeS₂) trace
- The siliceous component occurs as discrete clasts ranging in size from 0.2 - 7.0 mm in size. These are clearly of mechanically transported origin, presumably introduced into the well by the inflowing water.

Photograph 8: Close up of precipitate and scale debris that was removed from the well.
