KLUANE LAKE WATER QUALITY STUDY

A Water Quality Study under the Arctic Environmental Strategy

October 1993

**Patrick Roach
Area Studies Scientist
Water Resources Division
Northern Affairs Program
200 Range Rd.
Whitehorse, Yukon Y1A 3V1**

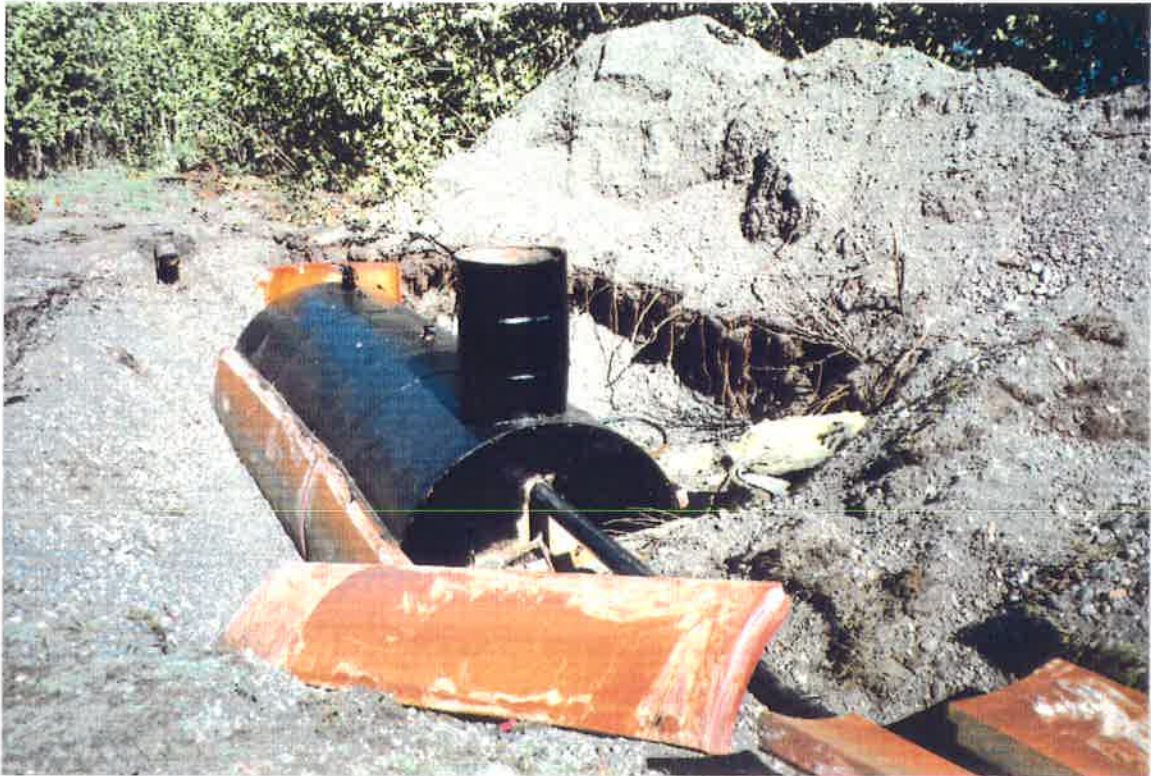
The Resort was found to have a defective septic system, located behind the Resort, which was actively discharging to Kluane Lake. While this discharge was at a low rate, it was in contravention of the Yukon Waters Act. Mr. Tony Polyck, of the Water Rights Section of the Northern Affairs Program, issued instructions to the owner of the Resort to rectify the situation. Under the direction of Mr. Allen Sales, of Health and Welfare Canada, a holding tank system (photo A) was installed by the Resort and the discharge to the Lake has ceased. Drinking water for the Resort is provided by a well located under the Resort.

Photo A: Burwash Resort Holding Tank

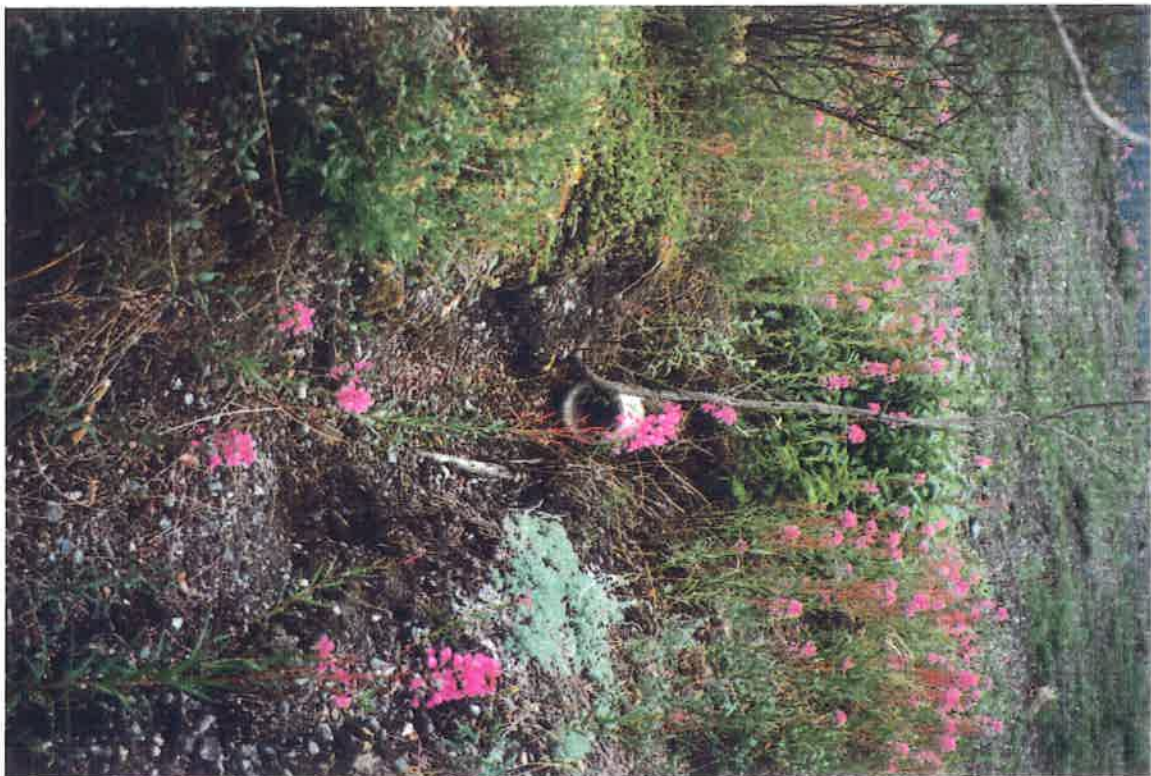
The Destruction Bay Sewage lagoon receives sewage piped from Destruction Bay and hauled from Burwash Landing, Burwash Landing Resort, Cottonwood Campground and the Arctic Institute of North America. The lagoon has been modified over the years to control the annual discharge more effectively. The original discharge point and channel (photo B), which are located on the lake-side of the lagoons two cells, have been replaced with a discharge point on the highway-side of the second cell and two containment ponds (photo C and D), which act as additional cells. They could eventually discharge to a lowland area (photo E), which floods only in the spring, is a half kilometre from the lake and is separated from the lake by a natural berm of secondary beach (photo F and G). When the main lagoon was drained in September of 1993, the discharge did not extend beyond the second containment pond (photo H). It is unlikely that the lagoon, at it's present size, could produce enough discharge to flood the lowland area and certainly not enough to reach Kluane Lake.

Photo B: Destruction Bay Sewage Lagoon - Old Discharge

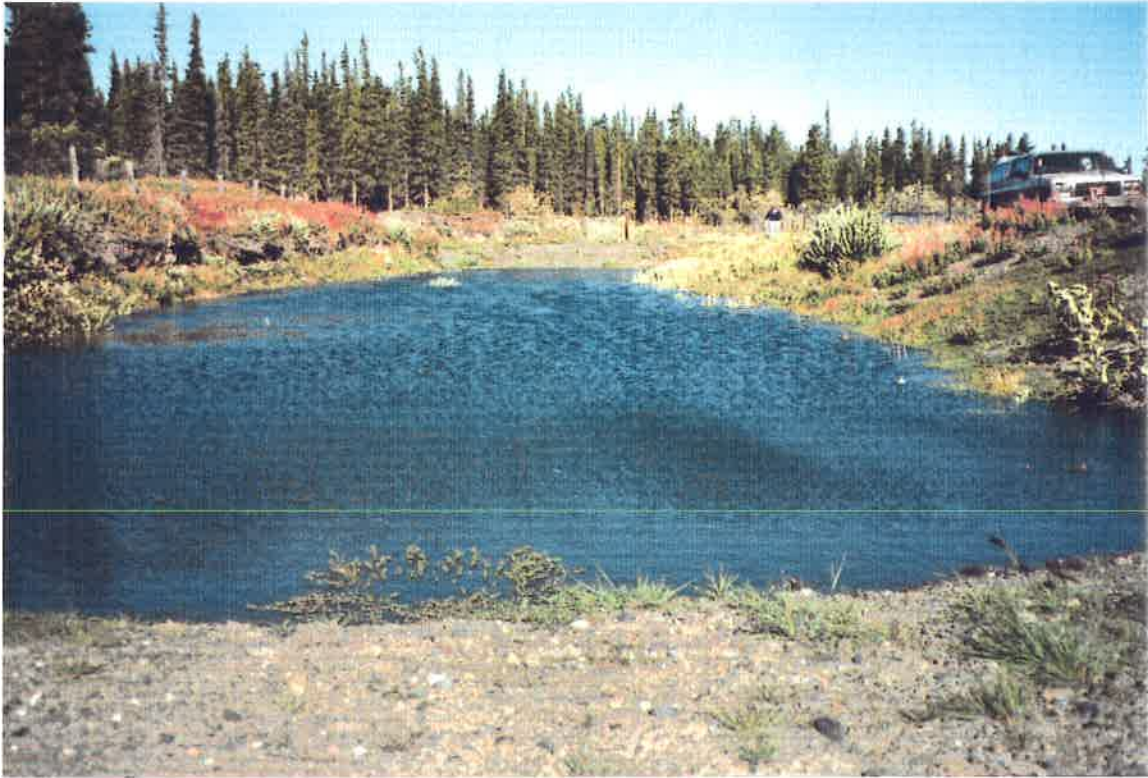
Photo C: Destruction Bay Sewage Lagoon - First Additional Containment Pond

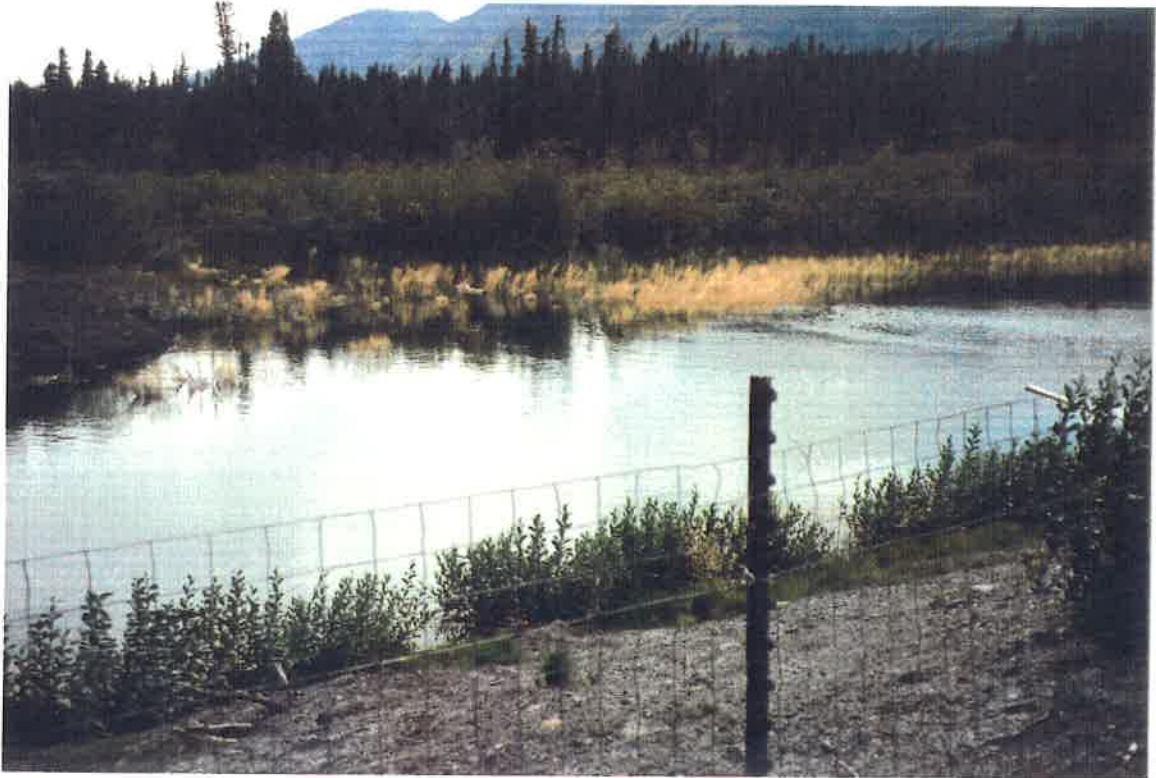
Photo D: Destruction Bay Sewage Lagoon - Second Additional Containment Pond

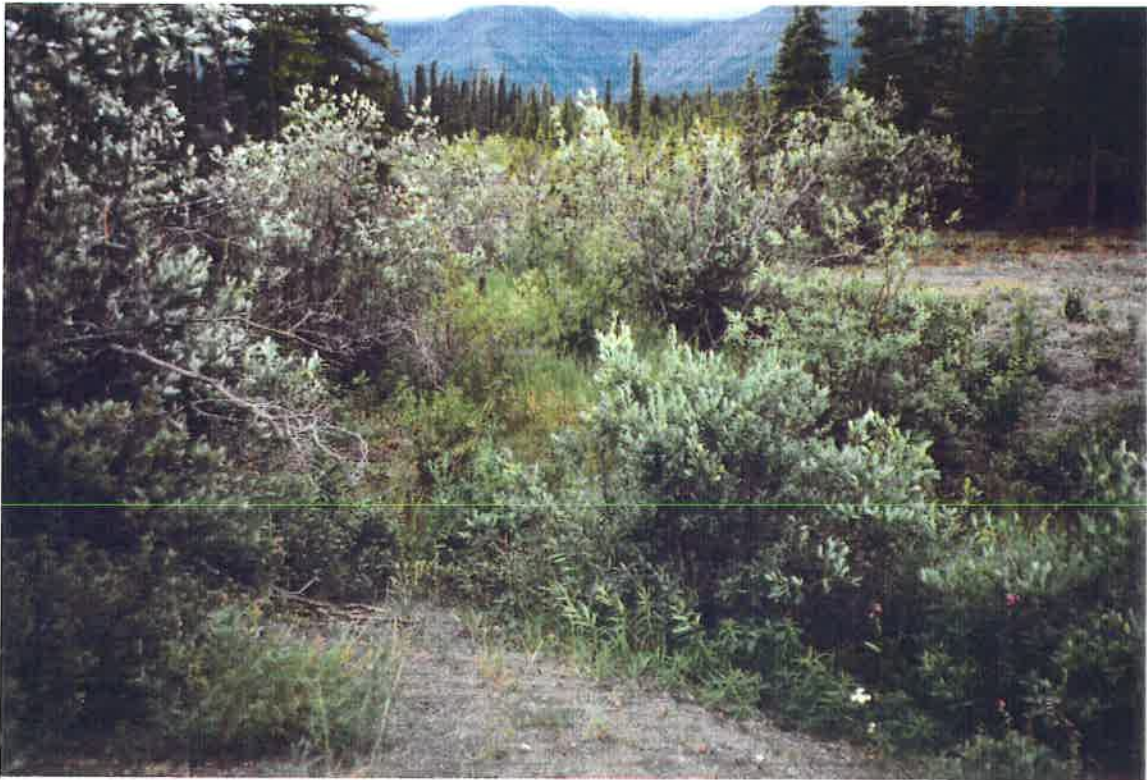
Photo E: Destruction Bay Sewage Lagoon - Lowland Discharge Site

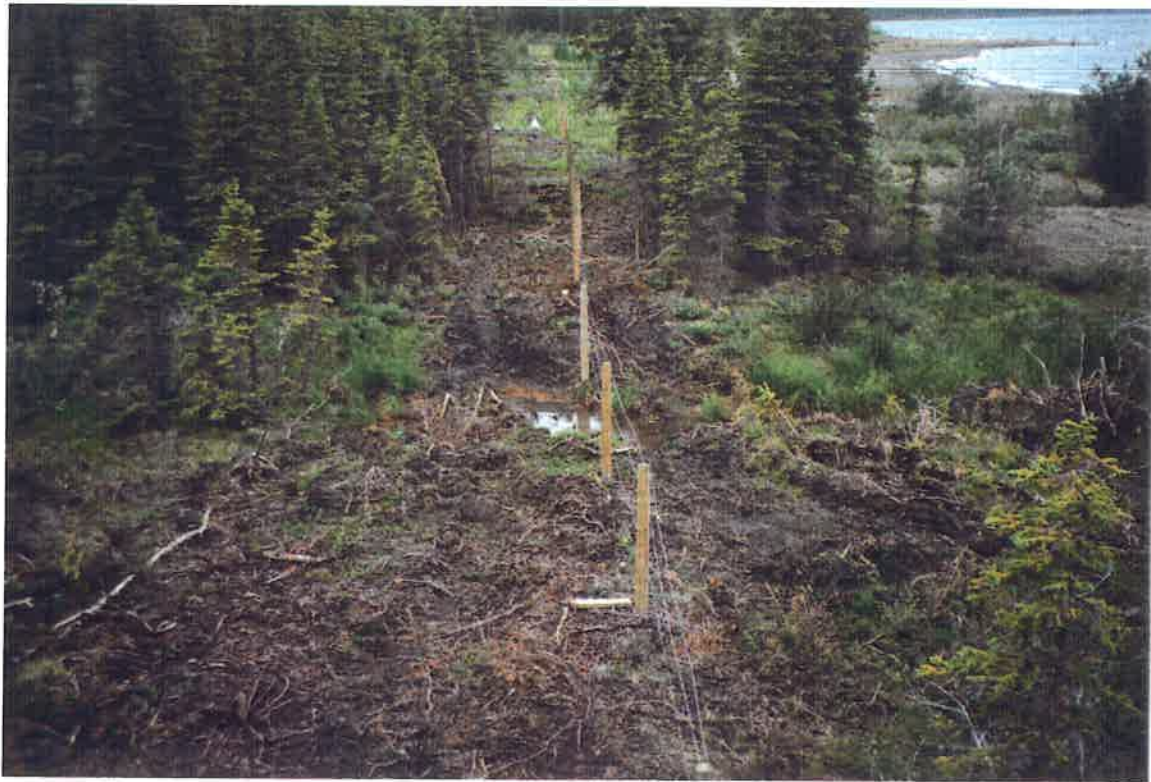
Photo F: Destruction Bay Sewage Lagoon - View of Lowland Drainage at Lake

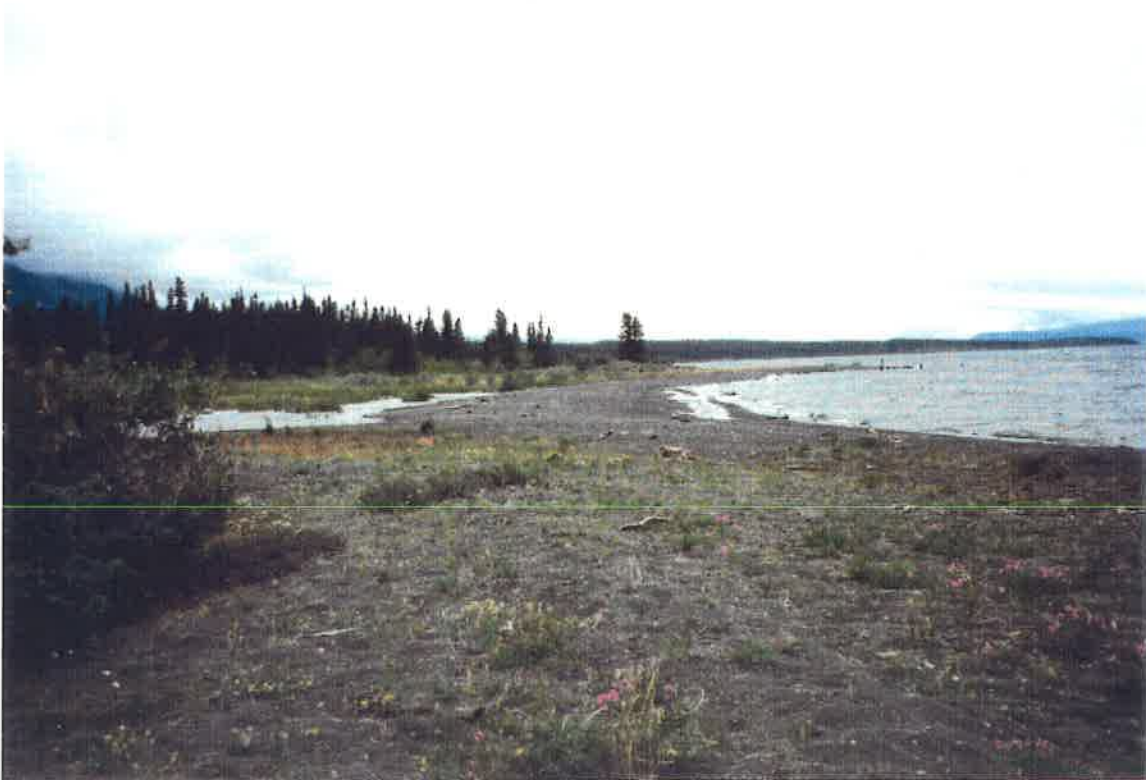
Photo G: Destruction Bay Sewage Lagoon - Secondary Beach at Kluane Lake

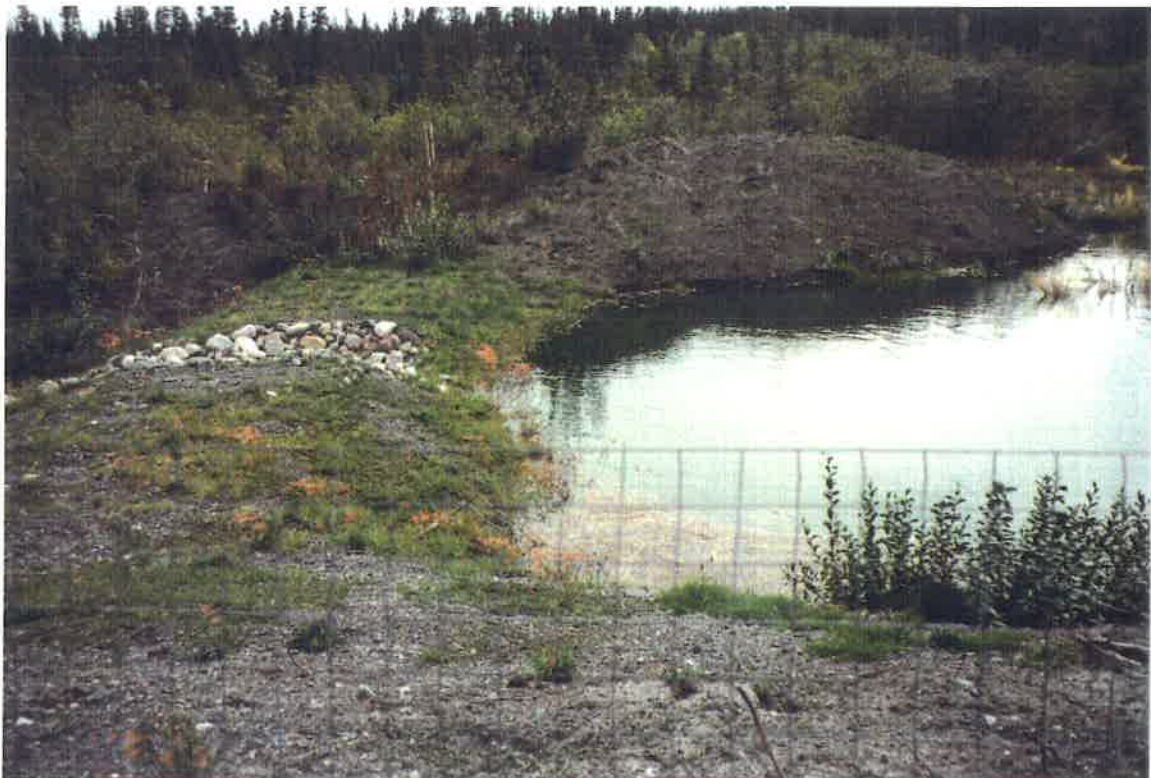
Photo H: Destruction Bay Sewage Lagoon - Level in Second Containment Pond

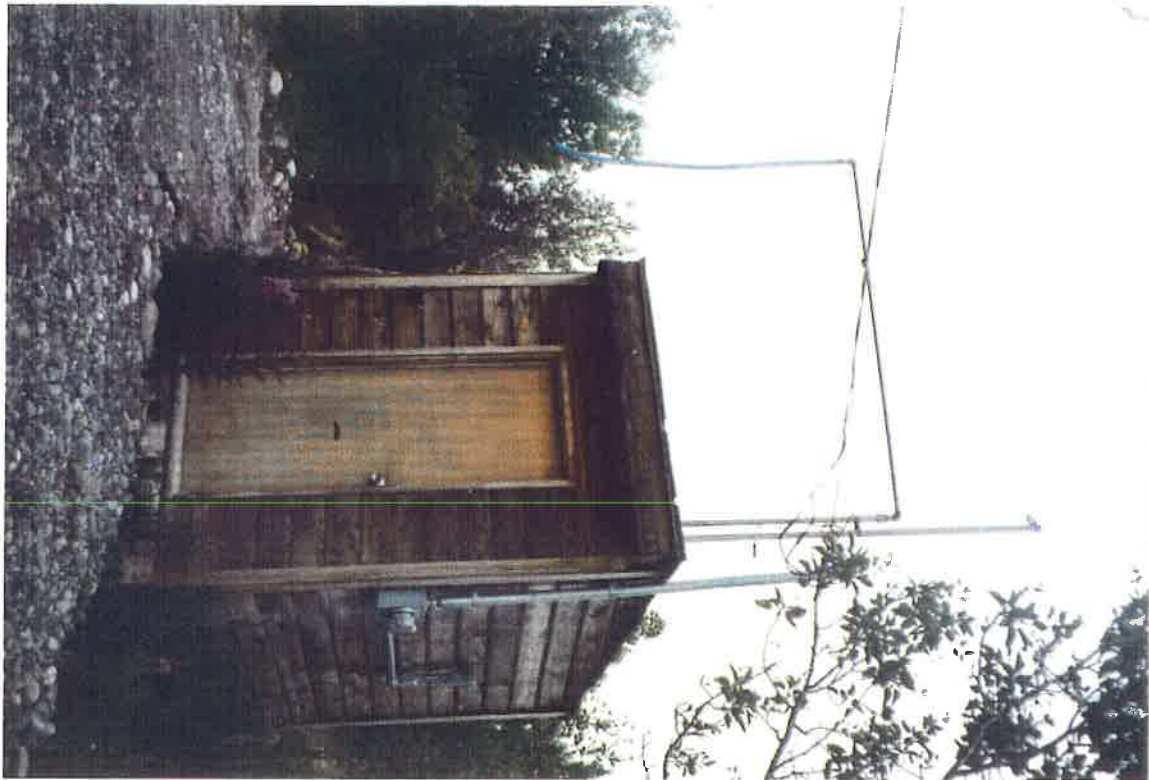
Currently the community of Burwash Landing obtains drinking water from two wells located within the community. One well serves the Elder's Residence and the other (photo I), is located west of the school. This well near the school has a pit privy (photo J) and, it has been suggested, a septic field located on either side of it. These septic facilities service two residences which were unoccupied during the time of the investigation, although anecdotal evidence suggests that they are occupied periodically. Water from the wells is distributed by a Band operated truck and disinfected with bleach added directly to the truck. Health and Welfare Canada samples the existing wells on a regular and has yet to find any contamination in either well. A third well (photo K) is located below the wash house, beside Kluane Lake. This is an infiltration well equipped with a chlorinator (photo L) which has been extensively damaged (photo M,N,O,P), and was not in service at the time of the investigation. This well has a pit privy (photo Q) located adjacent and above it. The wash house has it's own well.

Photo I: Burwash Landing - Well Site near School

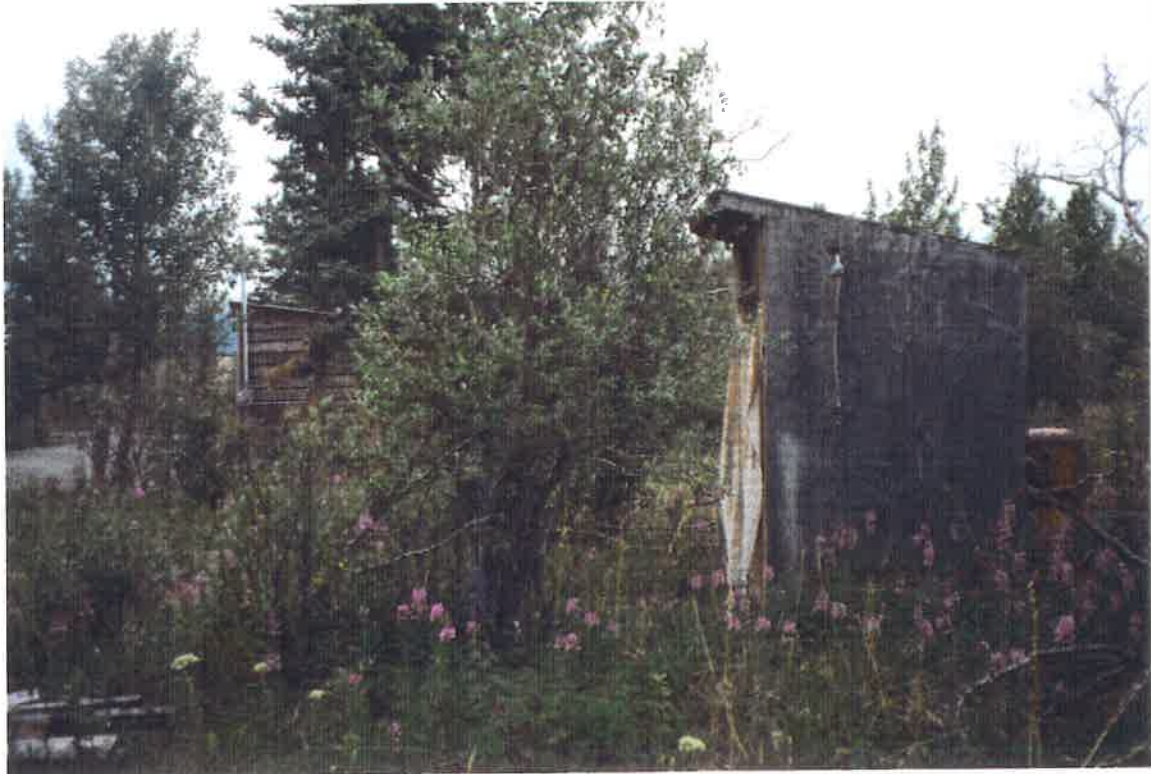
Photo J: Burwash Landing - View of Well Site near School including Pit Privy

In Burwash Landing itself, the community should be cautious in the placement, selection and operation of sewage systems, to avoid contamination of their groundwater and well supply. The pit privy, located near the well by the school, should be removed and the existence of a possible adjacent septic system determined. The presence of permafrost throughout the area, makes the use of septic systems difficult and they should be avoided above and around the location of any wells. The use of chlorination, whether at the well head or in the truck hauling the water, should be emphasized to compensate for potential contamination during handling and the growth of bacteria during storage.

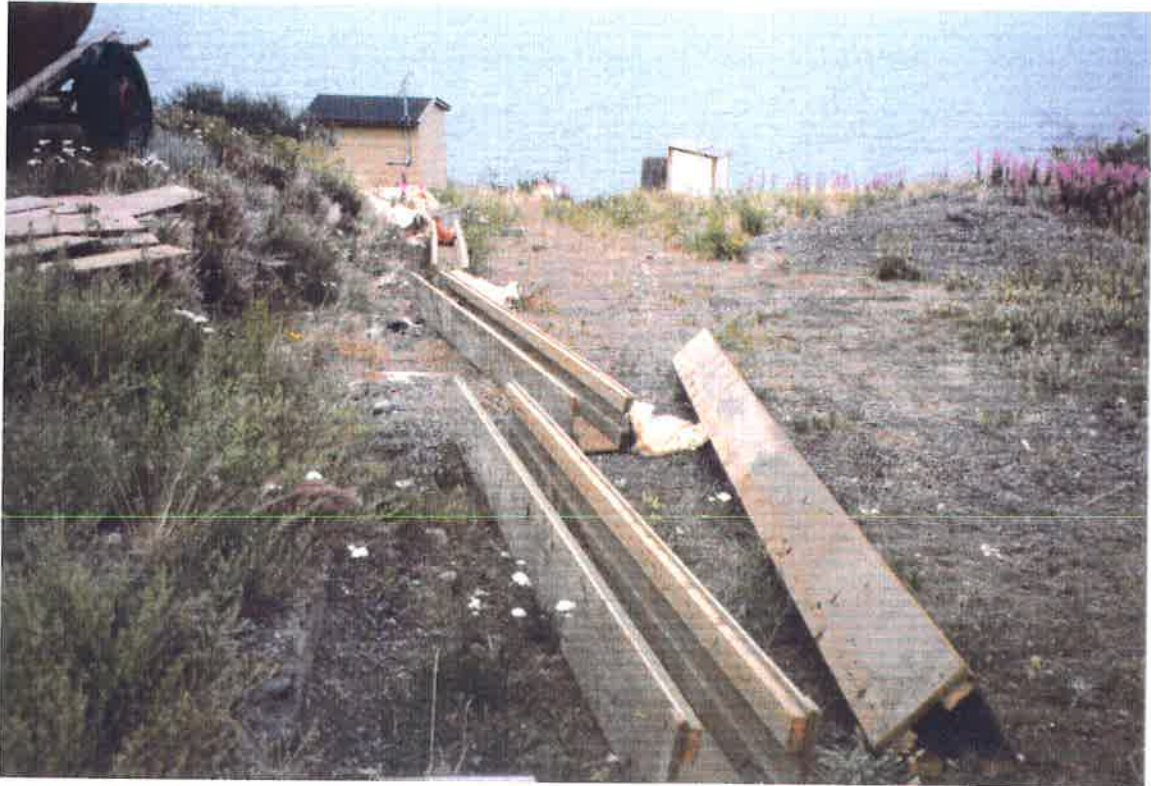
Photo K: Burwash Landing - View of Third Well Site and Pit Privy

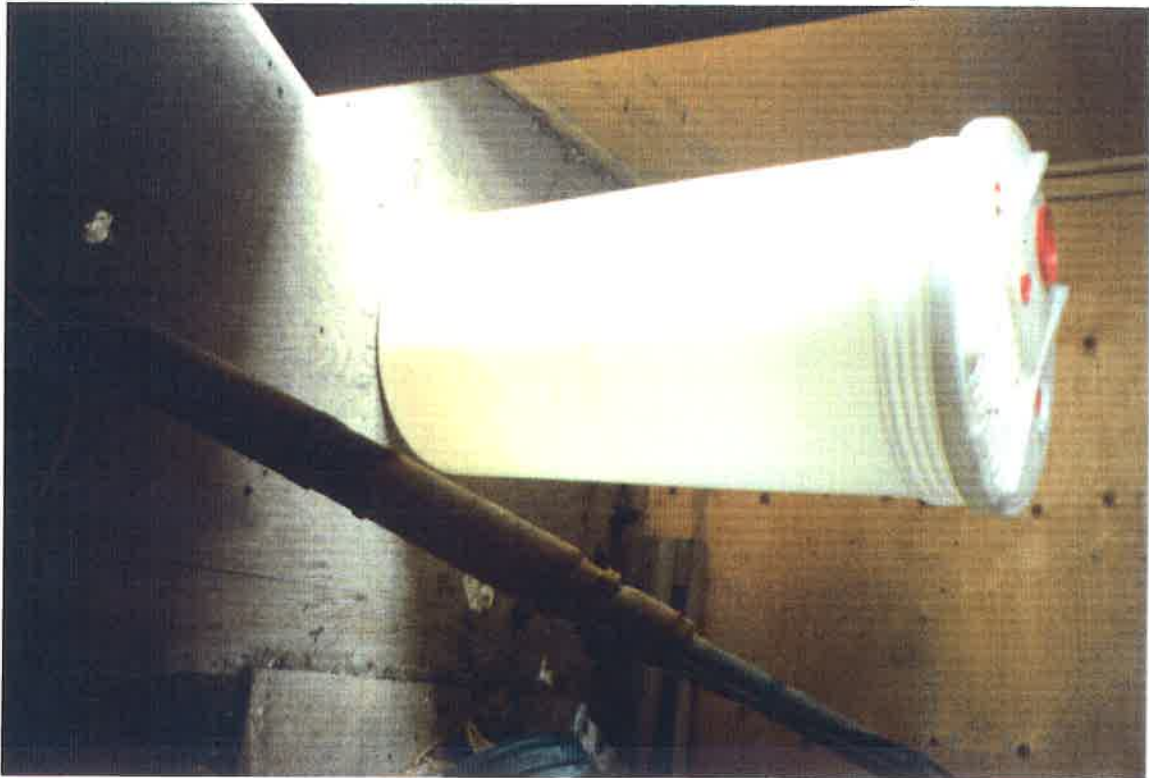
Photo L: Burwash Landing - Tank from Chlorination System

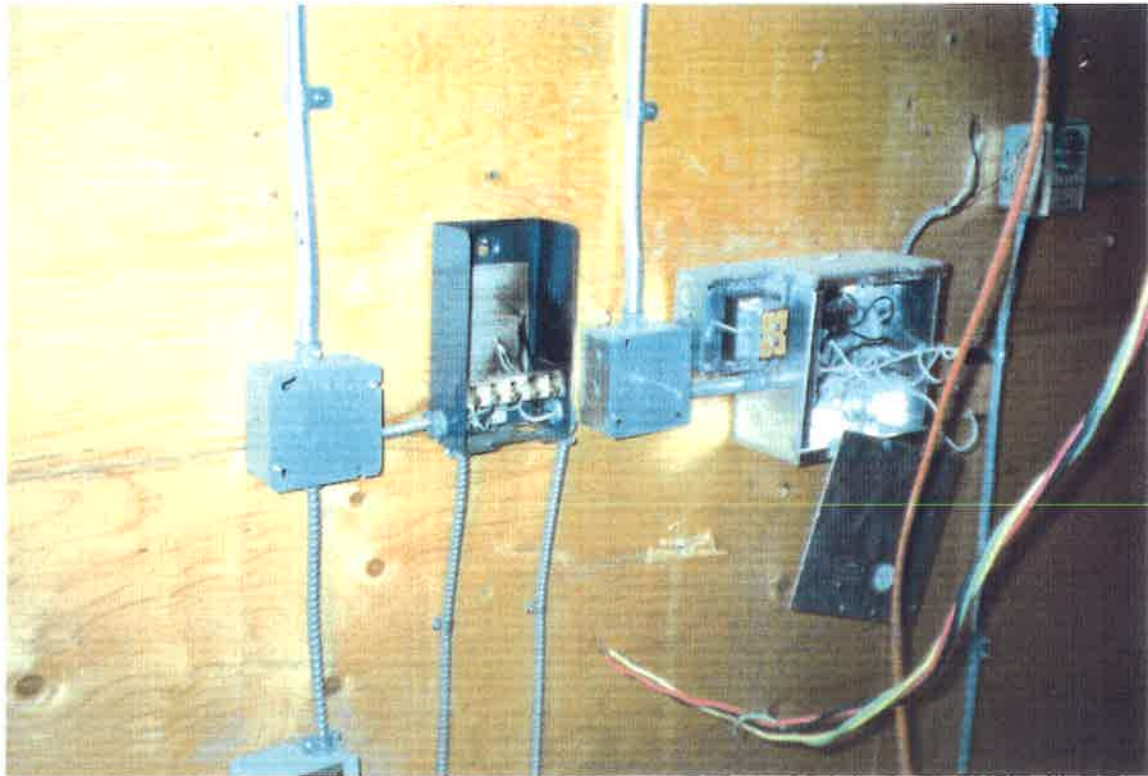
Photo M: Burwash Landing - Damaged Electrical Control Panel at Well

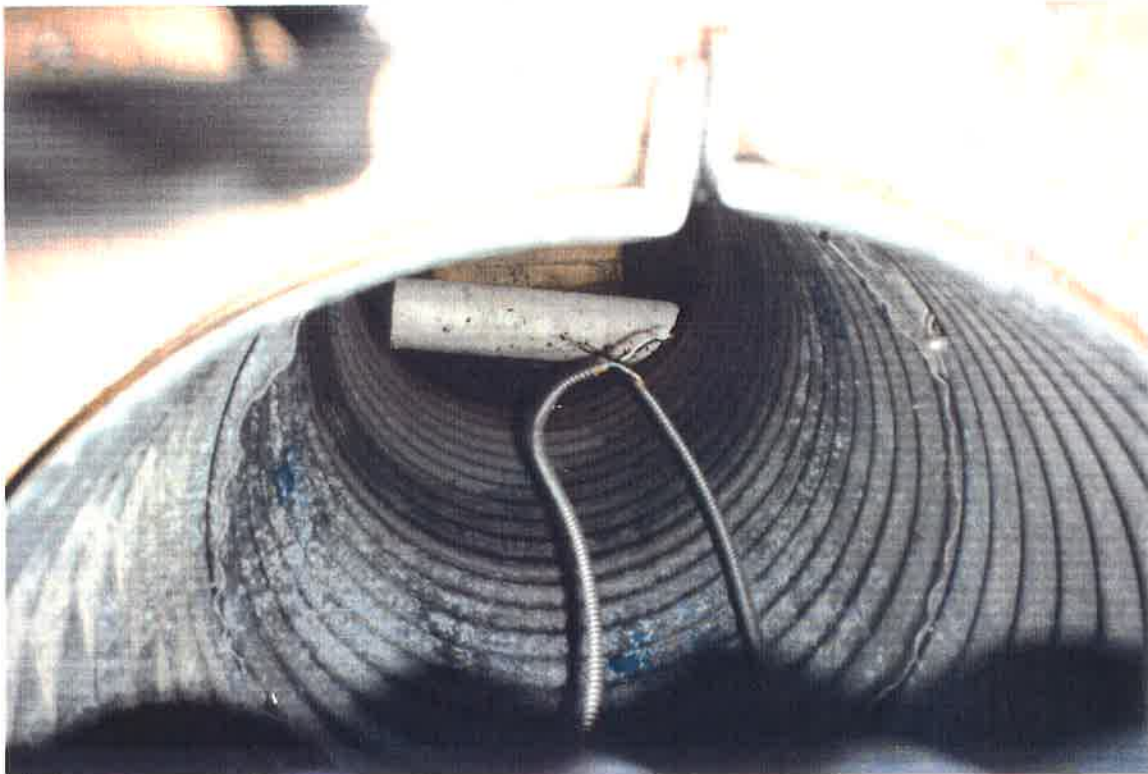
Photo N: Burwash Landing - View of Debris within Infiltration Well

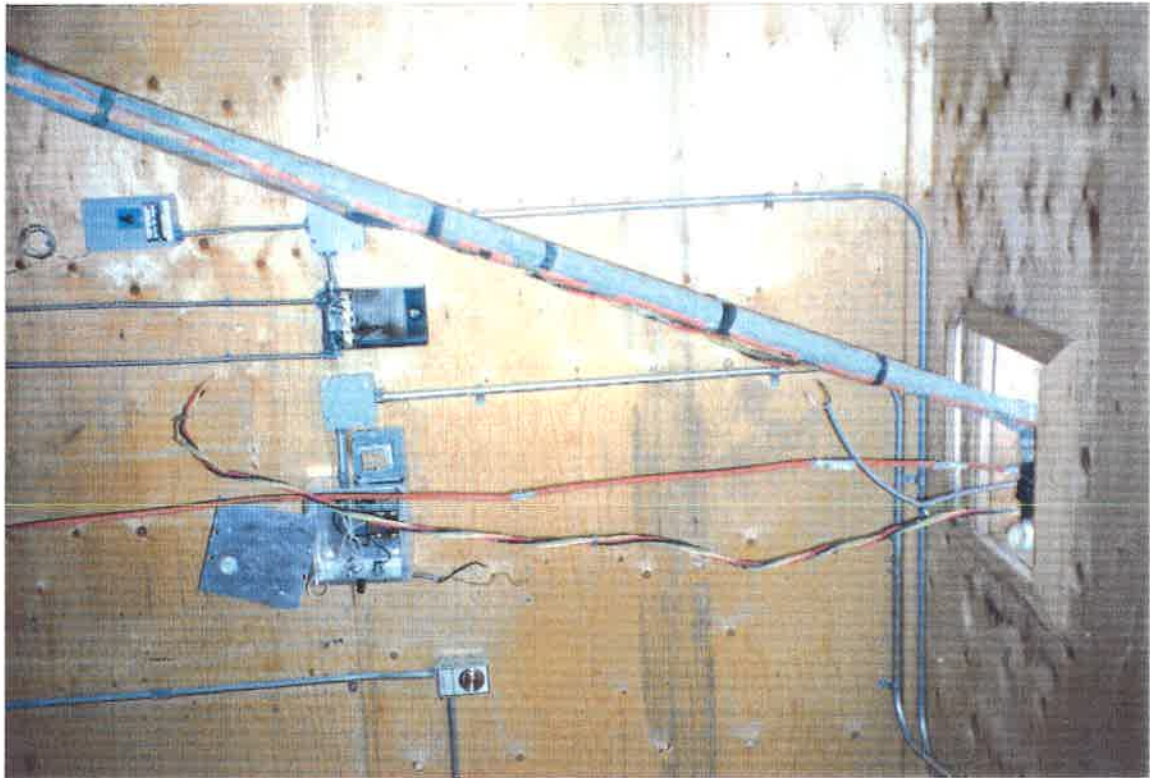
Photo O: Burwash Landing - Damaged Electrical Control Panel and Power Mast

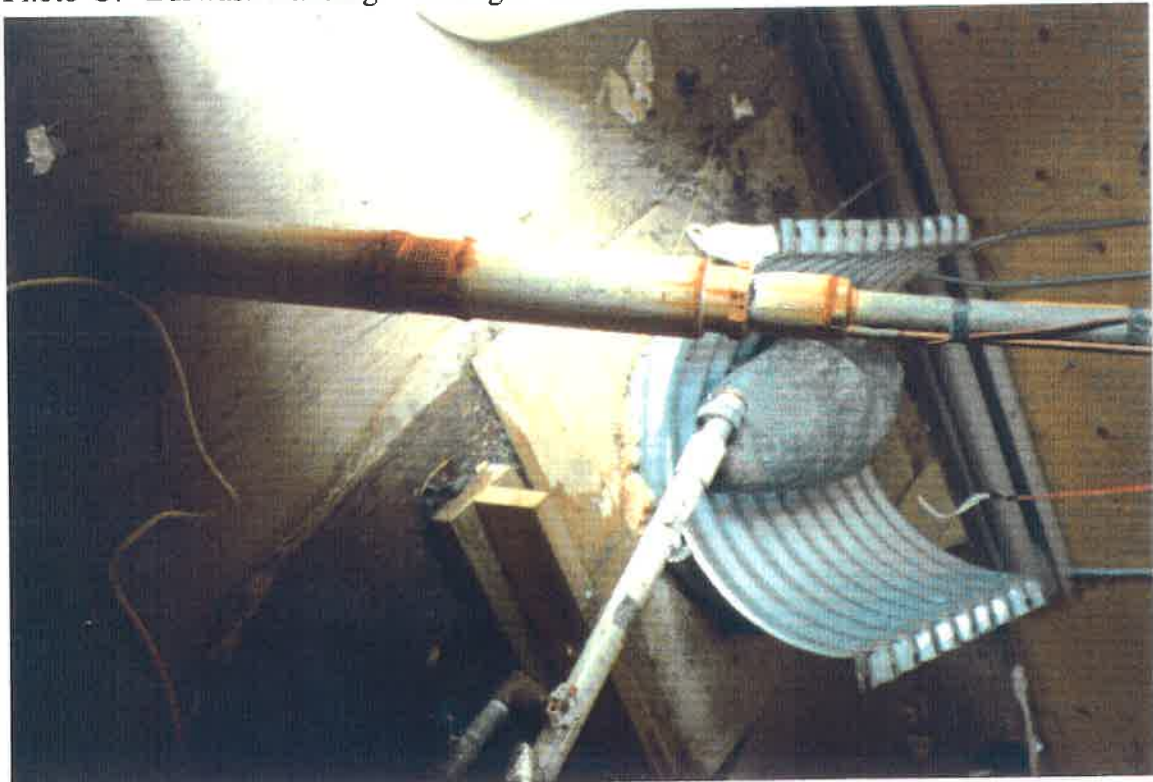
Photo P: Burwash Landing - Well Intake (removed)

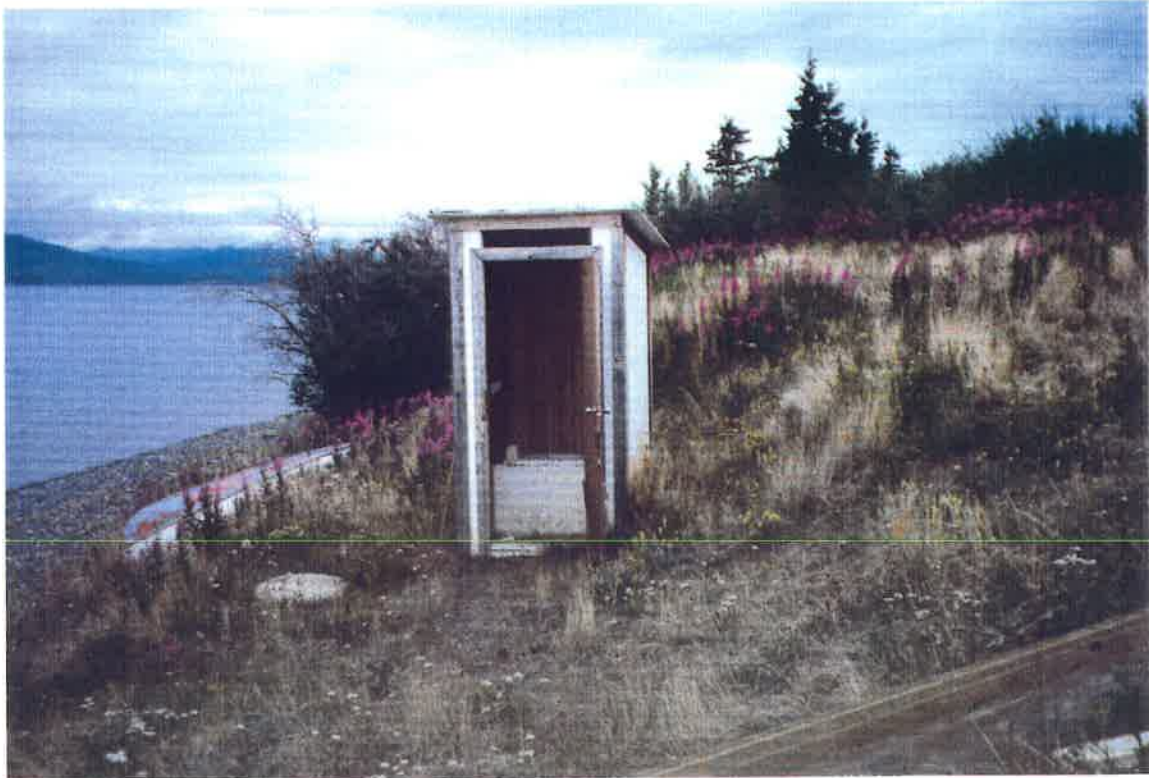
Photo Q: Burwash Landing - Pit Privy Above and Adjacent to Infiltration Well
