**REPORT ON RECLAMATION
AT
NORANDA EXPLORATION LTD.
McMILLAN PROPERTY NTS 95 D/12
AND AT
NORANDA EXPLORATION LTD.
ANKY CLAIMS NTS 105 J/2**

by Gordon MacKay P. Geo.

MACKAY FALKINER AND ASSOCIATES

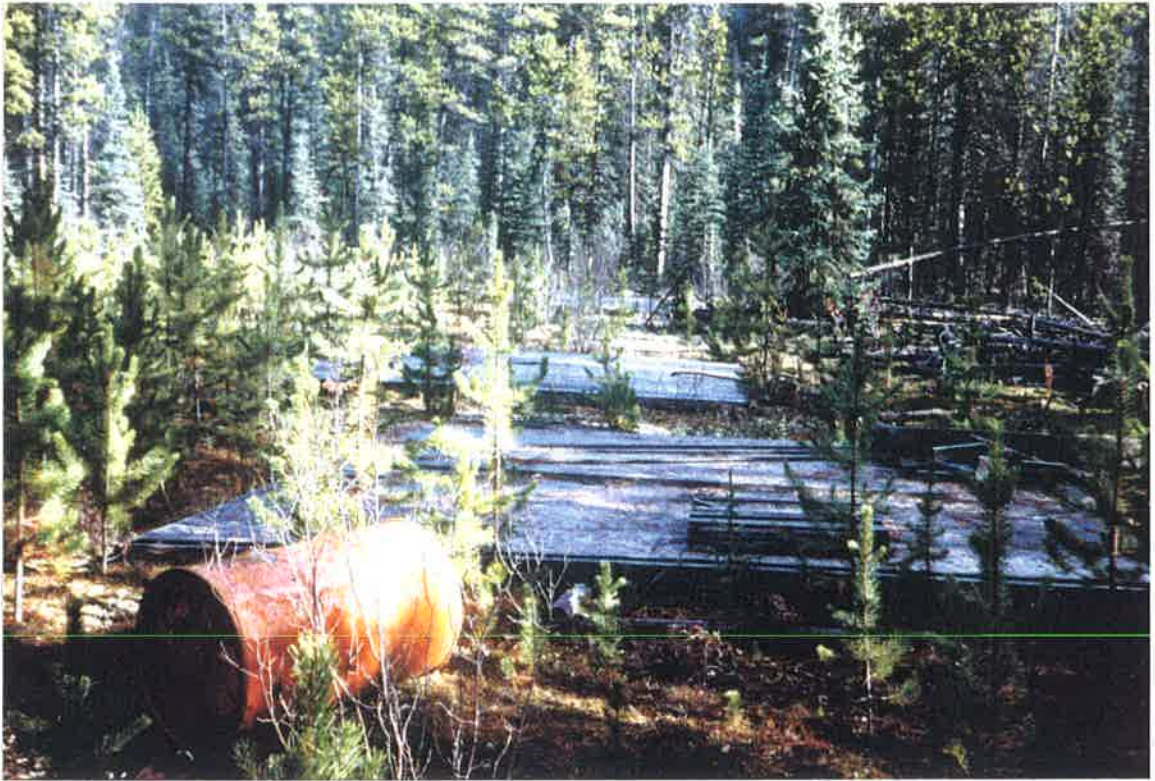
Photo 1: Site 1 - before reclamation

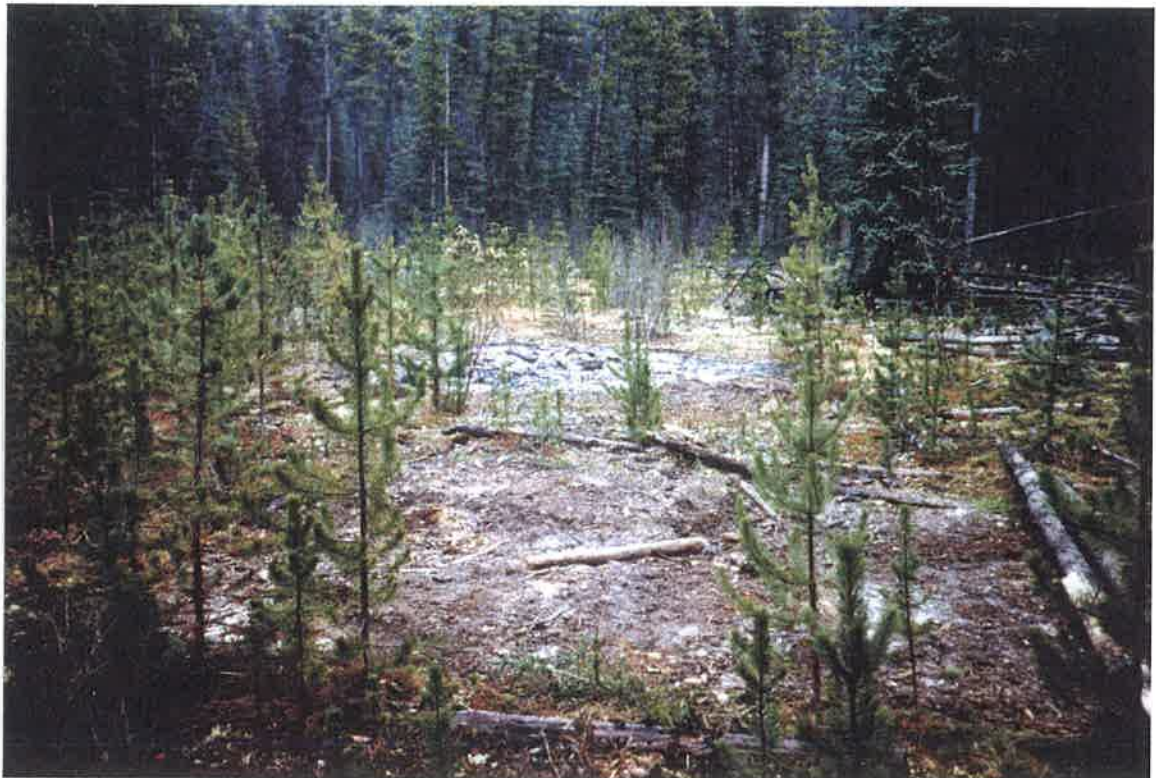
Photo 2: Site 1 - after reclamation

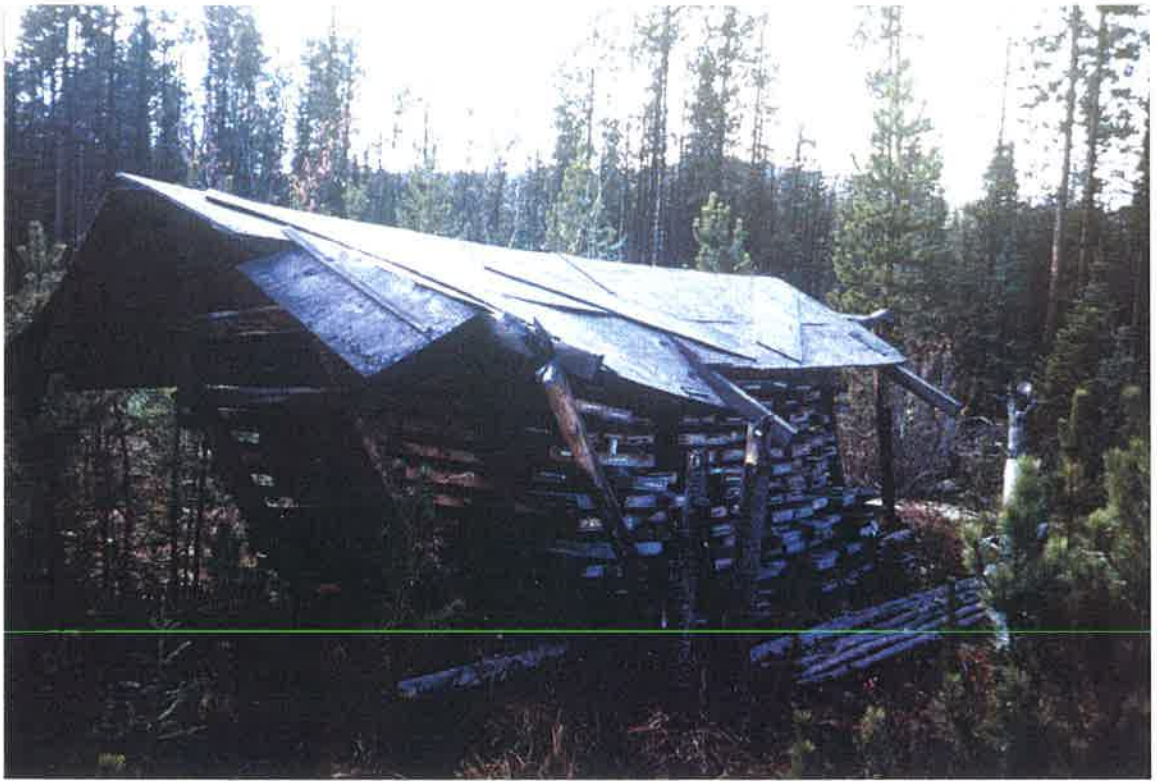
Photo 3: Site 1 - before reclamation

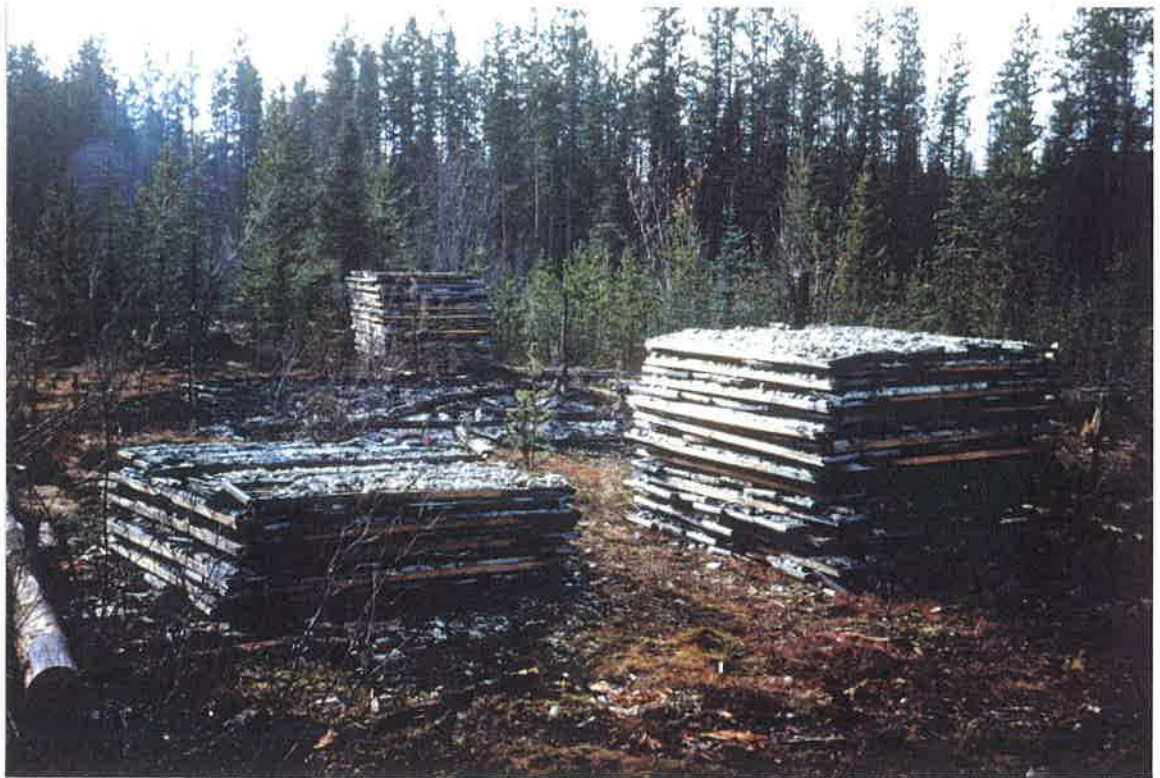
- four piles of boxed drill core, labelled and cross stacked (see photo 4).
- pile of decomposed drill mud (see photo 5).

Photo 4: Site 1 - After reclamation

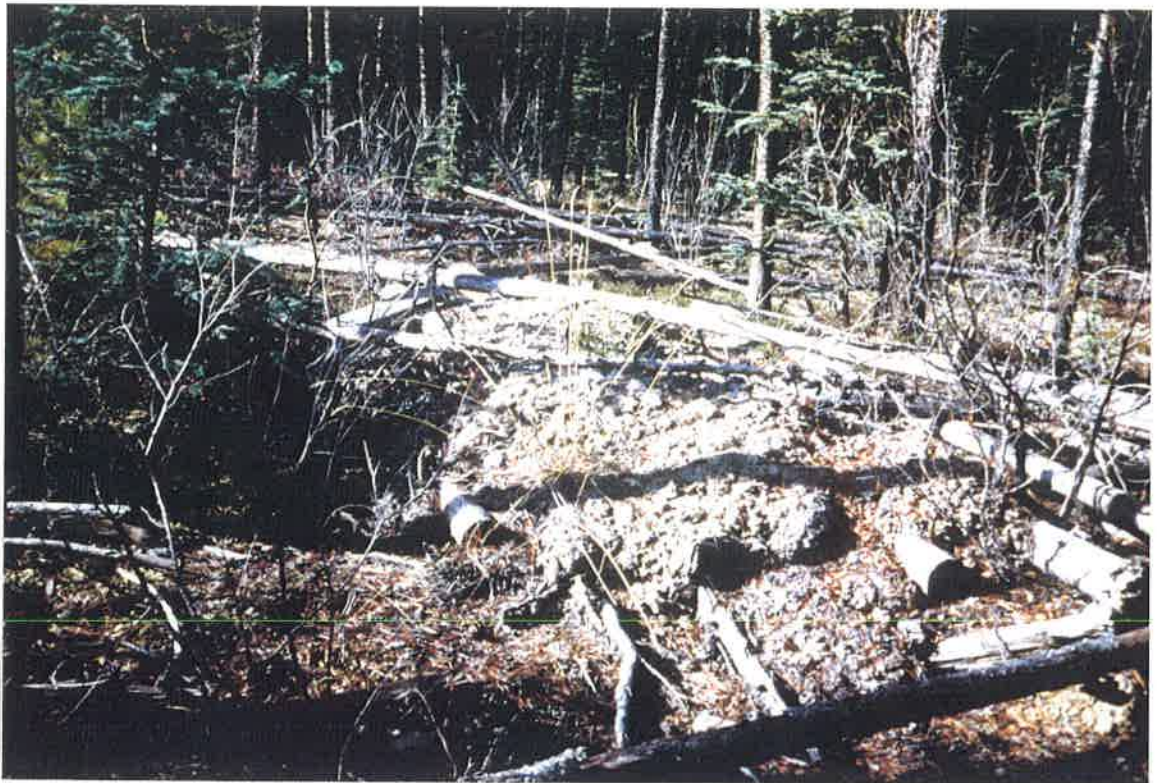
Materials removed from the site were slung by helicopter to the float plane dock on Quartz Lake where they were loaded on planes and taken to Watson Lake for disposal. The drill mud is located approximately 200 metres from the creek. The bags the mud was transported in have rotted away, leaving the mud exposed.

Photo 5: Site 1 - Drill mud

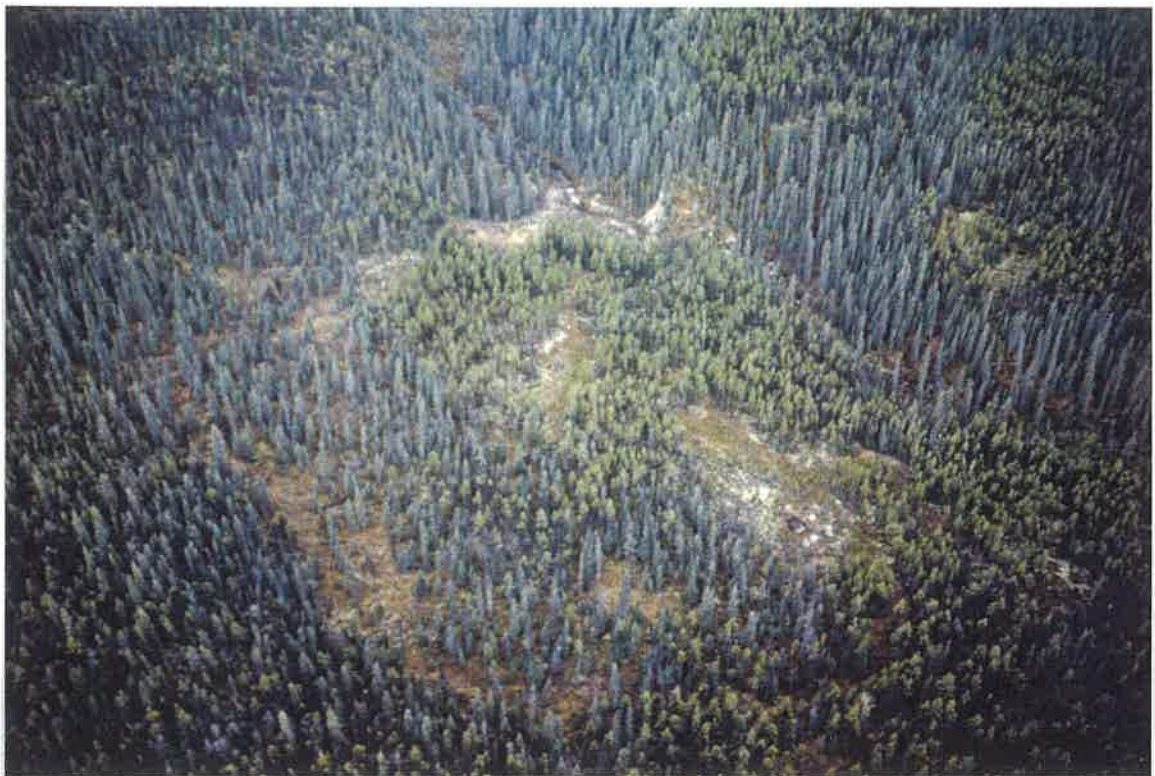
Photo 6: Site 1 - Air photo after reclamation.

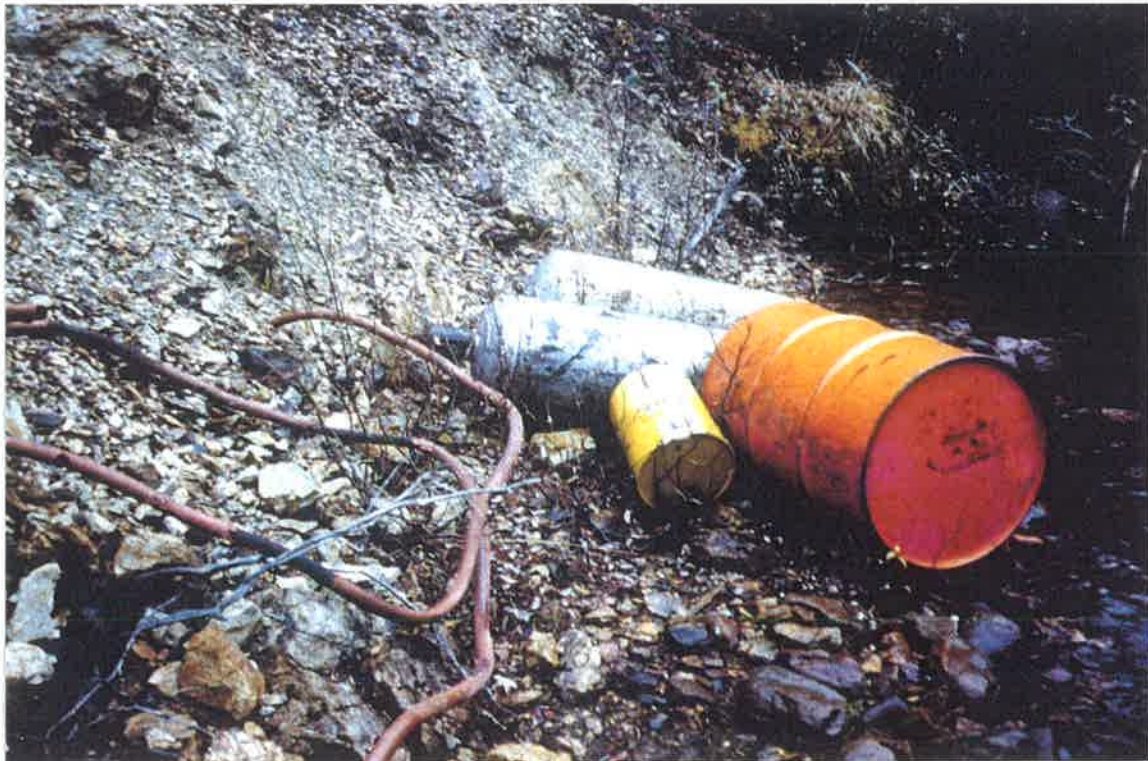
Photo 7: Site 2 prior to clean-up

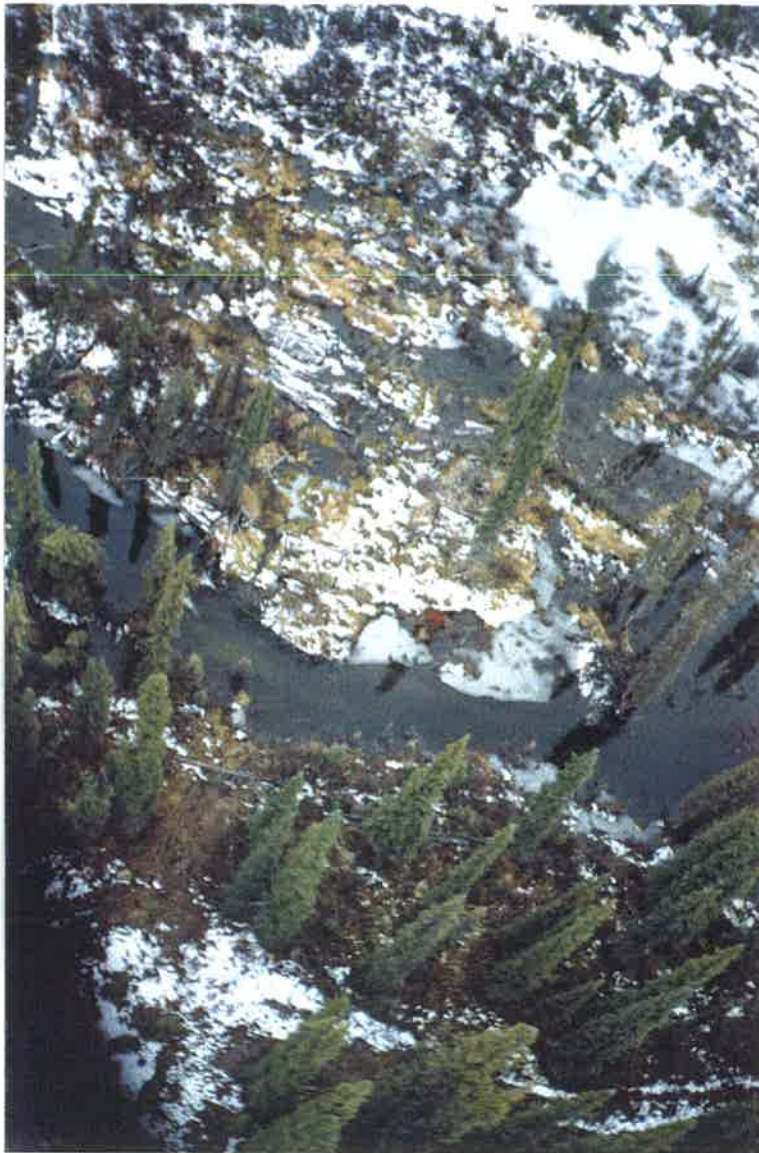
Photo 8: Site 1 - flooded camp, outline of floors can be seen in the central portion of the photo.

The lumber remaining at site 1 has been flooded by the beaver pond and is in an advancing state of decomposition. More disruption would likely be caused by removal and

burning than by leaving the material and allowing it to completely decompose.

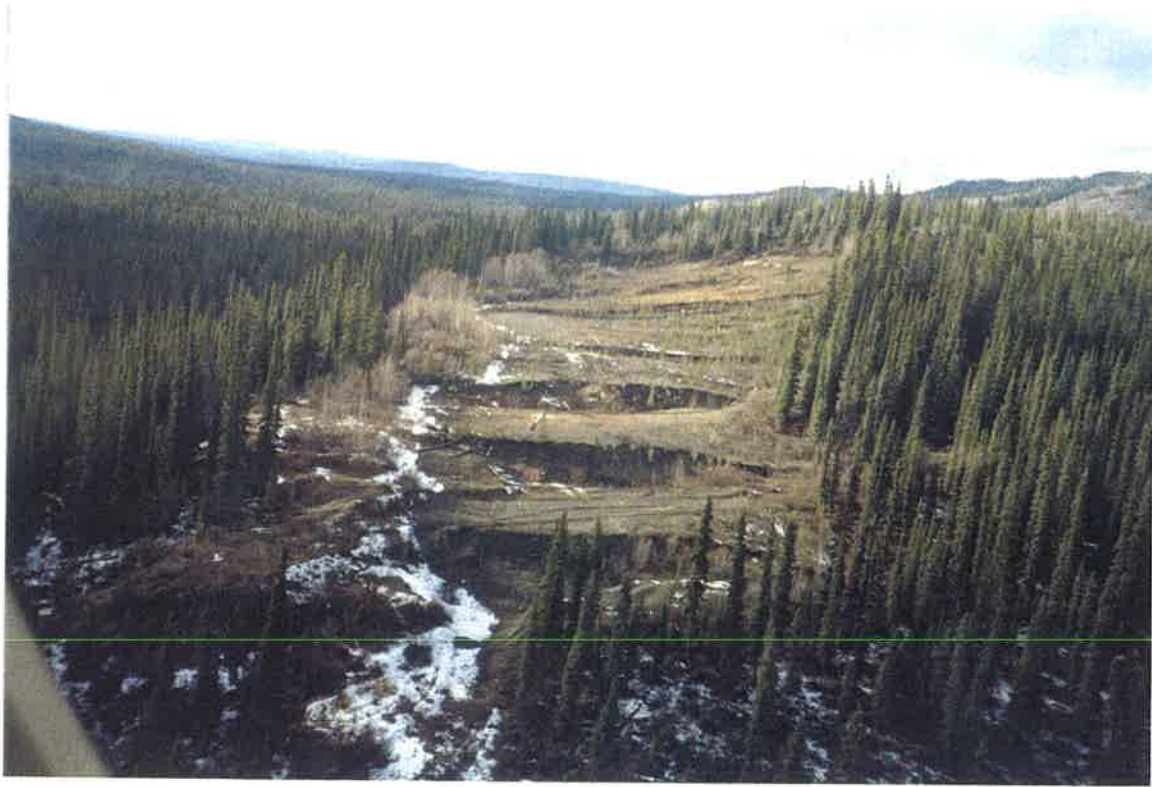
Trenches at this site are being reclaimed by natural revegetation (see photo 9).

Photo 9: Site 1 - trenches in the main showing kill zone.

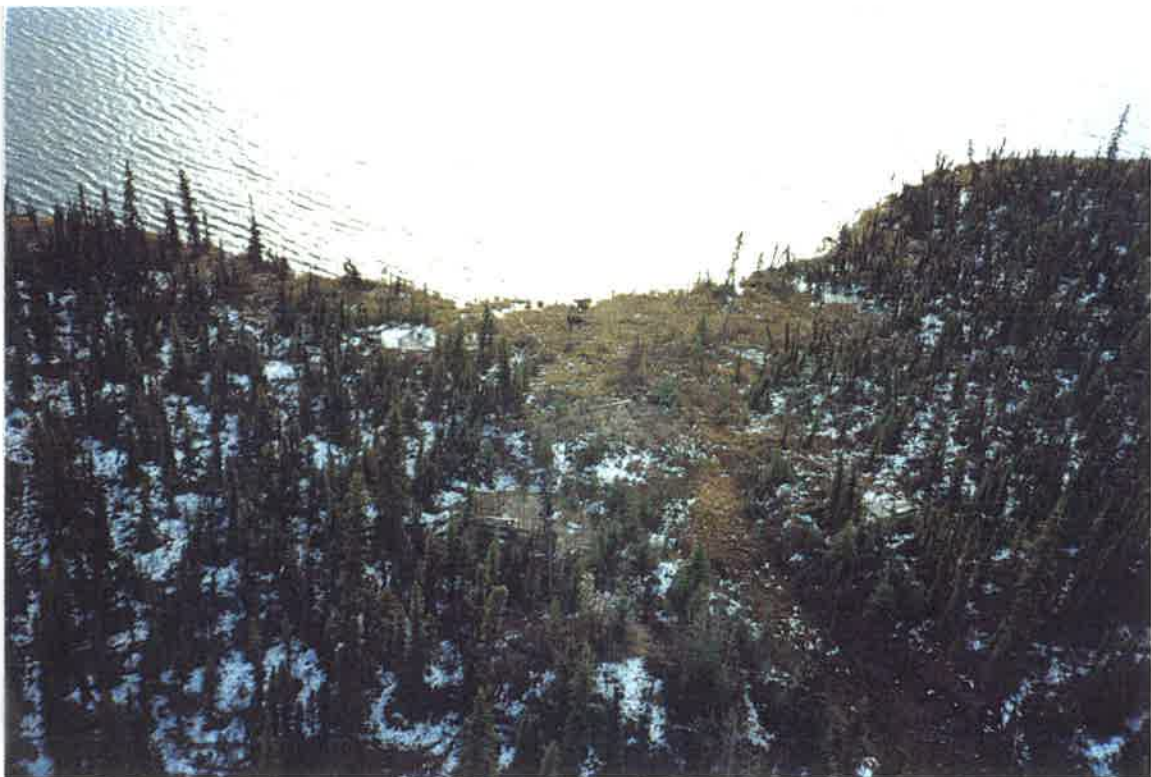
Photo 10: Site 2 - trapper's lumber.

This site was cleaned up by DIAND Land Branch. All drums and metal garbage was removed. Three plywood floors and a stack of lumber remain on site. This material is the property of a local trapper and is not to be removed (see photo 10).

The lumber remaining at site 2 reportedly belongs to the local trapper and is not a potential Noranda liability.

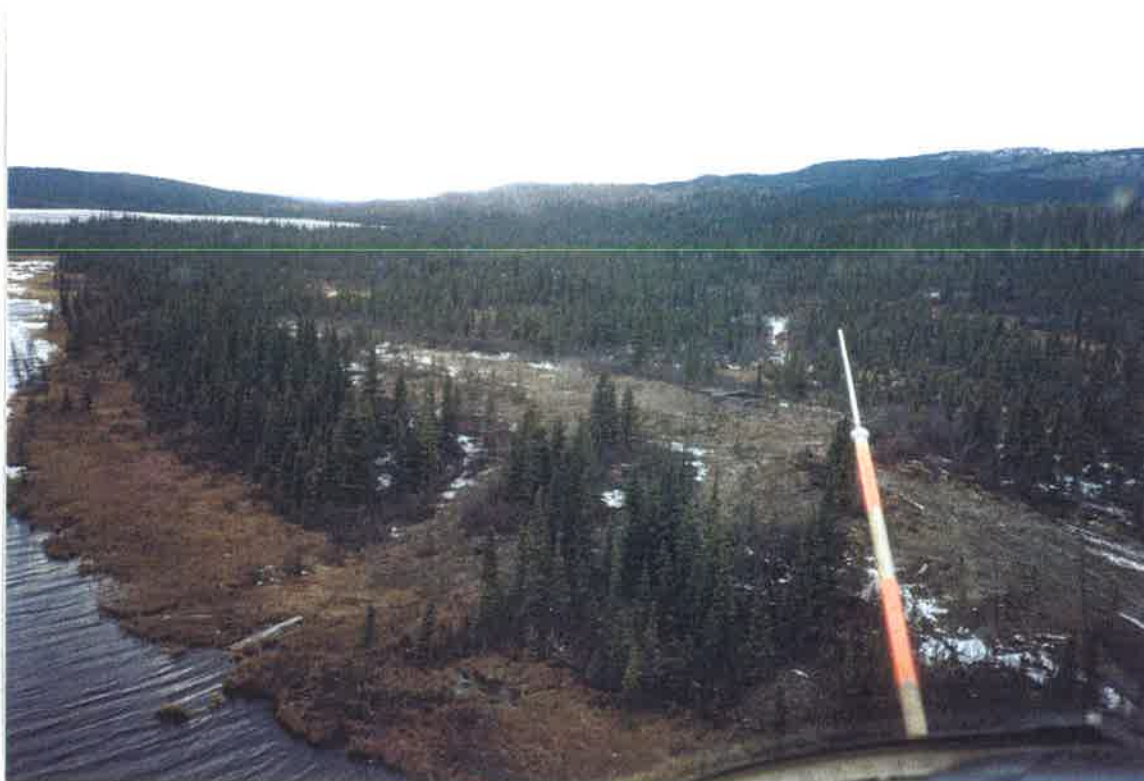
This site was also cleaned up by DIAND Land Branch. All drums and most of the metal garbage was removed. A further six bags of tin cans were removed from the site by MFA. Still remaining at the site is the remnant of a cabin and a three meter square area of soil that appears to have been contaminated by petroleum product. Evidence for the soil contamination is a discolouration of the soil. There is no oily residue at the site. The area of the soil contamination is approximately 100 metres from the lake shore (see photo 11, 12).

Photo 11: Site 3 - kill zone with remnant cabin.

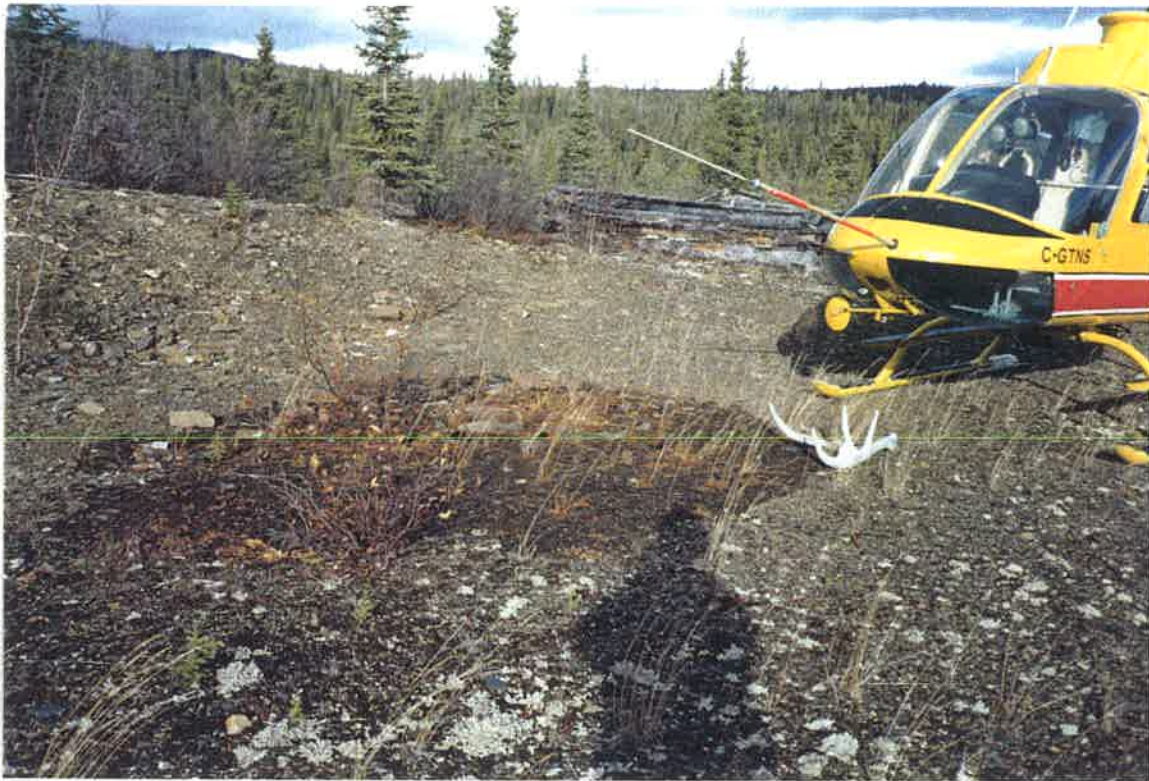
The contaminated soil at site 3 has not been cleaned up. During their clean-up DIAND Land Branch was reported to have poured fresh petroleum product on the site and attempted to burn it off. This was unsuccessful and probably ill advised.

Photo 12: Site 3 - contaminated soil.
