GEOLOGICAL SURVEY OF CANADA  
TOPICAL REPORT NO. 105

YUKON RIVER DRAINAGE BASIN  
DAM SITE INVESTIGATION

SITE No. 27

**HOOLE CANYON DAM SITE**  
(Map and Preliminary Report)

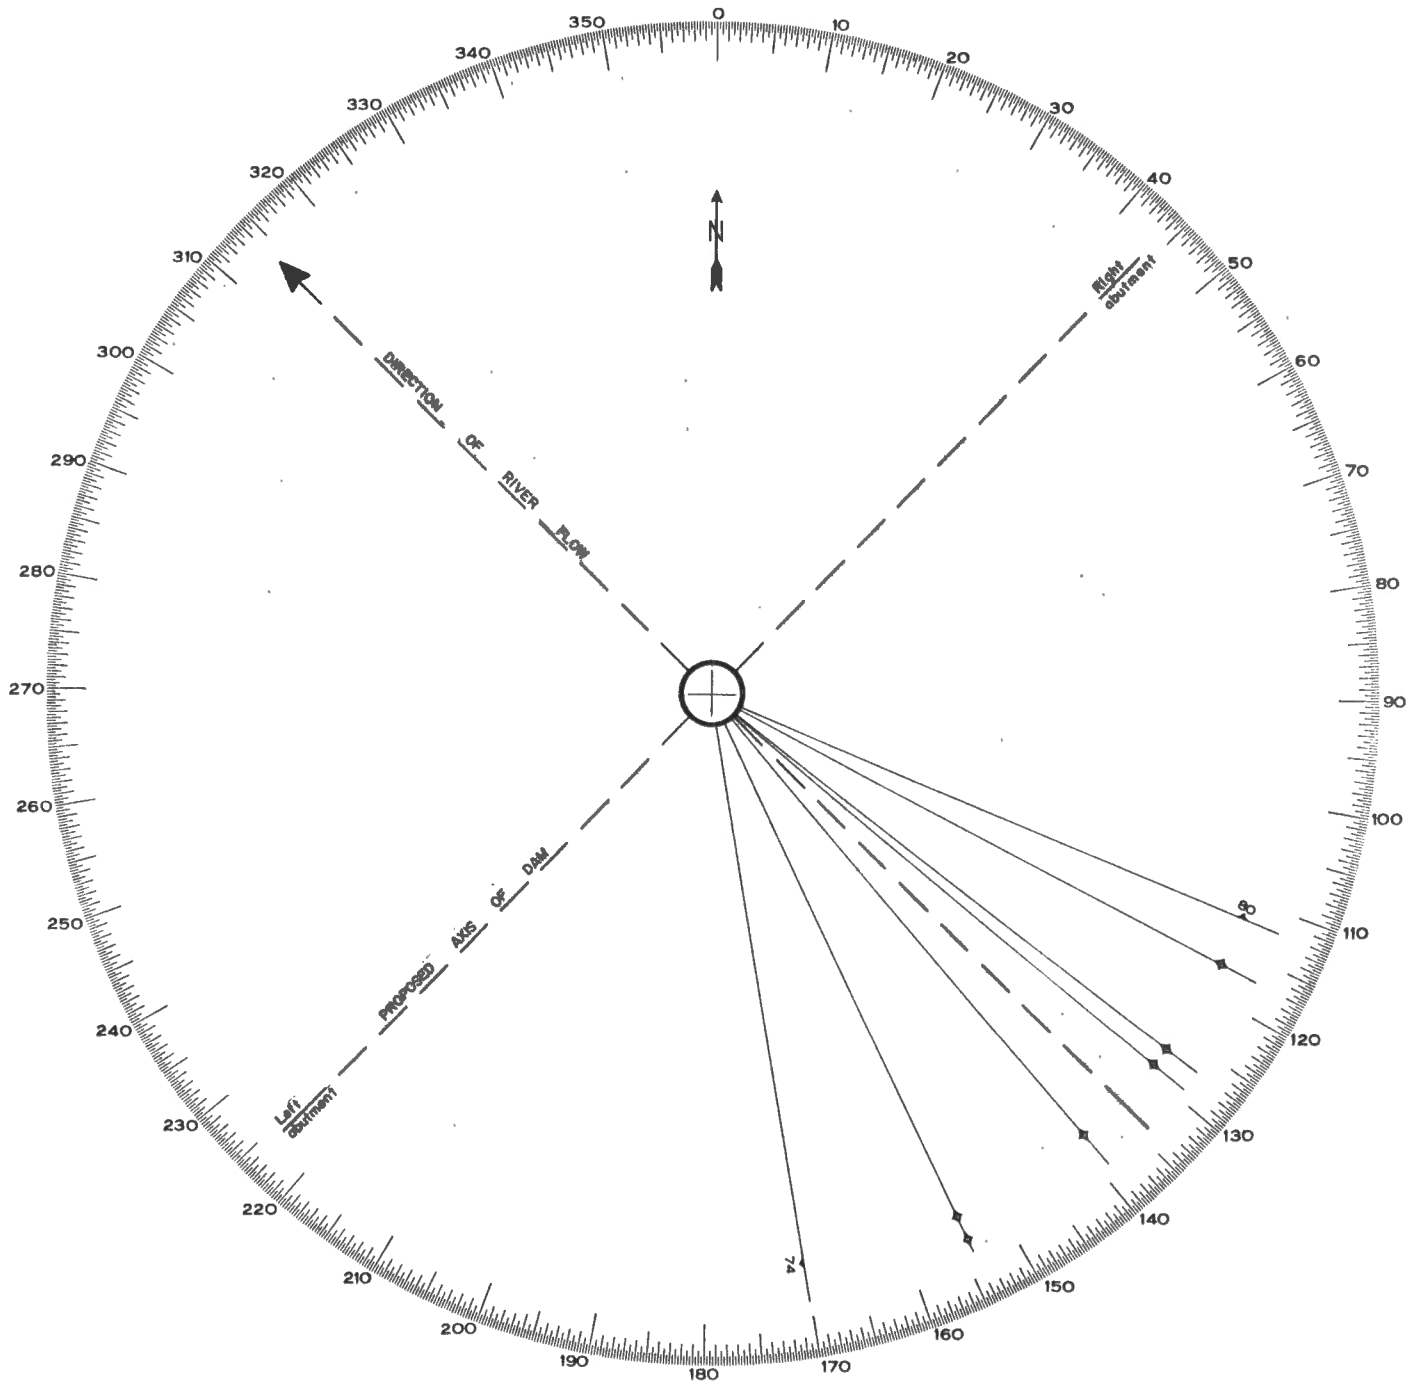
**FAULT ROSETTE**

Faulting at the site is confined chiefly to the quartzite in the downstream part. Some are bedding faults, i.e. their strike and dip are parallel to that of the strata but most intersect the bedding at angles up to 30 degrees. The dip is usually close to vertical. One large fault occurs in the right wall of the canyon about 1,200 feet upstream from the lower end of the site. Here a bed of limestone about 12 feet in width has been brought up against quartzite. An irregular deposit of soft, yellow-white powder probably deposited by groundwater occurs along this fault. The significance of this deposit is discussed briefly in the section on groundwater.

The above illustration presents diagrammatically the direction and dip of faulting in quartzite exposed at Hoole Canyon dam site.

The bearing capacity of the steeply-dipping quartzite beds in the downstream part of the canyon is doubtless less than if the beds were flat-lying. It is believed, however, these rocks will provide satisfactory foundation and abutment material. In this area the right end of the dam would extend across a narrow, gravel-covered terrace underlaid with quartzite and limestone to a ridge of ultrabasic rocks covered with a thin deposit of gravel. In the left abutment area the quartzite is exposed only to elevation 2,490. The quartzite is tight except along the zones of shattered rocks associated with faulting. Grouting will be necessary to seal these and to consolidate the rock.

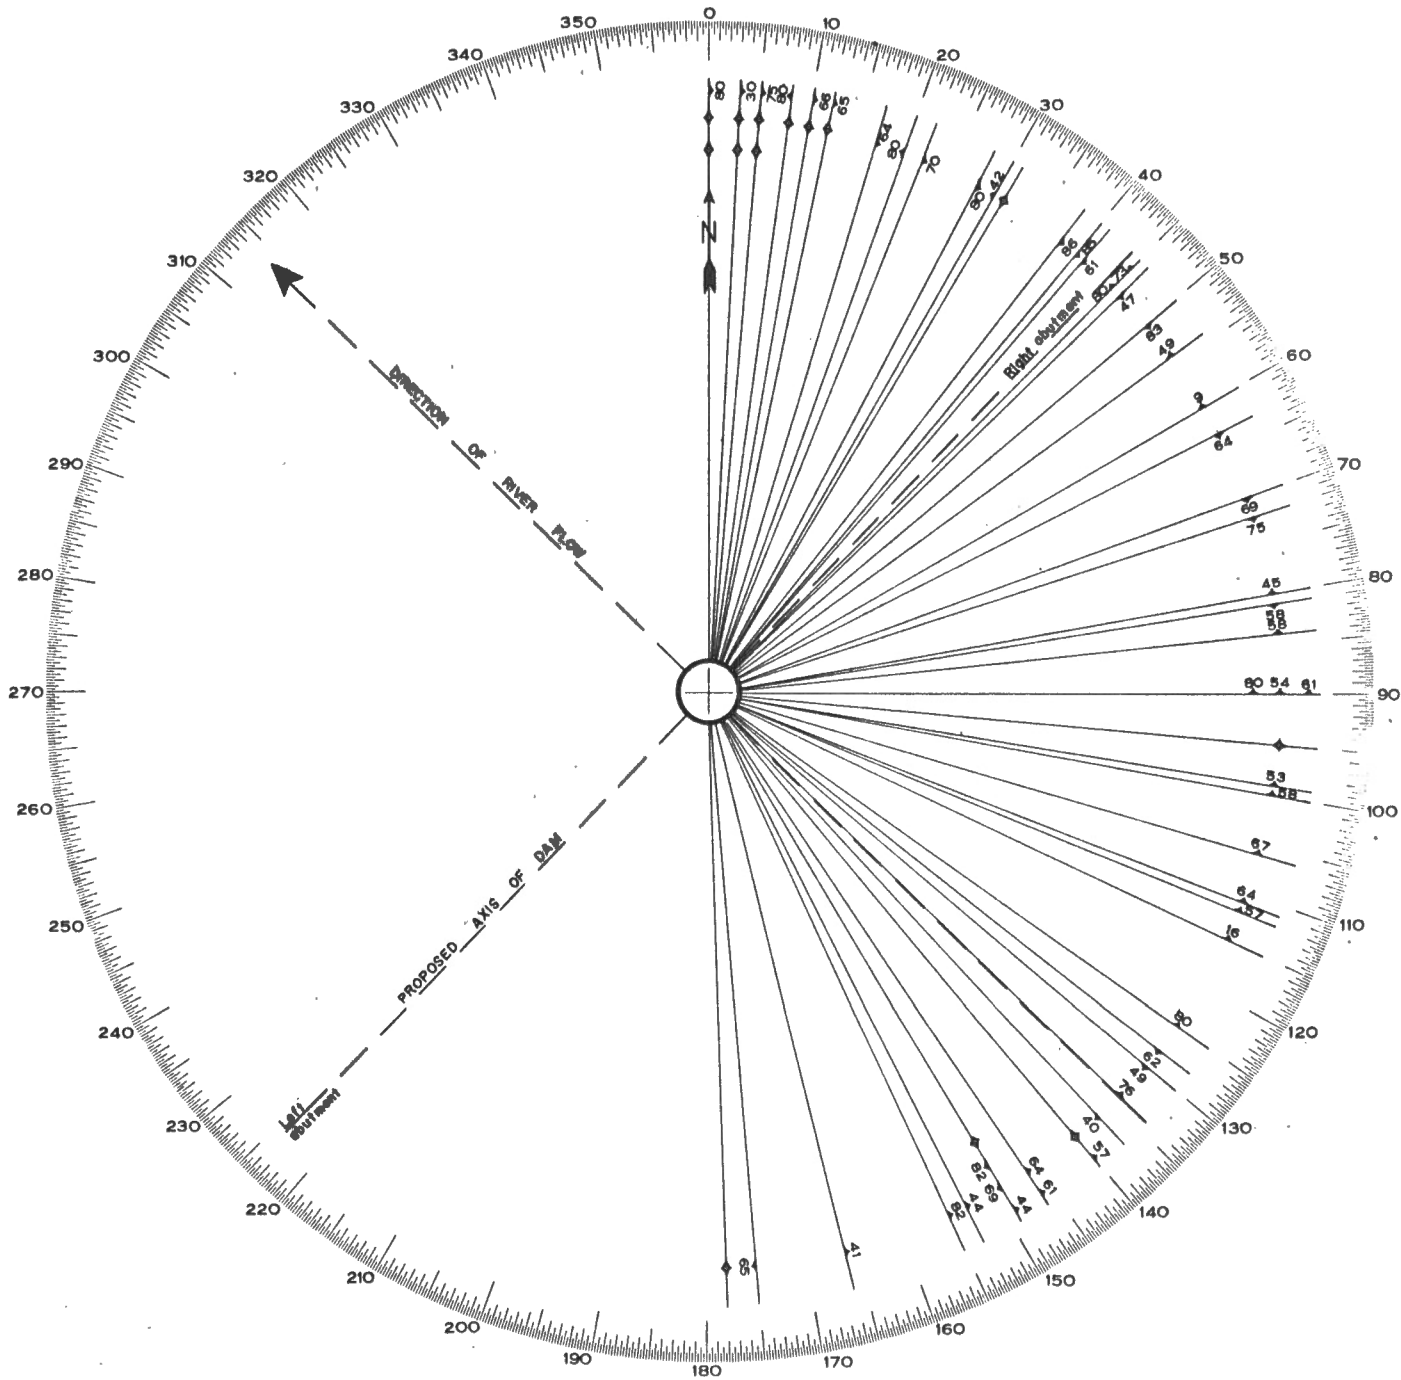
FRACTURE ROSETTE

The above illustration presents diagrammatically the direction and dip of fracturing in igneous rocks exposed at Hoole Canyon dam site.

From the standpoint of topography the most obvious place to locate the dam is in the centre part of the site area where the intrusive ultrabasic rocks are exposed. However, the presence of soft, greasy serpentine which is common in these rocks indicates they may be dangerous to construction. The serpentine occurs throughout the rock mass as pale green crystals probably resulting from the alteration of pyroxene and amphiboles and as fracture fillings which appear as numerous parallel bands extending for many feet throughout the rock. The bands of serpentine are important in considering these rocks as foundation or abutment material as they would appreciably lower the resistance of the rock to sliding. Most of the bands are either parallel to the river or intersect it at about 45 degrees. The dips are variable ranging from 45 degrees in either direction to vertical. In regard to the construction of tunnels in serpentinized rocks Terzaghi<sup>1</sup> has stated that "experience indicates the occurrence of large quantities of serpentine in a rock may be associated with exceptionally heavy pressure on the tunnel support. This association probably results from the fact that the alteration to serpentine involves a volume expansion which creates severe internal stresses in the body of rock subject to alteration".

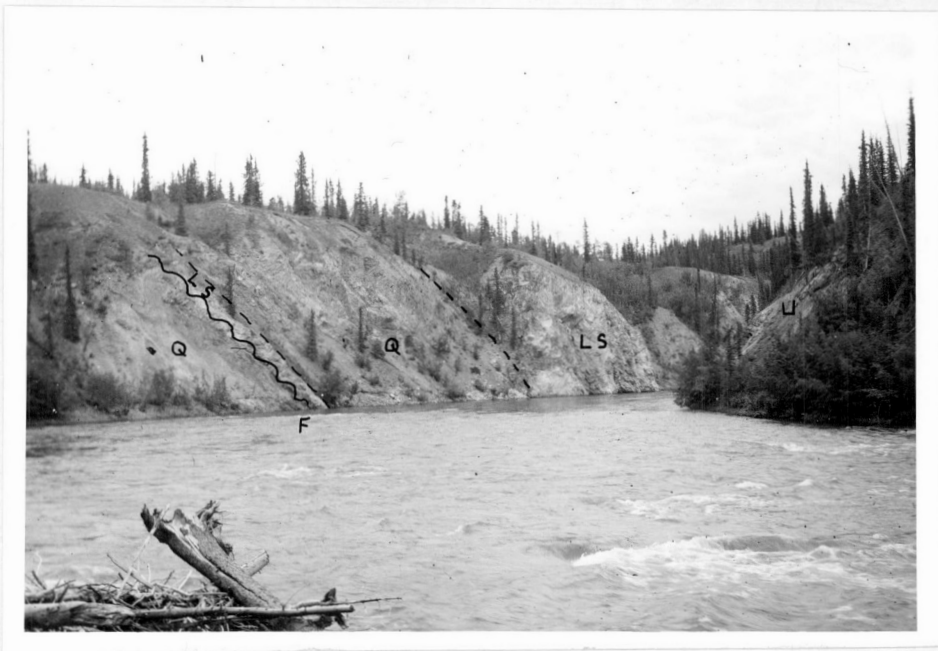
Plate 1

Hoole Canyon looking upstream, proposed centre line of dam is in the most narrow part of the canyon immediately beyond the bend in Pelly River. F - large fault; Q - quartzite; LS - limestone; U - ultrabasic rocks.

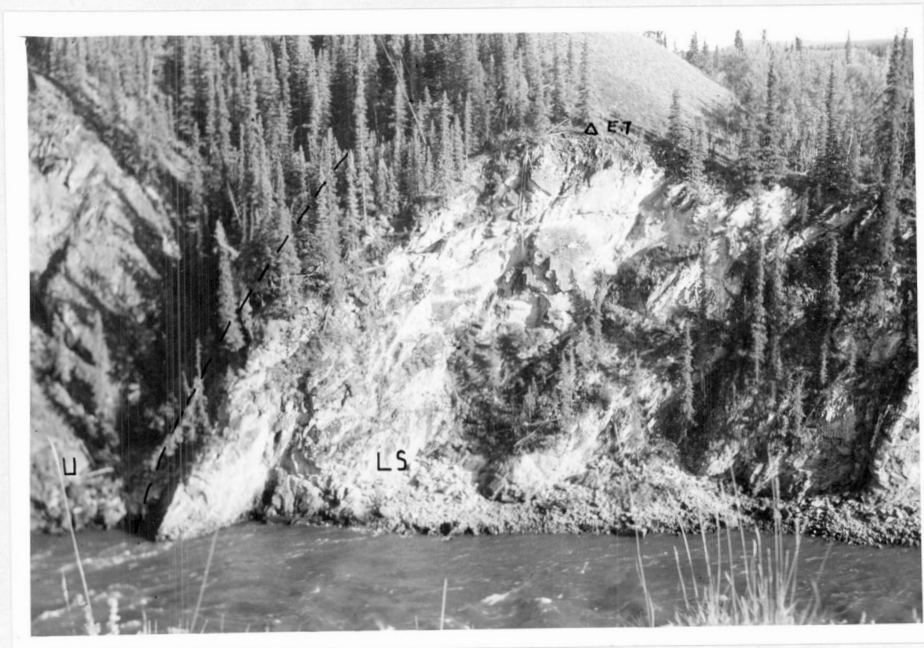
View looking east across the upstream end of Hoole Canyon along the contact of limestone and ultrabasic rocks. This area is believed to be a satisfactory site for the proposed dam. LS - limestone; U - ultrabasic rocks.

The most competent rock exposed at Hoole Canyon is the thick-bedded limestone that occurs at its upstream end. It is believed this rock would provide suitable foundation and abutment material for the proposed dam. There are few faults present and, although the rock is of the soluble type there are no solution cavities visible in the limestone exposed in the walls of the canyon. The tight folding present does not appear to have lowered the competency of the rock mass.

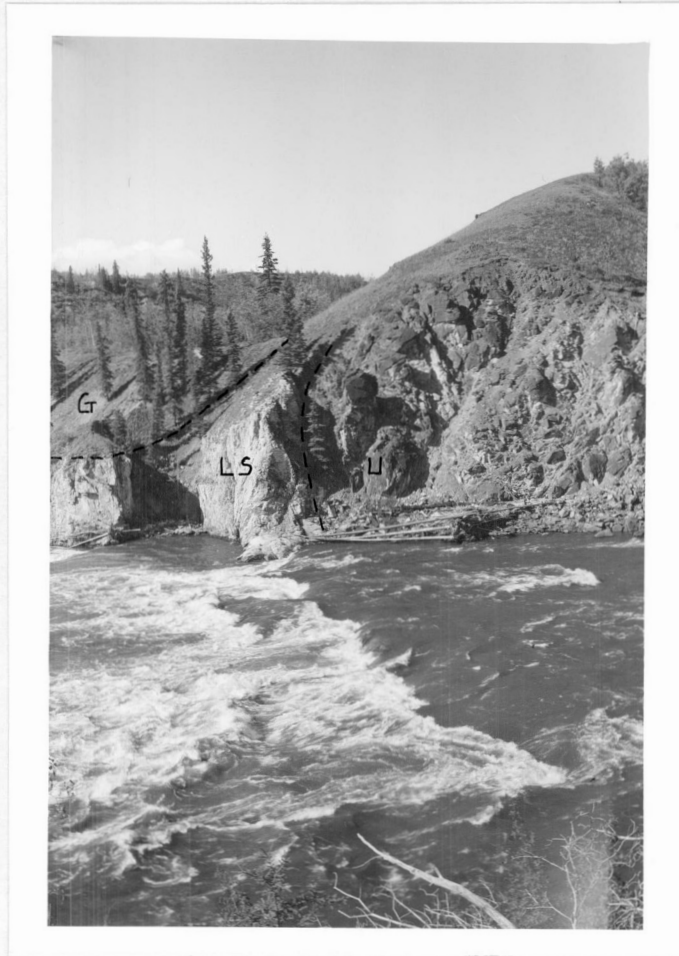
Plate 3

View looking west across the downstream end of Hoole Canyon along the contact of limestone and ultrabasic rocks. Pelly River drops about 3 feet where it crosses the contact. G - gravel, LS - limestone, U - ultrabasic rocks.
