GEOLOGICAL SURVEY OF CANADA
TOPICAL REPORT NO. 36

YUKON RIVER DRAINAGE BASIN
DAM SITE INVESTIGATION

SITE NO. 32

KLUANE CANYON DAM SITE
(MAP AND PRELIMINARY REPORT)

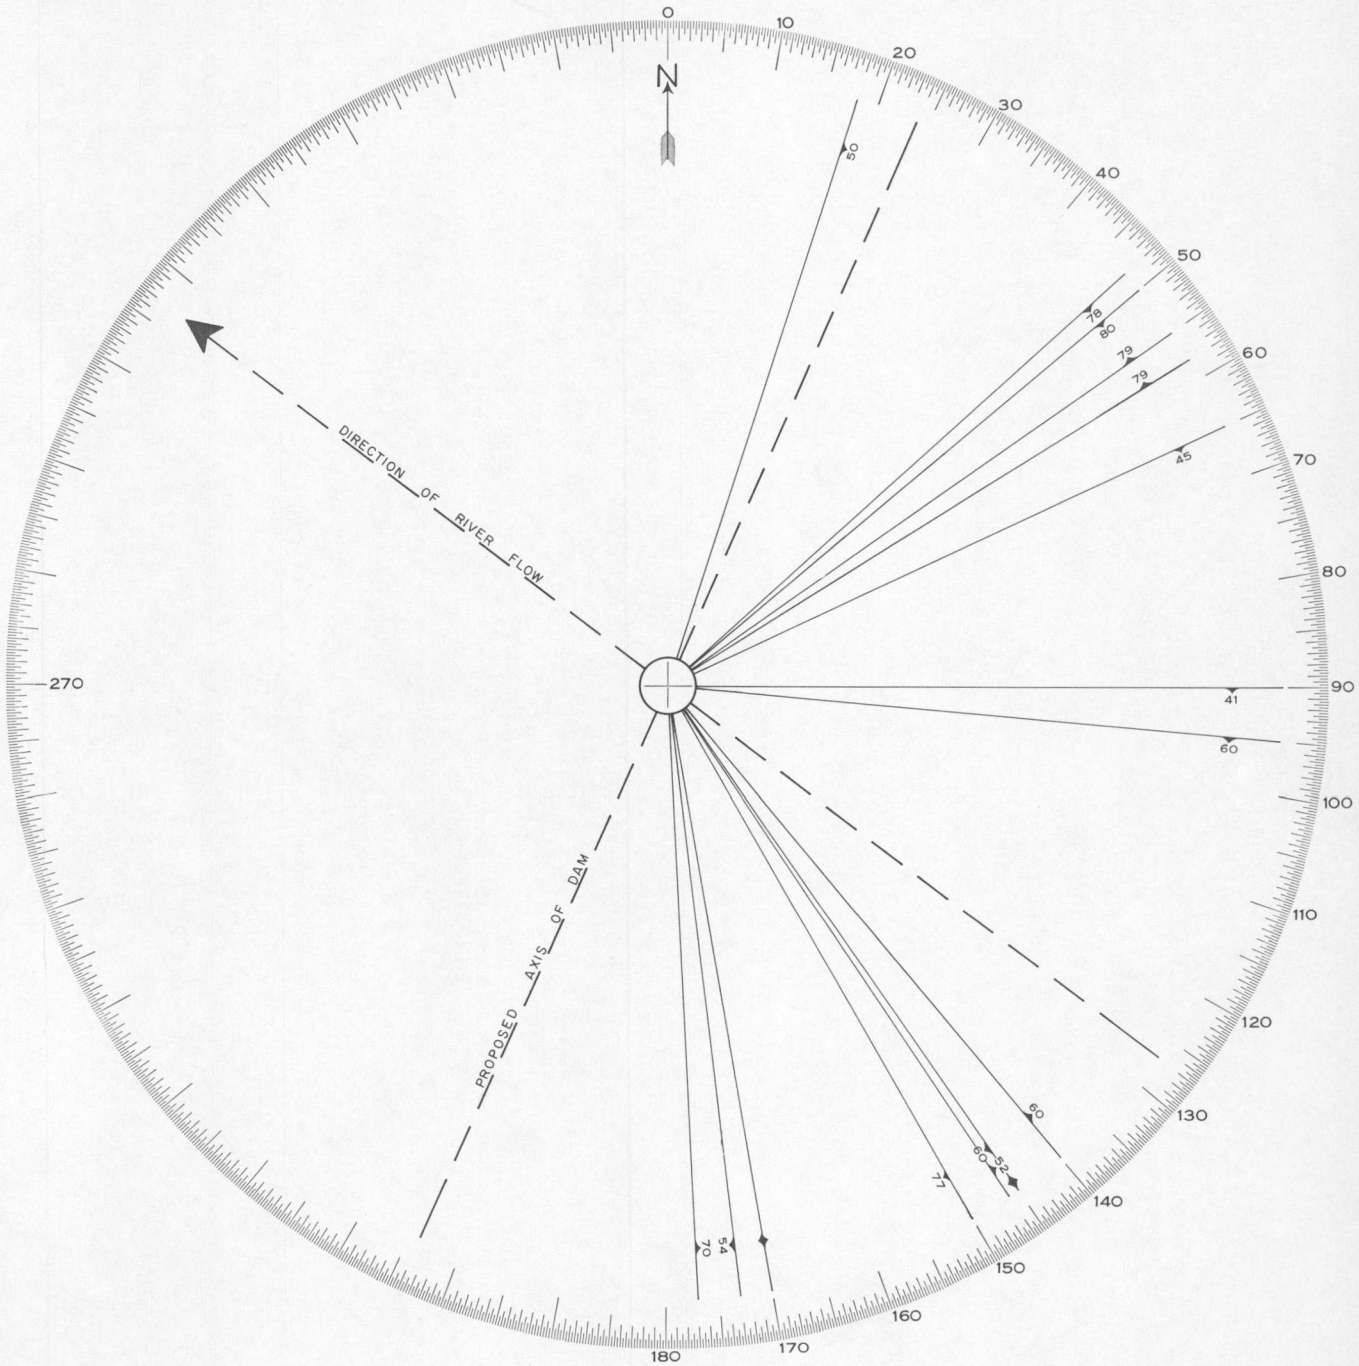
JOINT ROSETTE

The most prominent joint set intersects the River at angles between 11 and 28 degrees and dips steeply in both upstream and downstream directions. Other less pronounced jointing intersects the River at angles as great as 70 degrees and usually dips steeply downstream or toward the right abutment. A rosette indicating the relation between the jointing and the direction of flow of the River accompanies this report. It should be noted that on the rosette the proposed axis of the dam is not at right angles to the River. The reason for this is that the bedrock exposure on the right side of the River is about 150 feet downstream from that on the left. As bedrock forms the best abutment material at the site, the axis has been swung to take advantage of this fact. Faulting was not observed in the rock exposed in the site area. The foliation has little effect upon the competency of the rock.

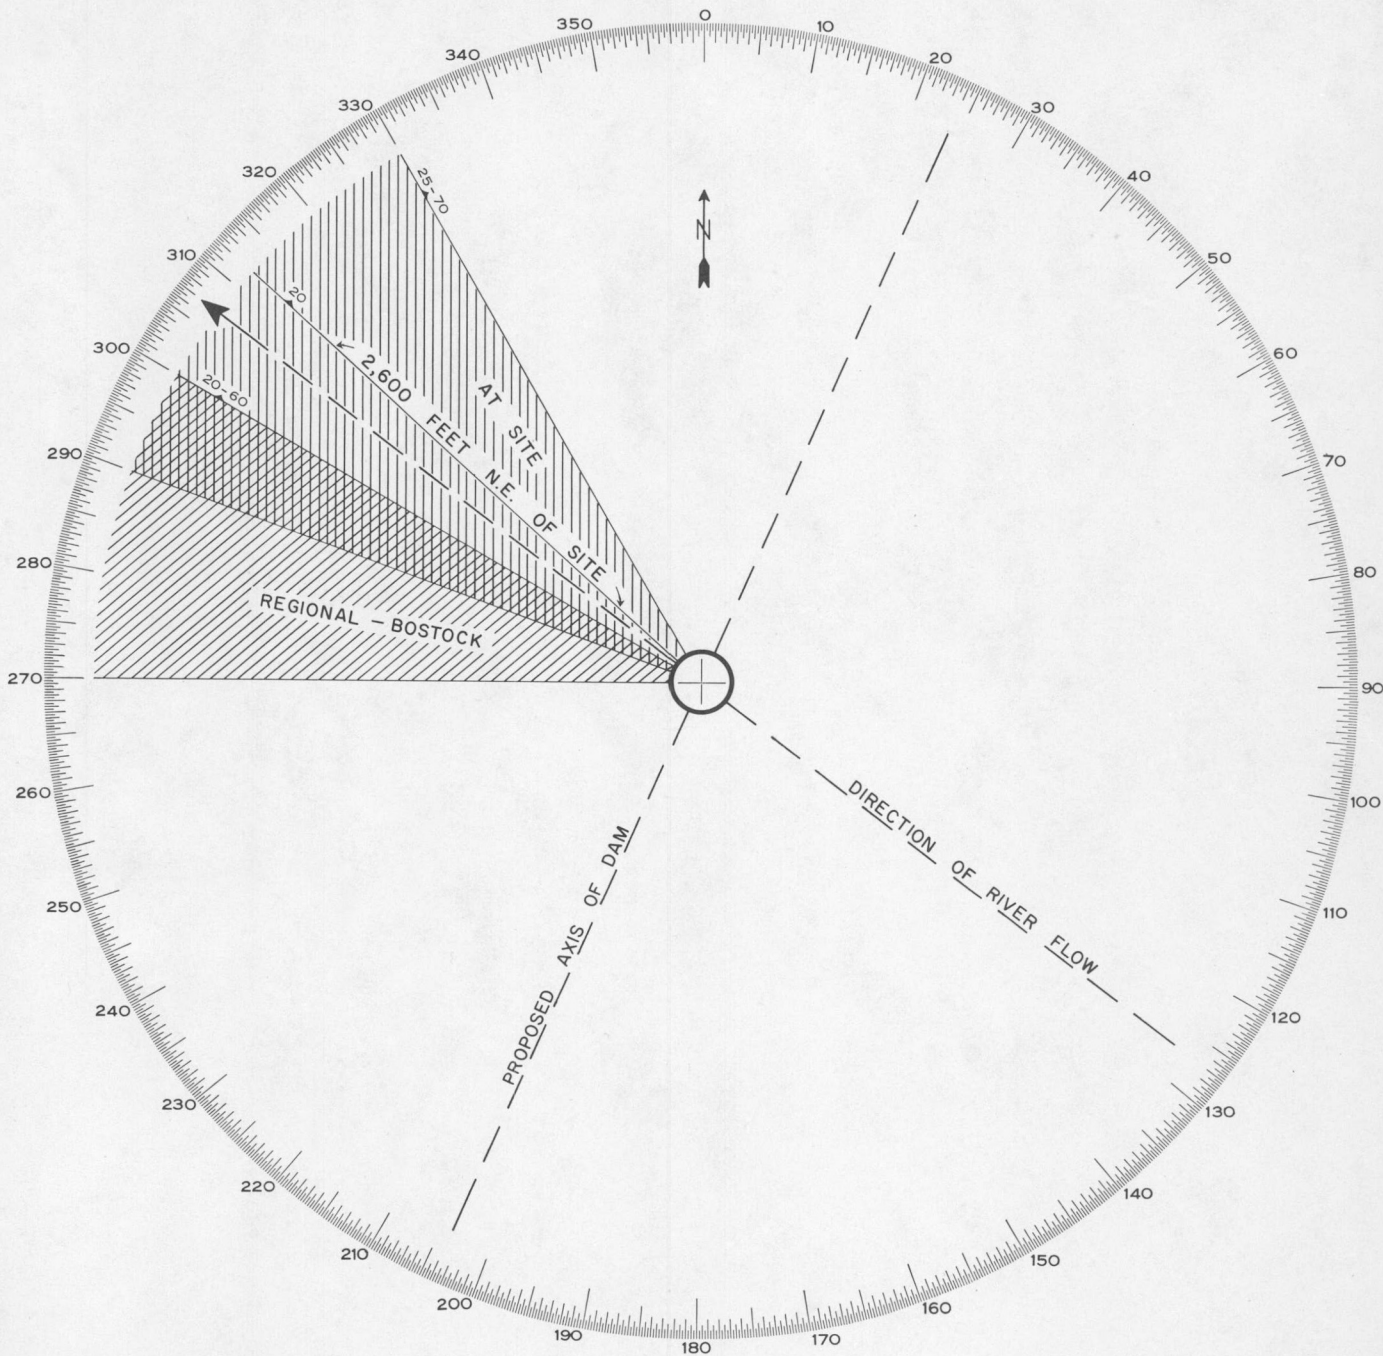
FOLIATION ROSETTE

Lake area strikes between north 60 degrees west and west and dips northeasterly to northerly at 20 to 60 degrees. The foliation in the rock exposed at the base of Outlet Hill northeast of the site strikes about north 48 degrees west and dips northerly at 20 degrees. At the site Kluane River is flowing north 53 degrees west or nearly parallel to the general trend of the foliation in this portion of Shakwak Trench. The foliation at the site strikes north 30 to 70 degrees west and dips northeasterly from 25 to 70 degrees. It intersects the River at angles from 20 to 30 degrees and dips toward the right abutment.

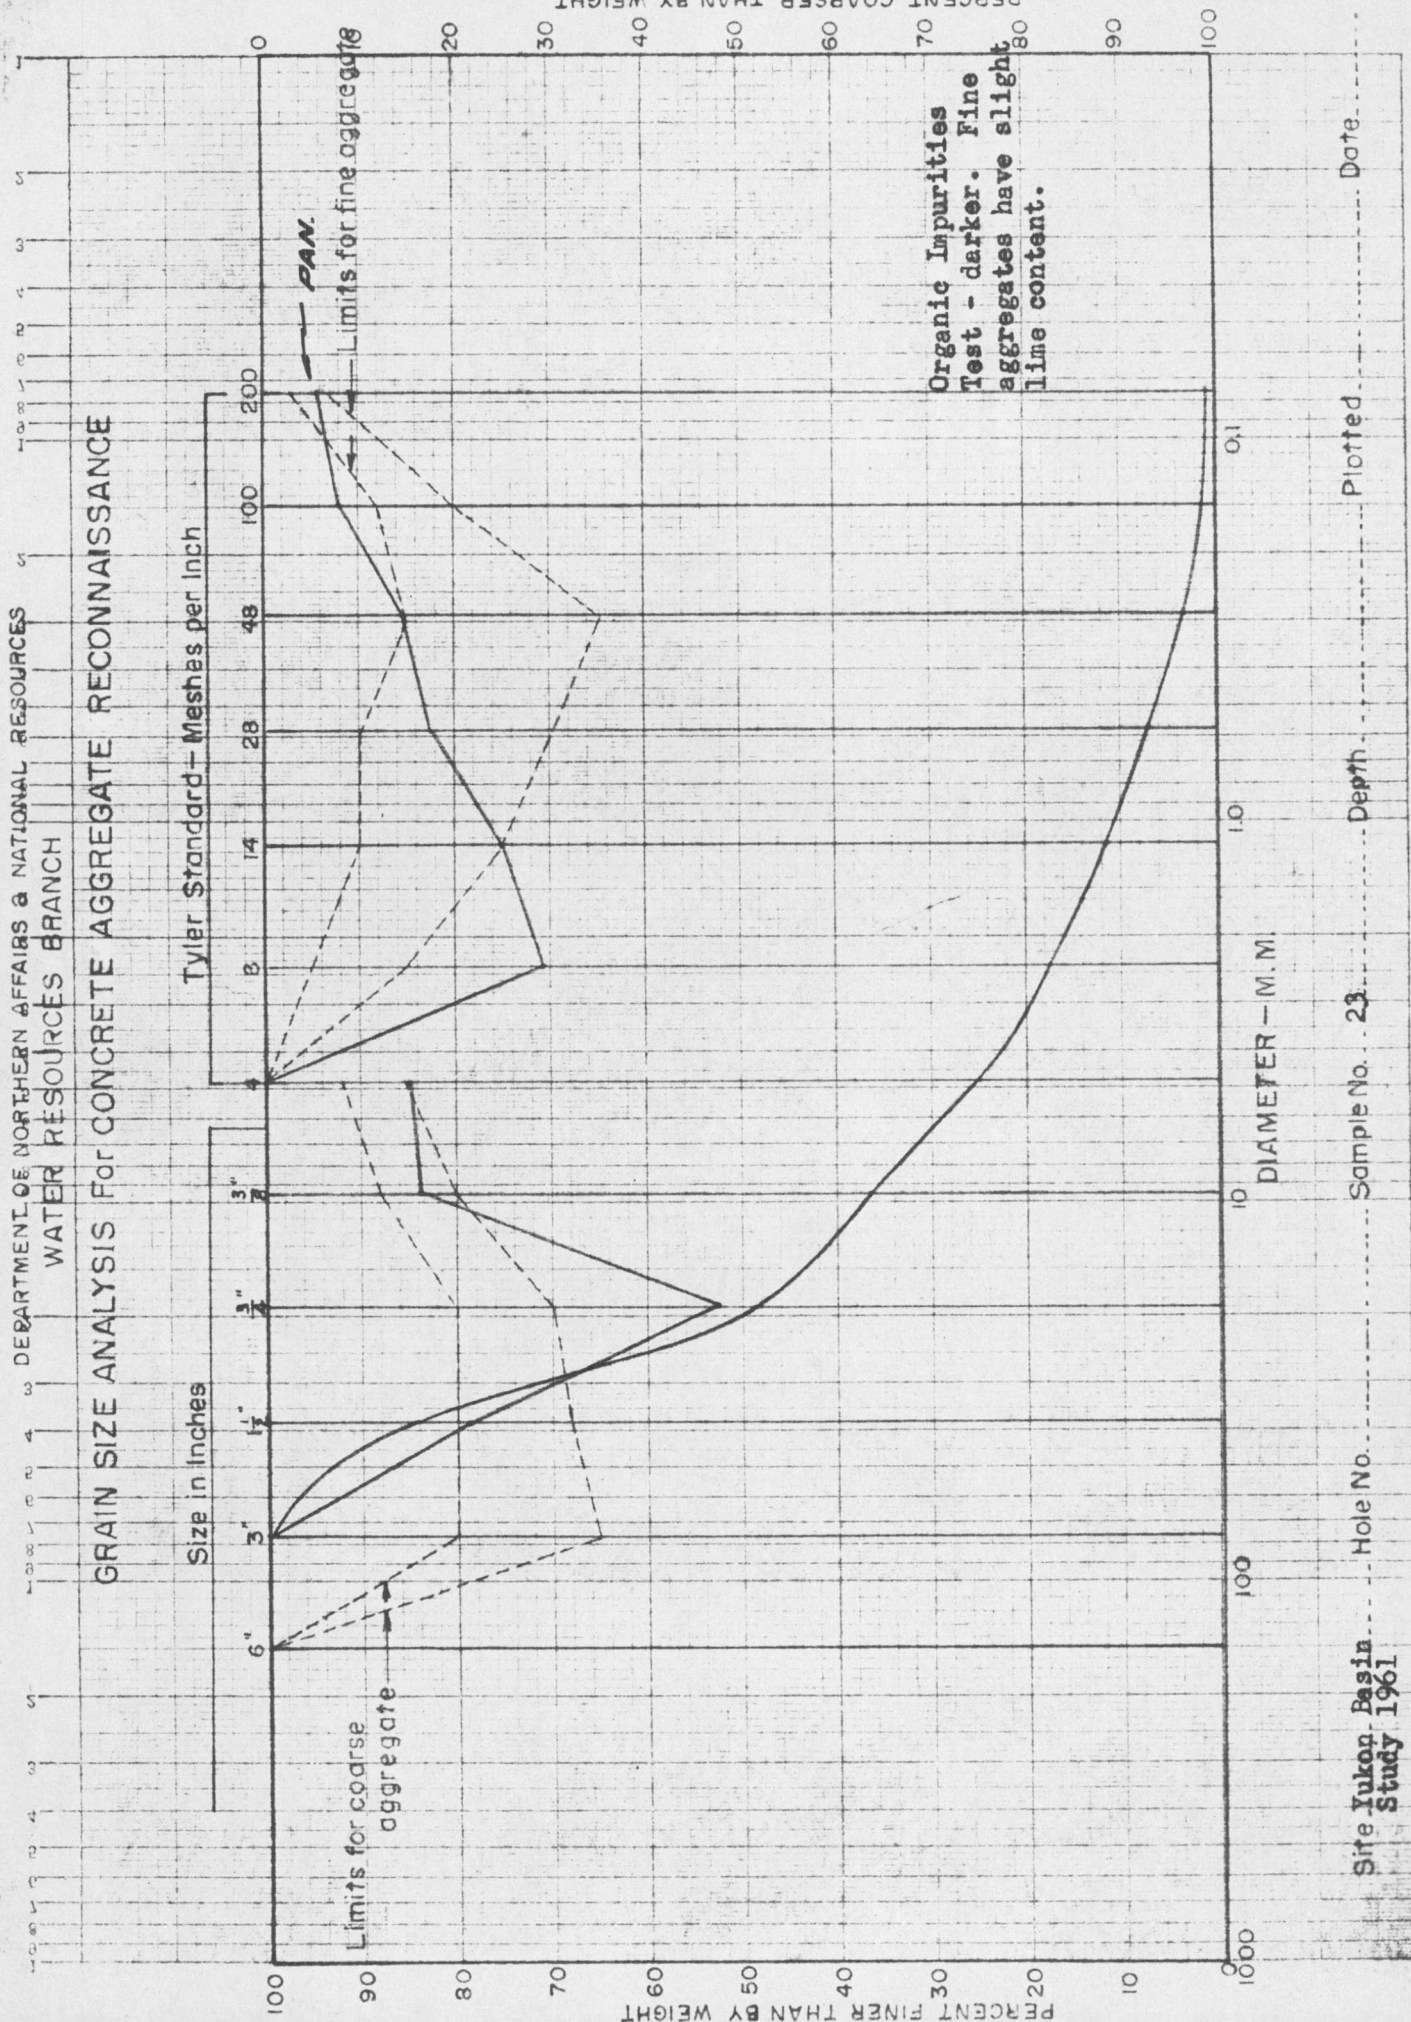
Site Yukon Basin Study 1961 Hole No. _____ Sample No. 23 Depth _____ Plotted _____ Date _____

Sample Number	Location	Field Description of Material	Field Description of Overburden	Thickness of Deposit	Areal Extent (Estimated)	Remarks
23	Pit on south side of Alaska Highway at mile 1095.2; 5 feet below ground surface.	Well graded, sandy gravel; very little silt; many pebbles in the 1- to 3-inch range; a few rounded boulders up to 12 inches; roughly stratified; material is similar to alluvial gravels immediately downstream from Lower Canyon dam site on White River. <u>Pebble and Cobble Lithology</u> Granitic (granite, syenite) - 40% Volcanic (ryholite, andesite, basalt) - 30% Sedimentary (sandstone, limestone) - 20% Metamorphic (gneiss, schist) - 10%	3 feet of silt and fine sand.	10+ feet	Unlimited; pit is 500 feet wide, 1,000 feet long and average 10 feet in depth.	Material was crushed to 1-inch size and used to surface Burwash Flight Landing strip.

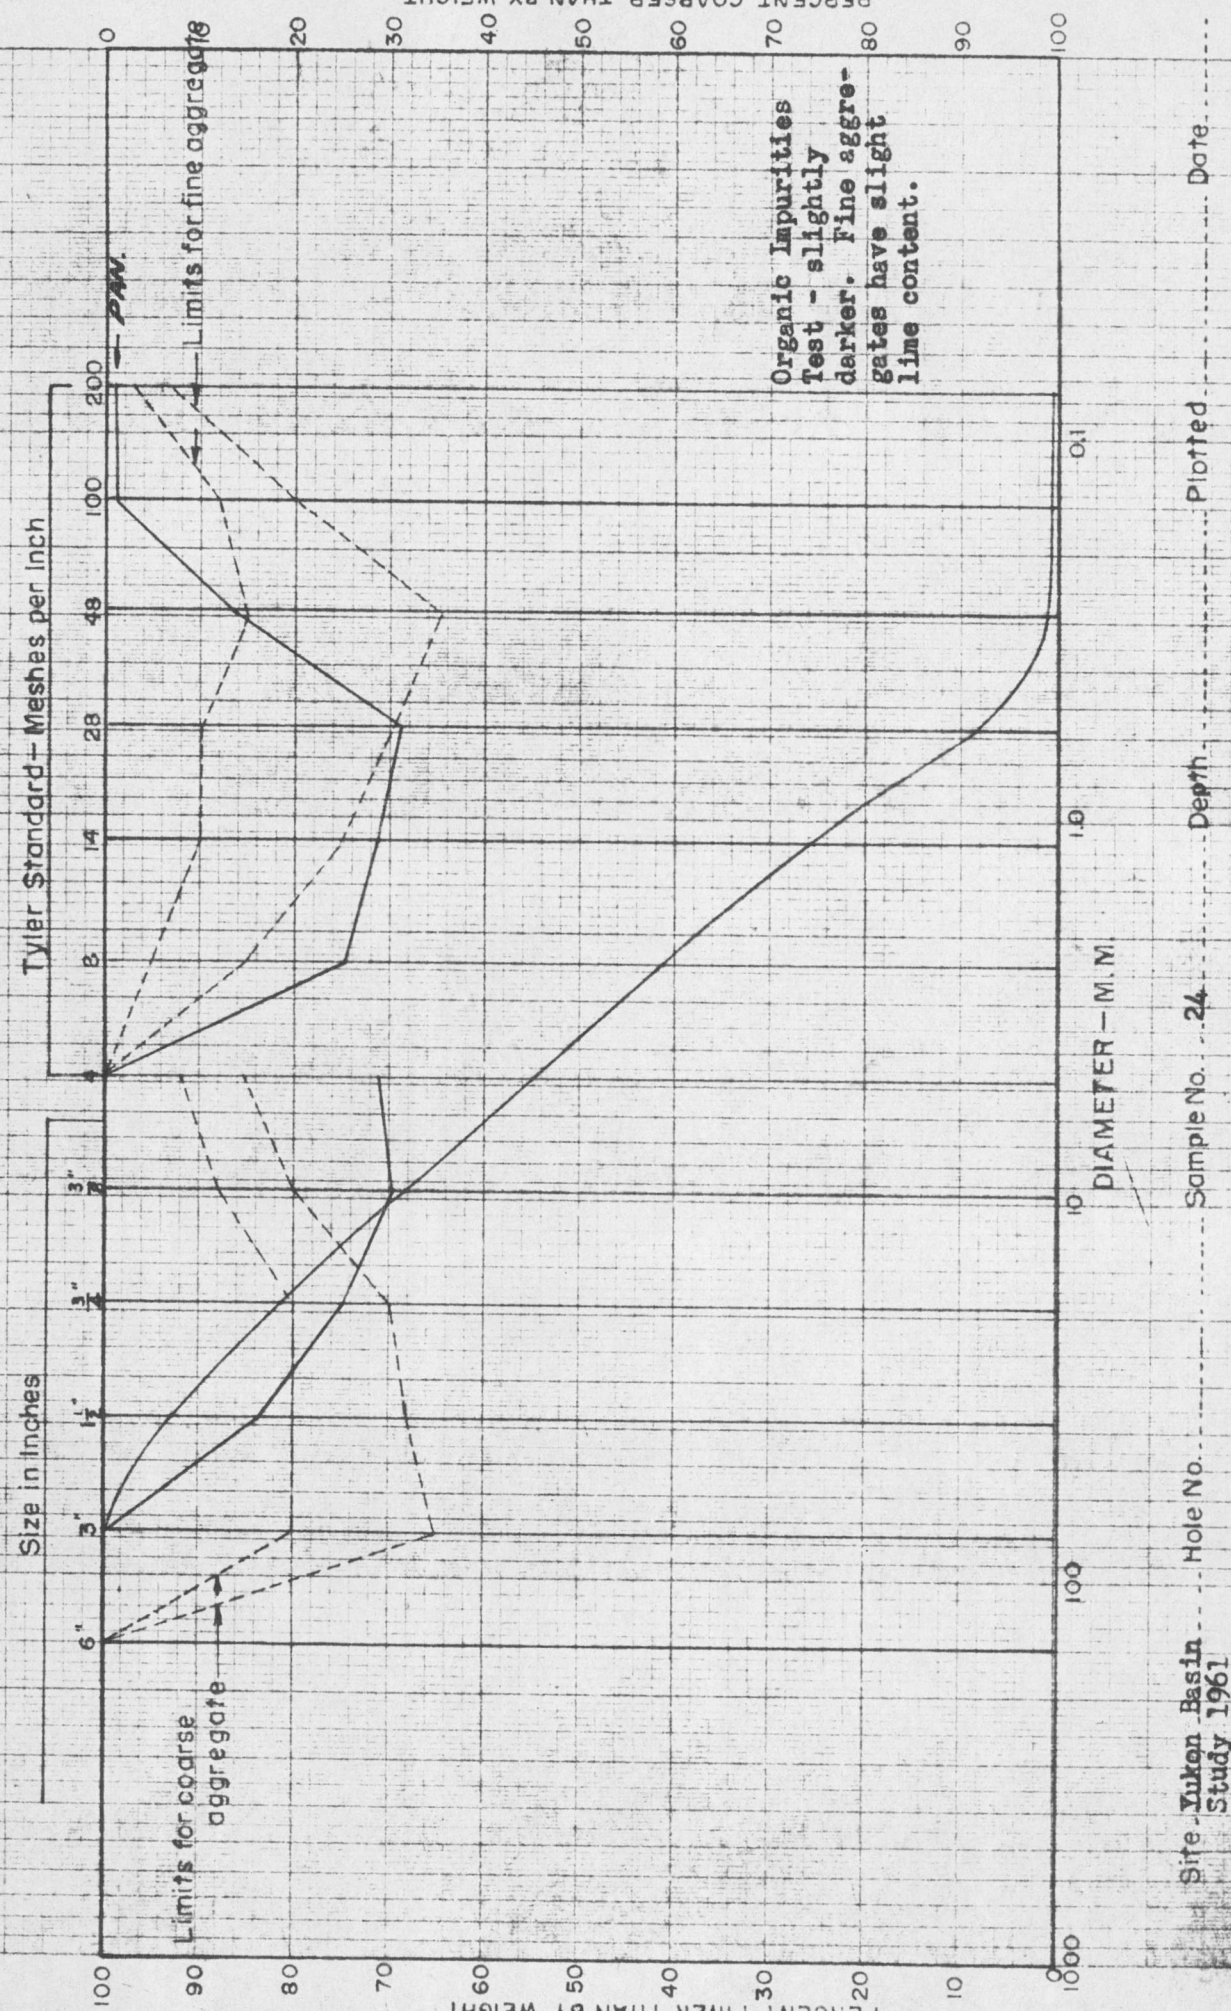
Site Tukon Basin Hole No. Sample No. 24 Depth Plotted Date

Sample Number	Location	Field Description of Material	Field Description of Overburden	Thickness of Deposit	Areal Extent (Estimated)	Remarks
24	From 15-foot bluff on right side of Kluane River; 800 feet upstream from rock outcrop; 4 feet below ground surface.	Fairly well graded sandy gravel; very little silt; numerous, rounded cobbles up to 6 inches in diameter; poorly stratified; no weathering.	2 feet of silt.	10 feet	Limited quantity available; width: 300+ feet length: 300+ feet height: 10 feet	Probably alluvium; overlies stratified sand and silt.

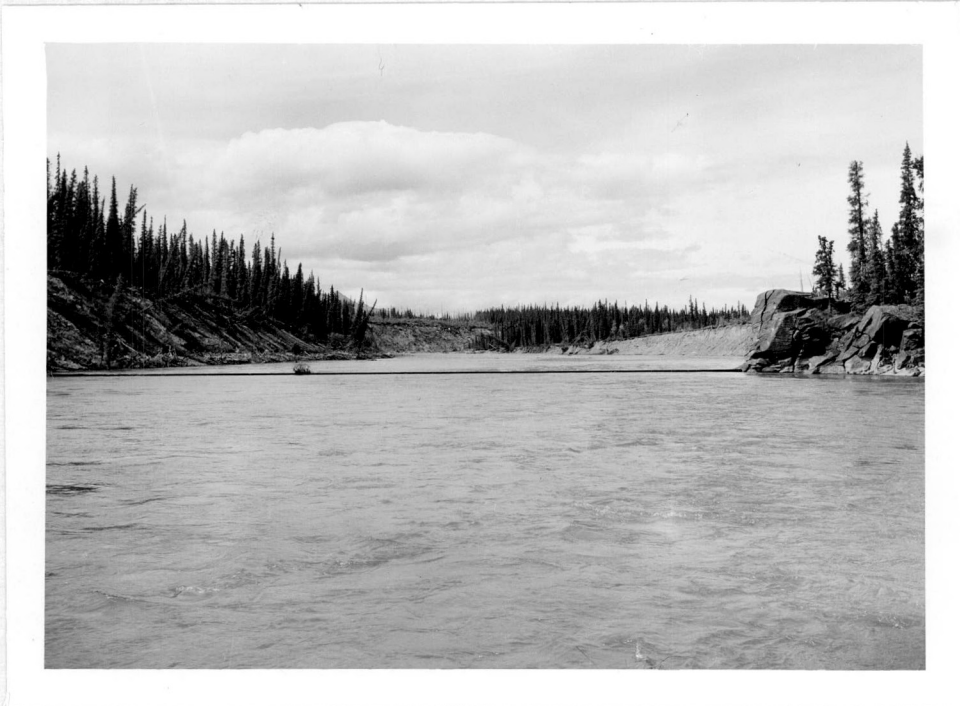
Plate 1

Kluane Canyon looking downstream; it is proposed that bedrock on the right side of the photograph form the right abutment of the dam and that either the till bluff directly opposite or bedrock exposed some 150 feet upstream form the left abutment.

It is suggested the axis of the proposed power dam be located so that bedrock exposed on the right side of the River will form the right abutment. The left abutment would consist either of till if the dam were constructed directly across the River or of bedrock if it were angled upstream to the bedrock exposures on the left side of the River.

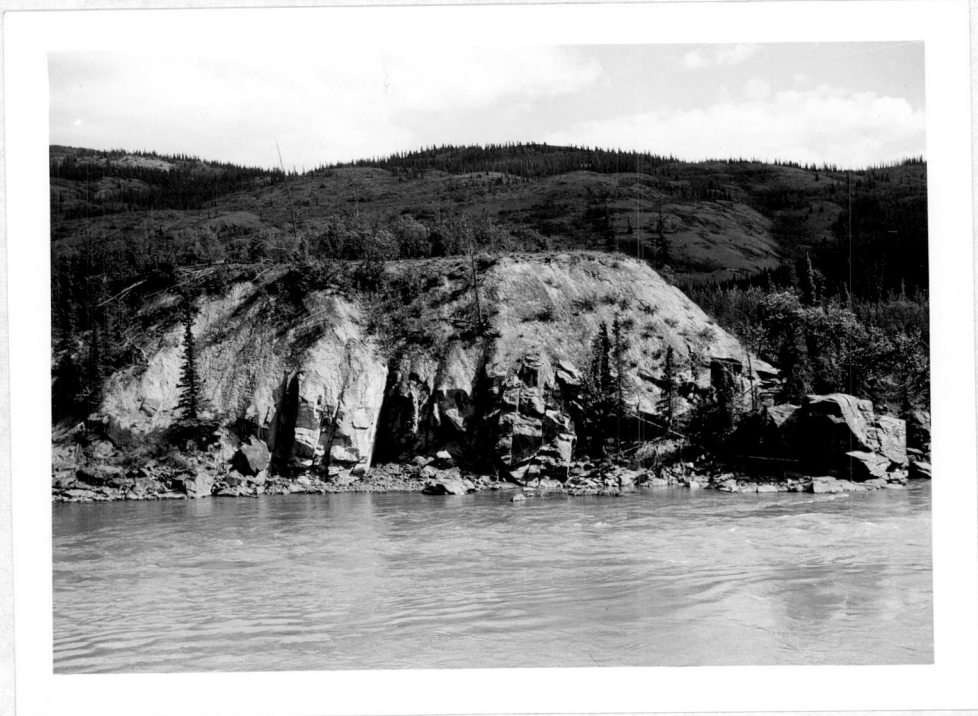
Plate 2

Right abutment; prominent jointing in bedrock is parallel to the proposed axis and dips steeply downstream; northeast side of Shakwak Trench in background.
