GEOLOGICAL SURVEY OF CANADA
TOPICAL REPORT NO. 39

YUKON RIVER DRAINAGE BASIN
DAM SITE INVESTIGATION

SITE NO. 28

ROSS CANYON DAM SITE
(MAP AND PRELIMINARY REPORT)

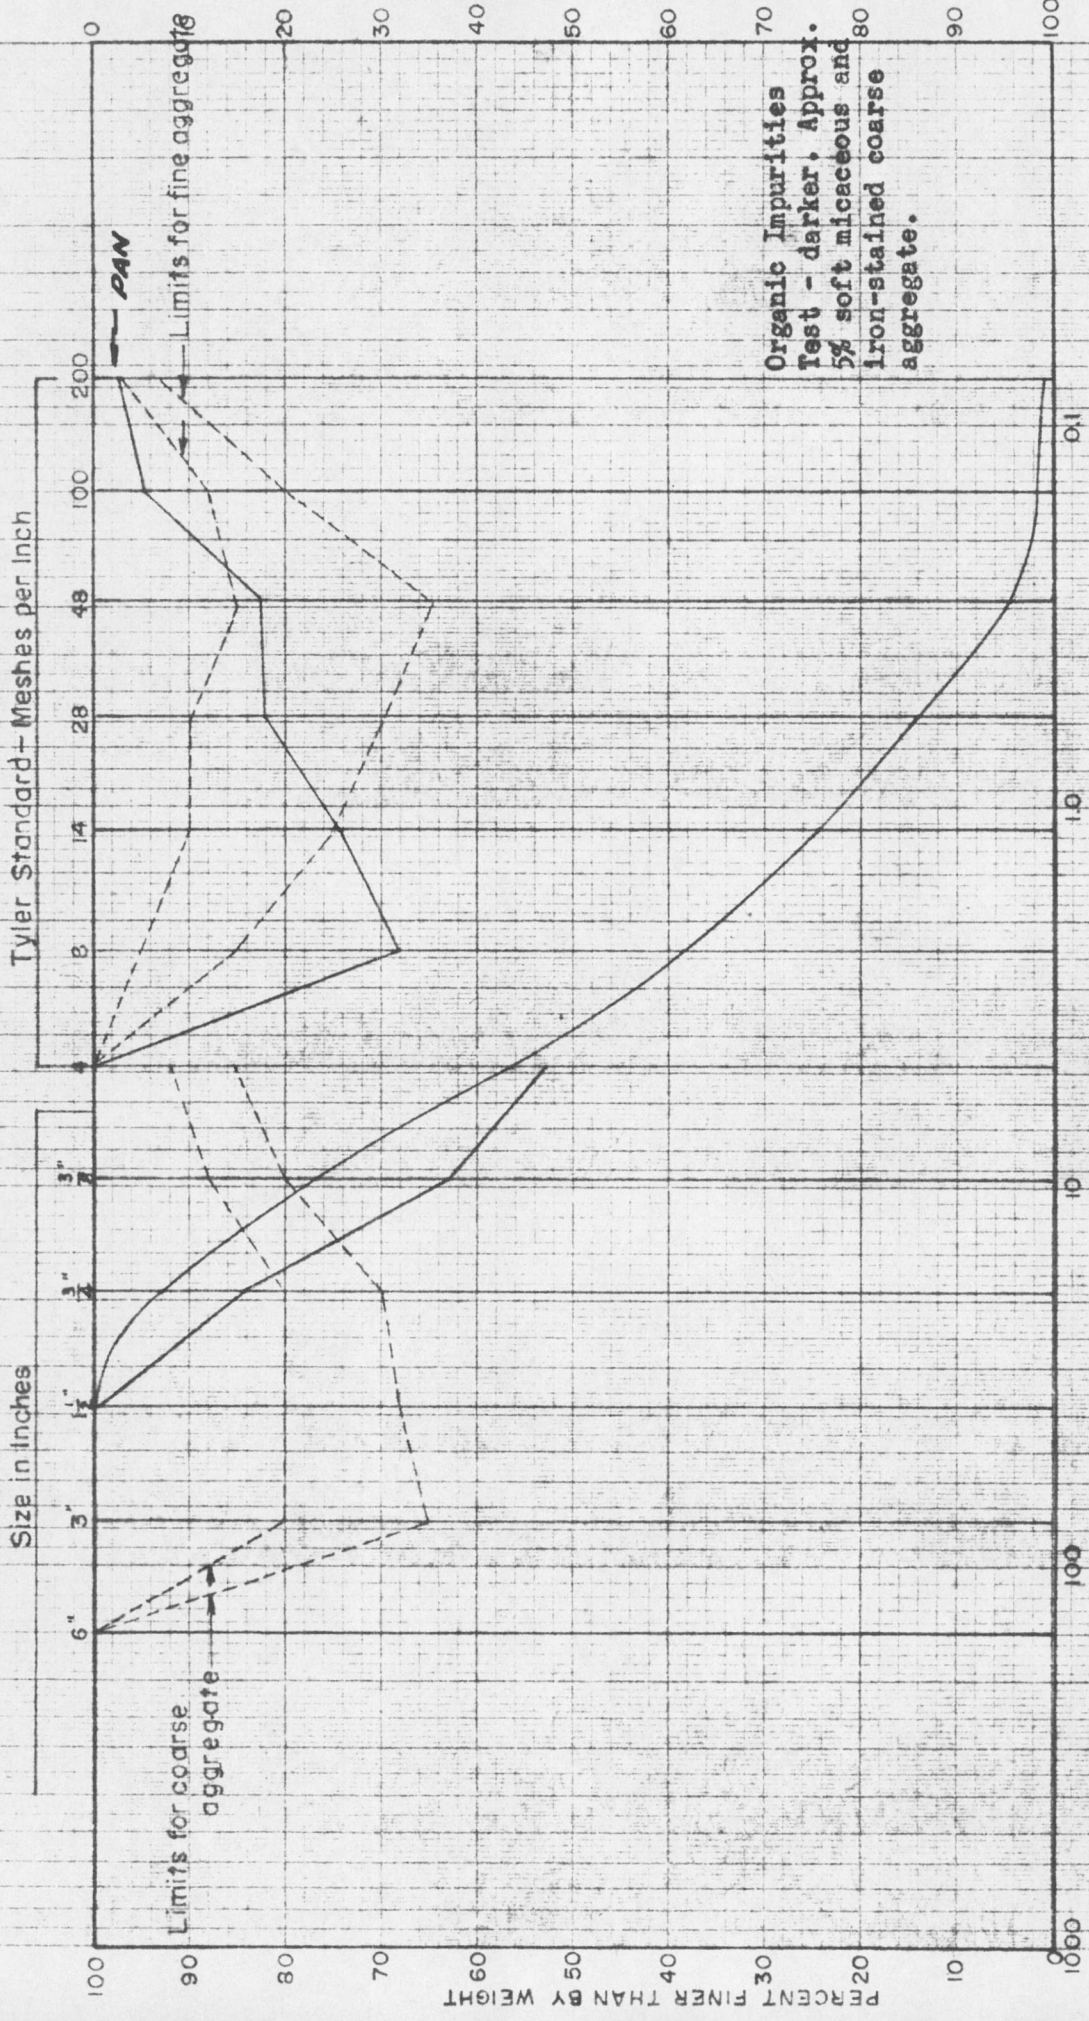
Site: Yukon Basin Study 1961
 Hole No. _____
 Sample No. 28
 Depth _____
 Plotted _____
 Date _____

Sample Number	Location	Field Description of Material	Field Description of Overburden	Thickness of Deposit	Areal Extent (Estimated)	Remarks
28	Borrow pit on Canol Road at mile 370.3; 2 feet below ground surface	Well graded, sandy gravel; a few rounded boulders up to 18 inches in diameter; stratified; upper 18 inches of gravel is weathered. <u>Pebble Lithology</u> Igneous (granitic, volcanic, quartz) - 50% Chert - 20% Shale - 10% Arkose, greywacke - 10% Metamorphic - 10%	18 inches of silt	5+ feet	Large	Alluvial deposit; used during construction of Canol Road
30	Cut bank on southwest side of Pelly River 8 miles down stream from community of Ross River; 6 feet below ground surface	Well graded sandy gravel; a few rounded boulders up to 12 inches in diameter; about 10% by volume of the material is larger than 6 inches in diameter; minor weathering; no stratification. <u>Pebble and Cobble Lithology</u> Igneous (granitic, volcanic, porphyry, quartz) - 60%	2 feet of silt	20 feet	Length - 1/4 mile Depth - 20 feet Width - 500+ feet	Probably glacio-fluvial material

Organic Impurities
 Test - darker, Approx.
 5% soft micaceous and
 iron-stained coarse
 aggregate.

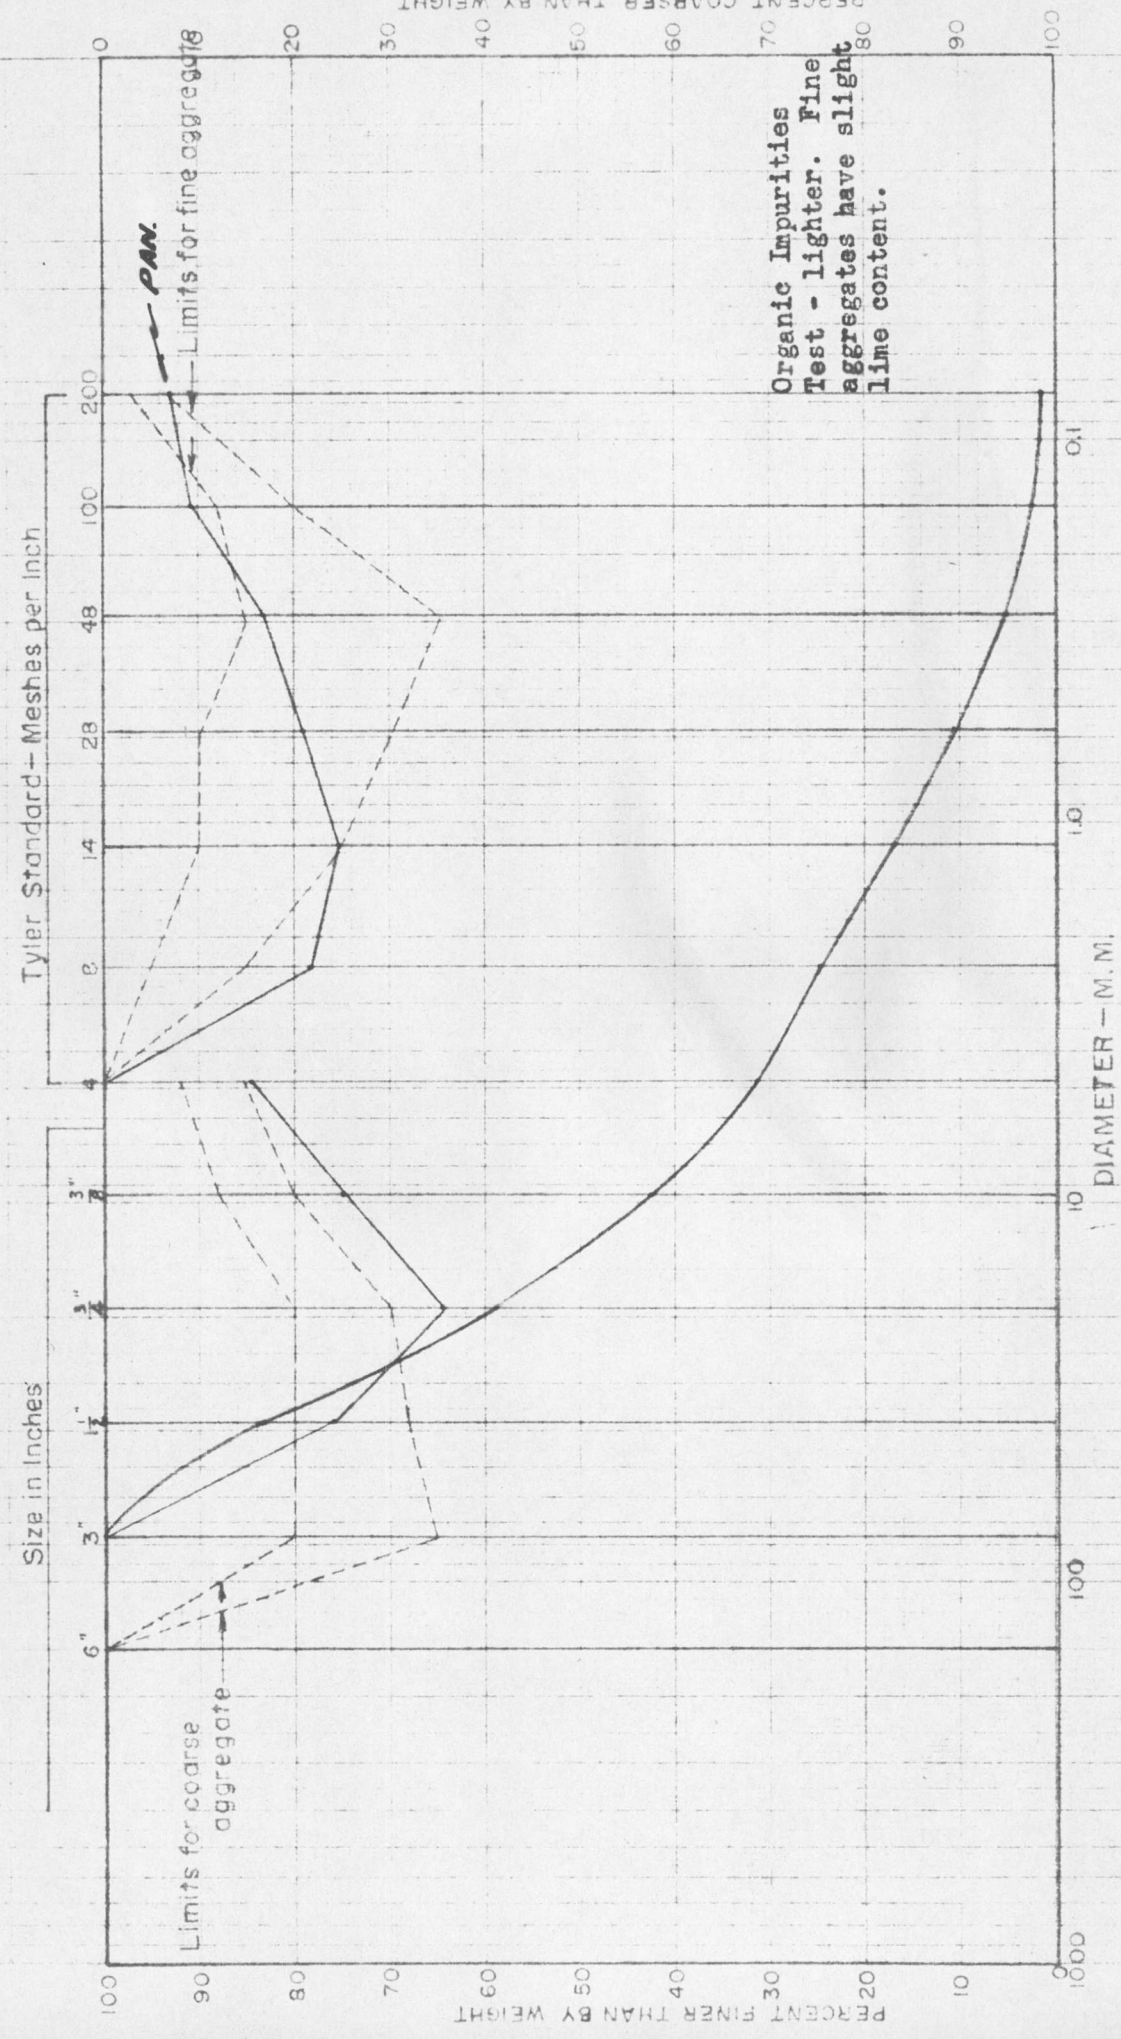
Site Yukon Basin Study 1961 Hole No. _____ Plotted _____ Date _____
Sample No. 31 Depth _____

Sample Number	Location	Field Description of Material	Field Description of Overburden	Thickness of Deposit	Areal Extent (Estimated)	Remarks
30 (Cont'd)		Metamorphic (schist, gneiss) - 15%				
31	Cut bank on north-east side of Pelly River 11.5 miles downstream from community of Ross River; 5 feet below ground surface	Fairly well graded gravel; very little silt and clay; rounded boulders up to 10 inches in diameter; about 10% by volume of the material is greater than 4 inches in diameter. Pebble and Cobble Lithology Igneous (granitic, volcanic, quartz) - 50% Metamorphic (schists, gneiss) - 20% Sedimentary (grey-wacke) - 20% Shale - 5% Chert - 5%	3 feet of stratified silt	15 feet	Length - 1/4 mile Depth - 15 feet Width - 200+ feet	Alluvial deposit; several higher terraces north-east of River contain glacio-fluvial gravel

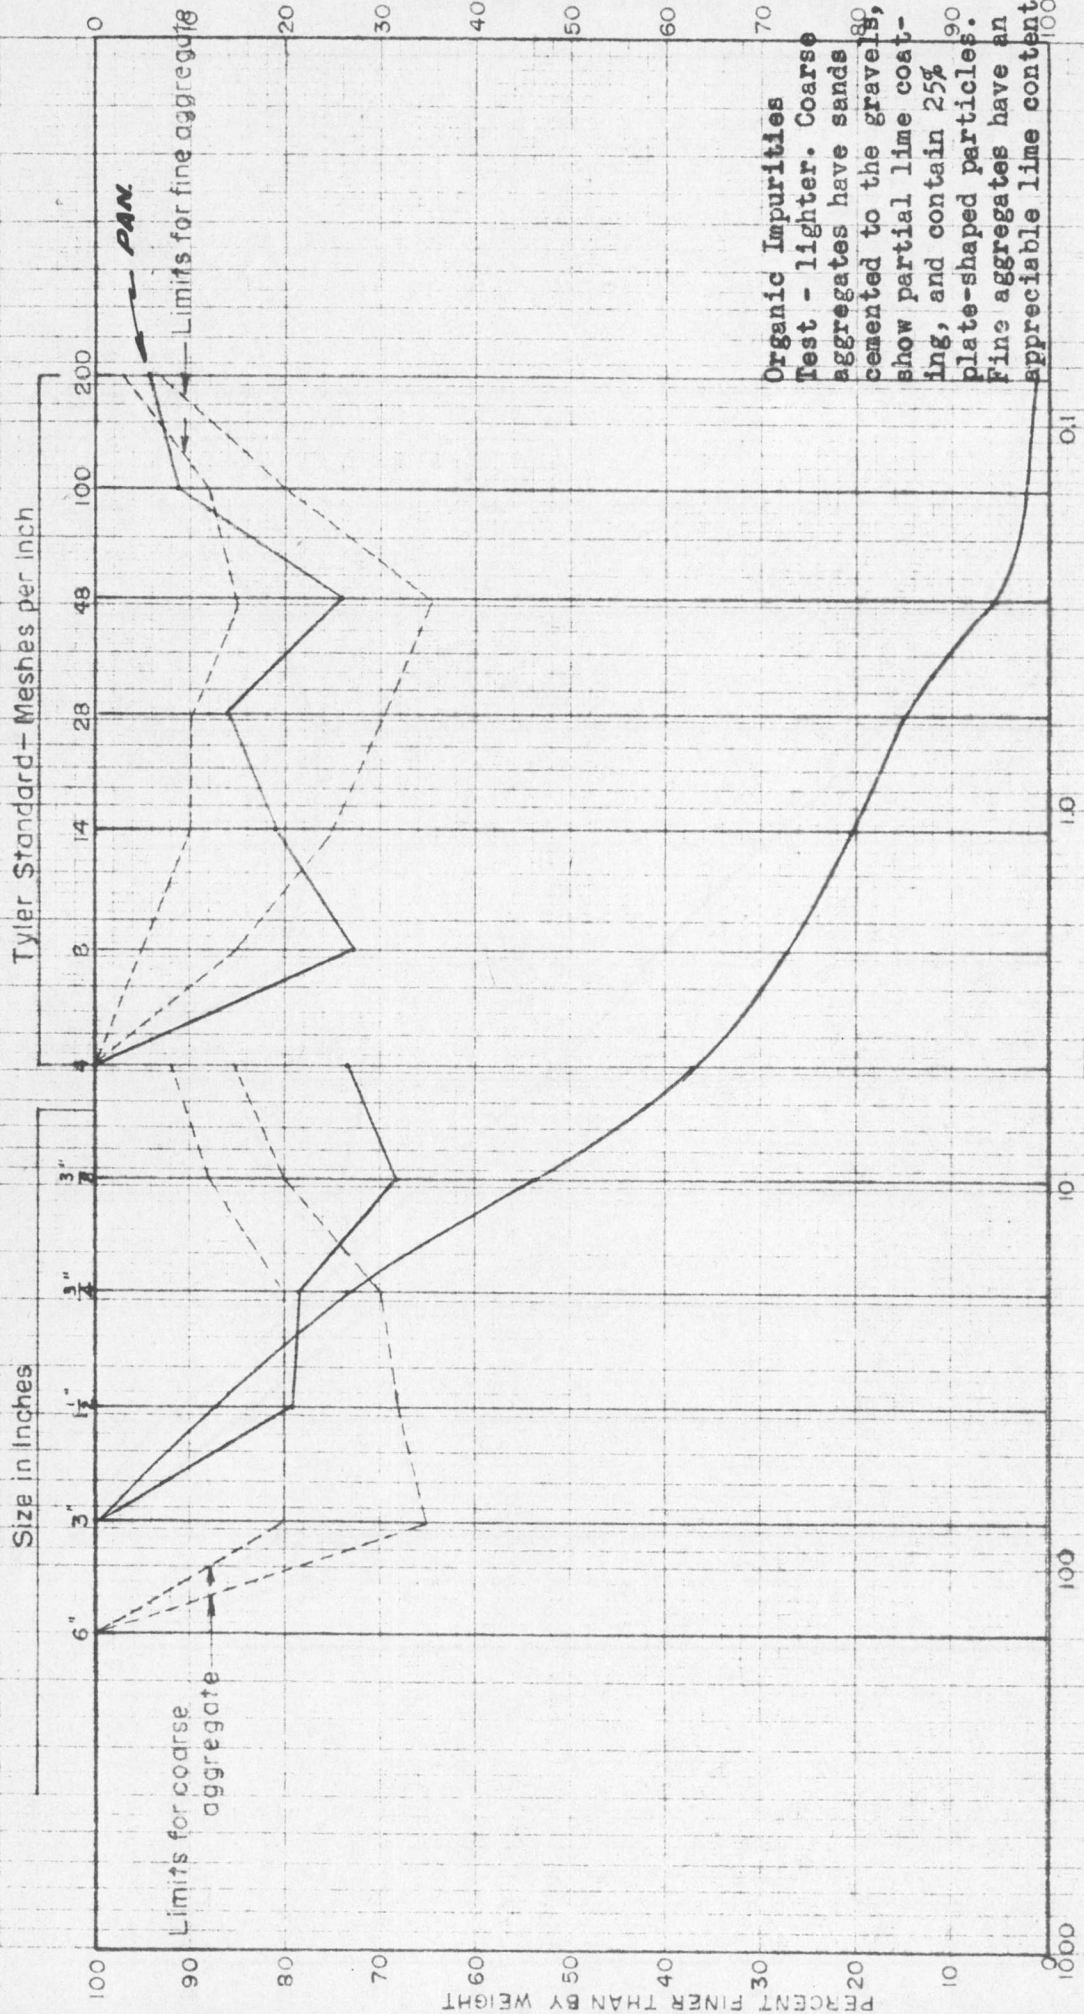
Site - Yukon Basin - Hole No. - - - - - Plotted - - - - - Date - - - - -
 Sample No. 32 - - - - - Depth - - - - -

Sample Number	Location	Field Description of Material	Field Description of Overburden	Thickness of Deposit	Areal Extent (Estimated)	Remarks
32	Cut bank on southwest side of Pelly River 16.5 miles upstream from community of Ross River; 4 feet below ground surface	Well graded gravel; a few rounded boulders up to 18 inches; considerable white carbonate on lower surfaces of pebbles in upper few feet; very little weathering; minor silt, chert and shale. Pebble and Cobble <u>Lithology</u> Igneous (granitic, volcanic, quartz) - 65% Sedimentary (grey-wacke, arkose) - 25% Metamorphic (gneiss, schist) - 10%	18 inches of silt	60+ feet	Length - 1/3 mile Depth - 55 feet Width - 1/3 mile	Glacio-fluvial material
33	Cut on Ketzakey mine road 6.1 miles from Canol Road; a representative sample from the upper 6 feet of material	Well graded sandy gravel; rounded boulders to 9 inches in diameter; considerable white carbonate on lower surfaces of pebbles in upper 4 feet; negligible silt; minor weathering.	18 inches of silt	20+ feet	Unlimited	Glacio-fluvial material

Organic Impurities Test - lighter. Coarse aggregates have sands cemented to the gravels, show partial lime coating, and contain 25% plate-shaped particles. Fine aggregates have an appreciable lime content.

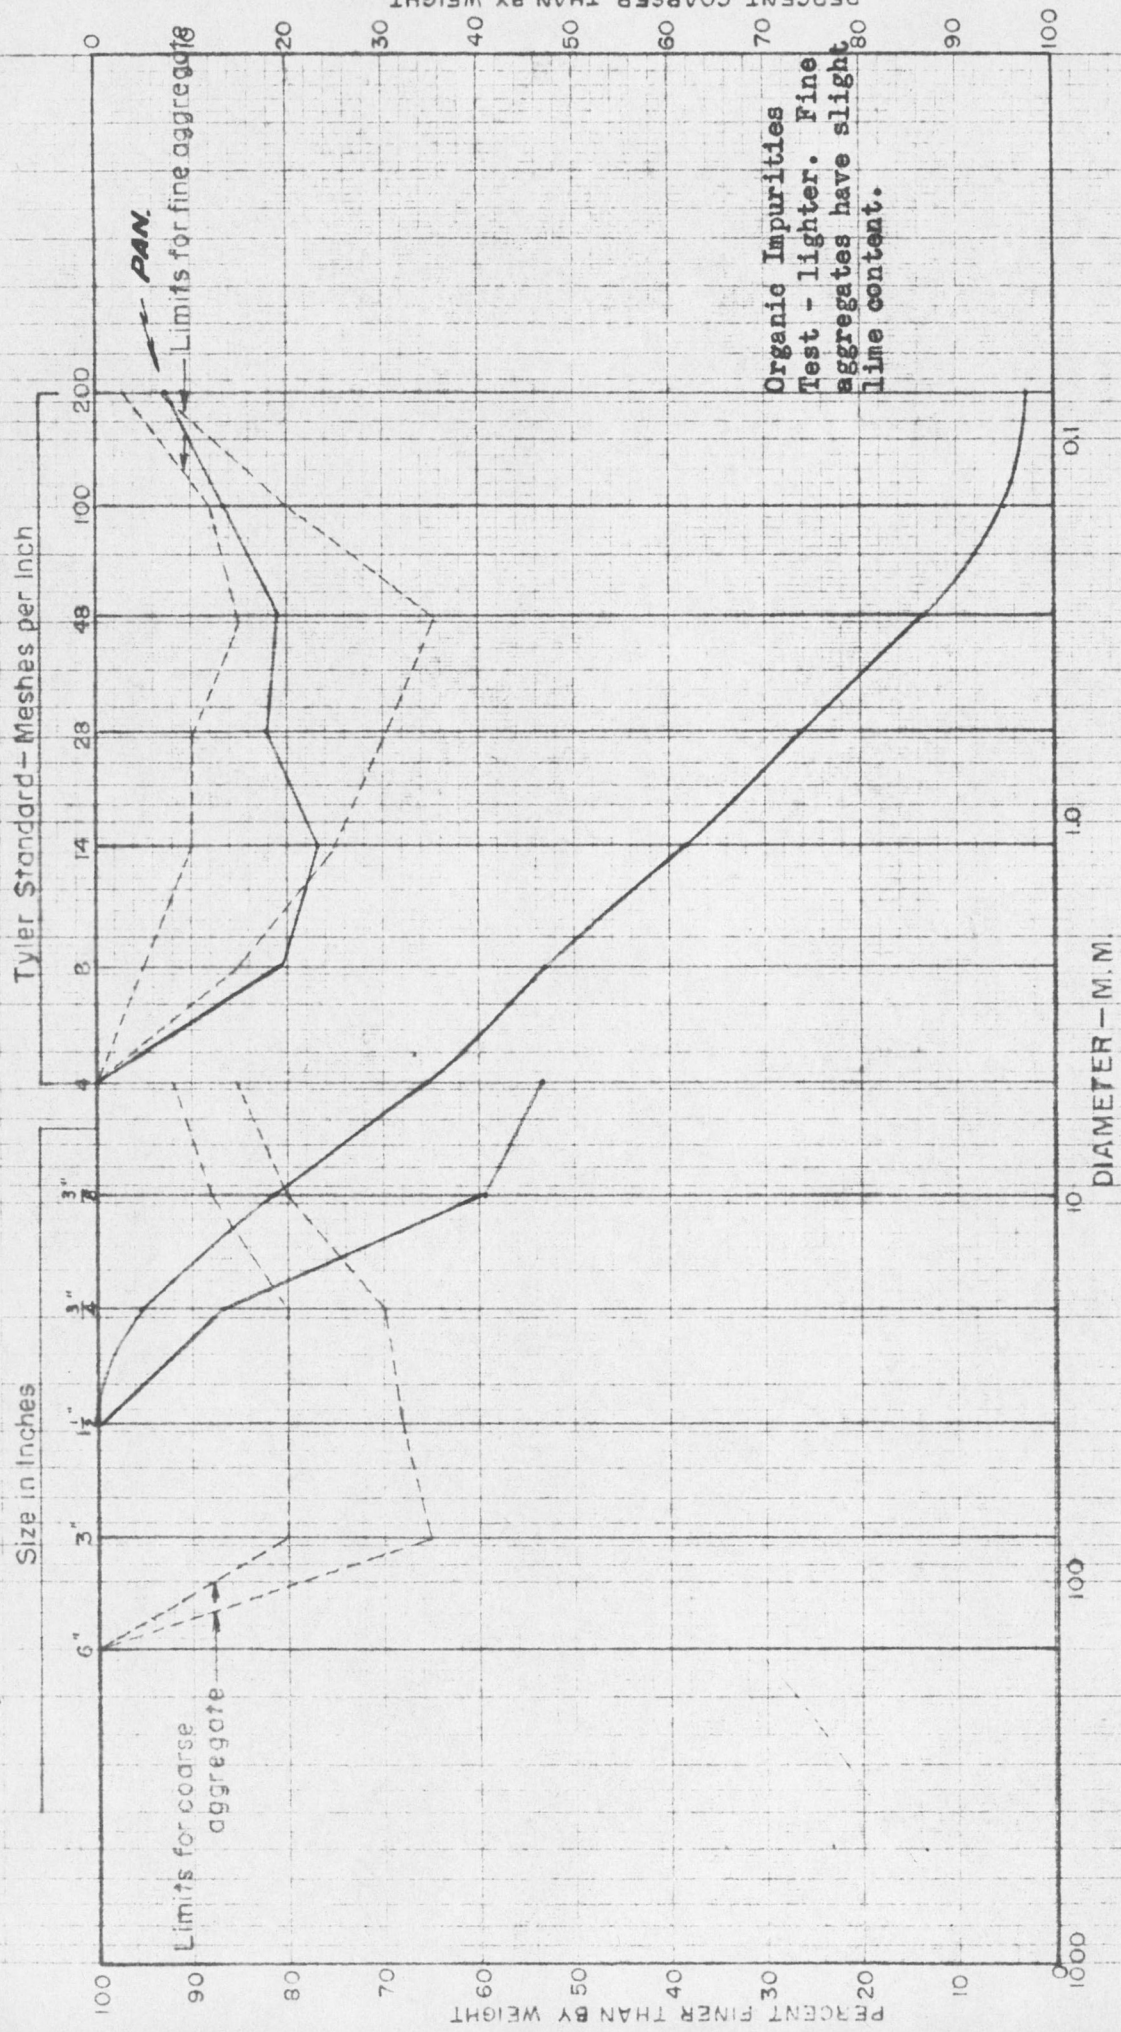
Sample Number	Location	Field Description of Material	Field Description of Overburden	Thickness of Deposit	Areal Extent (Estimated)	Permeability* (cm/sec.)
33-A	Cut bank on Canol Road 1/4 mile north of dam site area; 10 feet above road surface	Medium- to coarse-grained sand; minor gravel; very little silt or clay; material occurs as narrow, irregular lenses in till (sample No. 29)	-	1 to 4 feet	Limited	10^{-3}

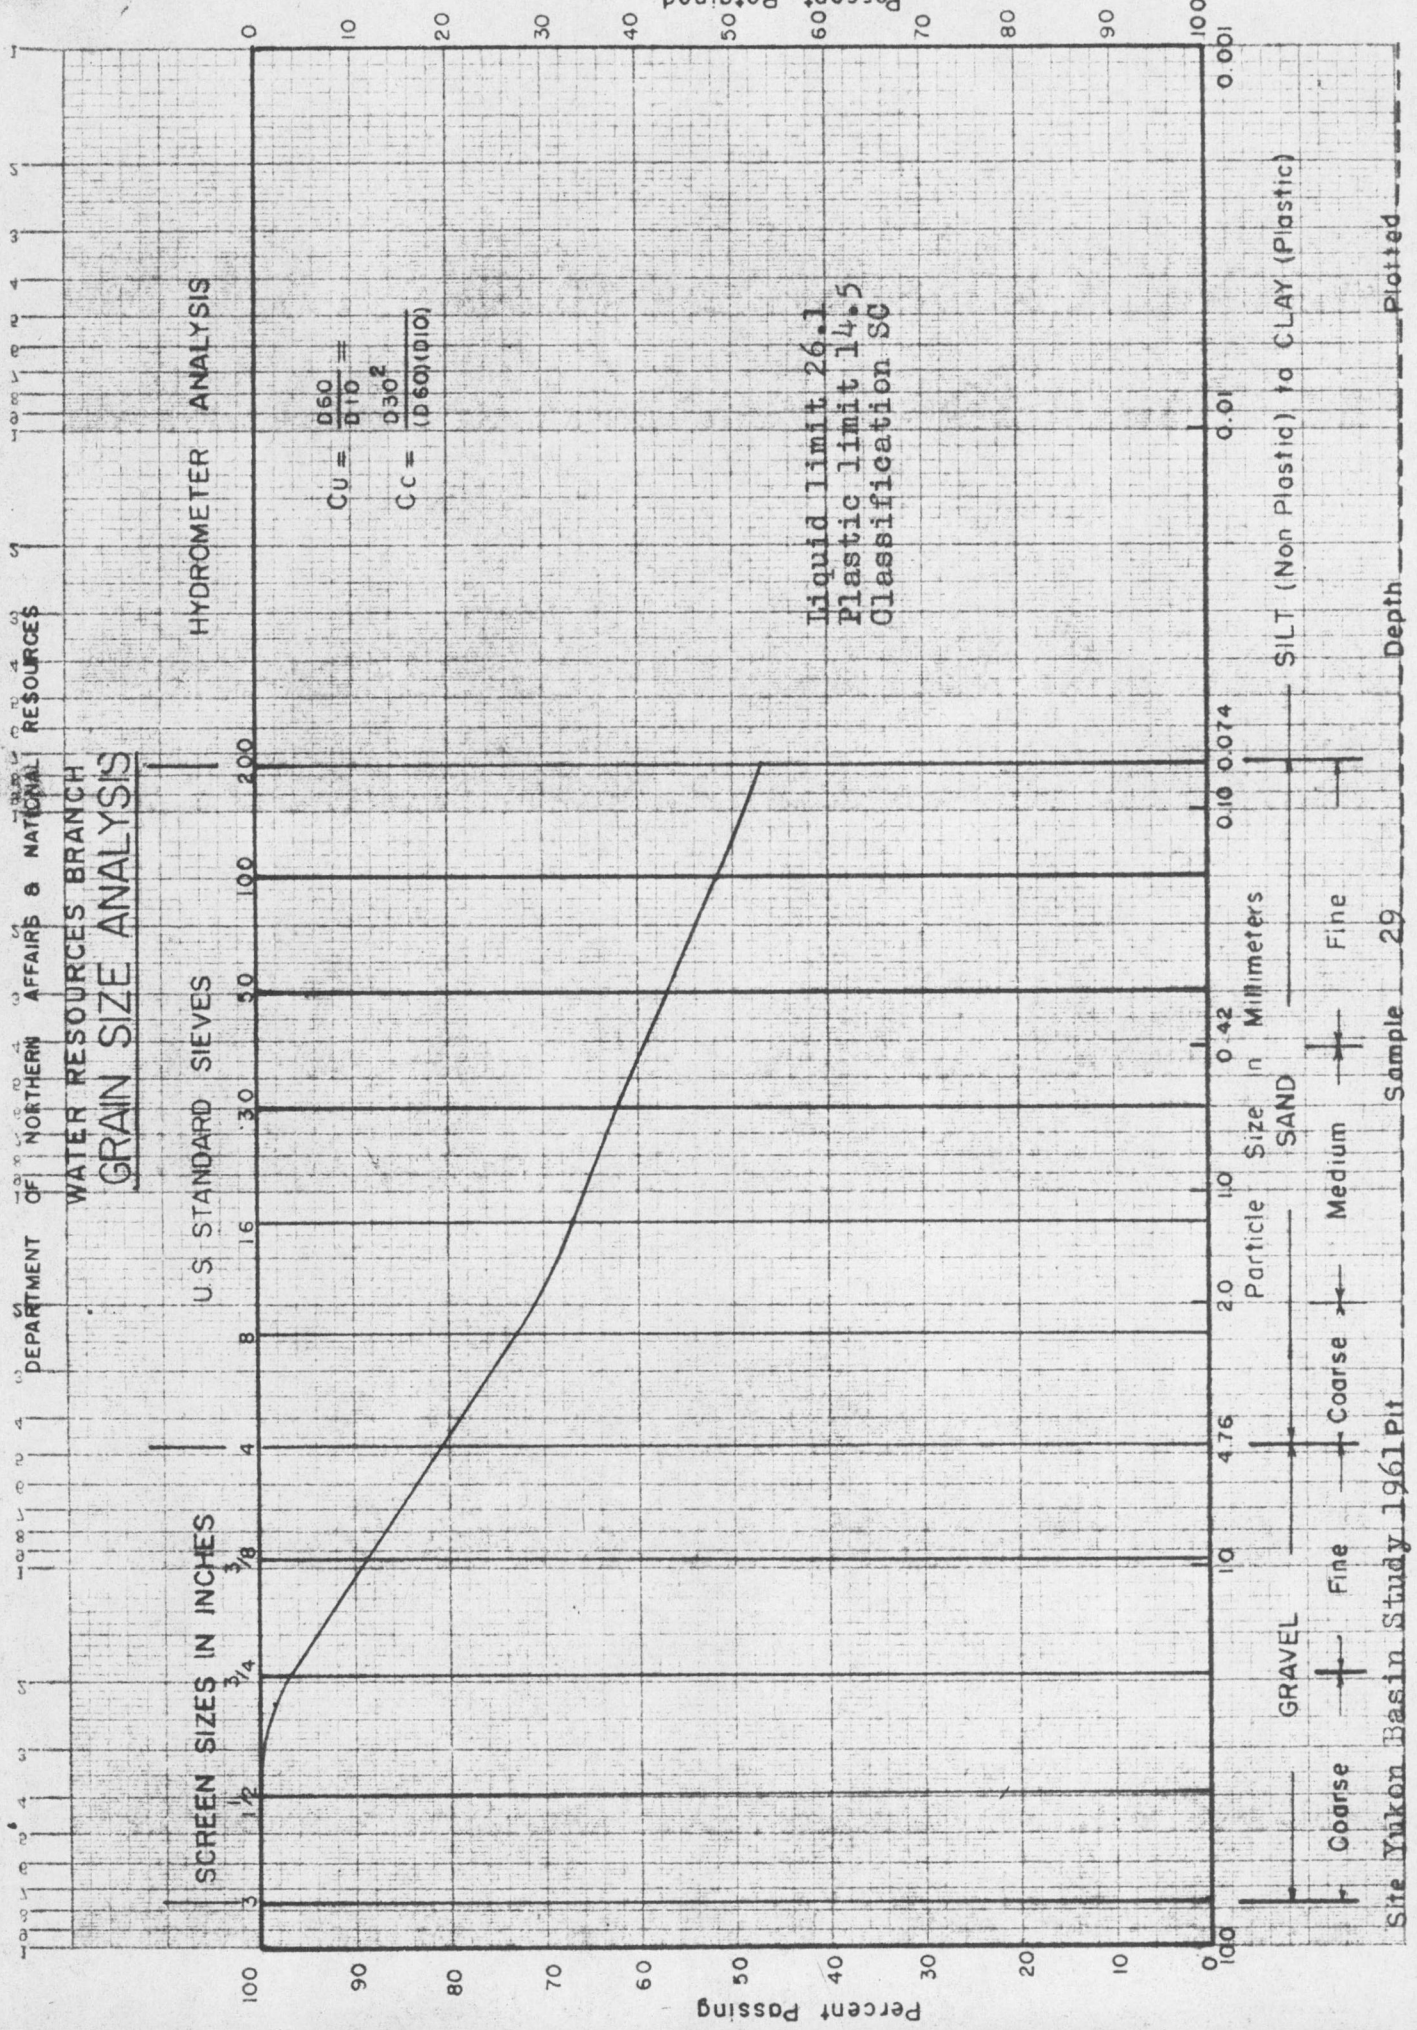
Sample 29

Sample Number	Location	Field Description of Material	Field Description of Overburden	Thickness of Deposit	Areal Extent (Estimated)	Remarks
29	Cut bank on Canol Road 1/4 mile north of dam site area; 5 feet above road surface	Dense, silty, clayey till; a few boulders up to 24 inches in diameter; high dry strength; minor brown weathering in upper 24 inches; contains a few narrow, irregular, sand lenses (sample No. 33-A); till contains a high percentage of black, chert pebbles	12+ inches of silt	100+ feet	Unlimited	Till extends for many miles along both sides of Ross River upstream from site

Liquid limit 26.1
Plastic limit 14.5
Classification SC

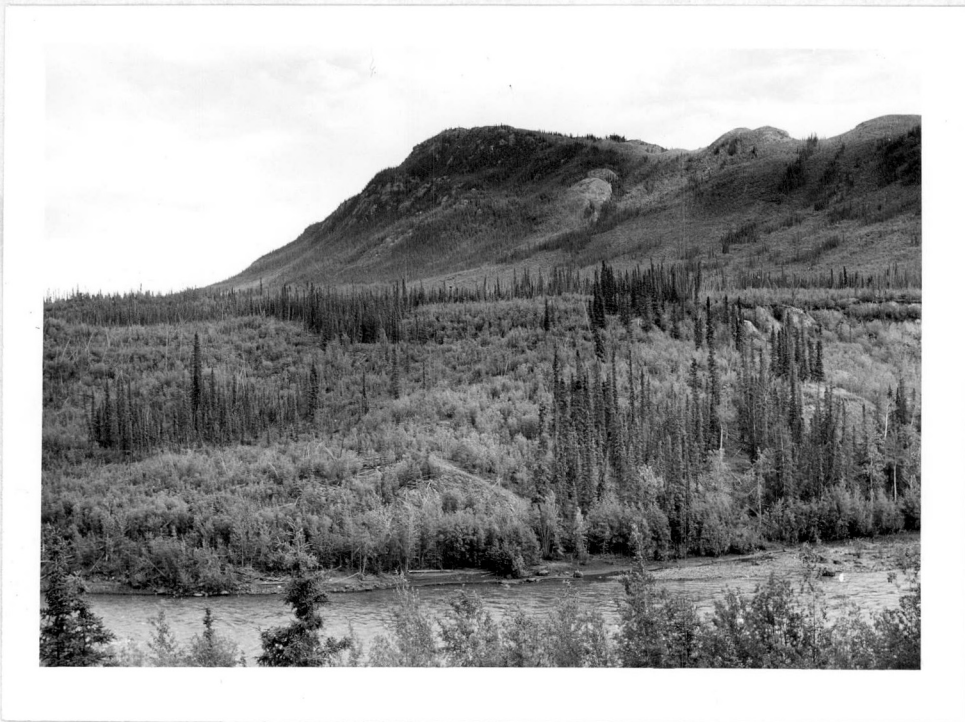
Plate 1

View looking east along proposed dam axis from right abutment. Steep, till bluff forming left abutment rises 180 feet above Ross River. Elevation of terrace above bluff is about 2,500.
