GEOLOGICAL SURVEY OF CANADA
TOPICAL REPORT NO. 41

MACKENZIE RIVER DRAINAGE BASIN
DAM SITE INVESTIGATION

SITE NO. 3

LOWER CANYON DAM SITE
(MAP AND PRELIMINARY REPORT)

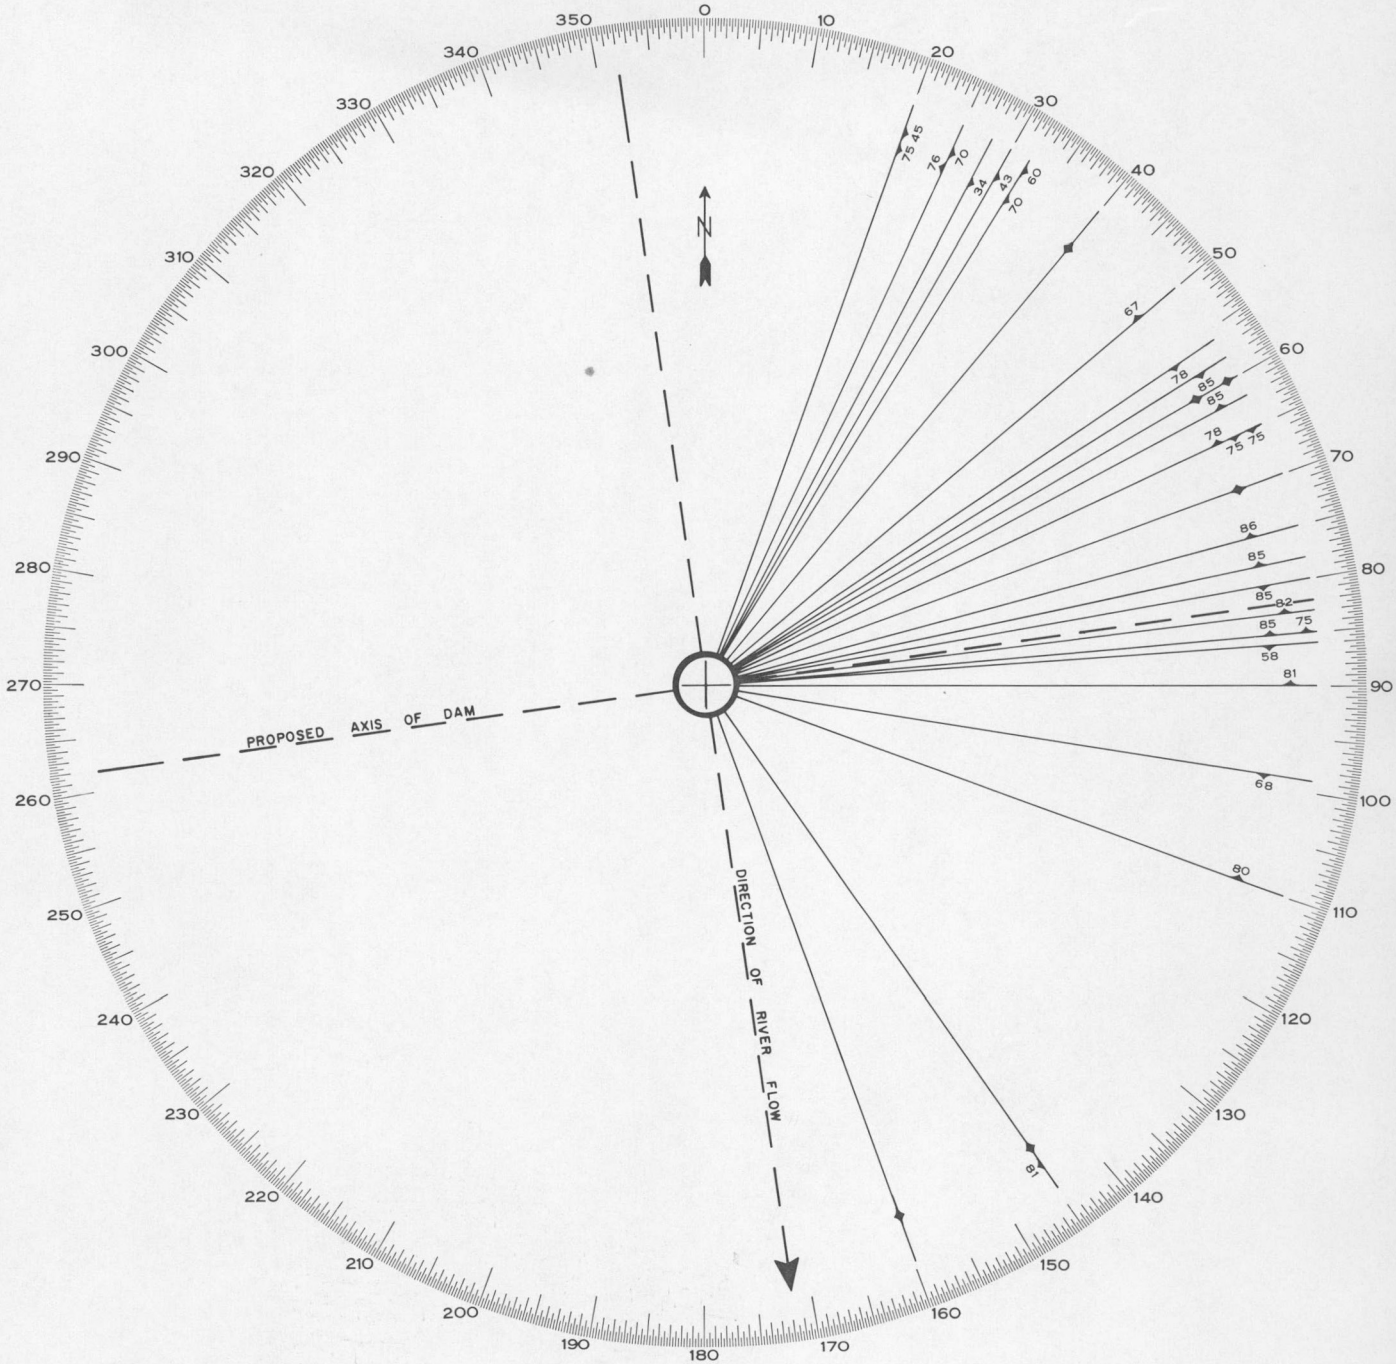
JOINT ROSETTE

Jointing is common at Lower Canyon dam site. The attitudes are exceptionally variable. The jointing intersects the proposed centre line of the dam at angles between zero and 70 degrees with relatively steep dips. Rosettes indicating the relation of the various bedrock structures at the site to the proposed dam axis are presented on the following pages.

The above illustration presents diagrammatically the direction and dip of the jointing in bedrock exposed at Lower Canyon dam site, Frances River

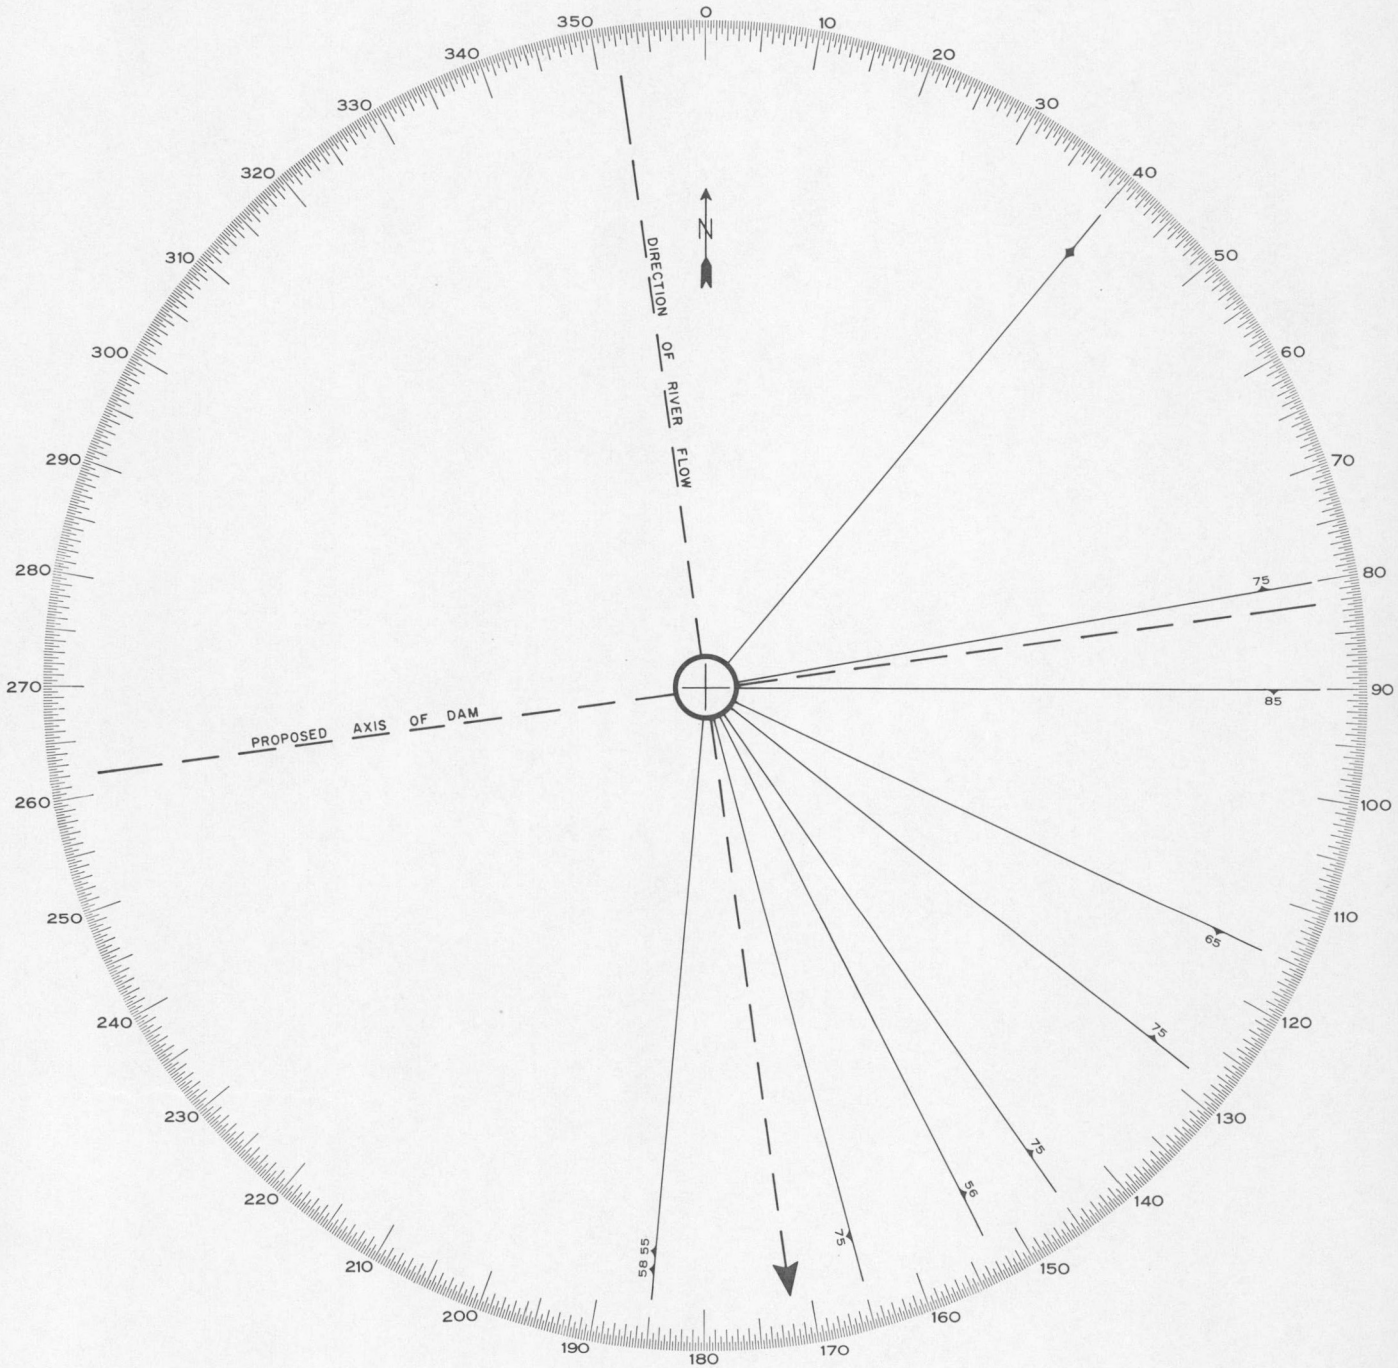
FAULT ROSETTE

Considerable faulting is visible in the bluff along the right side of the canyon. In many instances it is associated with the folding and parallel to it. Numerous small seepages of groundwater were observed at the base of the bluff issuing from the broken rock in the fault zones.

The above illustration presents diagrammatically the direction and dip of the faulting in bedrock exposed at Lower Canyon dam site, Frances River

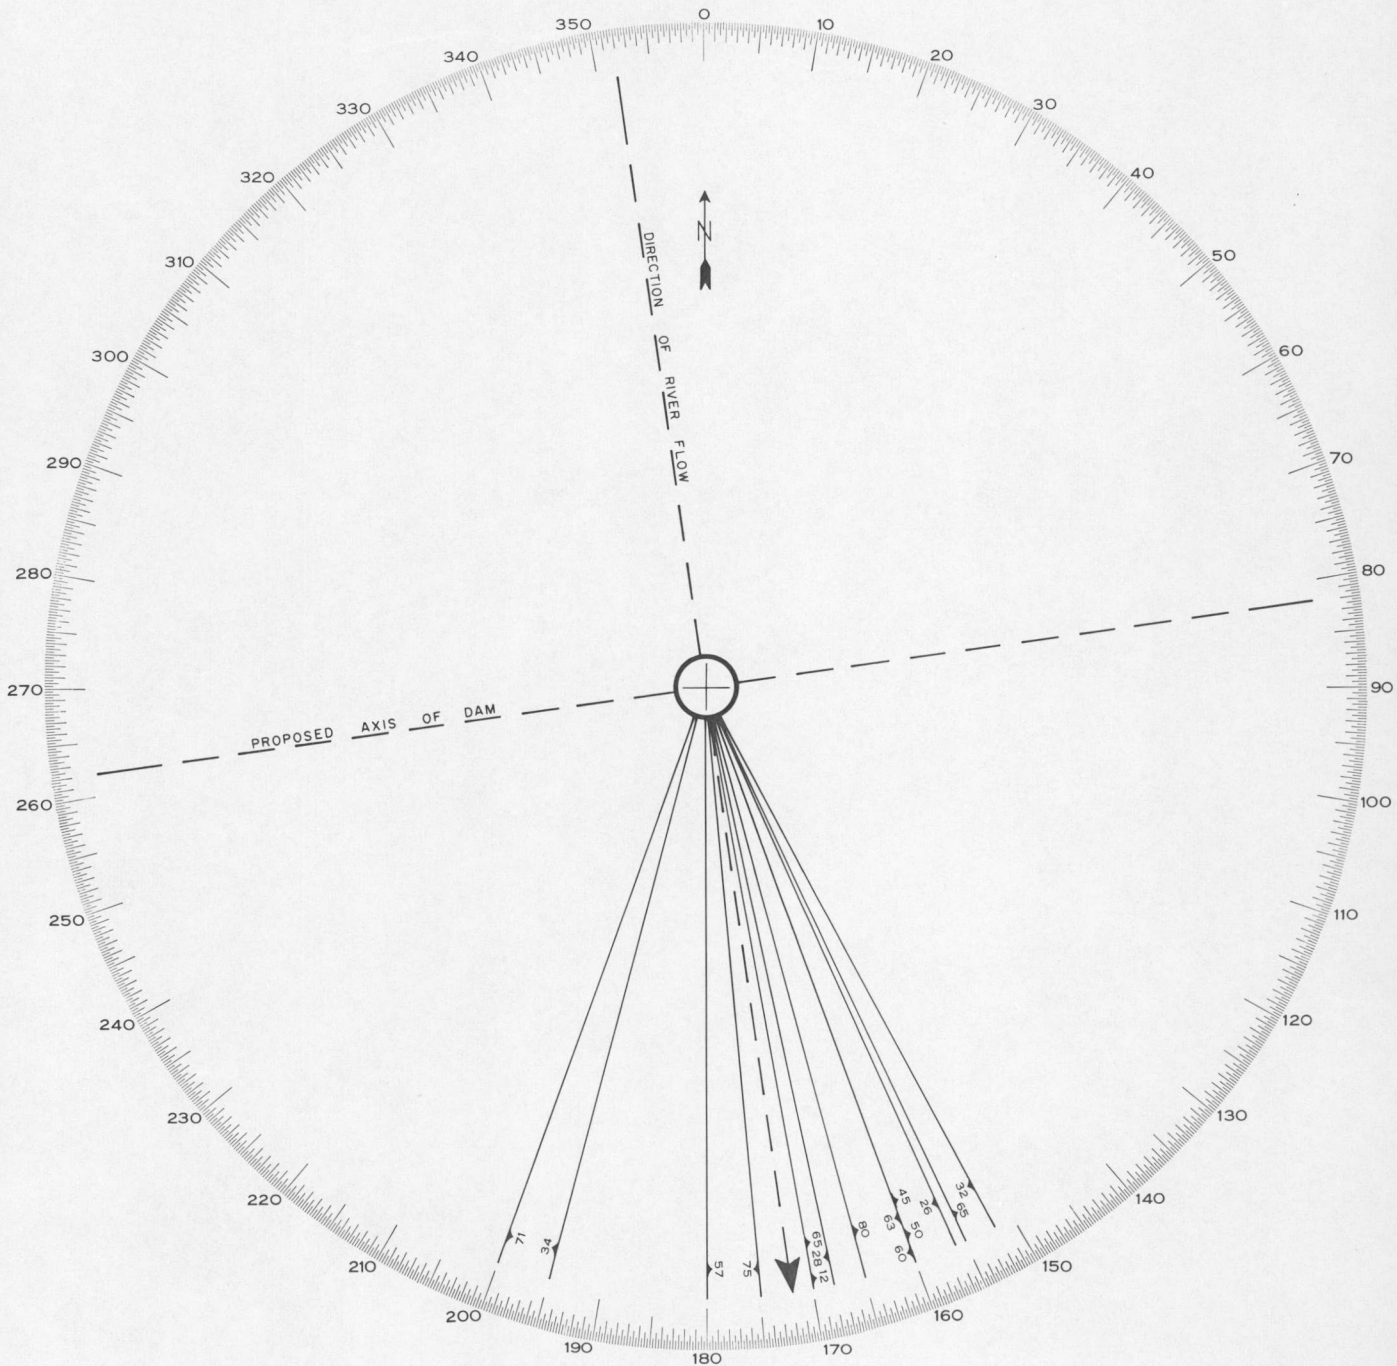
SHEAR ROSETTE

The above illustration presents diagrammatically the direction and dip of the shearing in bedrock exposed at Lower Canyon dam site, Frances River

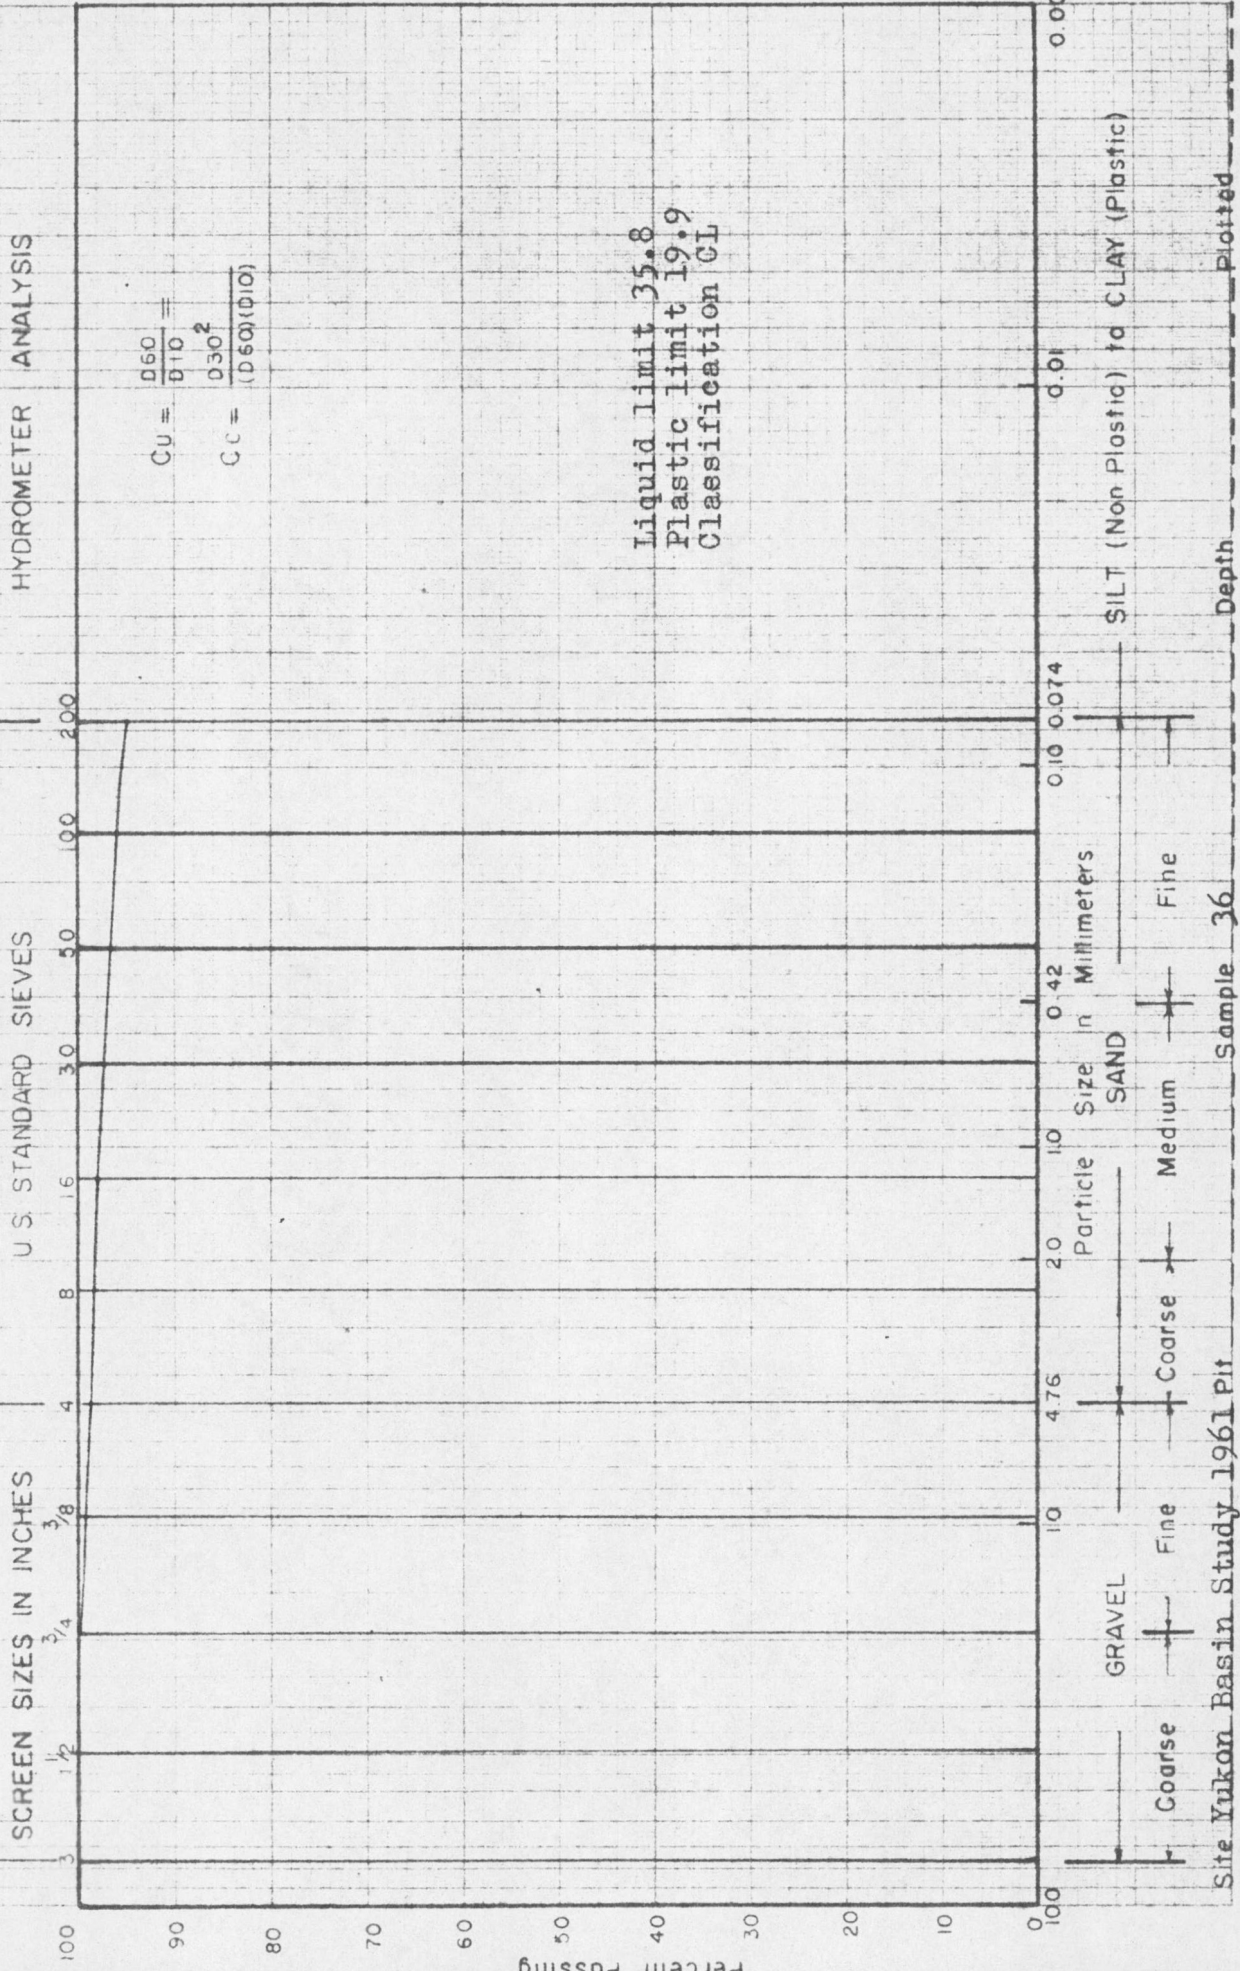
Sample 36

material. Grain size analyses curves for two representative samples of the till (Nos. 34 and 35) are included at the end of this report. Also included is a curve for an extremely dense, blue-grey, clay till (No. 36) encountered beneath the brown, sandy, clay till during excavation for the south approach to the new bridge over Frances River. The extent of the lower till is unknown. It was encountered along the road for a distance of about 900 feet commencing 100 feet south of the River.

Liquid limit 35.8
 Plastic limit 19.9
 Classification CL

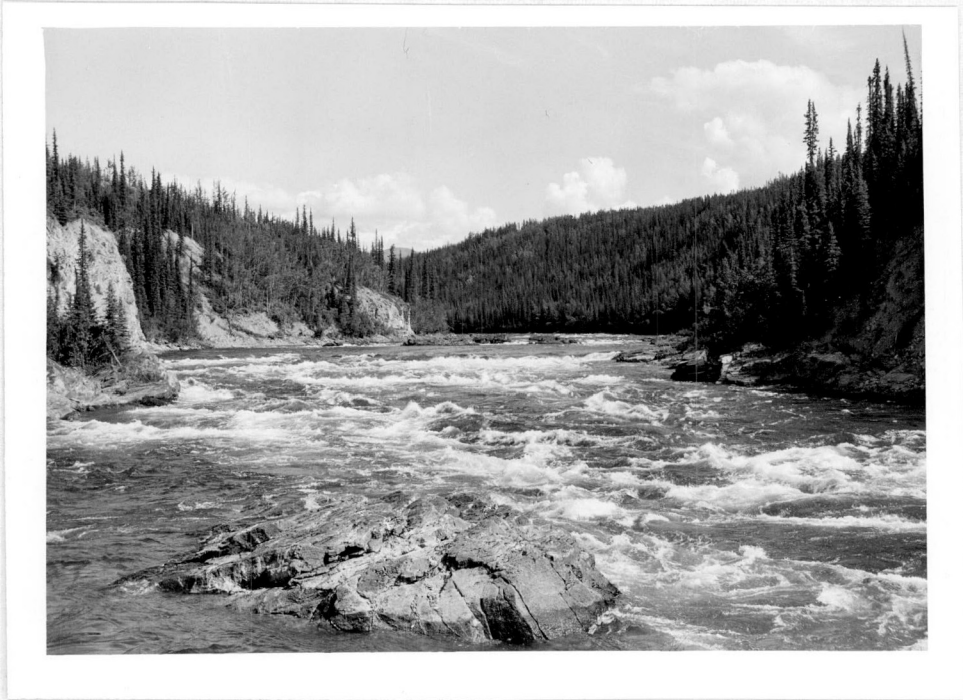
Plate 1

Lower Canyon looking upstream from right edge of River.
G.S.C. 5-3-61

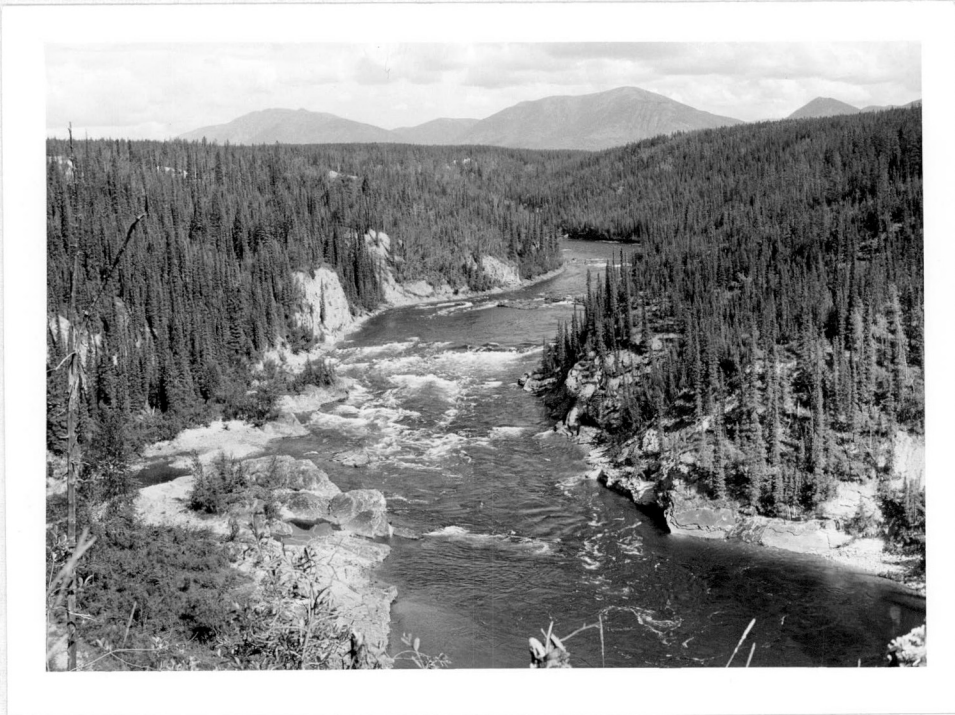
Plate 2

Lower Canyon looking upstream from top of bluff forming
right abutment.
