GEOLOGICAL SURVEY OF CANADA
TOPICAL REPORT NO. 42

MACKENZIE RIVER DRAINAGE BASIN
DAM SITE INVESTIGATION

LIARD CANYON (Upper) DAM SITE
(MAP AND PRELIMINARY REPORT)

BY
E. B. OWEN

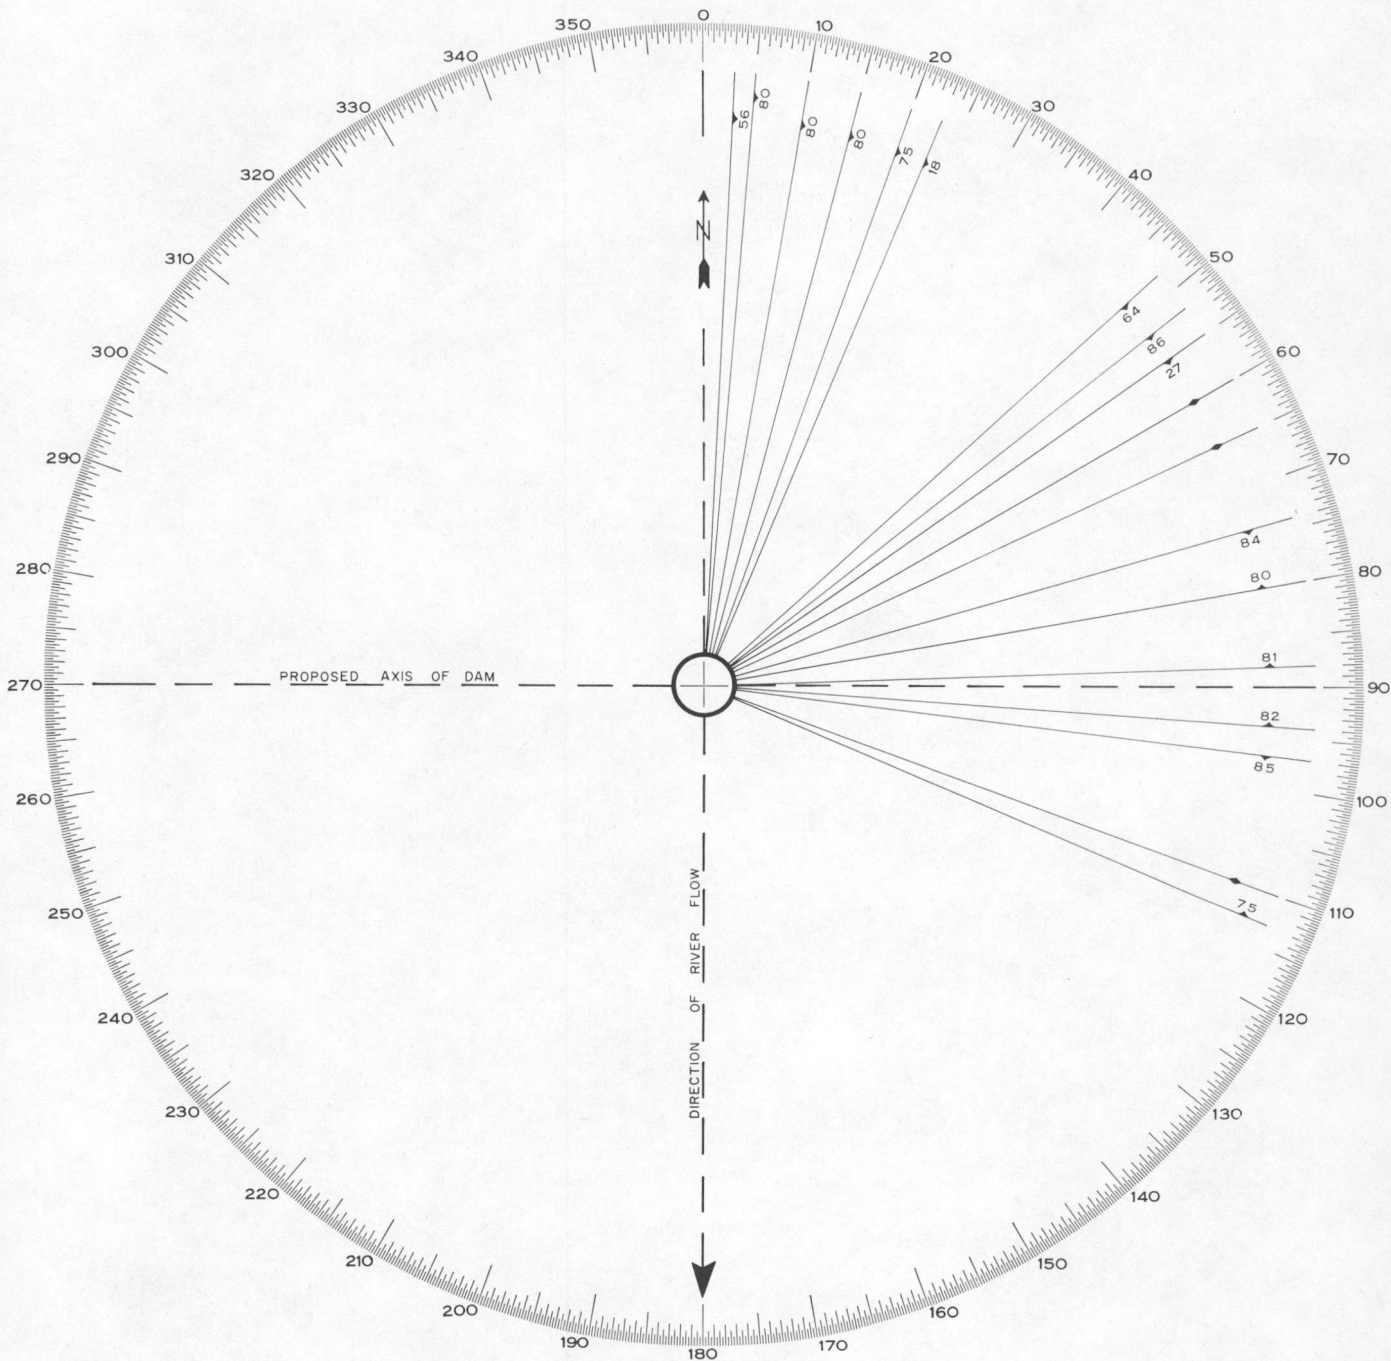
JOINT ROSETTE

There are 2 principal sets of joints at the site. Both sets have a considerable range of strike and dip. The most prominent intersects the river at angles between 2 and 42 degrees and the other between 67 and 88 degrees. The dips are relatively steep, ranging from 75 degrees to vertical. The spacing varies from a few inches to several feet. Most joints are tightly closed and do not act as aquifers. They will, however, influence the manner in which the rock will break during excavation.

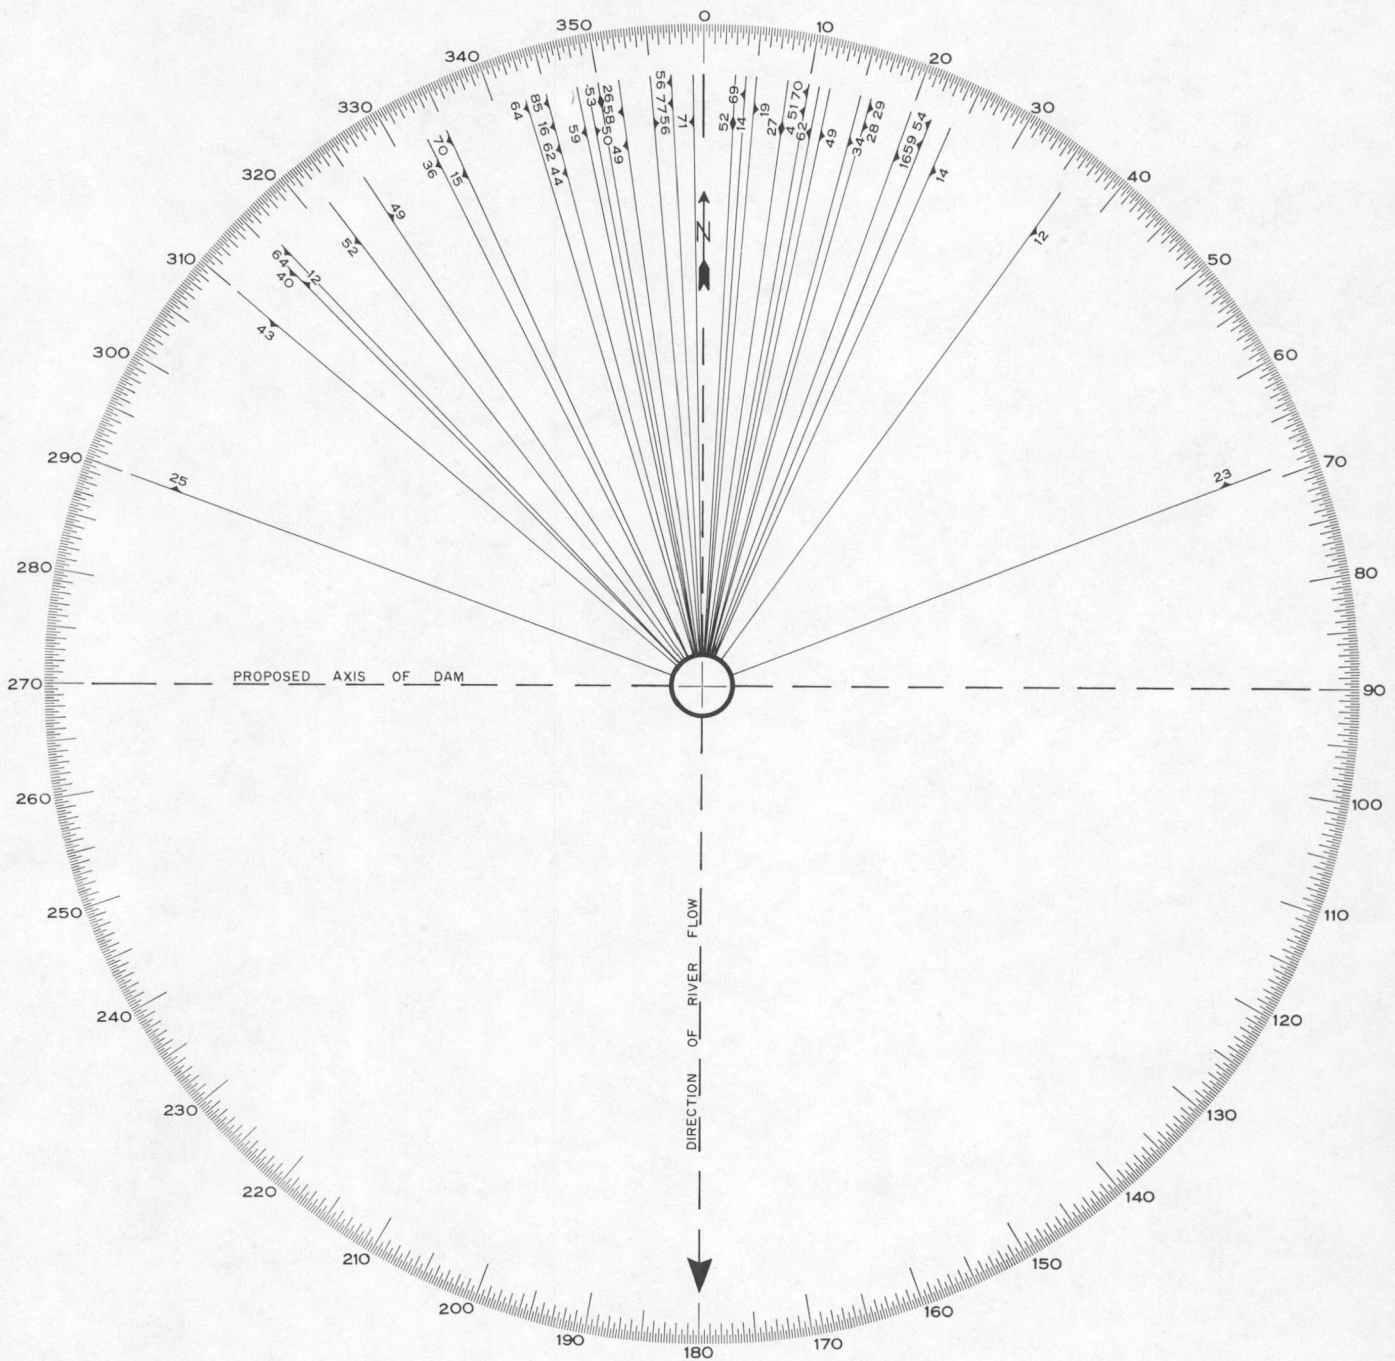
SHEAR ROSETTE

Minor faulting is common in the site area. Numerous bedding faults whose attitudes are parallel to the strike and dip of the bedding are exposed in both walls of the canyon. Bedrock adjacent to the faults is not badly fractured and there is little impervious, clayey gouge present. There are two consistent shear planes in bedrock exposed at the site. The more prominent shear dips steeply west toward the right abutment and the other has a more shallow dip east toward the left abutment. The strikes of the two shears are approximately parallel ranging from north 45 degrees west to north 24 degrees east. They intersect

the river at angles from zero to 50 degrees. Frequently the surfaces of the shear planes are smooth and slickensided. They are usually tightly closed so that water seepage is negligible.

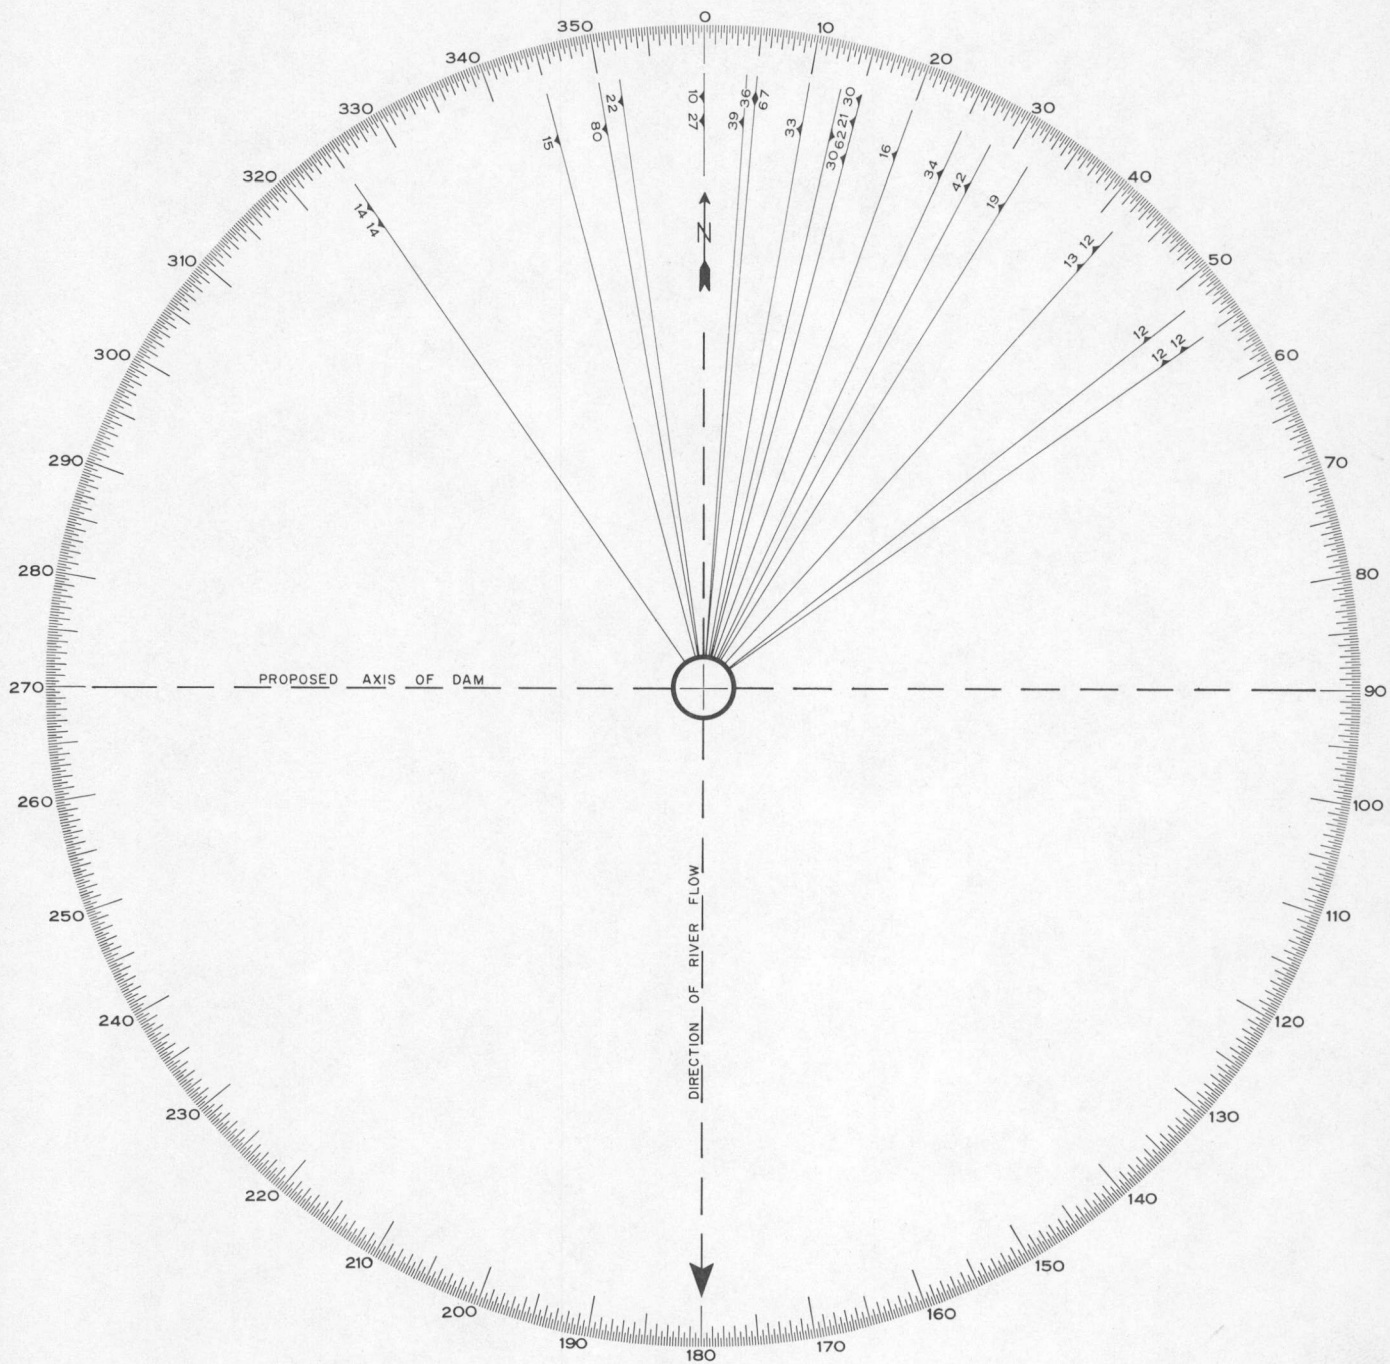
BEDDING ROSETTE

irregular. The trend is generally north-northeast. All the bedding attitudes taken at the site have been plotted on the accompanying bedding rosette. The bedding intersects the river at angles varying from zero to 55 degrees and generally dips at low angles upstream or toward the right abutment. Bedding exerts considerable control over the manner in which bedrock breaks. Many of the platy rock fragments in the talus have broken off along bedding planes. This characteristic of bedrock is important because it will influence the size and shape of the rock fragments produced by blasting and might cause the right abutment to be unstable when excavated.

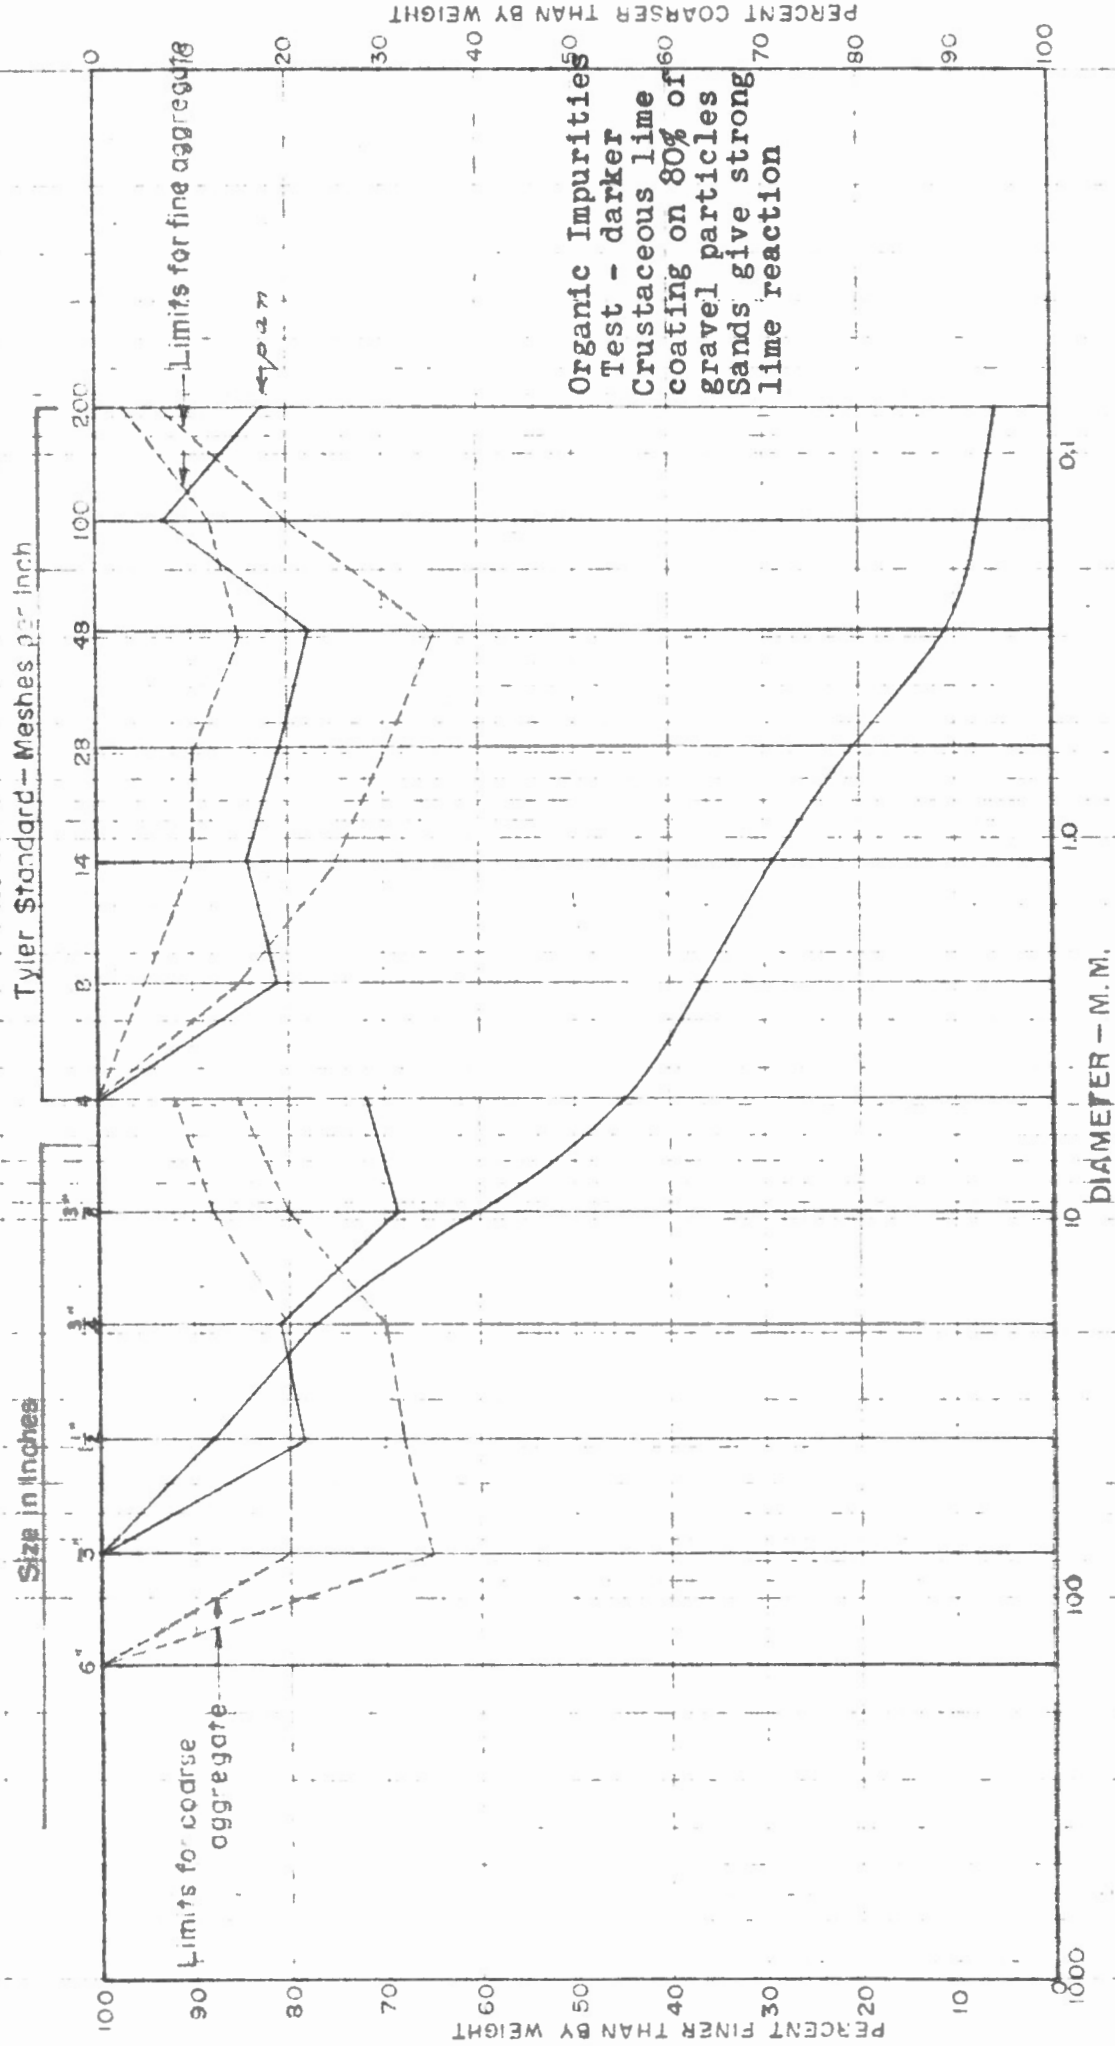
Site Upper Site, Hole No. 48
 Liard River
 Sample No. 48
 Depth
 Plotted Date

Organic Impurities⁵⁰
 Test - darker
 Crustaceous lime
 coating on 80% of
 gravel particles
 Sands give strong
 lime reaction

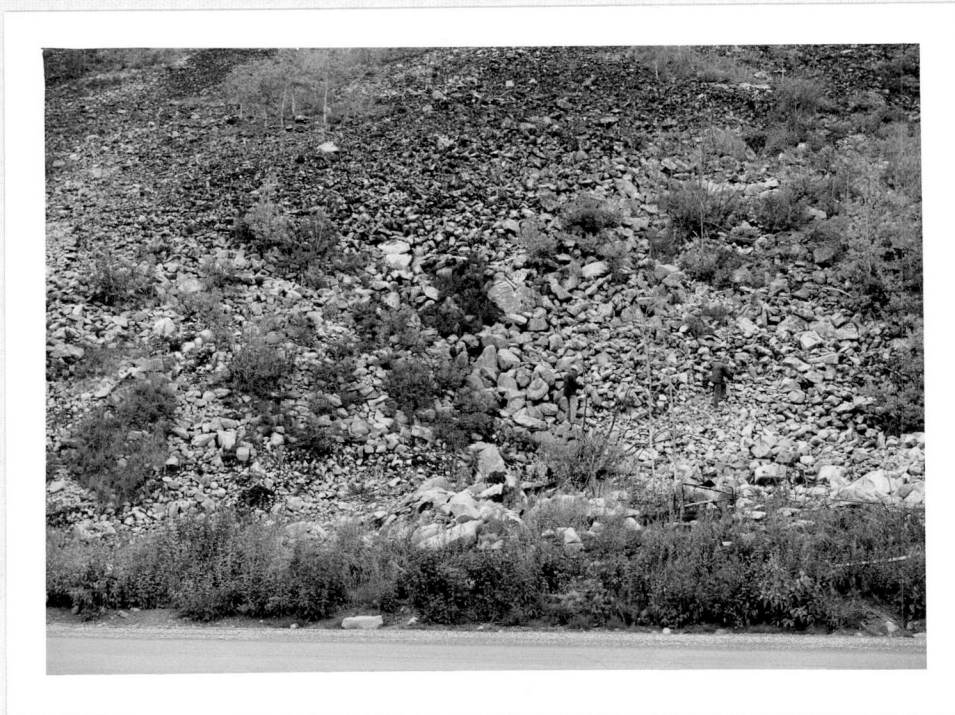
Plate 2

Bedrock exposed at the site will not provide suitable riprap or rock fill. The most accessible source of material from which satisfactory riprap could be obtained is the talus derived from granitic rocks exposed near Rancheria at mile 707.4, Alaska Highway. The rock fragments are roughly squared, durable and have a relatively high specific gravity. The major defects in using this material as riprap are the small size of the rock fragments and the long haulage distance along Alaska Highway to the site (about 80 miles). An extensive talus made up of fragments of porous, volcanic rocks occurs at mile 707.7, Alaska Highway. These rocks are less durable and have a lower specific gravity than the granite and consequently will provide less satisfactory

Potential riprap; talus
derived from granitic
rocks at mile 707.4,
Alaska Highway
G. S. C. 9-7-61

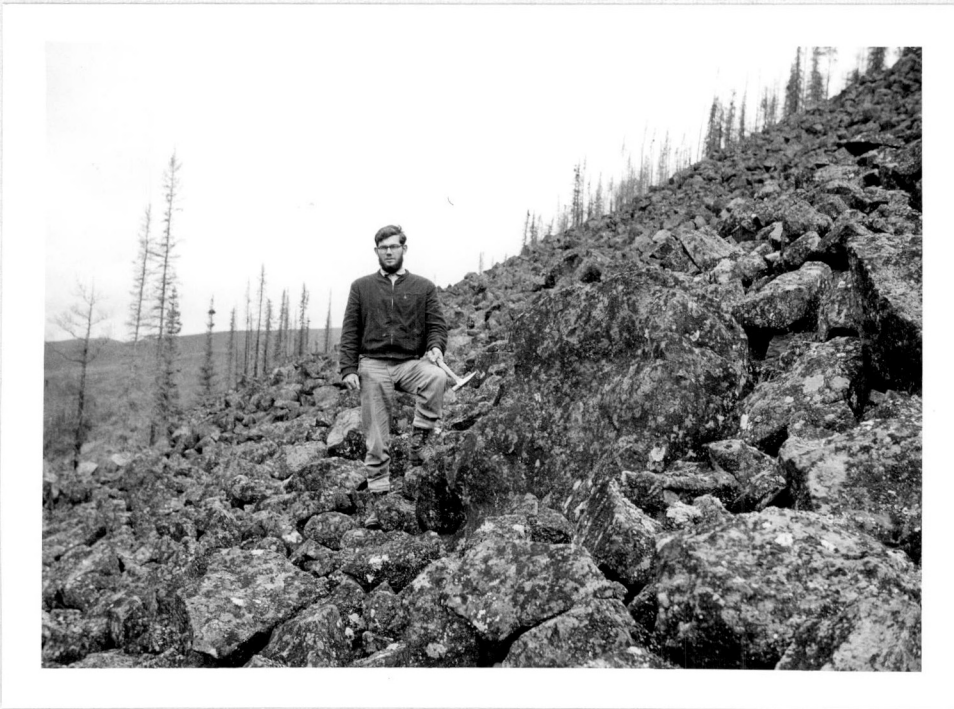
Plate 3

Potential riprap; talus
derived from volcanic
rocks at mile 707.7,
Alaska Highway
G. S. C. 9-8-61
