78  
GEOLOGICAL SURVEY OF CANADA  
TOPICAL REPORT NO. 78

MACKENZIE RIVER DRAINAGE BASIN  
DAM SITE INVESTIGATION

**BARRIER RIVER DAM SITE**

(MAP AND PRELIMINARY REPORT)

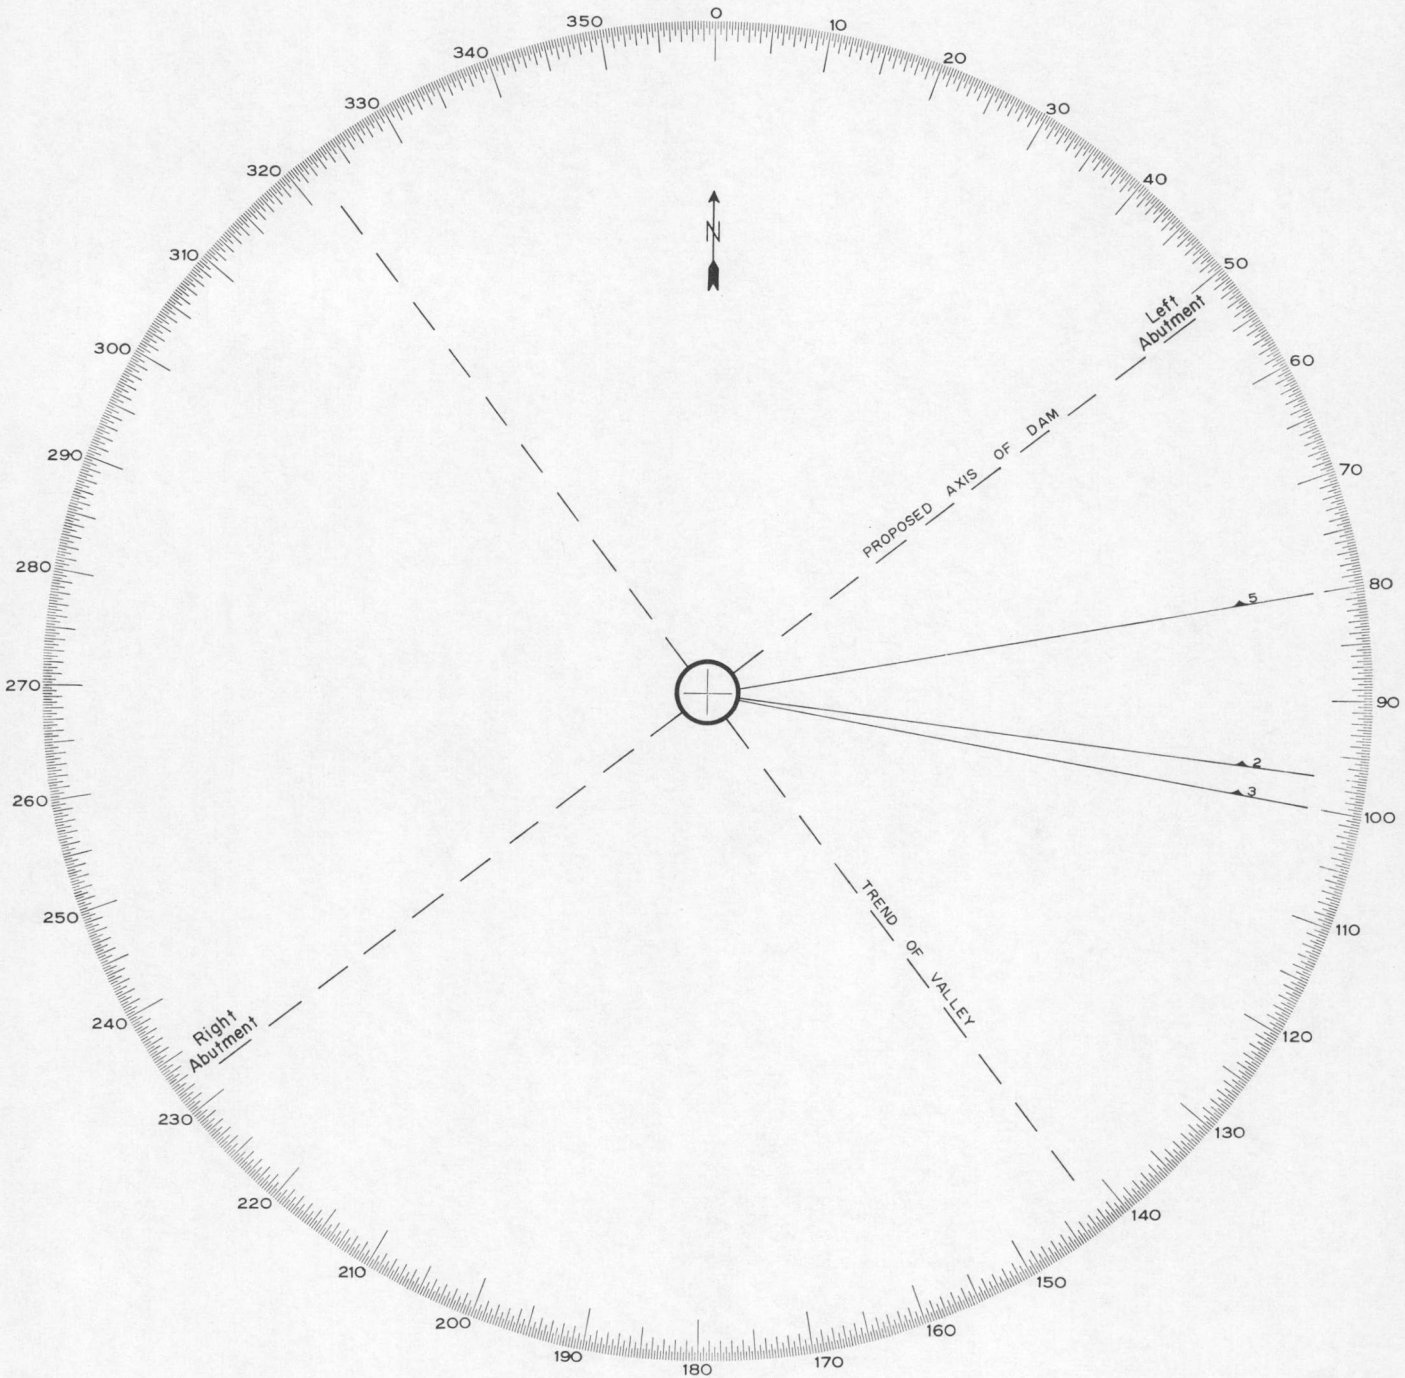
BEDDING ROSETTE

Bedding at the site is, in general, horizontal. However, there are minor, local undulations in the strata which have resulted in shallow upstream dips of 2 to 5 degrees. Here the bedding intersects

the proposed centre line at angles varying between 28 and 48 degrees.

The above illustration presents diagrammatically the direction and dip of bedding in bedrock exposed at Barrier site

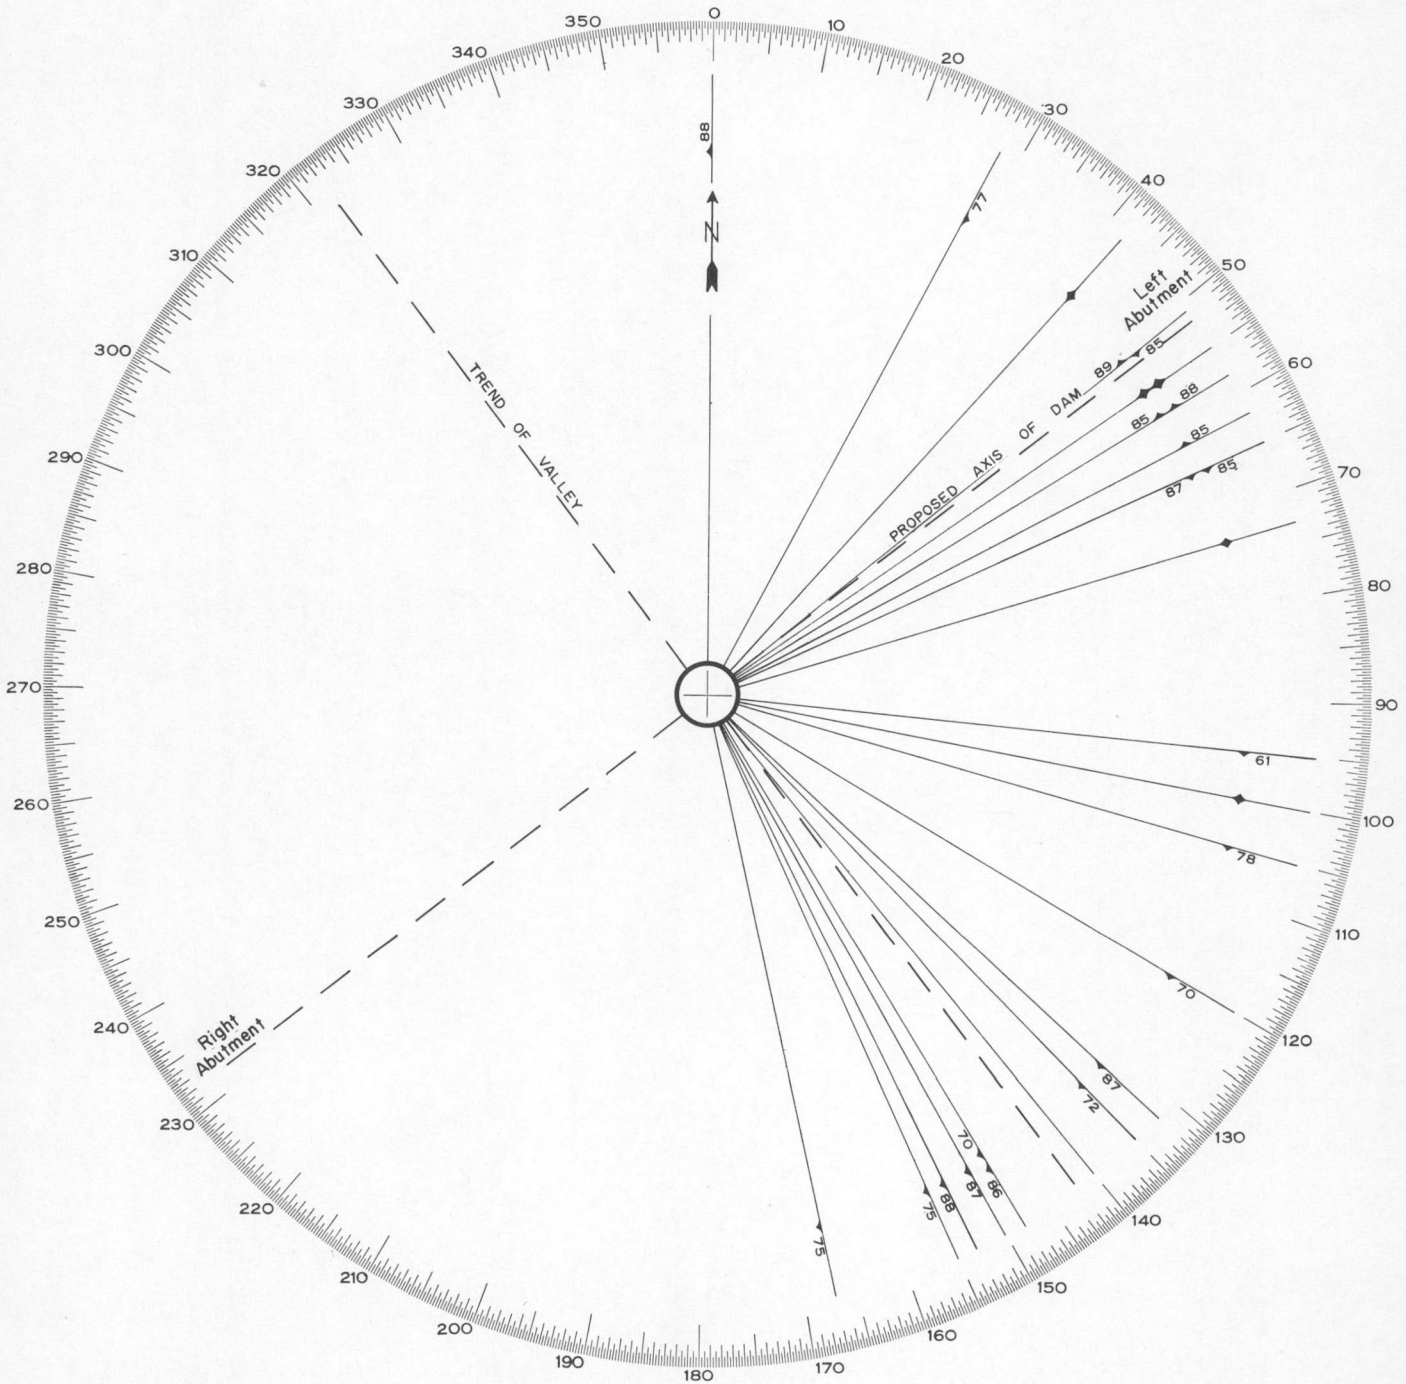
JOINT ROSETTE

There are 2 prominent joint sets in bedrock exposed at the site. One is close to vertical and intersects the proposed centre line at angles between zero and 20 degrees. The second set is almost at right angles to the first. It intersects the proposed centre line at angles between 70 and 90 degrees and dips steeply toward the right abutment. This set is parallel to the river and the other is approximately at right angles to it. As a consequence the faces of the strata exposed in the bluffs are frequently vertical and parallel to the river. A second result of these two intersecting joint sets is that many of the rock fragments in the talus are roughly squared and flat faced. Faulting was not observed at the site.

The above illustration presents diagrammatically the direction and dip of jointing in bedrock exposed at Barrier site

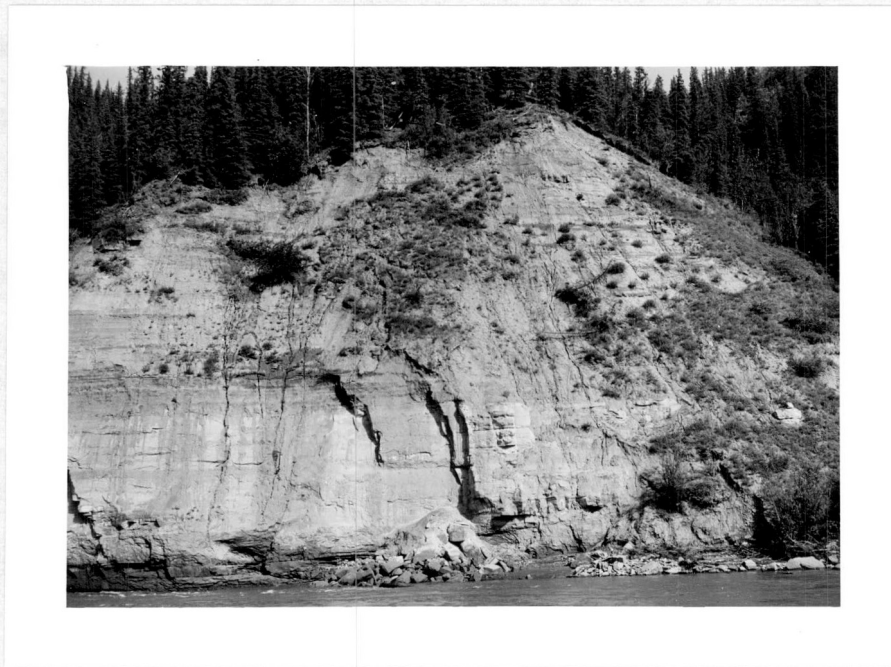
Plate 1

The thick sandstone beds visible in the left abutment constitute the most competent rock exposed at the site. If similar beds exist beneath the river they would probably provide satisfactory foundation material. These beds form about 20 per cent of bedrock exposed at the site. The remainder consist of thin beds of shale, sandstone and siltstone. The presence of these narrow interbeds would adversely effect the properties of the more massive rock and would decrease the ability of bedrock in the abutments to withstand the thrust of an arch dam. Bedrock at Barrier site is similar to that exposed at Longstick and Delta sites further downstream. The results of several laboratory tests made on samples of these rocks are included in the report on Delta site.

Steep, rocky bluff forming left abutment,  
Barrier River dam site.

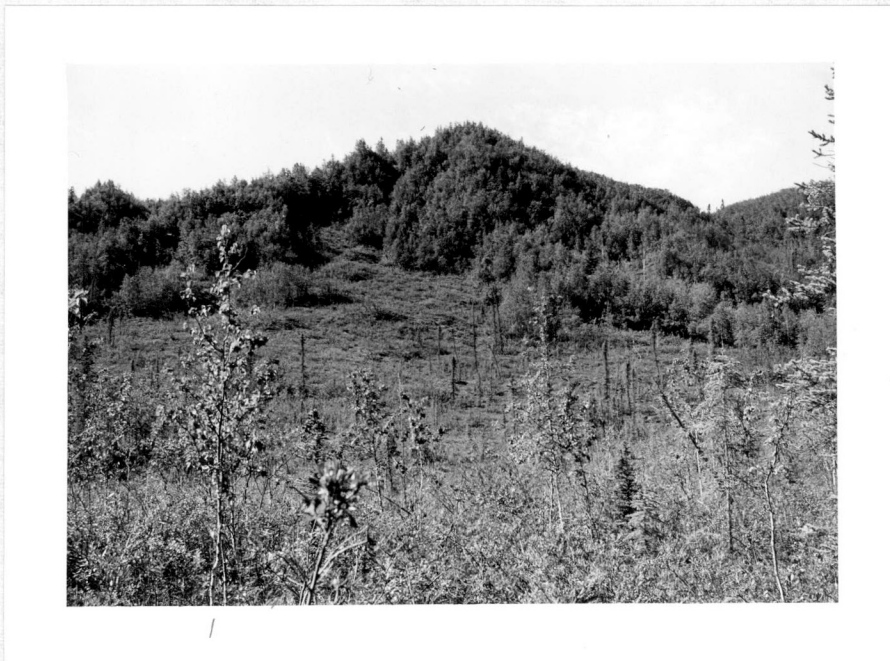
Plate 2

Vegetation-covered right abutment,  
Barrier River dam site.
