GEOLOGICAL SURVEY OF CANADA  
TOPICAL REPORT NO. 86

86  
YUKON RIVER DRAINAGE BASIN  
DAM SITE INVESTIGATION

SITES Nos. 34 AND 35

UPPER AND LOWER PORCUPINE CANYON DAM SITES  
(MAPS AND PRELIMINARY REPORT)

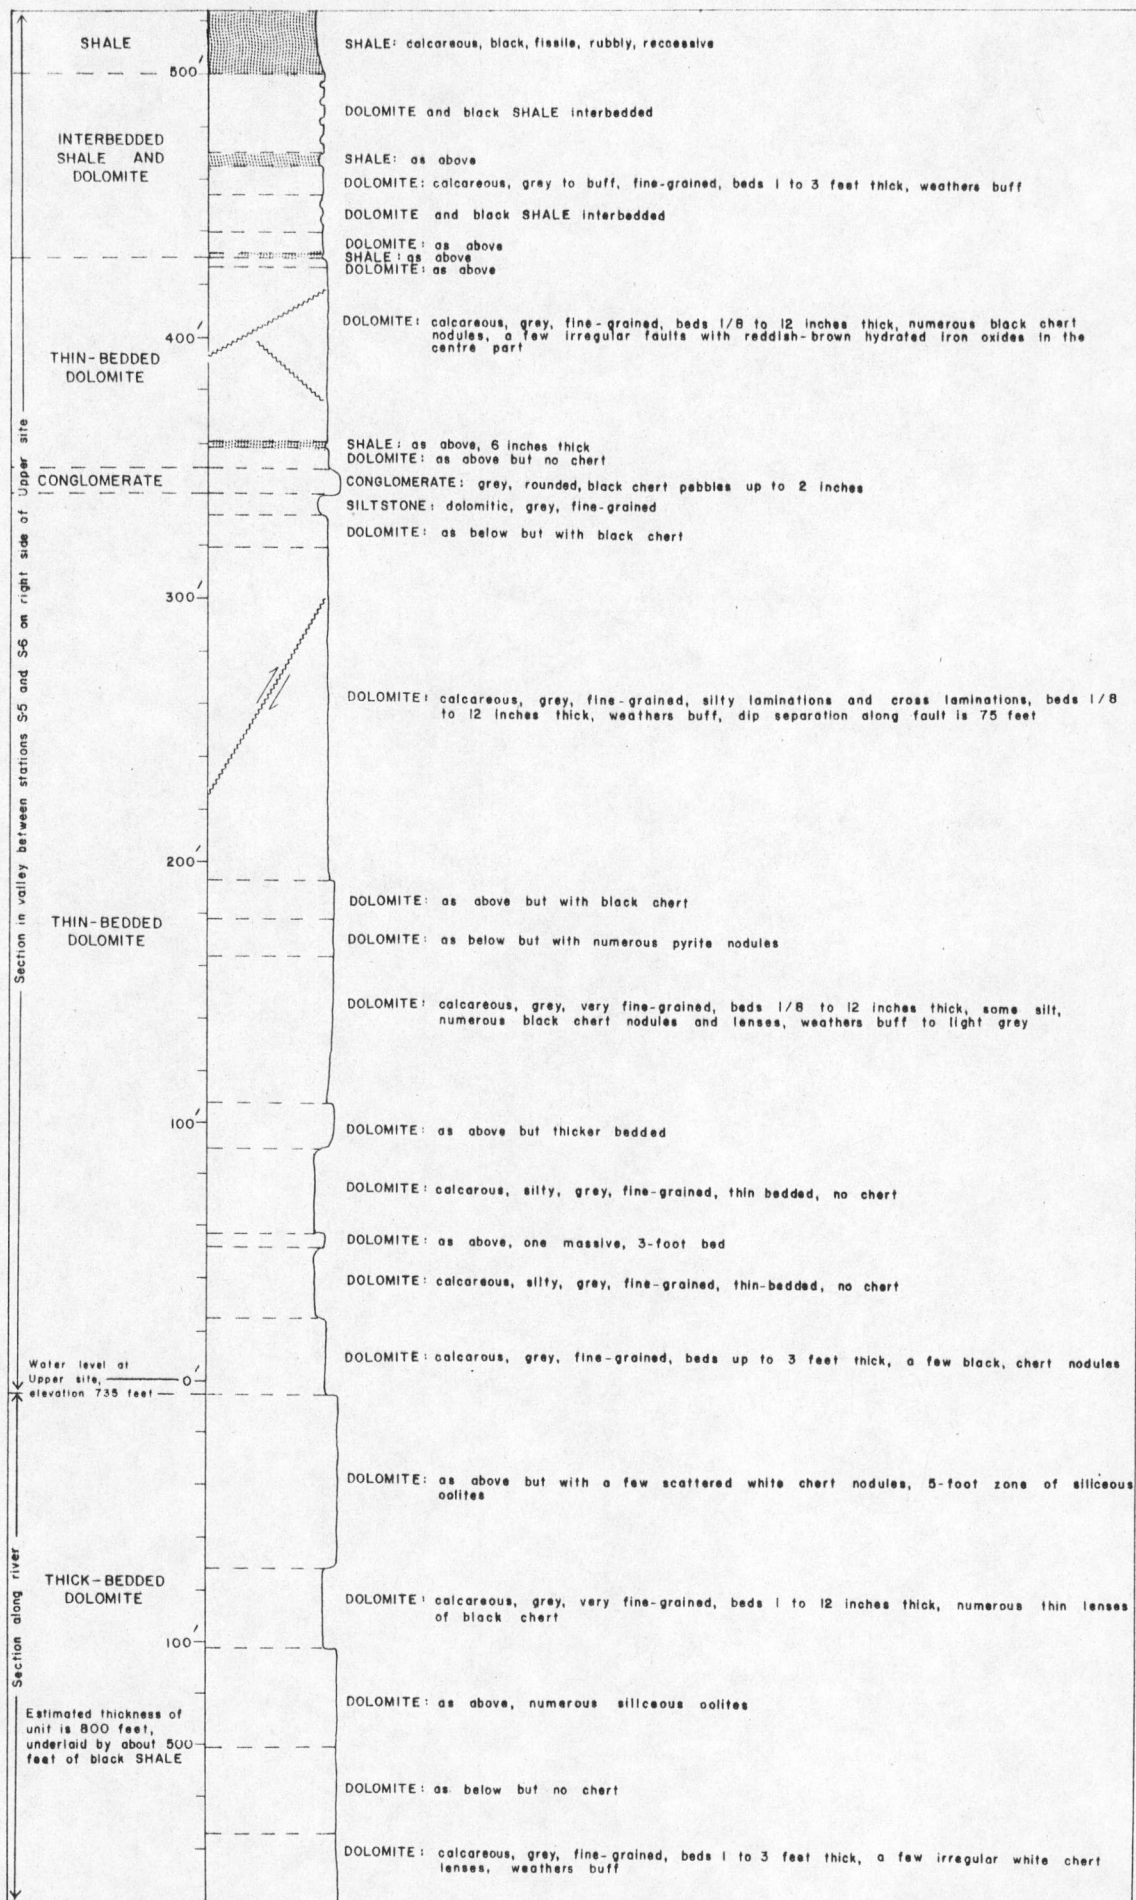
Section of bedrock exposed along right hand side of Porcupine River in the vicinity of Upper Porcupine Canyon site

at angles between 10 and 60 degrees occur at the Upper site. One of these faults, indicated on the bedrock section which accompanies this report, is a reverse or thrust fault which has a dip separation of about 75 feet. Many of the other faults are also believed to be thrust faults. It was not possible, however, to determine the amount of displacement along them. The zones of broken rock associated with these faults are as much as 100 feet in width. Some of the small, narrow, steep-walled valleys in the walls of the canyon, which are frequently filled with talus, resulted from the removal of this shattered rock. One such valley occurs below station S-15 in the Upper site. The gouge in these faults varies considerably in thickness but is nearly always present. It consists chiefly of sandy clay often containing small angular fragments of the adjacent wall rock. The gouge is believed to be relatively impermeable but the permeability of the adjoining shattered rock mass is probably high. Many of the rock fragments in the fault zones are covered with a brown coating of iron-bearing carbonates and oxides which may have been deposited by circulating groundwater.

The thickness of the thick-bedded dolomite unit is about 800 feet. As indicated on the accompanying bedrock section it underlies a thin-bedded unit which contains narrow interbeds of shale along with minor amounts of siltstone and conglomerate. The rocks in the thin-bedded unit are not as competent as those in the underlying thick-bedded unit and should be avoided as much as possible. The presence of shale interbeds along which, in many instances, movement has taken place suggests the degree of stability of the rocks in the thin-bedded unit is low.

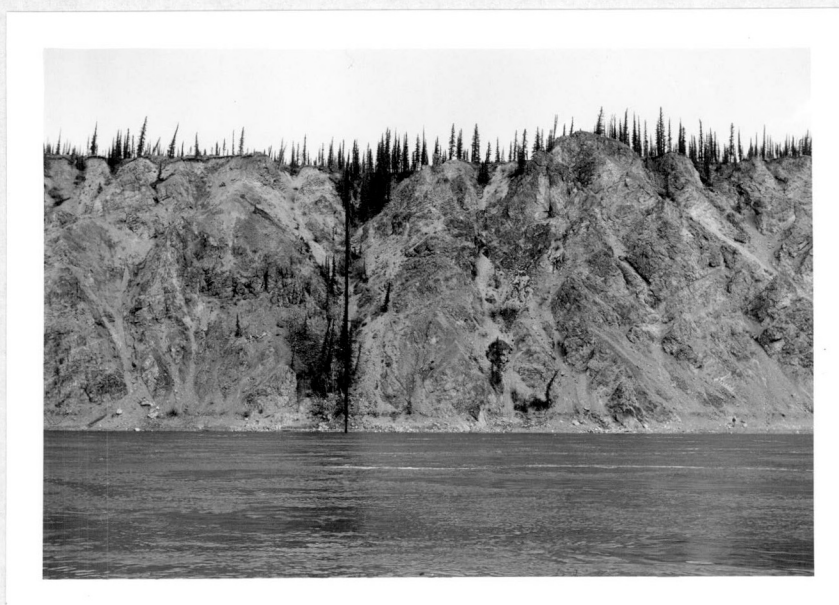
Plate 1

Right abutment of Upper site indicating proposed location of centre line; bed-rock is thick-bedded, calcareous dolomite; strata intersect river at 30 degrees and dip at about 60 degrees into the abutment; height of bluff is about 260 feet.

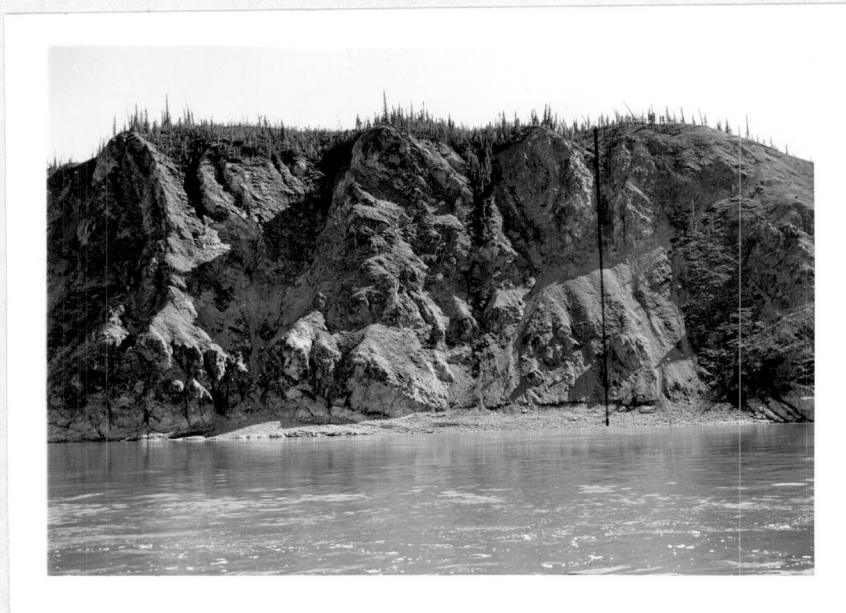
Plate 2

Left abutment of Upper site indicating proposed location of centre line; bed-rock is thick-bedded, calcareous dolomite as in right abutment; strata dip toward river; height of bluff is about 260 feet.

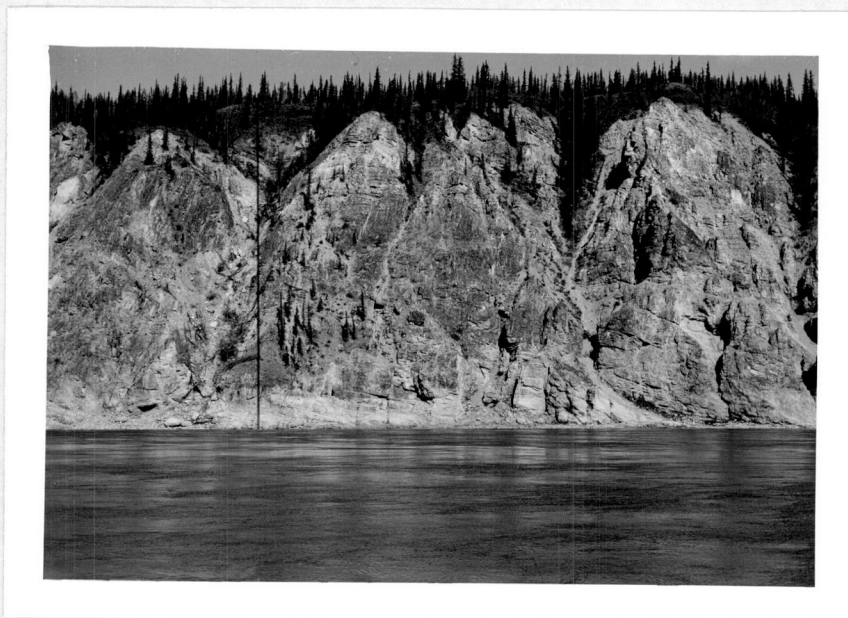
(Plate 3

Right abutment of Lower site indicating proposed location of centre line; bed-rock is thick-bedded, calcareous dolomite; strata intersect river at 45 degrees and dip into abutment at 23 degrees; height of bluff is about 270 feet.

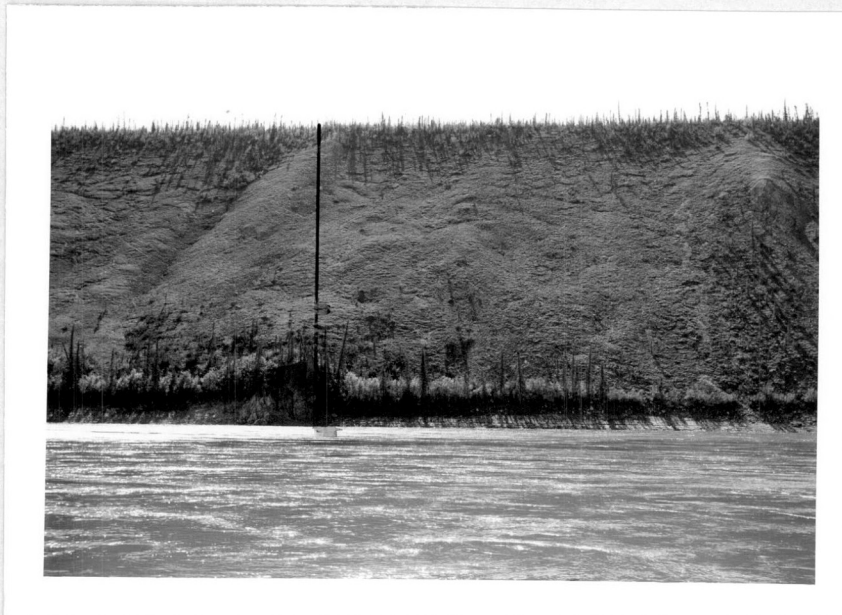
Plate 4

Left abutment of Lower site indicating proposed location of centre line; material on slope consists of a thin cover of talus overlying thick-bedded calcareous dolomite; height from river to level plateau above slope is about 350 feet.
