GEOLOGICAL SURVEY OF CANADA  
TOPICAL REPORT NO. 99

YUKON RIVER DRAINAGE BASIN  
DAM SITE INVESTIGATION

SITE No. 25

**PORCUPINE DAM SITE**  
(MAP AND PRELIMINARY REPORT)

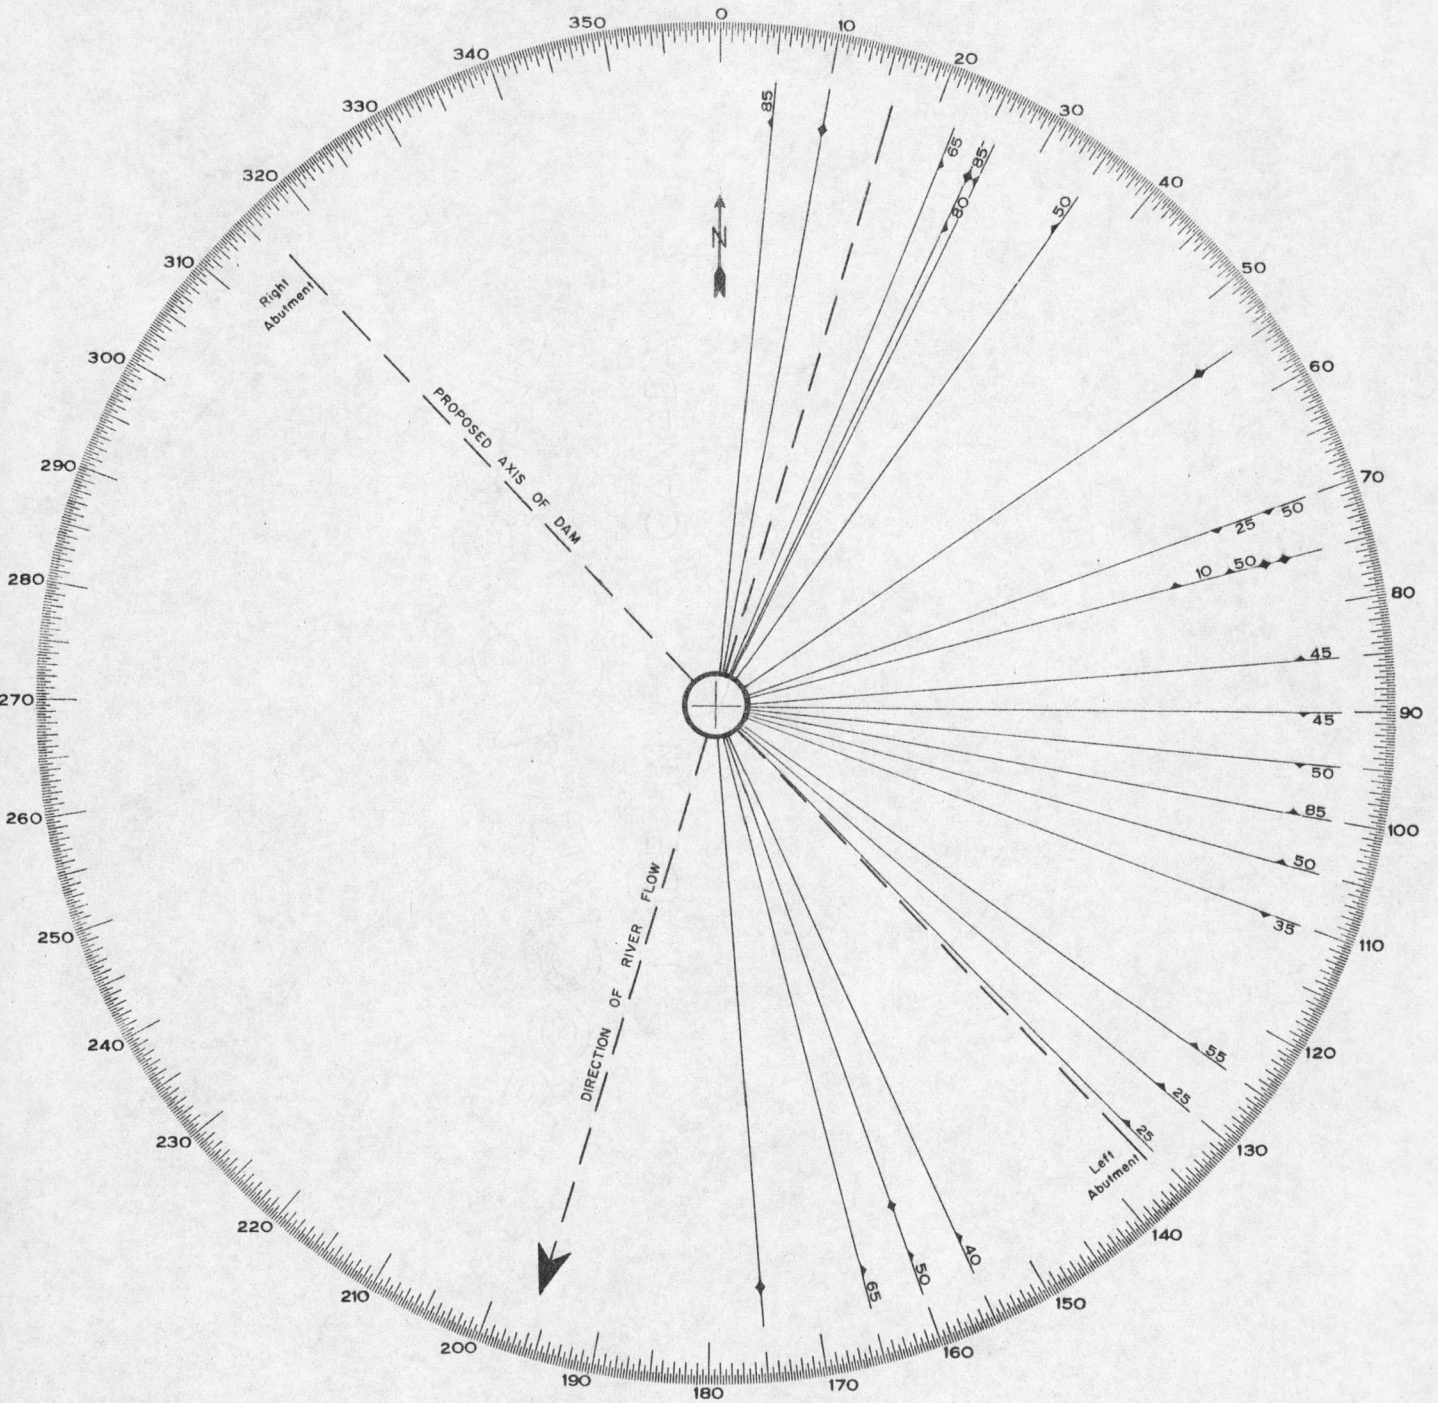
JOINT ROSETTE

The above illustration presents diagrammatically the direction and dip of jointing in bedrock exposed at Porcupine site

Jointing is common throughout bedrock. From the accompanying rosette it is apparent these structures are exceptionally irregular and that there are no prominent ~~sites~~<sup>sets</sup> present. The spacing of the jointing is close varying from an inch to about 2 feet. On bedrock surface the joint fractures range up to 3 inches in width and can be traced for distances up to 50 feet. The presence of these fractures has greatly increased the amount of weathering. The effect of the gneissosity will be mainly to influence the manner in which the rock will break when blasted. The gneiss consists of dark grey bands in which biotite mica predominates alternated with light grey material consisting almost entirely of quartz. Most fracturing occurs in the darker micaceous rock.

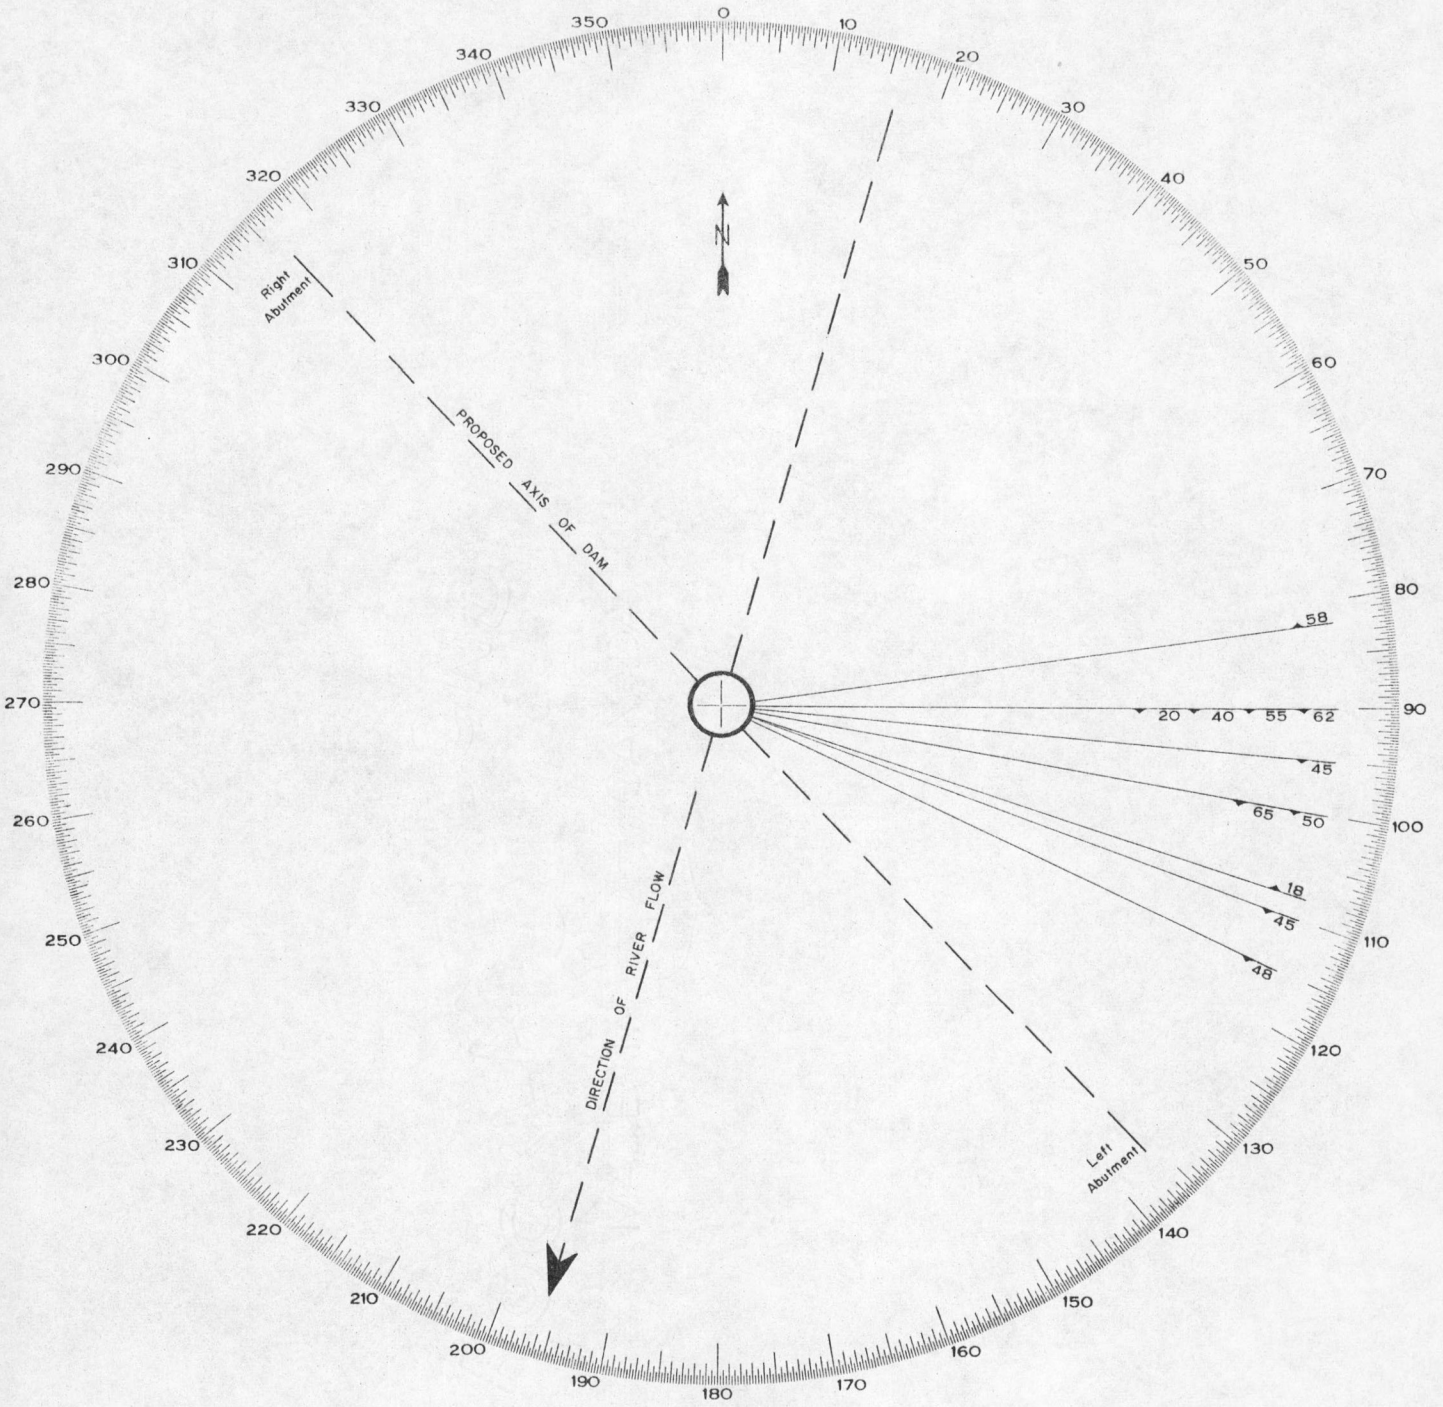
### GNEISSOSITY ROSETTE

The above illustration presents diagrammatically the direction and dip of gneissosity in bedrock exposed at Porcupine site

be necessary to consolidate bedrock in both the abutments and foundations beneath the dam. In general the dip of the gneissosity is downstream or into the left abutment. There is little danger of downstream sliding of the dam along the gneissosity but because of the tendency of the rock to break along the more micaceous bands some difficulty due to overhang may be experienced in excavating bedrock in the left abutment.

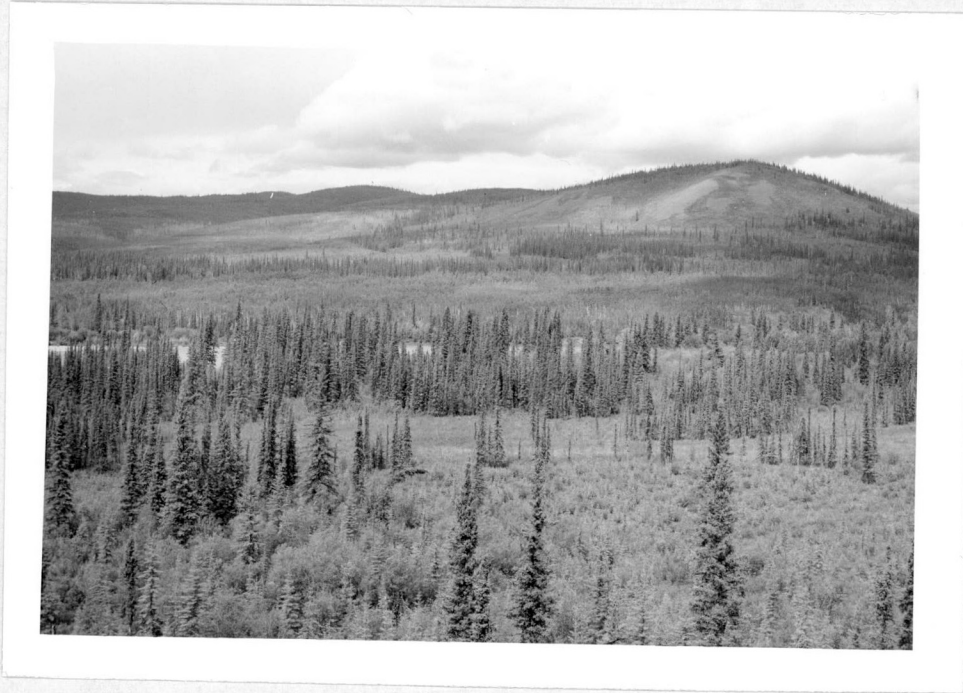
Plate 1

View along proposed centre line of Porcupine dam  
site from left abutment toward right abutment.

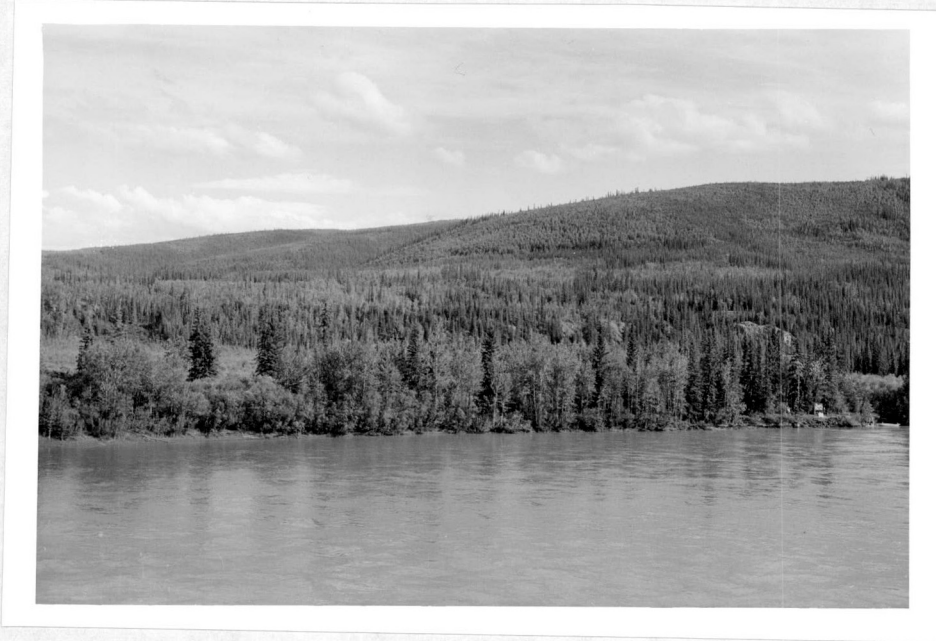
Plate 2

View along proposed centre line of Porcupine dam site from right abutment toward left abutment.
