SMALL PUBLIC WATER SYSTEMS ASSESSMENT
WESTERN REGION

BEAVER CREEK FIRE HALL
BUILDING # 3102
SITE LOCATION DIAGRAM
WELL ID: 3102

SMALL PUBLIC WATER SYSTEM ASSESSMENT

PART A: EBA Site Inspection

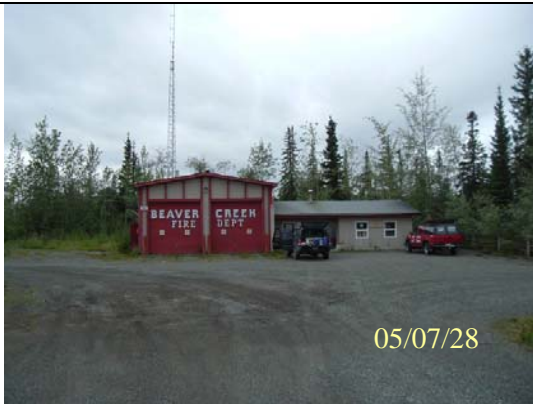
Photo 0574: 3102 Beaver Creek Fire Hall looking west

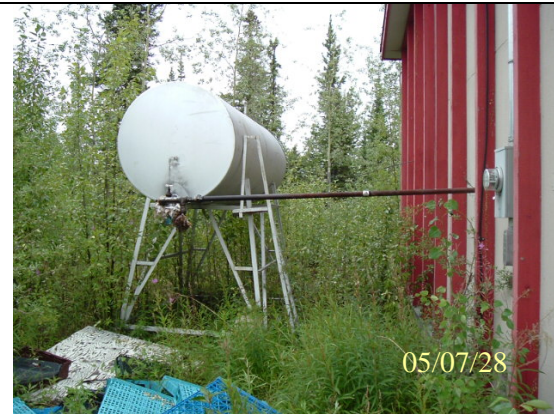
Potential Source 1: AST; Distance from well to Potential Source 1: ~3.5m

Photo 0575: 3102 Above ground fuel storage tank behind firehall

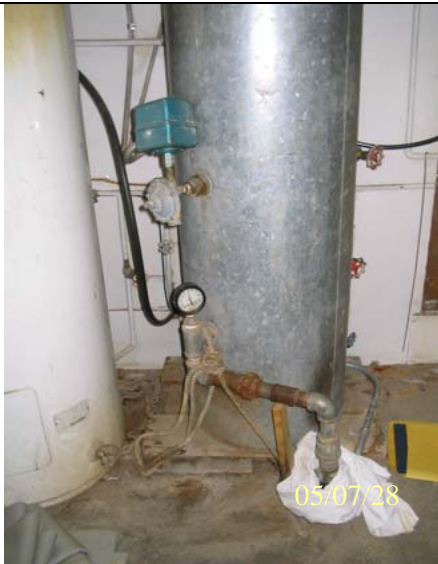
No cap ~ 4cm above grade

- i. Is the well head below grade? describe in detail ~40 mm above grade
- ii. Are there signs of ponding on the enclosure(e.g. water stains, etc.)? ☐ Yes ☒ No
- iii. Is the wellhead enclosed by fiberglass insulations? ☐ Yes ☒ No
- iv. Any evidence of rodents? Specify Access possible
- v. Does the well casing have a proper seal cap? ☐ Yes ☒ No
- If no, describe condition Cloth forced in casing

THIS INSTALLATION DOES NOT MEET CODE.

NO SANITARY WELL SEAL

CASING CUT AT GROUND LEVEL.

Photo 0104: 3102 Wellhead (bottom), pressure tank (top). Note well casing is covered with a piece of cloth

SHOCK CHLORINATE WELL & WATER SYSTEM
INCLUDING ALL TANKS. INSTALL PUMP
SYSTEM TO CODE.

INSTALL PROPORTIONAL CHLORINATOR TO FEED
ALL SOURCES.

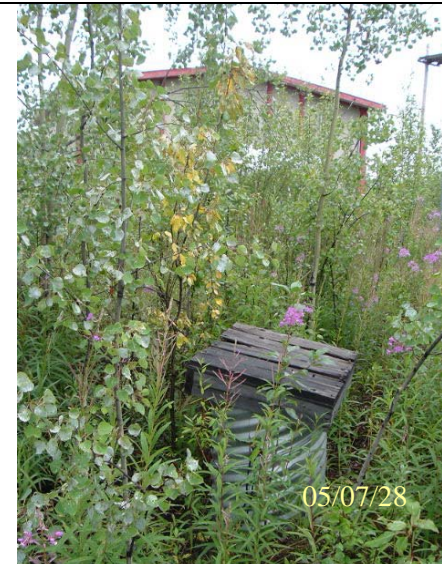
j. Distance from well to nearest point of known field: Septic tank or leach pit @ 16m

Photo 0576: 3102 Looking east at septic tank or leach pit (front), fire hall (rear)

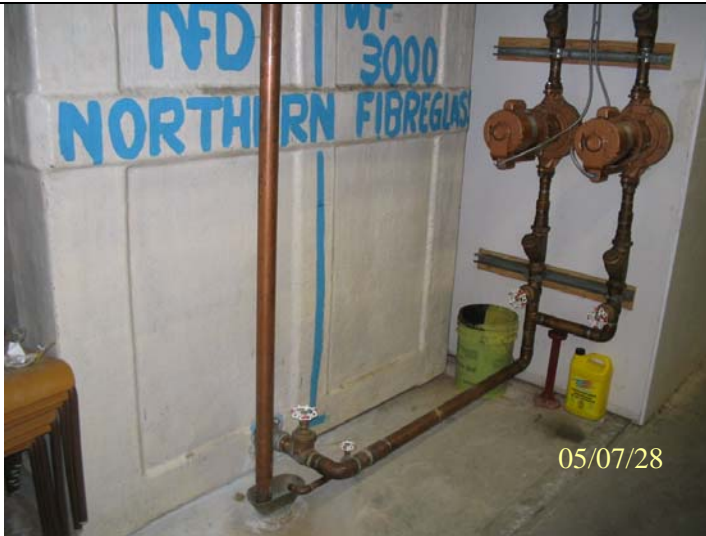
**Photo 0106:** 3102 Water storage tank

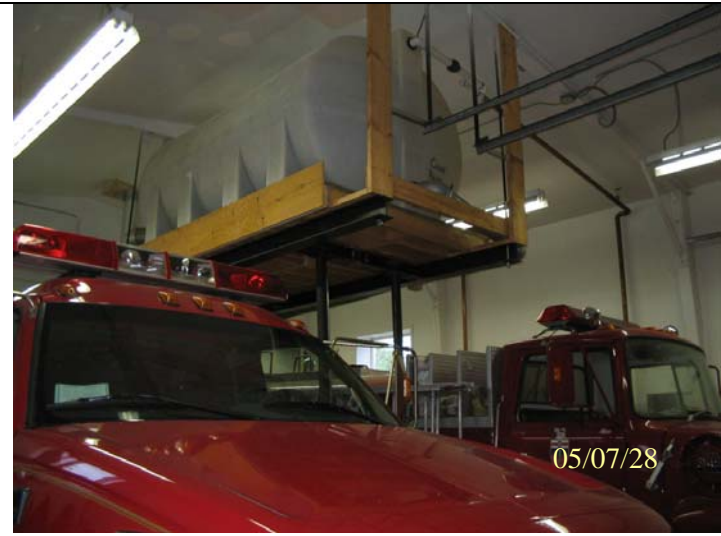
**Photo 0111:** 3102 Elevated water storage tank
