| SMALL PUBLIC WATER SYSTEMS ASSESSMENT WESTERN REGION | GOVERNMENT OF YUKON HIGHWAYS & PUBLIC WORKS |
| BEAVER CREEK VISITOR RECEPTION CENTRE BUILDING # 3121 SITE LOCATION DIAGRAM WELL ID: 3121 | REVISION ISSUE 0 |

SMALL PUBLIC WATER SYSTEM ASSESSMENT

PART A: EBA Site Inspection

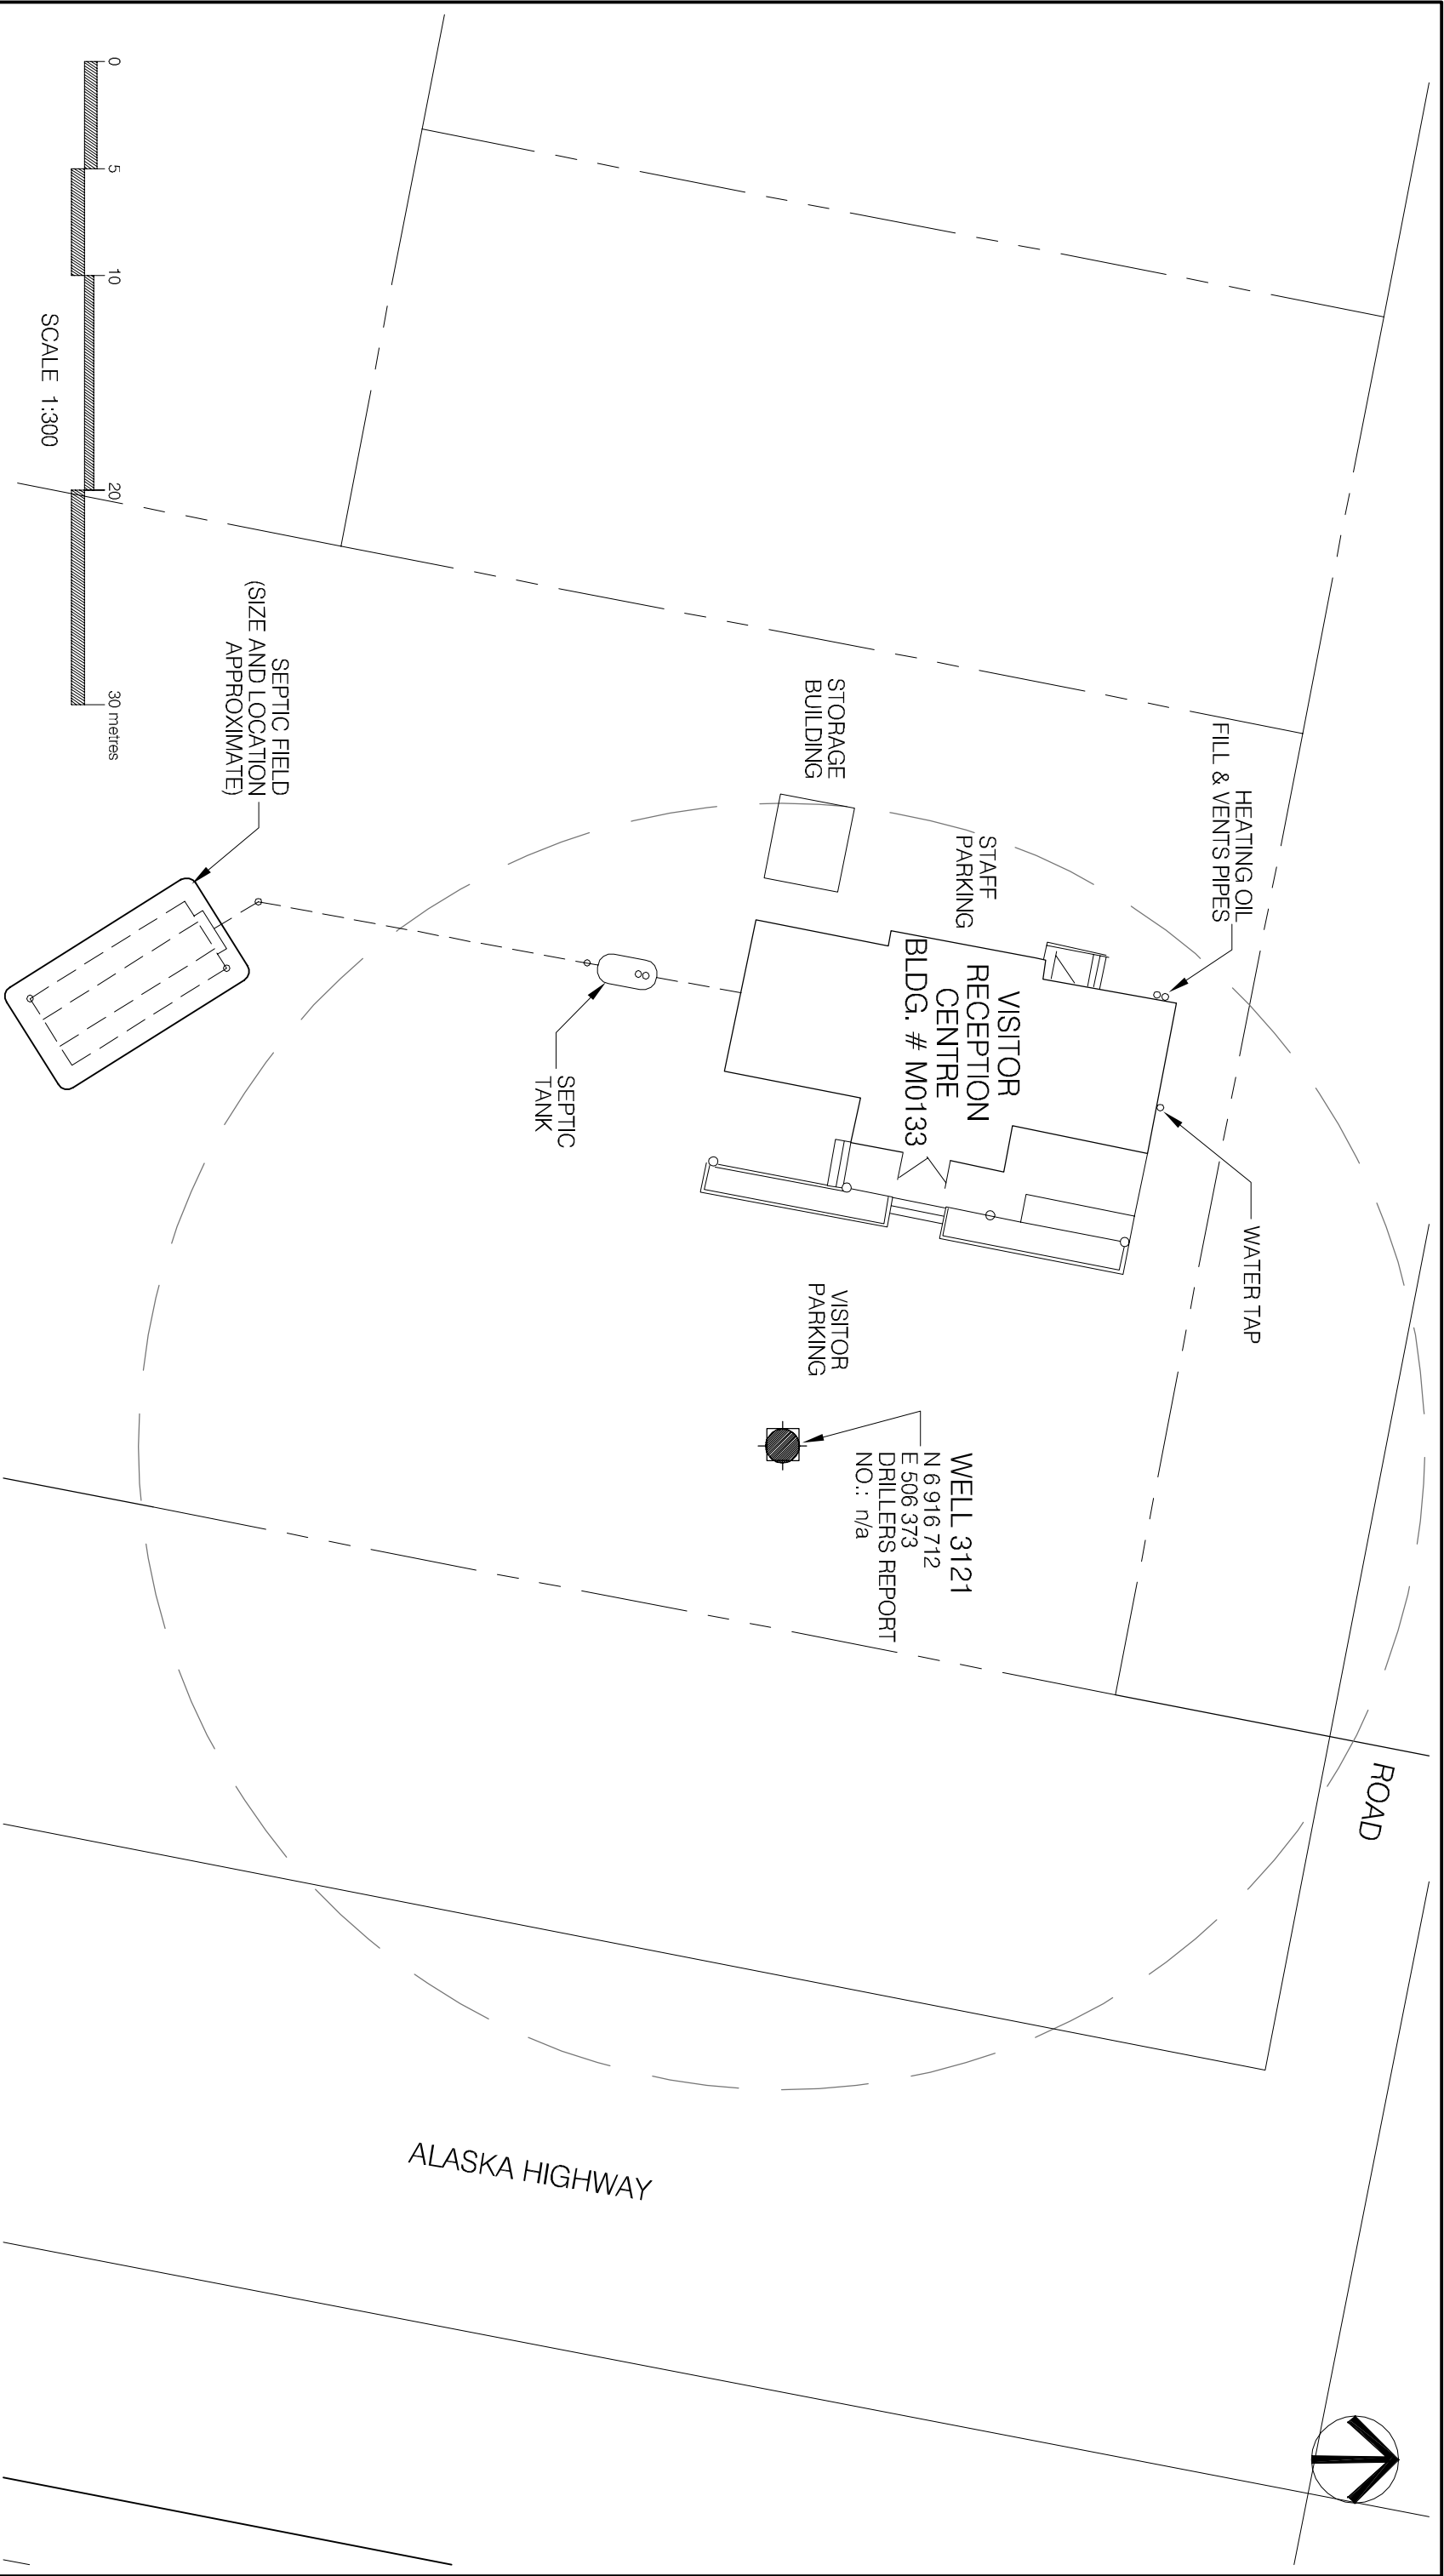
| FIGURE No. FIGURE 3121-A | |

30 m RADIUS FROM WATER WELL FOR CONSIDERATION OF PROXIMITY TO POTENTIAL CONTAMINANT SOURCES.

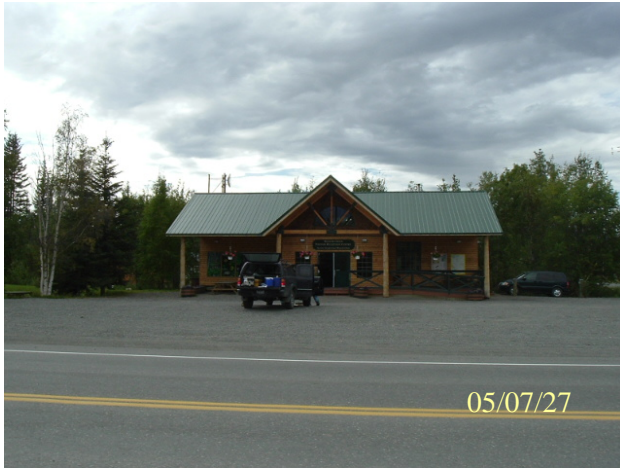
**Photo 0562:** 3121 Beaver Creek Visitor Reception Centre looking east

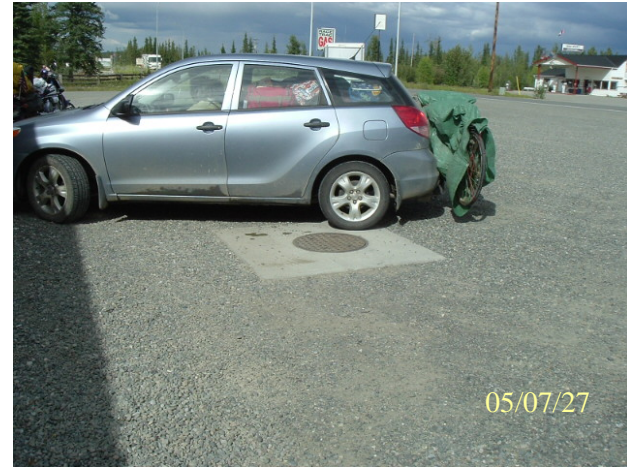
Enclosure covered by heavy manhole, but no lock

located at low point in V.R.L. parking lot

**Photo 0559:** 3121 Wellhead enclosure in parking lot

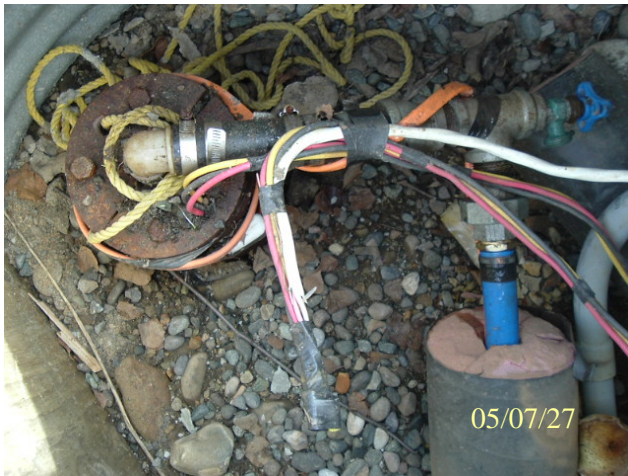
Access possible - mushrooms growing in pit floor

- i. Is the well head below grade? describe in detail ~0.45m below grade
- ii. Are there signs of ponding on the enclosure(e.g. water stains, etc.)? ☒ Yes ☐ No
- iii. Is the wellhead enclosed by fiberglass insulations? ☐ Yes ☒ No
- iv. Any evidence of rodents? Specify No
- v. Does the well casing have a proper seal cap? ☒ Yes ☐ No

If no, describe condition split gasket cap

**Photo 0561:** 3121 Wellhead in pit

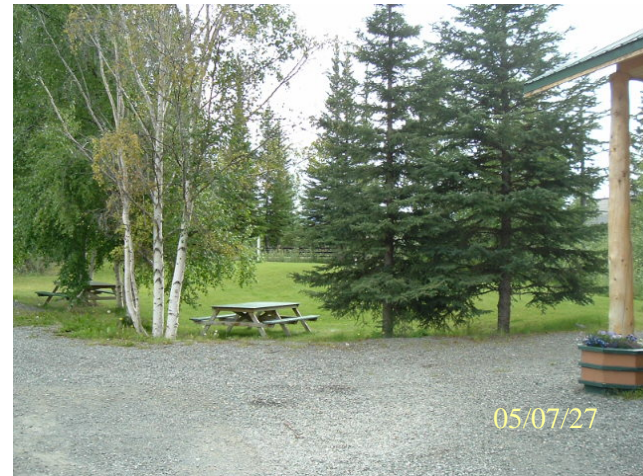
j. Distance from well to nearest point of known field: septic tank @ ~18m, field @ 33m

**Photo 0563:** 3121 Septic field at rear to south of building

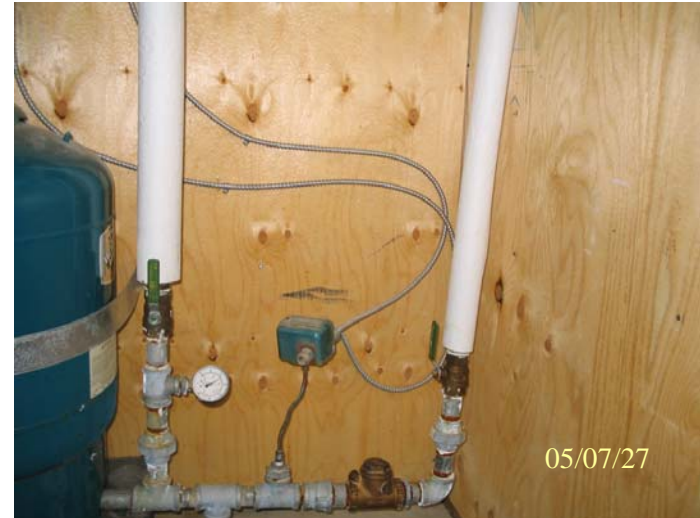
THE PUMP CONTROL SYSTEM DOES NOT MEET CODE.

Photo 0099: 3121 Point of entry and pressure tank

REPIPE THE PUMP CONTROLS WITH MATERIAL
THAT MEETS THE PLUMBING CODE. REPLACE
THE PRESSURE SWITCH - IT DATES BACK TO 1970.
INSTALL TREATMENT IF REQUIRED TO SUIT UV
INSTALLATION. INSTALL UV (NSF55 CERTIFIED)
STERILIZER.
INSTITUTE B. ANNUAL WELL MAINTENANCE PROGRAM
SERVICE UV SYSTEM REGULARLY.
