Western Region – Swimming Pool
Building # 3122

SMALL PUBLIC WATER SYSTEM ASSESSMENT

PART A: EBA Site Inspection

WELL ID #	Owner	Location Description
<u>3122</u>	<u>YTG</u>	<u>Beaver Creek Swimming Pool</u>

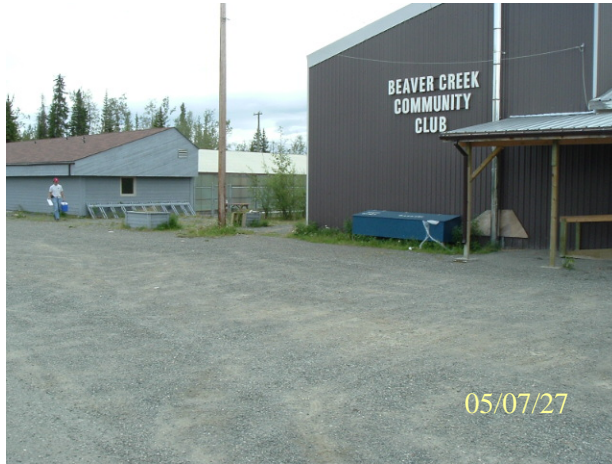
Photo 0538: 3122 Beaver Creek Swimming Pool (left), Beaver Creek Community Club (right)

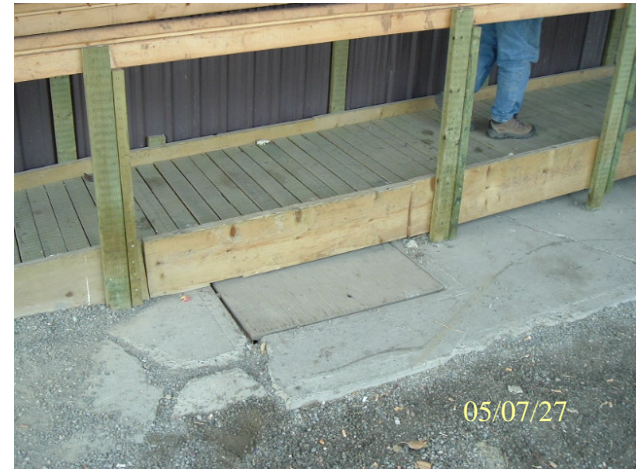
Unauthorized access by humans? ☐ Yes ☒ No
Unlocked enclosure

Entrance by animals? ☐ Yes ☒ No
Access possible

Photo 0537: 3122 Wellhead enclosure under wheelchair ramp

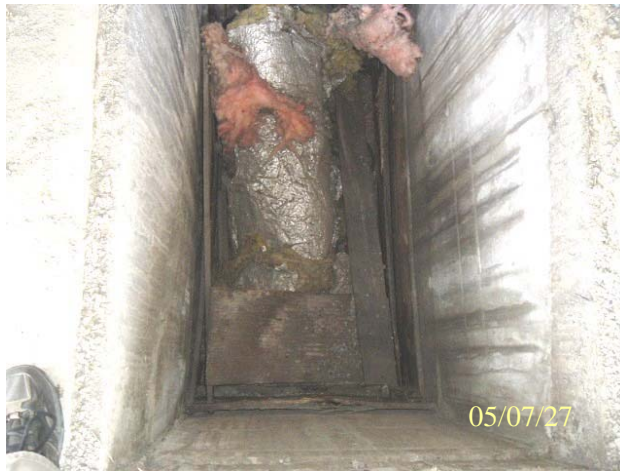
- q. Is the well site well drained? ☐ Yes ☒ No Ground around well is flat - no apparent drainage

- m. Is the well head: ☐ in pumphouse ☒ in pit ☐ pitless adaptor ☐ in a building
Concrete pit with pwf plywood lid
☐ in a wooden enclosure other, describe _____

- i. Is the well head below grade? describe in detail ~1.4 m below grade
- ii. Are there signs of ponding on the enclosure(e.g. water stains, etc.)? ☐ Yes ☒ No
- iii. Is the wellhead enclosed by fiberglass insulations? ☐ Yes ☒ No
- iv. Any evidence of rodents? Specify Access possible
- v. Does the well casing have a proper seal cap? ☐ Yes ☐ No

Photo 0535: 3122 Wellhead in pit

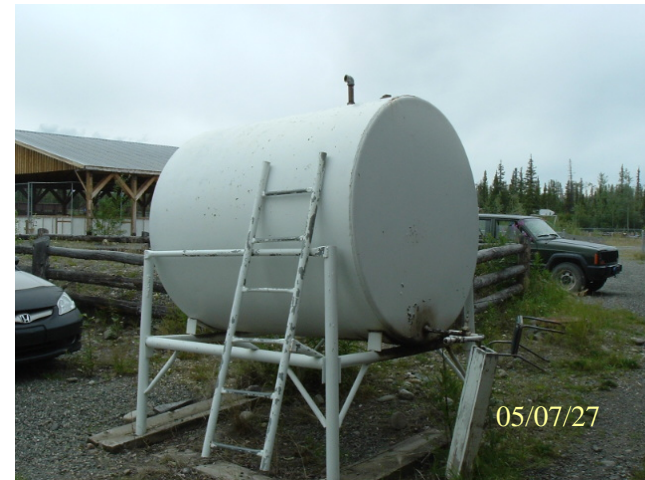
Potential Source 1: AST; Distance from well to Potential Source 1: ~20m

Photo 0539: 3122 Above ground fuel storage tank

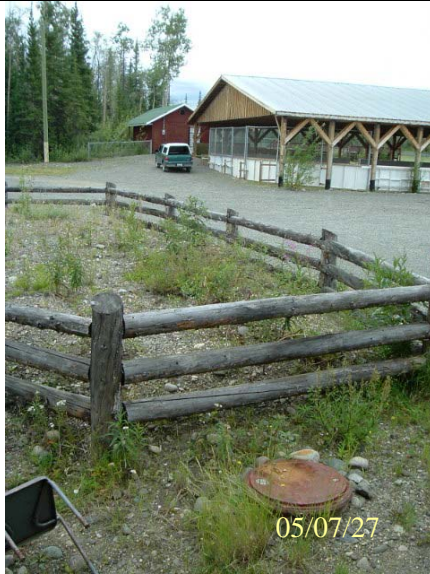
j. Distance from well to nearest point of known field: ~22m (~20m to tank)

- l. Is there any part of a sewage disposal system(s) or other potential sources of pollution that may pose a health and safety risk within 30 m? ☒ Yes ☐ No

**Photo 0540:** 3122 Community Club septic field

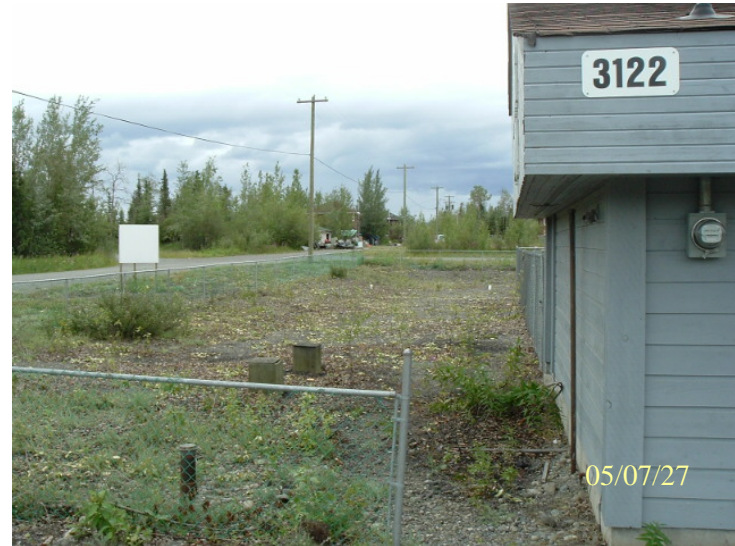
There is also a septic tank and field ~50m from the well

**Photo 0542:** 3122 Swimming pool septic field

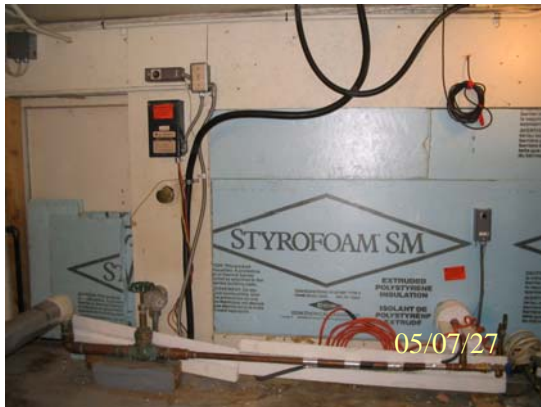
**Photo 0083:** 3122 Point of entry to Community Club

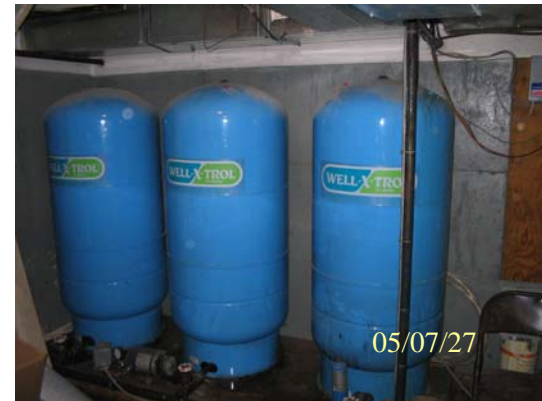
THIS IS A PROFESSIONAL BUT OLD INSTALLATIONS. 2 OF THE TANKS HAVE SLIGHT LEAKS. THE PUMP IS VERY NOISY AND RUNS FOR A LONG TIME. IT IS WORTH NOTING THAT THIS SYSTEM HAD EARLIER BEEN SERVED BY A 2 HP SUB. PUMP. IT NOW HAS ONLY A 3/4 HP PUMP.

**Photo 0087:** 3122 Pressure tanks in crawl space of Community Club

REPAIR THE LEAKS. BRING INSTALLATION BACK UP TO CODE IE INSULATE THE COPPER LINES AS THEY ARE SWEATING ~~HEAVY~~ HEAVY AT THIS POINT. INSTALL TREATMENT AS DETERMINED BY THE WATER ANALYSIS TO SUIT UV TREATMENT. INSTALL APPROPRIATE UV FOR FLOW REQUIREMENT. INSTITUTE AN ANNUAL WELL MAINTENANCE PROGRAM.
