# Western Region – Beaver Creek Air Terminal Building Building # 3125

#### SMALL PUBLIC WATER SYSTEM ASSESSMENT

PAI	RTA: EBA Site Inspect	ion	
	ector: Ryan Martin		Date July 27, 2005
	ı		
	WELL ID#	Owner	Location Description
	3125	Y76	Beaver Creek Airport Terminal Building

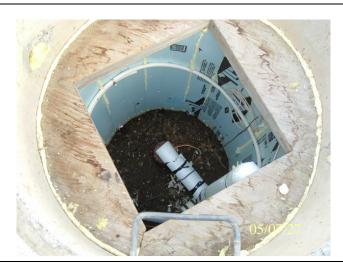
Photo 0531: 3125 Wellhead in pit

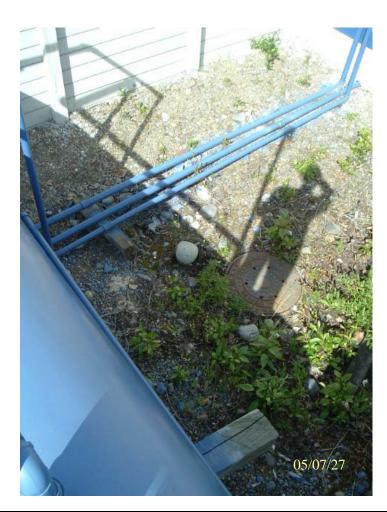
**Photo 0532:** 3125 Manhole to septic system
