**EBA Engineering Consultants Ltd.**

SMALL PUBLIC WATER SYSTEMS ASSESSMENT
WESTERN REGION

BEAVER CREEK HEALTH CENTRE
BUILDING # 3964
SITE LOCATION DIAGRAM
WELL ID: 3964

SMALL PUBLIC WATER SYSTEM ASSESSMENT**PART A: EBA Site Inspection**Inspector: Ryan Martin, Luke LebelDate July 27, 2005

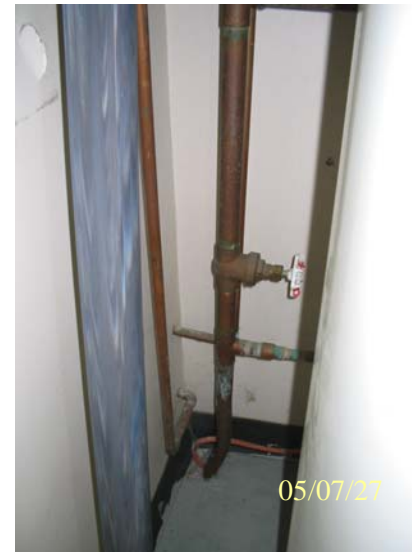
Photo 0079: 3964 Point of entry
