Yukon Highways and Public Works Property Management Branch</div>				TITLE WATER SYSTEM DISTRIBUTION/TREATMENT SCHEMATIC SYSTEM ID.: 3201 BURWASH LANDING AIRPORT					
DATE	SEPT. 2005	DWN.	JSB	CHKD.	FMN	FILE NO.	1260002.003	DWG.:	FIGURE 3201-B

Western Region – Burwash Landing Airport Building
Building # 3201

SMALL PUBLIC WATER SYSTEM ASSESSMENT**PART A: EBA Site Inspection**Inspector: Ryan Martin, Luke LebelDate July 28, 2005

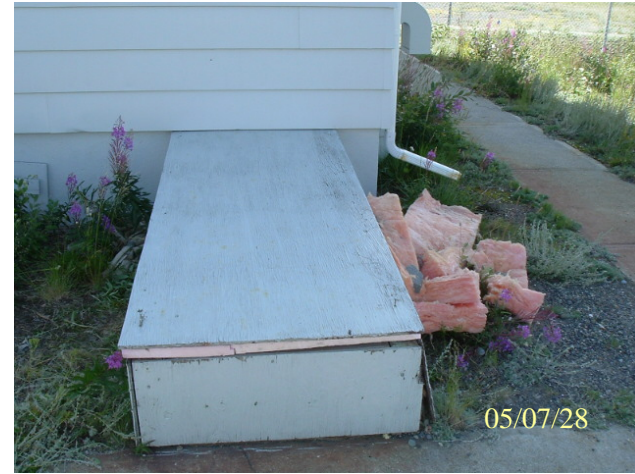
Entrance by animals? ☐ Yes ☒ No
wooden enclosure with mouse droppings present

**Photo 0585:** 3201 Wellhead enclosure

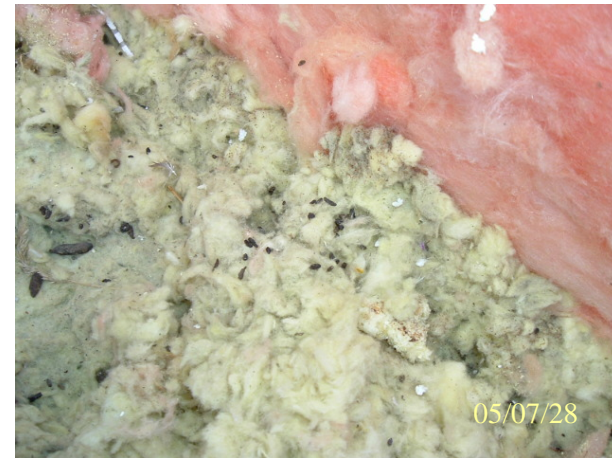
**Photo 0578:** 3201 Insulation around wellhead with evidence of mouse feces

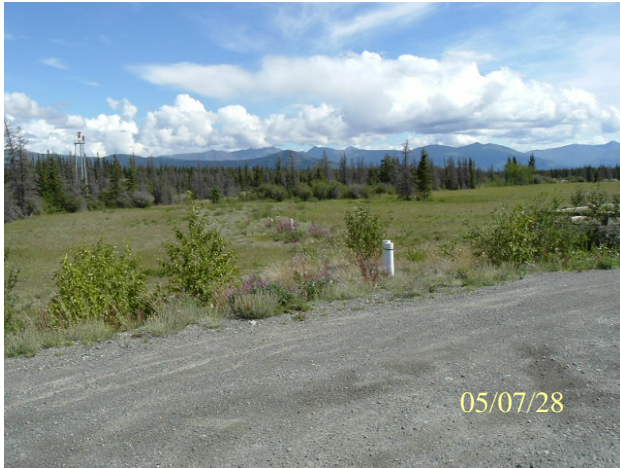
l. Is there any part of a sewage disposal system(s) or other potential sources of pollution that may pose a health and safety risk within 30 m? ☒ Yes ☐ No

**Photo 05980:** 3201 Septic system

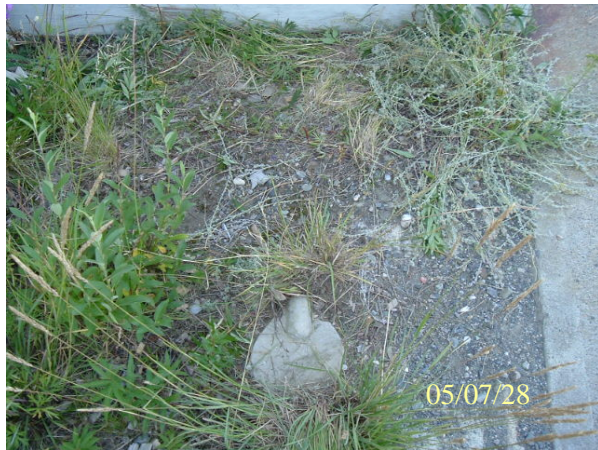
How many? 1 ☐ in use ☒ abandoned ☐ require proper sealing

~1m from existing well

**Photo 0584:** 3201 Abandoned well adjacent to existing well

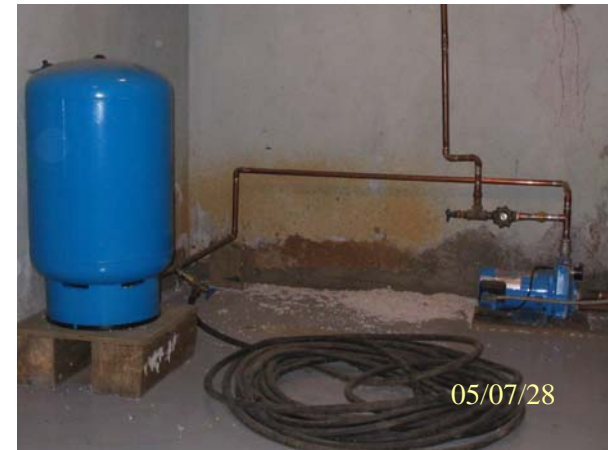
THIS INSTALLATION IS OLD, BUT WORK DONE.
WHEN PUMP NEEDS REPLACING UPGRADE
TO SUB. PUMP SYSTEM

**Photo 0114:** 3201 Pressure tank (left), and jet pump (right)

INSTALL TREATMENT IF REQUIRED BY WATER
ANALYSIS FOR UV PRETREATMENT. INSTALL
5 GPM (NSF 55 CERTIFIED) UV SYSTEM
WITH NECESSARY PRETREATMENT - 1 BIG
BLUE 5 MICRON FILTER.
