SMALL PUBLIC WATER SYSTEMS ASSESSMENT WESTERN REGION	
GOVERNMENT OF YUKON HIGHWAYS & PUBLIC WORKS	
BURWASH LANDING FIRE HALL BUILDING # 3204 SITE LOCATION DIAGRAM WELL ID: 3204	REVISION ISSUE 0
FIGURE No. FIGURE 3204-A

SMALL PUBLIC WATER SYSTEMS ASSESSMENT
WESTERN REGION

SMALL PUBLIC WATER SYSTEM ASSESSMENT**PART A: EBA Site Inspection**Inspector: Ryan Martin, Luke LebelDate July 28, 2005

WELL ID #	Owner	Location Description
3204	YTS	Burwash Fire Hall

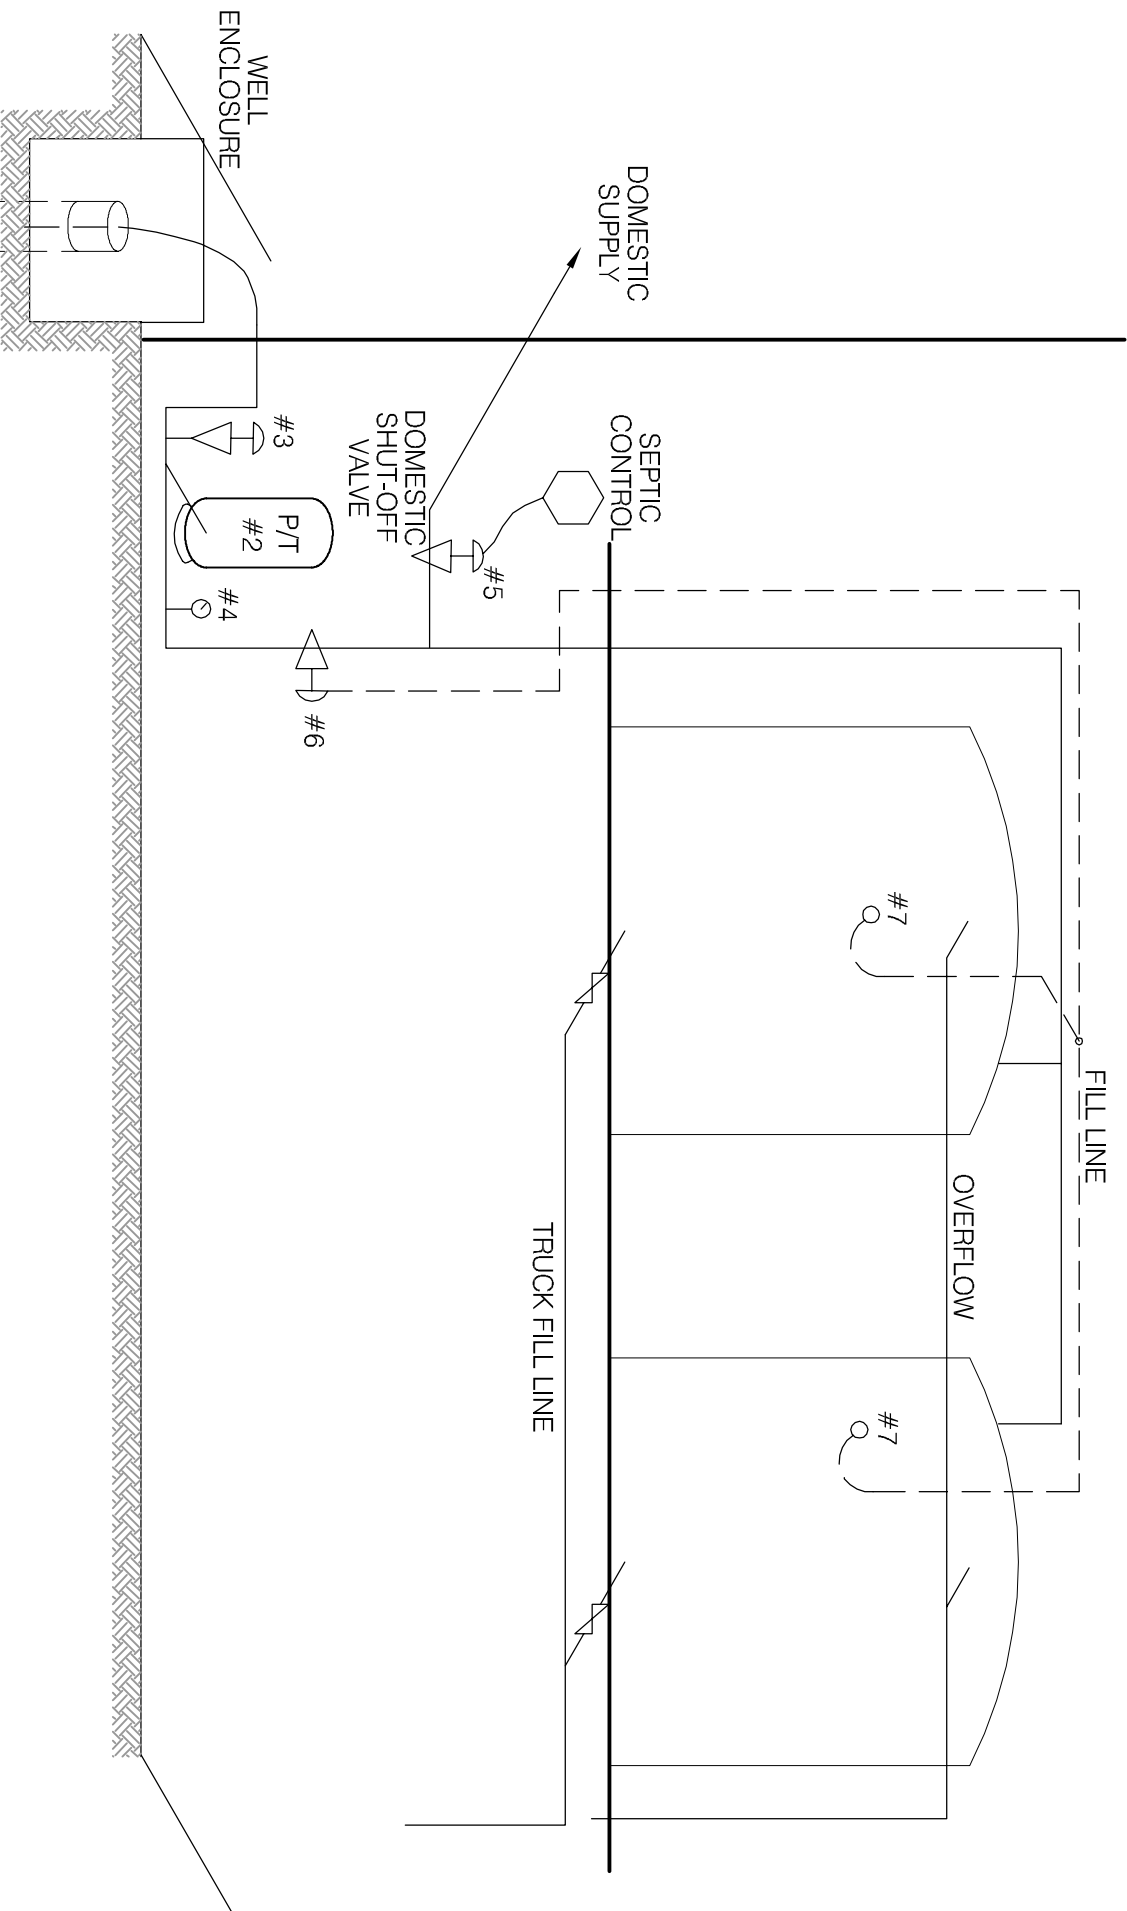
Yukon Highways and Public Works Property Management Branch</div>			TITLE WATER SYSTEM DISTRIBUTION/TREATMENT SCHEMATIC SYSTEM ID.: 3204 BURWASH LANDING FIRE HALL		
DATE SEPT. 2005	DWN. JSB	CHKD. RMM	FILE NO. 1260002.003	DWG.: FIGURE 3204-B

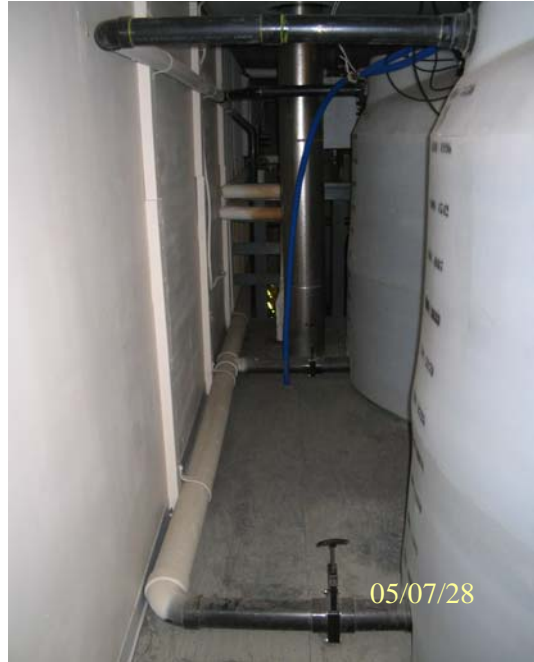
Does the lid have a tight seal and is it watertight when closed? YES (NO)

Are there signs of staining or biofouling? (YES) NO

Is there any sediment or scum in bottom of tank? (YES) NO

Does the tank appear that it has been cleaned recently? YES (NO)

Photo 0585: 3204 Water storage tanks

INSTALL WATER TREATMENT AS REQUIRED BY
WATER ANALYSIS FOR UV PRETREATMENT.
INSTALL UV FOR DOMESTIC WATER SUPPLY
AT ONCE. UV MUST MEET (NSF55 CERTIFICATION)
INITIATE BI ANNUAL WWM MAINTENANCE
PROGRAM.
INITIATE REGULAR CLEANING SCHEDULE
FOR FICE STORAGE TANKS.

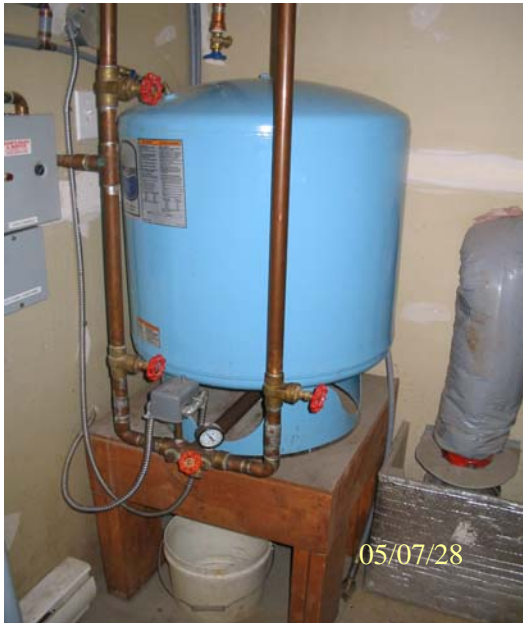
Photo 0577: 3204 Pressure tank.
