SMALL PUBLIC WATER SYSTEMS ASSESSMENT WESTERN REGION	
GOVERNMENT OF YUKON HIGHWAYS & PUBLIC WORKS	
KLUANE LAKE SCHOOL BUILDING # 3171 SITE LOCATION DIAGRAM WELL ID: 3171	REVISION ISSUE 0
FIGURE No. FIGURE 3171-A

SMALL PUBLIC WATER SYSTEM ASSESSMENT

PART A. EBA Site Inspection

WELL ID #	Owner	Location Description
3171	YTG	Kluane Lake School

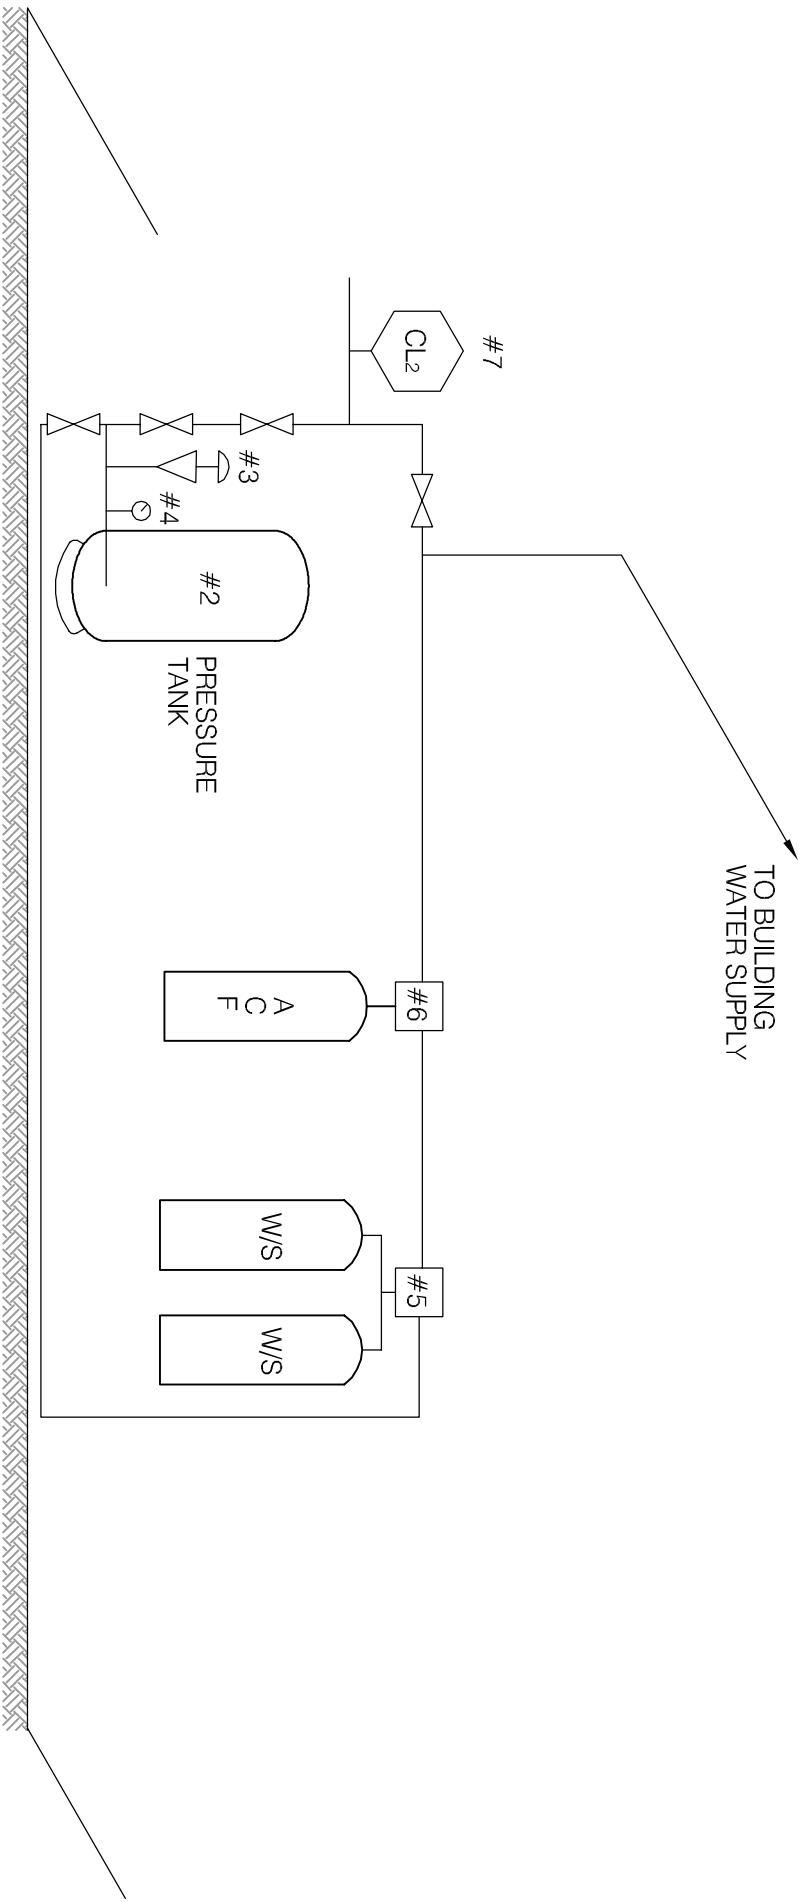
Yukon Highways and Public Works Property Management Branch</div>			TITLE WATER SYSTEM DISTRIBUTION/TREATMENT SCHEMATIC SYSTEM ID.: 3171 KLUANE LAKE SCHOOL		
DATE SEPT. 2005	DWN. JSB	CHKD. RMM	FILE NO. 1260002.003	DWG.: FIGURE 3171-B

THIS INSTALLATION IS SOUND. HOWEVER IF
A CHLORINE RESIDUAL IS DESIRED, CONFIGURATION
CHANGES ARE REQUIRED.

REMOVE PUMP CHLORINATOR - INSTALL
12 GPM (NSF55 CERTIFIED) UV WITH PREFILTER.

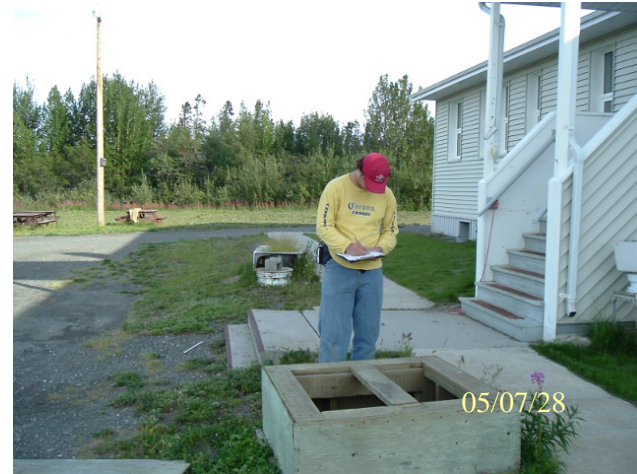
Unauthorized access by humans? ☒ Yes ☐ No Entrance by animals? ☐ Yes ☒ No
fastened shut w/ screws Access possible

- i. Is the well head below grade? describe in detail ~0.65 m below grade
- ii. Are there signs of ponding on the enclosure(e.g. water stains, etc.)? ☐ Yes ☒ No
- iii. Is the wellhead enclosed by fiberglass insulations? ☐ Yes ☒ No styrofoam insulation
- iv. Any evidence of rodents? Specify Access possible
- v. Does the well casing have a proper seal cap? ☒ Yes ☐ No

**Photo 0617:** 3171 Wellhead enclosure

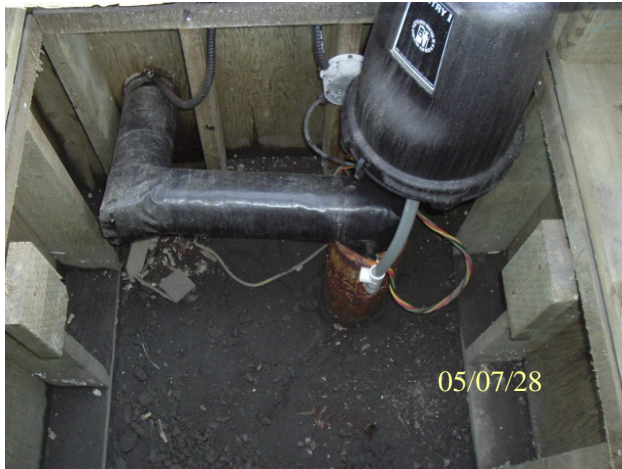
- m. Is the well head: ☐ in pumphouse ☒ in pit ☐ pitless adaptor ☐ in a building
☒ in a wooden enclosure other, describe _____
- n. If the well head is located in a wooden enclosure,

**Photo 0615:** 3171 Wellhead in pit, pellet chlorinator

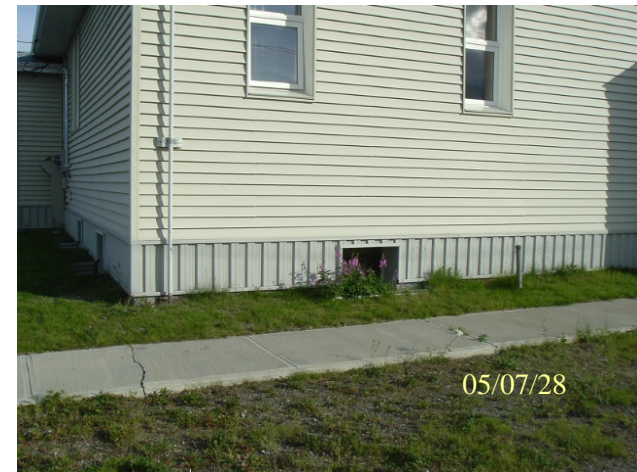
- r. Is there a buried fuel tank on the property? ☒ Yes ☐ No

Distance from the well to known buried tank ~ 9m

**Photo 0616:** 3171 Underground fuel storage tank

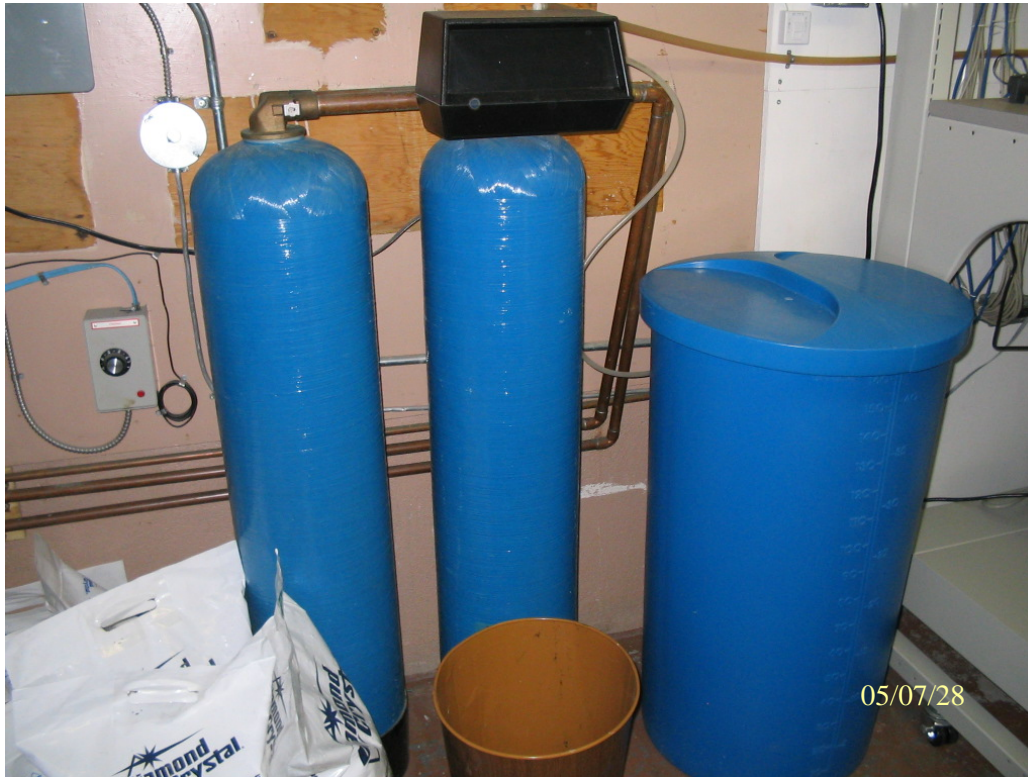
Photo 0124: 3171 Water softener and brine tank

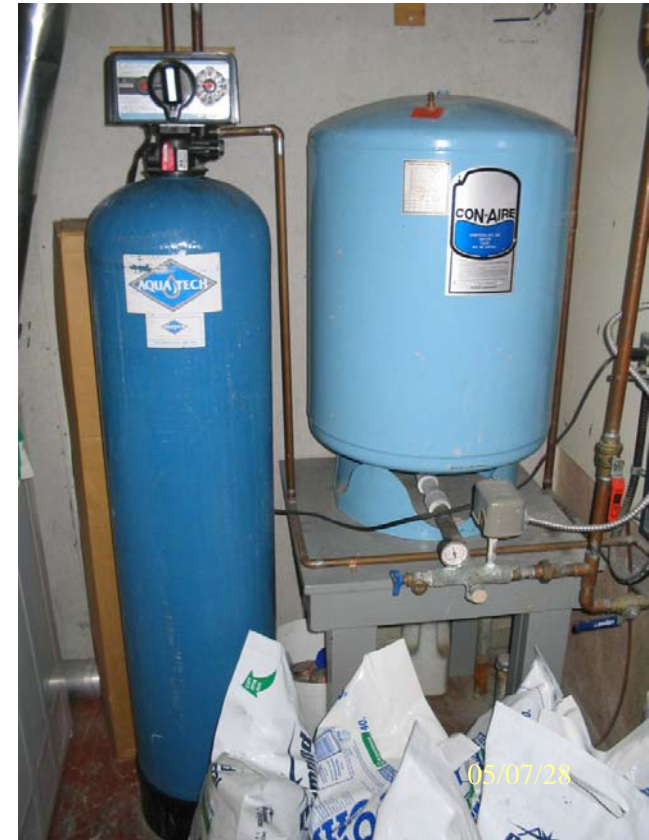
Photo 0123: 3171 Pressure tank (right), activated carbon filter (left)
