SMALL PUBLIC WATER SYSTEMS ASSESSMENT WESTERN REGION	
GOVERNMENT OF YUKON HIGHWAYS & PUBLIC WORKS	
DESTRUCTION BAY FIRE HALL BUILDING # 3172 SITE LOCATION DIAGRAM WELL ID: 3172	
FIGURE No. 0	FIGURE 3172-A

SMALL PUBLIC WATER SYSTEMS ASSESSMENT
WESTERN REGION

SMALL PUBLIC WATER SYSTEM ASSESSMENT

WELL ID #	Owner	Location Description
3172	YTG	Destruction Bay Fire Hall

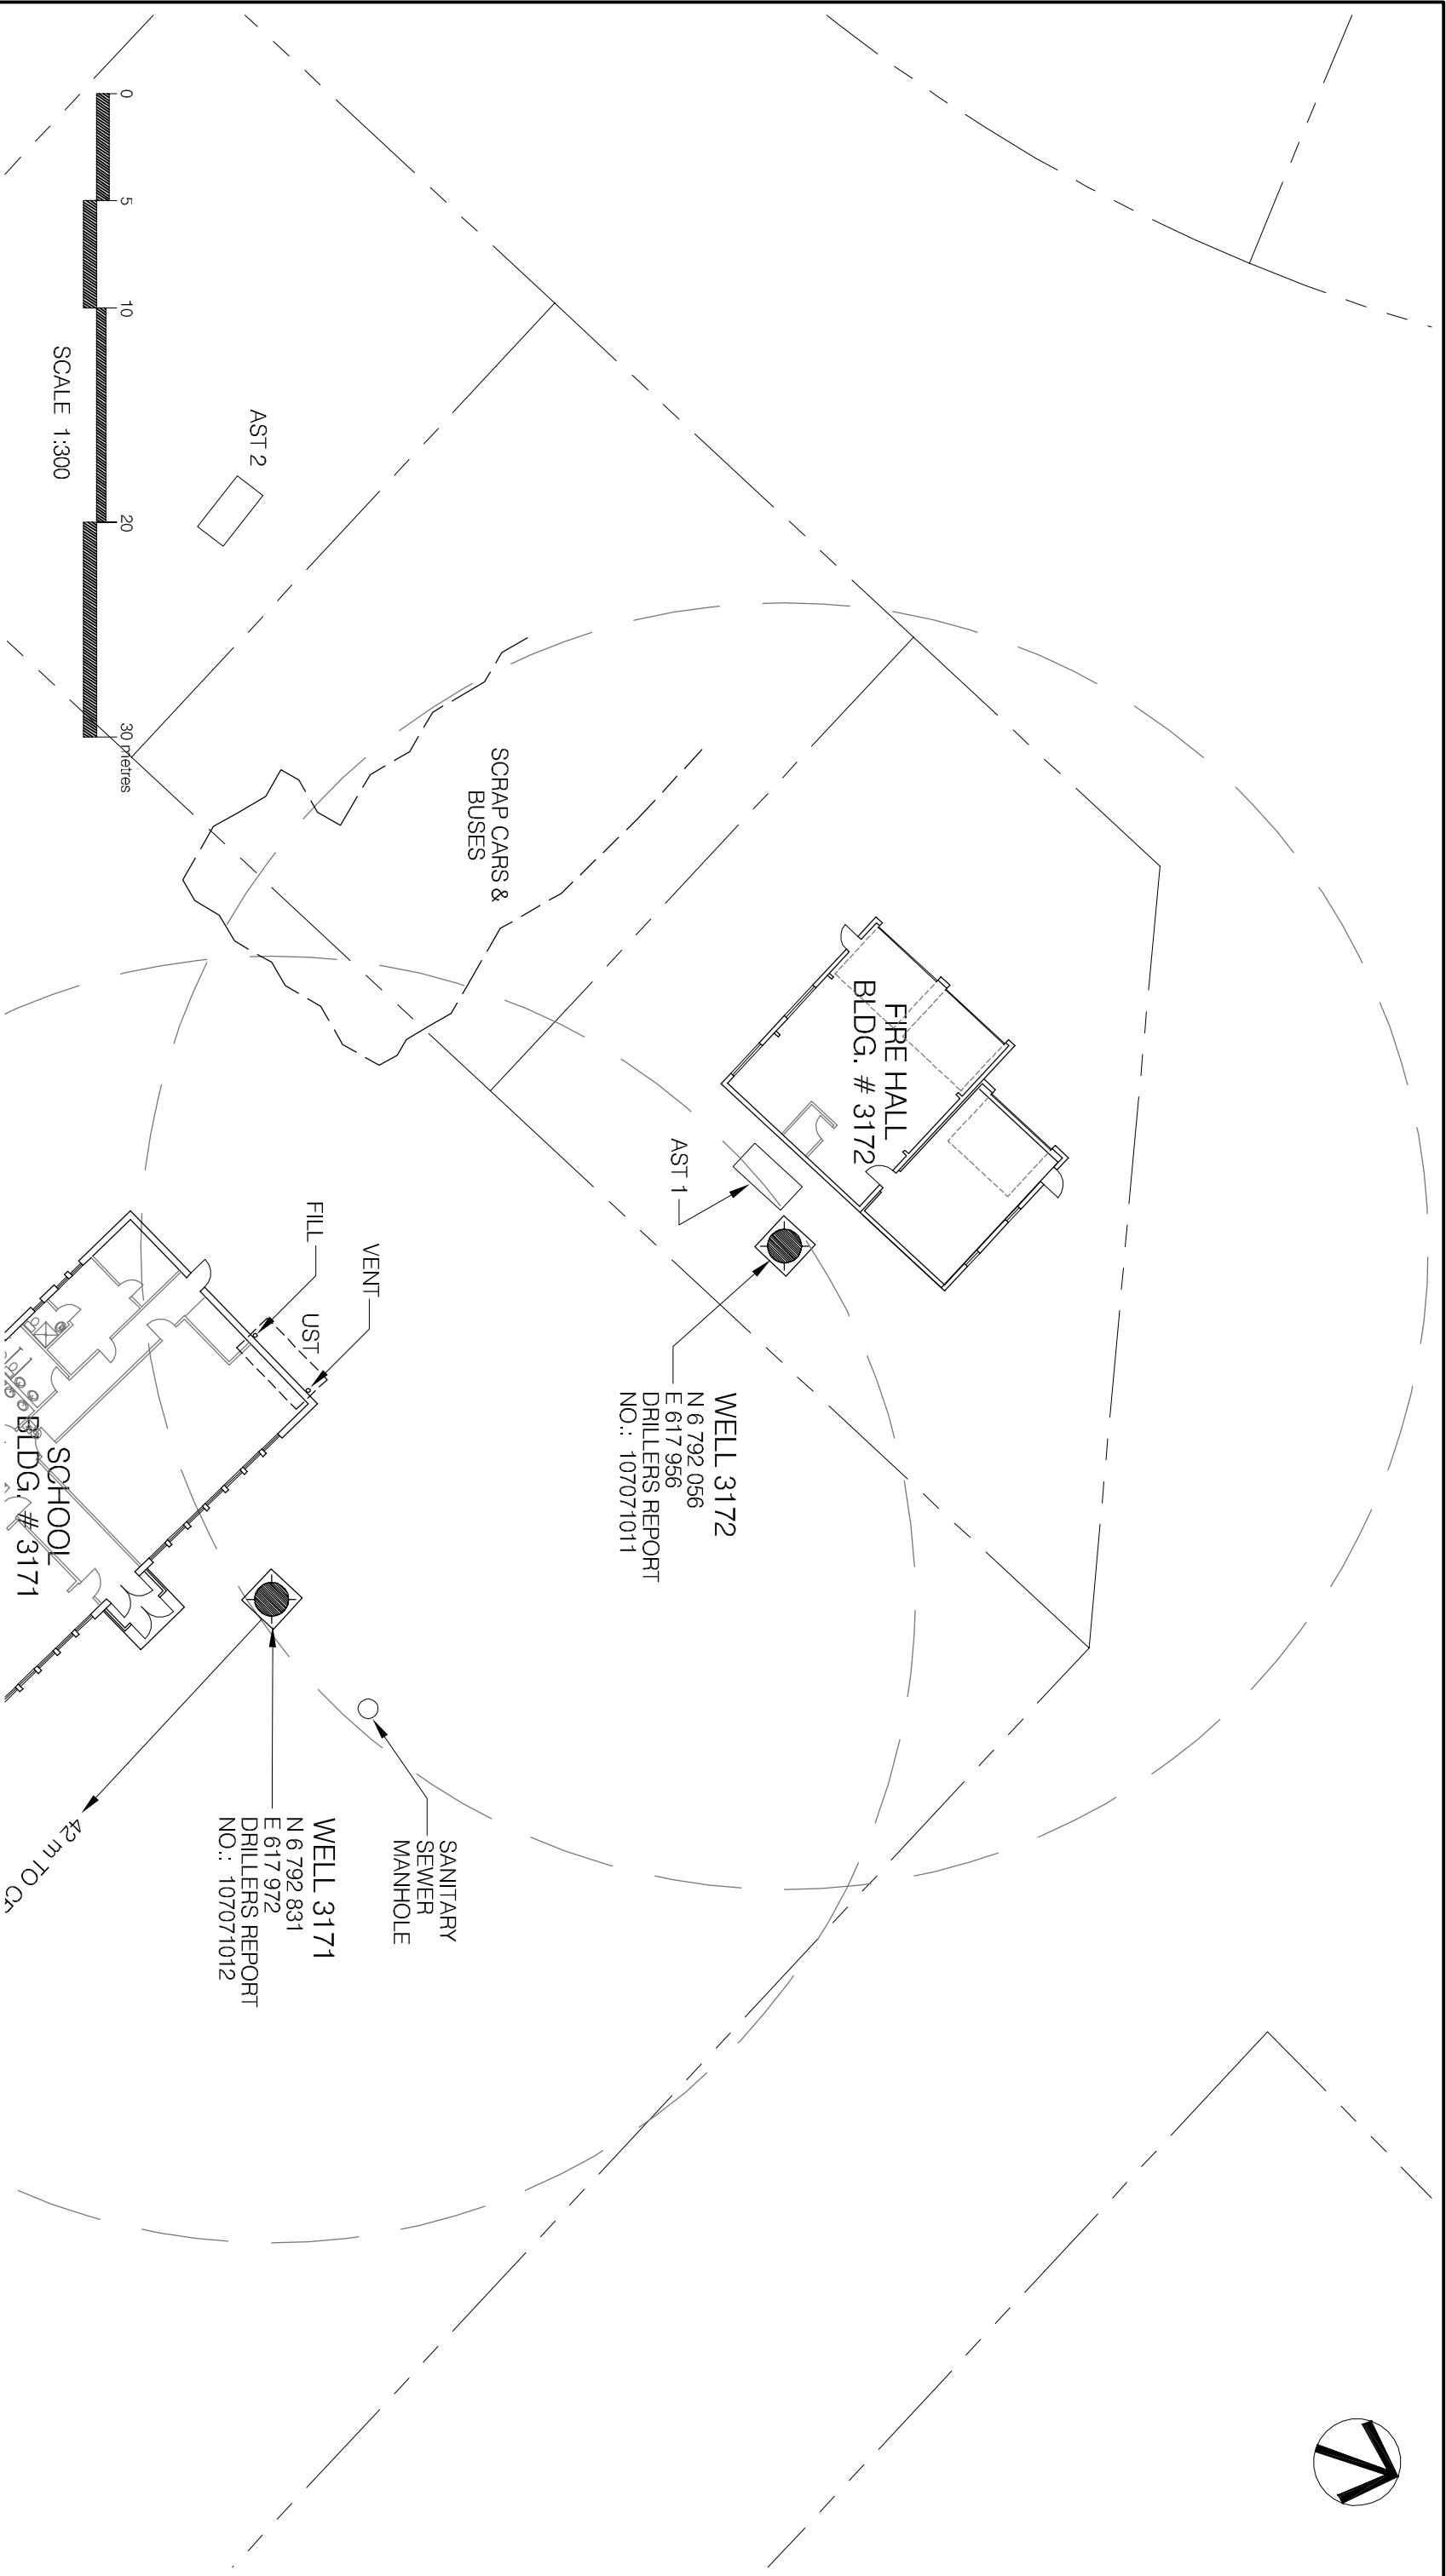
30 m RADIUS FROM WATER WELL FOR CONSIDERATION OF PROXIMITY TO POTENTIAL CONTAMINANT SOURCES.
BUILDING STRUCTURES RELATIVE TO PROPERTY LINES ARE APPROXIMATE ONLY.

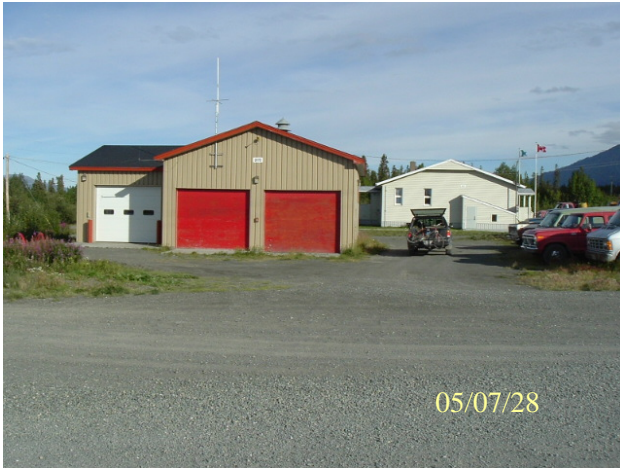
**Photo 0610:** 3172 Destruction Bay Fire Hall

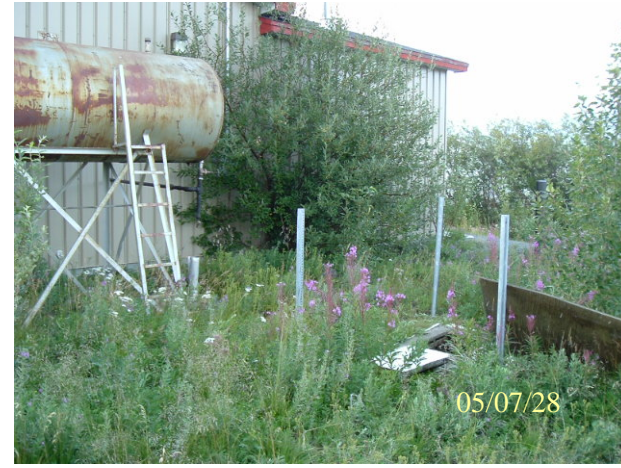
Potential Source 1: AST 1; Distance from well to Potential Source 1: ~ 2 m

Potential Source 3: AST 2; Distance from well to Potential Source 3: 3 m

**Photo 0611:** 3172 Above ground fuel storage tank (left), wellhead enclosure (right)

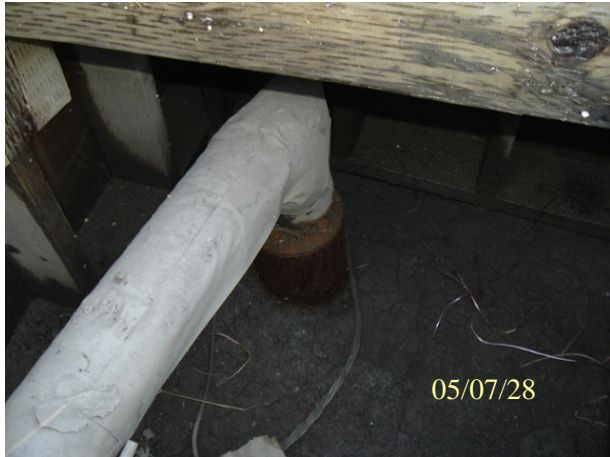
Access possible, Evidence of insects

- i. Is the well head below grade? describe in detail ~ 0.7 m below grade
- ii. Are there signs of ponding on the enclosure(e.g. water stains, etc.)? ☒ Yes ☐ No
- iii. Is the wellhead enclosed by fiberglass insulations? ☐ Yes ☒ No
- iv. Any evidence of rodents? Specify Access possible
- v. Does the well casing have a proper seal cap? ☒ Yes ☐ No
- If no, describe condition split gasket cap

**Photo 0612:** 3172 Wellhead in pit

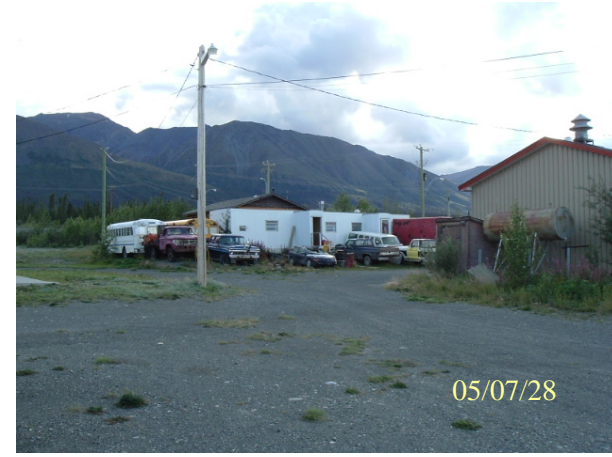
Potential Source 4: Scrap Cars; Distance from well to Potential Source 4: ~ 20 m

**Photo 0613:** 3172 Junk cars (centre), fire hall (right)

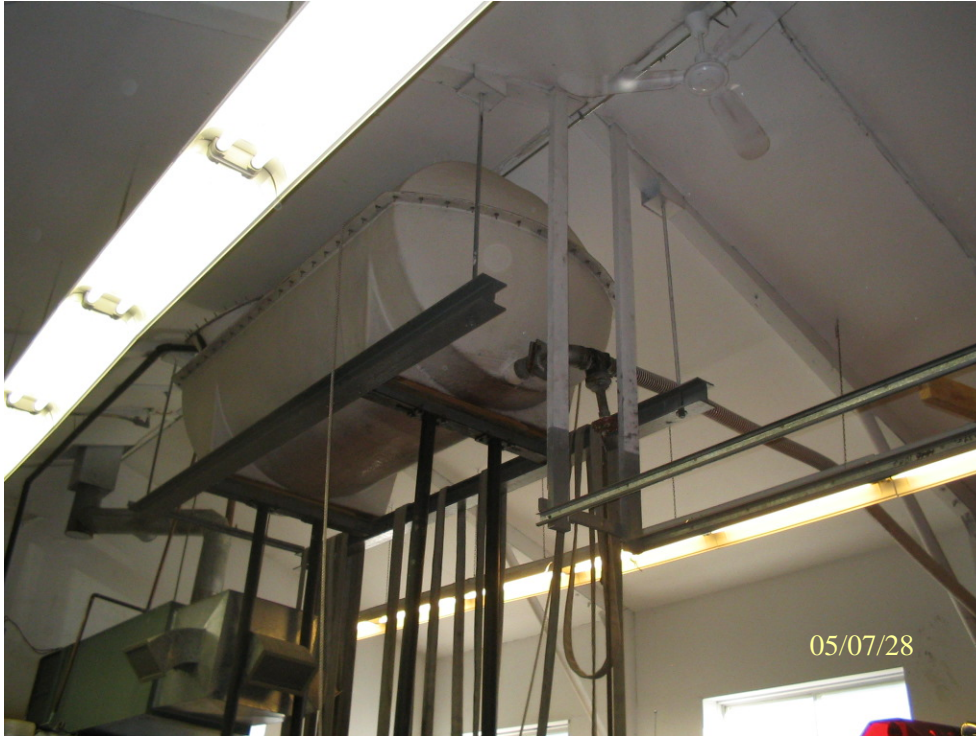
Photo 0122: 3172 Elevated water storage tank

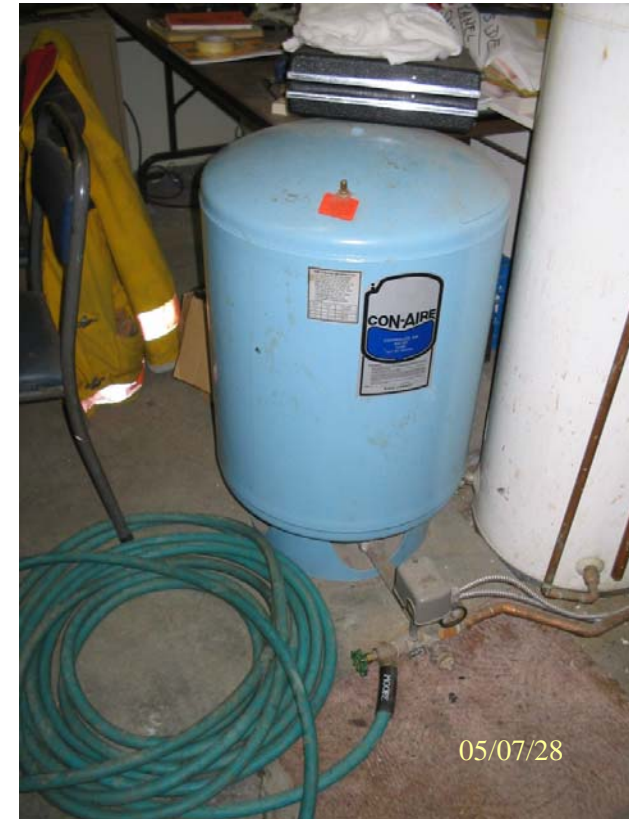
Photo 0119: 3172 Pressure tank
