SMALL PUBLIC WATER SYSTEMS ASSESSMENT WESTERN REGION	GOVERNMENT OF YUKON HIGHWAYS & PUBLIC WORKS
DESTRUCTION BAY GRADER STATION BUILDING # 3186 SITE LOCATION DIAGRAM WELL ID: 3186-C	REVISION ISSUE 0
	FIGURE No. FIGURE 1

Western Region – Destruction Bay Grader Station  
Building # 3186

## SMALL PUBLIC WATER SYSTEM ASSESSMENT

WELL ID #	Owner	Location Description
3186	YTG	Destruction Bay Grader Station

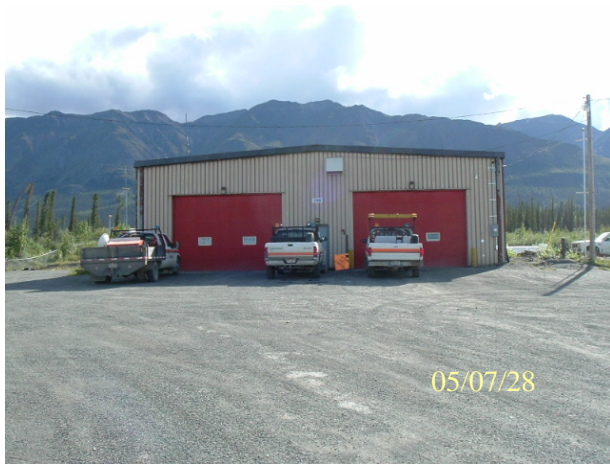
**Photo 0608:** 3186 Destruction Bay Grader Station maintenance garage

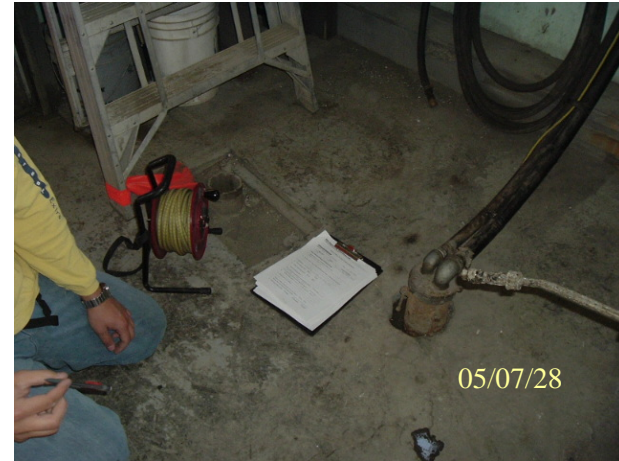
How many? 1 ☐ in use ☒ abandoned ☒ require proper sealing  
~ 0.65 m from existing well

There is a sign in washroom stating "Contaminated water, Do Not Consume"  
It appears that bottled water is provided. There is an abandoned well  
with a static water level of 3.07m below grade,

**Photo 0609:** 3186 Existing well (right) and abandoned well (left)

DRINK A NEW WEL. THIS WEL IS NOT A GOOD  
CANDIDATE FOR IMPROVEMENT

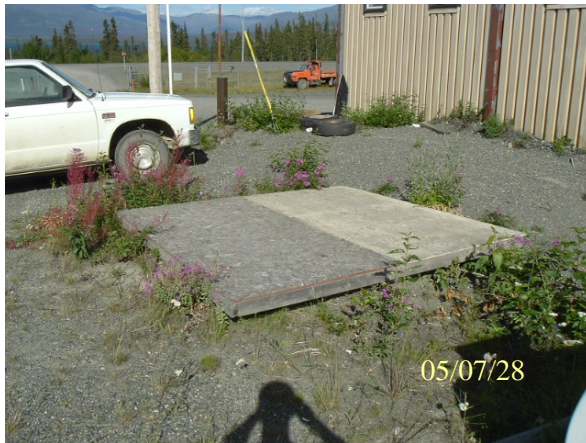
leach pit @ 13m, septic tank @ 23m - effluent field unknown, rock pit @ 17m

**Photo 0601:** 3186 Leach pit

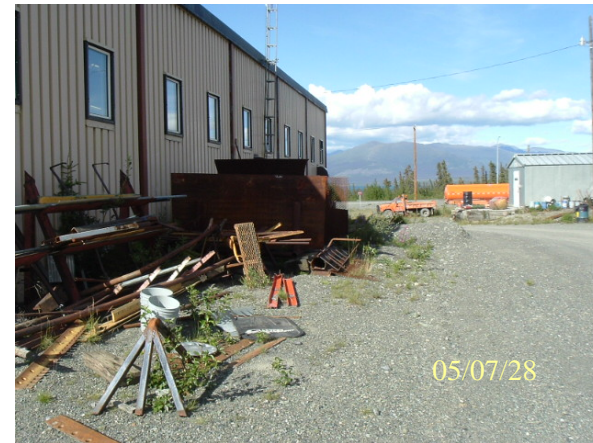
**Photo 0604:** 3186 Scrap metal

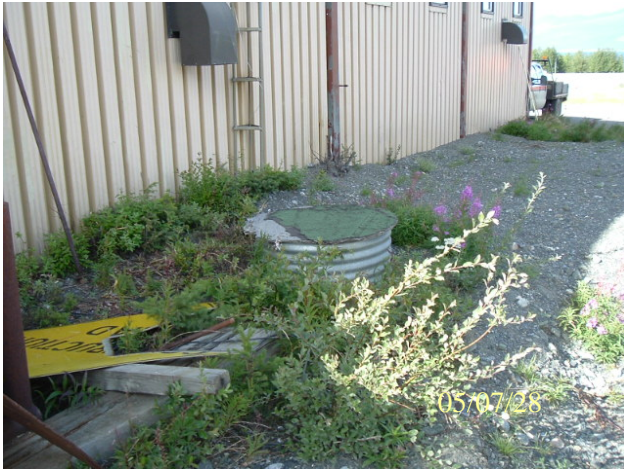
**Photo 0605:** 3186 leach pit

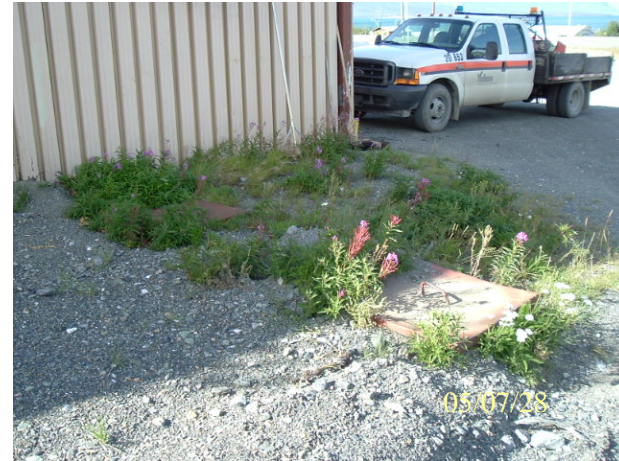
**Photo 0606:** 3186 septic tank

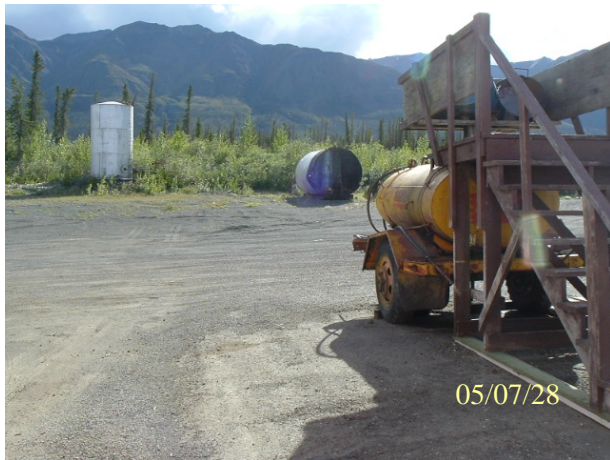
Potential Source 3: Tar tank; Distance from well to Potential Source 3: ~ 45m

**Photo 0599:** 3186 Tar tank

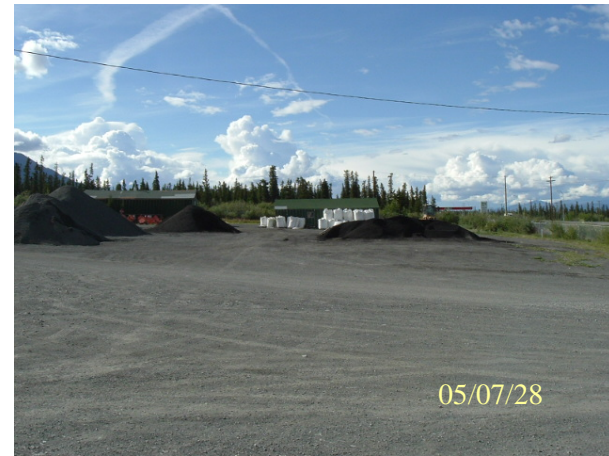
Salt and cold mix storage > 60m; fuel pumping area @ ~ 36m

**Photo 0607:** 3186 Asphalt piles and salt storage
