SMALL PUBLIC WATER SYSTEMS ASSESSMENT
WESTERN REGION

Western Region – Destruction Bay Health Centre
Building # 3957

SMALL PUBLIC WATER SYSTEM ASSESSMENT

PART A: EBA Site Inspection

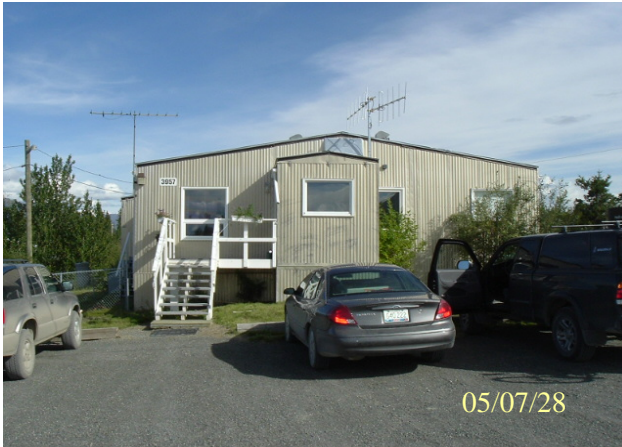
**Photo 0586:** 3957 Destruction Bay Health Centre

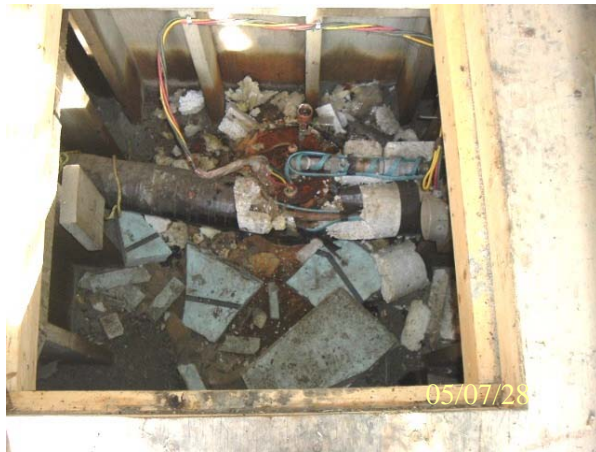
- i. Is the well head below grade? describe in detail ~ 0.35 m below grade
- ii. Are there signs of ponding on the enclosure(e.g. water stains, etc.)? ☒ Yes ☐ No
rust on casing
- iii. Is the wellhead enclosed by fiberglass insulations? ☐ Yes ☒ No styrofoam
- iv. Any evidence of rodents? Specify Mice and Squirrels
- v. Does the well casing have a proper seal cap? ☒ Yes ☐ No

If no, describe condition split gasket cap modified for artesian well

**Photo 0594:** 3957 Wellhead in pit below floor at well house

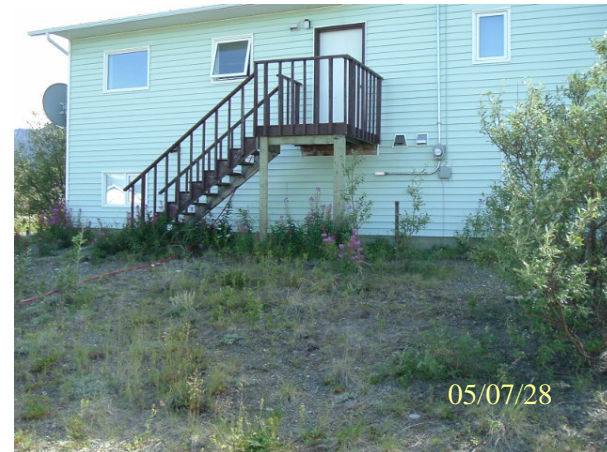
One of the nursing residences is only supplied by a garden hose.

**Photo 0596:** 3957 Nursing residence #2

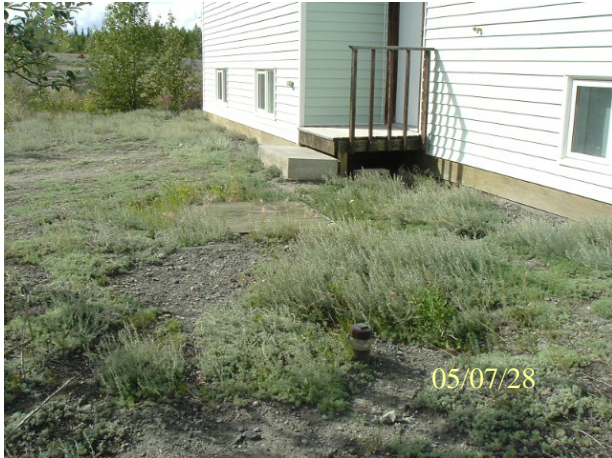
How many? 1 ☐ in use ☒ abandoned ☐ require proper sealing

**Photo 0597:** 3957 Abandoned well nursing residence # 2 (back)

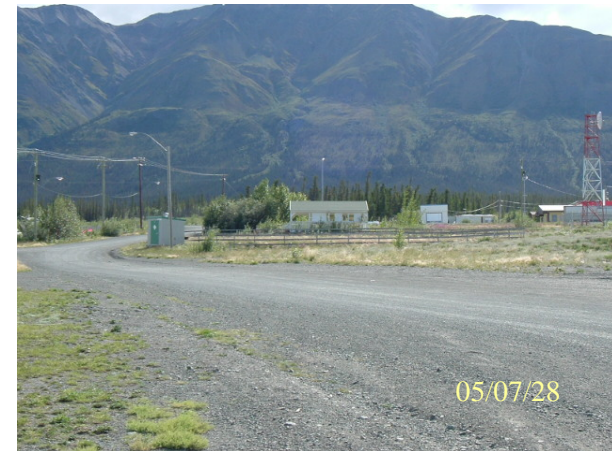
**Photo 0590:** 3957 Destruction Bay community septic system # 2

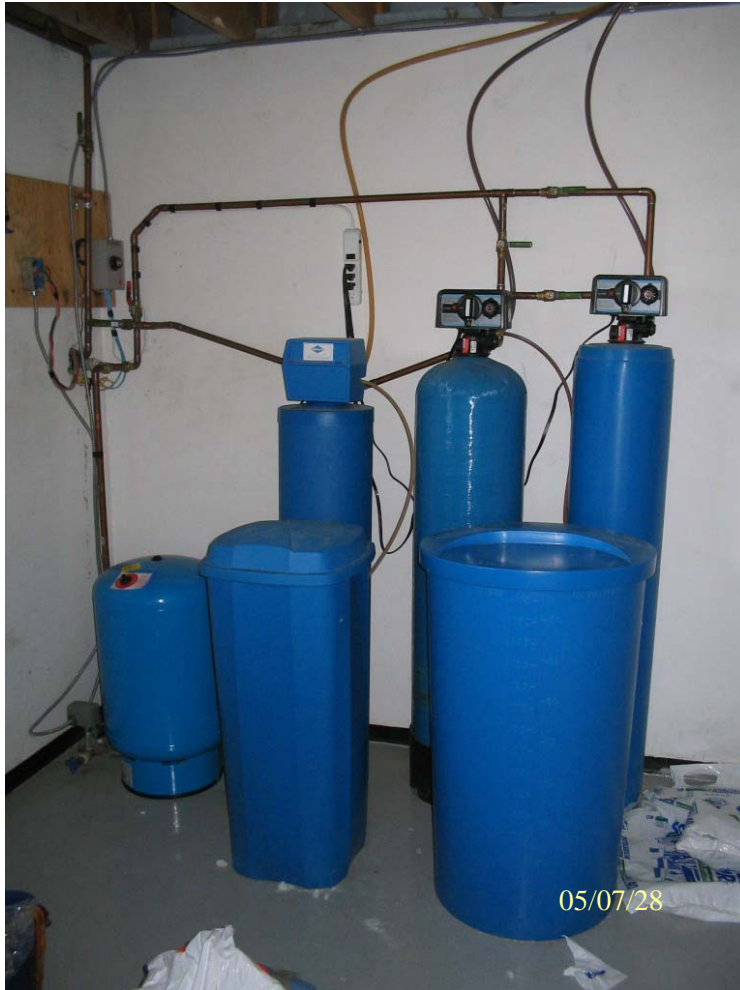
THIS IS A REASONABLY GOOD INSTALLATION WITH THE
FOLLOWING EXCEPTION - FILTER DRAIN LINES HAVE
NO AIR GAP
FILTER TANKS ARE NOT RESTRAINT.

Photo 0116: 3957 (from left to right) Pressure tank, water softener and brine tank, colour remover, neutralizer and brine tank

BRING FILTER INSTALLATION TO CODE.
FILTER SYSTEM REQUIRES FINE TUNING A
NEUTRALIZER IS OVER ADJUSTING THE PH.
FIELD TESTS SHOWED 9.4.
ADD PREFILTER AND UV. SHOCK
CHLORINATE THE COMPLETE SYSTEM.
INSTITUTE BI-ANNUAL WELL MAINTENANCE
PROGRAM.

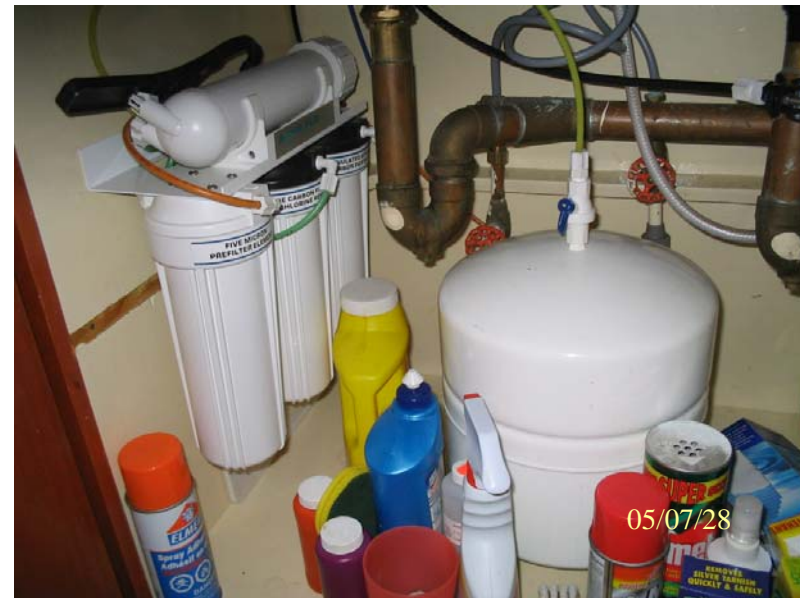
Photo 0118: 3957 Reverse osmosis treatment system for nursing residence
