<b>EBA Engineering Consultants Ltd.</b>			<b>SMALL PUBLIC WATER SYSTEMS ASSESSMENT</b>		
			DESIGNED BY: <u>R. MARTIN</u>			<b>GOVERNMENT OF YUKON</b>		
			DRAWN BY: <u>J. BUYCK</u>			<b>HIGHWAYS &amp; PUBLIC WORKS</b>		
			DATE: <u>AUG. 2005</u>			<b>HAINES JUNCTION INITIAL ATTACK</b>		
			SCALE: <u>AS SHOWN</u>			<b>BASE BUILDING # 3443</b>		
			PROJECT No.: <u>1260002.003</u>			<b>SITE LOCATION DIAGRAM</b>		
			ACAD FILENAME: <u>003-WESTERN REGION</u>			<b>WELL ID: 3443</b>		
REVISION						FIGURE No.		
No.	DESCRIPTION	DATE	APPROVED				REVISION ISSUE	
0	ISSUED FOR CLIENT REVIEW	DD/MM/YY	XXX				0

## SMALL PUBLIC WATER SYSTEM ASSESSMENT

### PART A: EBA Site Inspection

WELL ID #	Owner	Location Description
3443	YTG	Haines Jct Initial Attack Base

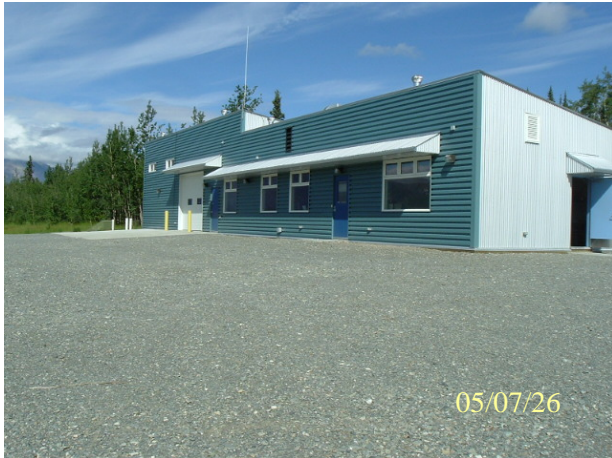
**Photo 0497:** 3443 Haines Junction Initial Attack Base

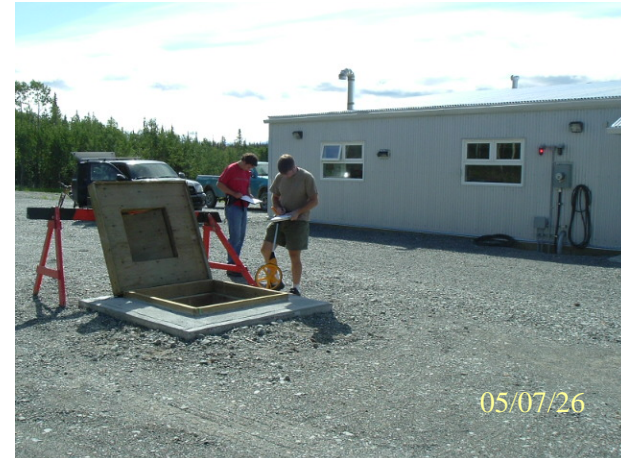
WATER STORAGE TANK IS SUBJECT TO CONTAMINATION AS LIP IS INSIDE PWF ENCLOSURE THAT MAY FLOOD. PERSONNEL ON SITE BELIEVE THAT MANHOLE EXTENSION IS NOT SEALED PROPERLY. IF TANK IS OVERFILLED WATER ESCAPES THROUGH THE JOINT AND RETURNS FROM THE GROUND WHEN WATER LEVEL RECESSES IN TANK CARRYING DIRT WITH IT.

**Photo 0506:** 3443 Top of underground water storage tank enclosure

ABANDON U/G TANK - INSTALL ABOVE GROUND TANK IN BUILDING ATTACHED TO COMPLEX. ASSURE DELIVERED WATER HAS AT LEAST 5 PPM FREE CHLORINE WHEN DELIVERED. MONITOR RESIDUAL FREE CHLORINE AT REGULAR INTERVALS.

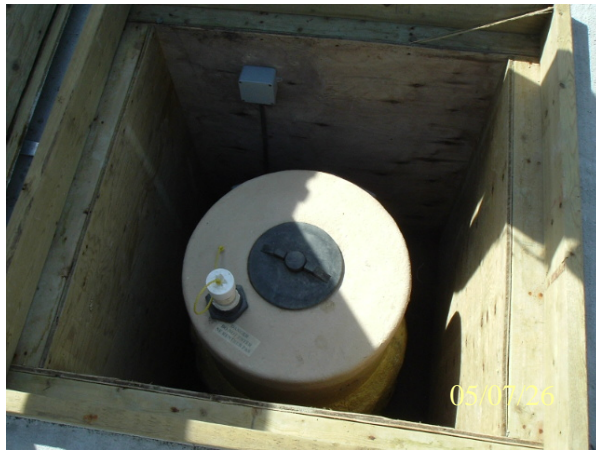
This system is on water delivery. The water storage tank is  
outside and underground. The seal between the manhole and  
the tank has reportedly not been installed properly and when  
water is filled too high soil and dirt can leach in.

**Photo 0505:** 3443 Underground water storage tank

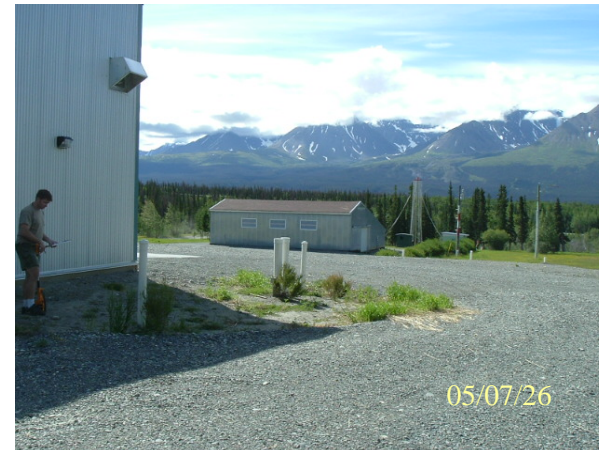
j. Distance from <sup>water storage tank</sup> well to nearest point of known field: ~ 28m

**Photo 0501:** 3443 Septic tank and field

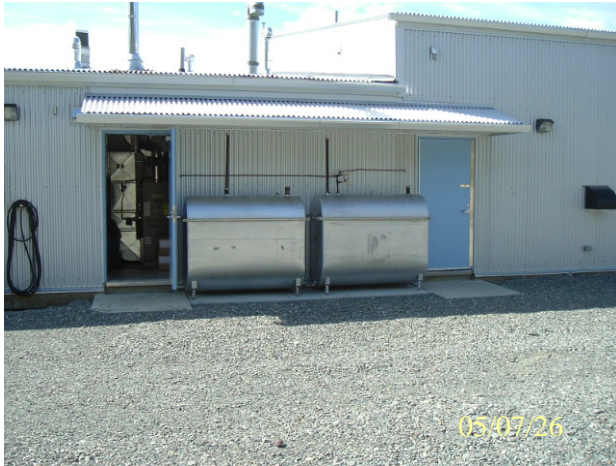
Potential Source 1: AST (2); Distance from well to Potential Source 1: ~10 m

**Photo 0504:** 3443 Above ground fuel storage tanks

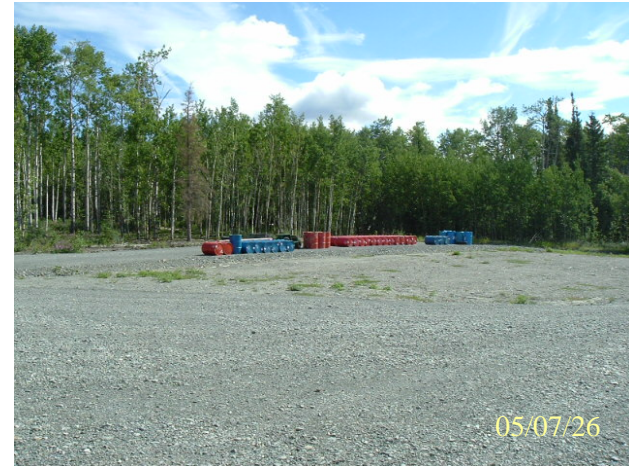
Potential Source 2: Av gas Drums; Distance from well to Potential Source 2: ~50 m

**Photo 0500:** 3443 Aviation fuel drums

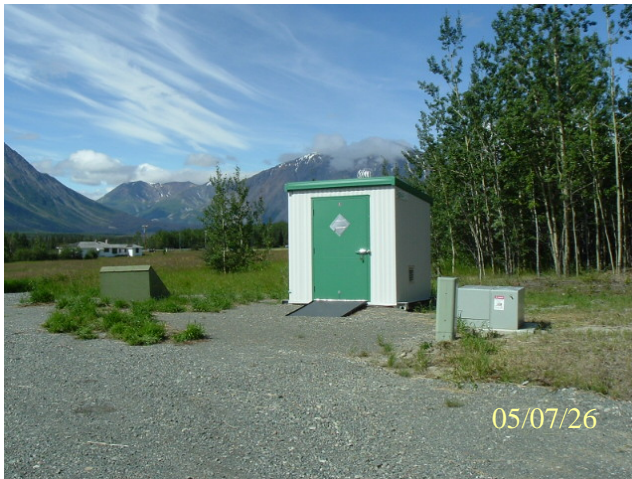
**Photo 0502:** 3443 Chemical storage

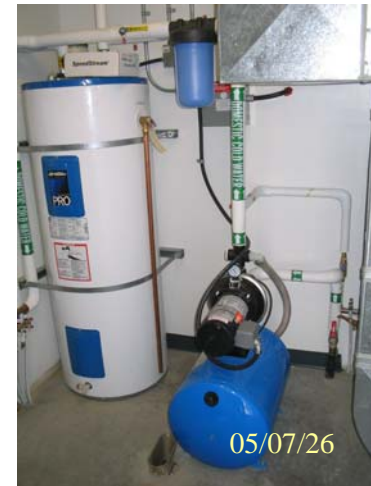
**Photo 0067:** 3443 Jet pump and pressure tank (centre), water heater (left)

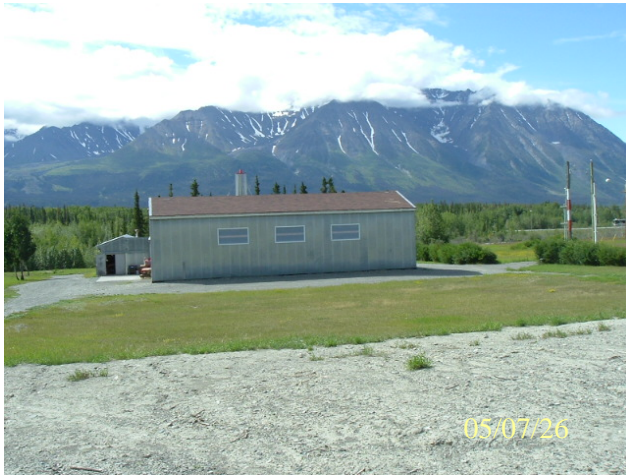
**Photo 0510:** 3443 Warehouse

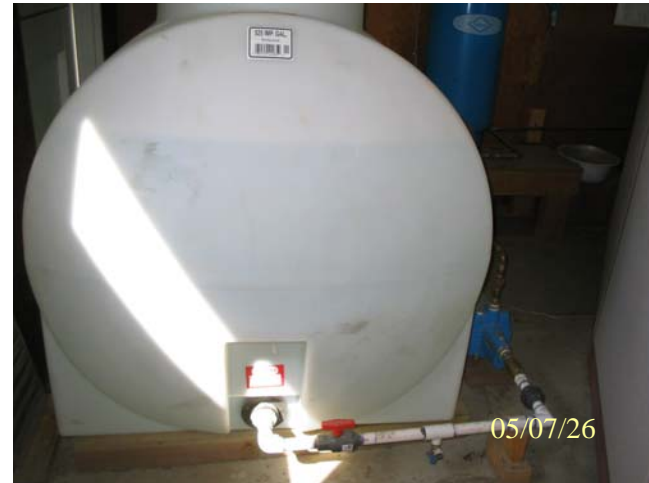
WITH THE EXCEPTION OF THE FILL & VENT PIPE  
OF ABS MATERIAL AND NO OVERFLOW PIPING  
THE INSTALLATION IS ACCEPTABLE.

**Photo 0069:** 3443 Warehouse water storage tank

CHANGE FILL & VENT PIPE TO PVC. INSTALL  
PROPER OVERFLOW PIPING.  
TEST FREE CHLORINE RESIDUAL ON A  
REGULAR BASIS.

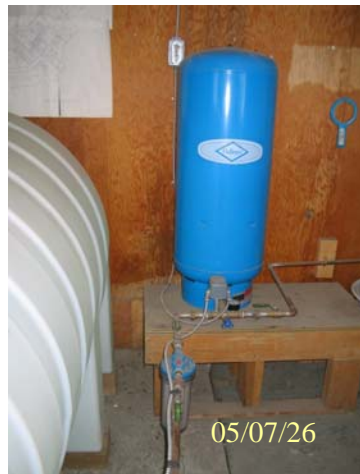
**Photo 0071:** 3443 Warehouse pressure tank

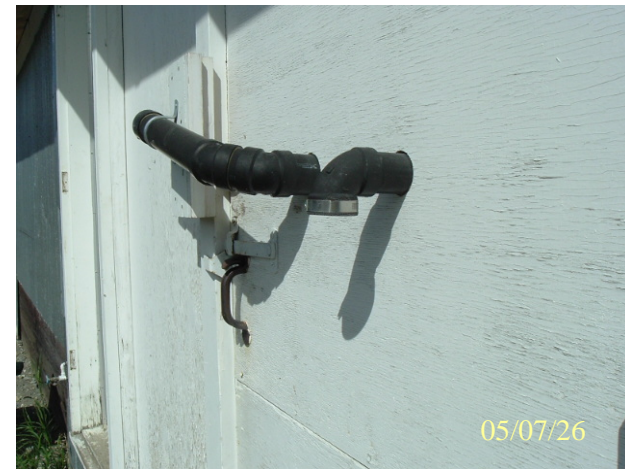
Comments: FULLER PIPE ABS

**Photo 0511:** 3443 Warehouse ABS fill pipe
