SMALL PUBLIC WATER SYSTEMS ASSESSMENT WESTERN REGION	
GOVERNMENT OF YUKON HIGHWAYS & PUBLIC WORKS	REVISION ISSUE
BEAVER CREEK RCMP DETACHMENT BUILDING # M0131 SITE LOCATION DIAGRAM WELL ID: M0131	0
FIGURE No.	FIGURE M0131-A

SMALL PUBLIC WATER SYSTEMS ASSESSMENT
WESTERN REGION

SMALL PUBLIC WATER SYSTEM ASSESSMENT

PART A: EBA Site Inspection

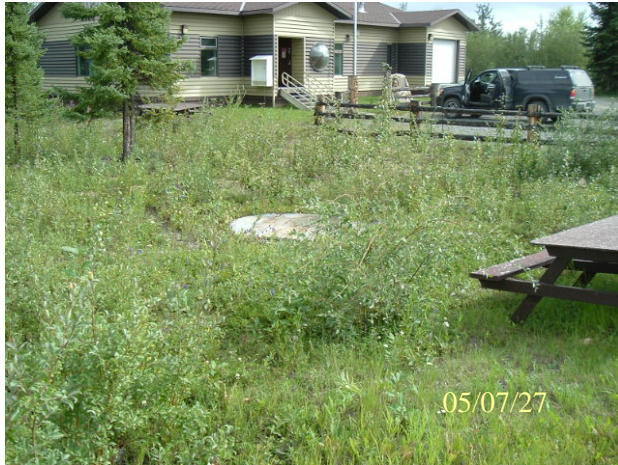
Unauthorized access by humans? ☐ Yes ☒ No Entrance by animals? ☒ Yes ☐ No
unlocked enclosure

Photo 0553: M0131 Beaver Creek RCMP Detachment (rear), wellhead enclosure (front)

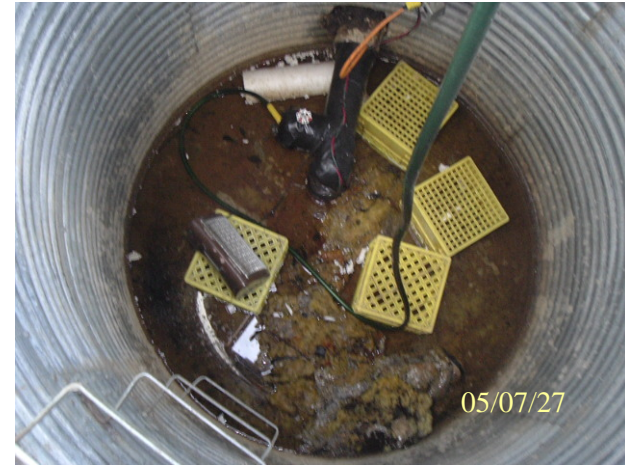
- q. Is the well site well drained? ☐ Yes ☒ No low point on property

- i. Is the well head below grade? describe in detail ~ 2.7 m below grade
- ii. Are there signs of ponding on the enclosure(e.g. water stains, etc.)? ☒ Yes ☐ No
flooding at bottom of pit (~5cm)
- iii. Is the wellhead enclosed by fiberglass insulations? ☐ Yes ☒ No
- iv. Any evidence of rodents? Specify No
- v. Does the well casing have a proper seal cap? ☒ Yes ☐ No
If no, describe condition likely, but could not be seen due to insulation

Photo 0551: M0131 Wellhead in pit

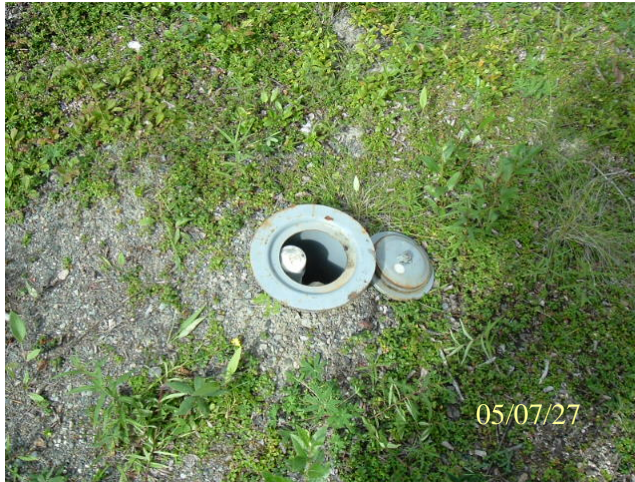
How many? 1 ☐ in use ☐ abandoned ☐ require proper sealing
monitoring well

Photo 0554: M0131 Monitoring well

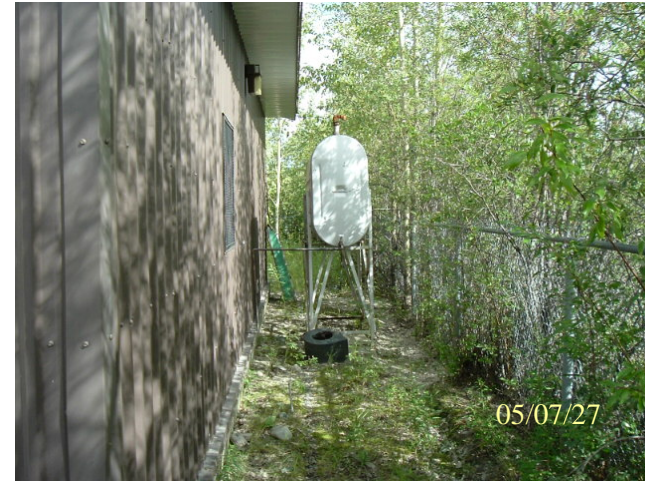
Potential Source 1: AST 1+2; Distance from well to Potential Source 1: ~37m

Photo 0557: M0131 Above ground fuel storage tank

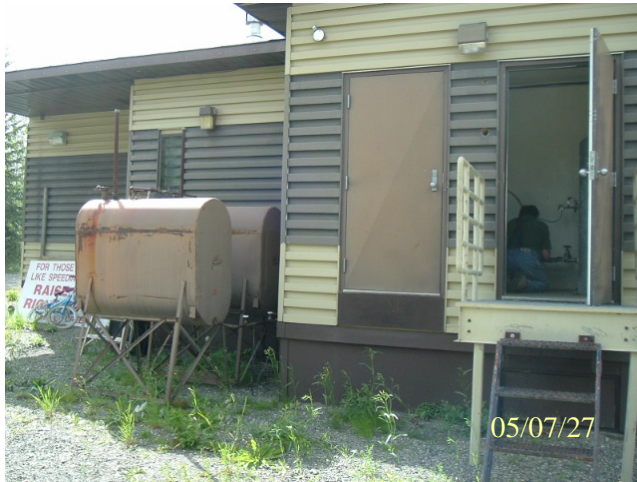
YES ☒ NO ☐
Comments: TEMPORARY HEATER IN PLACE

Photo 0556: M0131 Above ground fuel storage tanks (left), maintenance room containing water system equipment (right)

INSTALL PERMANENT HEAT SOURCE IN ROOM.

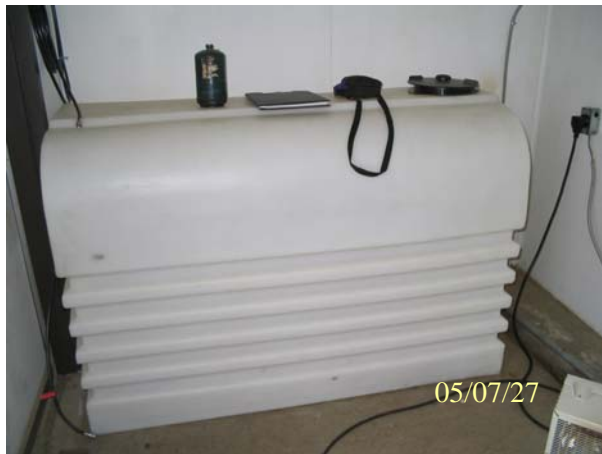
Photo 0097: M0131 Water storage tank

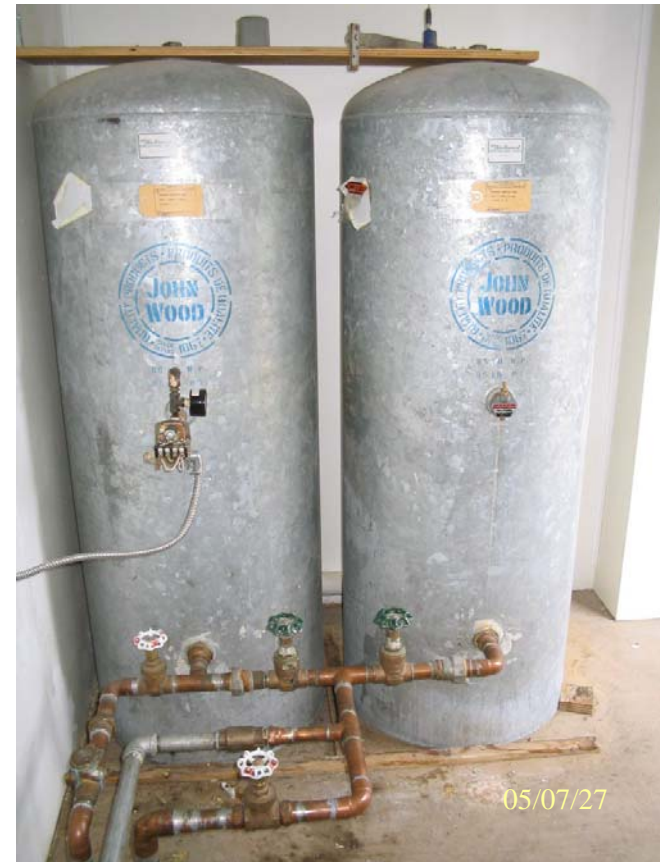
THIS INSTALLATION DOES NOT MEET CODE.

Photo 0095: M0131 Pressure tanks

REPIPE PRESSURE TANKS. REPLACE WITH
PROPER BLADDER TANKS.
